Damp Inspection

In respect of:

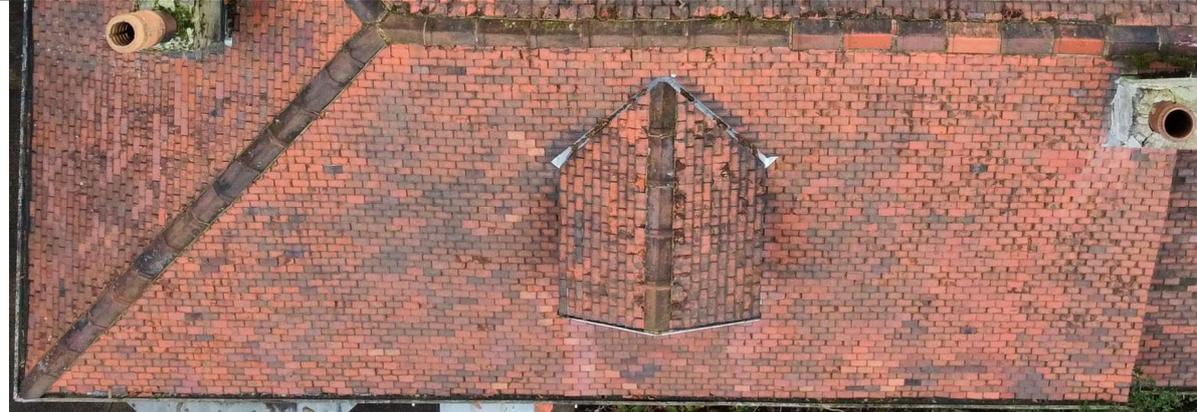
Hip and ridge pointing – this is coming away in places along the length of the hip and ridge. The defective pointing needs to be removed and replaced, preferably with a hot lime-based mix to maintain flexibility.

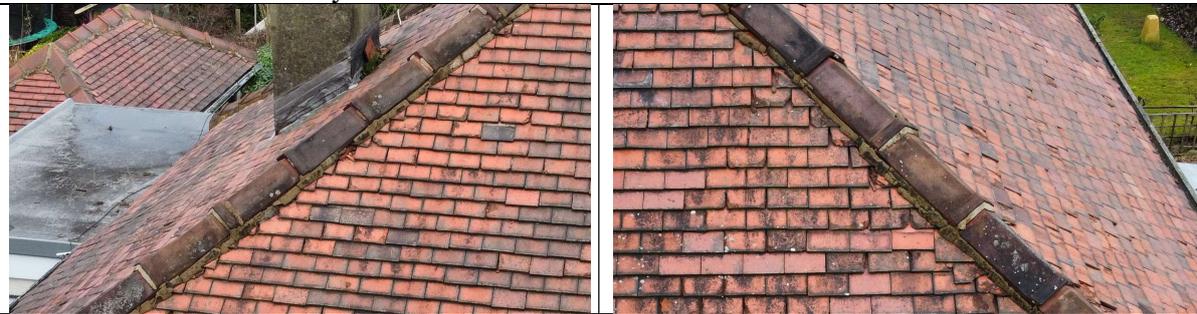
Dormer window – the roof covering is in poor condition, pointing is missing from the ridge and the valleys are becoming blocked with debris.

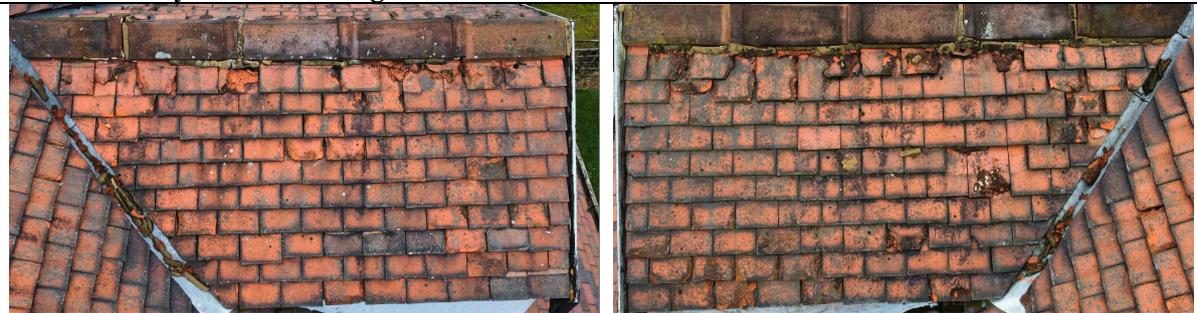
The timber around the front of the dormer window is saturated and looks to be starting to decay.

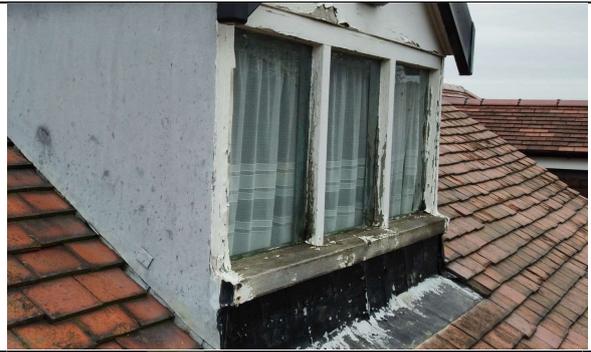
The fascia is beginning to rot and needs replacing.

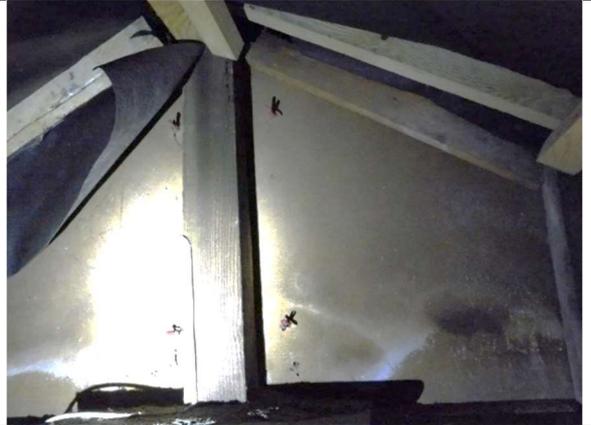
Moss is building up on the inside of the window in the roofspace. This demonstrates the prolonged period of time that the timber has been saturated.

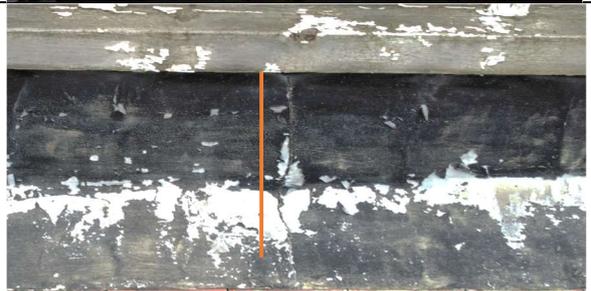
This should be replaced as soon as possible. Two sections of lead should be used.

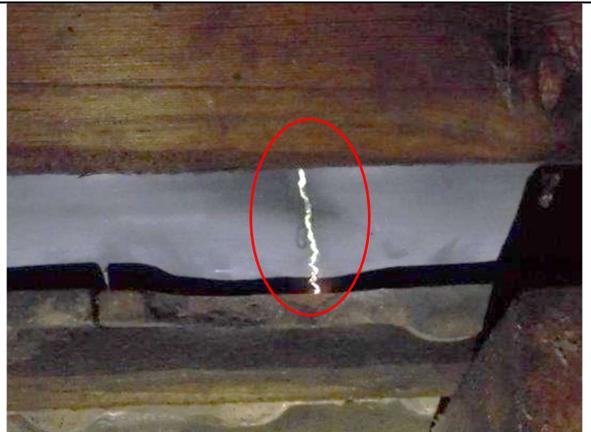
The bay window roof covering is at the end of its useful life. Detailing between pieces and where it is detailed to the wall is poor and areas look to have been overcoated with bituminous paint.

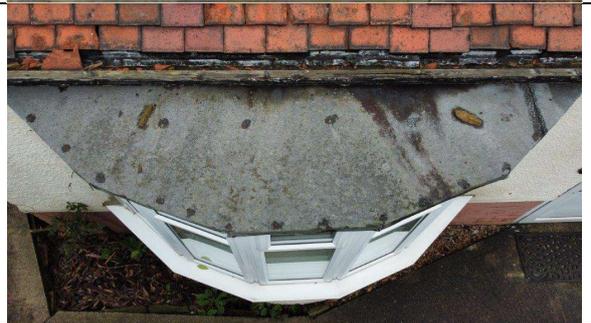
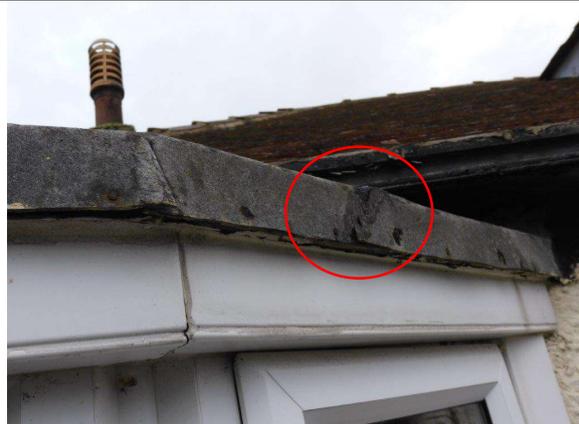
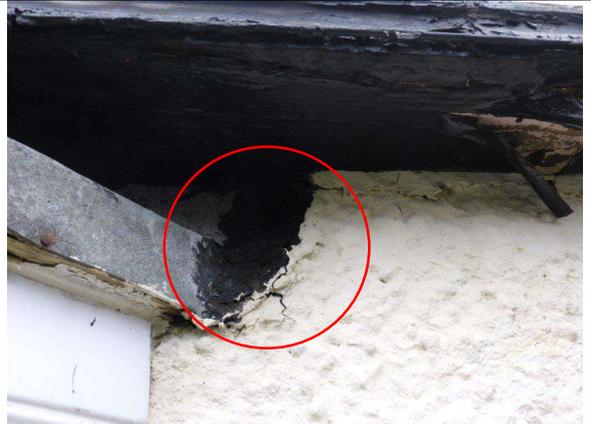
Canopy – the covering is coming to the end of its useful life. There are cracks in the detailing with the front elevation.

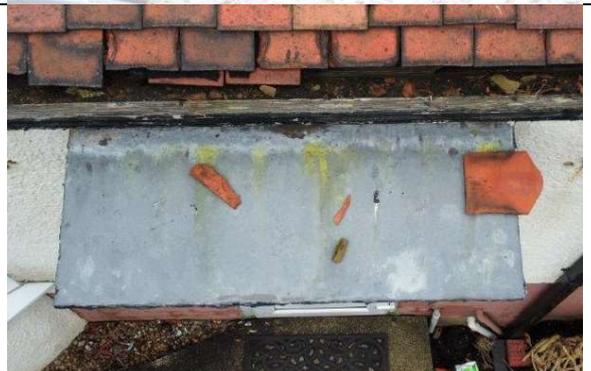
Note the damaged roof tiles from the front pitch.

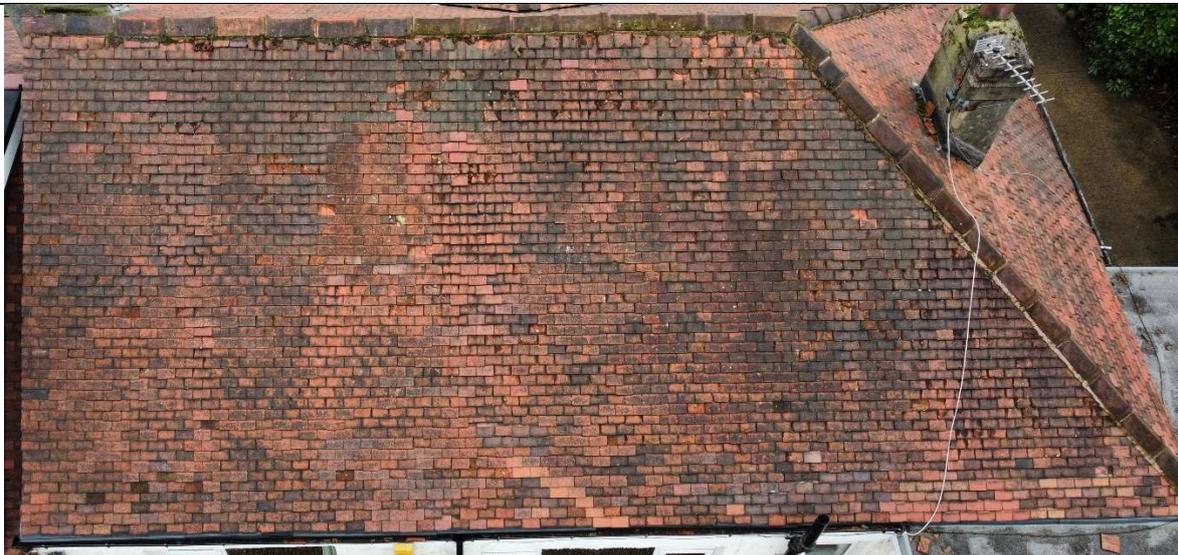
Pointing missing from the ridge – this should be replaced as soon as possible.

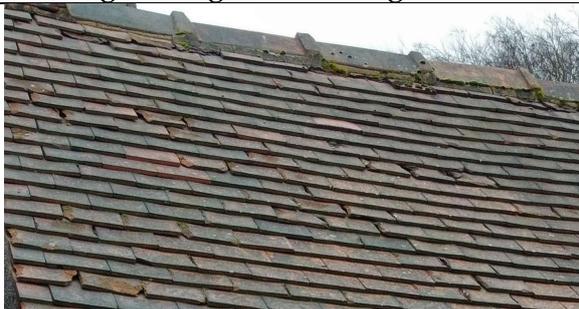
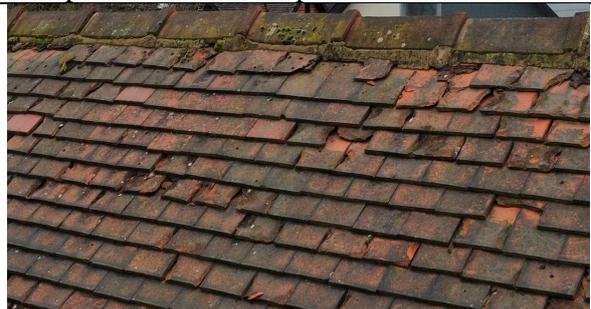
Pointing missing around the hip. This should be replaced as soon as possible.

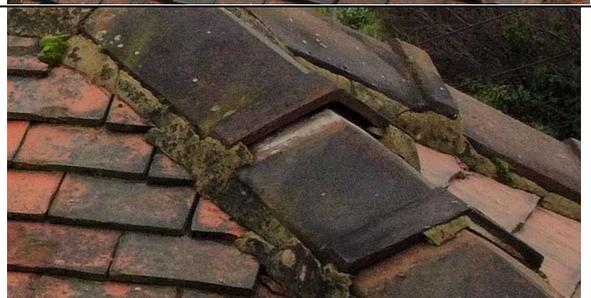
Close-up photo of the general condition of the roof covering.

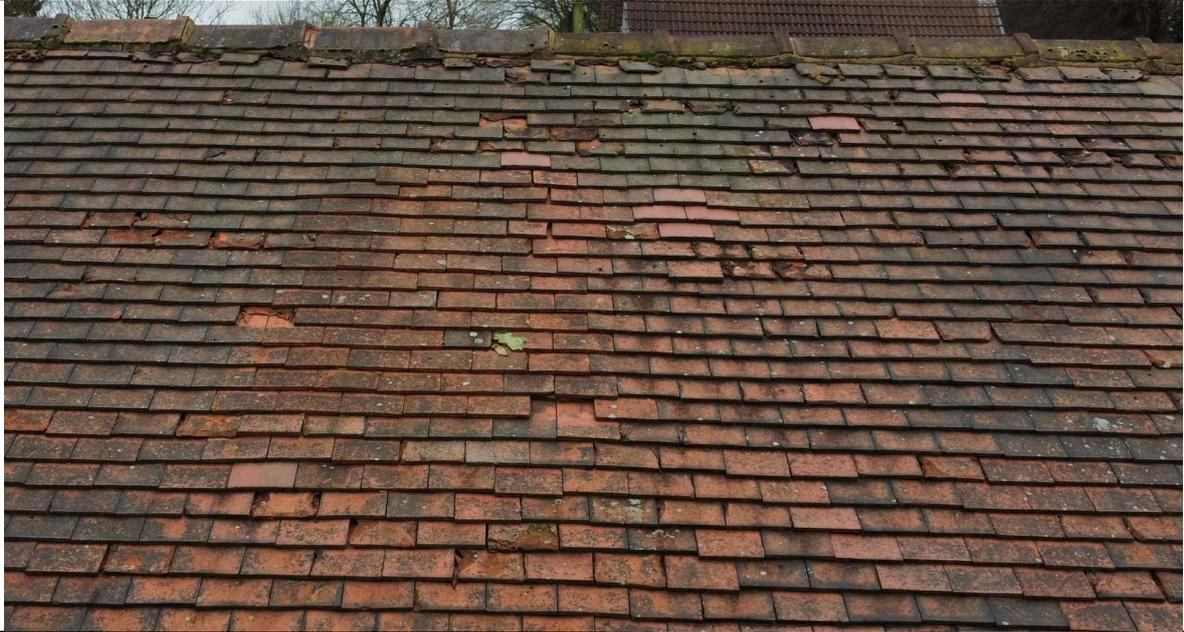
The tiles do not project far enough over the guttering and an eaves board has been added to try to compensate for this.

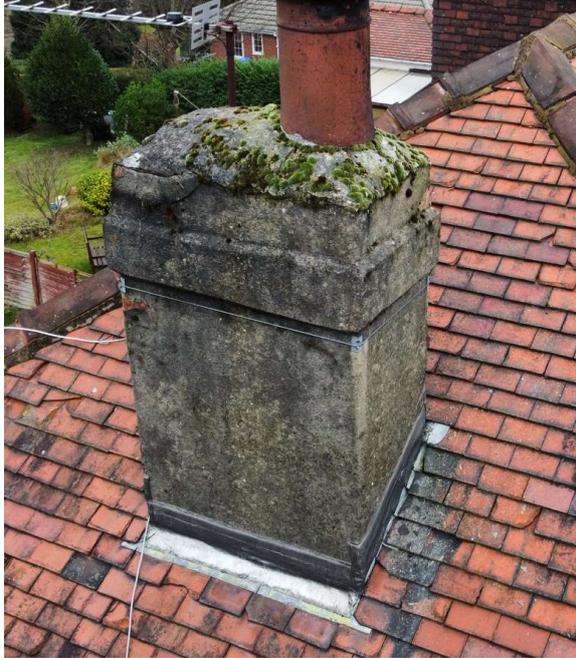
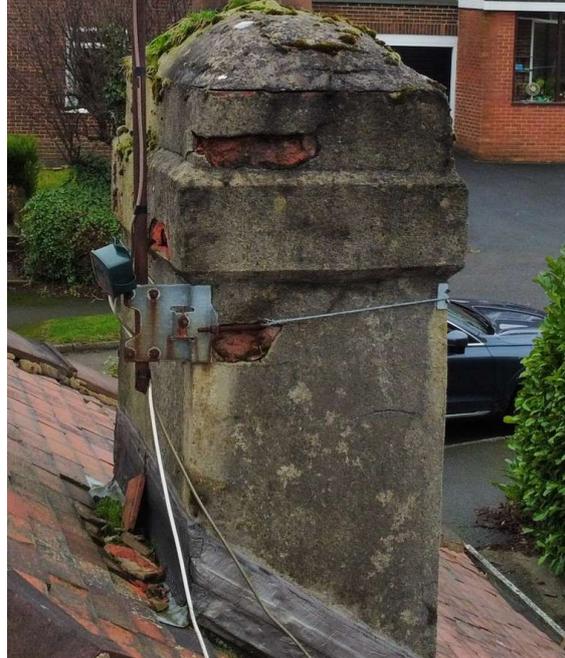
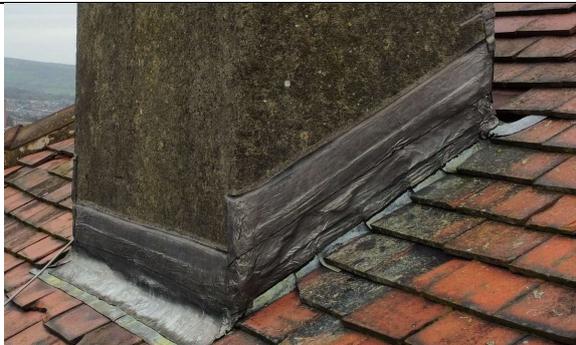
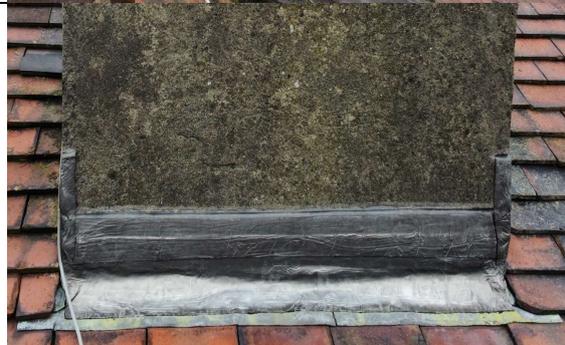
Close-up of the flaunching.

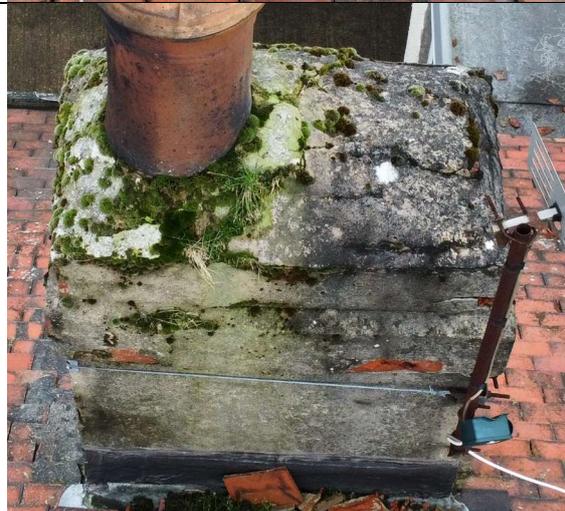
Right-hand stack – the stack is in poor condition and maintenance is long overdue. There is no vented cap on the pot, the flaunching is cracked and the render is in a precarious state. This needs immediate attention to prevent it from falling off and causing further damage to the roof covering.

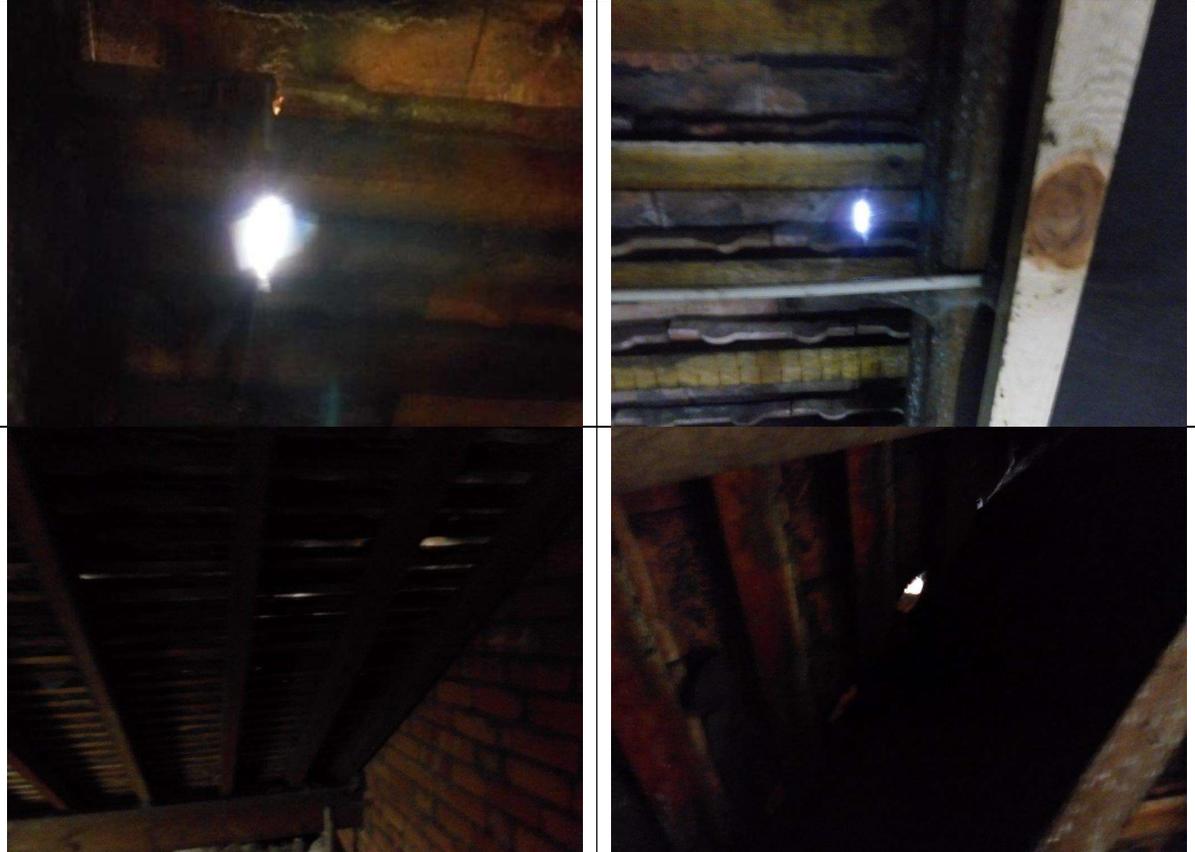
Thermo-hygrometer – ambient readings.

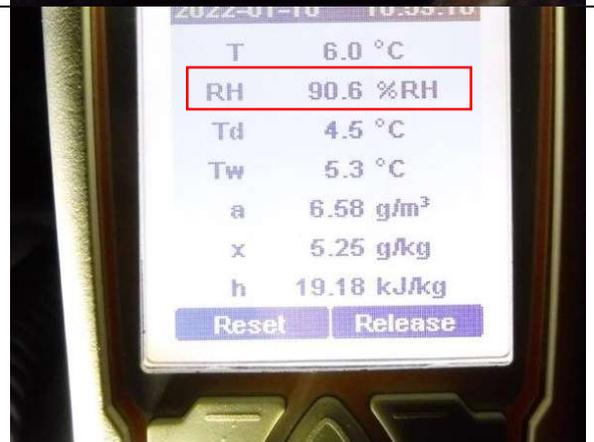
Thermo-hygrometer – behind retro-fitted felt.

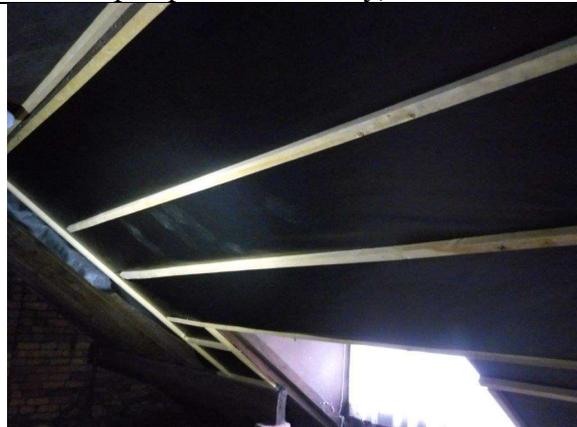
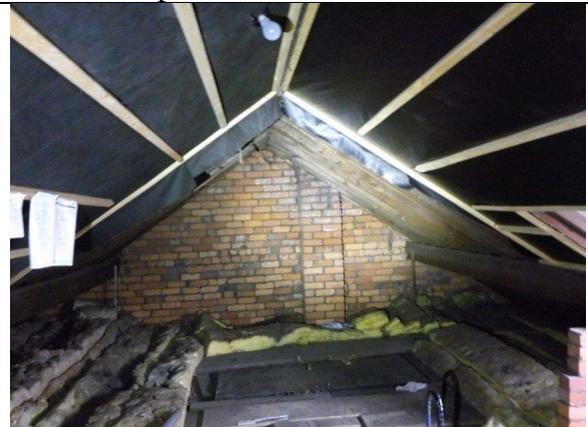
Decay to a rafter head underneath the dormer window.

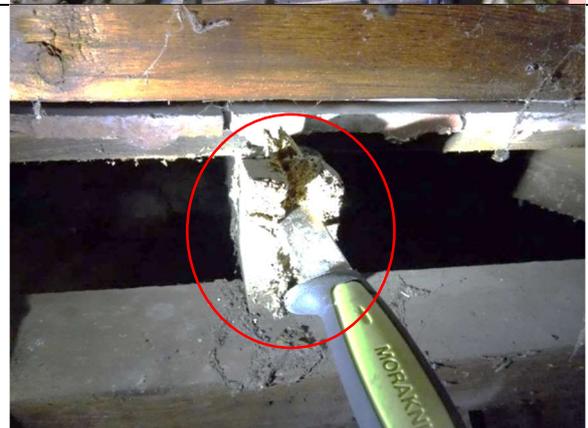
There is white roof mould covering most of the timbers on the left-hand side of the roof.

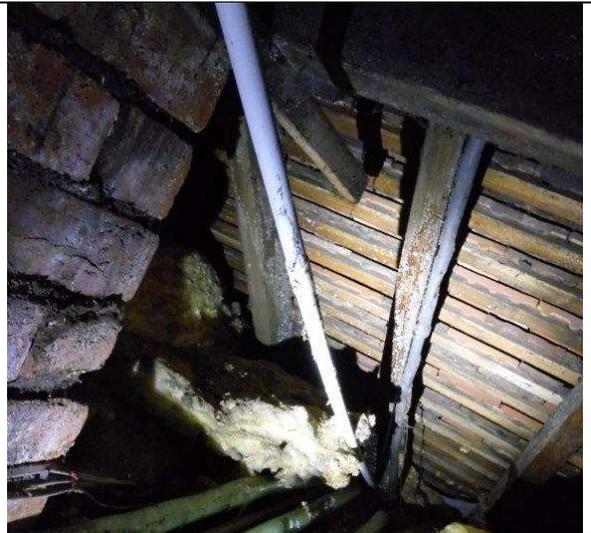
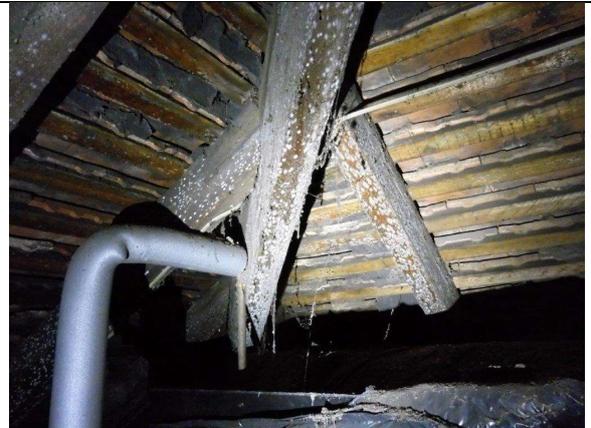
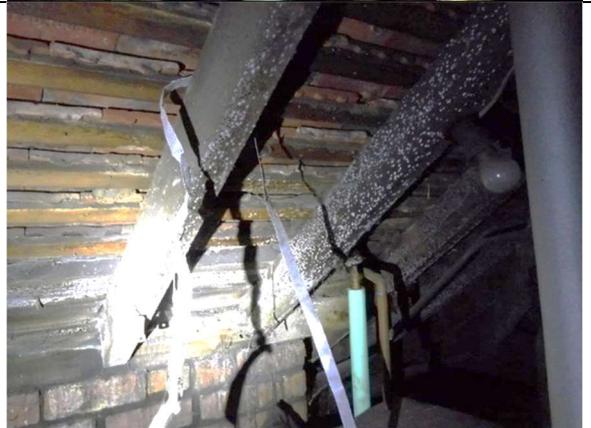
We removed some of the insulation pushed up against the ceiling joists. Moisture is getting trapped in the insulation against the timber and in the debris below.

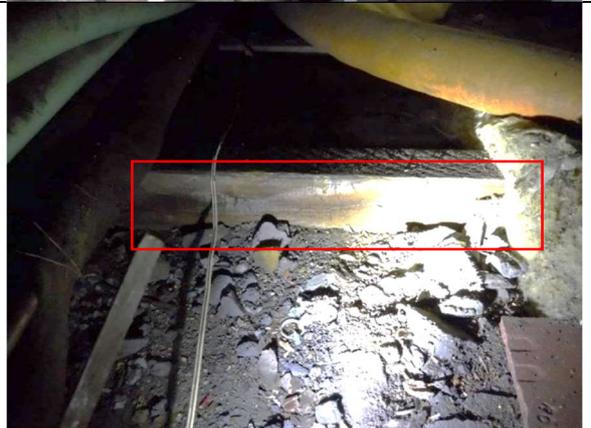
Not all of the water system has been drained down.

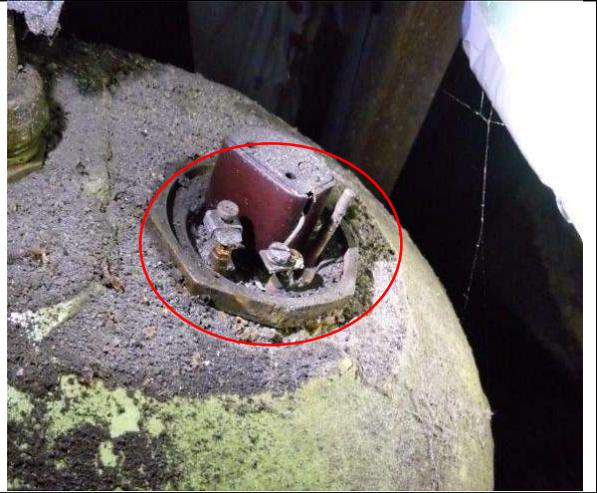
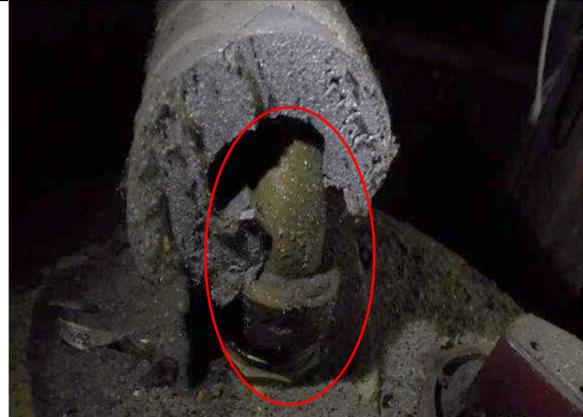
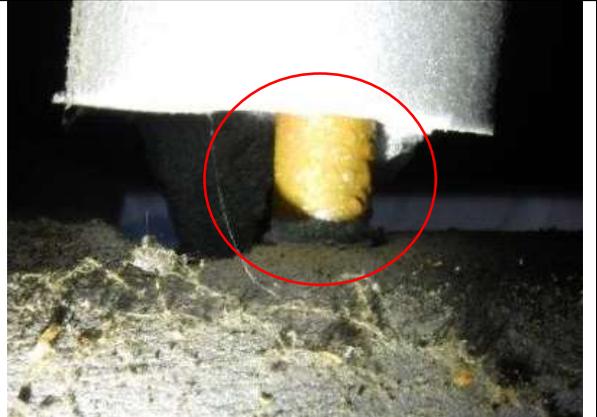
This tank is part full of water and is either leaking or there is a significant amount of condensation building up on the sections of pipe that are not insulated.

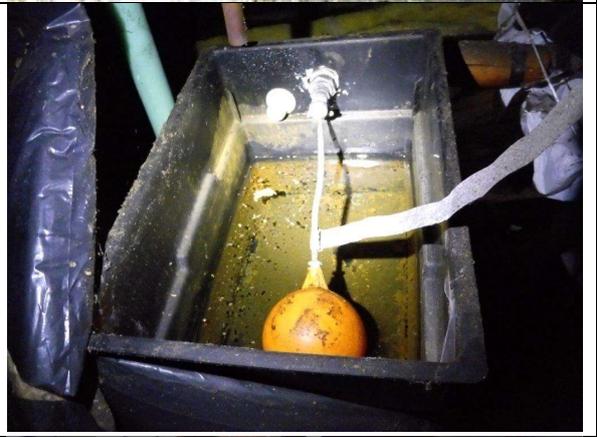
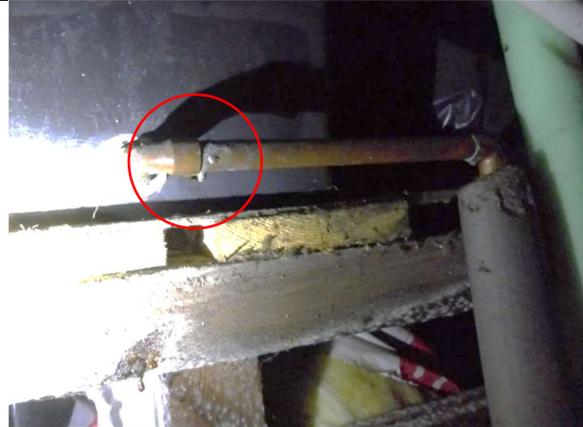
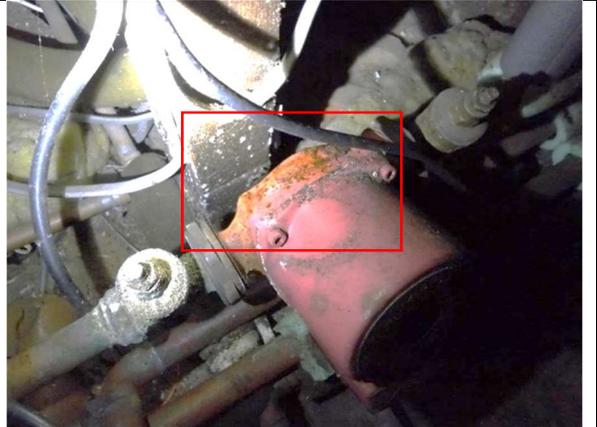
Left-hand chimney stack – parts of the pointing are missing completely. Along some of the perp joints, the knife goes straight through into the flue.

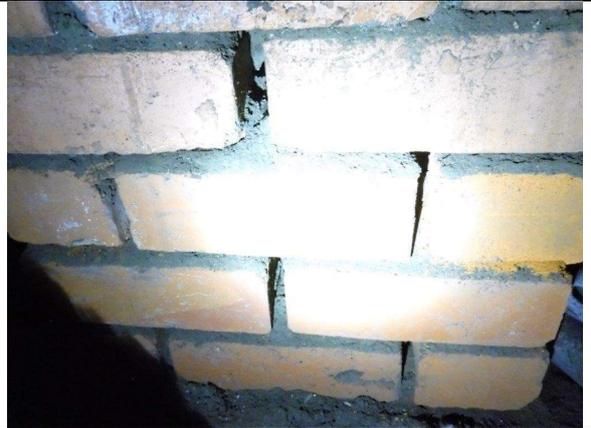
Stained timber underneath the right-hand stack.

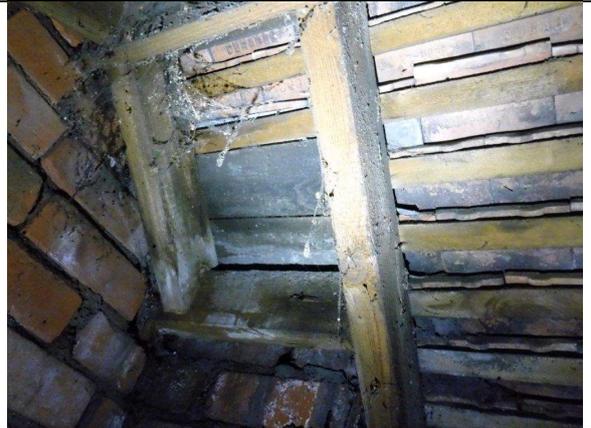
Once the stack has been repaired, the impurities can be cleaned off the timber.

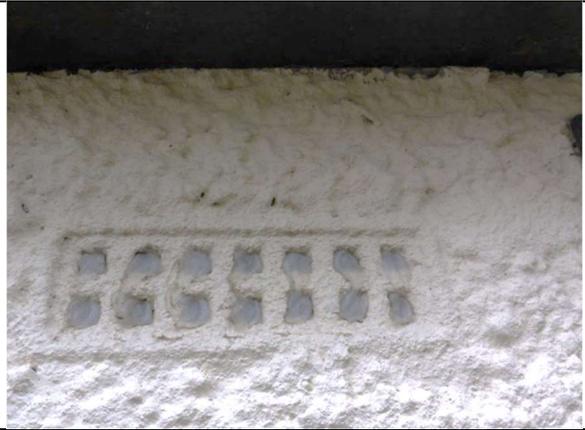
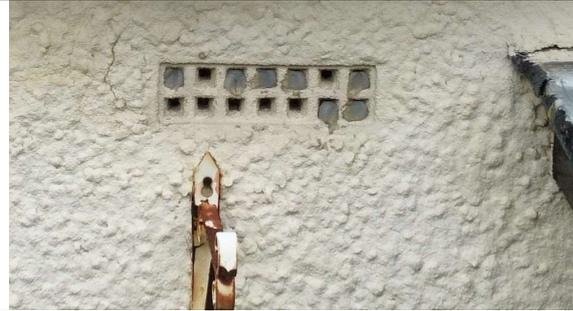
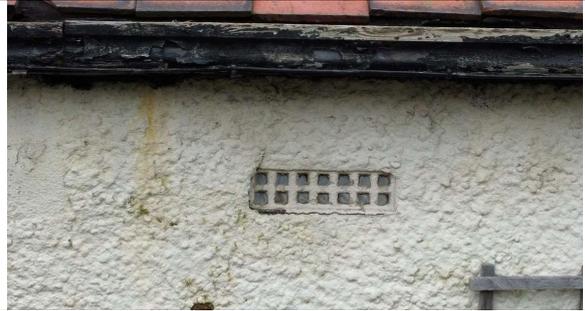
Examples of cracks and blown render.

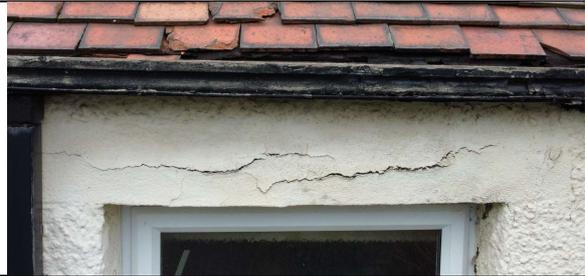
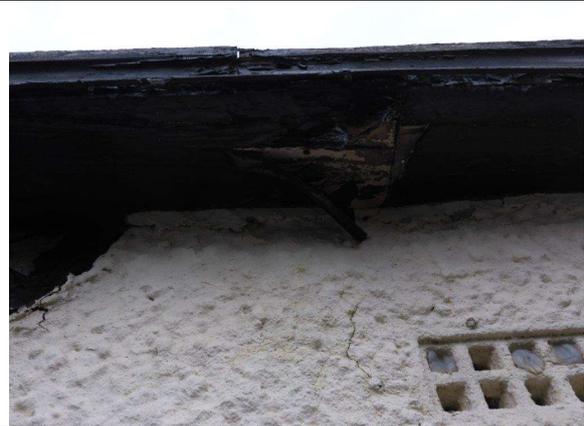
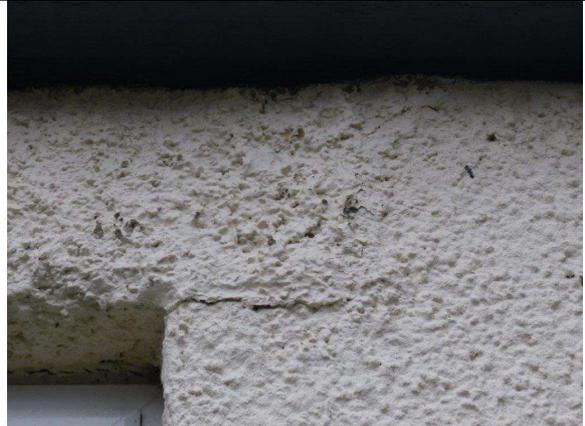
Bedroom 3 – there are gaps around the window frame and the reveal. This will allow driving rain to penetrate the wall, soak the cavity fill and bridge to the inner leaf.

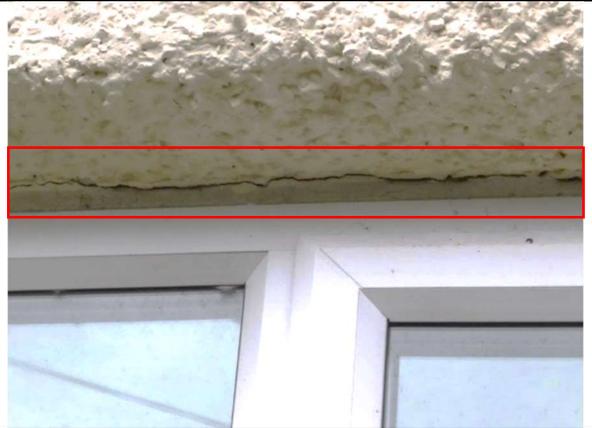
Living room window – the detailing around the window is poor and likely allowing rainwater penetration around the cracks. On the right-hand side, the render is stained from moisture, this is likely to be caused by splashback from the roof.

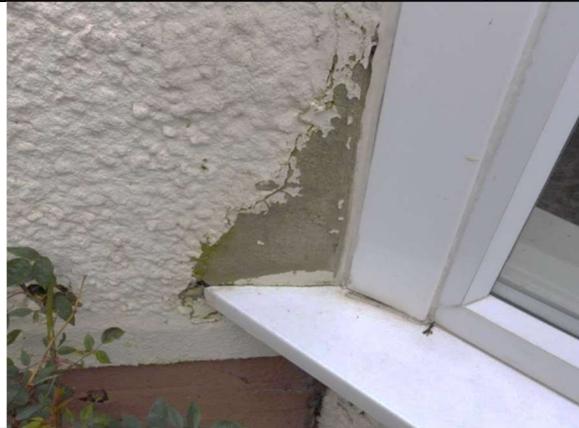
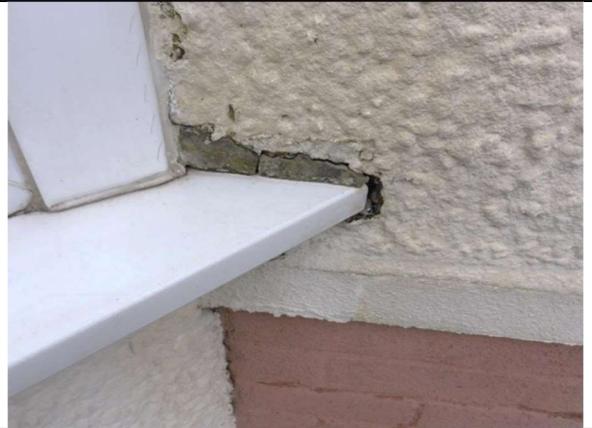
The large bush on the right-hand side should be removed as it will affect the evaporation cycle of the wall and its roots may undermine the structure.

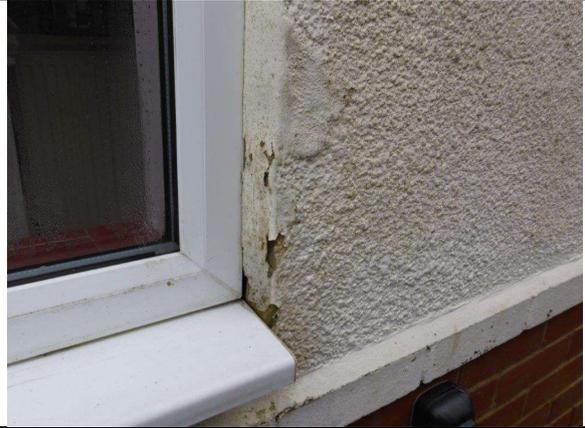
A poor job has been made of detailing the upper section of the side door.

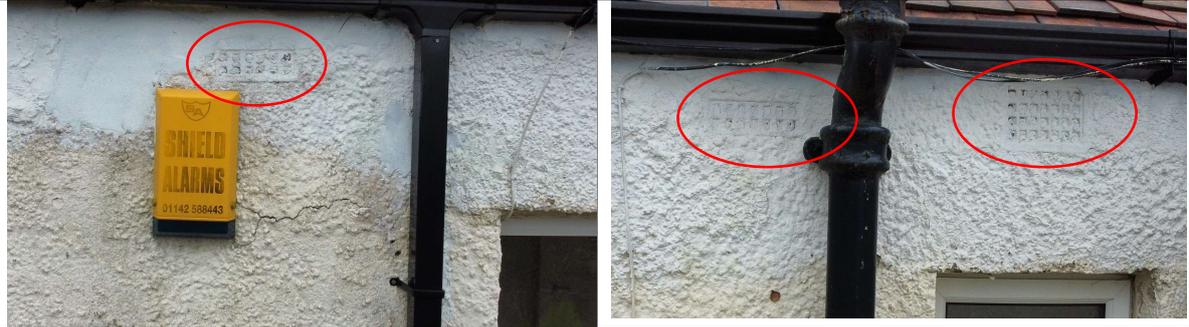
Examples of poor quality repairs to the render.

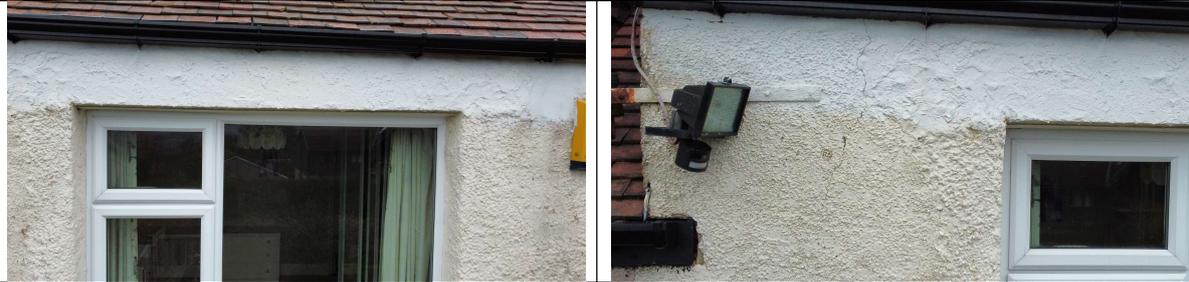
Examples of where damaged render has not been repaired/repairs have failed.

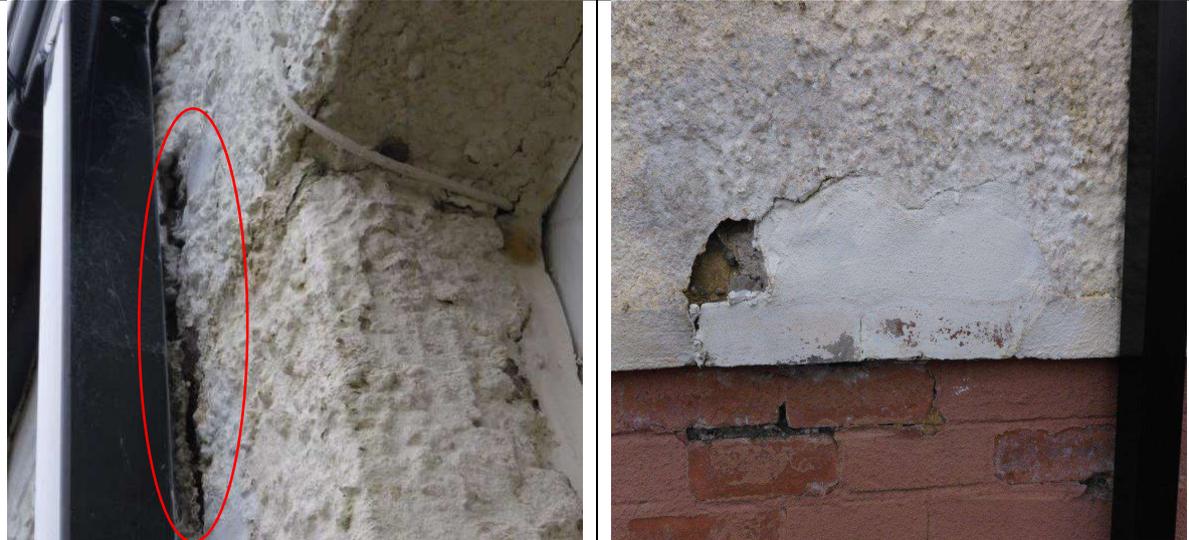
Areas of render have debonded and been left to deteriorate further.

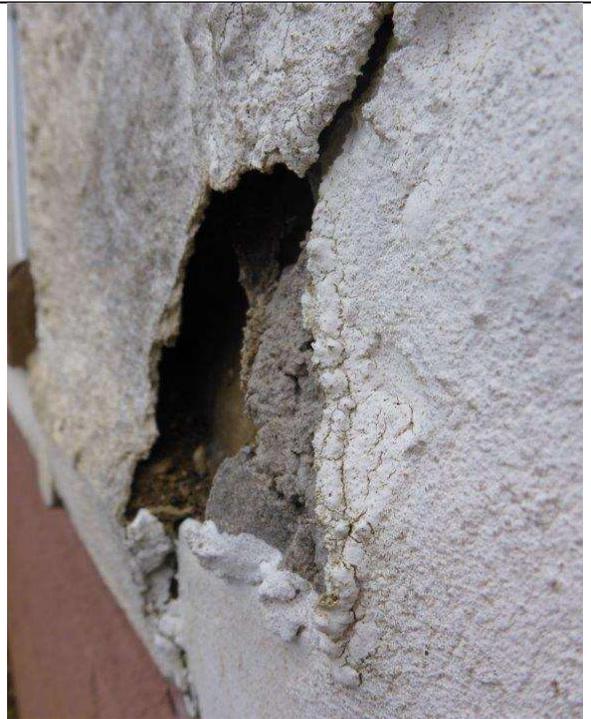
Bedroom 1 – poor detailing around the window frame. This should be addressed as soon as possible.

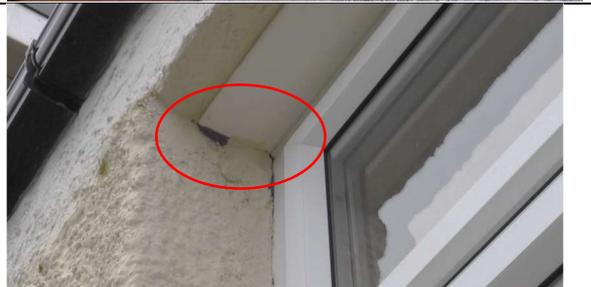
Bedroom 2 – poor detailing around the window frame. The silicone has shrunk and there is now a gap around the window. This needs to be addressed as soon as possible as it is contributing to internal moisture problems.

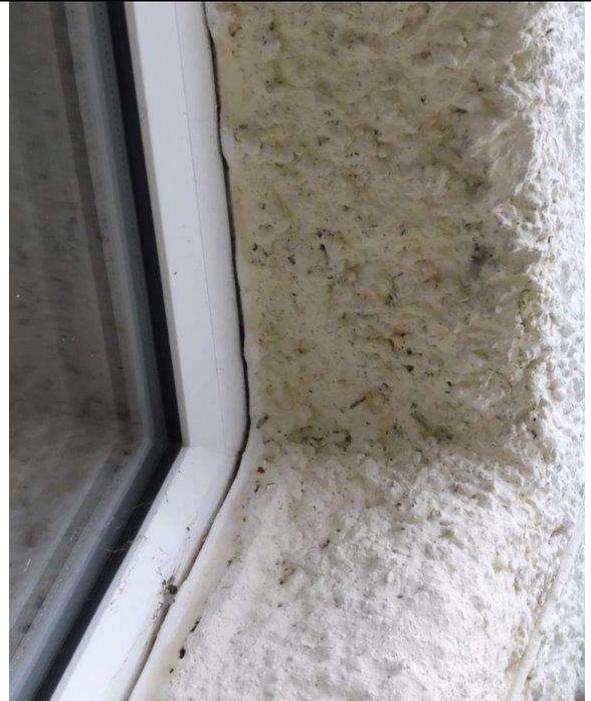
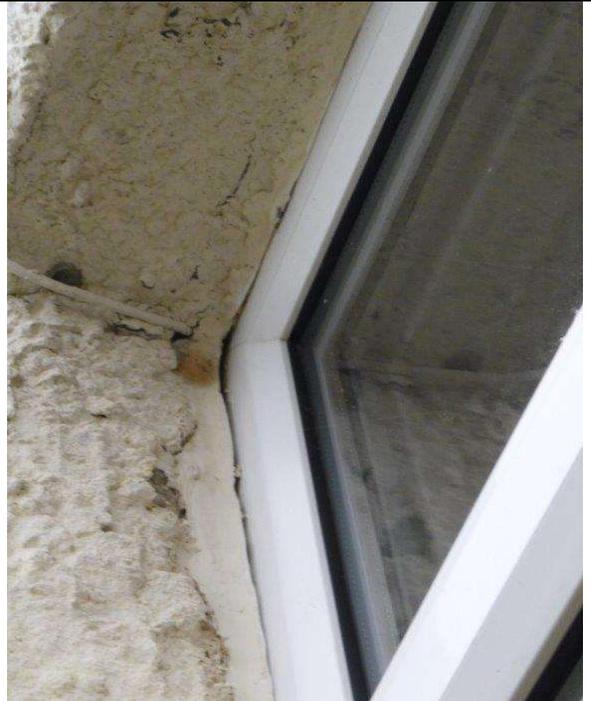
Hairline cracks around the pointing. Likely occurred when the cavity wall insulation was being installed.

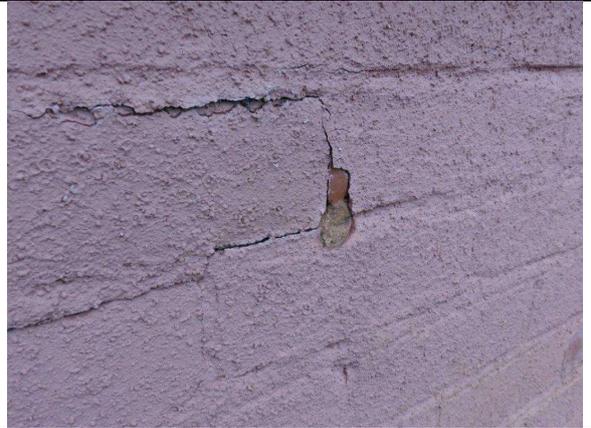
These all need raking out and repointing to prevent rainwater ingress.

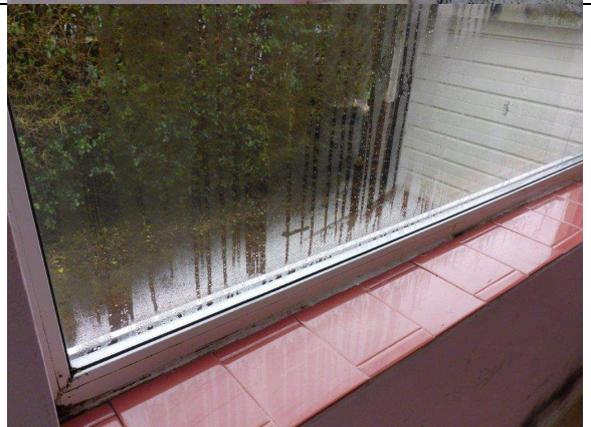
The floorboards in front of the porch door are beginning to decay.

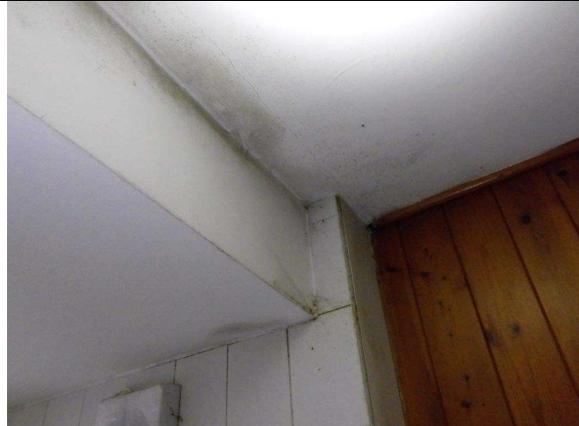
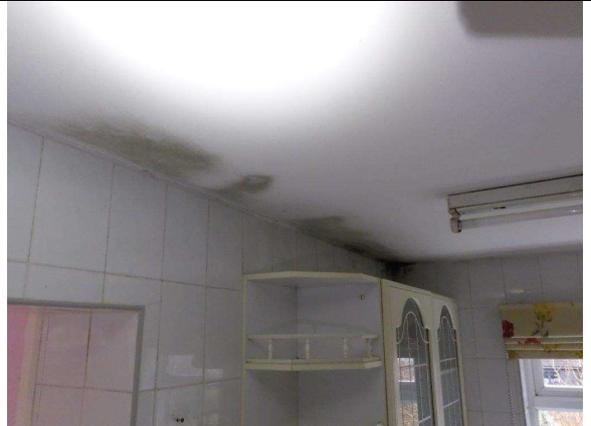
Water is staining the ceiling, likely from either the roof, chimney or the plumbing above.

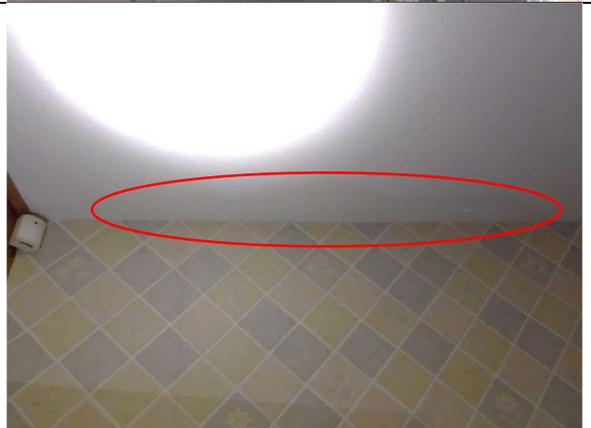
Again, in the kitchen, some areas are only 2 degrees above their dew points.

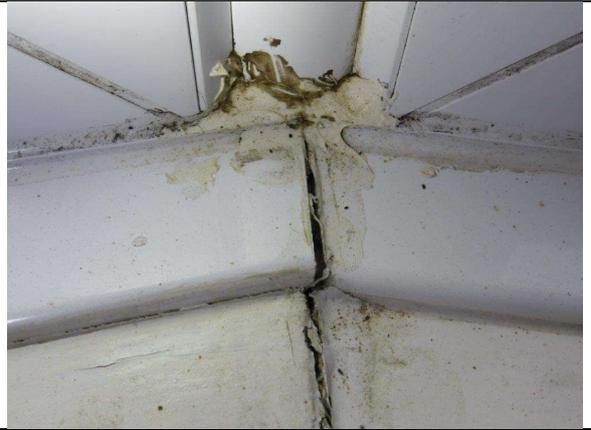
Staining and mould are building up on the wall and ceiling on the right-hand side of the bay window.

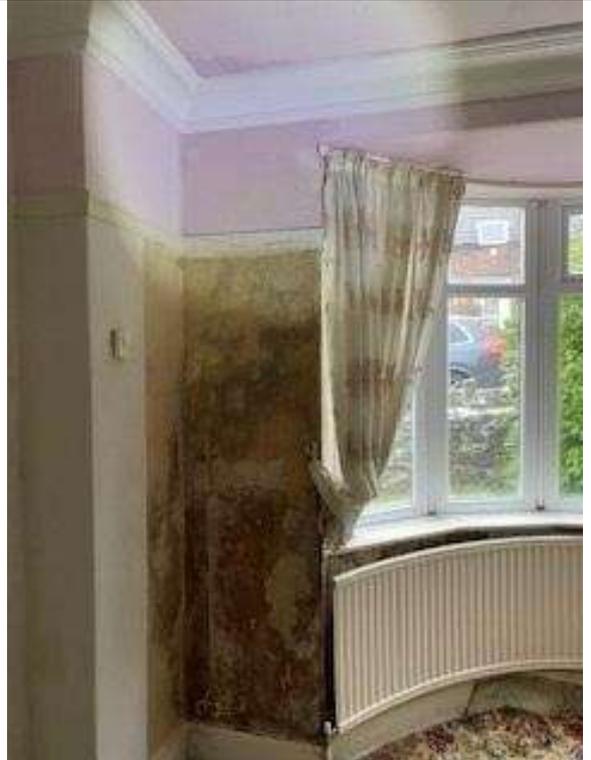
There is moisture all around the right-hand side of the bay window. Plaster is blowing and wallpaper has come off the wall.

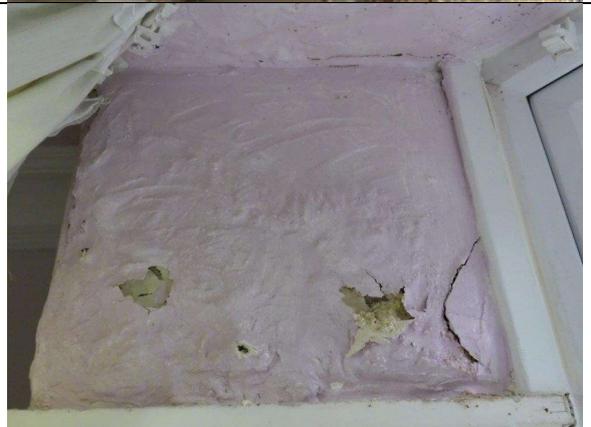
We used the thermo-hygrometer in the area of blown plaster.

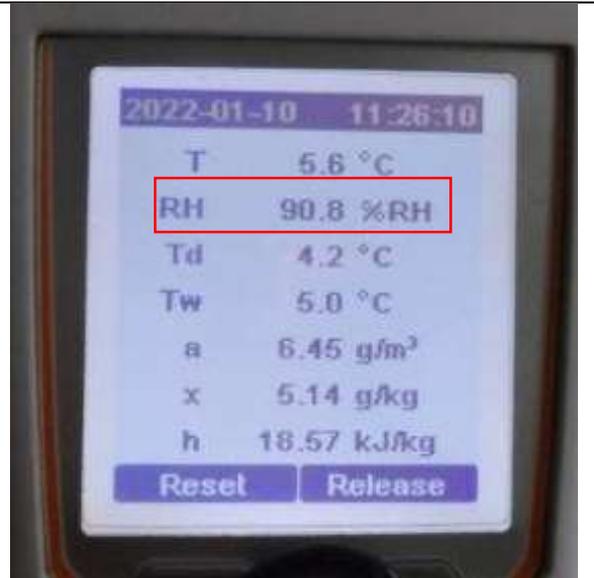
There is staining to the wall and ceiling on the chimney breast and on the right-hand alcove.

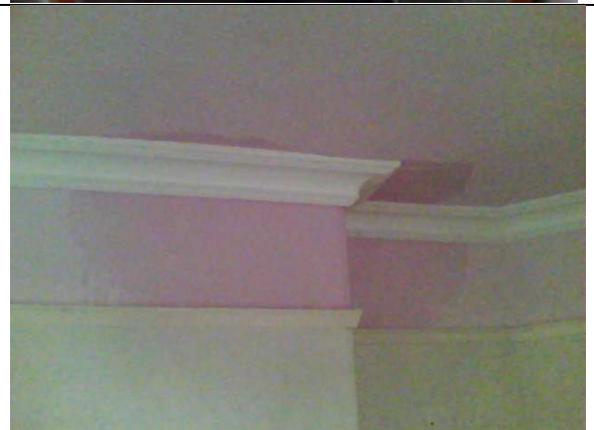
Moisture is getting up the back of the skirting boards. Note the corrosion around the ferrous metal fixings.

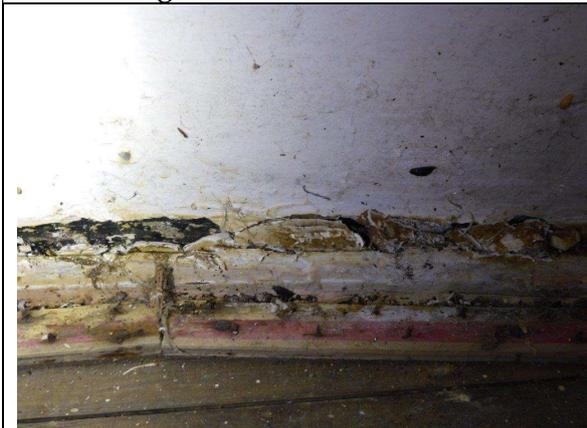
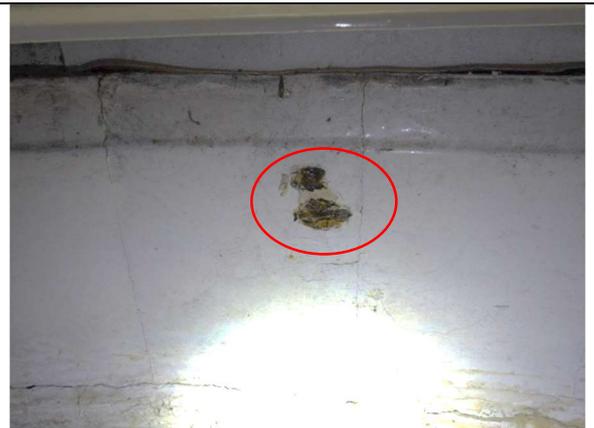
We placed the thermo-hygrometer probe through a hole in the floor in the front left-hand corner of the room. The air is nearly at saturation point and it is likely that timber will be decaying (see an example of this in 3.4.9).

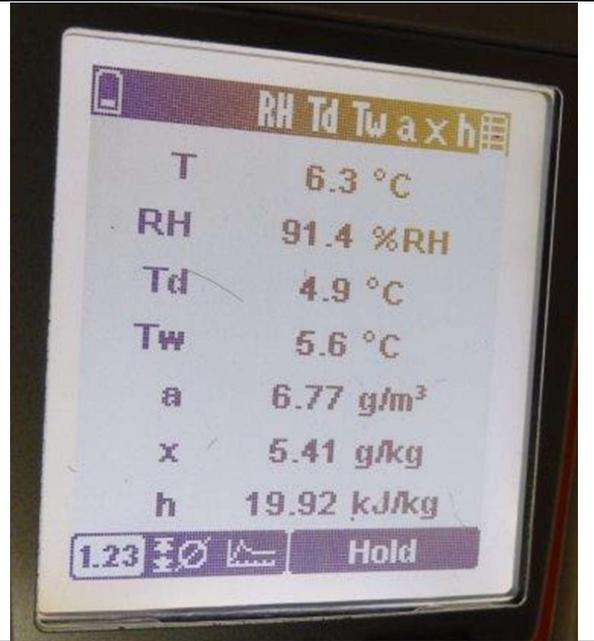
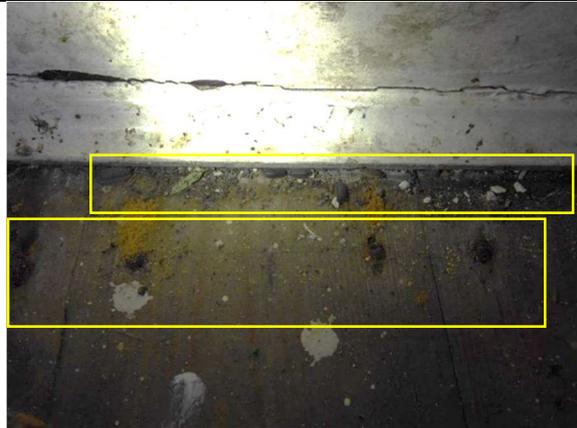
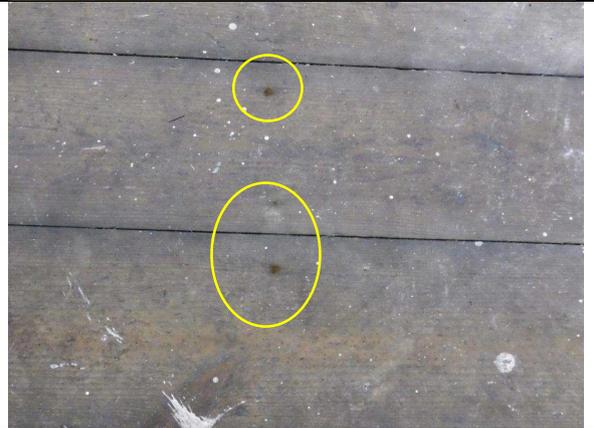
The surface is only 2 degrees above the dew point.

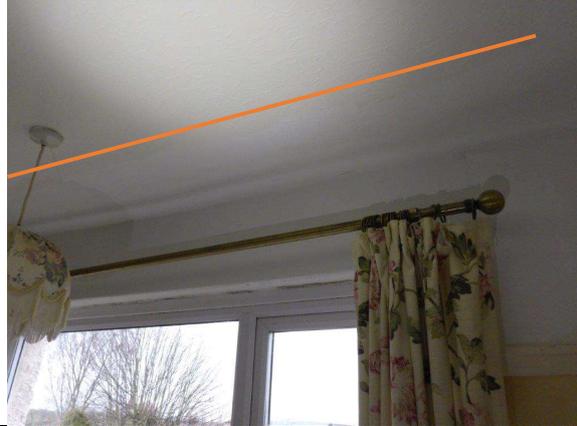
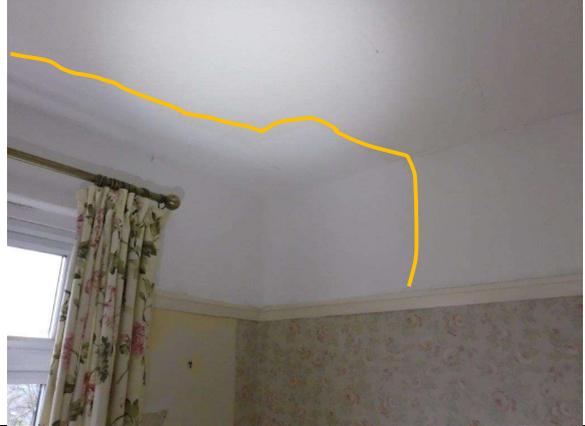
Staining to the left of the window frame.

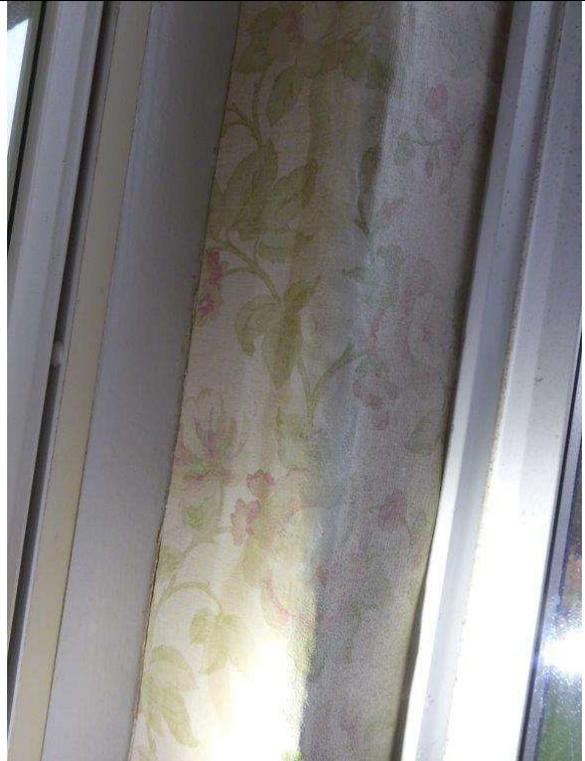
Black spore mould is building up both on and around the window frame.
