Damp Inspection

In respect of:

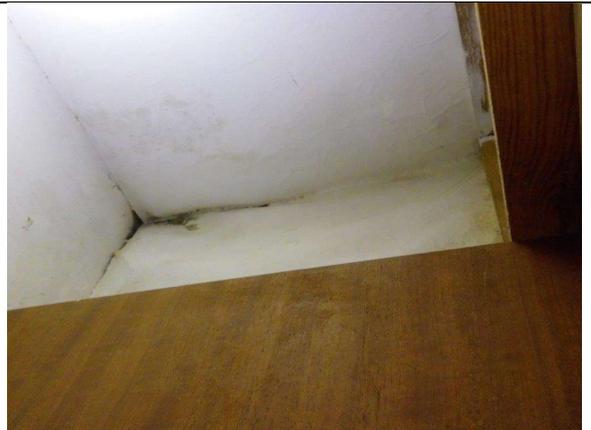
The gripper rod has completely decayed and the fixings in the gripper rod and the floorboards are corroding. This is could be one or a combination of the radiator leaking and moisture rising from the sub-floor.

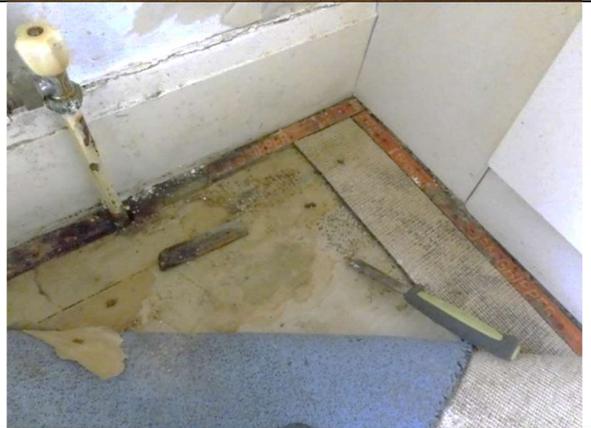
2.5 degrees above the dew point. Note that the only area of heat is coming from the dividing wall with the neighbouring property.

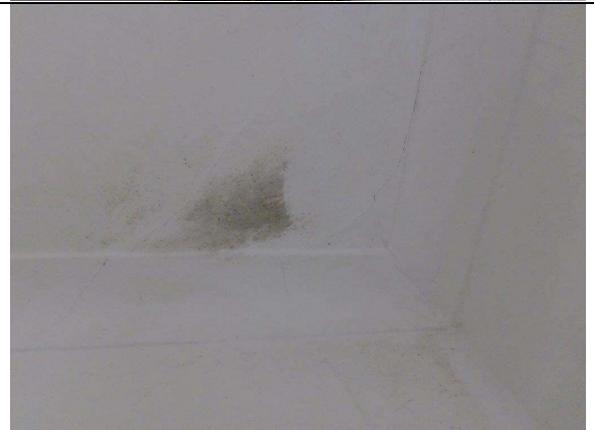
Moisture is rising up from the sub-floor area/the radiator has been leaking. Note the corroded fixings in the floorboards and the gripper rods.

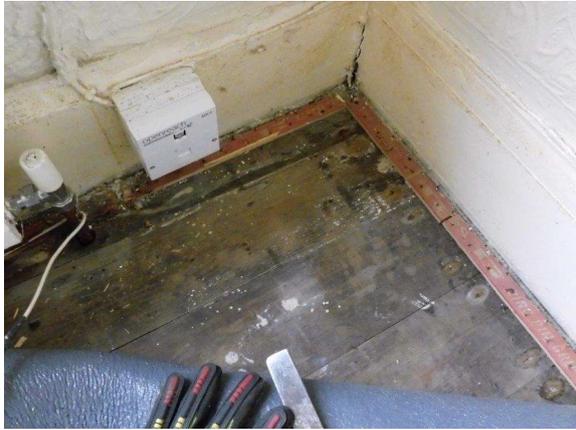
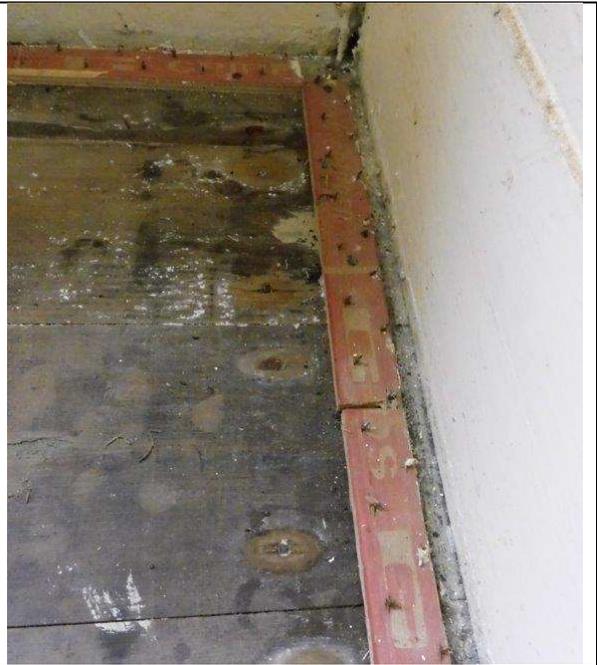
3 degrees above the dew point. The cavity fill looks cooler and is likely saturated.

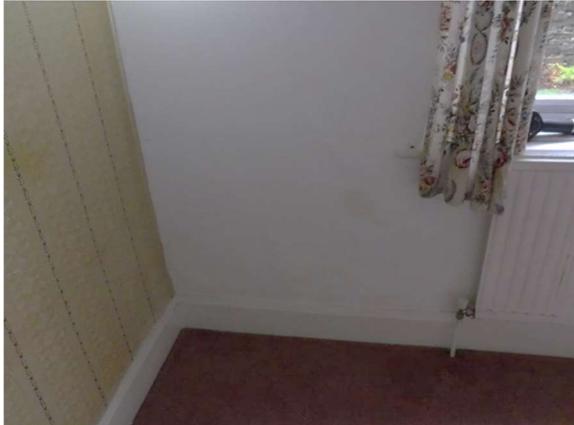
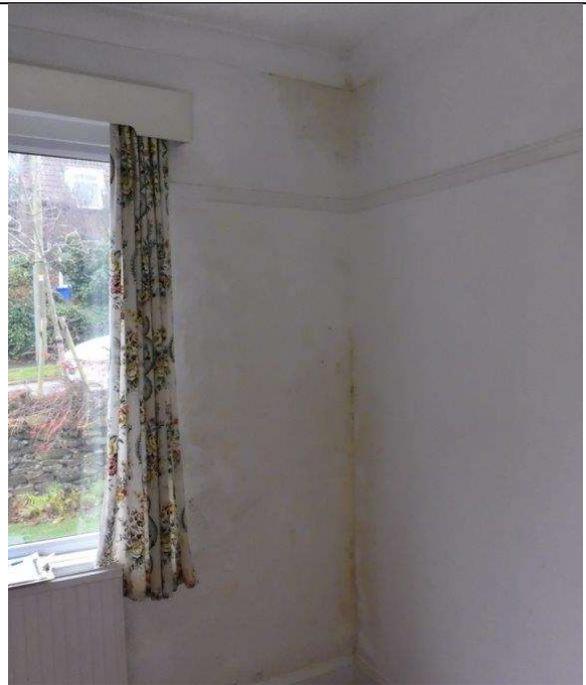
The hit and miss vent in the chimney breast was closed at the time of our inspection.

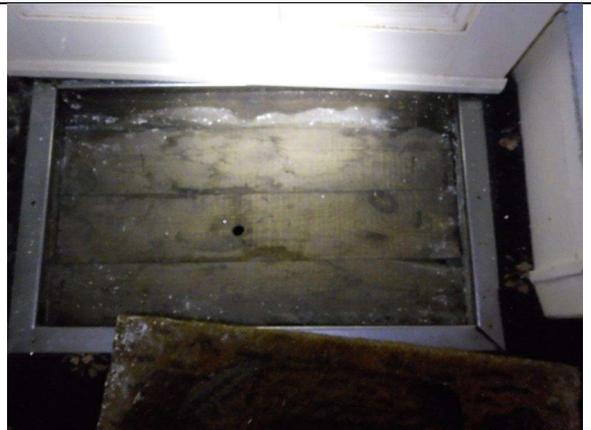
The atmosphere in the sub-floor area urgently needs addressing. The air is saturated and this will cause timber decay and insect attack if action is not taken.

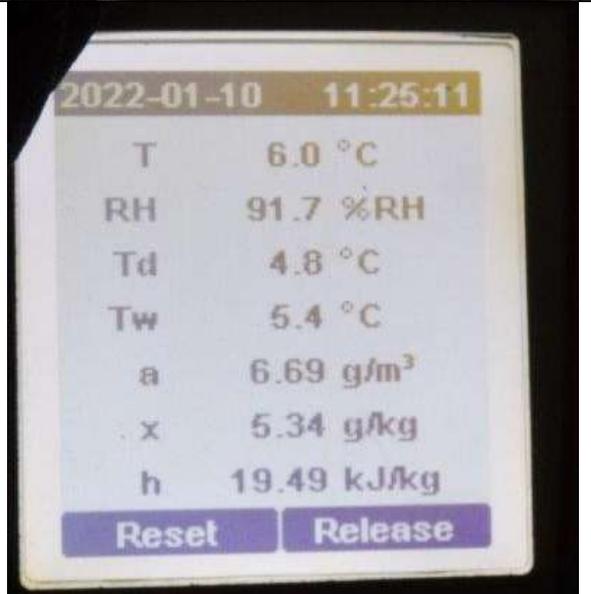
Timber socketed into the front elevation is beginning to decay. Urgent action is required.

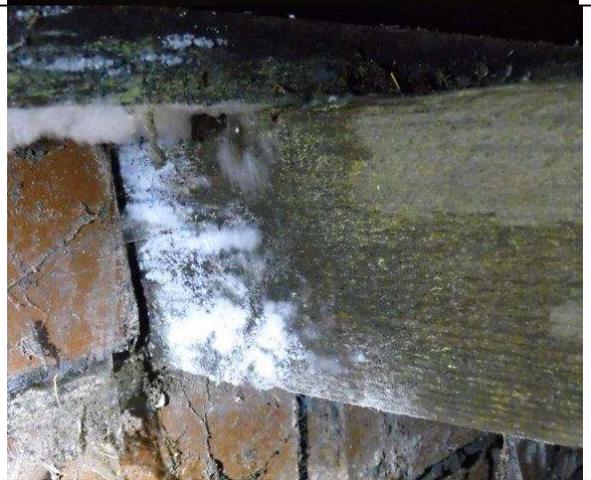
It looks like a radiator has leaked in the hallway.

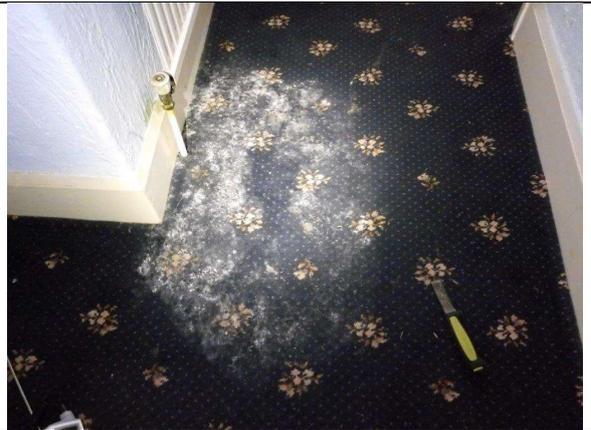
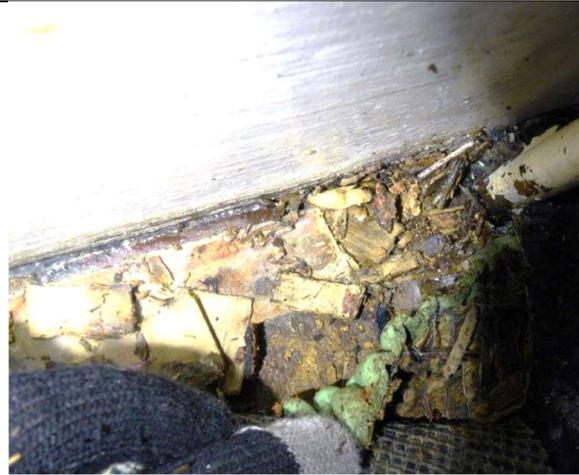
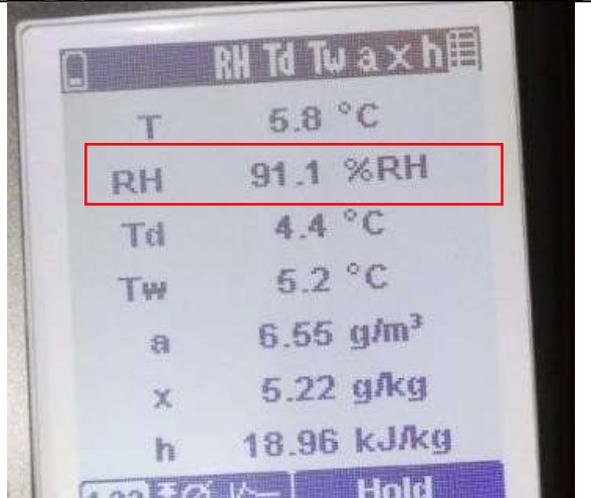
We recommend that the carpet be taken up as soon as possible to prevent timber decay.

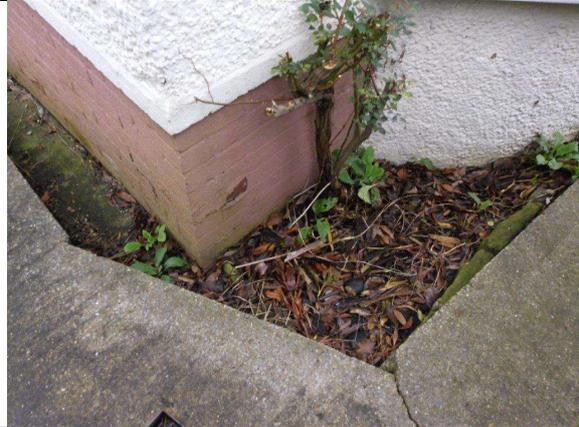
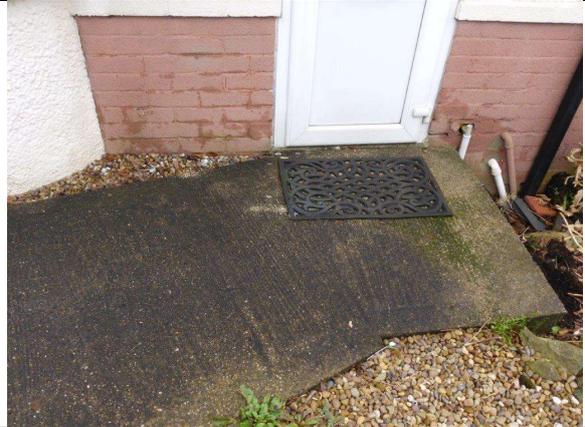
A trench has been formed down the side of the living room in order to address the ground level issue noted above.

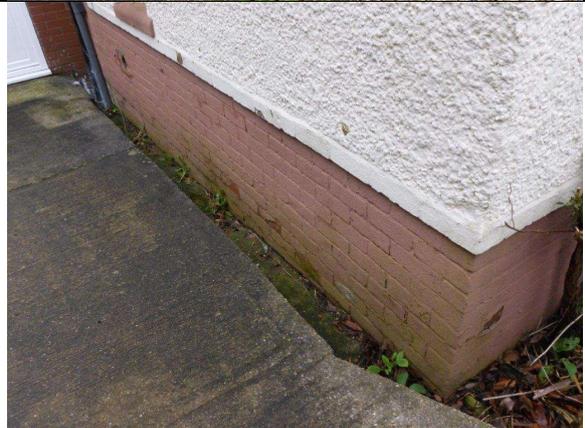
Porch – the ramp is bridging the damp proof course – see orange arrow.

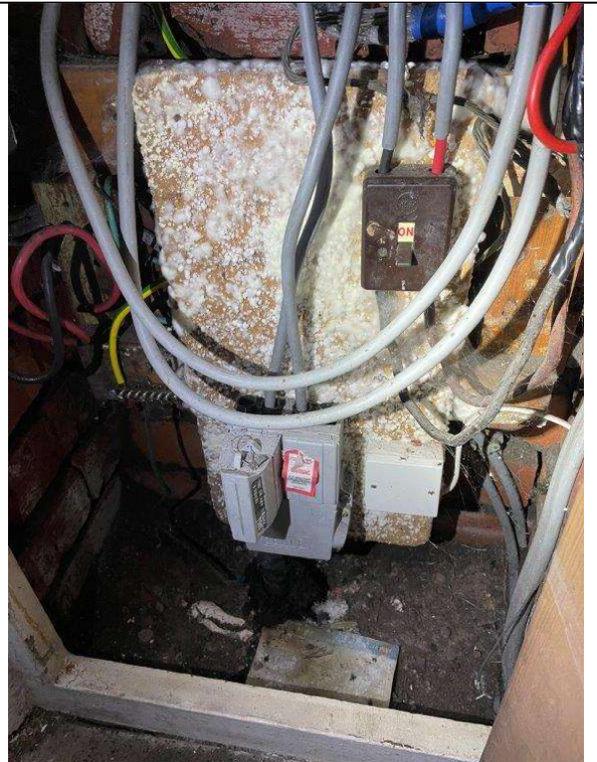
We have not inspected any of the services; however, noted that the incoming fuse board is covered in mould due to the moisture getting into the meter cupboard.
