## **Historic Building Survey**

**Thorpe Salvin**

**FOR AND BEHALF OF  
Simon Hollis Limited  
30<sup>th</sup> June 2021**

## Building Survey Report

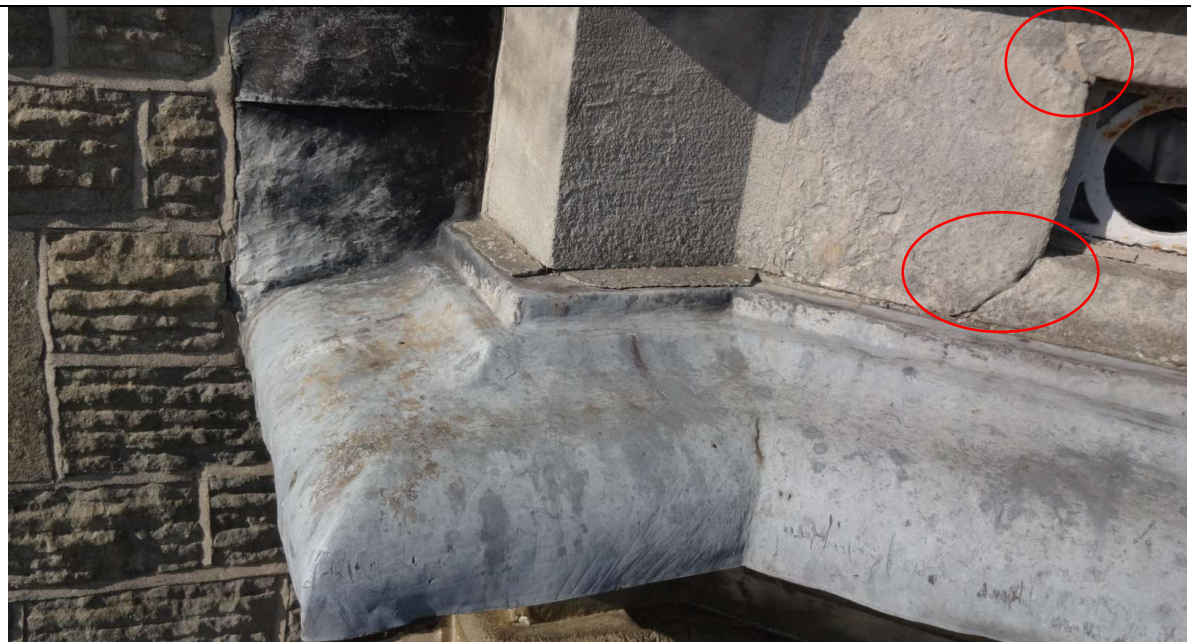
Example of letterbox detailing that needs to be prepared and redecorated.

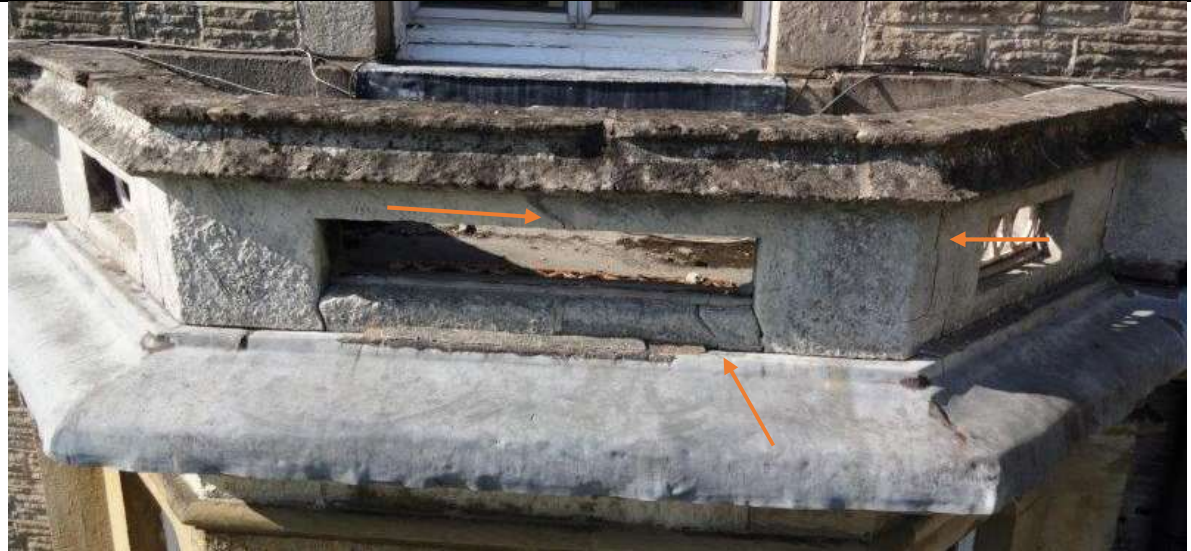
Some examples of localised repairs to the lead detailing. They are not perfect but don't seem to be causing any problems.

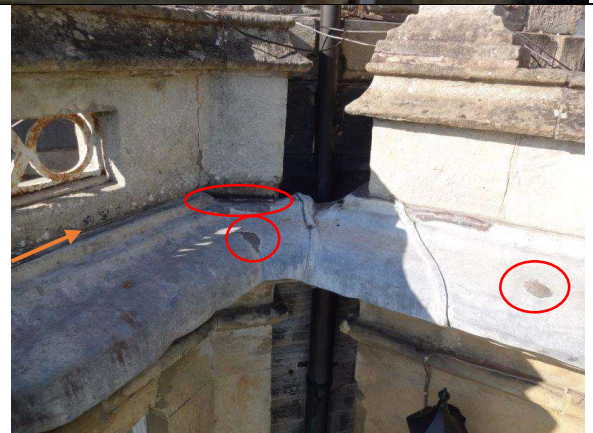
The pointing detail is coming away and lifting (orange arrow). This should be replaced with a hot lime-based mix when you next undertake any pointing work, however, there is no immediate rush.

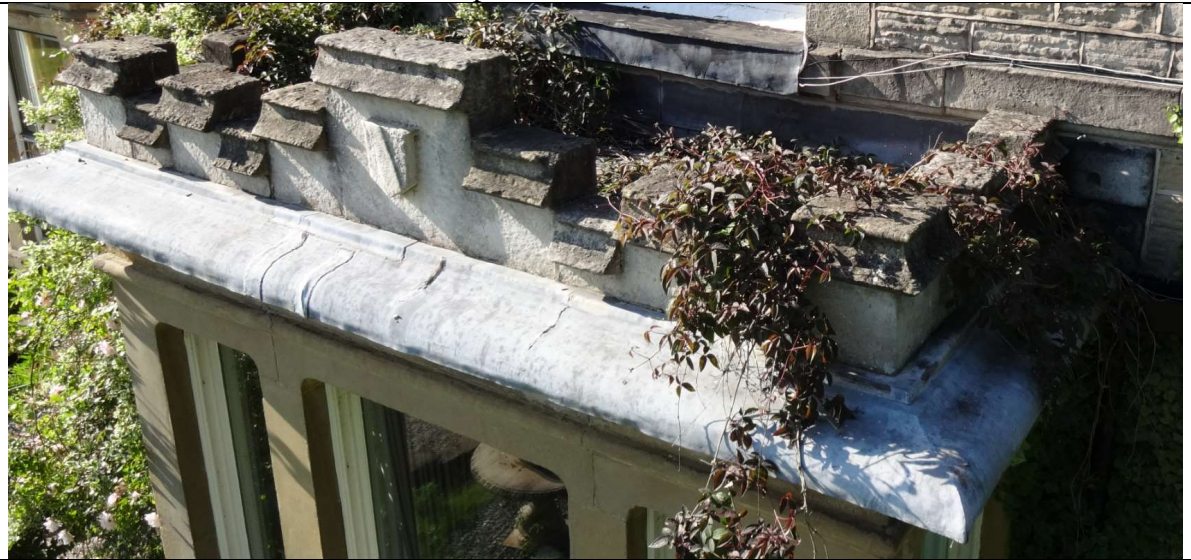
Previous repairs to the lead apron detail.

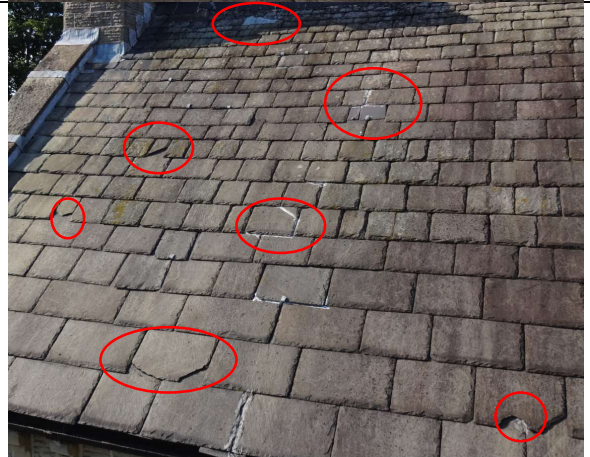
An example of where Leadmate has been used to stick slates to the pitch. This is inappropriate.

Also, note the repair to the valley.

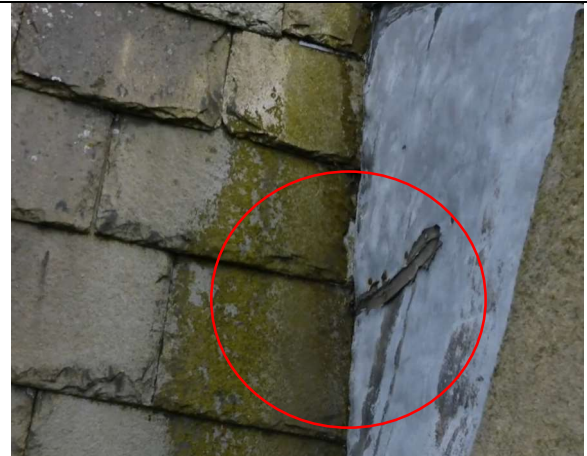
Daylight is visible from the roofspace accessed via the large attic storeroom.

The covering looks to have been disturbed to make access for the solar water heating infrastructure. We recommend that this area is inspected close-up and any dislodged roofing components repaired/replaced. This should be undertaken in the short term.

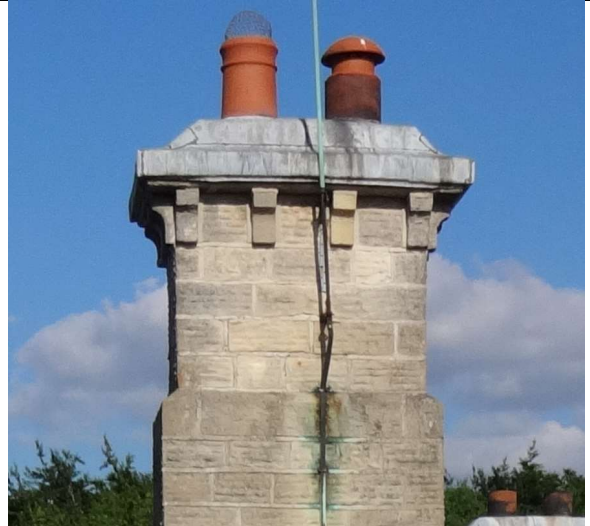
The kitchen stack is very slender.

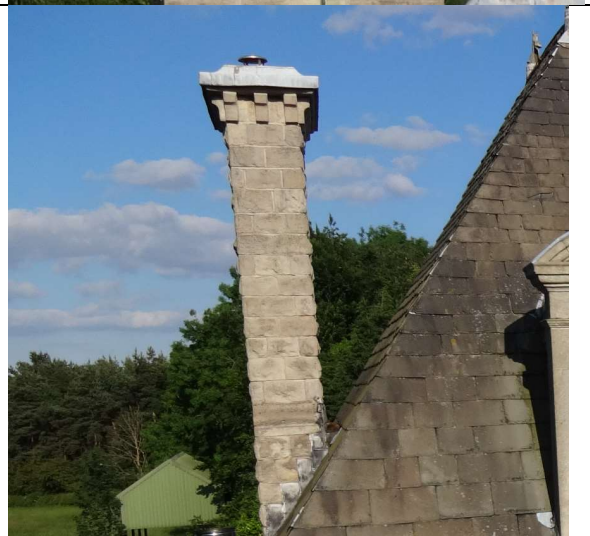
Rear right-hand side drawing room stack – this looks to have three flues running through it.

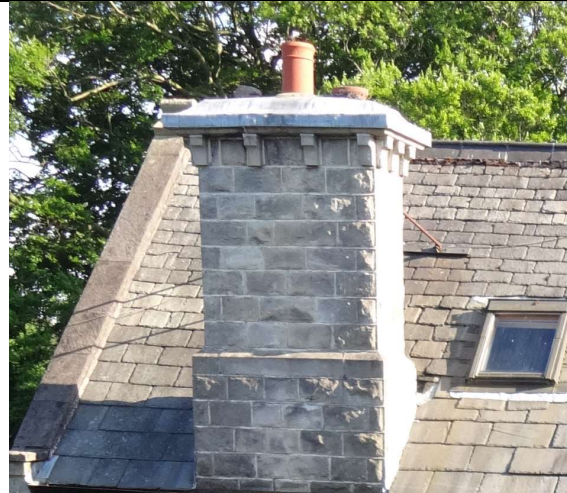
The bracing plate on the rear of the chimney looks to be cracking some of the stone.

We recommend inspection by a suitably qualified professional as soon as possible.

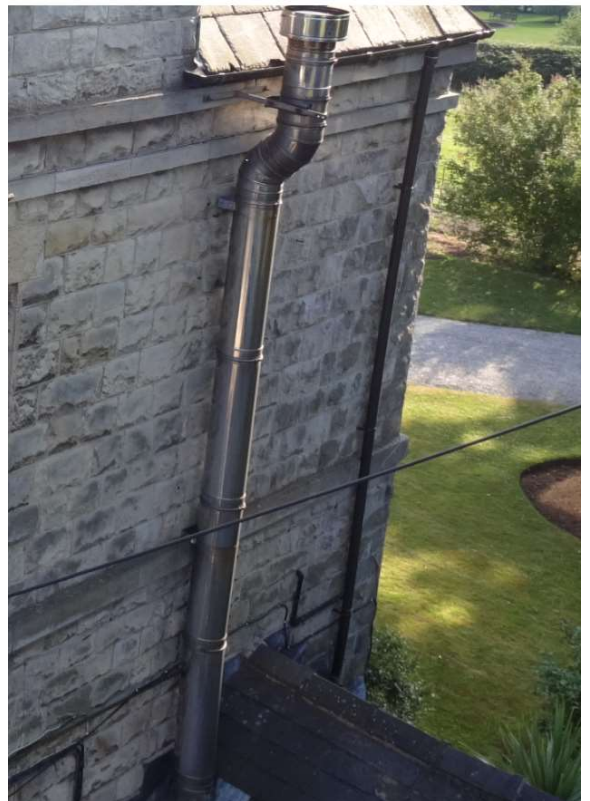
Valley gutters should not be used as cable routes.

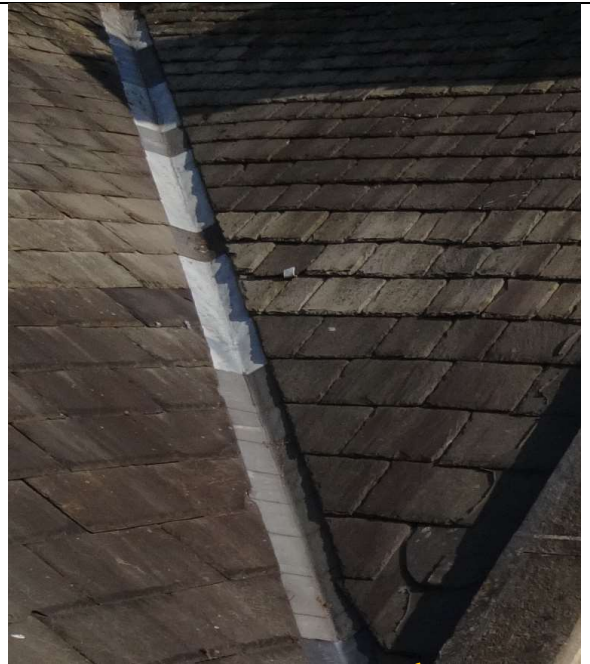
A closer view of the abovementioned area taken from the bedroom window.

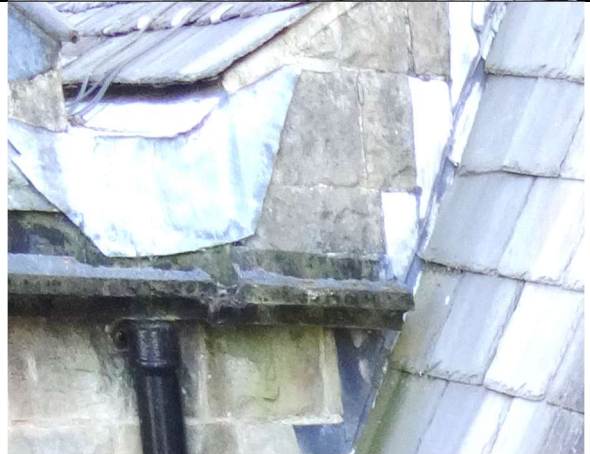
The guttering below the abovementioned area looks to have been overflowing and has stained the walls below both externally and internally in the bathroom and landing area.

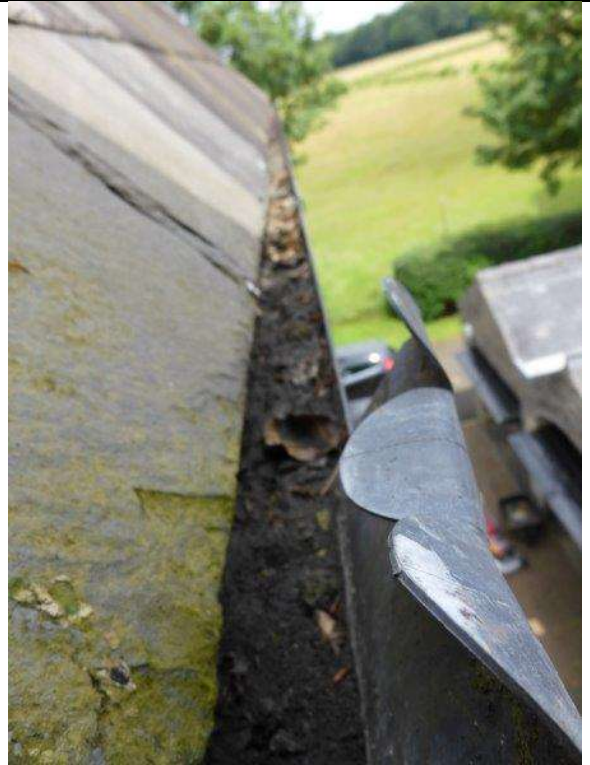
We could not get right into the centre of the roof due to the overhead cables. From what we could see, we recommend that the debris is cleared out of the valley and if possible, the cables re-routed.

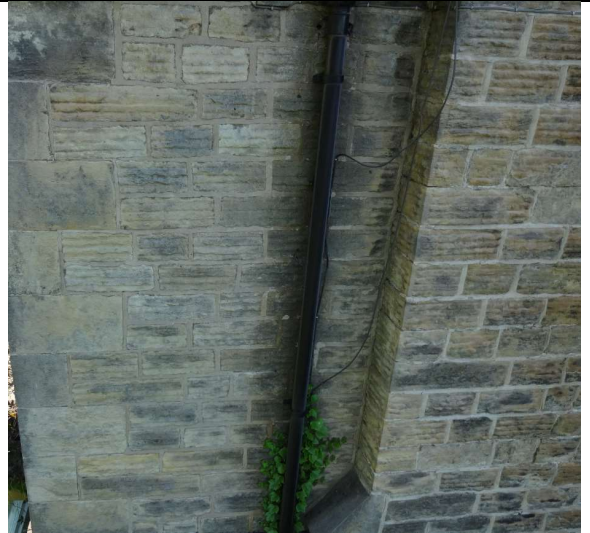
Front elevation – we cannot see how this hopper is affixed to the house; it may be just supported on the fall pipe.

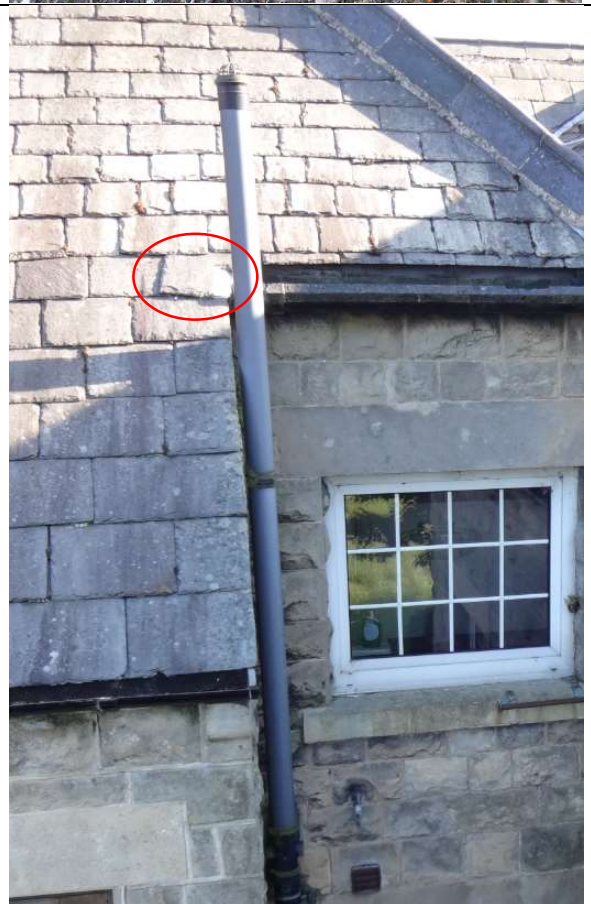
One of the connections on the abovementioned pipe may also be leaking as there is a lot of moss and algae around the branches and bossing.

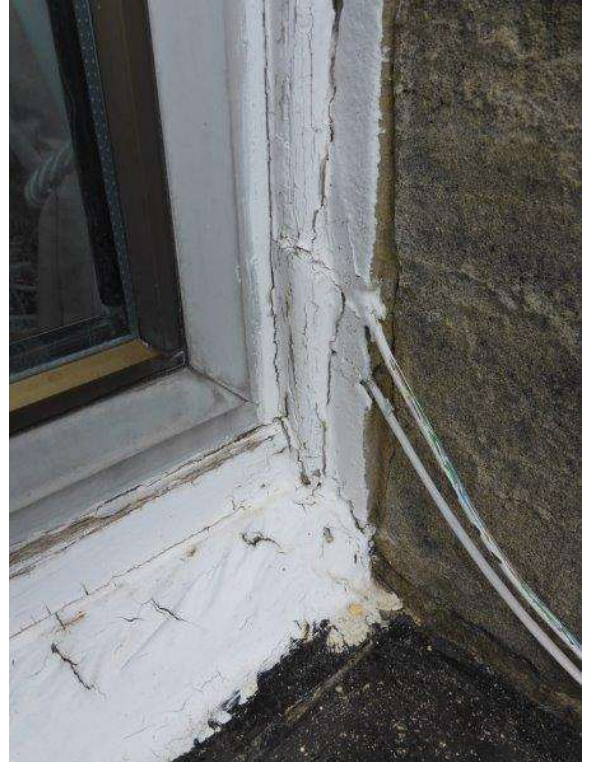
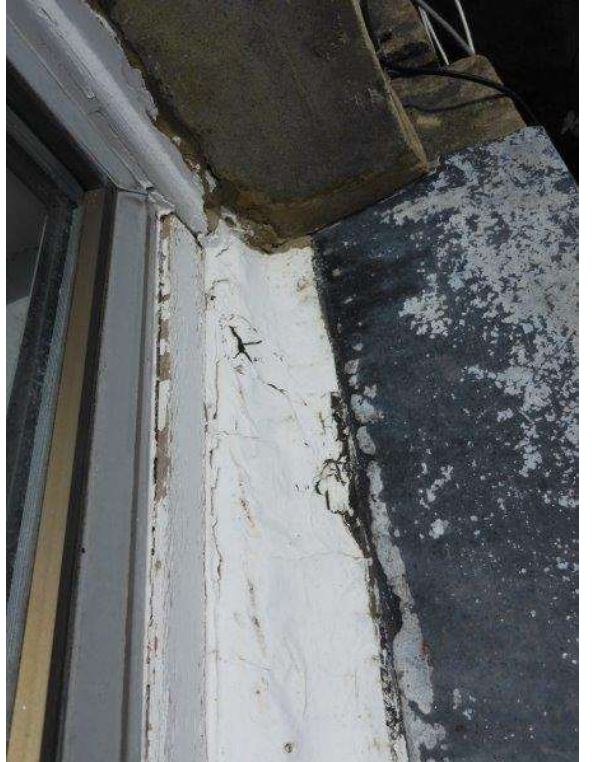
Example of timber detail at the base of the window that needs redecorating.

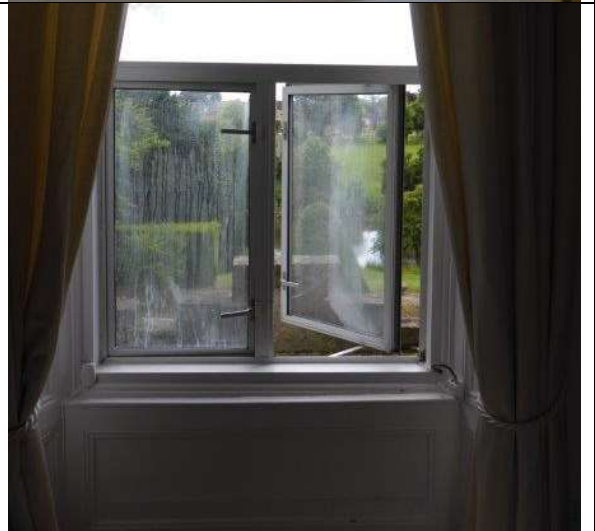
The en-suite bathroom to bedroom three – the window is very stiff and we did not want to force it open beyond this point. The mechanisms should be lubricated and left before trying to open it further.

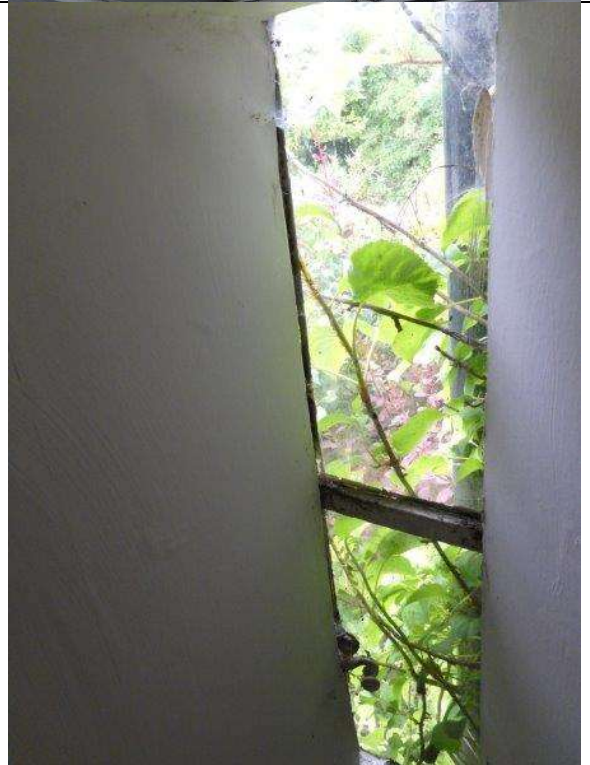
Rear attic storeroom (above the kitchen) – there have been numerous attempts to repair the leadwork around the windowsill

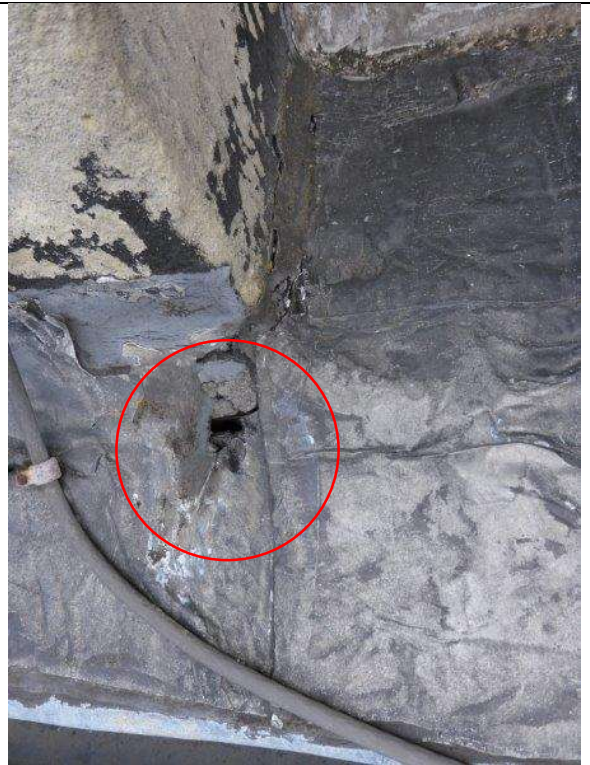
Split seal on the second-floor bathroom window frame. This window does not fit in the frame particularly well.

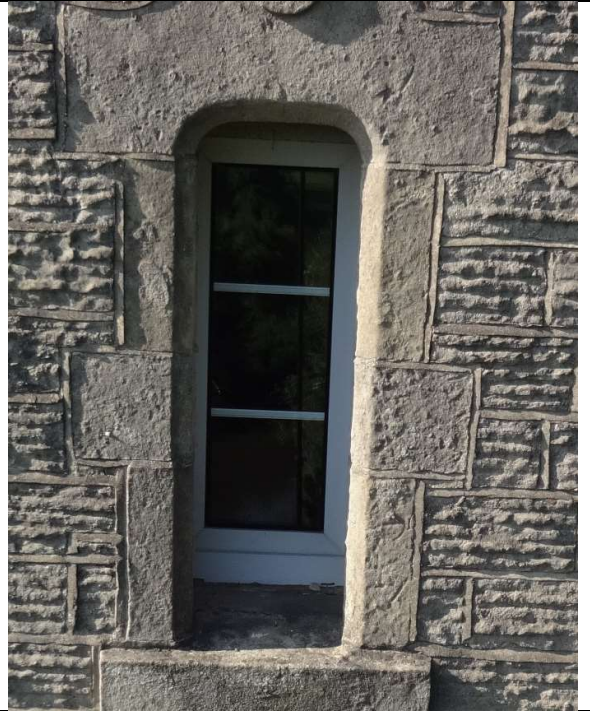
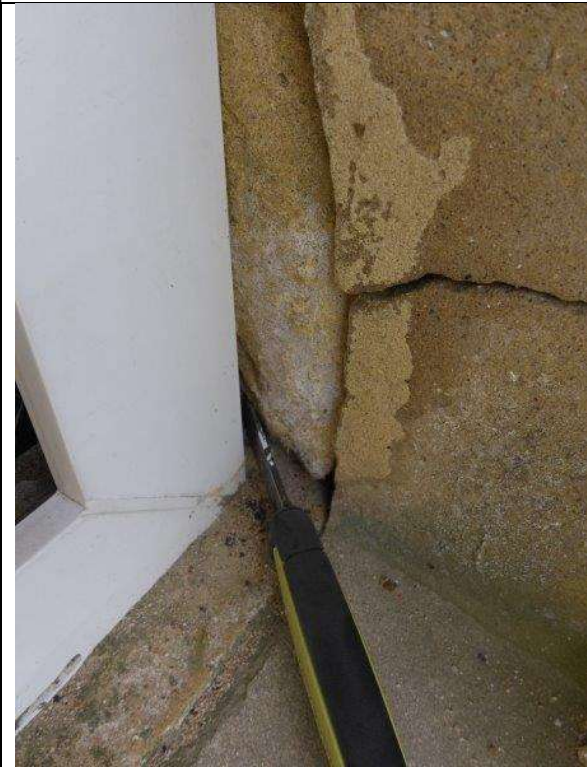
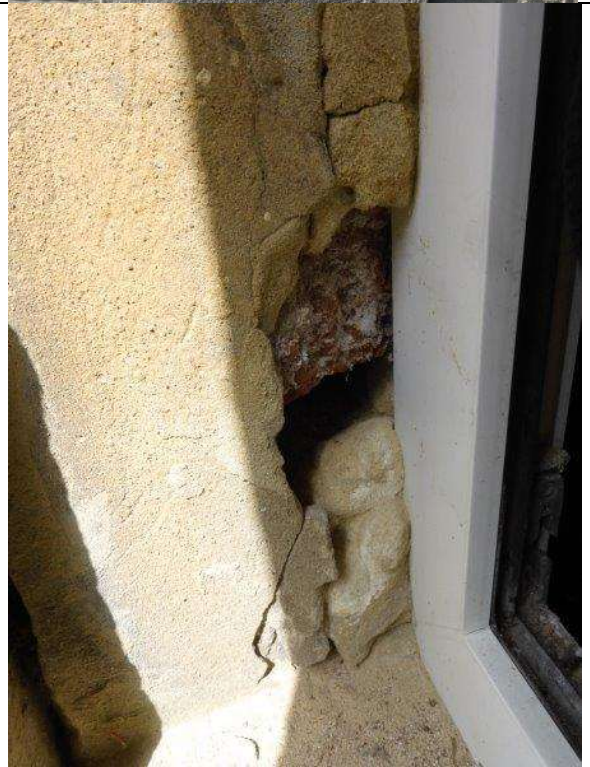
Photos below show the gaps around this window frame.

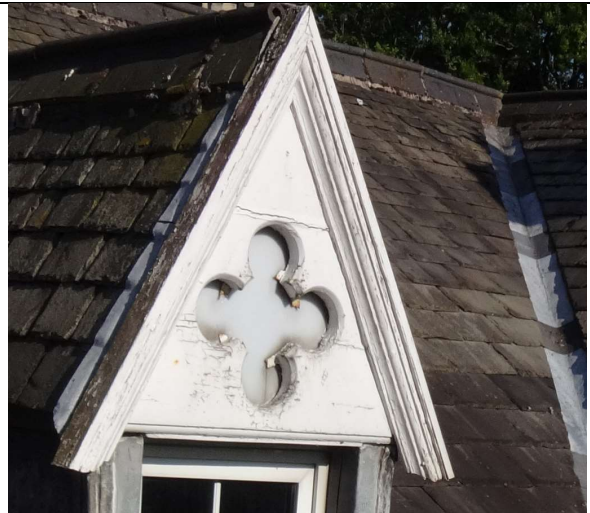
The cupola on the garage roof is looking a little worse for wear and should be redecorated in the next couple of years.

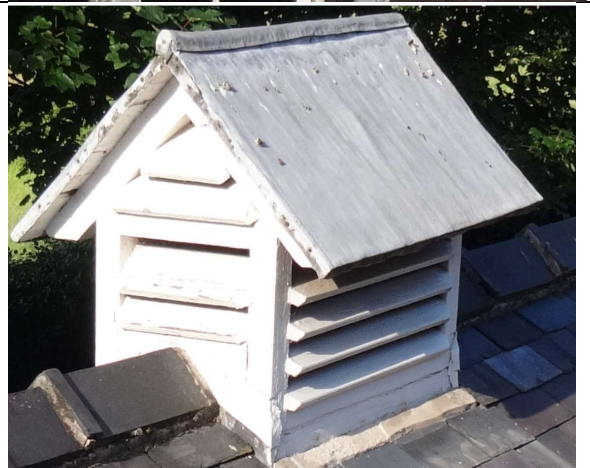
Patination oil should be used on the lead to prevent lead oxide from washing onto the slates below as can be seen in this photo.

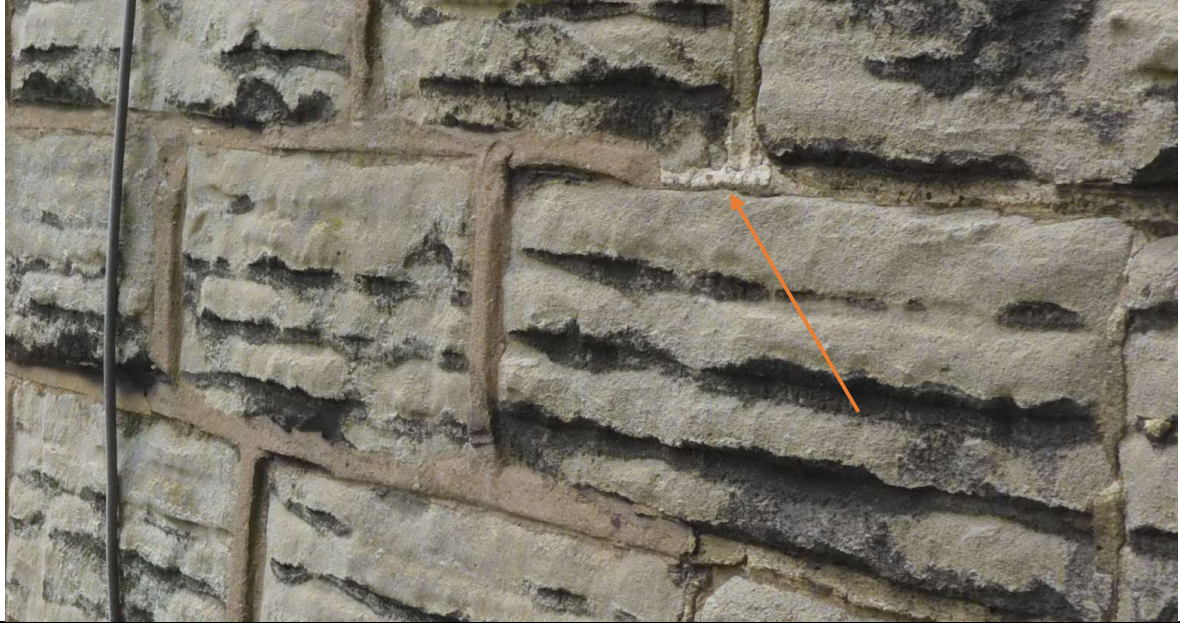
On the photo below note the more recent repointing in a 'strap/ribbon' style over the top of the older lime pointing (orange arrow).

Looking at areas where the pointing is coming away, it does not look like the repointing has been done particularly well in places. Joints need to be raked out to a minimum of 25mm or twice their width. In some places, it looks like the re-pointing mix has been applied straight over the older mix without any raking out. Where there is no pointing, repairs should be carried out in the short term, before winter 2021.

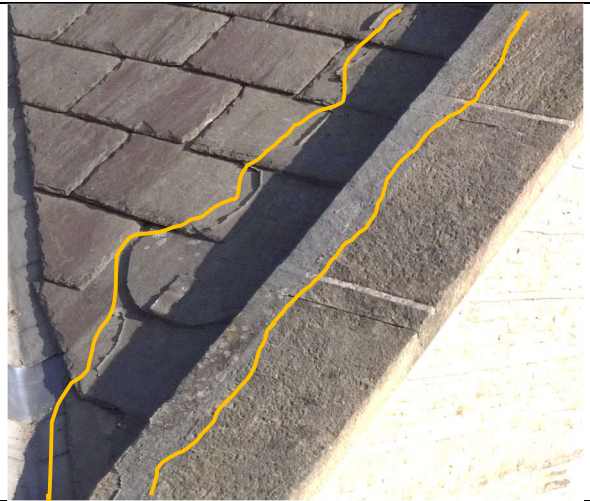
Also in this area, two of the lead joint flashings have been removed and the joints filled with mortar. We recommend that the flashing pieces are replaced to match the rest.

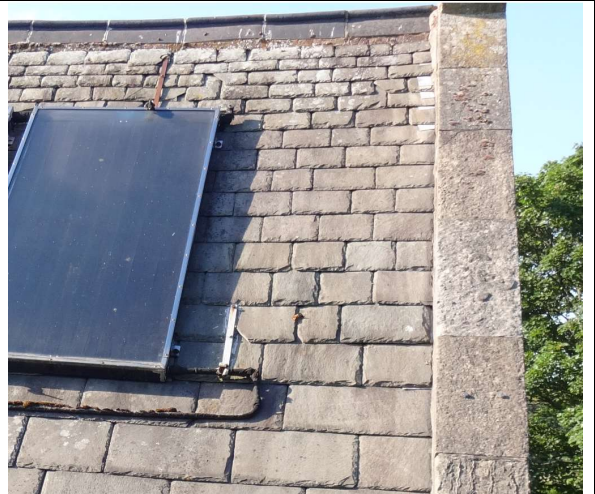
Above bedroom two - note the absence of the lead detailing on the joints between the coping stones.

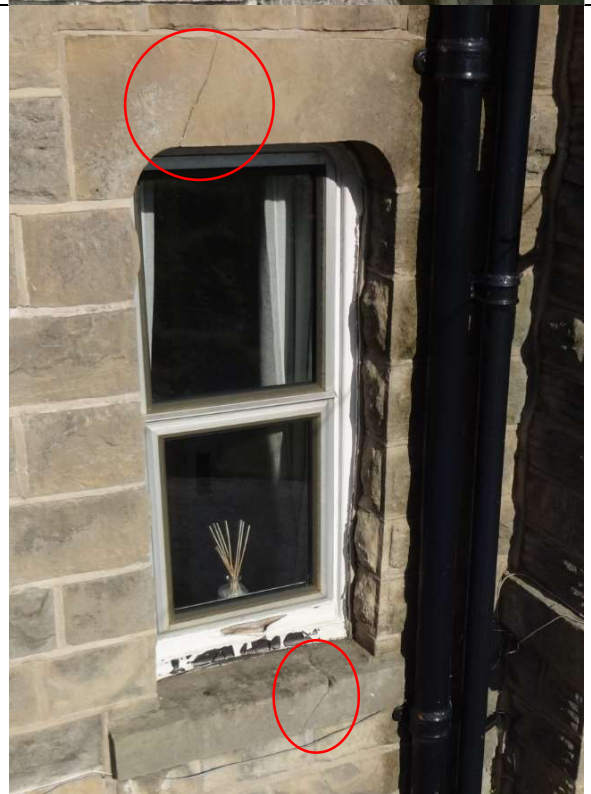
This is the windowsill under the left-hand elevation of the dining room. There is a wethered crack to the sill and some erosion to the stone.

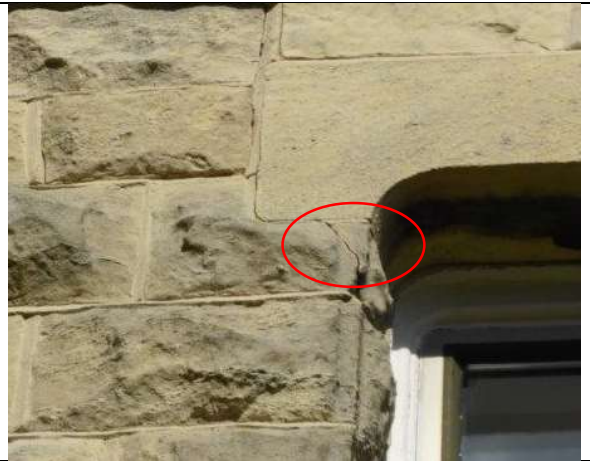
There is a missing section of pointing on the string course under the abovementioned bedroom. We recommend that this is repointed before winter 2021.

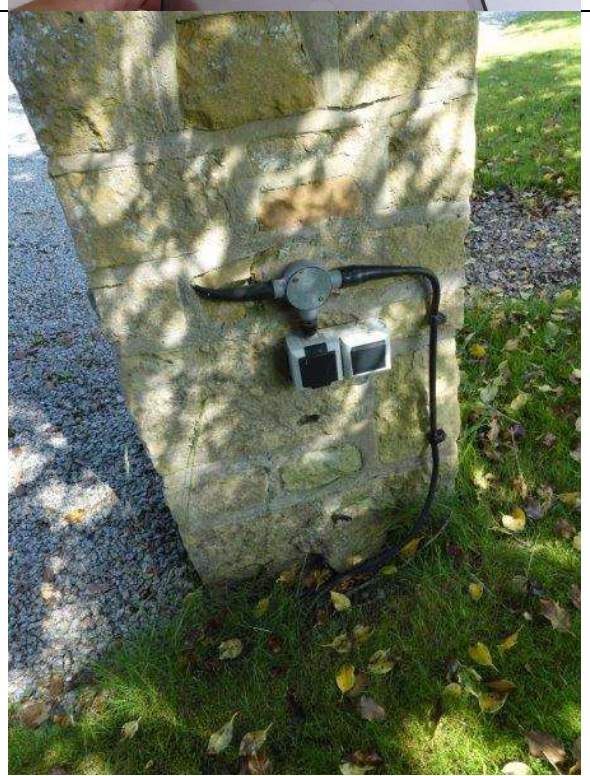
The distribution board in the garden – looks in a precarious condition.

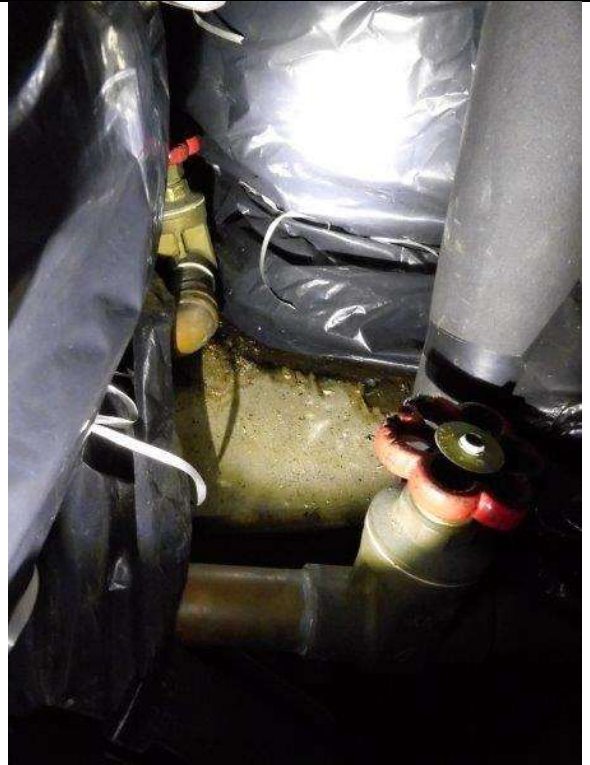
The overflow from the tank room stops well short of the ground below. If a constant leak developed, this could lead to a penetrating damp problem in the W.C. below.
