Inspection Summary

Halifax

Report produced by Simon Hollis MRICS

7th September 2021

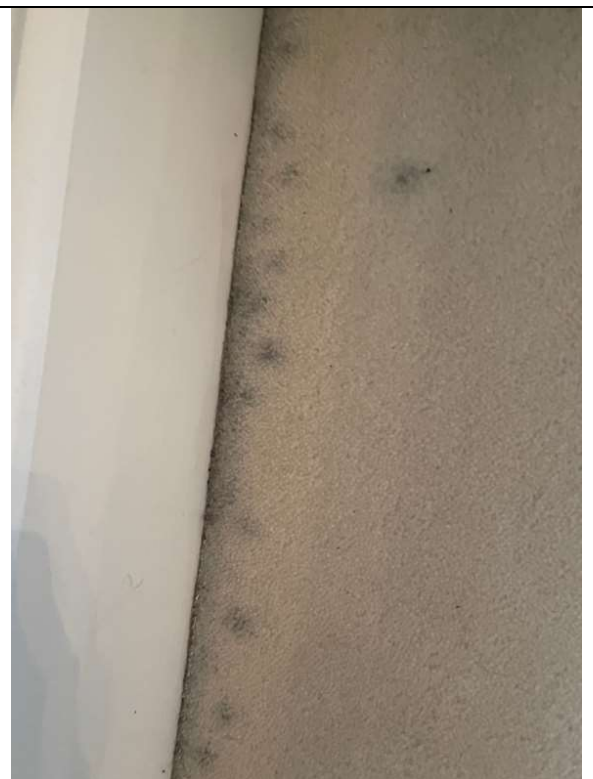
These dark spots around the perimeter of the carpet are marks where the teeth on the gripper rods holding the carpet down are corroding and this is then staining the carpet as it gets damp.

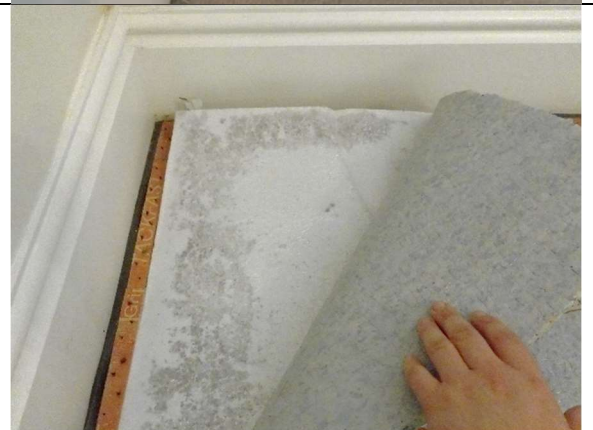
Example of mildew on the top side of the thermal underlay.

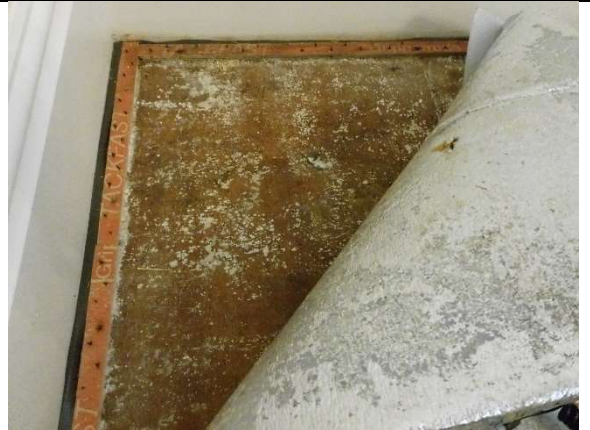
Example of mildew on the back side of the thermal underlay.

When the issues have been resolved, we do not recommend that the thermal underlay is reinstated.

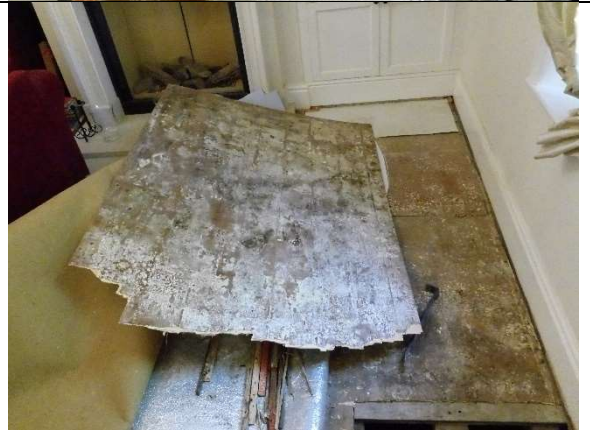
Example of plywood sheeting that has white mould and mildew present all over its surface.

When the issues have been resolved, we do not recommend that plywood sheeting is put back down.

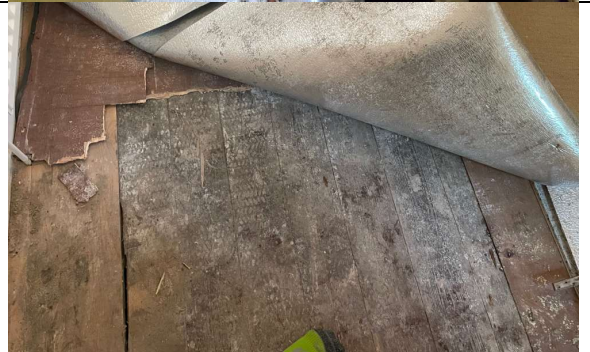
Example of mould on the floorboards under the plywood sheeting.

Once the various layers above this have been removed, this can be cleaned off with a 1:10 solution of household bleach and hot water.

Usual health and safety precautions to be taken when working with bleach.

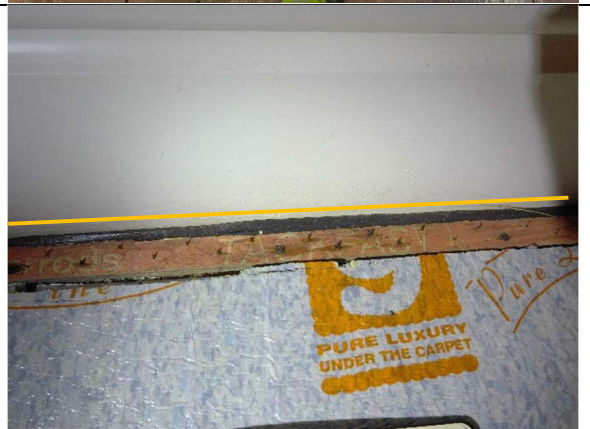
Example of the draft proof strip between the floorboards and skirting boards.

We recommend that these are removed and not reinstated.

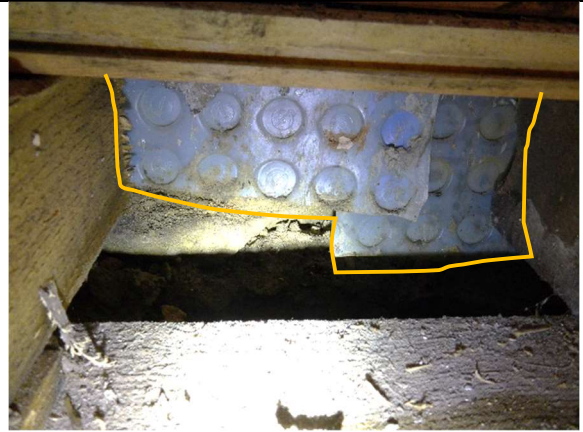
Example of the membrane that has been put against the walls. This membrane was dripping with condensation at the time of our inspection.

We assume that this system has been used along all of the walls and sits behind the plaster. Any condensation that is building up behind this membrane will trickle down it and run into the sub-floor void from where it is struggling to escape. Repointing the external mortar joints will assist the wall in managing its moisture and reduce condensation problems as the drier wall will be able to better use its thermal mass to hold heat.

Whilst managing the disruption of dealing with the sub-floor area, it would be prudent to consider whether or not to remove the wall finishes to remove the plastic membrane from the walls. We cannot be certain what sort of problems this is causing without removing it, however, this system is not something that we would recommend is present in a traditionally constructed building. As noted above, the membrane is dripping with condensation – this may be building up in the membrane up to ceiling height or it may be water vapour rising up from the sub-floor and thus not go all the way up.

Should you decide to do this, we recommend that the walls are built back up in non-hydraulic lime plaster. Usually, this is built up in three coats, however, if the stone is flat, you may be able to just use two coats. Once the walls are dry, the thick stone will provide good thermal mass and retain heat (when the wall is wet, its u-value increases and it becomes very hard to heat the room). If you wanted to increase the insulation properties of the wall, you could put a coat of lime plaster and hemp shiv on the wall. If you are considering this, I am happy to discuss this with your builder, ██████████. Once the plaster has carbonated, it should be redecorated with clay-based paint e.g. Earthbourne.

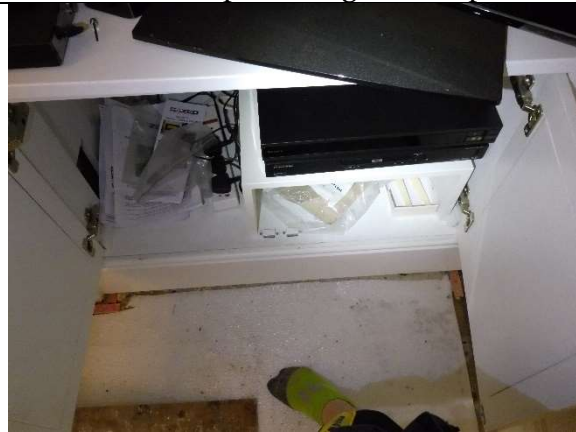
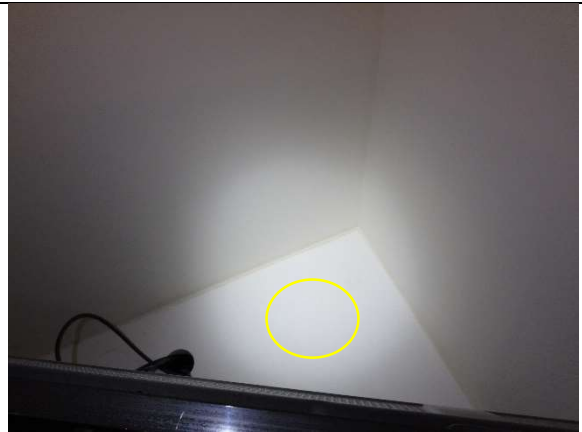
Below are two photos of the television cabinet. It is important that built-in furniture has ventilation to it too. A vent should be created in the base of the unit and also on the top, this does not need to be anything fancy, a decorative vent could be bought and then holes cut to the size so they are obscured from view, but still serves their purpose e.g. it could go behind the television as per the right-hand photo.

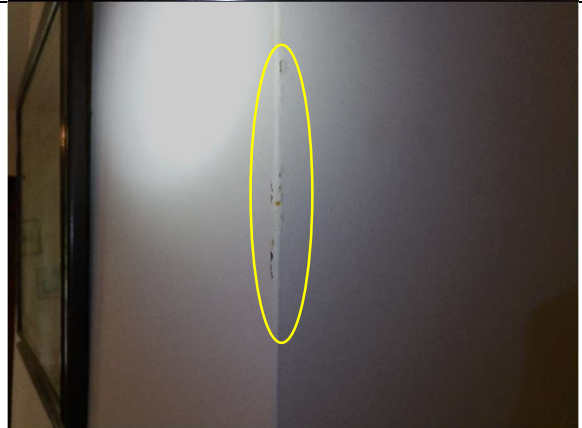
Moisture is getting up behind the plasterboard bead and causing corrosion of the bead. This is a difficult problem to cure as corrosion staining is very difficult to eradicate, especially where there is still moisture present.

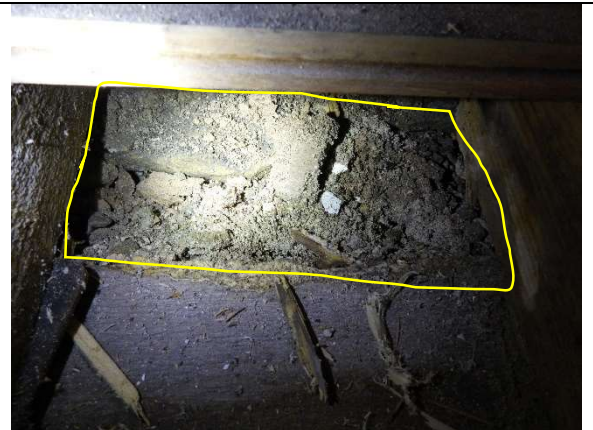
Inbetween the external wall and the right-hand timbers (other areas may also be affected) there is sopping wet dirt/debris packed up against timber. This has probably got wet due to the condensation dripping off the blue membrane that is behind the walls.

All of this debris should be removed as soon as possible – having wet dirt up against timber will cause decay.

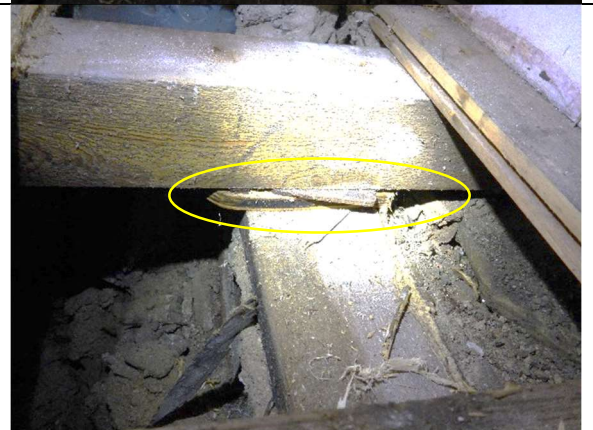
Timber is packed up on timber, this is not ideal and the timber would be better packed on slate.

As there is so much moisture in the sub-floor area it is difficult to tell exactly what is going on here, however, the packers are saturated.

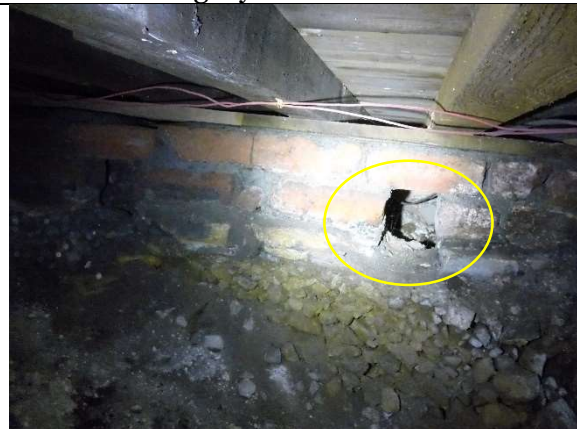
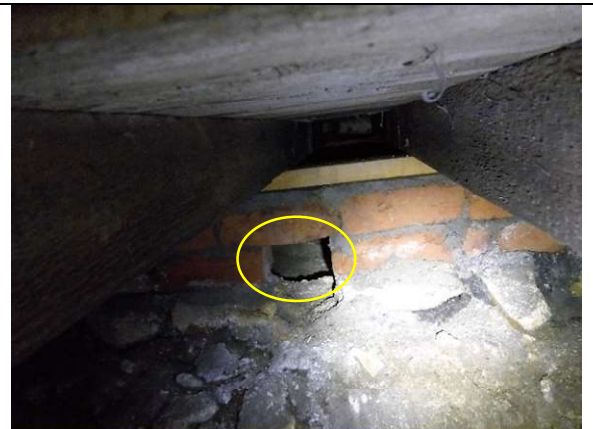
In the sub-floor area, sleeper walls support the floor joists mid-span so that they do not have to be as deep as they would be without support. These walls are usually built in a honeycomb formation to allow a better cross flow of ventilation to the sub-floor area. Here, there is just the odd gap between the bricks. This, combined with the inadequate ventilation is contributing to the build-up of moisture. When the floor is lifted, it would be a good idea to increase the gaps in the wall, as long as doing this does not compromise its structural integrity.

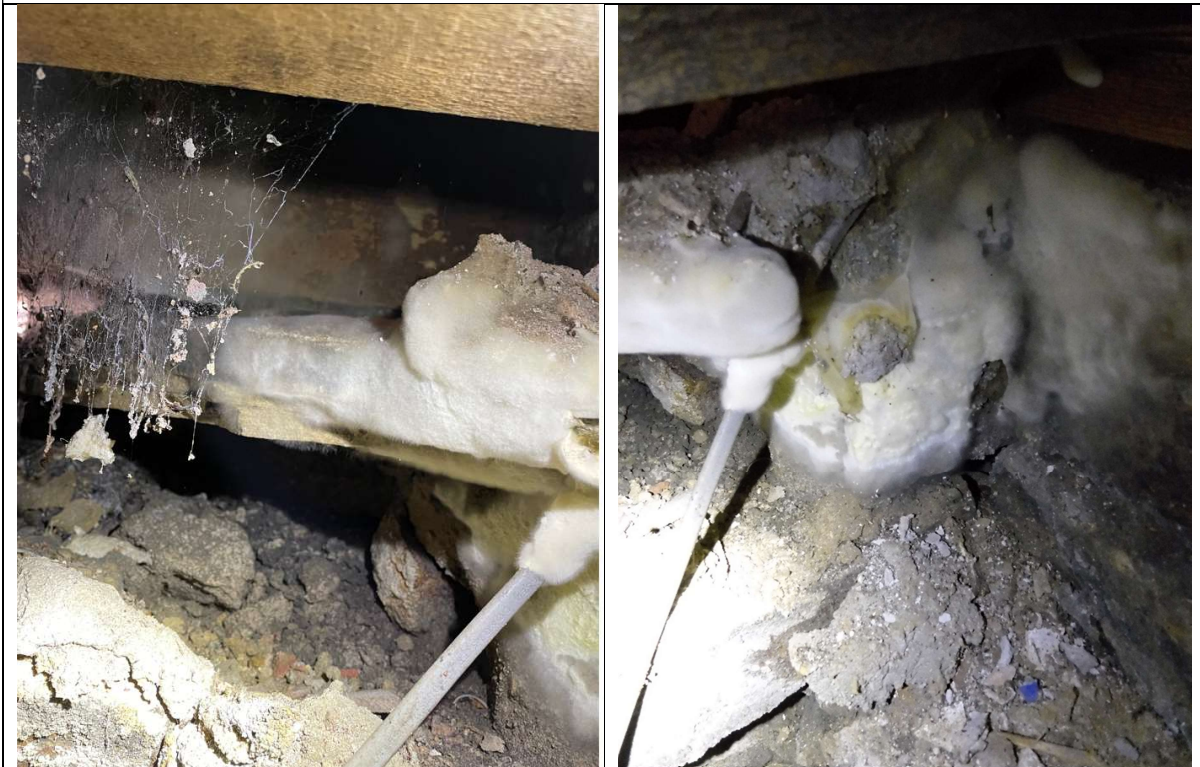
Underneath the left-hand of the two inspection hatches, there is an area of dry rot, note the yellow tinges to the fungus.

Whilst the timber is still wet, it is not possible to determine the extent of the damage. At the moment, the timbers still look in acceptable condition; however, they may distort and crack as the timber dries out and some cutting back/support may be necessary.

In the first instance, the treatment for this needs to be to reduce the humidity in the sub-floor area, which ranged from 90.6% - 95.6% at the time of inspection (and with the hatches open to the room). Cutting off the fungi's access to moisture is the most effective way to stop it from spreading. We have detailed this further down.

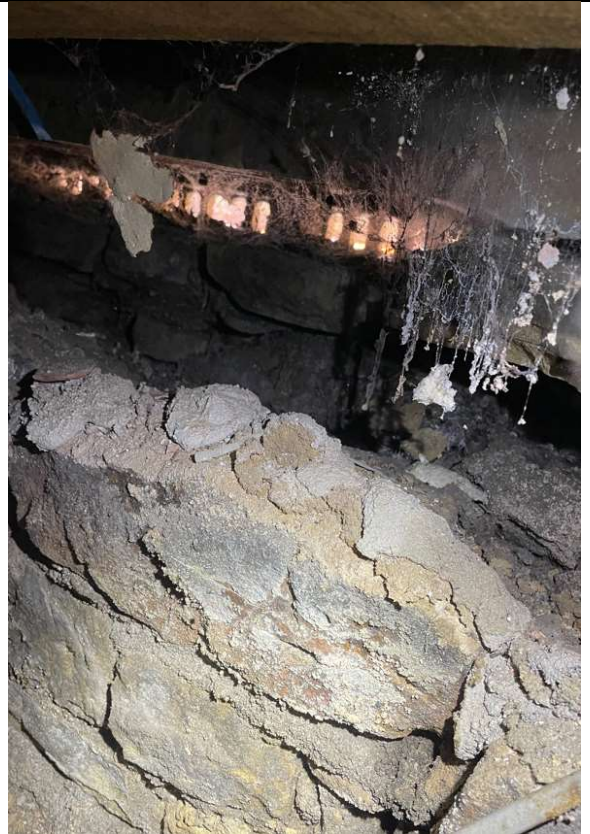
There is debris in front of the rear sub-floor vent and part of the inner leaf of stone is missing.

We recommend that this area is cleared and the stone re-built.

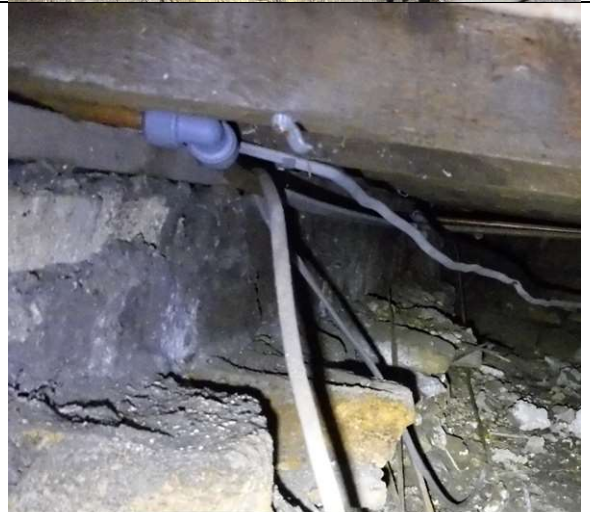
Pipes in the subfloor area are not lagged. This cause condensation to form and drop down onto the ground beneath and pond.

All pipes in the sub-floor area should be lagged (and electrical cables properly clipped up to joists).

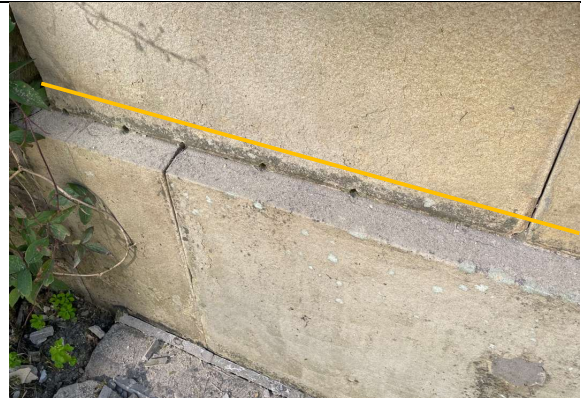
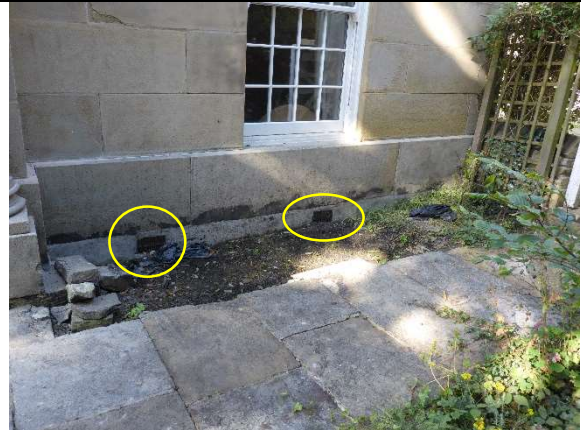
To the front elevation, there are two air grills to ventilate the sub-floor. This is not enough and a third should be fitted to this elevation as a minimum.

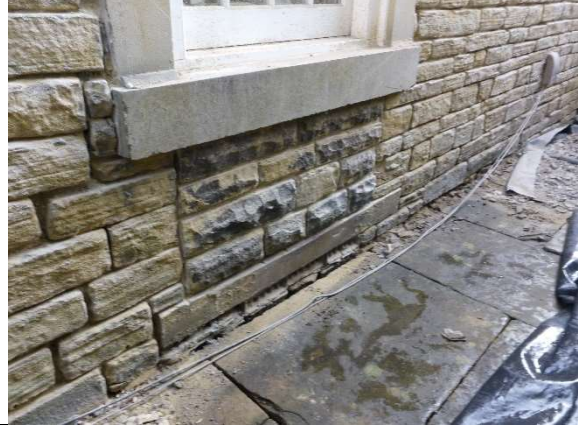
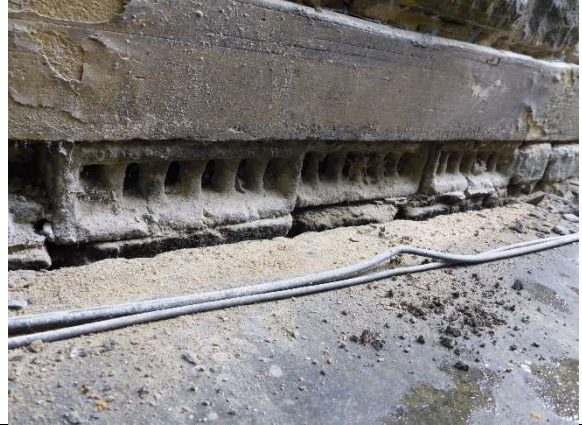
To the rear elevation, there are three small air bricks under what was the old doorstep. Again, this is not sufficient for a room of this size that only has ventilation on two sides.

First, the internal area in the hatch should be observed during heavy rainfall to ensure that rain/surface water is not getting into the sub-floor area when it rains. If it is, then a plan needs to be formed on how best to deal with this. You could mimic this with a hosepipe and spray gun.

Second, you should speak to your builder to see if they can put in two additional vents close to either end of the wall.

It would be good to get to the point where there is at least 1 per meter.

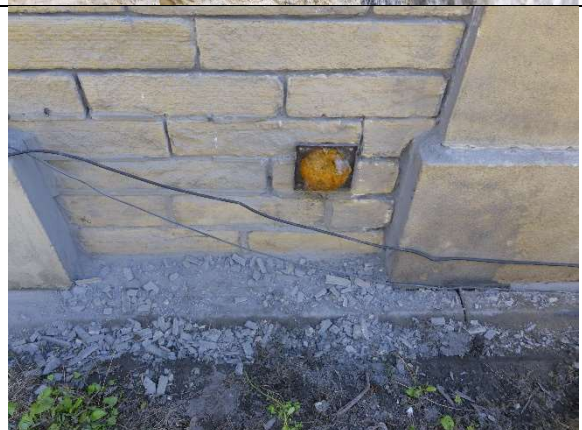
There is a redundant vent in the living room that comes out behind a radiator. This has been filled externally with expanding foam and internally with the surface finishes in the room. As it is behind a radiator, it is difficult for this to be opened back up to serve its original purpose of ventilating the room.

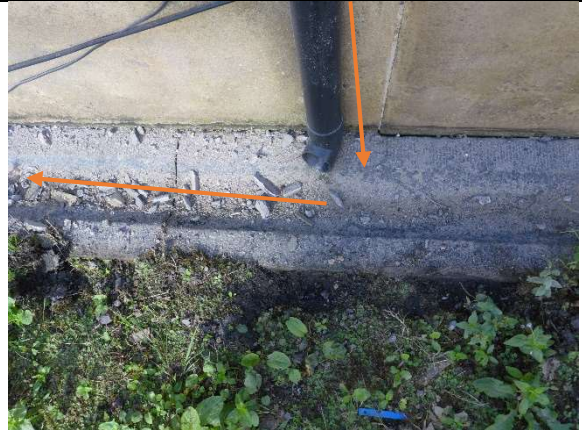
Rainwater from the roof comes down this fall pipe and runs along this open gully.

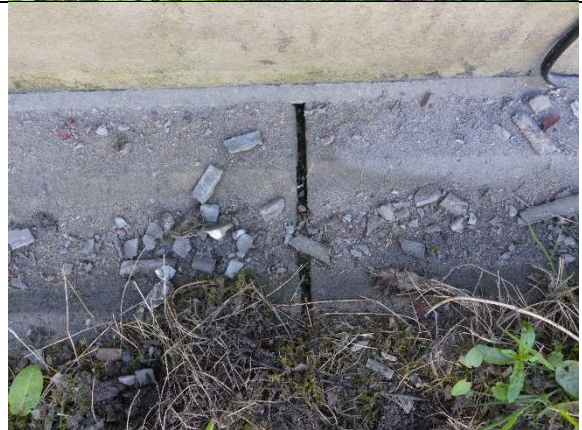
There are gaps in this gully that will cause rainwater to go down around the footings of the house. Some of this water could be getting through into the sub-floor void. All pointing should be carefully removed and the gully repointed in a flexible mortar mix.

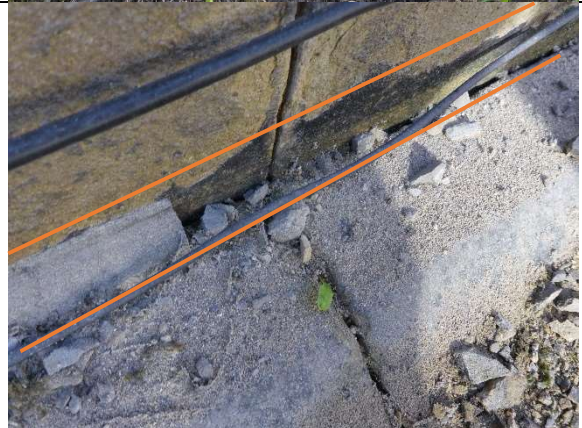
There was previously a wethered mortar fillet between the base of the wall and the gully. This has disappeared in places. We recommend the remains are removed and the fillet reinstated in a non-hydraulic hot lime-based mix.

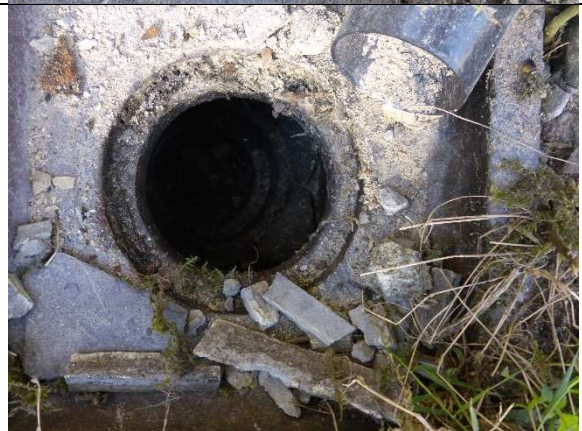
There is some debris in the gully. This should be cleaned out to aid its operation and prevent a blockage further down the drainage system.

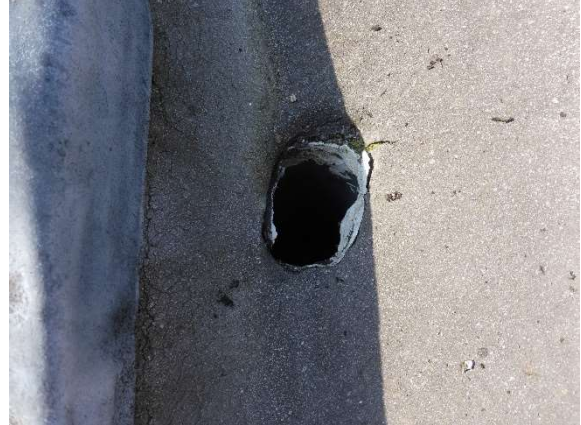
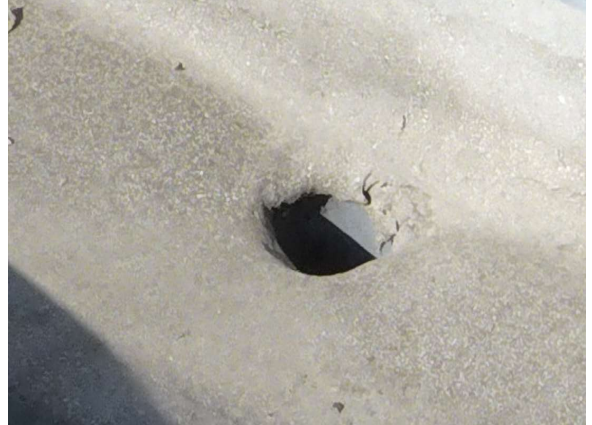
Whilst we were on site, we had a quick look on the roof. The perimeter is formed in hot asphalt which is not uncommon for a roof like this. Lead would be better. Some of the outlet details do not look like they have been very well-formed. For example, the one in the photo on the left does not have the asphalt detailed into it, the one on the right does. Rainwater could be getting down the sides of here and leaking internally. A plan needs to be formed on the best way to repair this. We are not experts in this type of roof, but could research repair options if you like?

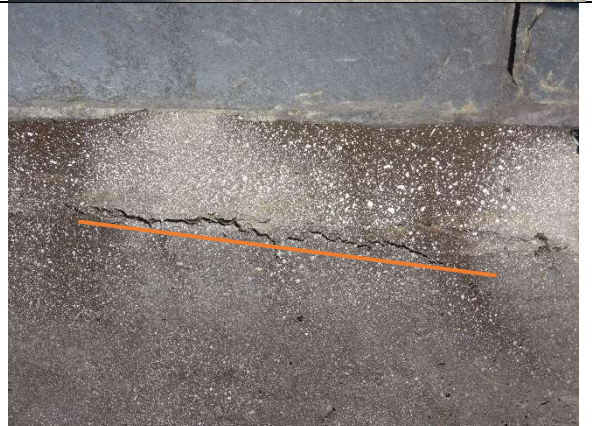
There are also some cracks in the asphalt that need to be repaired.

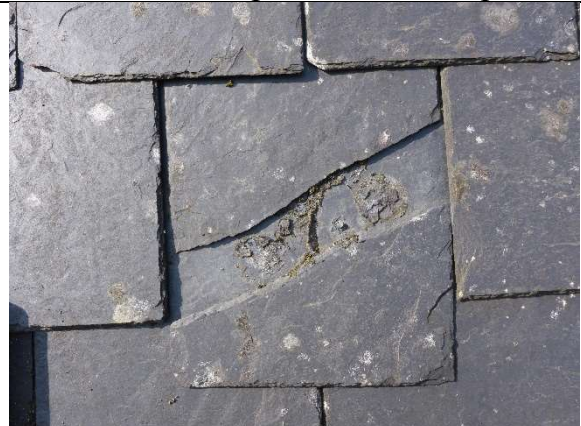
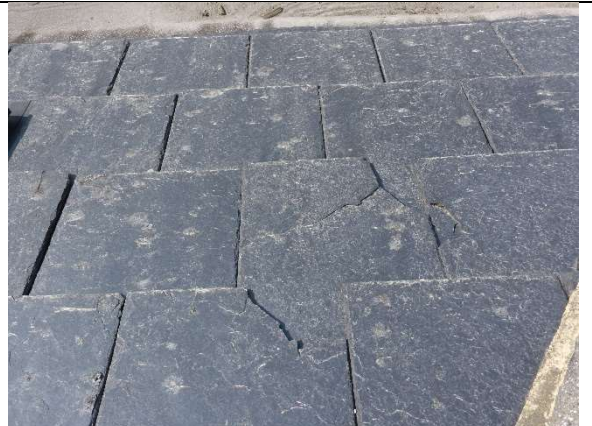
There are several damaged slates, we have included some photographs of examples below. These should be replaced as soon as possible.

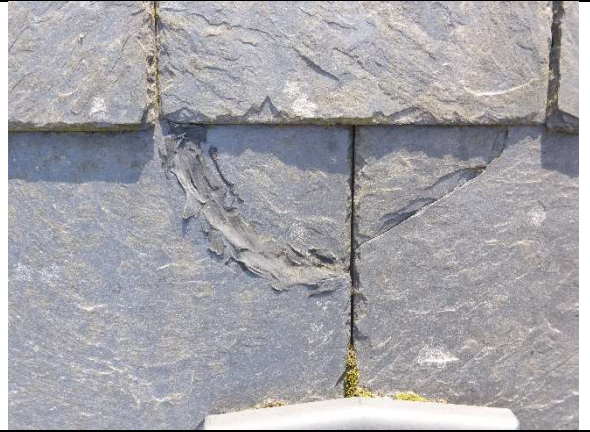
Here, two broken slates have been poorly repaired with mastic. These slates should be replaced as soon as possible.

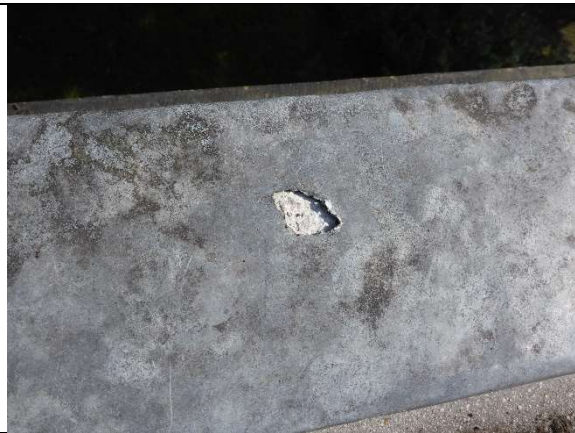
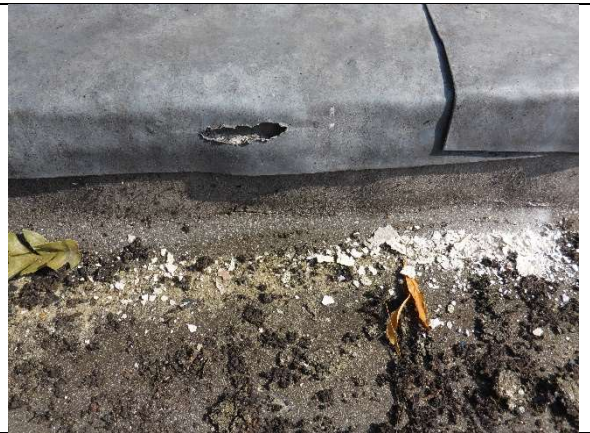
The upstands are dressed in lead. Unfortunately, there are some tears in this which should be repaired as soon as possible. A temporary repair may need to be affected first before the lead can be bossed.

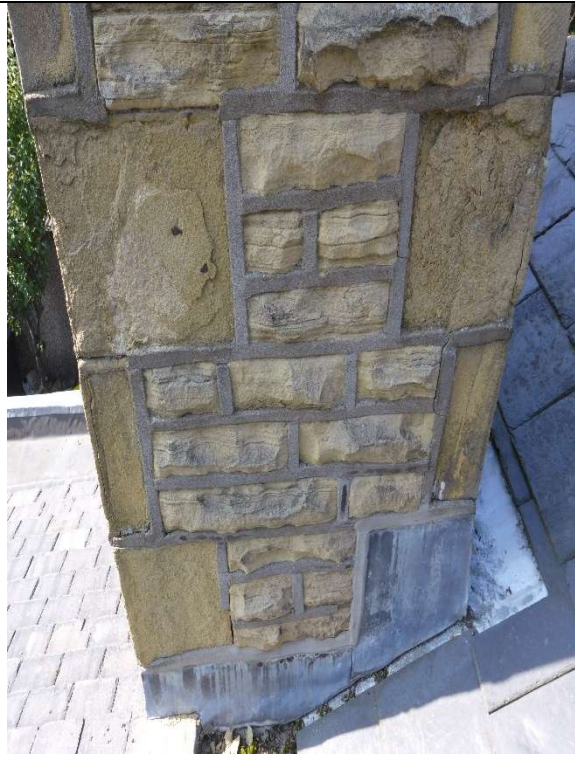
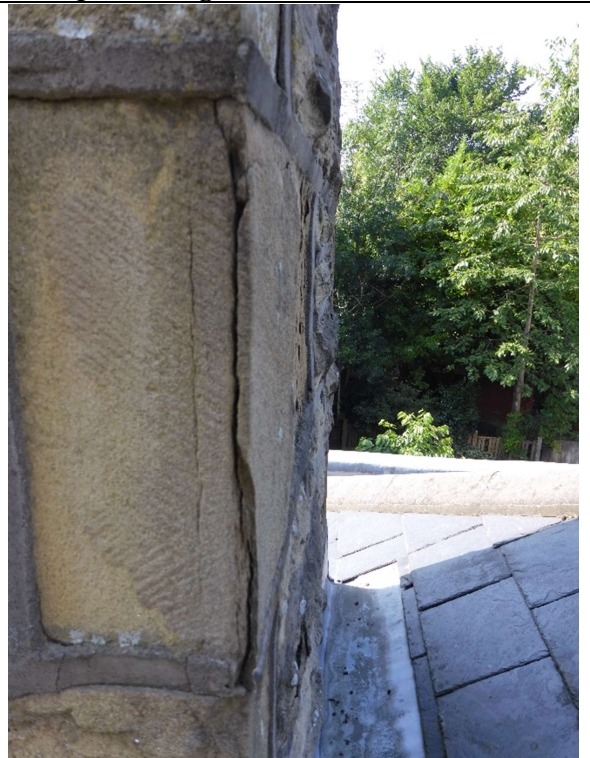
Chimney stack – some of the stones appear to be bedded on their side and have started to delaminate. There is little that can be done about this without re-building the stack. The cementitious pointing should be replaced as soon as possible with a hot lime mix so that the moisture stress within the stack is reduced thus preserving the stone.

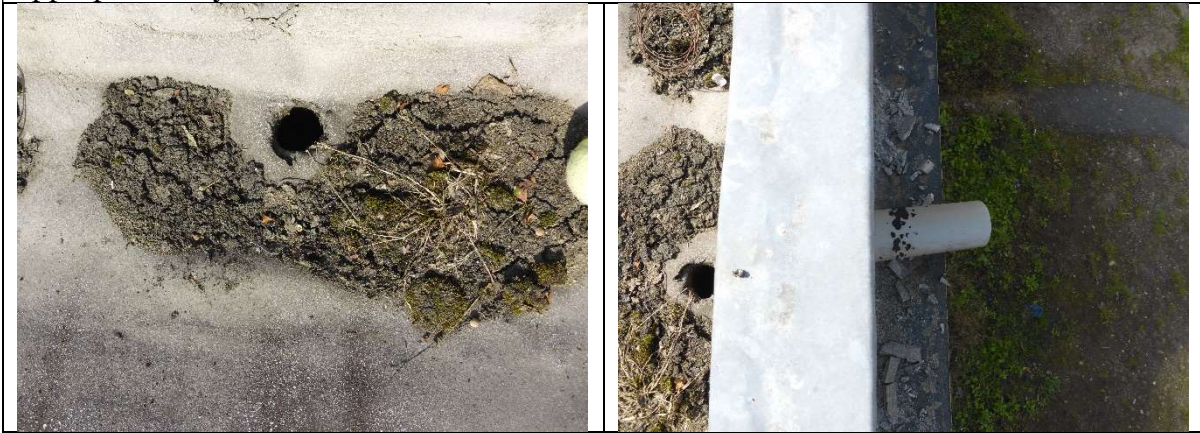
The outlet on the right-hand side is higher than the roof covering meaning water has to be ponding up to it before it can get down the outlet. This is why there is debris built up in this area. Again, asphalt is a specialist area and advice should be sought on the most appropriate way to address this.
