Roof Inspection Report
In respect of:

**Report produced by Simon
Hollis MRICS**

Drone Inspection Report - Summary of Findings

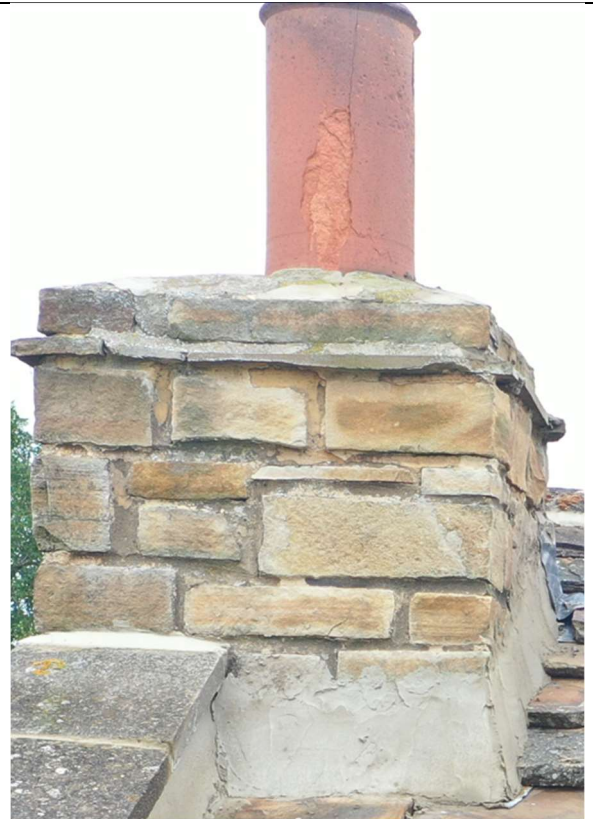
There is a single clay roll-top chimney pot. This is cracked in several places and the fire skin is spalling.

The flaunching is cracked and in generally poor condition. This should be replaced and a non-hydraulic lime mortar should be used for this (a pozzolan will likely need to be gauged into the mix to attain the correct performance characteristics).

The corbelling is damaged and will no longer be able to effectively shed rainwater clear of the stack. The top course of stone and corbelling should be removed and replaced.

From looking at the construction photos and the finished job, it looks like soakers have been installed but no lead flashing pieces (despite there being a chase cut into the stack)?

The standard of the mortar is amongst the worst I have seen this year.

It should be replaced and a vented cap should be added to prevent rainwater ingress whilst ventilating the flue (if it is redundant). If it is in use, the appropriate vented cap should be used for the type of appliance in use.

All of the mortar should be removed and replaced with a lead flashing/soaker detail

and the chase pointed up in a non-hydraulic lime-based mortar.

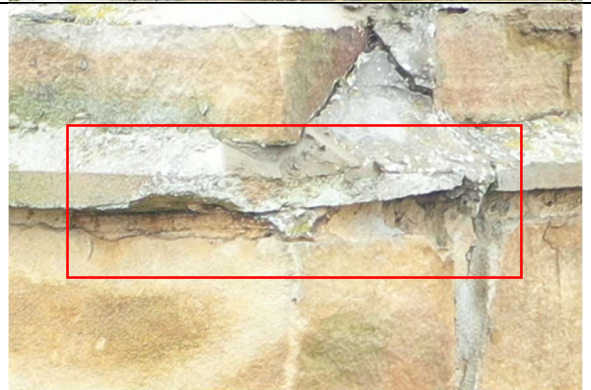
Close-up of flashing during and post-completion.

If there is a flashing under the mortar, this could be described as a 'belt and braces' approach, however, it is likely that the belt would stop the braces from functioning correctly.

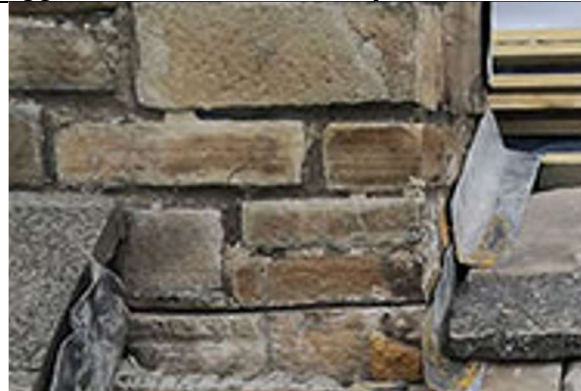
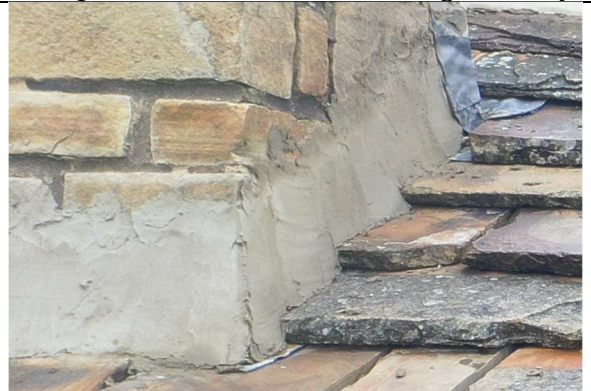
From the construction photos, it looks like there may be more than one layer of mortar at the base of the stack as this photo shows cracked mortar.

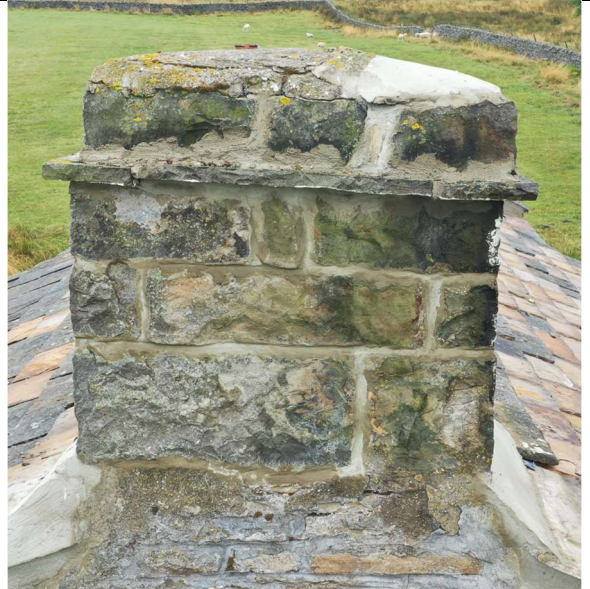
There are no pots, the stack has been crudely capped off.

Half of the flaunching has been replaced, the other half is cracked/lifting and in generally poor condition. This should all be replaced and a non-hydraulic lime should be used for this (a pozzolan will likely need to be gauged into the mix).

The pot (s) should be re-instated with vented caps so that the flue (s) can be ventilated.

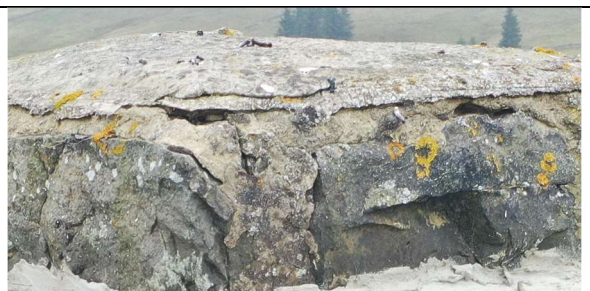
Close up – cracks around the flaunching and poor pointing detail above the corbelling.

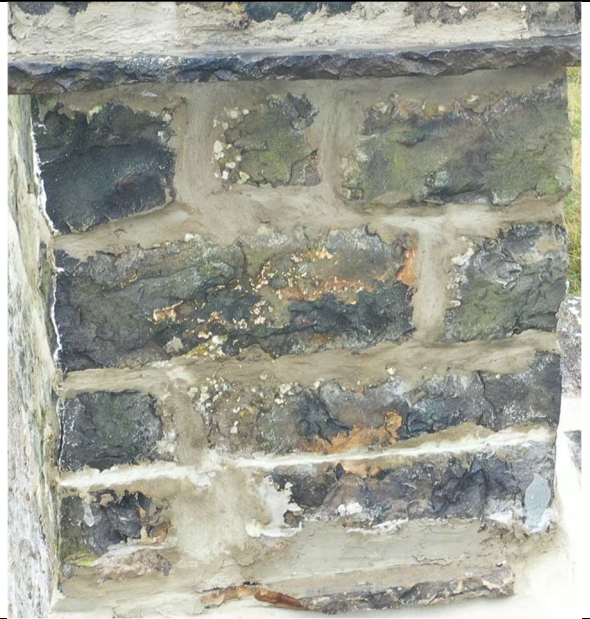
Close-up of the pointing detail on the stack.

There should be a stepped lead flashing and soaker detail and a saddle piece here.

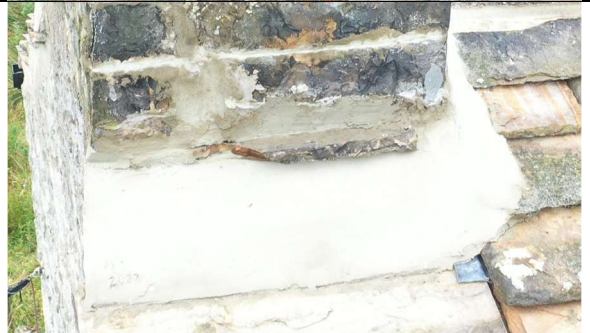
Flashings – there should be a front apron detail in lead on the fronts of the stack. Here, there just looks to be mortar.

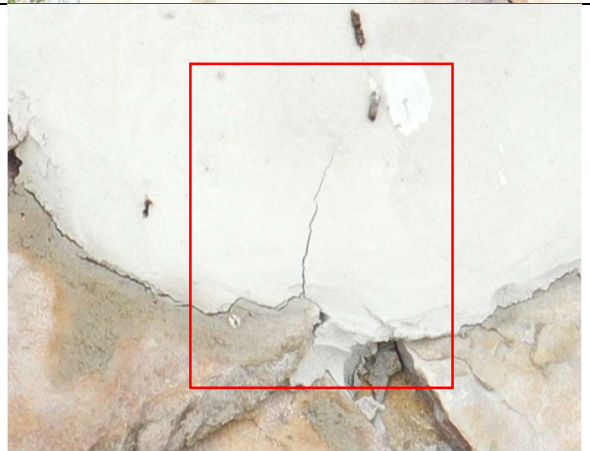
Flashing – example of a hairline crack to the mortar on the front part of the stack.

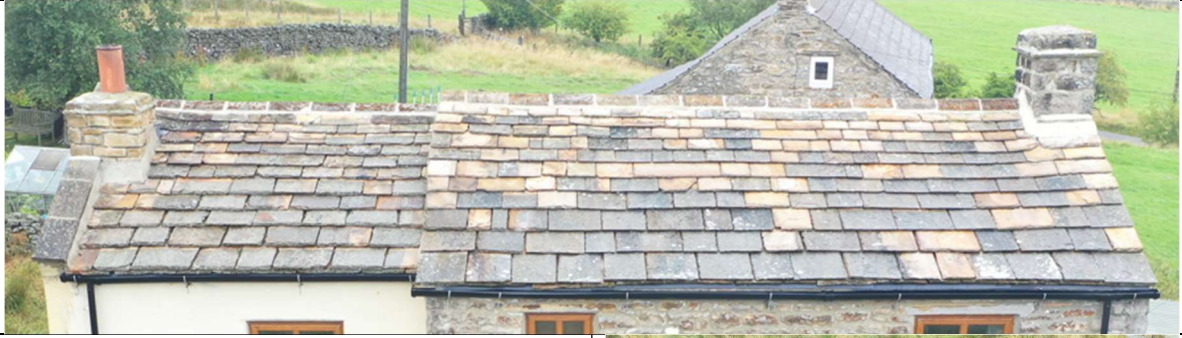
Ridge tiles – the moss should have been cleaned off these before they were re-used.

The moss will trap rainwater against the tiles and when this freezes, the tiles will continue to spall.

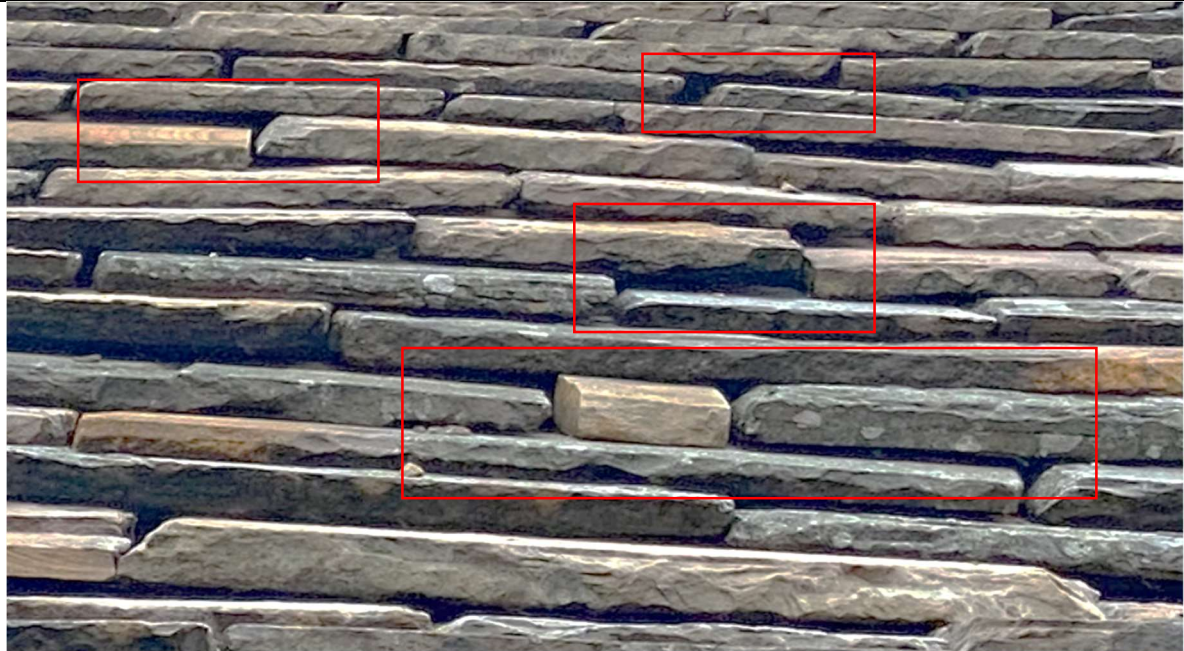
To prevent problems with wind-driven rain (which is likely going to be a problem due to the exposed location of the property), the slate courses need to be laid as flat to each other as possible. In the photo below, we can see some examples of where the slates are not laid flat against each other. This is likely to increase the chances of problems occurring from wind-driven rain.

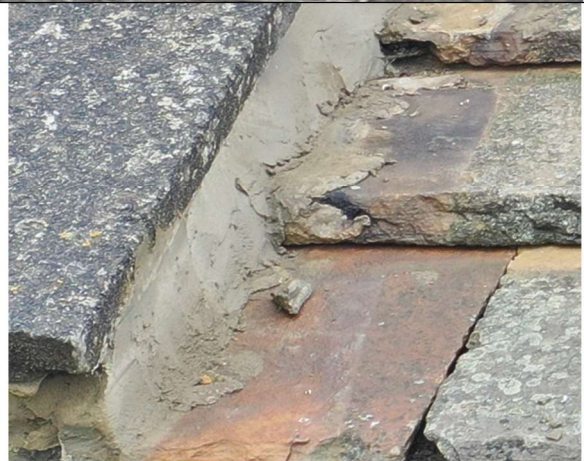
The detailing on the parapet wall is poor. There is no projection on the stones which are acting more as capping stones as opposed to coping stones. I would have expected a contractor to make the client aware of this and provide the option of fitting a wider stone so that sufficient projection (>50 mm) could be achieved.

The finish on the mortar is poor, particularly towards the bottom of the pitch. Detailing this in lead would have been superior.

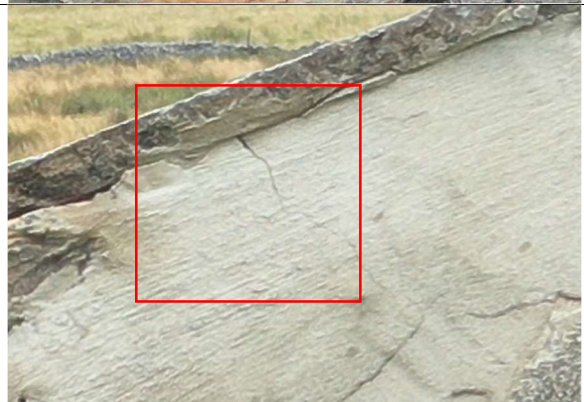
Parapet – example of hairline cracking in the mortar.

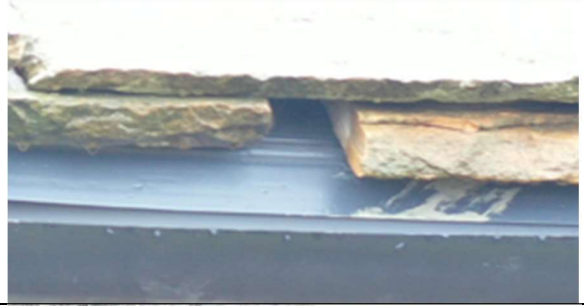
Eaves – the eaves handle the most amount of rainwater so it is important that the area is detailed correctly.

Here is an example of a large gap in between the slates which is not acceptable.

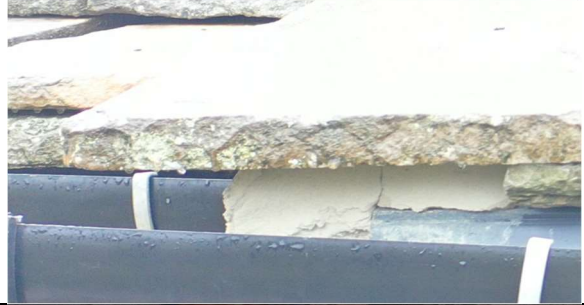
In this photo, the gap has been pointed.

There is a hairline crack in the pointing.

Several sections should be monitored during heavy rain to ensure that the eaves trays deflect rainwater into the guttering and not onto the wall head.

This could also be tested with a hosepipe.

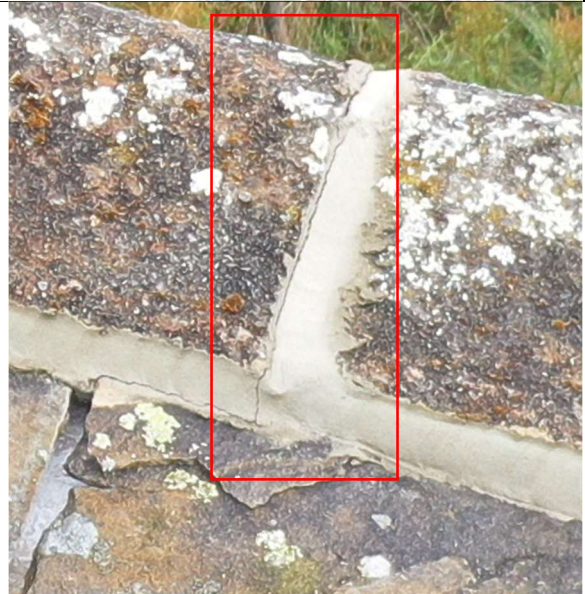
Ridge – example of a hairline crack to the pointing detail.

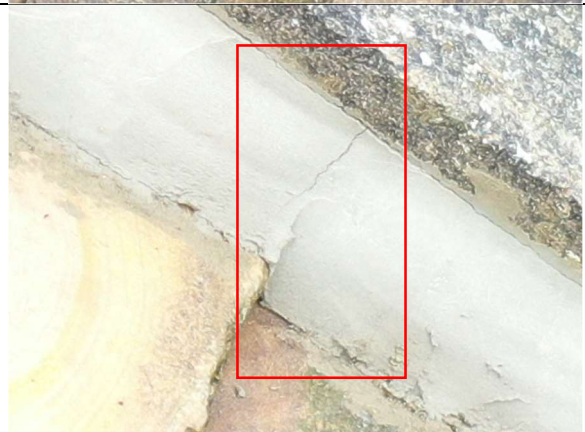
Parapet detailing – example of a hairline crack that has formed in the mortar fillet.

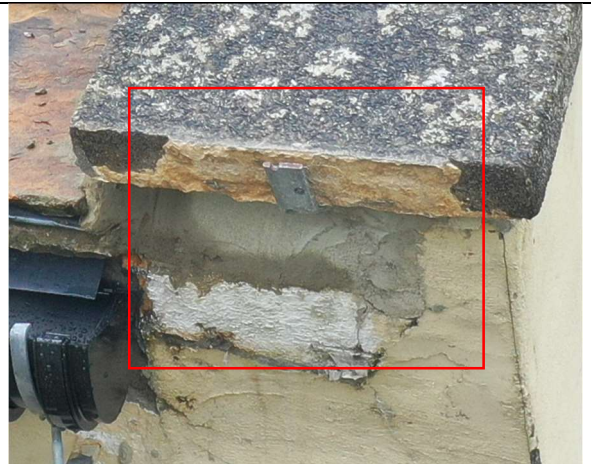
At the foot of the parapet wall, a strap band looks to have been used to hold the stone in place.

On the front pitch, a hip iron has been used.

The pointing detail is not the best.

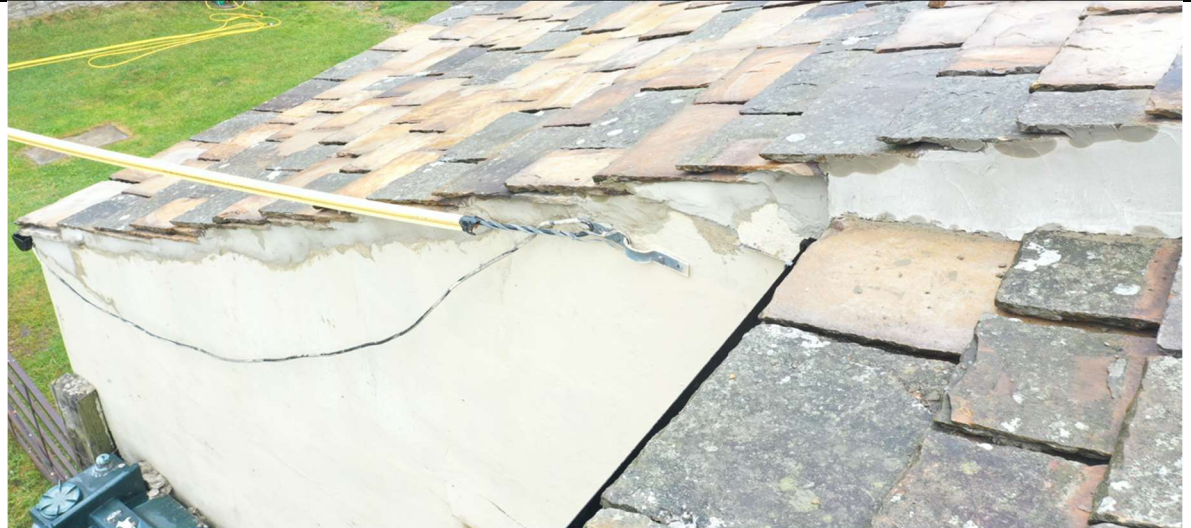
From the ridge down the cat-slide to the eaves, there is no projection on the slates. There should be at least a 50 mm projection on the slates so rainwater can be shed clear of the wallhead.

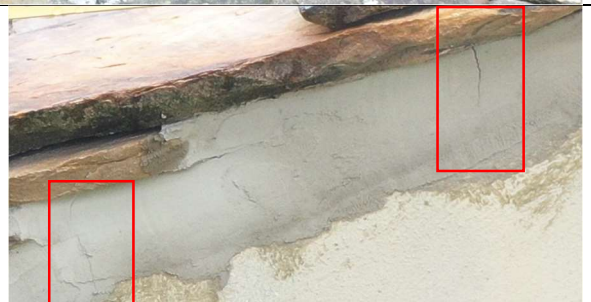
The finish to the pointing is inconsistent in places and there are hairline cracks appearing.

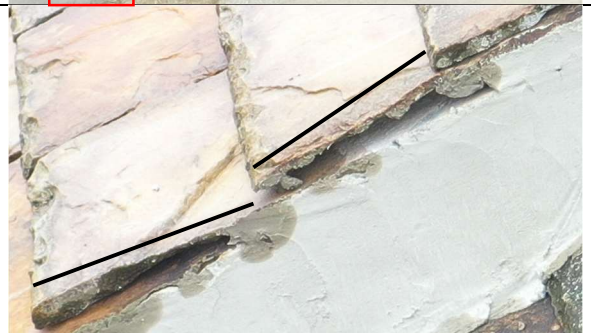
Where there is a step in the roof coverings, there is no pointing in the top of the verge (black line) and we are unsure how this has been designed to manage wind-driven rain.

Note that the mortar is holding in rainwater where the slates lap.

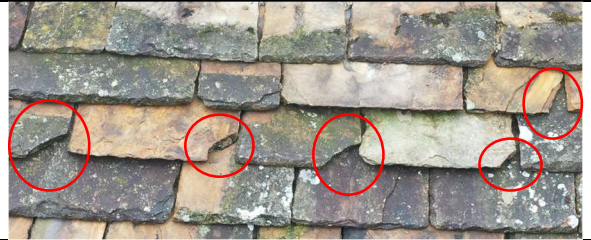
The chipped slates should have been re-tooled to make smaller slates, not put back on the roof already damaged.

This photo is an example, there are several other areas like this across the pitch.

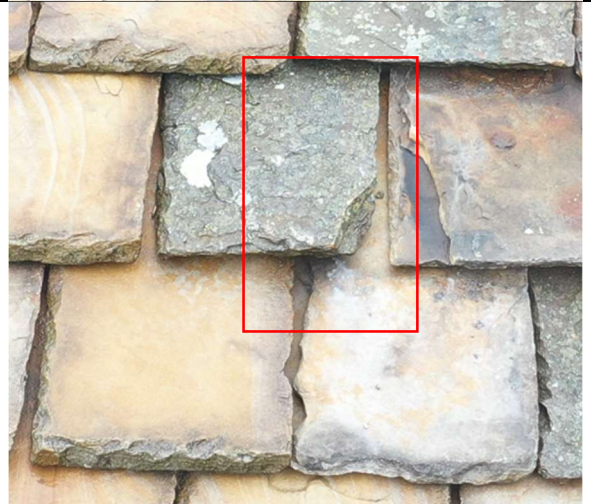
An example area of where the bonding of the slates is not the best, particularly in the red box area.

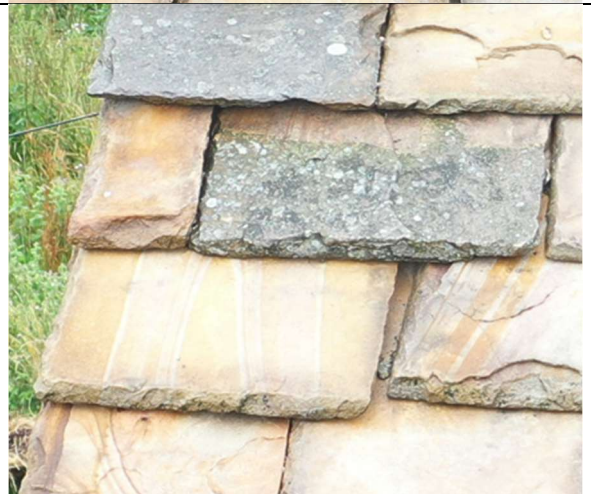
Example of where smaller slates have been used along the verge.

We have not included a photo of every slate that is too small.

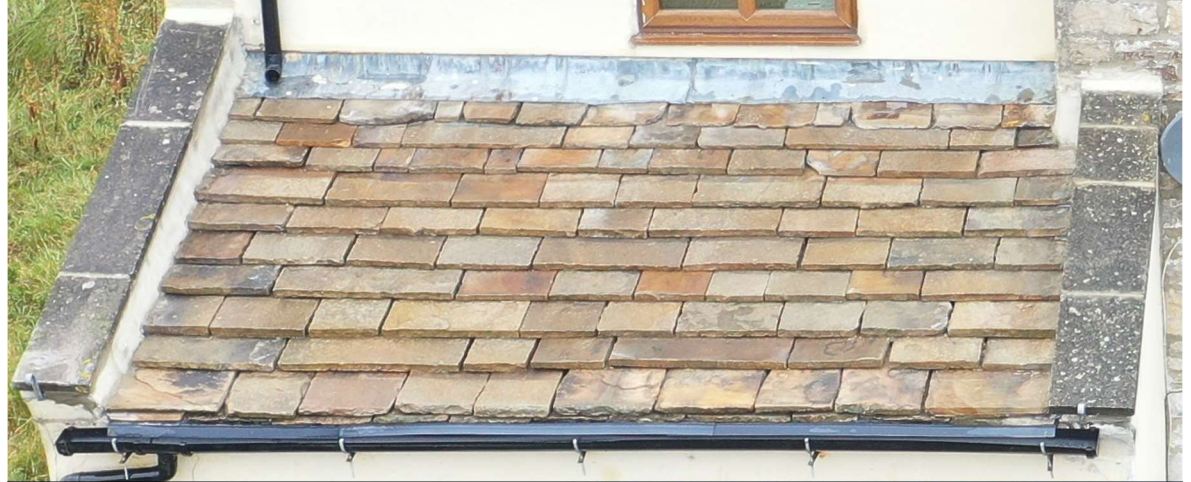
There look to be several problems with this roof.

Pitch – the roof looks like it has a very shallow pitch – this means that it will be more susceptible to the problems caused by wind-driven rain and it is therefore important that the slates sit as flat on top of each other as possible and that the head lap is reduced.

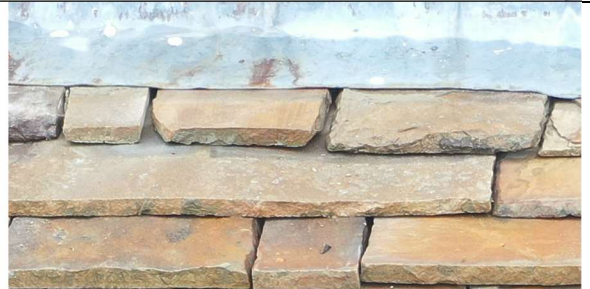
In an exposed location, the lead flashing should be clipped into place, it has not been.

We are unsure how wide this section is, however, the two strips of lead look like they are longer than the 1500 mm recommended.

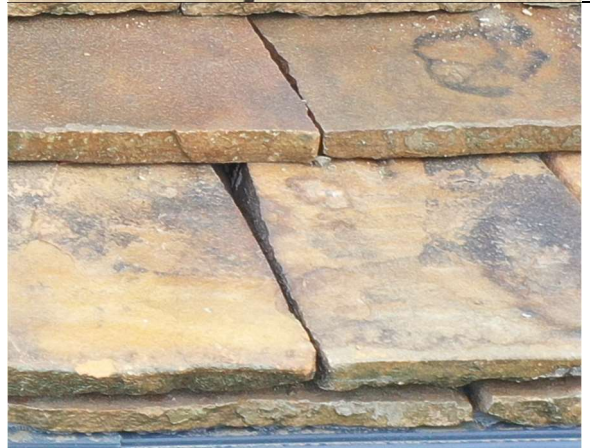
Poor bonding detail and inconsistent tooling of the side of the slate.

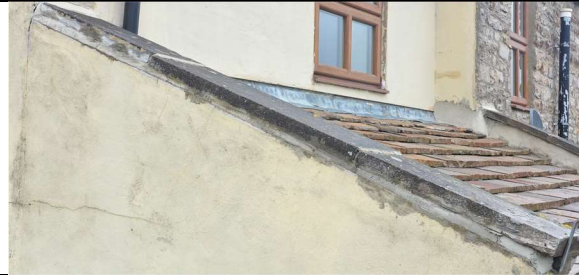
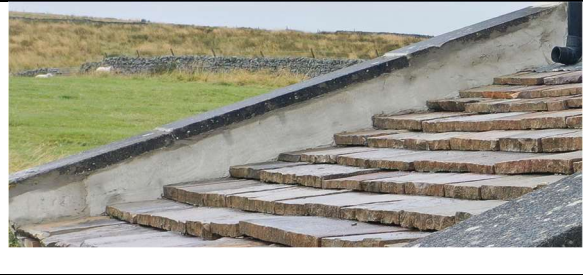
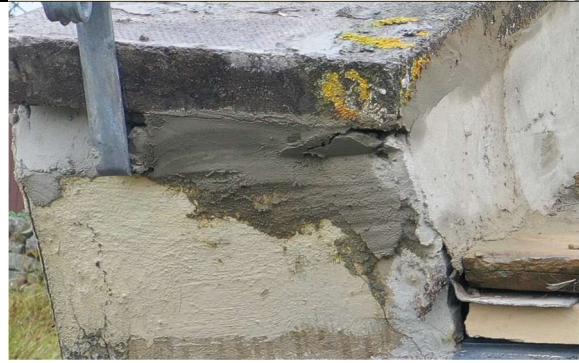
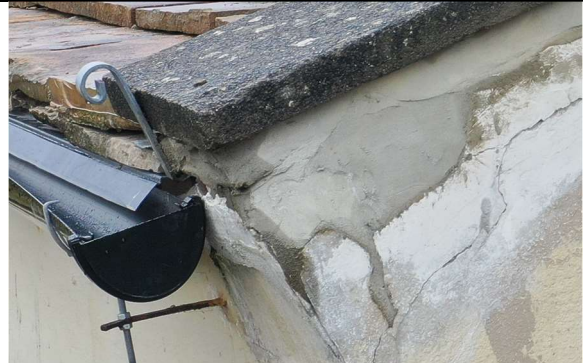
Parapet Wall – the mortar detailing in the inside and outside of the parapet wall looks poor.

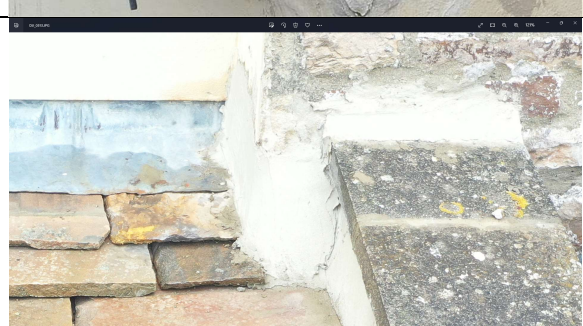
We are not sure what this detailing around the abutments is.

We recommend it is removed and replaced in the appropriate lead detail.

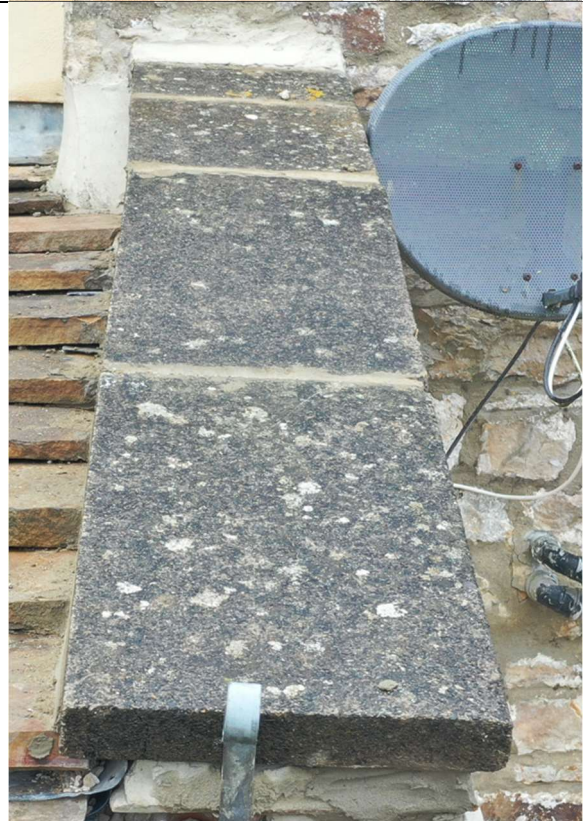
The coping stones do not look to have been put back on square.

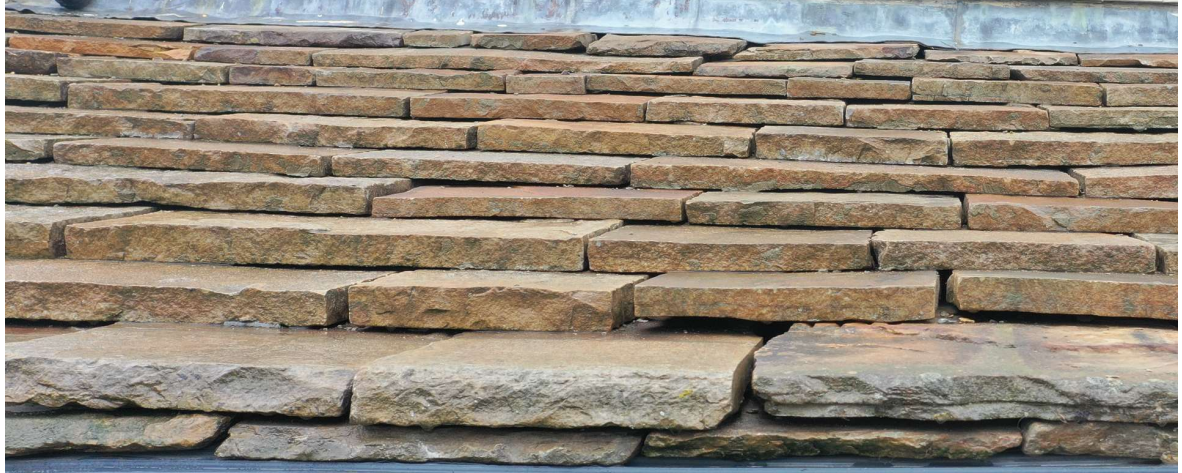
Gaps between and under the slates.

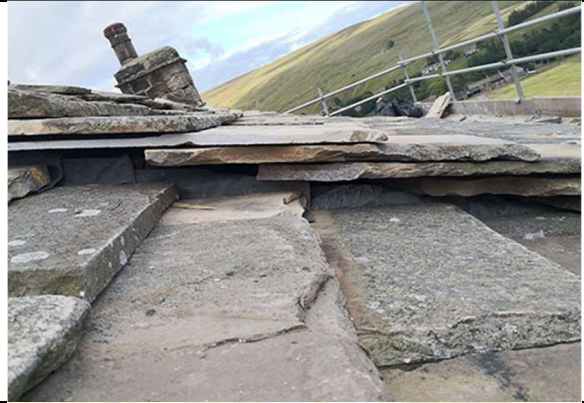
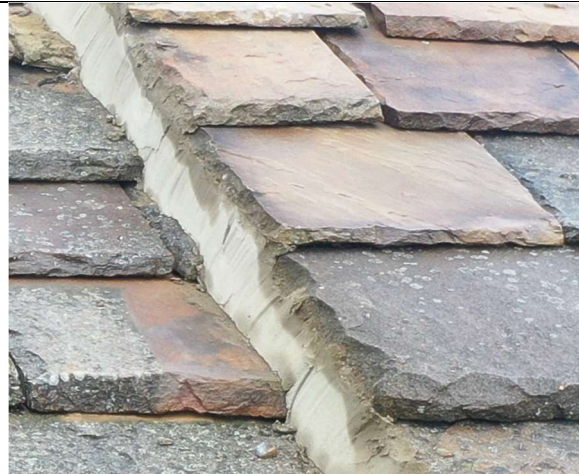
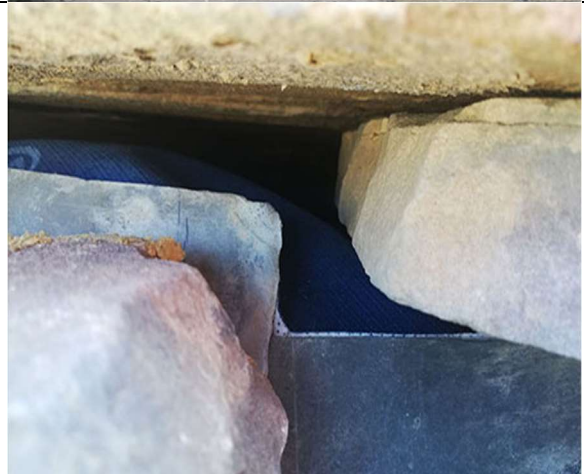
Back Roof - 1

Step detail – we are not aware of how this has been designed, however, the cementitious fillet that has been used will crack and fail.

An appropriate projection detail and secret gutter would have been a more appropriate solution.

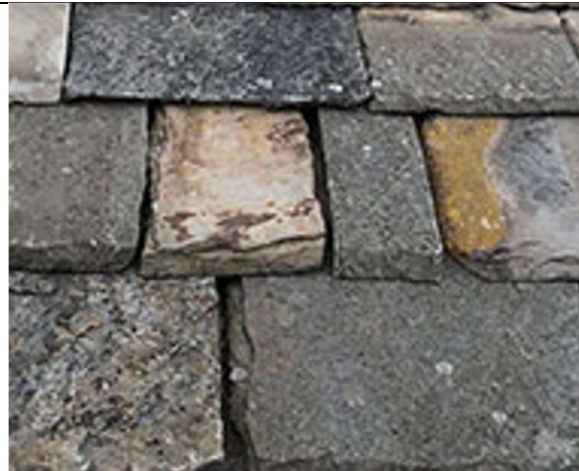
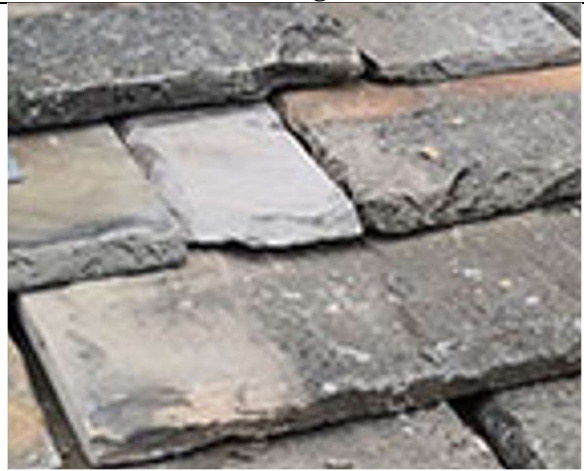
Several slates that are more like off-cuts have been used in the covering.

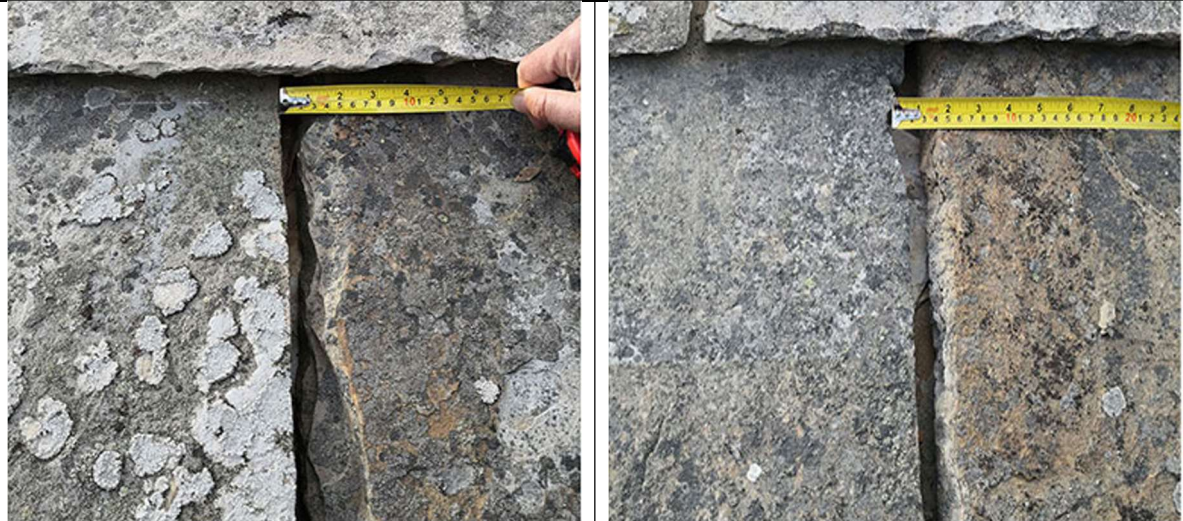
Back Roof - 2

The photos below show the inconsistent edge profile of some of the slates. In places, this is causing a gap in the bond of up to 40 mm.

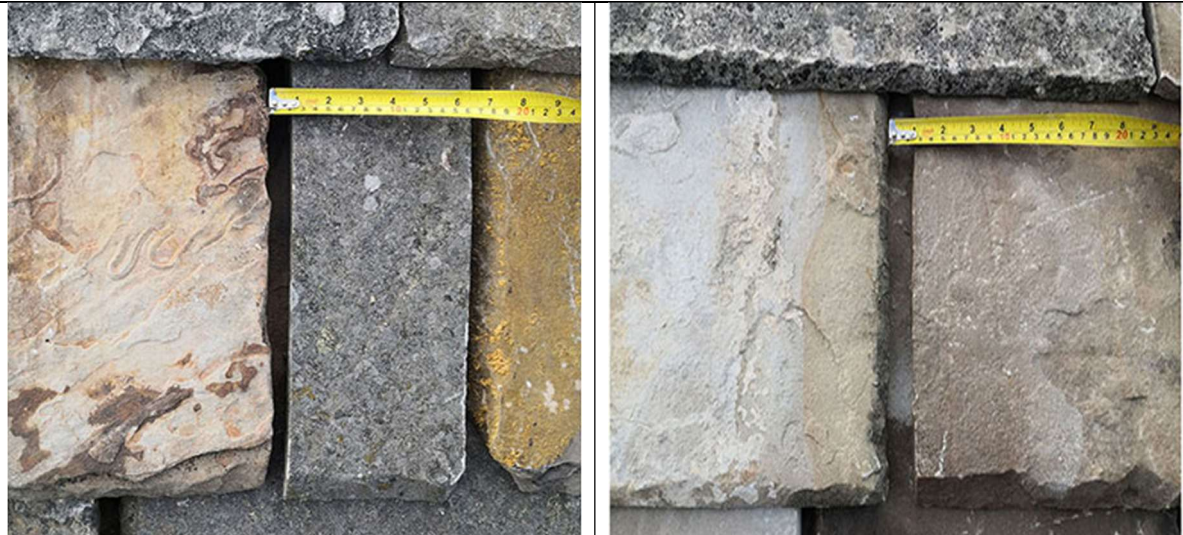
In some areas, there are gaps between the slates where the slates look square. There is no need for this and the bond should be closer.

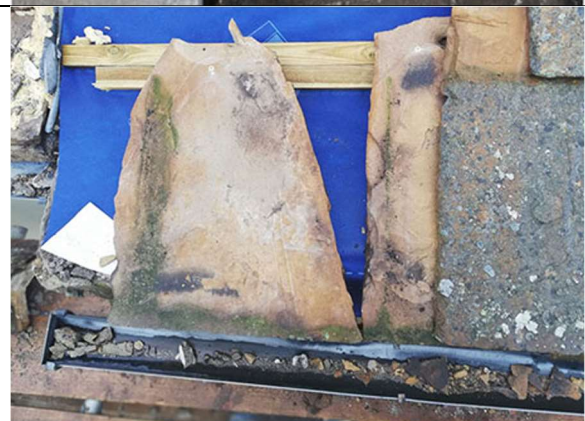
This slate is not of an appropriate shape to use. It looks like it only has one fixing hole right near the edge.

We do not consider this to be appropriate, especially on the eave's under-course.

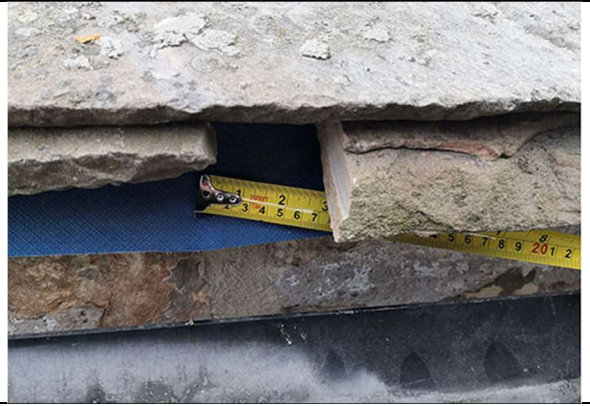
At the foot of the roof, it does not look like an eaves tray has been used, nor has the felt been lapped into the gutter (which is an inferior option).

The gap between some of the slates is c. 60 mm. This is likely to cause problems with wind-driven rain getting into the wall head which is about the worst place it can get.

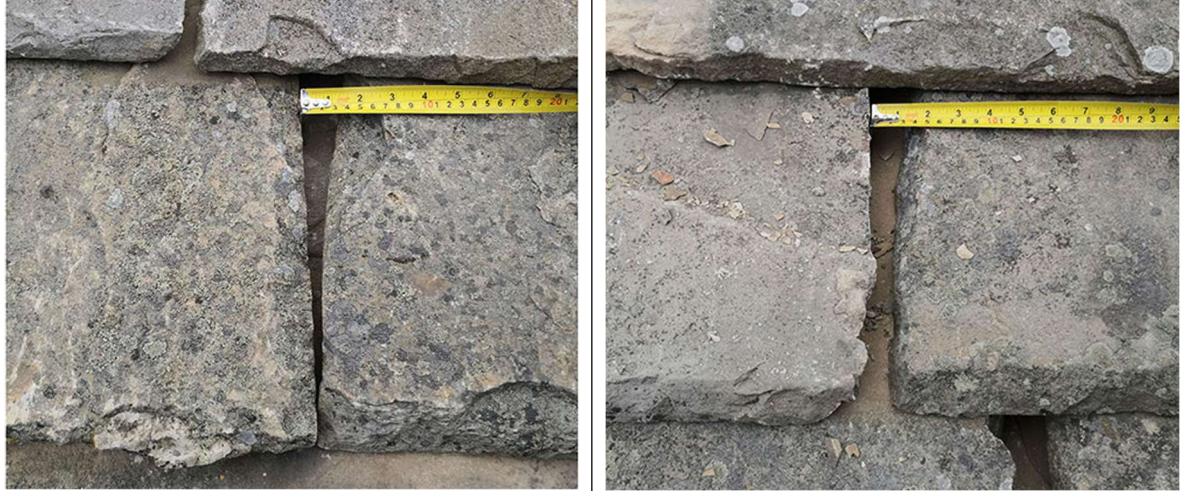
As detailed above, the slates are not square/do not sit square with each other.

This would be less of a problem if we were certain that all of the slates had square heads, however, as we have seen, many have shoulders/large areas of their top sections missing.

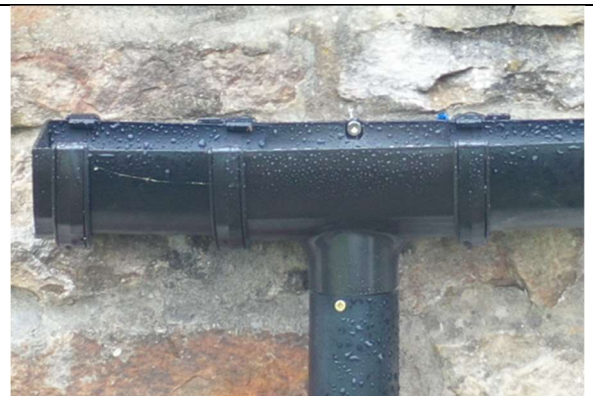
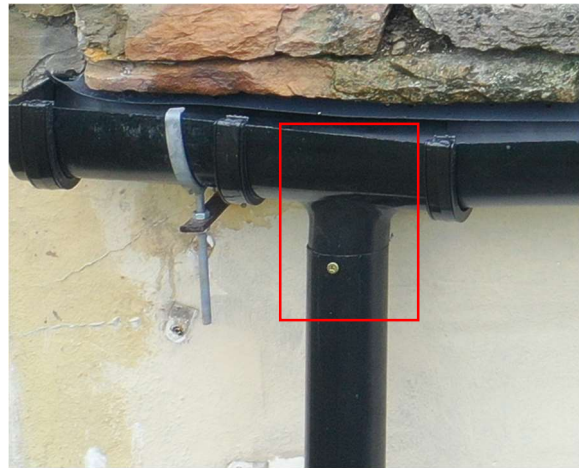
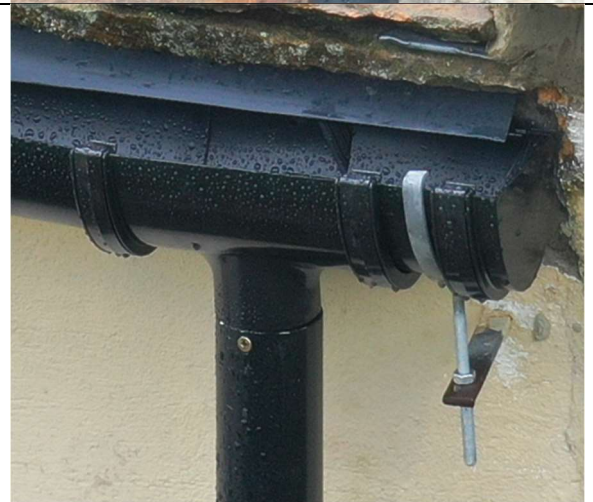
Front and rear elevations – the guttering is warped in places and does not sit square in all of the unions and outlets.

There are no pipes clips at the head of the fall pipes. The wood screw that has been fitted to hold the fall pipe to the outlet is inappropriate and will place additional pressure on the rise and fall brackets, outlets and guttering runs.

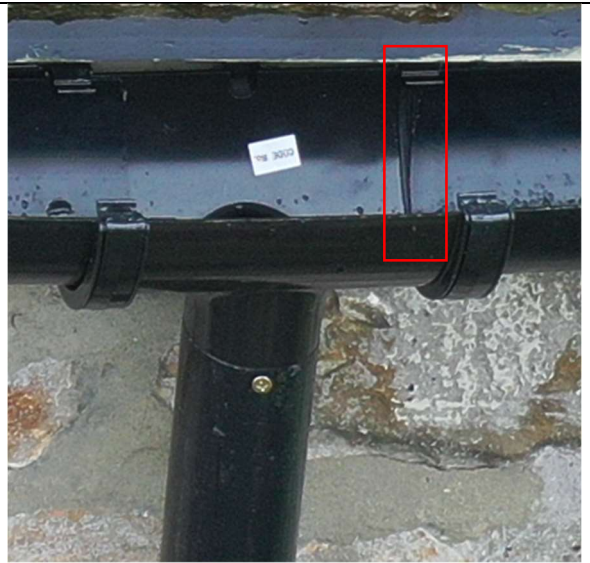
Front, right-hand side – the right-hand section of guttering has been cut too short and is not correctly seated in the outlet clamp.

Also, as noted above, there is no pipe clip at the head of the fall pipe.

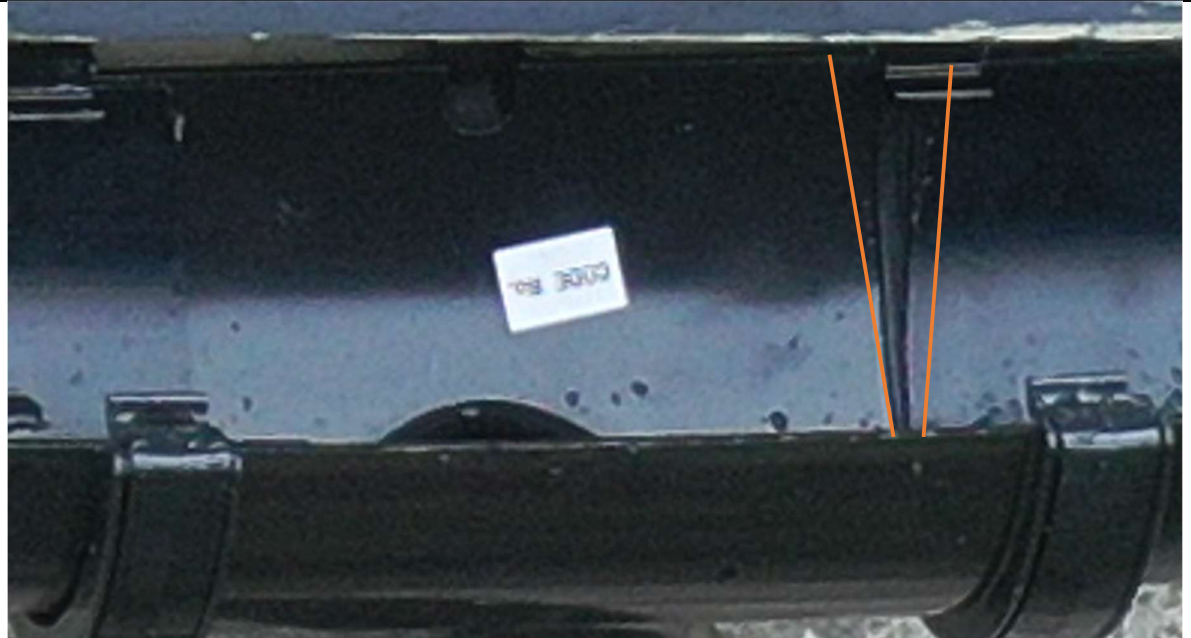
Close-up of this area – note the distance from the left-hand section to the outlet compared with the right-hand section. The left-hand section has been pushed into the built-in stop ends, the right-hand section has not. The seal is visible between the orange lines.

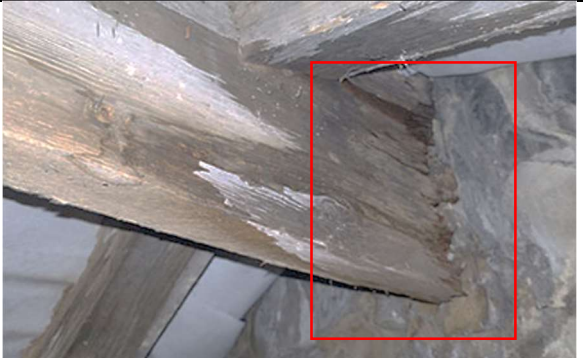
<p>Client's photo of the ridge beam – this is decayed where it is bearing on the gable end.</p> <p>Repair work will be required.</p>

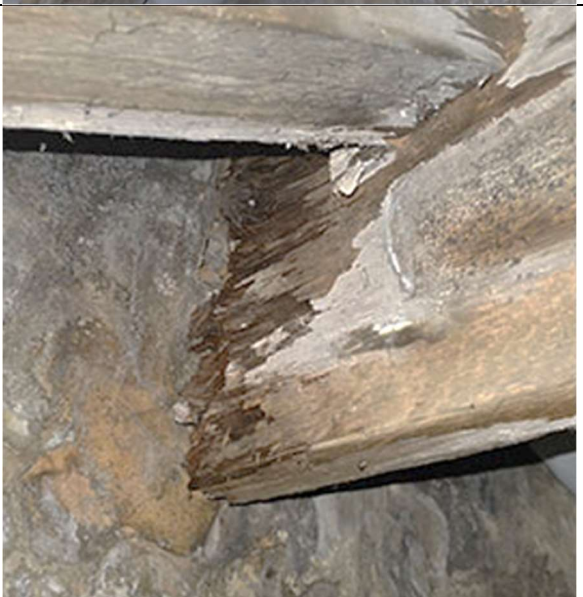
<p>Photo of the other side of the ridge beam</p>

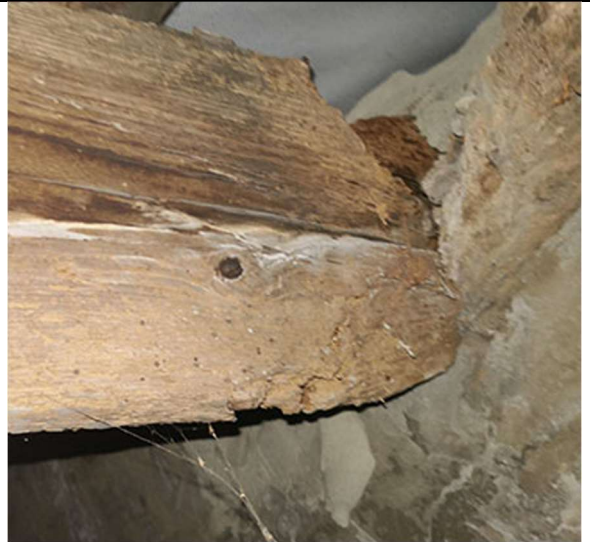
We are not sure what this is a photo of (client's photo), however, the timber will likely need additional support as it looks to be decayed where it bears into the wall.

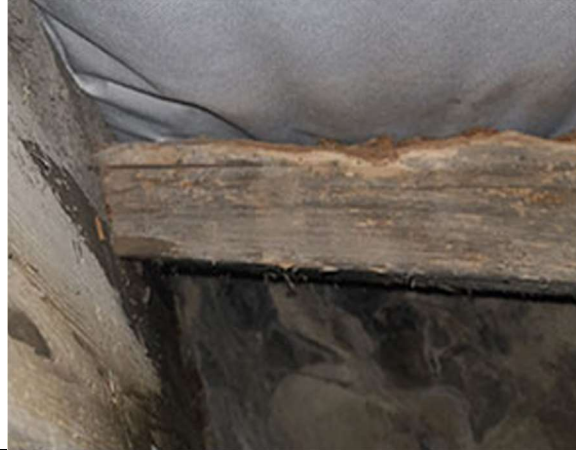
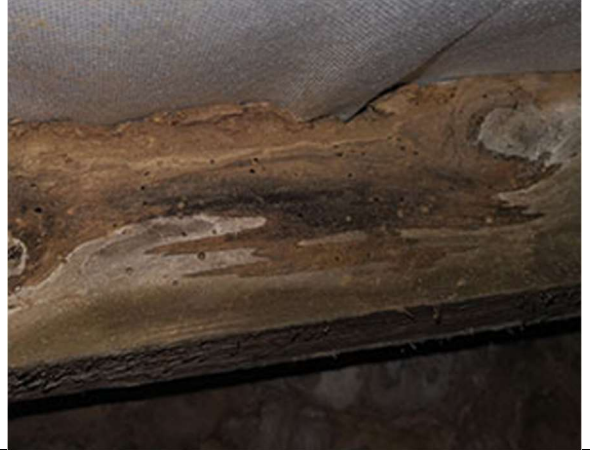
Decayed timber should be carefully removed from the rafters in an effort to see how much sound timber is left. Bracing/sistering may be required.

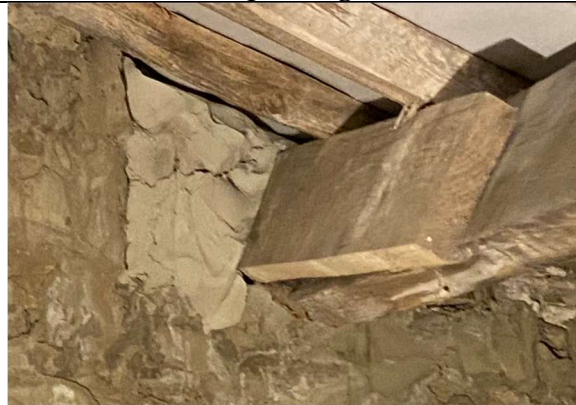
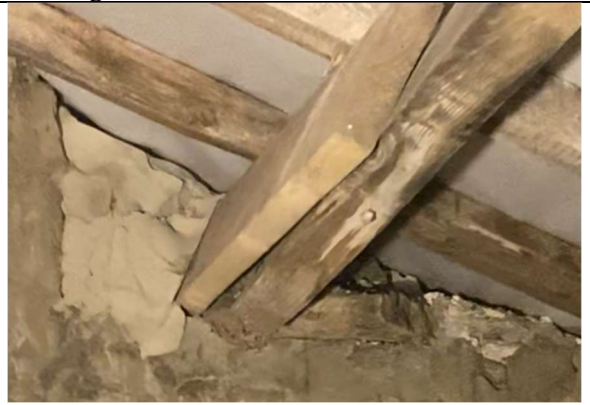
If the end of this purlin is decayed, this is not an appropriate repair. It needs a proper brace or a boot, depending on the extent of the damage.

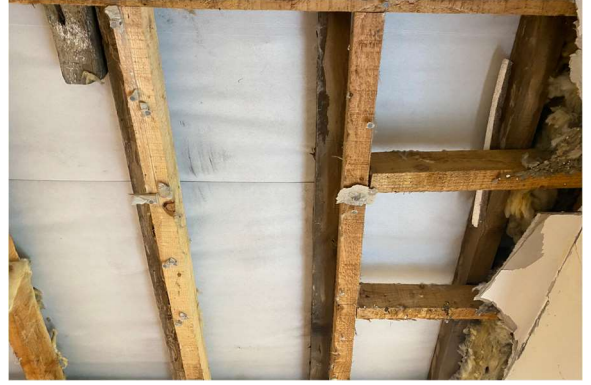
Where we can see the membrane, this looks to be pulled tight between the rafters.

There should be a slight sag to the membrane to allow moisture run off to the foot of the roof and onto the eaves board and into the guttering.

If water cannot run down the membrane, it will collect and eventually penetrate the membrane and cause the roofing timbers to decay.

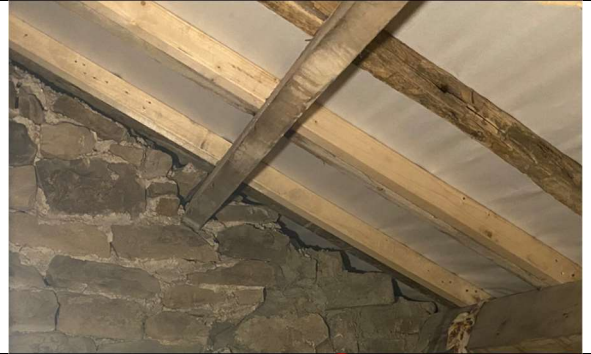
Where some of the rafters have been replaced, it does not look like treated timber has been used.

This may not be necessary depending on their natural resilience to decay/coniferous strength.

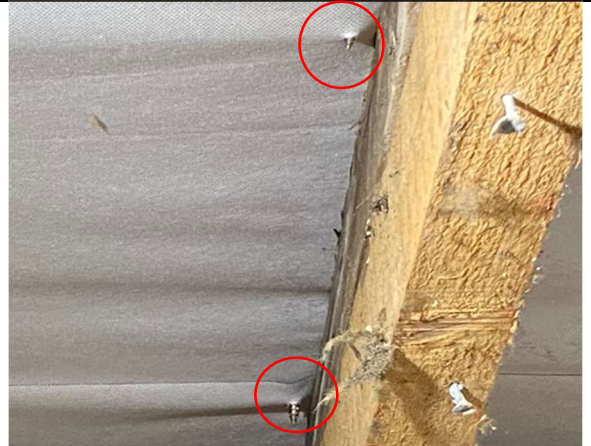
Batten screws have penetrated the membrane in several places. We have included some examples of this.

Each penetration creates a weakness in the membrane which is acting as a second line of defence.

As the covering has been laid, this is going to be problematic to remedy.

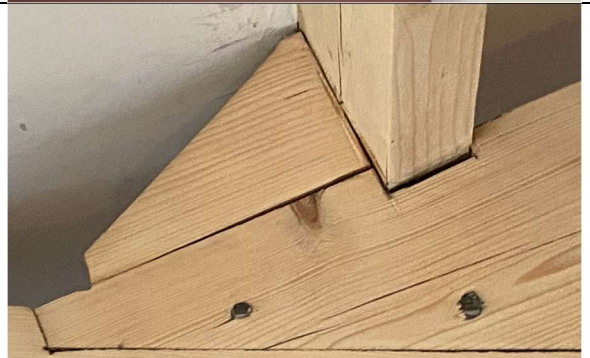
In our opinion, these timber elements should fit together with a better tolerance than this and the purlins should be trenched deeper into the truss [however, we have not seen the designs].

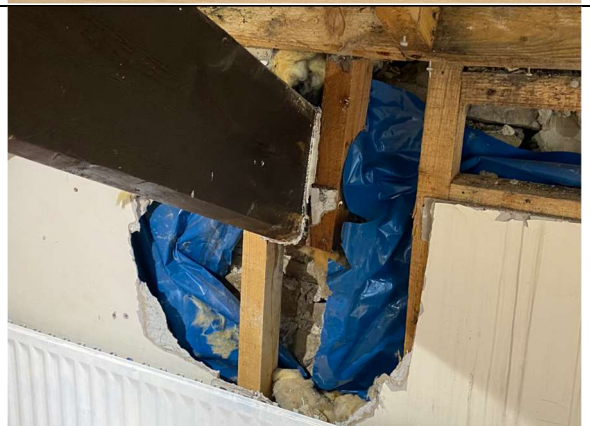
Whilst this is not related to the roof covering, we observed plastic sheeting and fiberglass insulation up against the internal leaf of the external wall.

This is not appropriate and will likely cause moisture-related problems.
