# Roof Inspection Report

Report produced by Simon Hollis MRICS

22<sup>nd</sup> December 2022

Drone Inspection Report - Summary of Findings

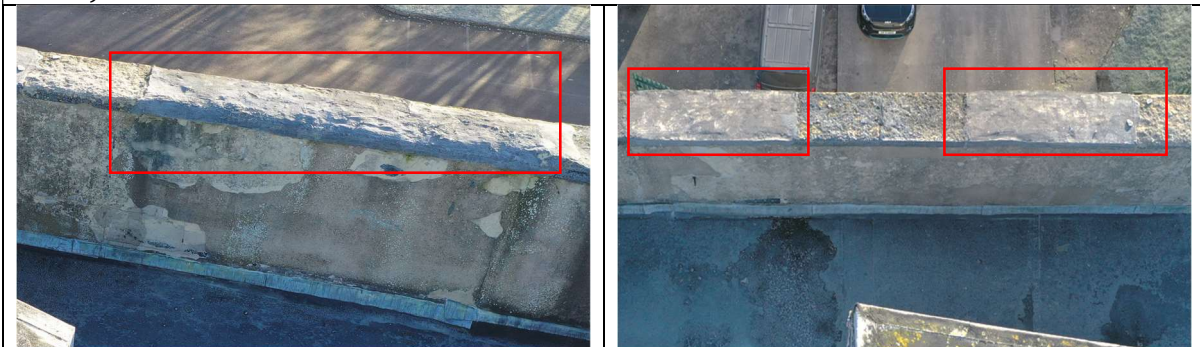
The tower has a perimeter parapet wall with a capping slab. This has been inappropriately repaired in places. These repairs should be removed and correctly repaired in an appropriate repair compound (this is specialist work and appropriate advice should be taken).

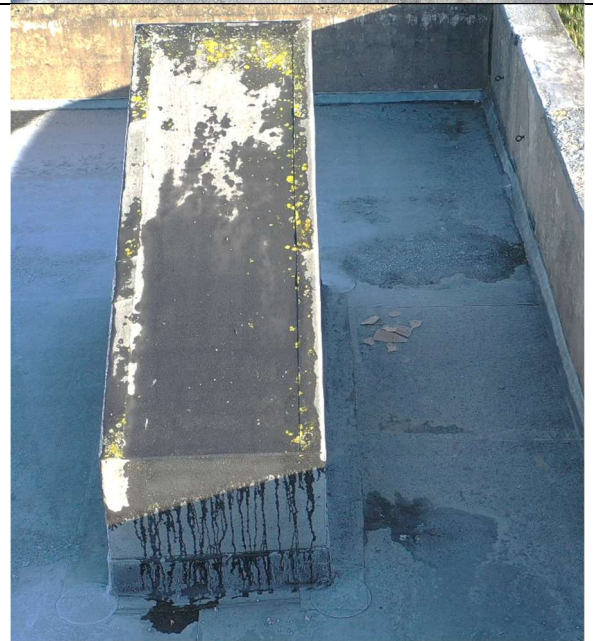
Access way detail – the capping sheet is missing from this detail. A capping sheet should be added in the spring.

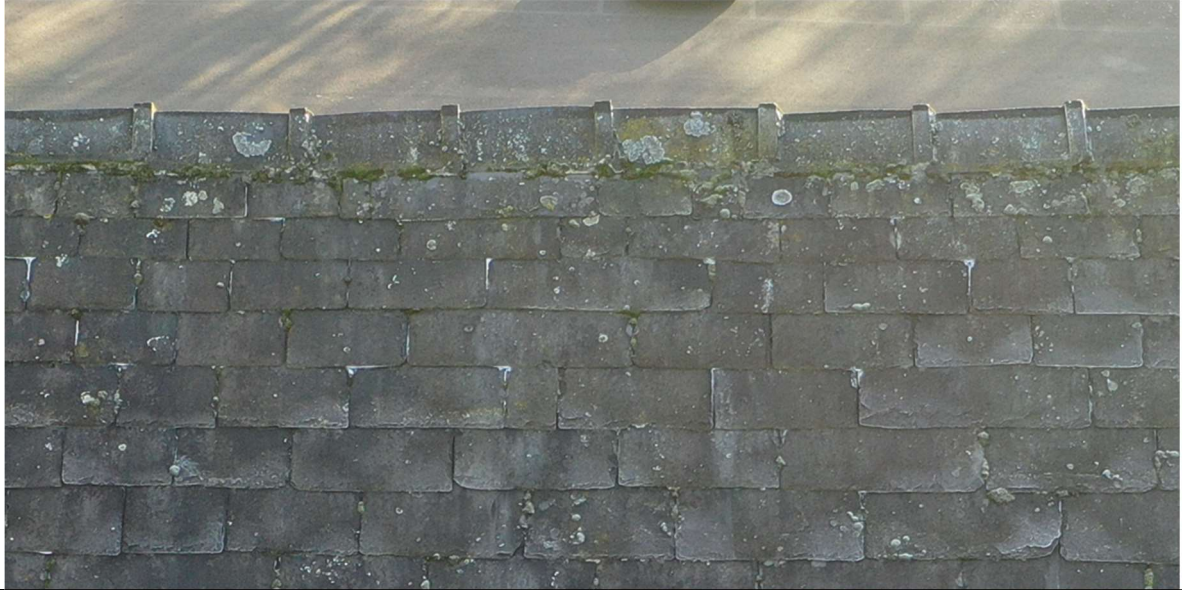
Ridge, an example photo – the ridges and hips are covered in moss and sections of pointing are missing. The moss should be killed and then removed before the ridges and hips are repointed in an appropriate mortar mix. This should be undertaken in the spring.

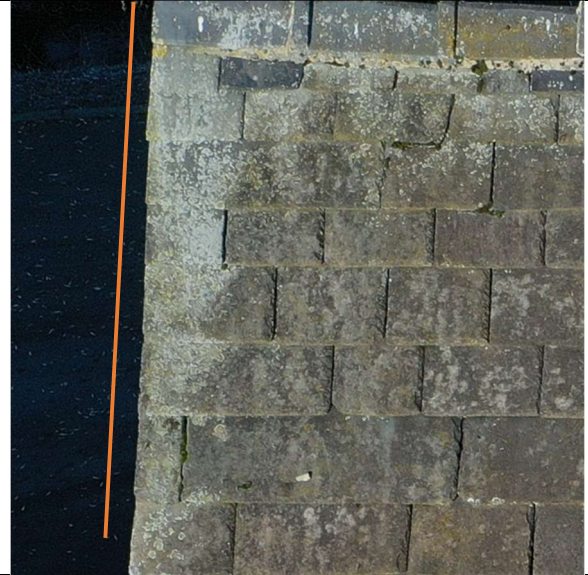
There is no economical way of addressing this, but it should be considered if and when the building is re-roofed.

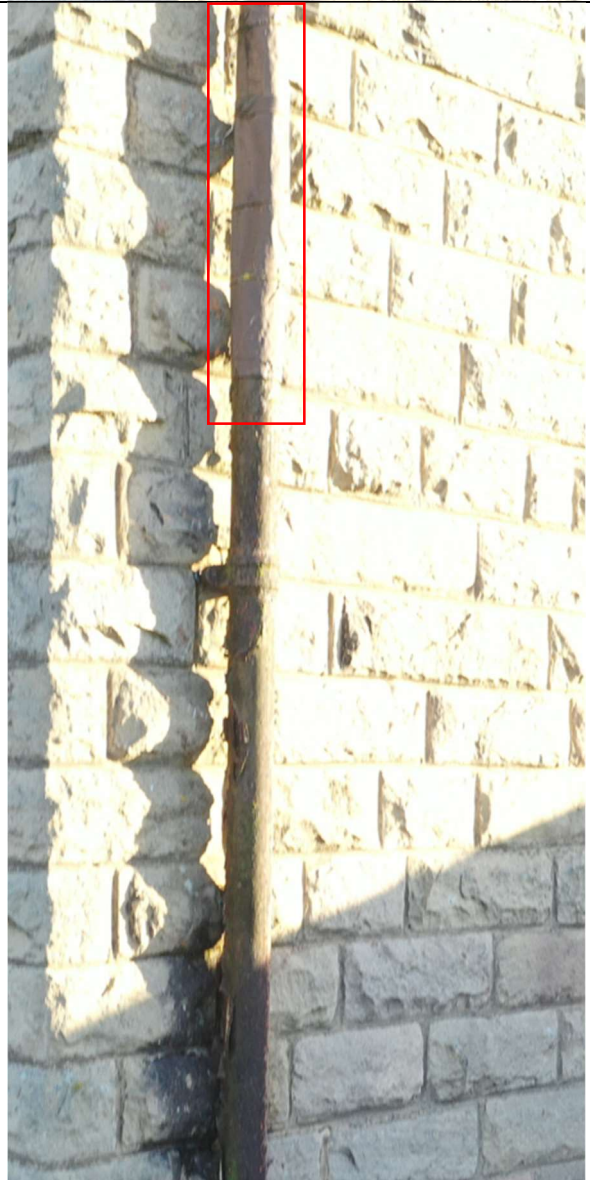
The lower section is leaking and the wall behind is moisture stained.

Fixings are also coming away and this needs urgent action to ensure its stability.

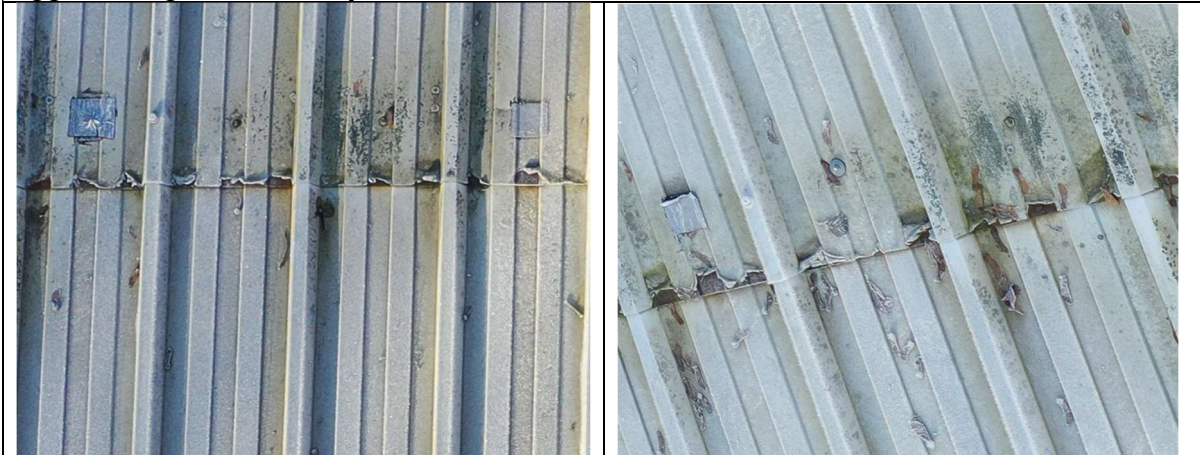
Example photos of cut-edge corrosion where the sheets join horizontally and at the foot of the roof. This is at the point of needing to be cleaned up and treated before it gets worse and this job becomes more difficult. We have included two example photos below, as opposed to photos of every area of corrosion.

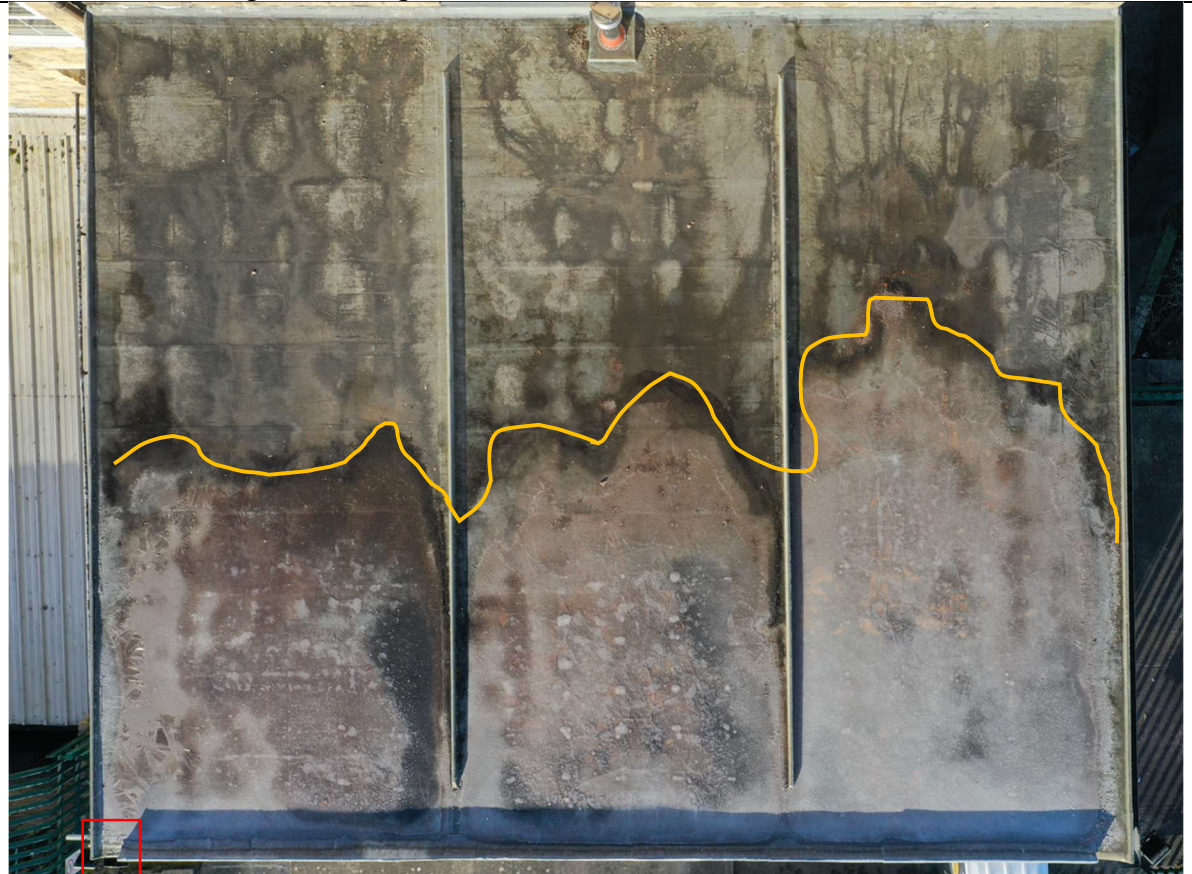
Overhead photo of the roof – it looks like the roof has been ‘re-designed’ to discharge water via just one outlet – red box, bottom left corner. This does not look to be set at the lowest point, and there are large areas of ponding water (that had turned to ice at the time of our inspection). This adds weight to these areas which causes further deflection in the substrate and compounds the problem.

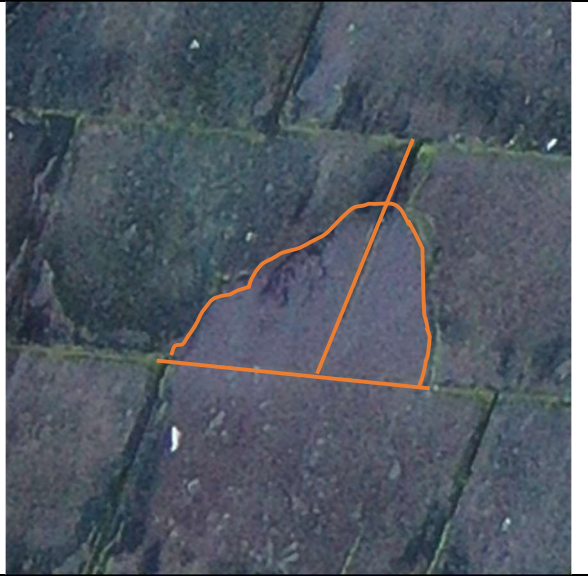
The two damaged slates should be replaced as soon as possible.

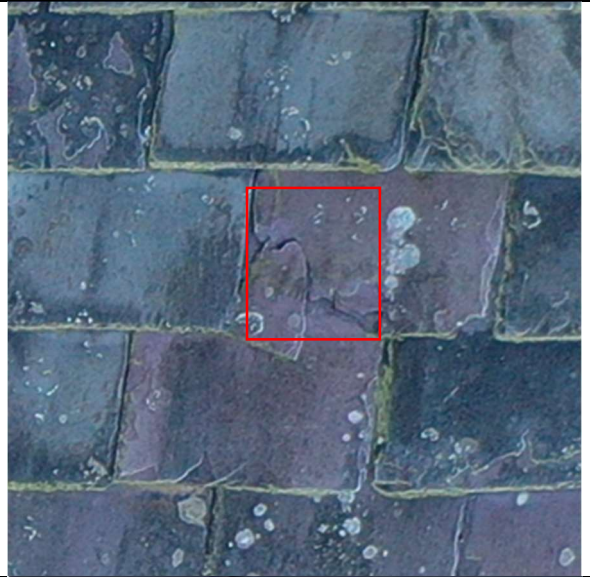
The lesser damaged slates should be replaced in the spring.

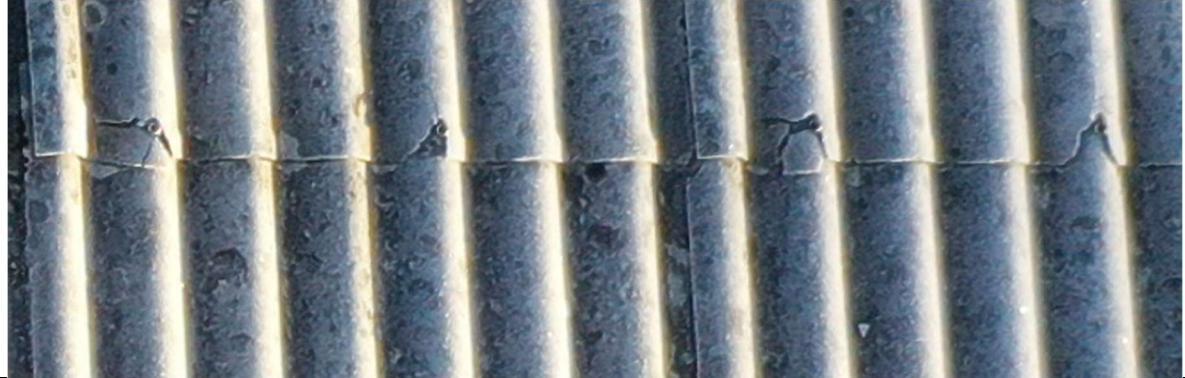
The photo below shows an example of what the edges of some of the sheets are like. Where the fixings no longer have any material to grip onto, they will be subject to wind uplift.

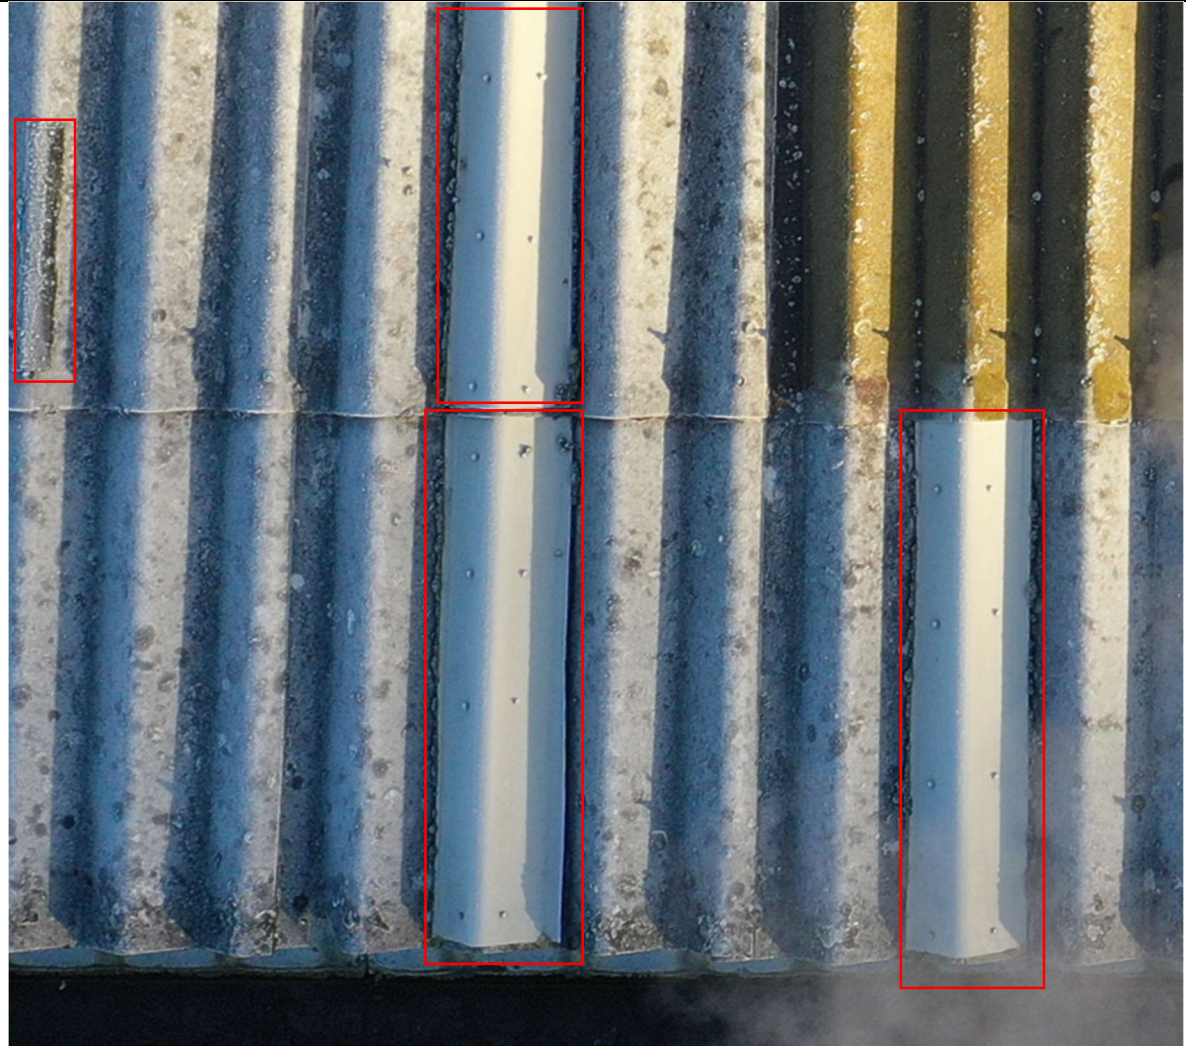
There have been many repairs to this pitch. The photo below shows some examples of the repairs and the condition of the rooflights.

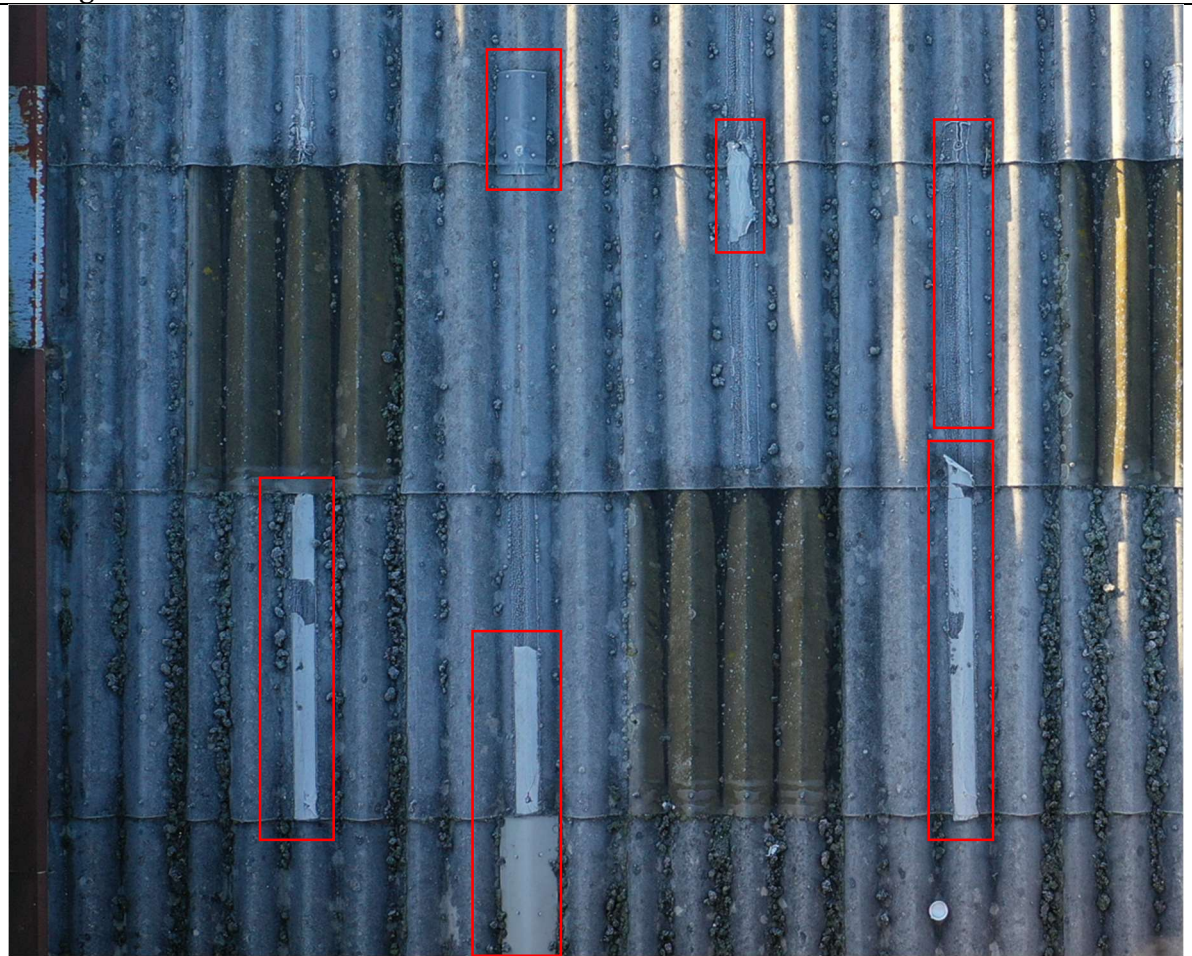
There have been many repairs to this pitch, and it is in the worst condition of the four pitches. The photo below shows some examples of the repairs and the condition of the rooflights in one area.

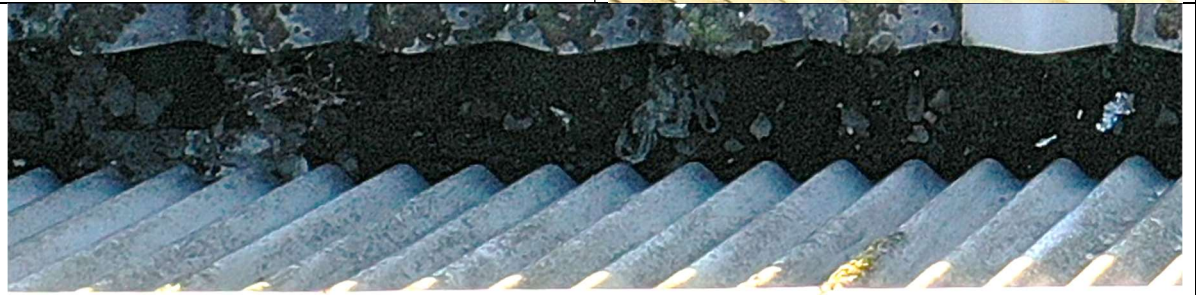
Guttering – example photos showing the amount of debris building up in the guttering run. This should be cleared out as soon as possible.

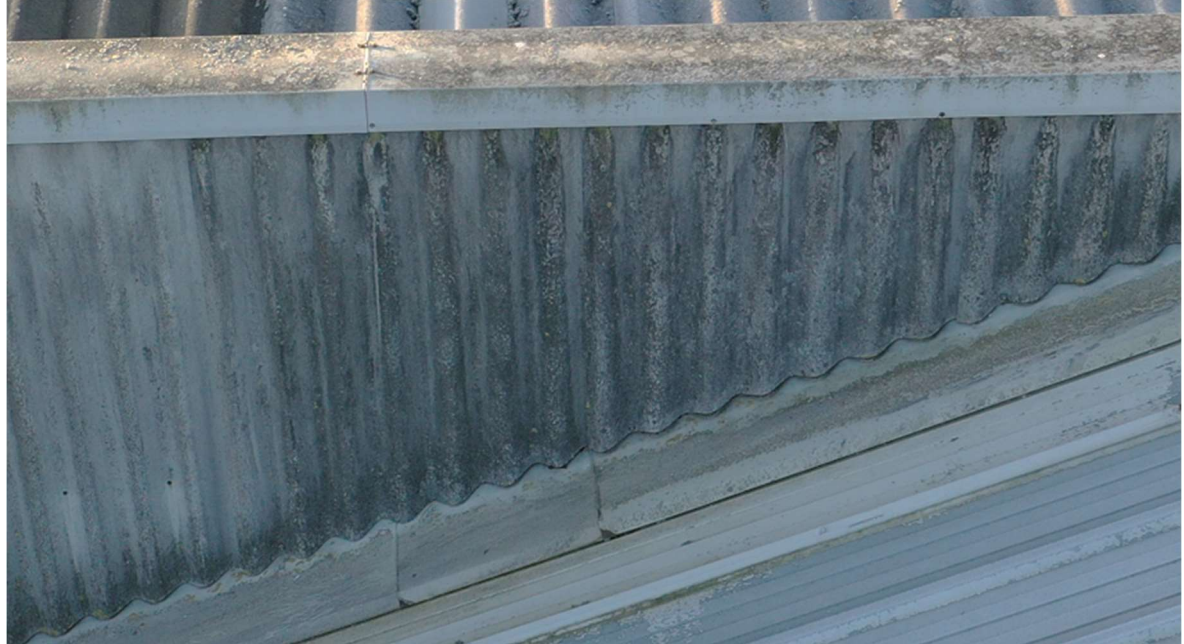
Example photo of the general condition of the cladding where Roof B and Roof C abut. The cladding is quite heavily stained.

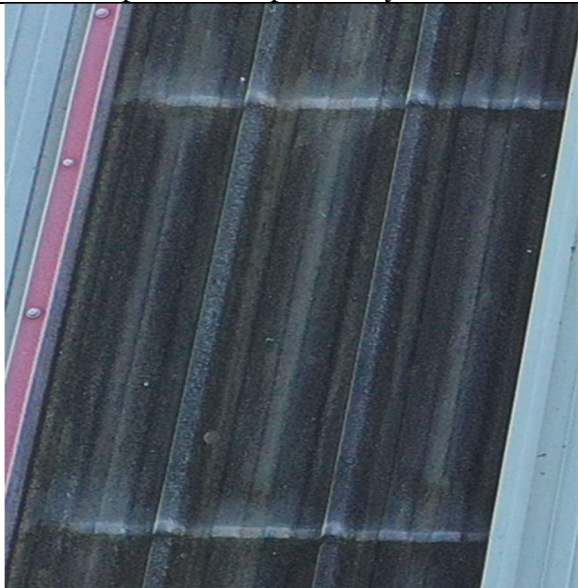
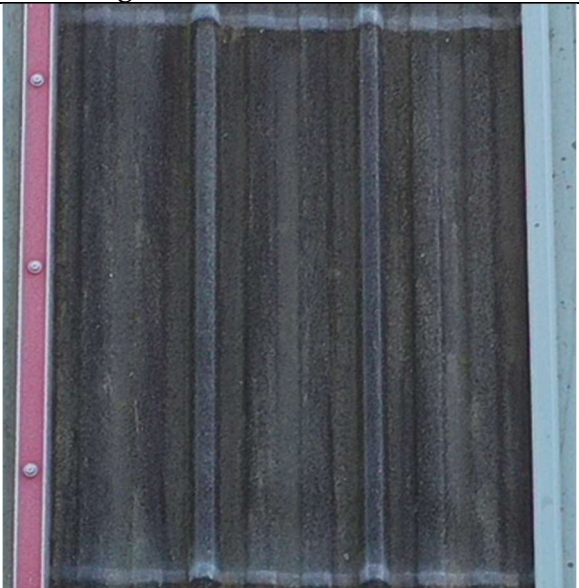
Example photos of where the rooflights have lost their transparency. The rooflight sheets can be replaced independently of the rest of the covering.

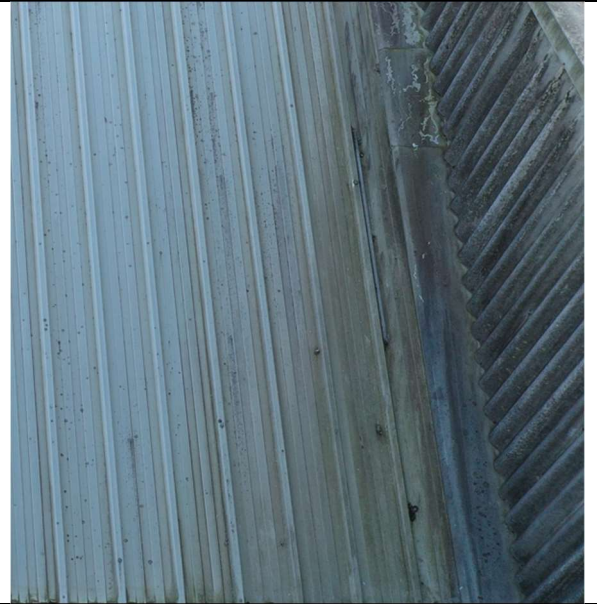
Example of staining to the covering from the capping on the adjoining Roof B.

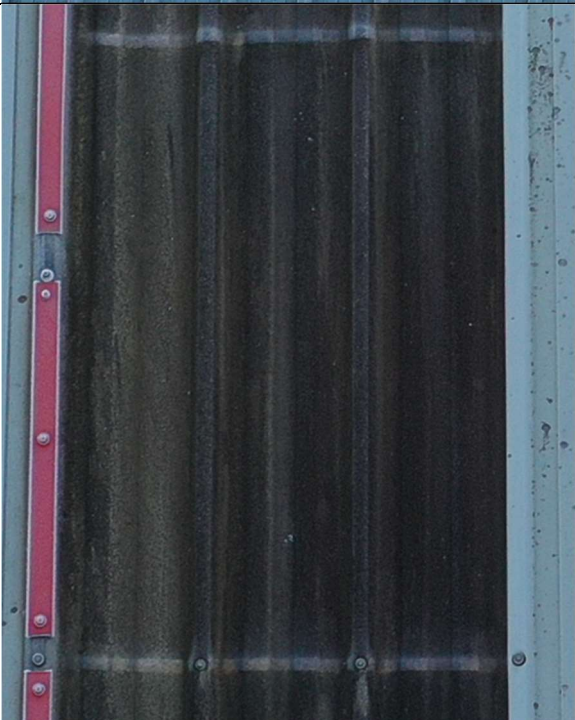
<p>Example photo of where the rooflights have lost their transparency.</p> <p>The rooflight sheets can be replaced independently of the rest of the covering.</p>

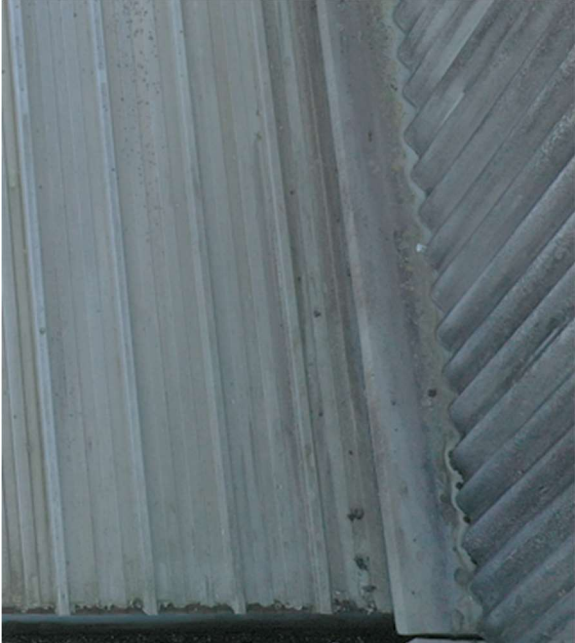
<p>Example of staining to the covering from the capping on the adjoining Roof B.</p>

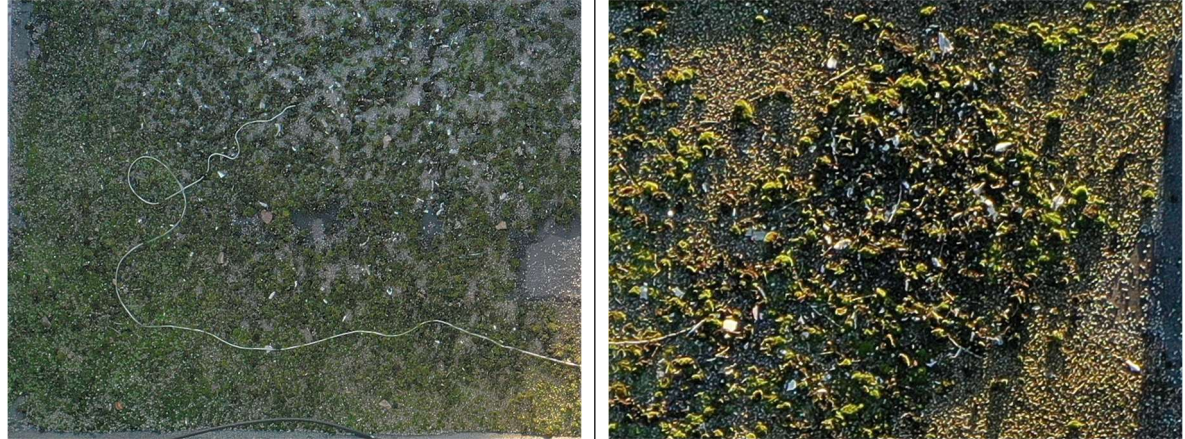
Example photos of moss building up on the roof. This should be killed and cleared in the spring.

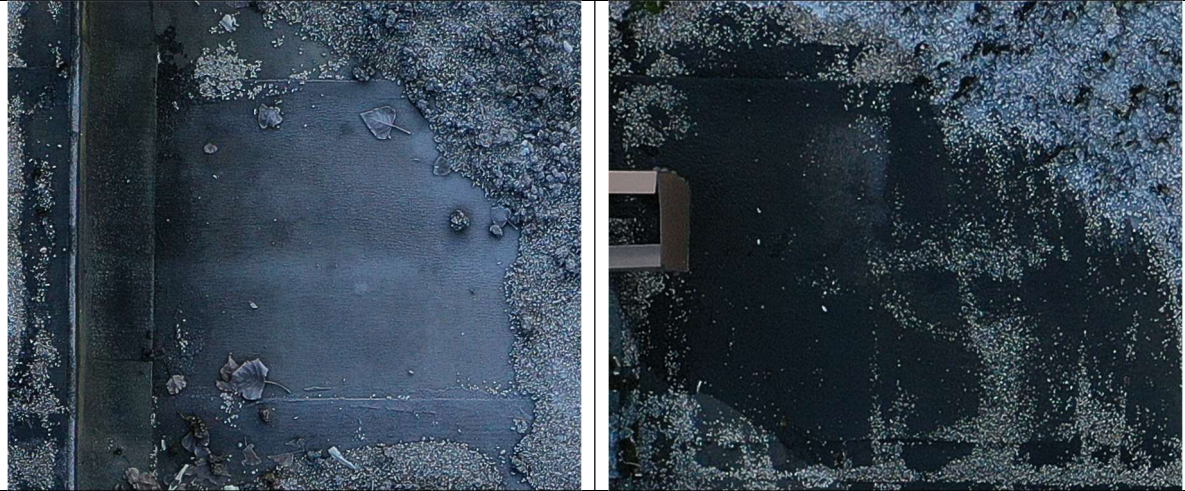
An example photo of where the solar reflective coating is missing from the top of the felt. The areas without chippings will be subject to increased UV degradation and failure of the felt. Once the moss has been cleared, fresh chippings should be bedded in bitumen in these areas.

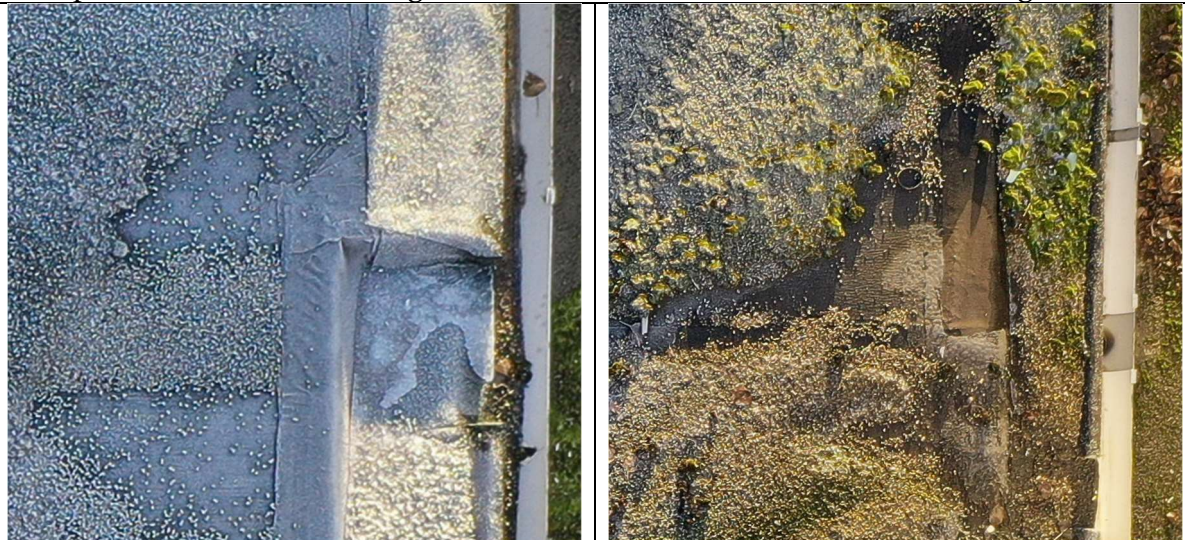
Examples of ill-thought-out/executed repairs to the covering. These repairs look to have created high spots in front of the outlets which will cause problems with ponding on the roof. Once the moss has been cleared and the weather has improved, these areas should be reinspected to see if re-detailing would take the moisture stress off the covering.

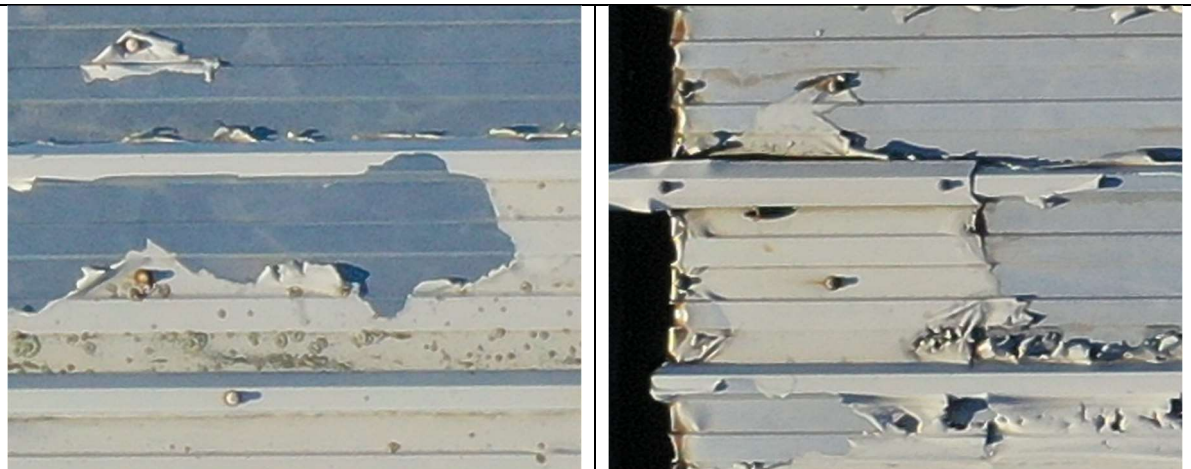
It looks like the roof has been overcoated before, however, this is now peeling off across all of the covering. A plan needs to be made to address this before more serious corrosion sets in.

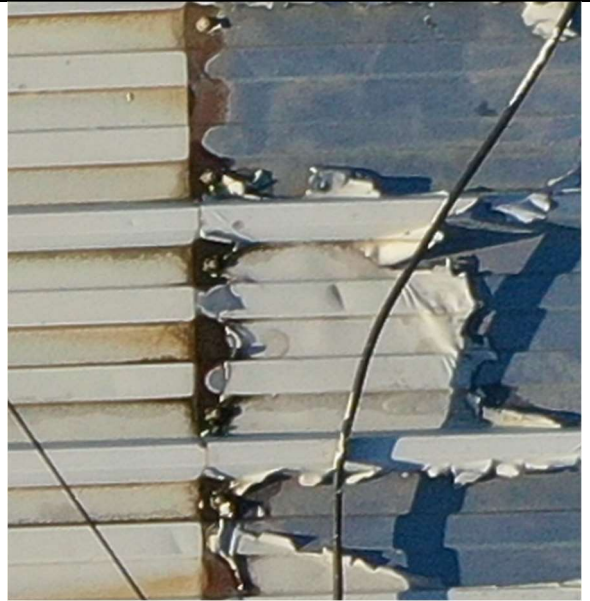
Example photos of the poor condition of the profiled sheets. There is cut edge corrosion all along the foot of the roof and all along where the sheets abut.

Urgent action is required to address this.

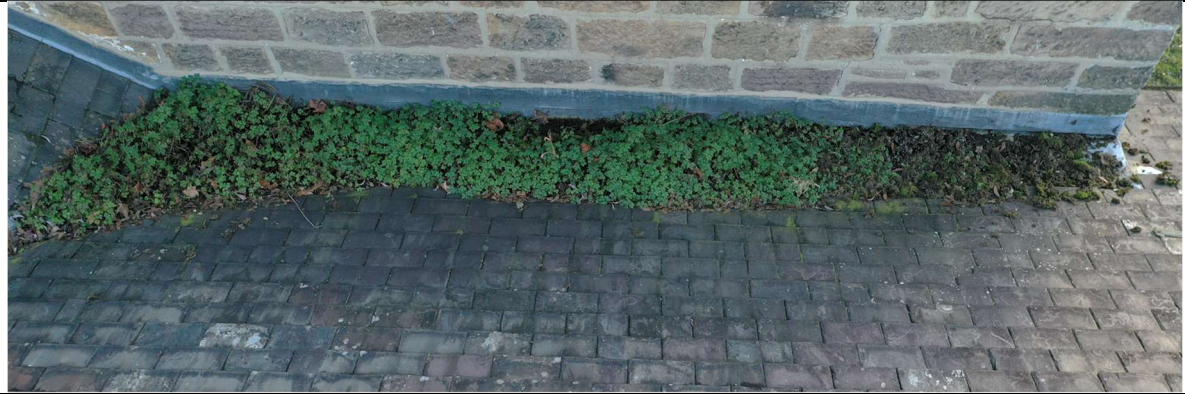
Rear pitch, valley and box gutter – the foot of the valley and the box gutter are packed with debris. This needs to be cleared out as a priority (as soon as possible) as rainwater will back up and cause problems with water ingress internally.

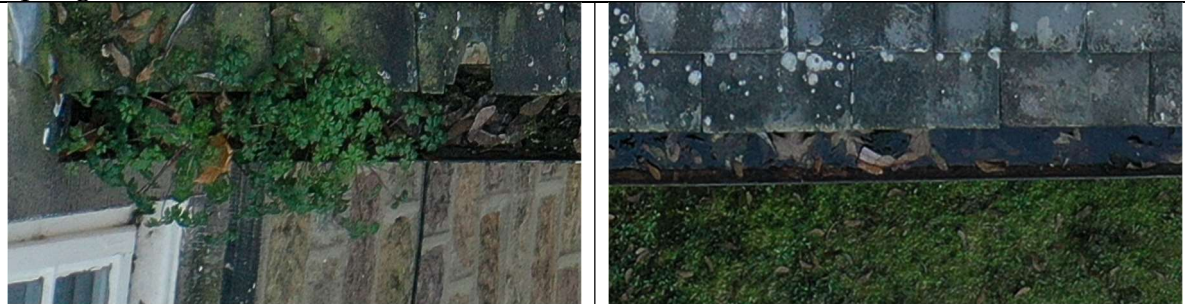
Left-hand pitch – the guttering run is full of debris and the ice (as a result of ponding water) illustrates that the run is not set to the correct fall. The guttering should be cleared of debris as soon as possible and the fall reset in the spring.
