Level 3 Survey in Respect of:

Report prepared by Simon
Hollis MRICS

18th July 2023

Building Survey Report

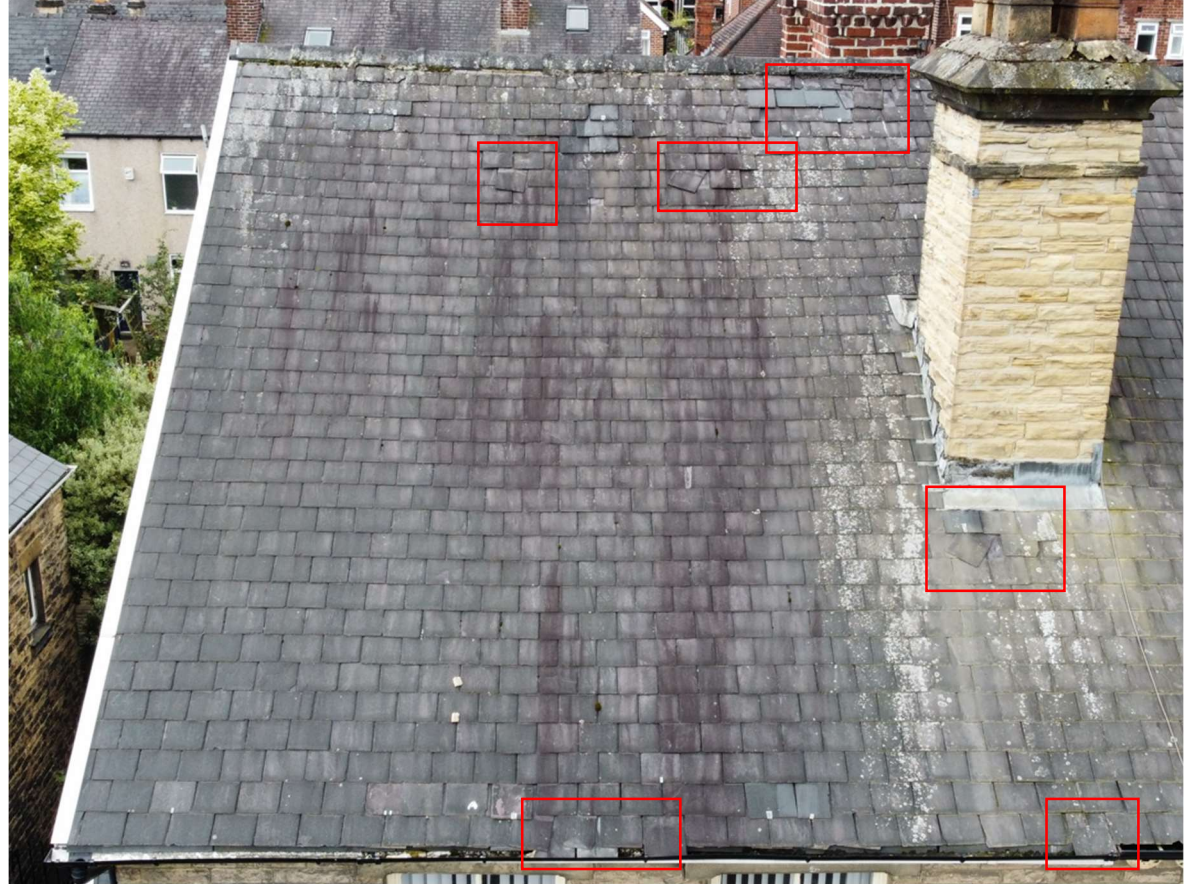
Overhead photo of the front pitch, the ridge is covered in this section. There are several areas of slipping slates across the front pitch (red boxes). This is likely as a result of 'nail sickness' where the fixings are failing which is causing the slates to slip. Slipping slates can be replaced, however, at some point, this will become un-economical and the roof covering will need to be replaced. We have not been able to inspect the underside of the covering so we have not been able to see how serious this is at present.

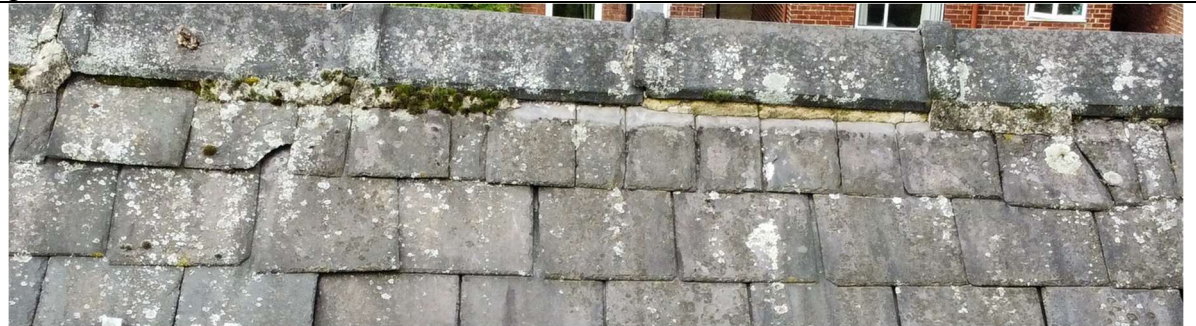
Ridge – there are several sections of the ridge pointing that are missing. The defective pointing should be raked out and replaced before winter. We have included some example photos below.

Side-on photo of the ridge – note the missing pointing between the tile abutments.

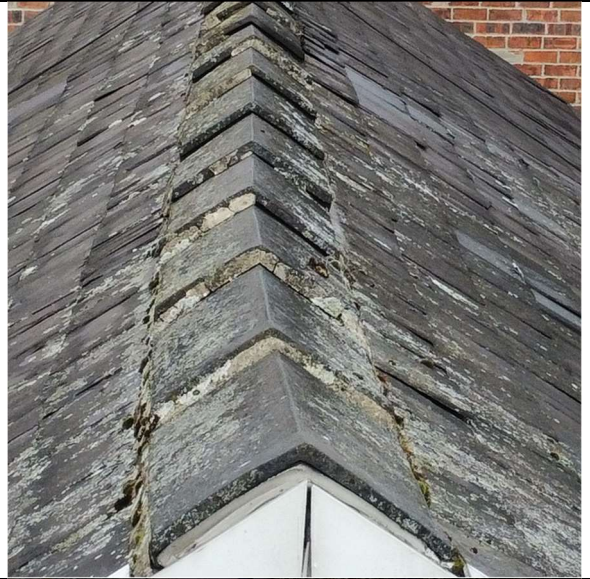
Note that the ridge tiles are not sat square along the ridge.

Example photo of where an area of slates has been replaced, but more slates are slipping.

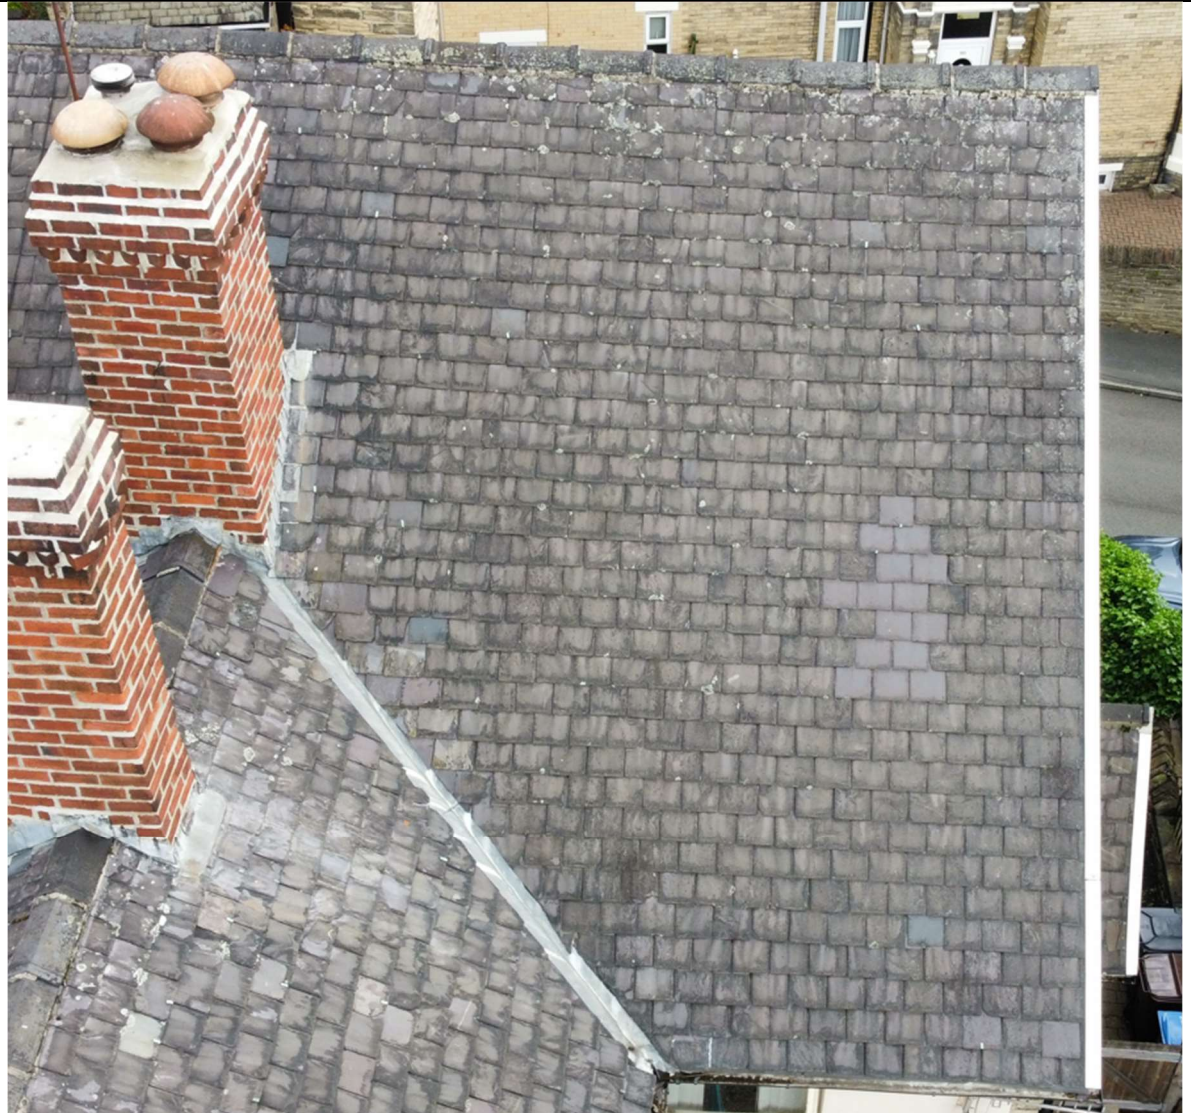
Overhead photo of the rear pitch – the covering is in better condition than that on the front elevation, however, some repairs are required and regular maintenance will likely be needed until the covering is replaced.

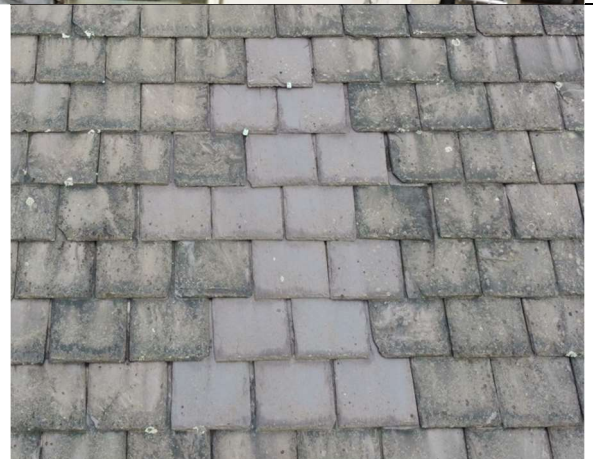
Example photo of an area of slates that have been replaced.

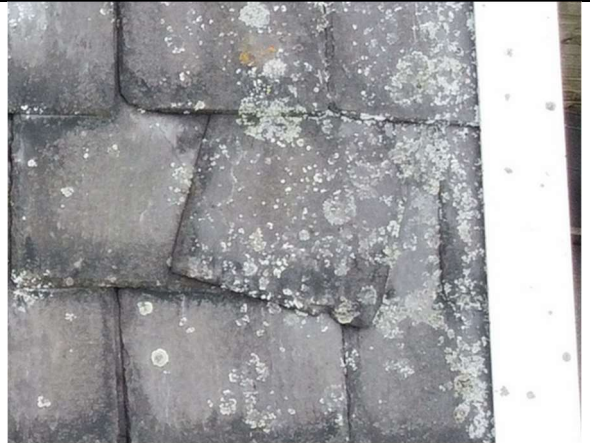
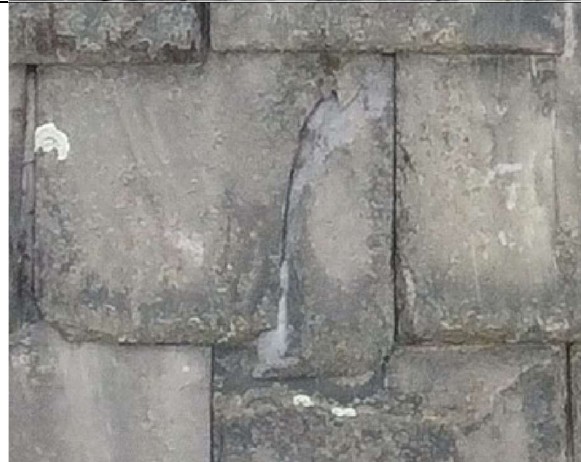
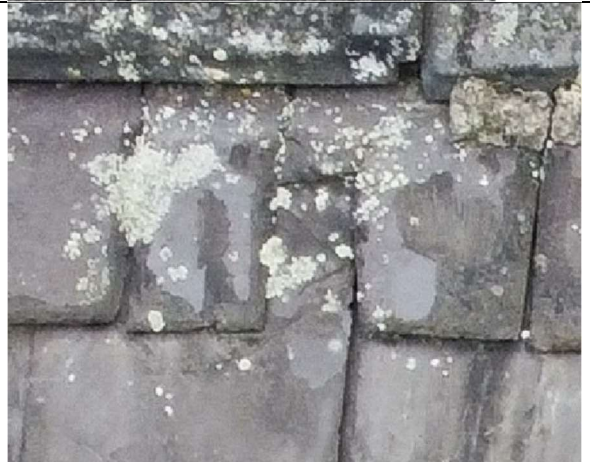
Example photos of slipped and damaged slates – all of these should be replaced before winter.

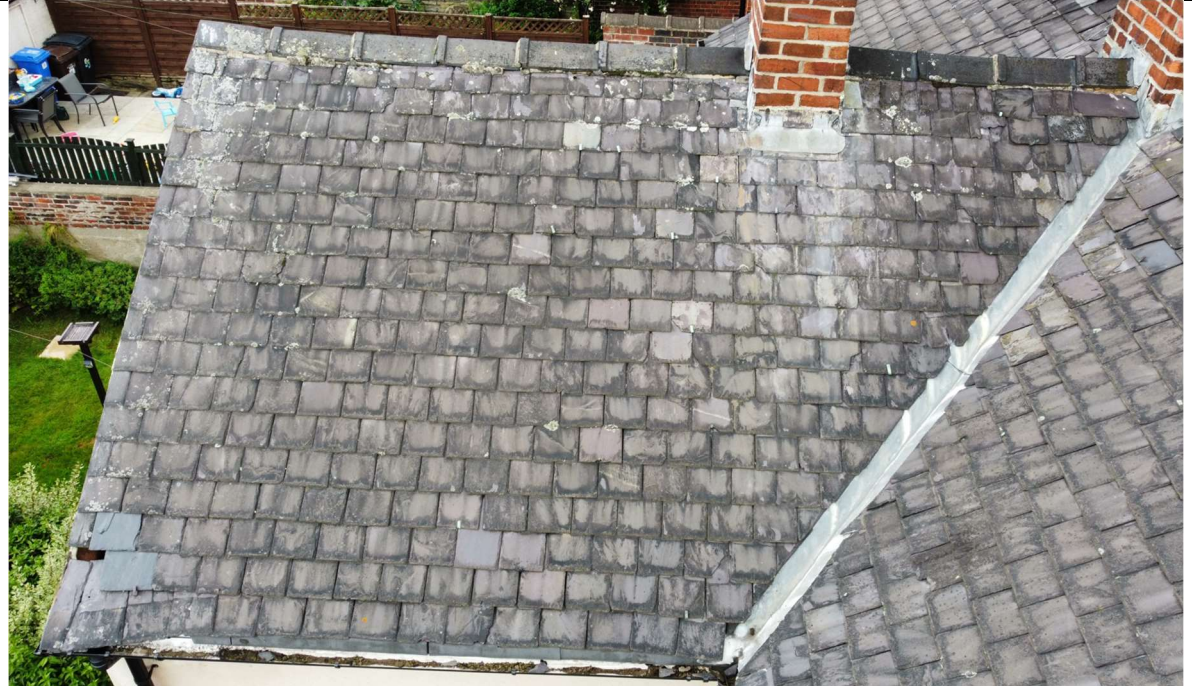
Overhead photo of the off-shot and valley.

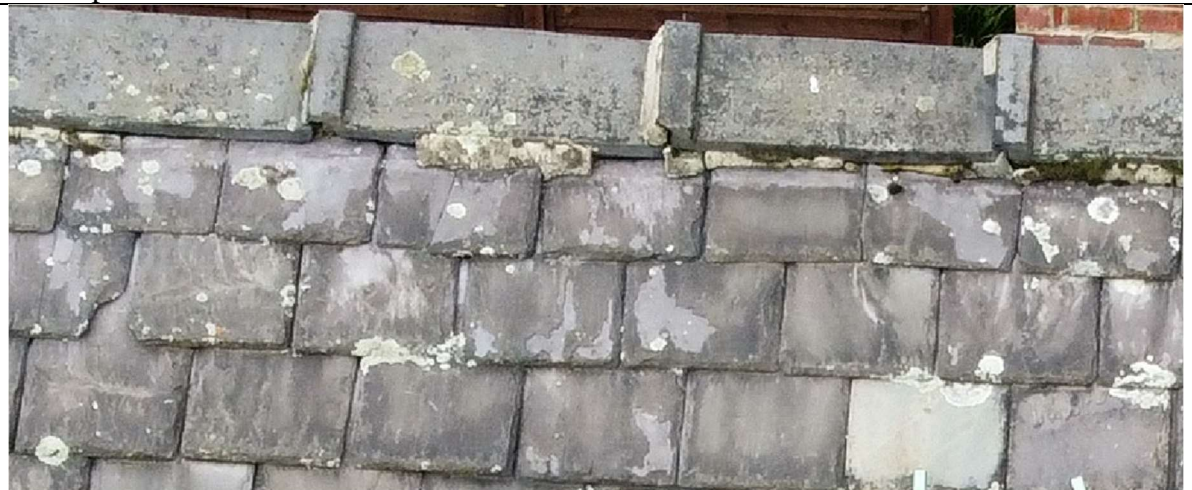
Ridge – there are sections of damaged and missing pointing. The ridge should be raked out and repointed before winter.

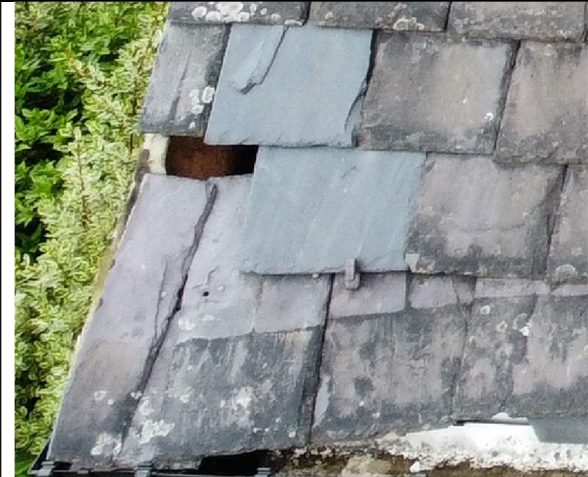
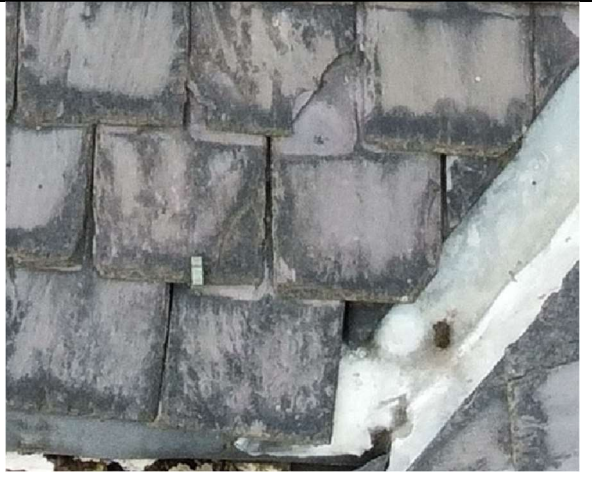
The areas of slipped, missing and damaged slates need to be repaired immediately. Example photos are below.

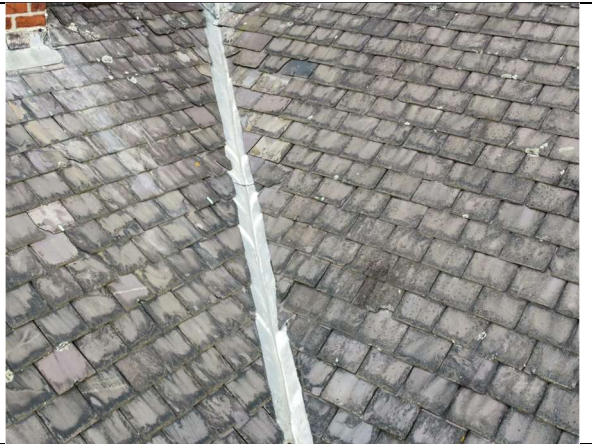
Valley – the lengths of lead used to line the valley are likely too long – the individual lengths should be no longer than 1500 mm, here, they look closer to 2m.

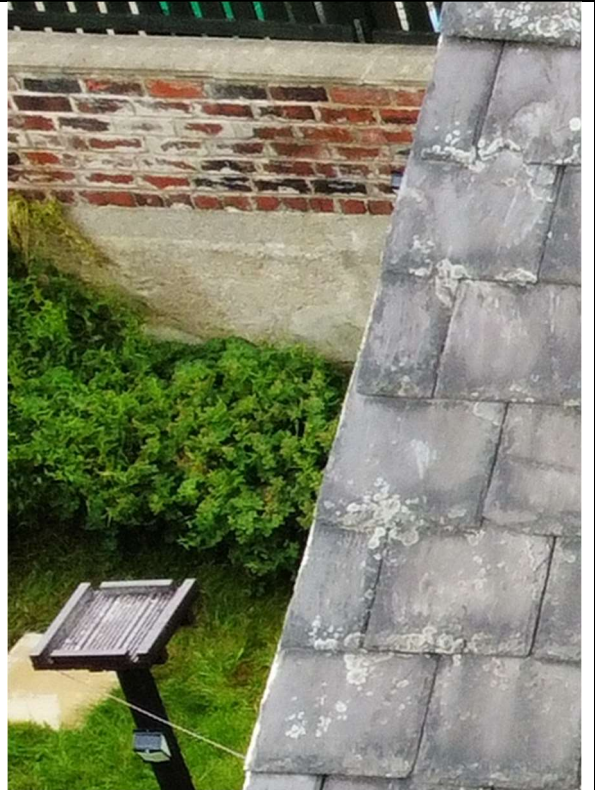
The small slates likely only have one fixing hole and will therefore be more prone to premature failure by wind uplift and rattling through their fixings.

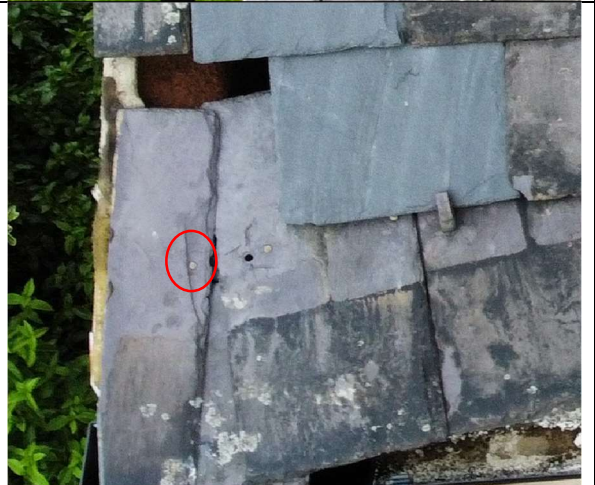
Red circle – there is only one fixing hole in this half-slate and it is slipping off the verge.

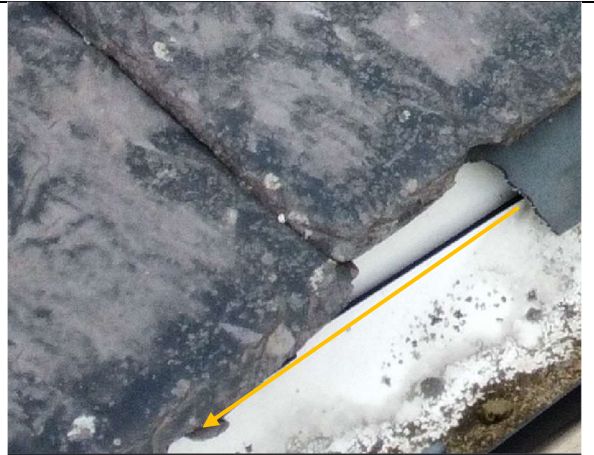
The abovementioned eaves tray is damaged/missing towards the outlet and should be replaced to mitigate against the incorrectly positioned eaves course.

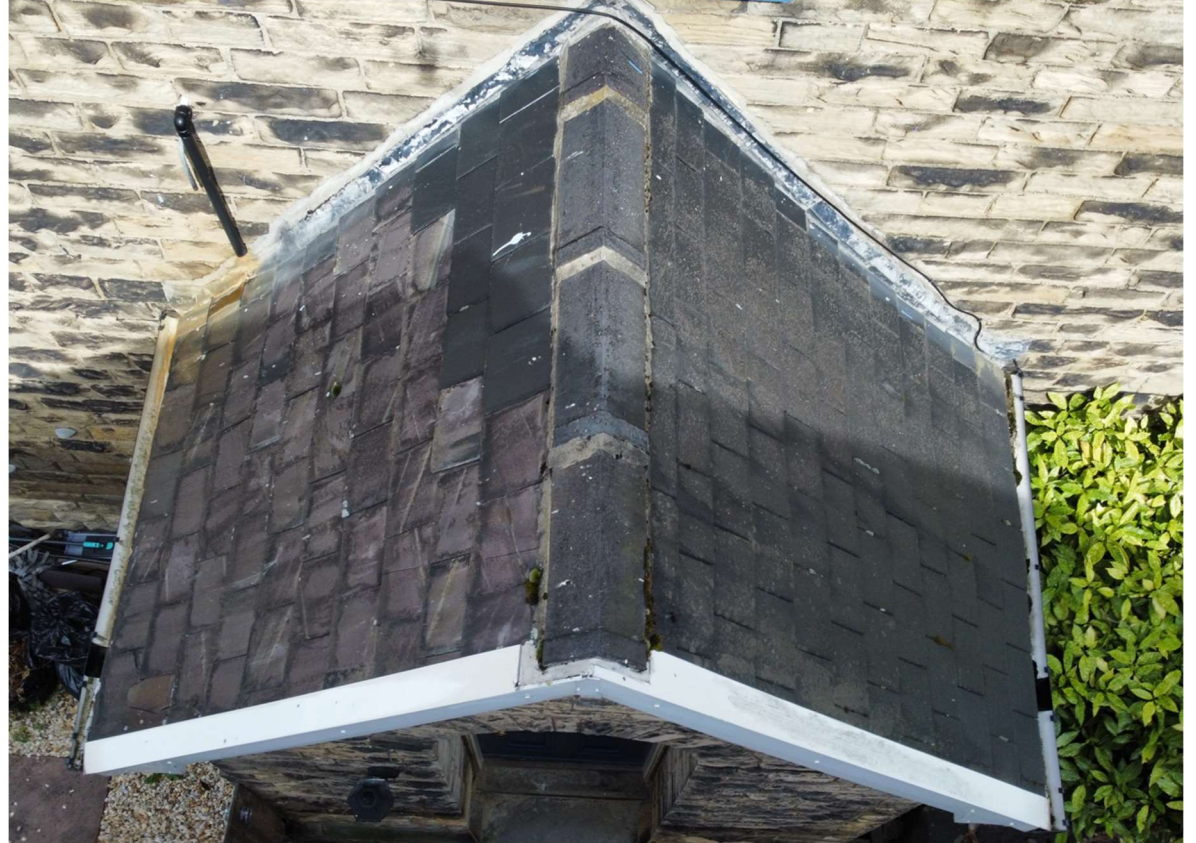
Overhead photo of the porch roof

Some of the slates have been replaced and others are cracked.

The cracked slates should be replaced in the short-medium term.

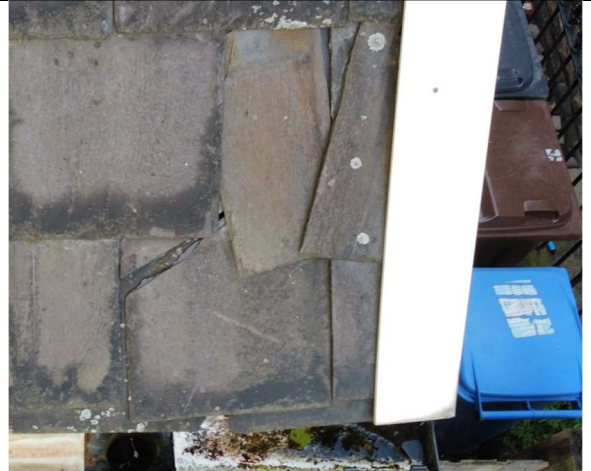
Rear left-hand eaves – the area of damaged slates needs to be repaired before winter.

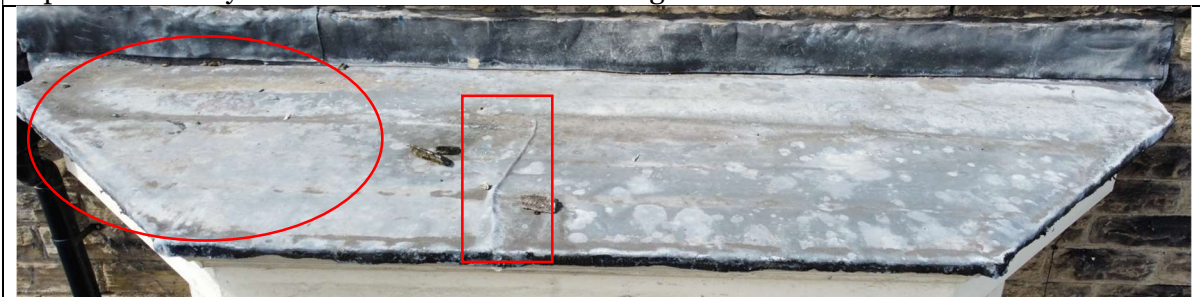
Front elevation, bay window roof – the covering is made from a single sheet of lead, which is too large for this purpose and is ruckling in the centre (red box). Red circle – internally, there is a cool spot in this area suggesting that moisture may be getting in. A plan should be made to replace the covering before it damages the substrate or this will be a much more significant job. We recommend that two sheets of lead are used with a mopstick detail down the centre. The cover flashing has been more recently replaced and the reason for this replacement may be what caused the moisture ingress noted above.

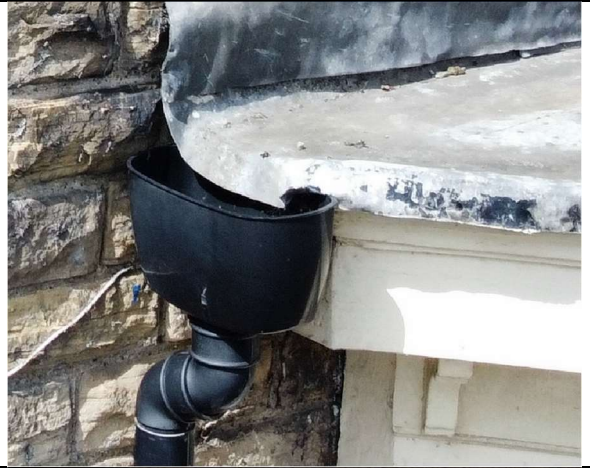
Front elevation, bay window – the guttering arrangement is not ideal. You should observe this from the bedroom window during and following rain to see if the rainwater is contained.

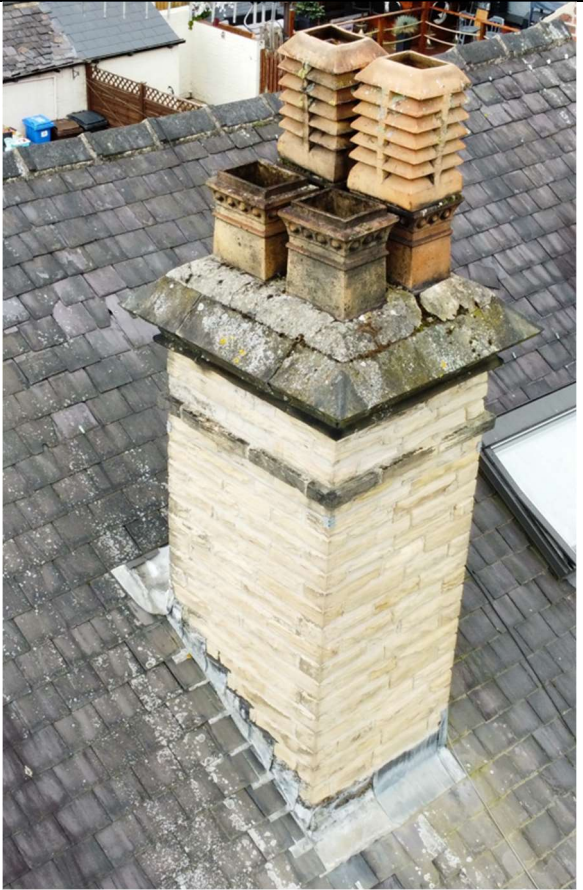
<u>Front Chimney Stack</u>	
<u>Pots</u>

Two clay pots, these appear to be in acceptable condition from the drone photos. We recommend that vented caps are added to the tops of the pots to minimise rainwater ingress (subject to using one suitable for the gas fire in the front room if this is to be retained).	
<u>Flaunching</u>	
This is in acceptable condition with only a couple of cracks and will likely last another couple of years before it needs to be replaced.	
<u>Corbelling</u>	
The corbelling is soot-stained, however, is in acceptable condition.	
<u>Stack</u>	
Due to the property's elevated position, we have not been able to get as far back as we would like to have to check the stack for plumbness from the ground, however, we did not notice any significant lean from the vantage point across the road.	
There are areas of decay to the stone that forms the stack and some of these stones

have been inappropriately repaired with mortar.

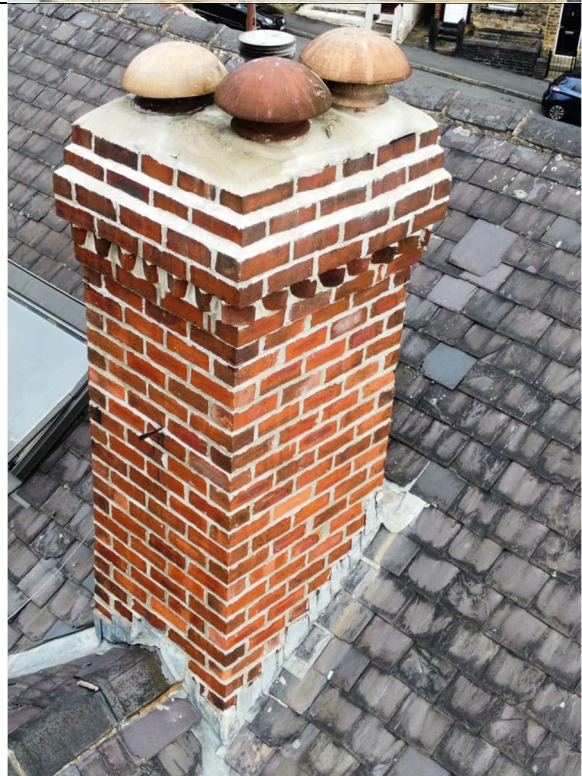
The lead looks to be the original lead (based on its colour and condition). This will likely last a few more years until it needs to be replaced.

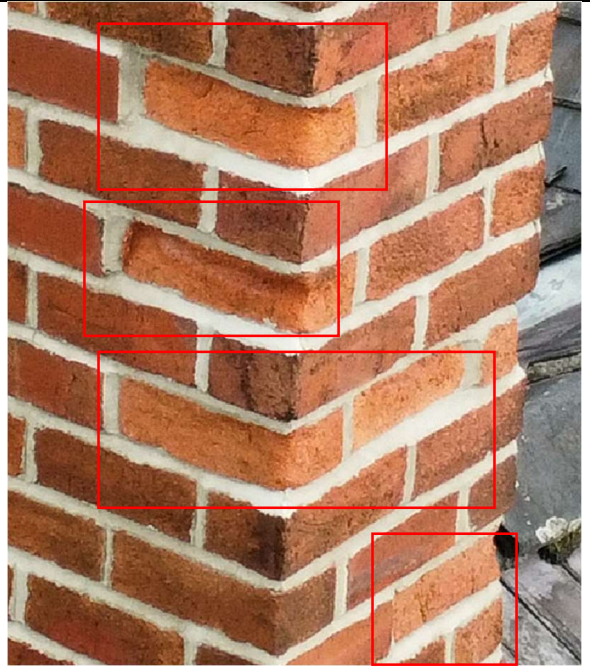
Example photo of some of the decayed bricks.

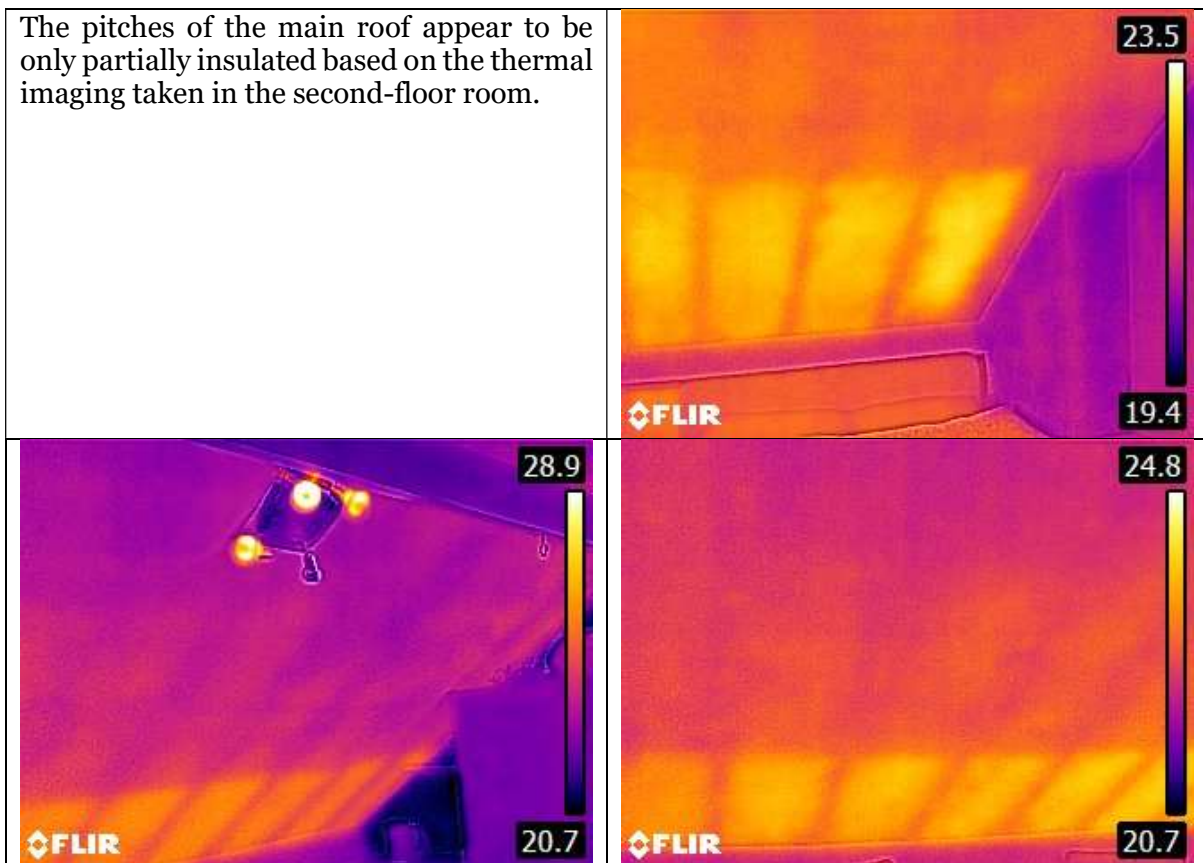
The pitches of the main roof appear to be only partially insulated based on the thermal imaging taken in the second-floor room.

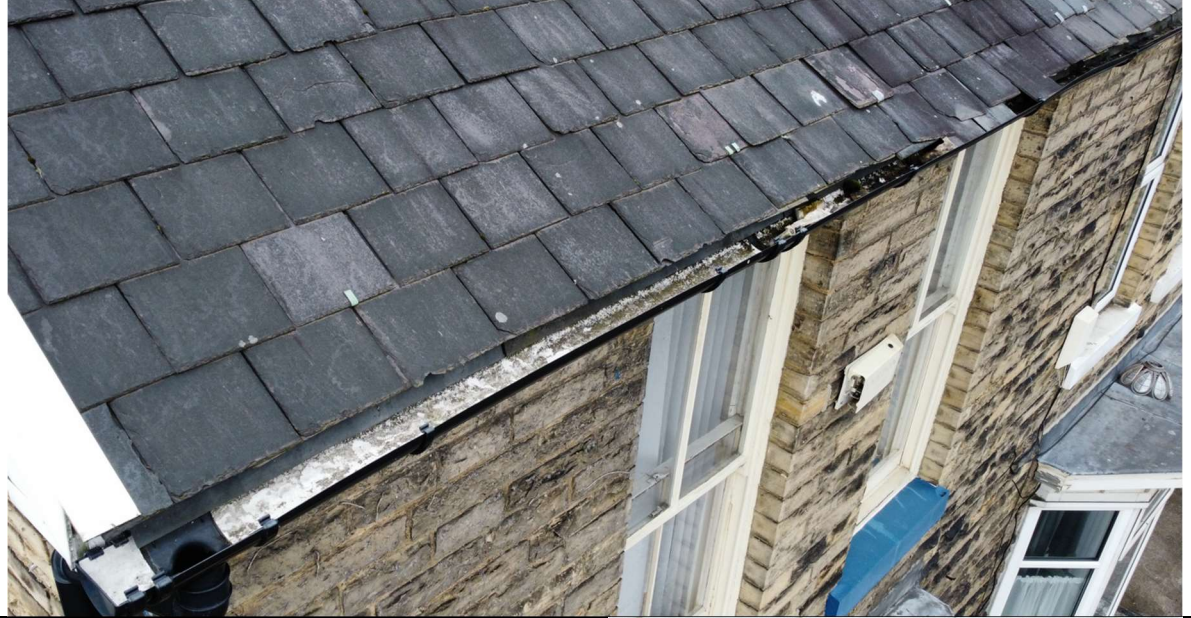
Front guttering run, uPVC – there is debris trapped at the right-hand side of the run, away from the outlet, this is likely a result of the guttering not being set to the correct fall. Consideration should be given to re-setting the guttering to the correct fall (1:40).

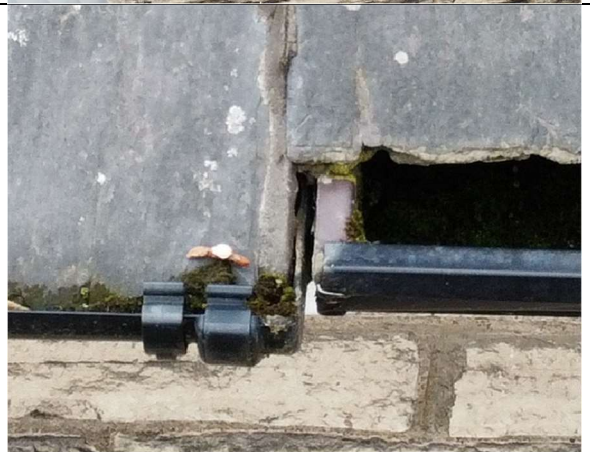
A lead saddle should be added where the two runs of guttering abut.

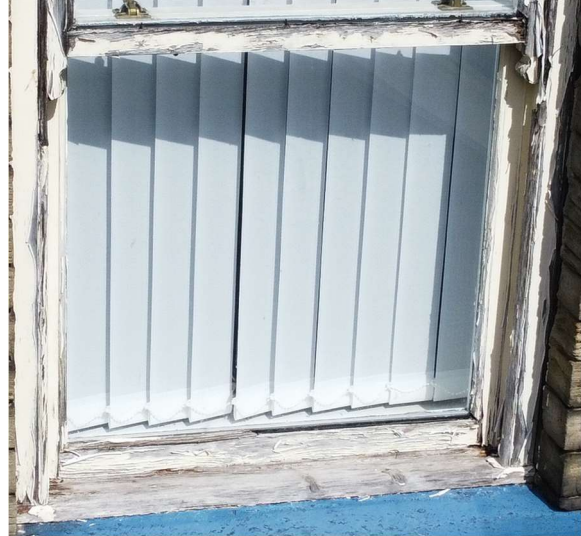
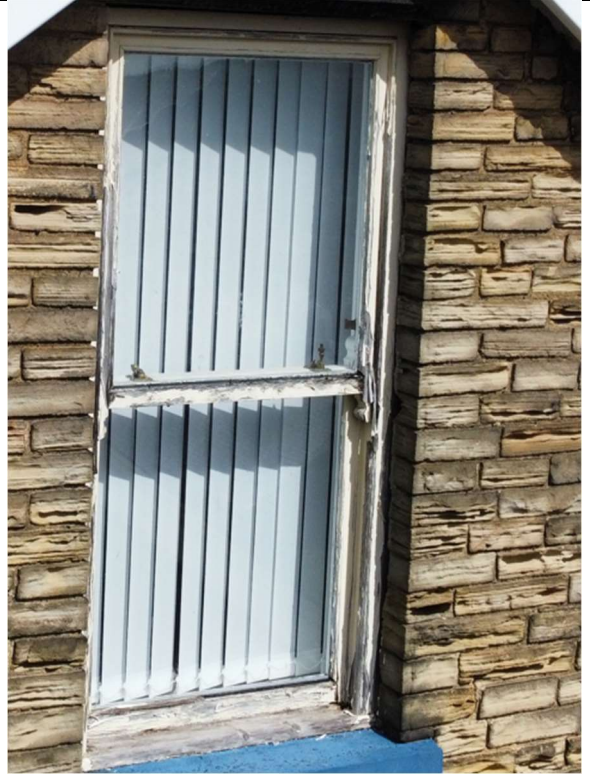
Second-floor window – the frame is in poor condition, repair, preparation and redecoration are required; we recommend before winter. Where the frame abuts the reveal, it has been sealed with expanding foam and there is a large gap. This should be sealed with burnt sand mastic before winter.

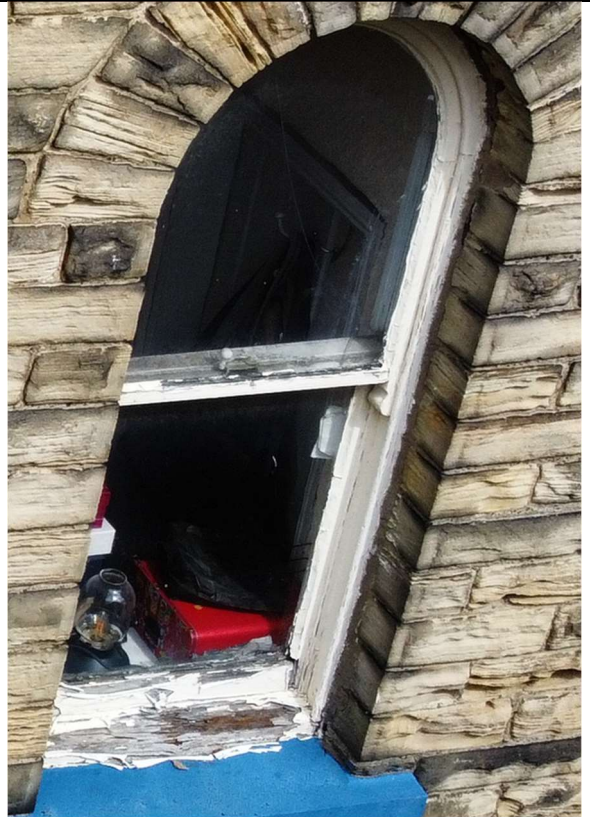
First-floor window – this is in poor condition and the glazing is cracked. The window should be repaired/replaced in the next year or so.

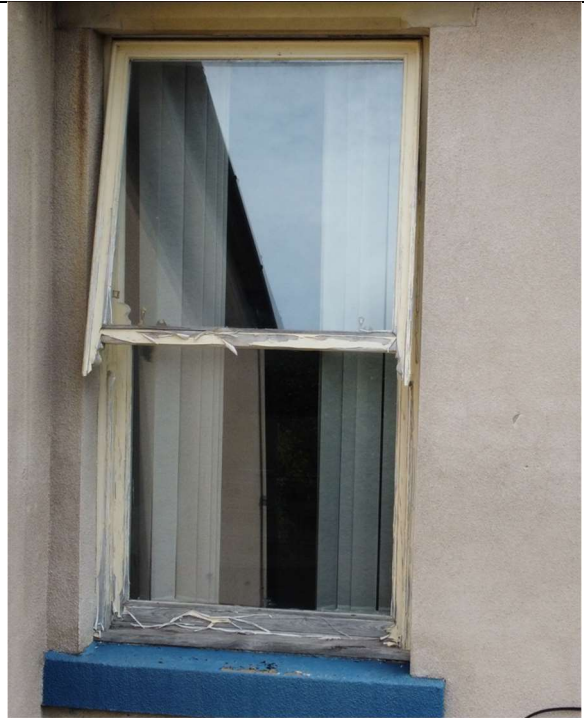
First floor, rear bedroom – the frame needs preparation and redecoration, we recommend that this is undertaken before winter.

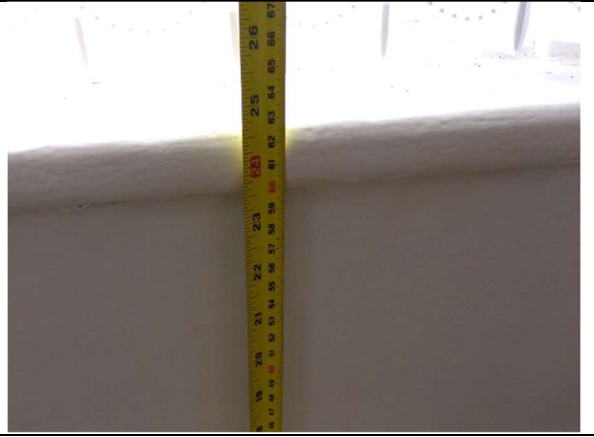
Where the windows are below 800 mm from the floor, toughened safety glass should have been used in the lower panes (which it has not been).

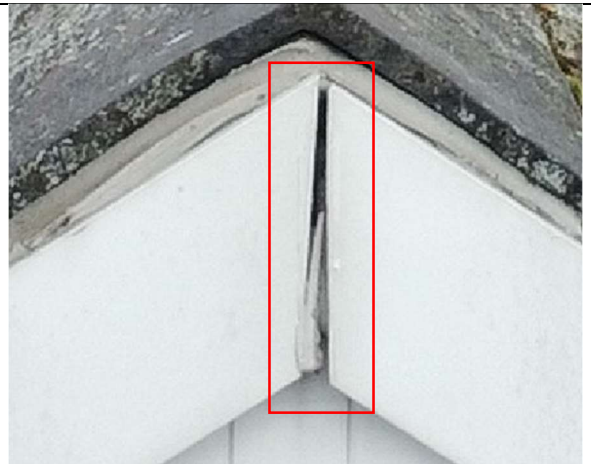
Ridge – there should be a cover strip that fits across the mitred abutment.

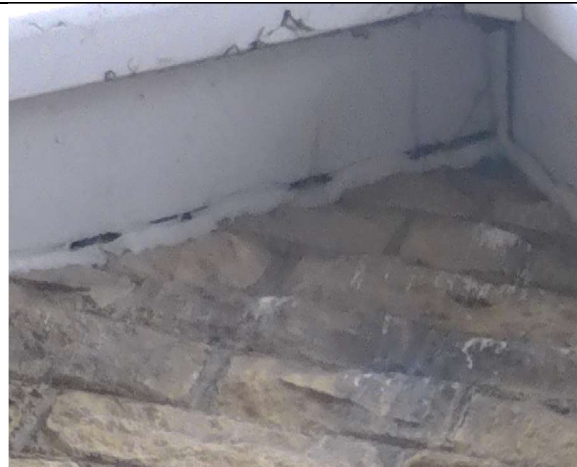
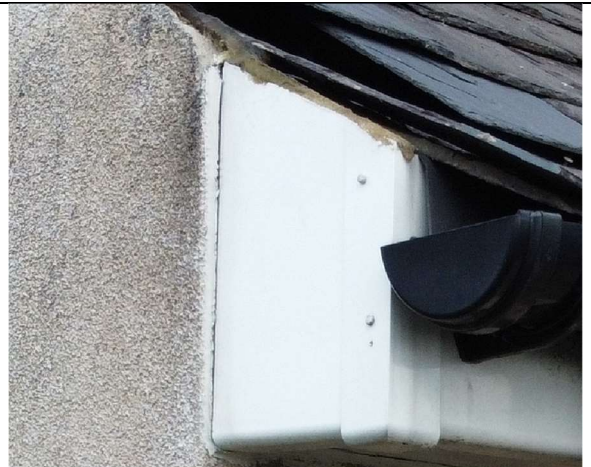
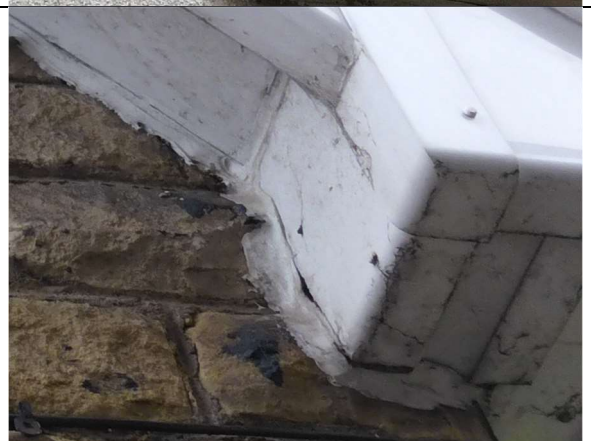
In several areas, the seal around the perimeter of the uPVC elements and the elevations is broken/shrunk. Although this is good for ventilation, it could allow insects etc. into the voids.

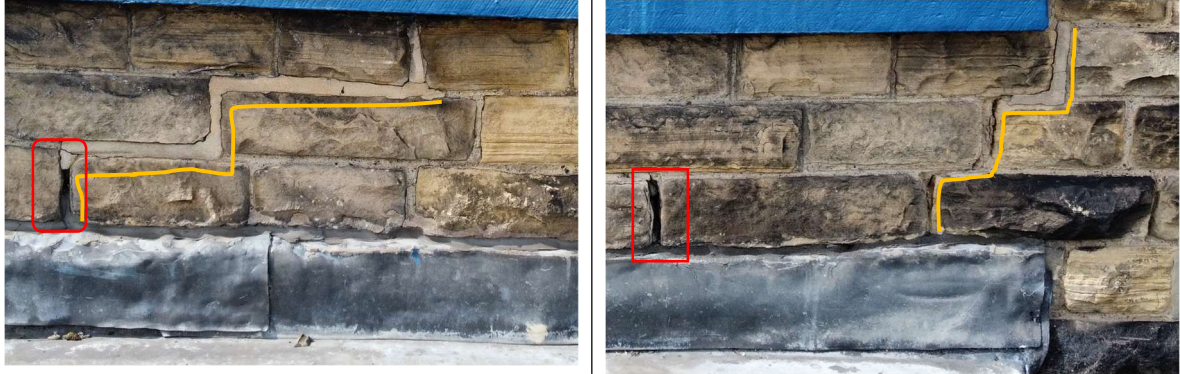
The area below the front bedroom window/above the living room bay – there are two areas of stepped cracking that have been repointed and some perp joints that have no mortar in them. We did not note any cracking to any of the stones. There could be several reasons for this – tree roots and/or drainage may have caused some structural movement and/or there may have been some water ingress that has damaged the bressummer beam above the bay window. In the first instance, we recommend that this area is recorded, properly repaired (joints raked out to a minimum of 25 mm and repointed in hot lime) and then monitored for at least one year (in each season) to establish if there is any active movement. If the joints do open back up, further invasive investigation and repair will be required.

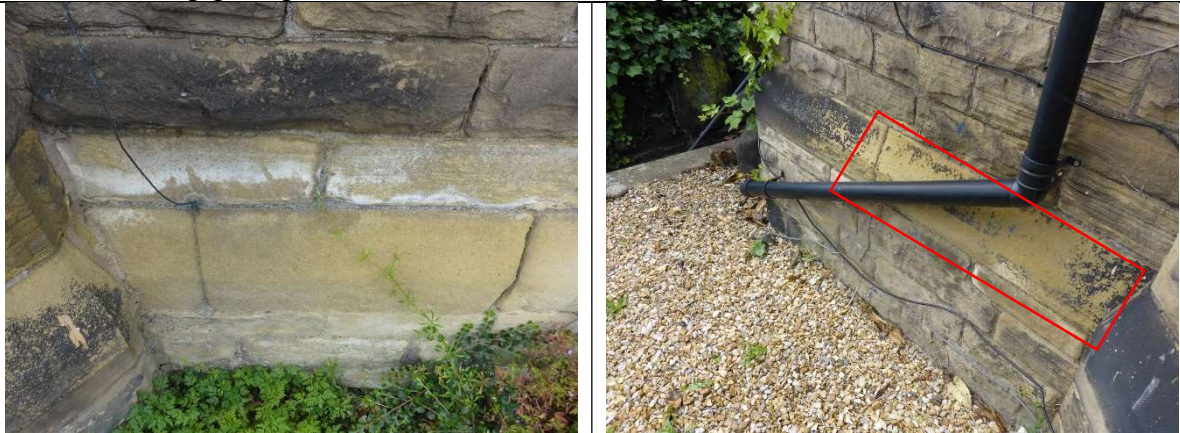
There is some surface decay to the plinth stones, these should be defrassed by a stone mason.

An additional pipe clip should be added to the fall pipe under the elbow.

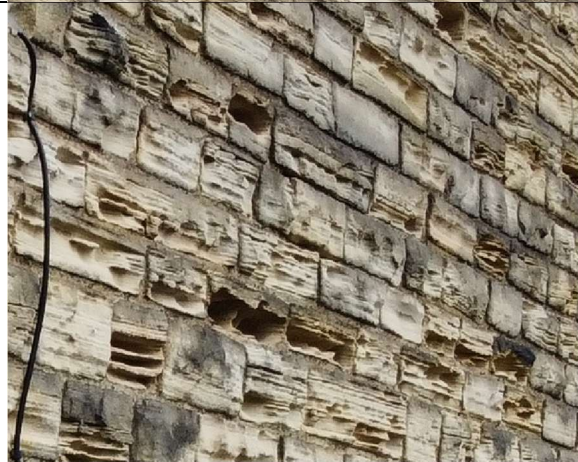
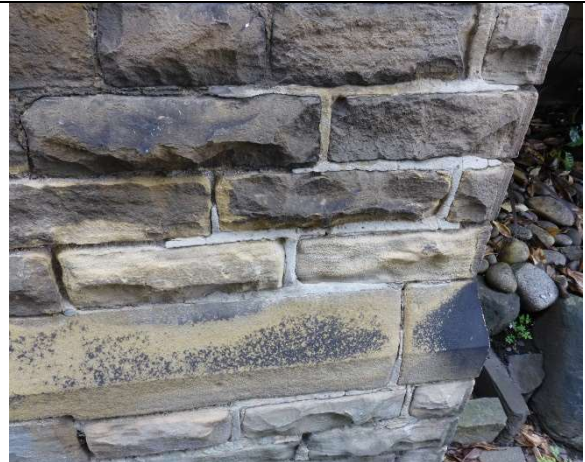
Left-hand elevation – some examples of stone decay. Some of the stones that are worse affected will need to be replaced in the medium term. A matching stone should be sourced in advance of the works. There are perhaps 25 – 35 stones that will need to be replaced, many of these are at high level and a scaffold will be required.

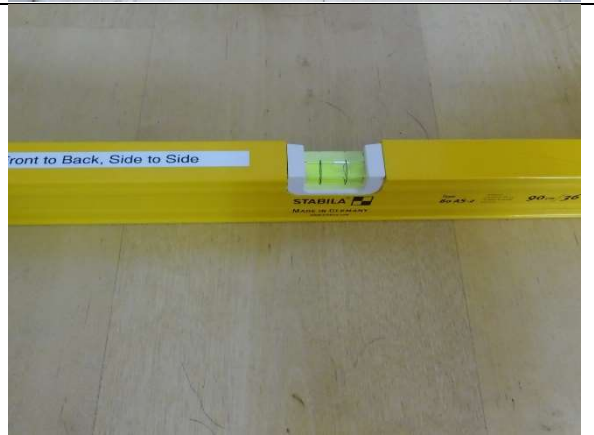
Front bedroom – the floor is c. 10 mm out of level side-to-side in front of the cupboard and has perhaps dropped a little. As the floor is laminate, we could not lift this to check.

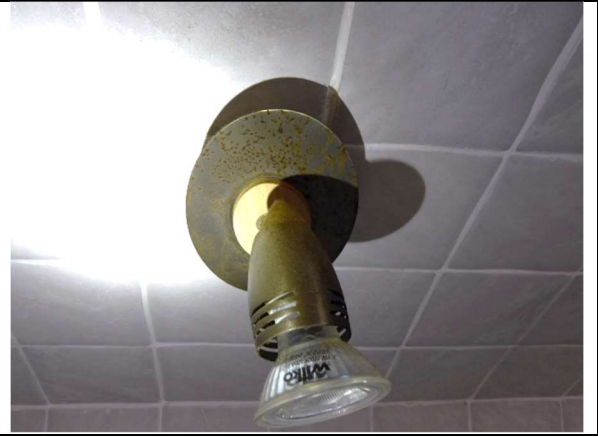
Kitchen – there is surface corrosion to the light fittings – ventilation in the room needs to be improved.

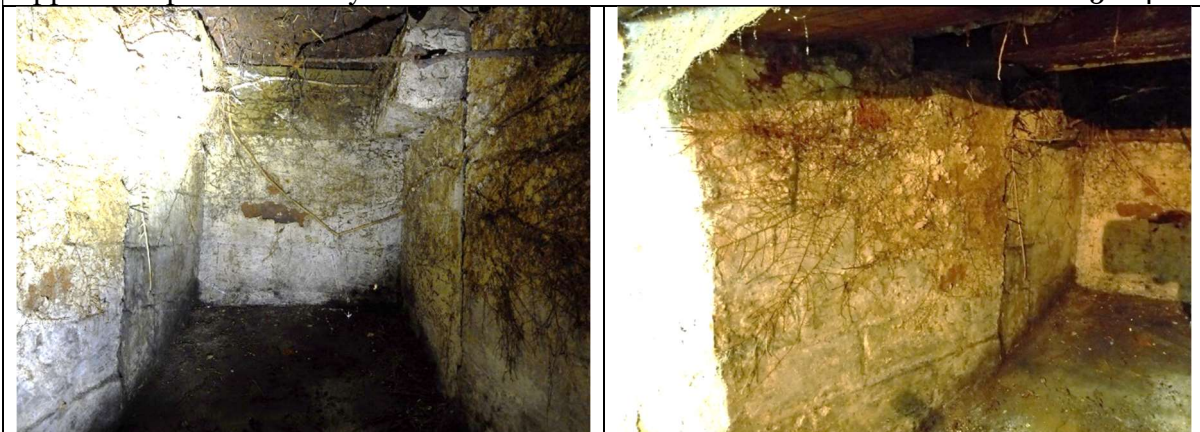
Around the front coal hole, front left-hand corner and along the front left-hand elevation, there are roots coming in between the brickwork and around a blocked-over sub-floor ventilation grille. Immediate action should be taken to begin reducing the vegetation mass (gradually, so as to prevent ground heave). These roots are likely to cause structural damage to the property and drainage systems. We have included example photos below as opposed to photos of every root. Sub-floor ventilation is detailed further in Section 5.6.4.

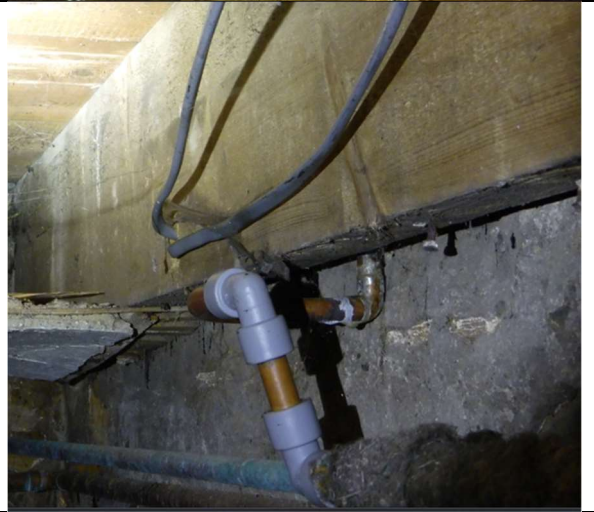
All service cabling should be appropriately clipped into place and all service pipework should be appropriately lagged and clipped into place.

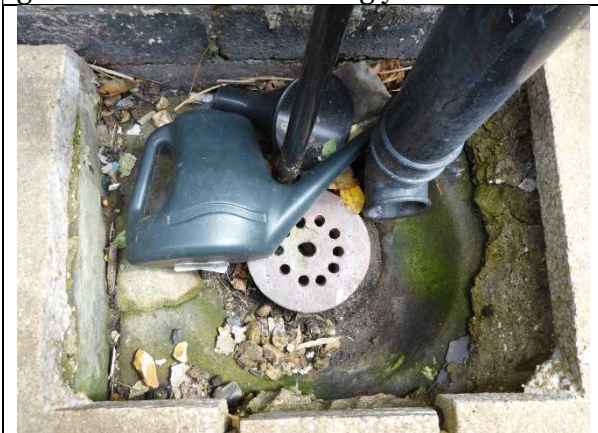
Rear elevation – the ground levels have been increased around the rear, a good measure of this is that the gullies would have originally been set at ground level and now the ground is c. 120 mm above the gully height. We recommend that plans are made to reduce the ground levels in the coming year.

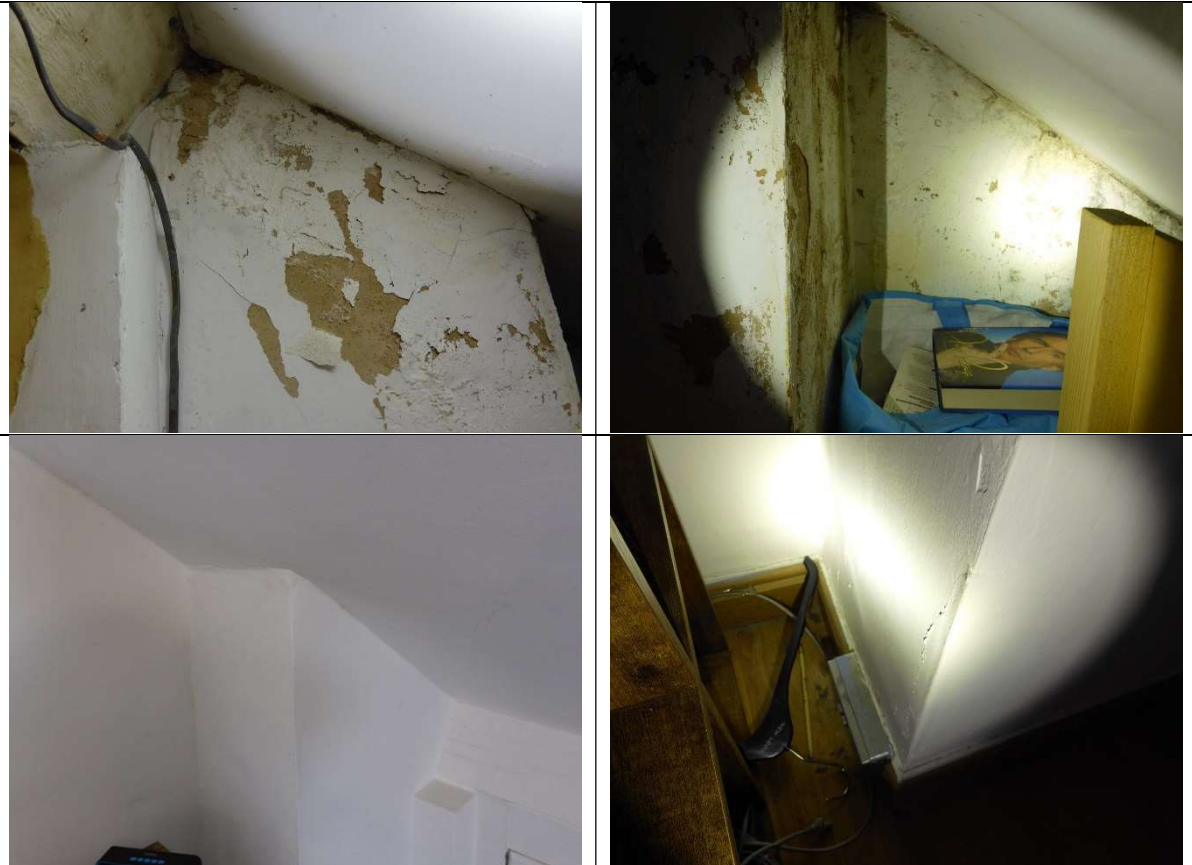
Front roofspace area, right-hand side – moisture has been getting in through the roof covering and tracking around the chimney stack/breast. The roof needs to be repaired as detailed above and the wall can then be redecorated.
