Level 3 Survey in Respect of:

Report prepared by Simon
Hollis MRICS

18th July 2023

Building Survey Report

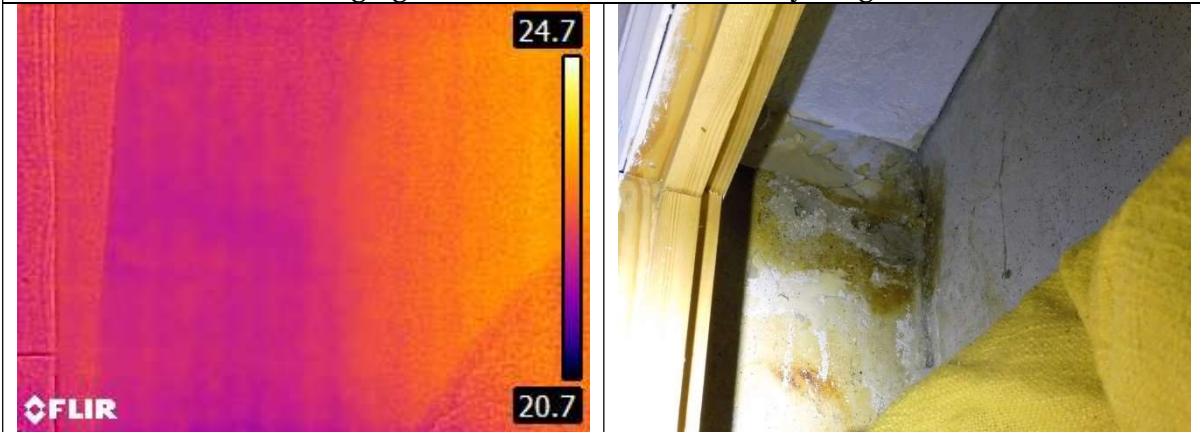
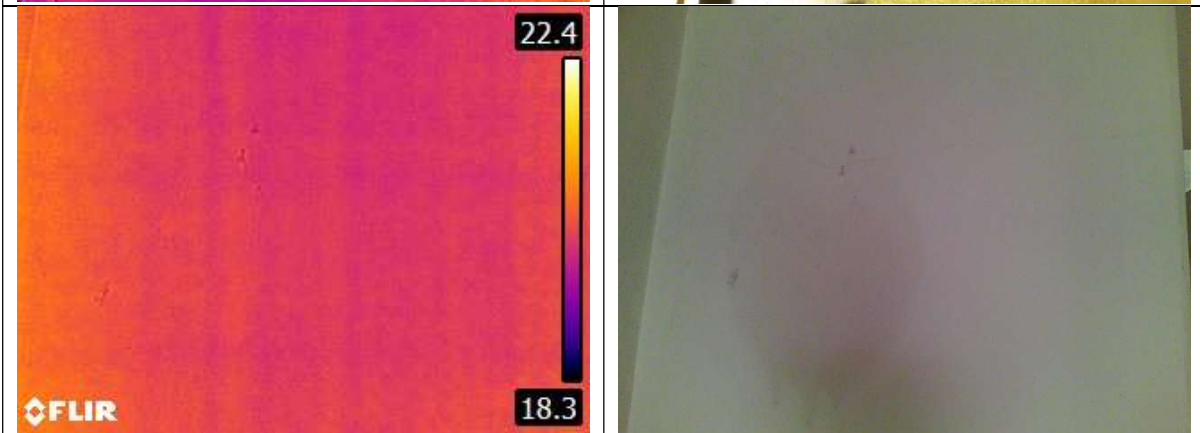
Landing cupboard/bathroom – there is some moisture staining in the landing cupboard/bathroom underneath the redundant off-shot chimney stack. We examined the area with the thermal imaging camera and did not notice anything unusual.

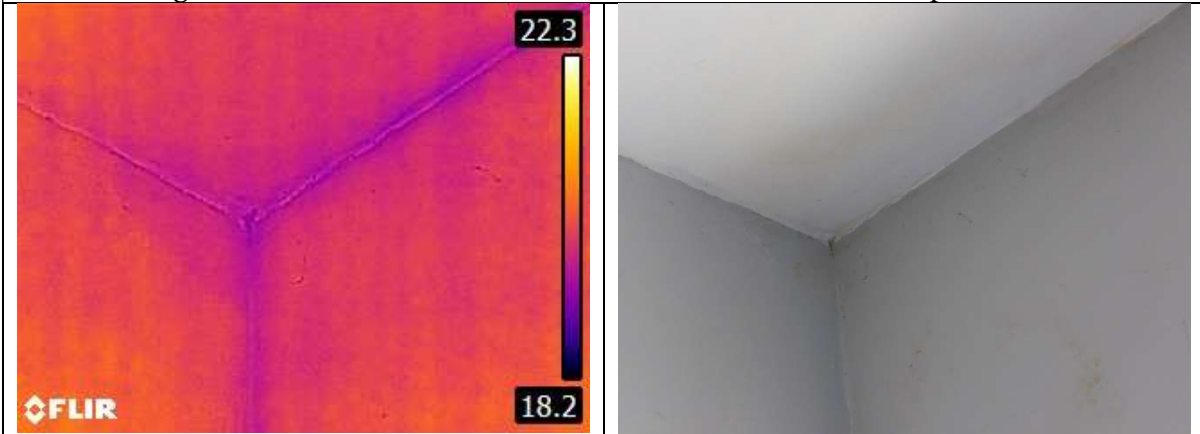
Kitchen, dining room elevation – there is moisture staining around the ceiling/walls in this corner. We inspected the area with the thermal imaging camera and did not notice anything unusual. This area is immediately below the shower a leak is the likely cause of this higher level staining. It should be checked for leaks before redecoration takes place.

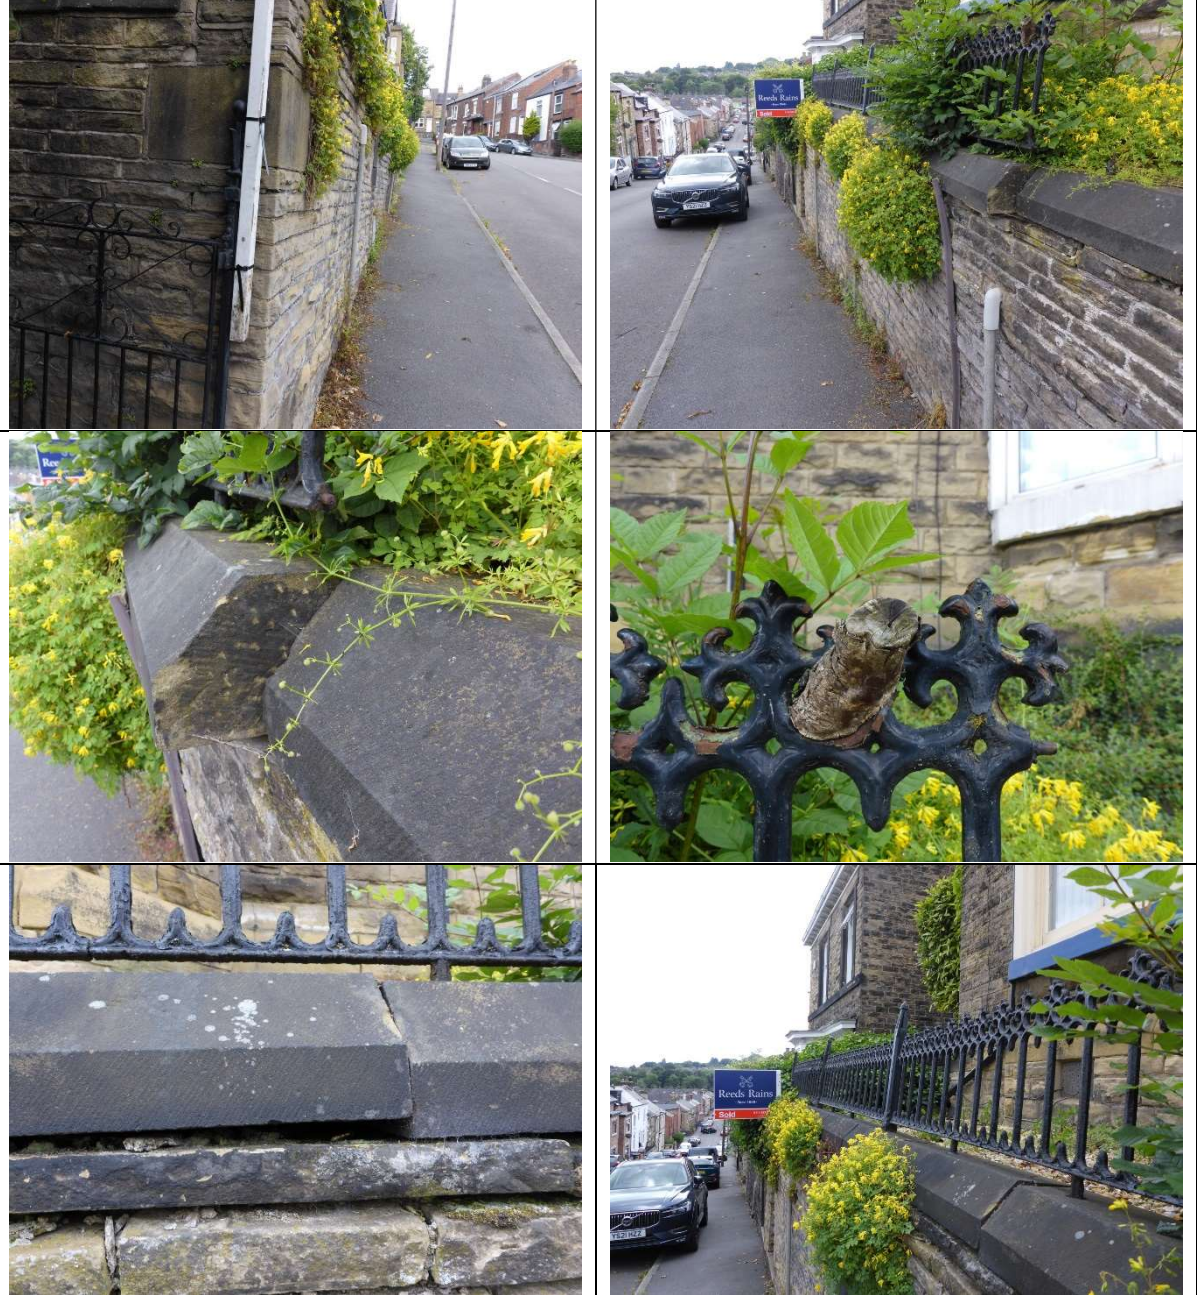
Front, retaining boundary wall – the wall head has been pushed out along most of its length, likely at least in part as a result of a large tree/bush. We have included some example photos below. At some point, the upper section of the wall is going to need to be taken down and rebuilt to correct this. The iron fencing is damaged in places and the capping stones are leaning back towards the house. We recommend the drains and soakaways are inspected prior to this work being undertaken as if the front gullies run into a soakaway in the front garden, this may need emptying and remaking at the same time. This work will likely require some of the pavement to be cordoned off. We have included example photos below.

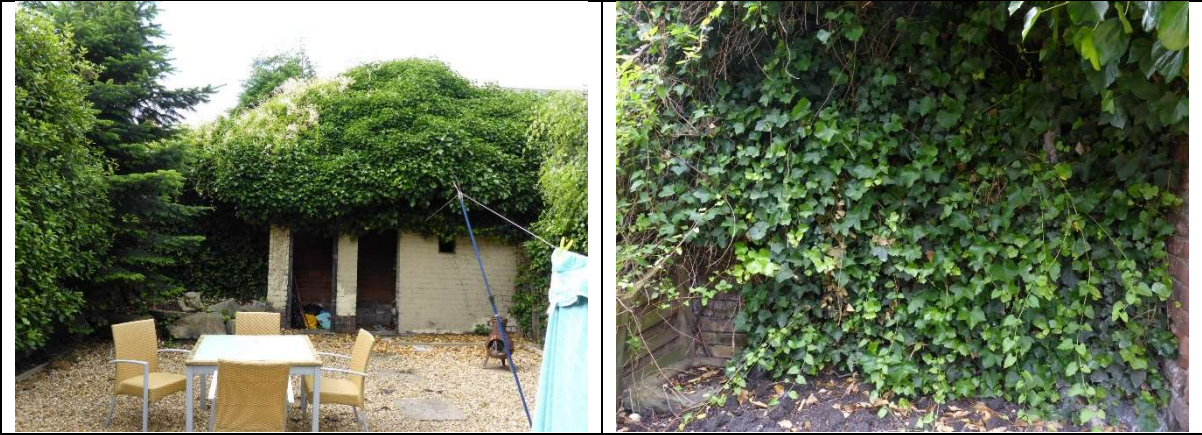
Rear boundary – we have been unable to inspect the rear boundary as it has been completely overtaken by ivy and vegetation. We recommend that the ivy is gradually killed and removed and the boundary re-inspected when it is visible. Note that this work should be a gradual process to prevent ground heave.
