Level 3 Building Survey

Report prepared by Simon  
Hollis MRICS

31<sup>st</sup> August 2023

## Building Survey Report

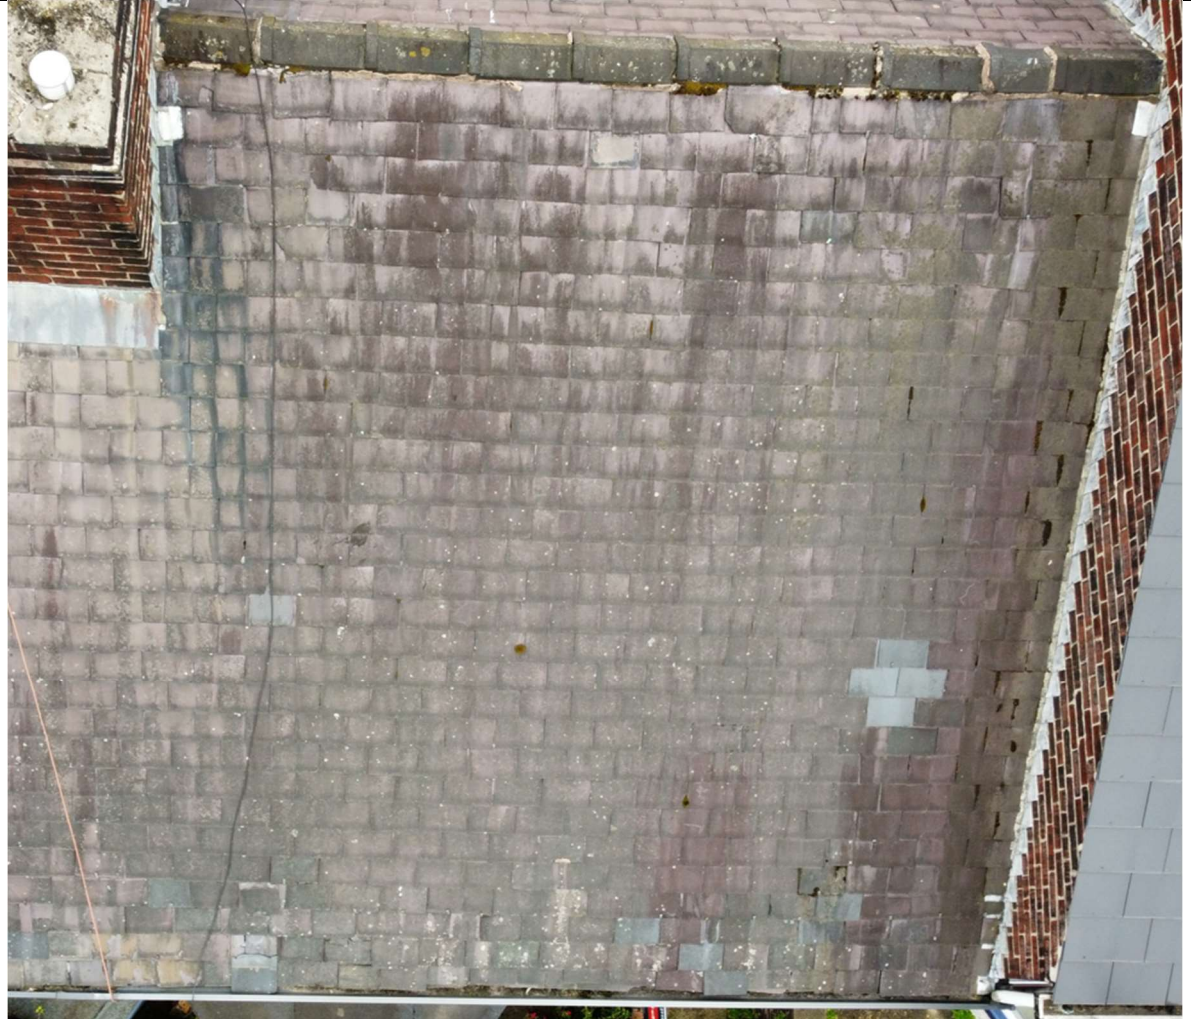
Overhead photo of the front roof pitch. Note the heavy staining to the slates.

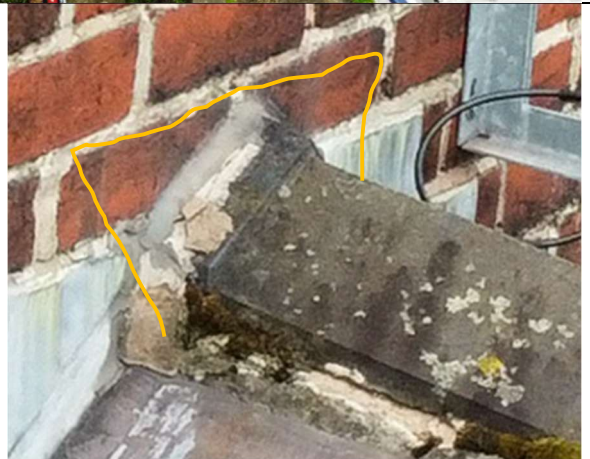
There is no saddle piece where the ridge abuts the chimney stack or right-hand gable wall.

A saddle piece should be added next time high-level works are undertaken.

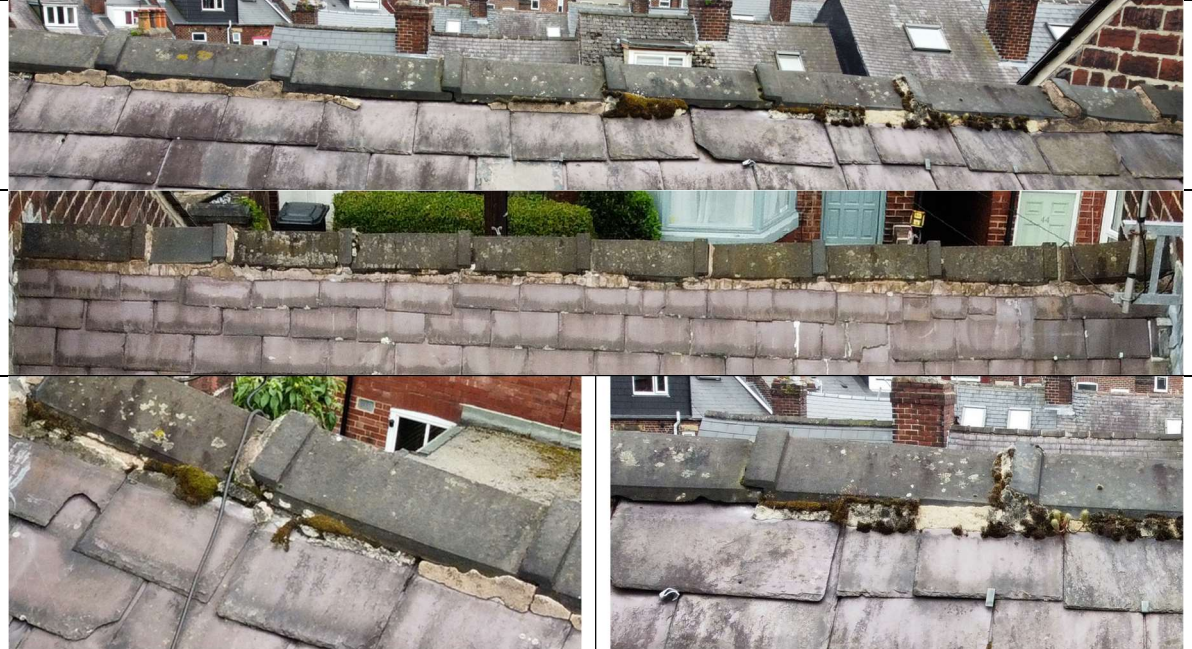
Ridge – clay overlapping ridge tiles wet bedded in mortar. A couple of tiles are damaged and most of the ridge pointing is missing or damaged.

The front and rear ridge are in the photos below with some close-up photos below them.

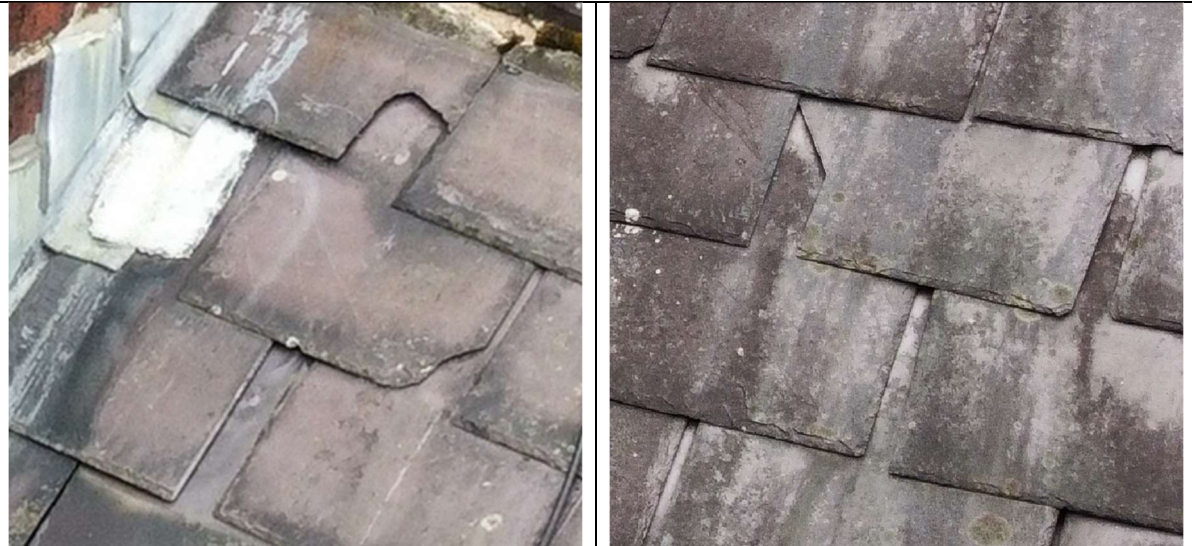
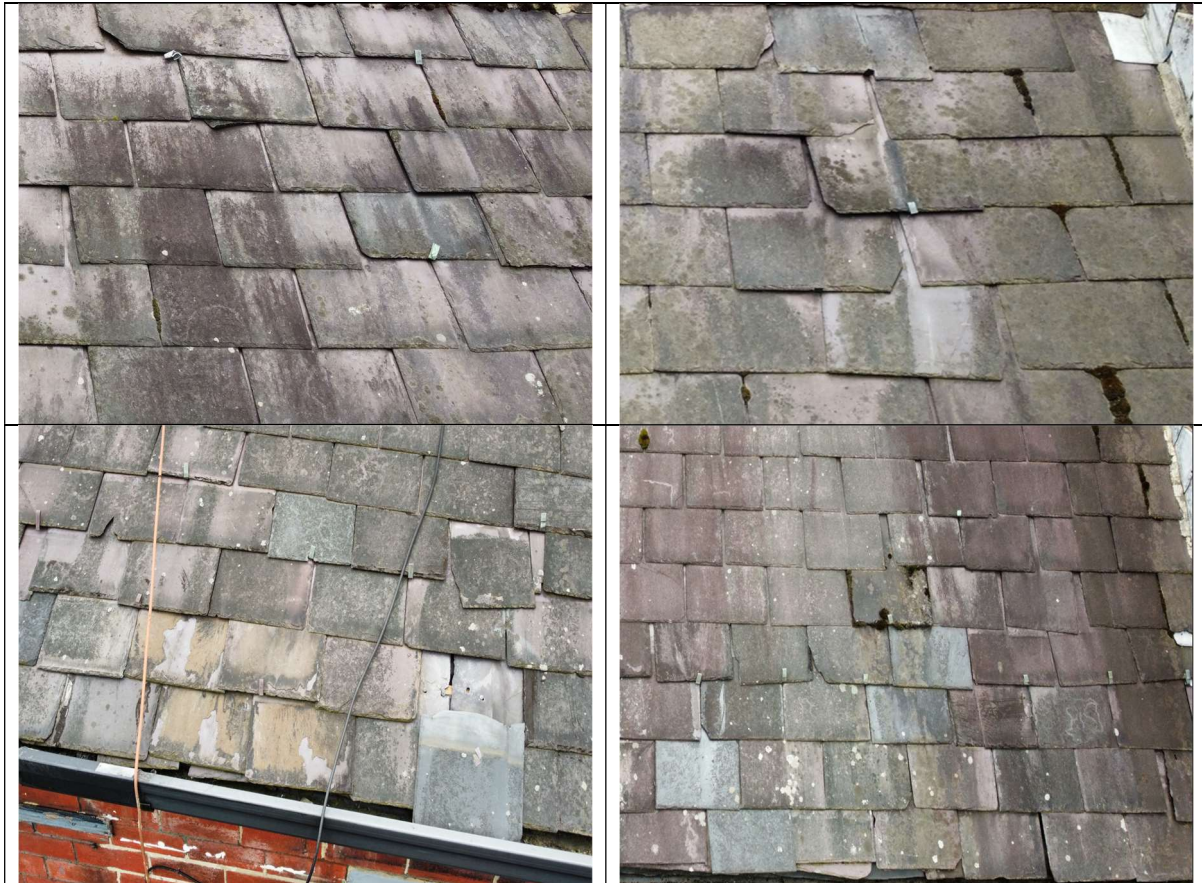
There are several areas of damaged slates across the pitch, all areas of damaged slates should be repaired/replaced as soon as possible. We have included some example photos of the areas below.

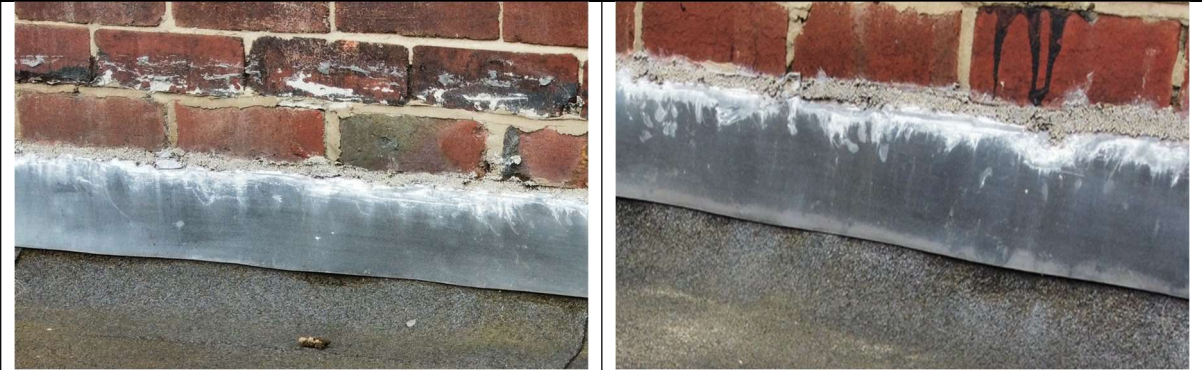
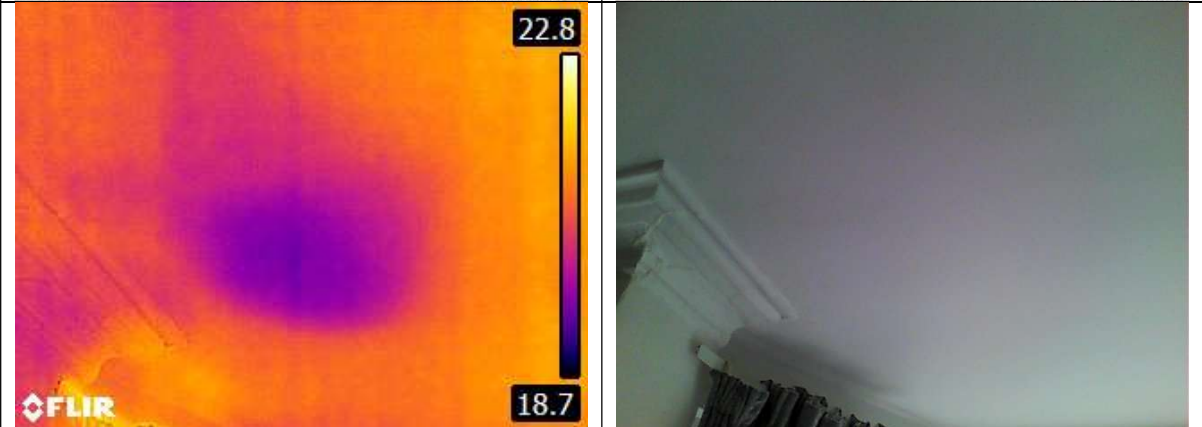
Internally, there is a cold spot on the right-hand side, perhaps the location of a previous leak. We have included the internal thermal imaging photos below.

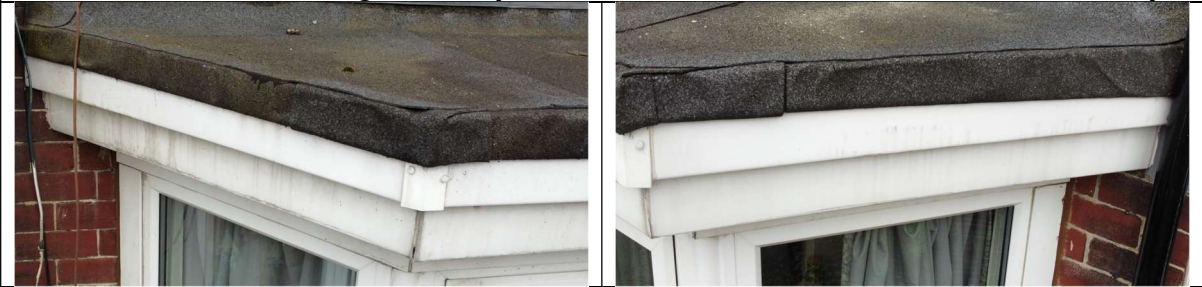
The felt is ruckled and not particularly well detailed around the front and sides of the bay.

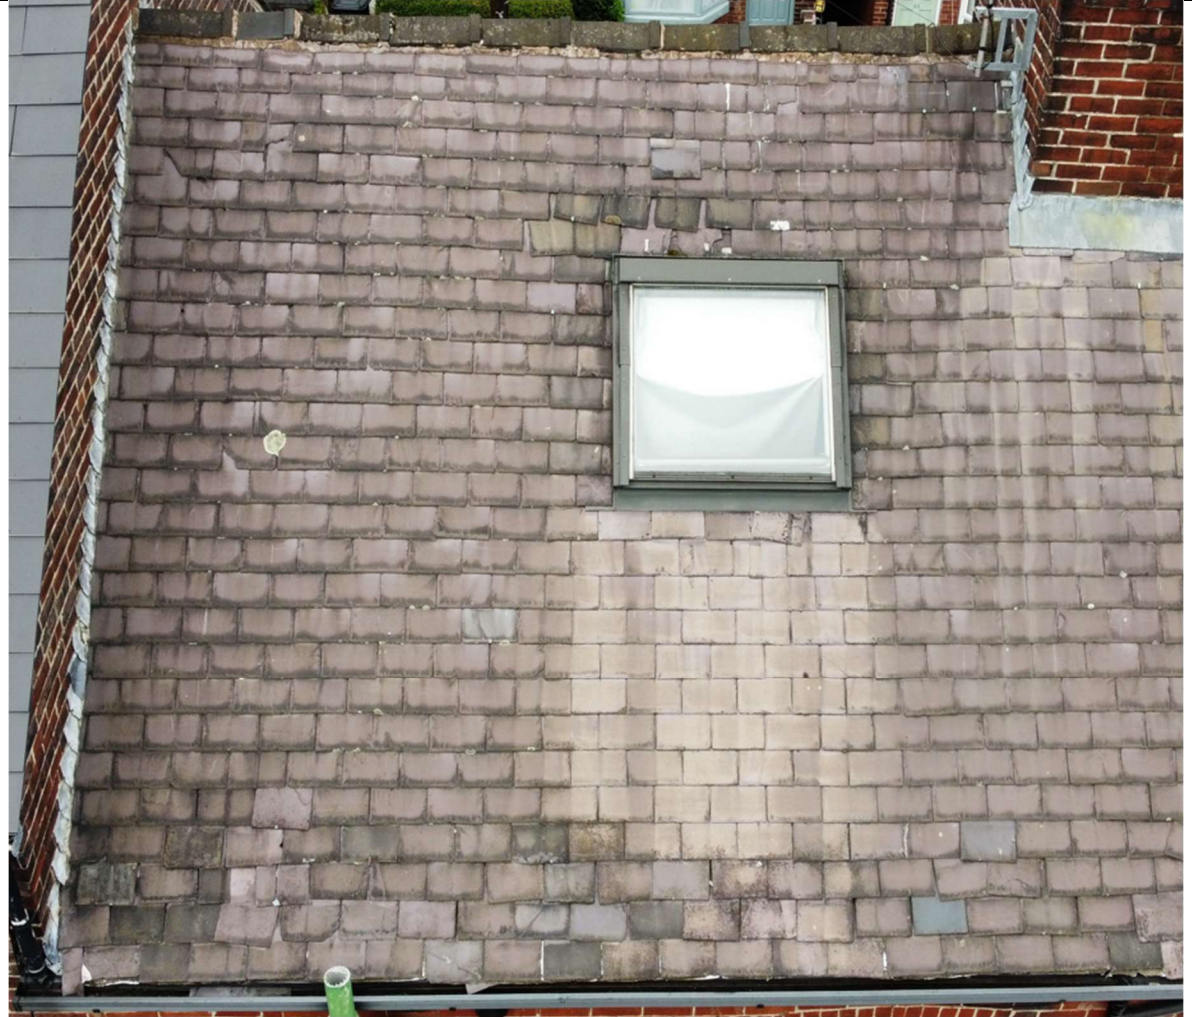
Overhead photo of the rear pitch. There is less pollution staining on the slates on this pitch.

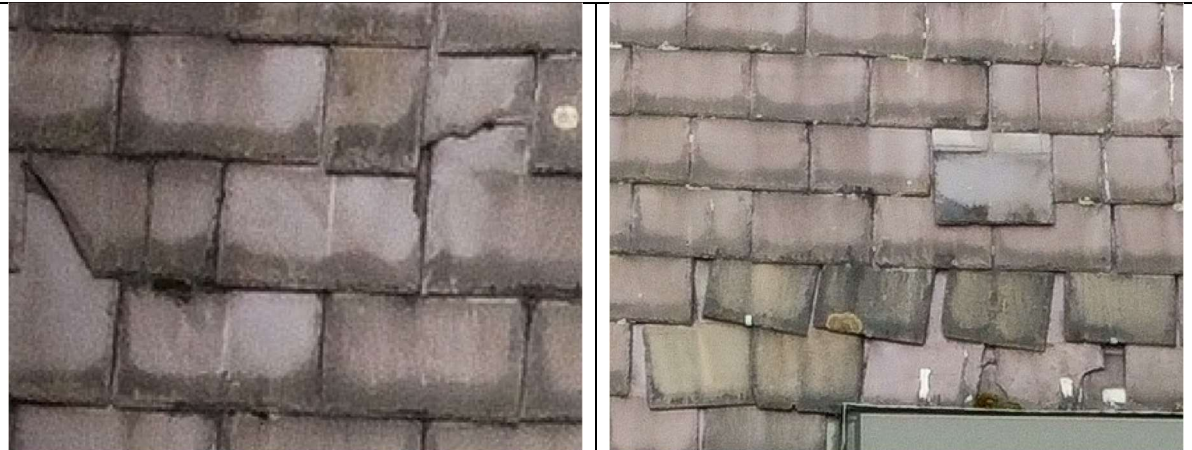
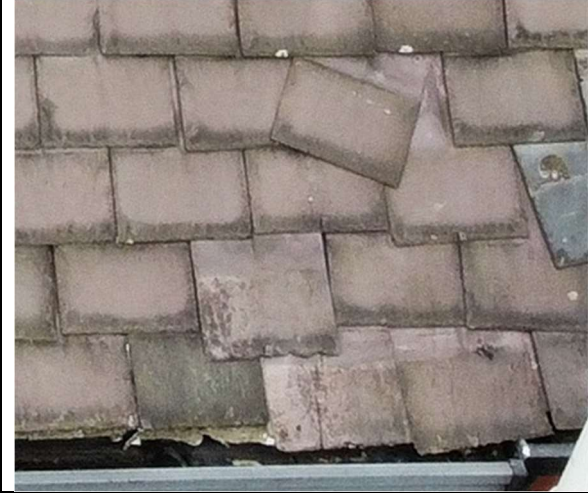
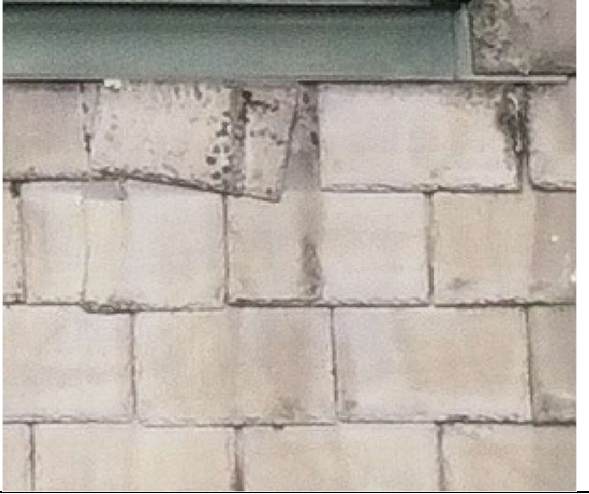
There are several areas of damaged slates across the pitch. All areas of damaged slates should be repaired/replaced as soon as possible. We have included some example photos of the areas below.

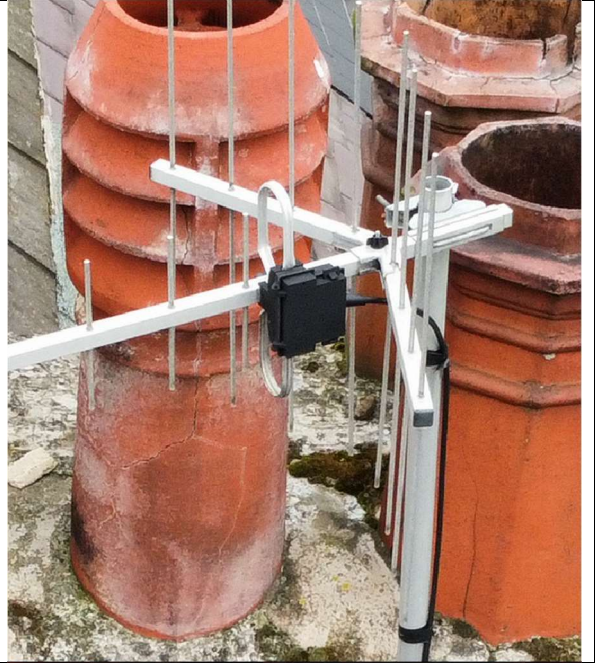
The centre rear and rear pots are both cracked.

The rear can probably be strapped up for now as opposed to being replaced.

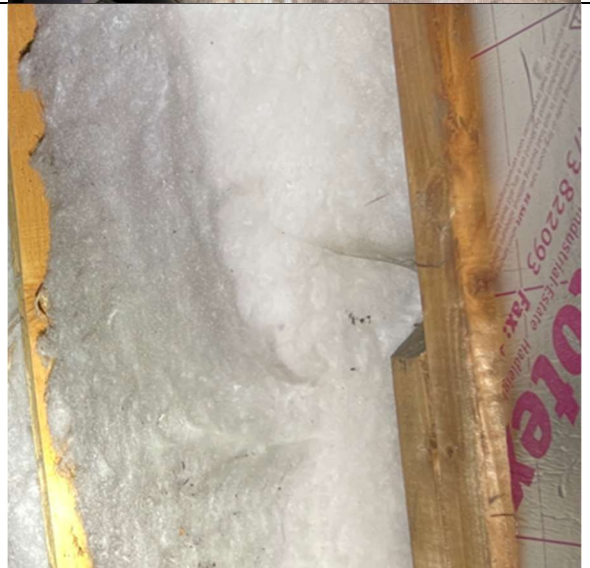
The fibreglass and mineral wool insulation that is laid across the first-floor bedroom ceilings can trap moisture.

Consideration should be given to replacing these with permeable insulation such as sheep's wool insulation

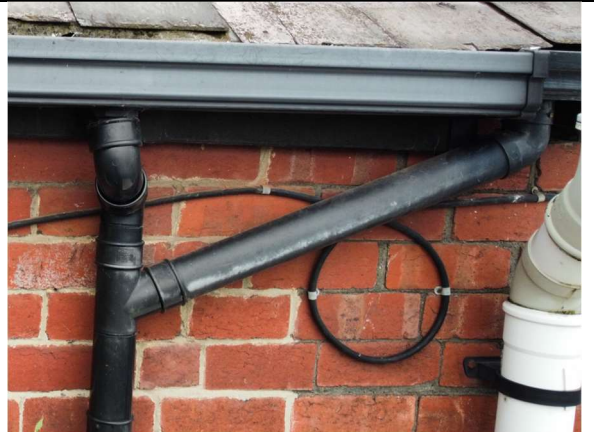
Water is leaking from the guttering – we cannot see if this is from the subject property or the neighbouring property.

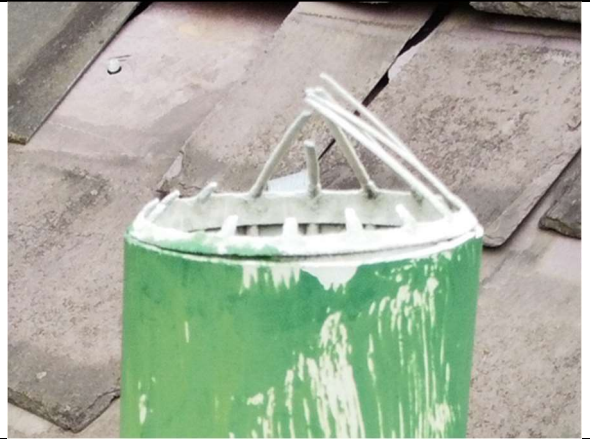
Soil vent pipe – the damaged bird guard needs to be replaced next time high-level works are undertaken.

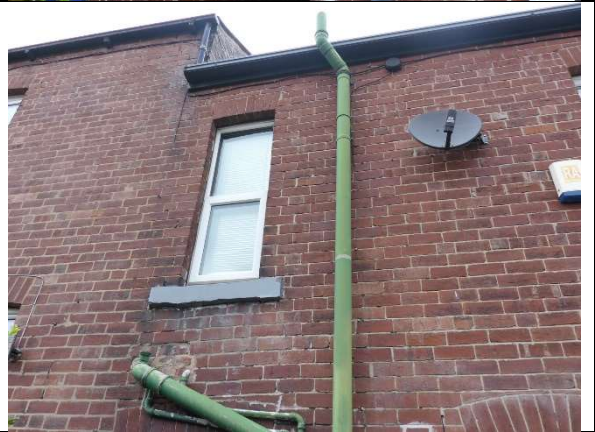
The kitchen waste pipe is sun-bleached, this will likely lead to premature failure.

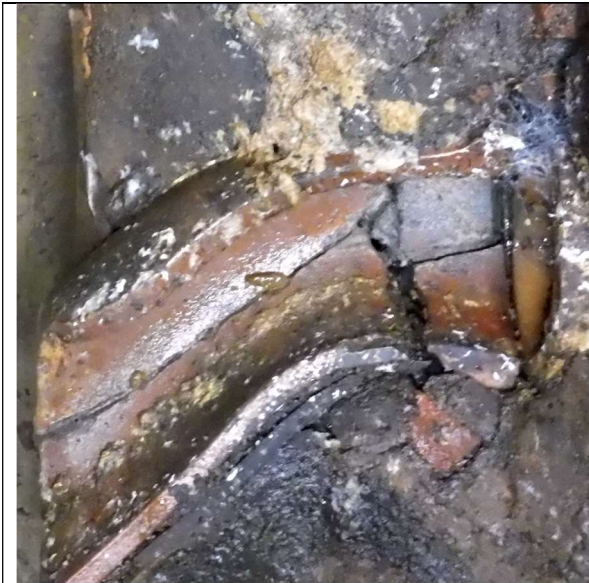
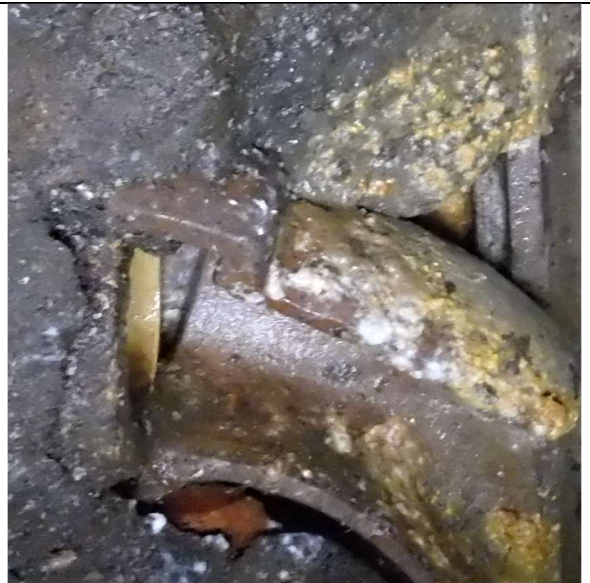
The pathway has collapsed along the route of this drainage run so it may be damaged and needs to be part of the drainage inspection.

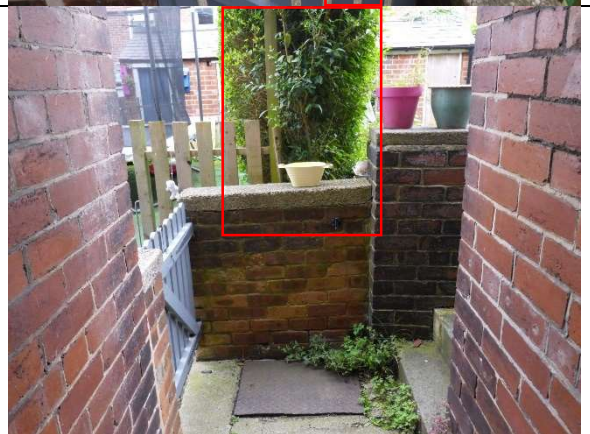
The roots of the hedge may cause damage to the drainage run and we recommend that this is inspected with the rest of the drainage and any required repairs are undertaken.

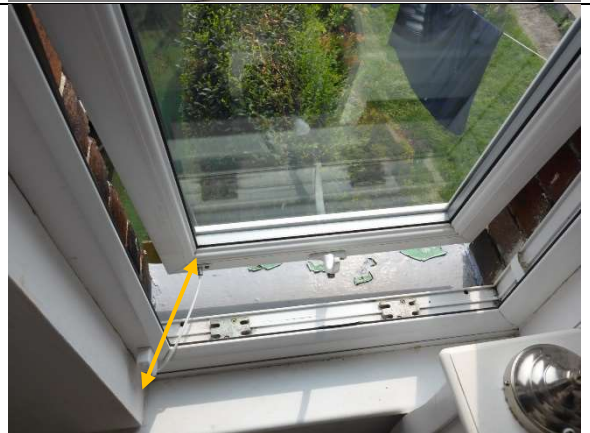
Kitchen window – the seal is damaged and should be replaced.

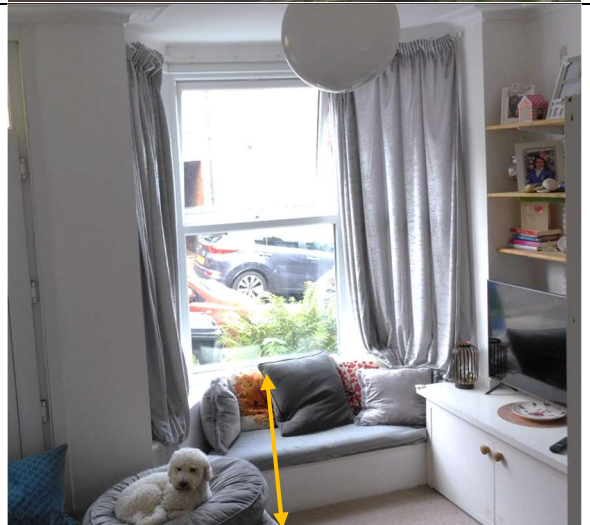
Living room – there is a small area of damage around the seal. This section should be replaced.

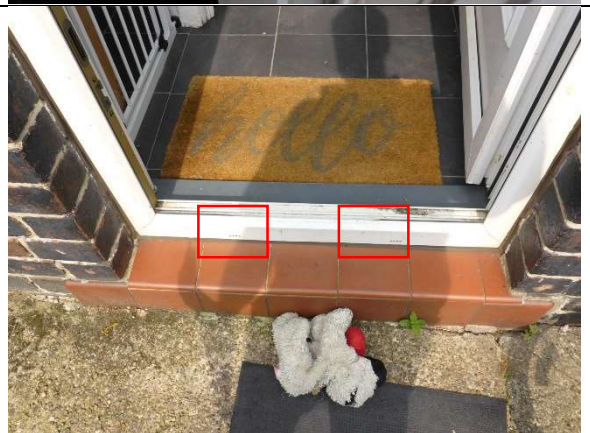
Front and kitchen doors – the weep vent covers are missing and should be replaced.

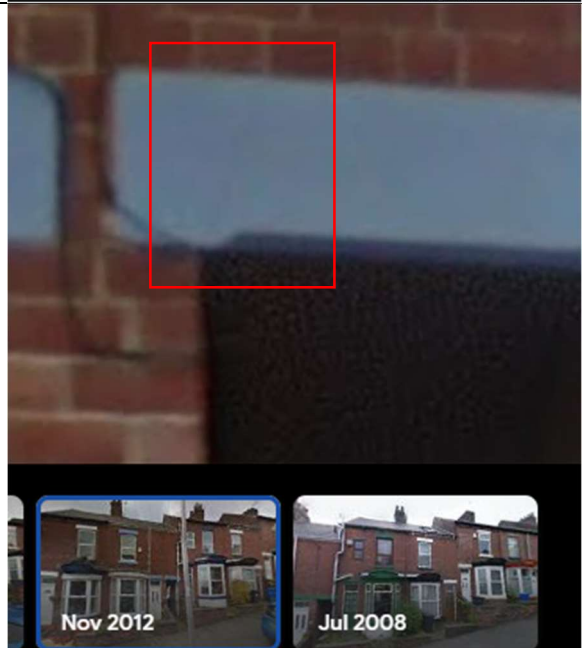
Google Street View October 2014 – the crack is clearly visible in this photo and photos since this date.

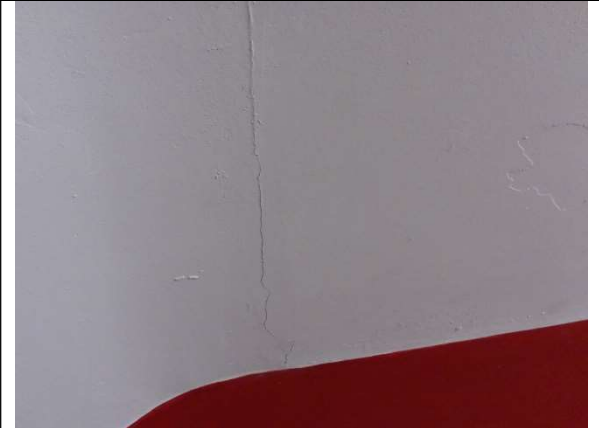
| <p>Attic room – the ceiling has been damaged where the light fitting has been replaced and there are some areas of hairline cracking and poorly finished paintwork.</p> <p>Example photos below.</p> | |

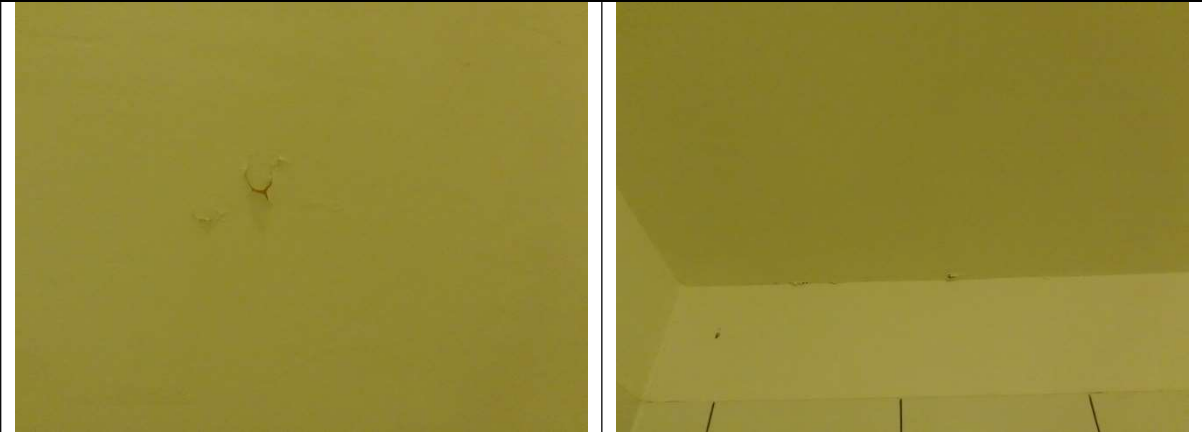
Bathroom – there are some areas of peeling paint around the ceiling, likely as a result of a build-up of condensation due to inadequate heating and ventilation. See comments below on ventilation.

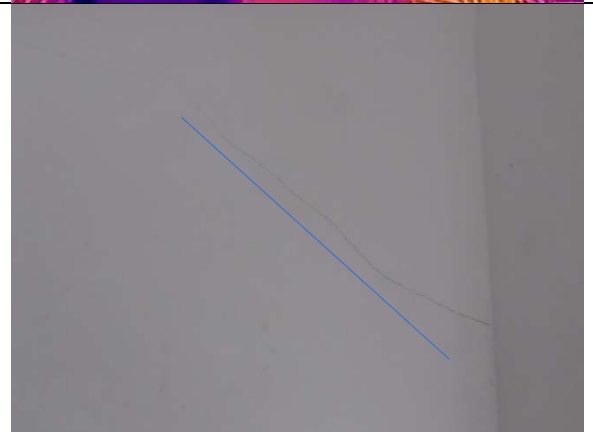
Second-floor staircase – there is a hairline crack in the plaster running front to back.

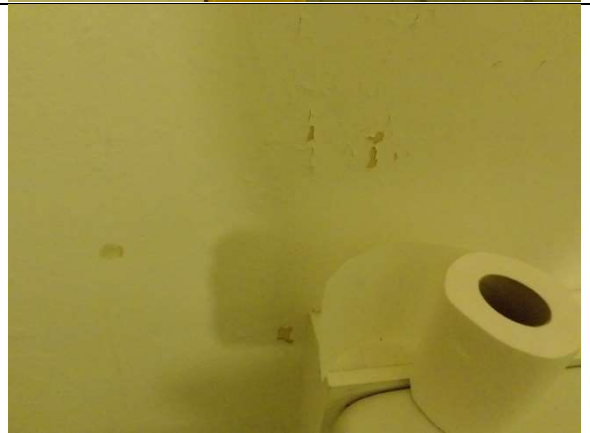
Bathroom – the walls are generally plumb; however, the surface finishes are not all flat, note the gap at the rear of the level.

This is likely a result of condensation building up due to inadequate heating and ventilation.

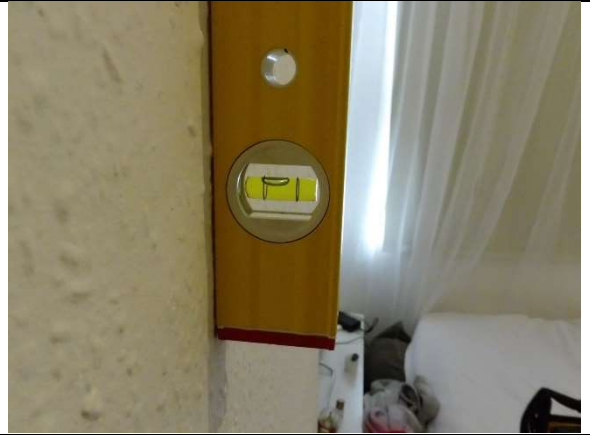
First-floor rear bedroom – the chimney breast appears a little out of plumb, however, we could not get the level completely flat on the woodchip paper.

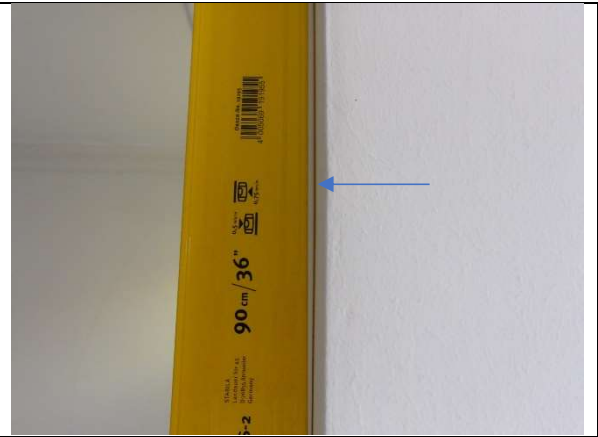
Living room – the walls were generally plumb, however not all of the surface finishes were flat. Note the gap at the back of the spirit level.

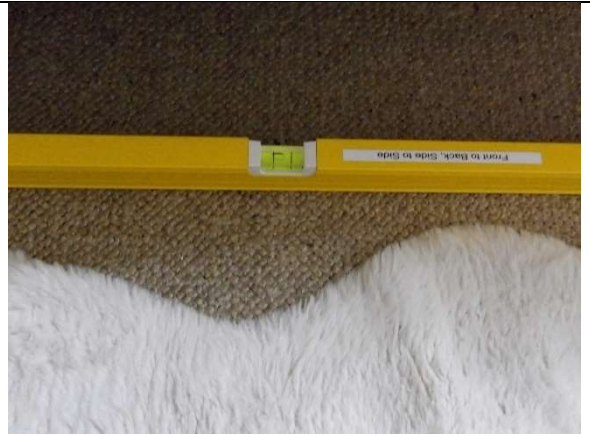
Attic floor – the floor is out of level c. 5 mm front to back.

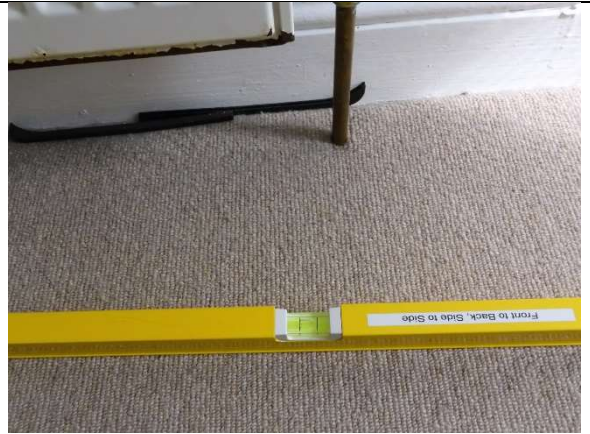
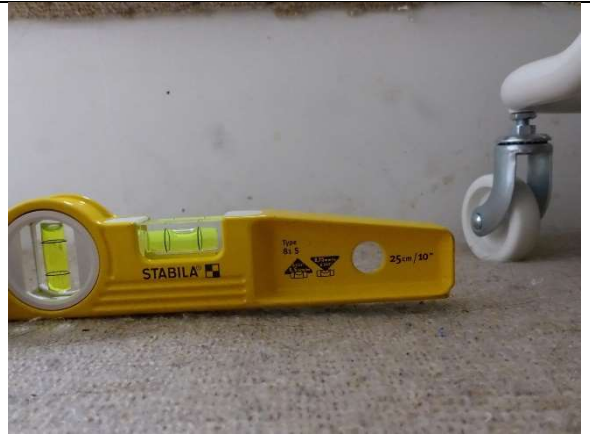
Landing – the floors are uneven front-to-back and side-to-side. Likely as a result of undersized timbers/missing noggins/reconfiguration and service penetrations.

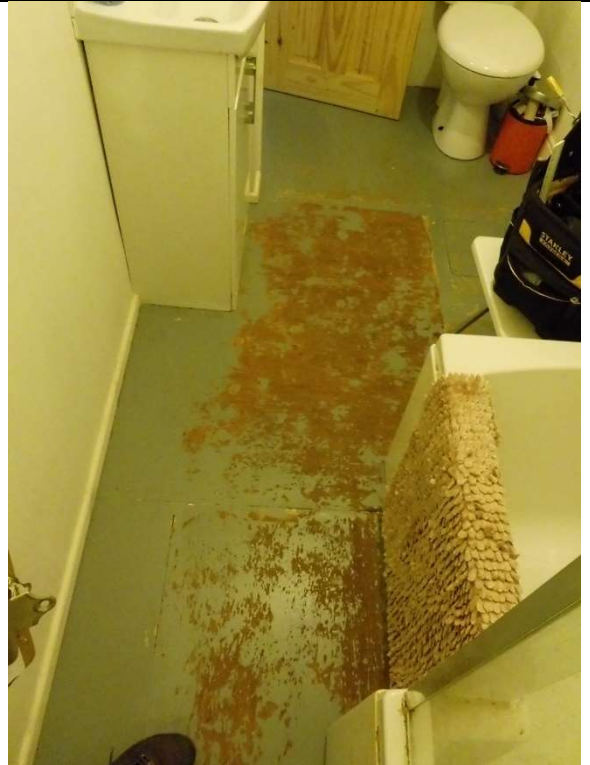
Bathroom – note that there is no floor covering down in the bathroom. The surface timber is moisture-damaged in places.

Ideally, there should be a water-impermeable covering down across the bathroom floor.

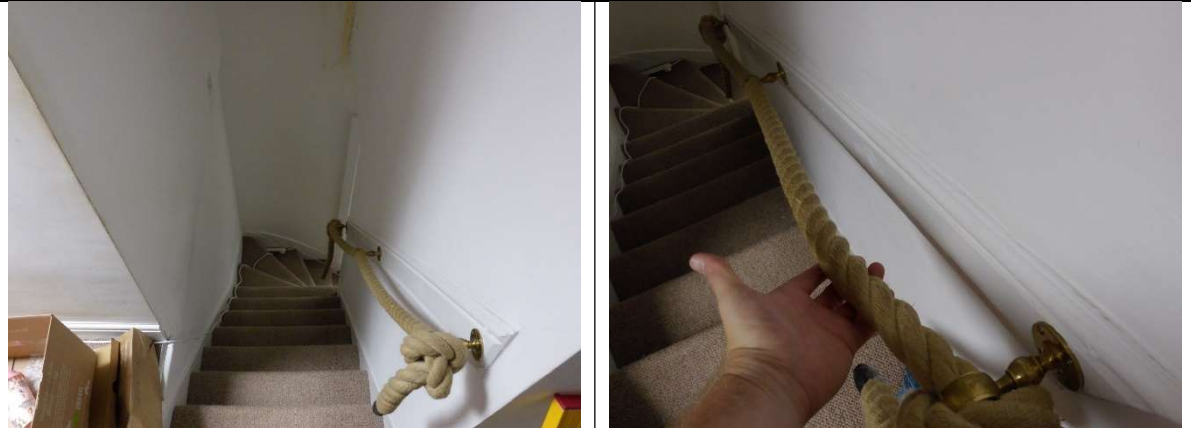
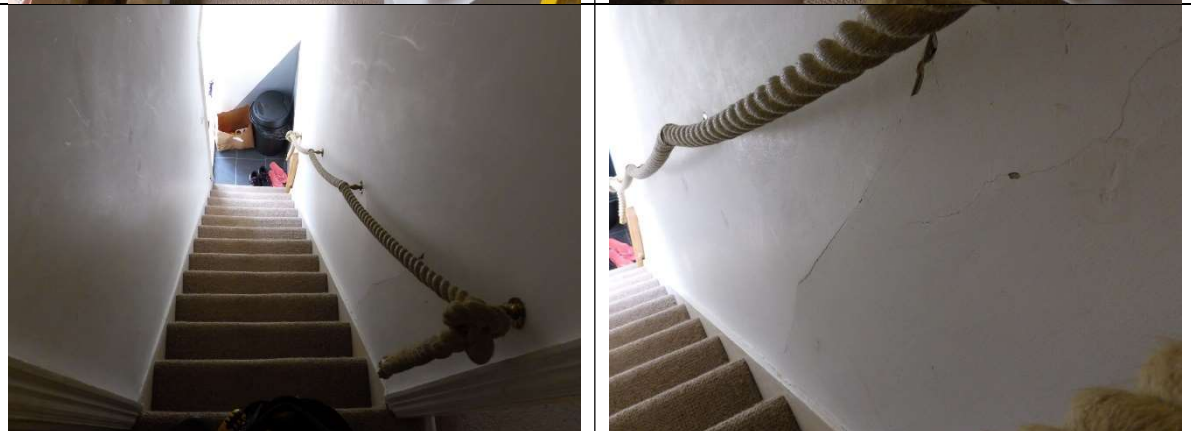
The kite winders on the second-floor staircase creak excessively, perhaps as a result of expansion caused by the historic leak detailed below in Section 5.6.3. A suitably competent joiner may be able to improve the creaking.

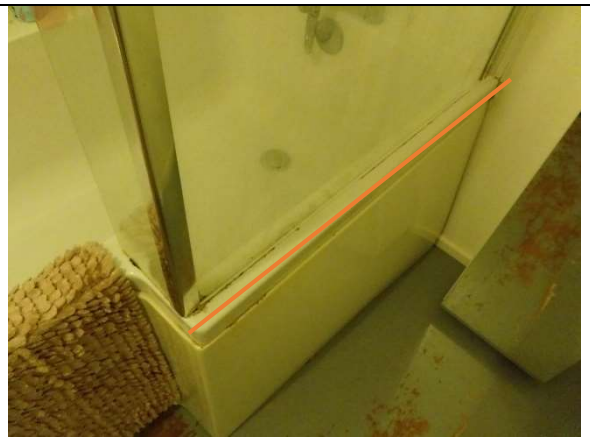
Bathroom – the seal around the shower screen is not the best.

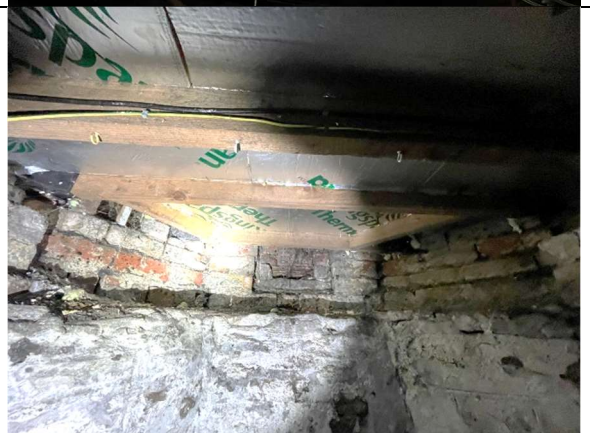
We inspected a sample of the floor joists and did not note any areas of timber decay or insect attack...

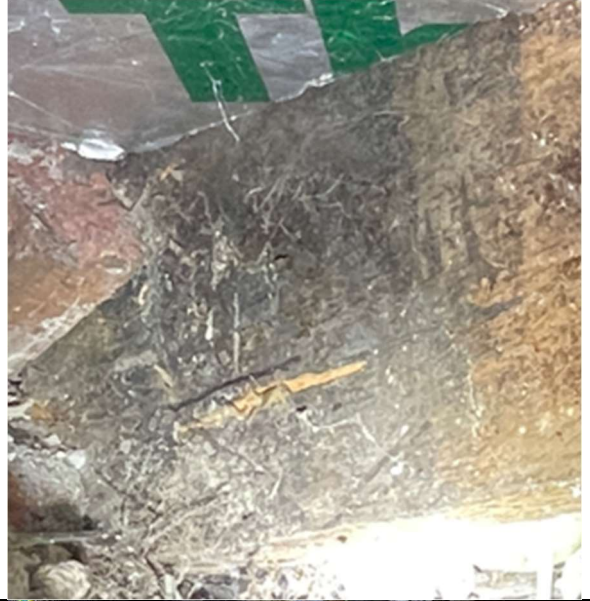
Some of the joist ends have been coated with some sort of preservative. We do not recommend this as it can trap moisture and cause the timber to decay.

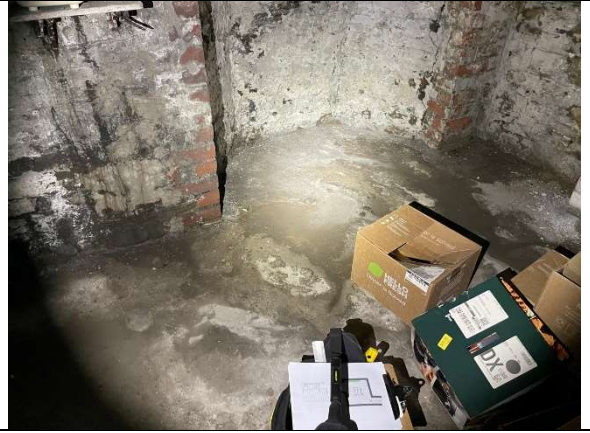
The floor was generally touch dry at the time of our inspection.

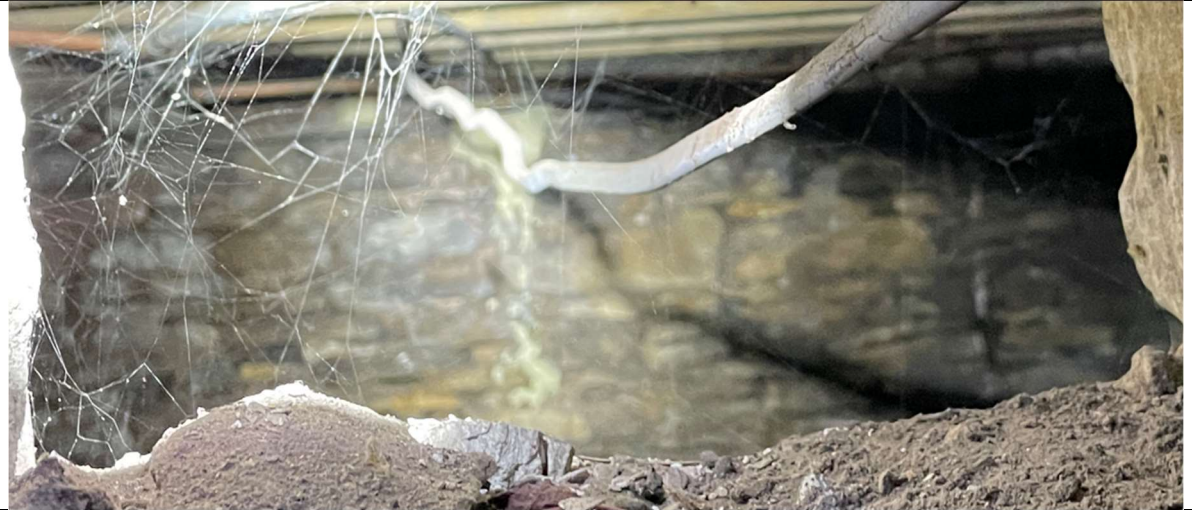
A photo taken of the sub-floor area under the kitchen (there was no access into this area). From what we can see, it looks like the floor structure has been rebuilt at some point.

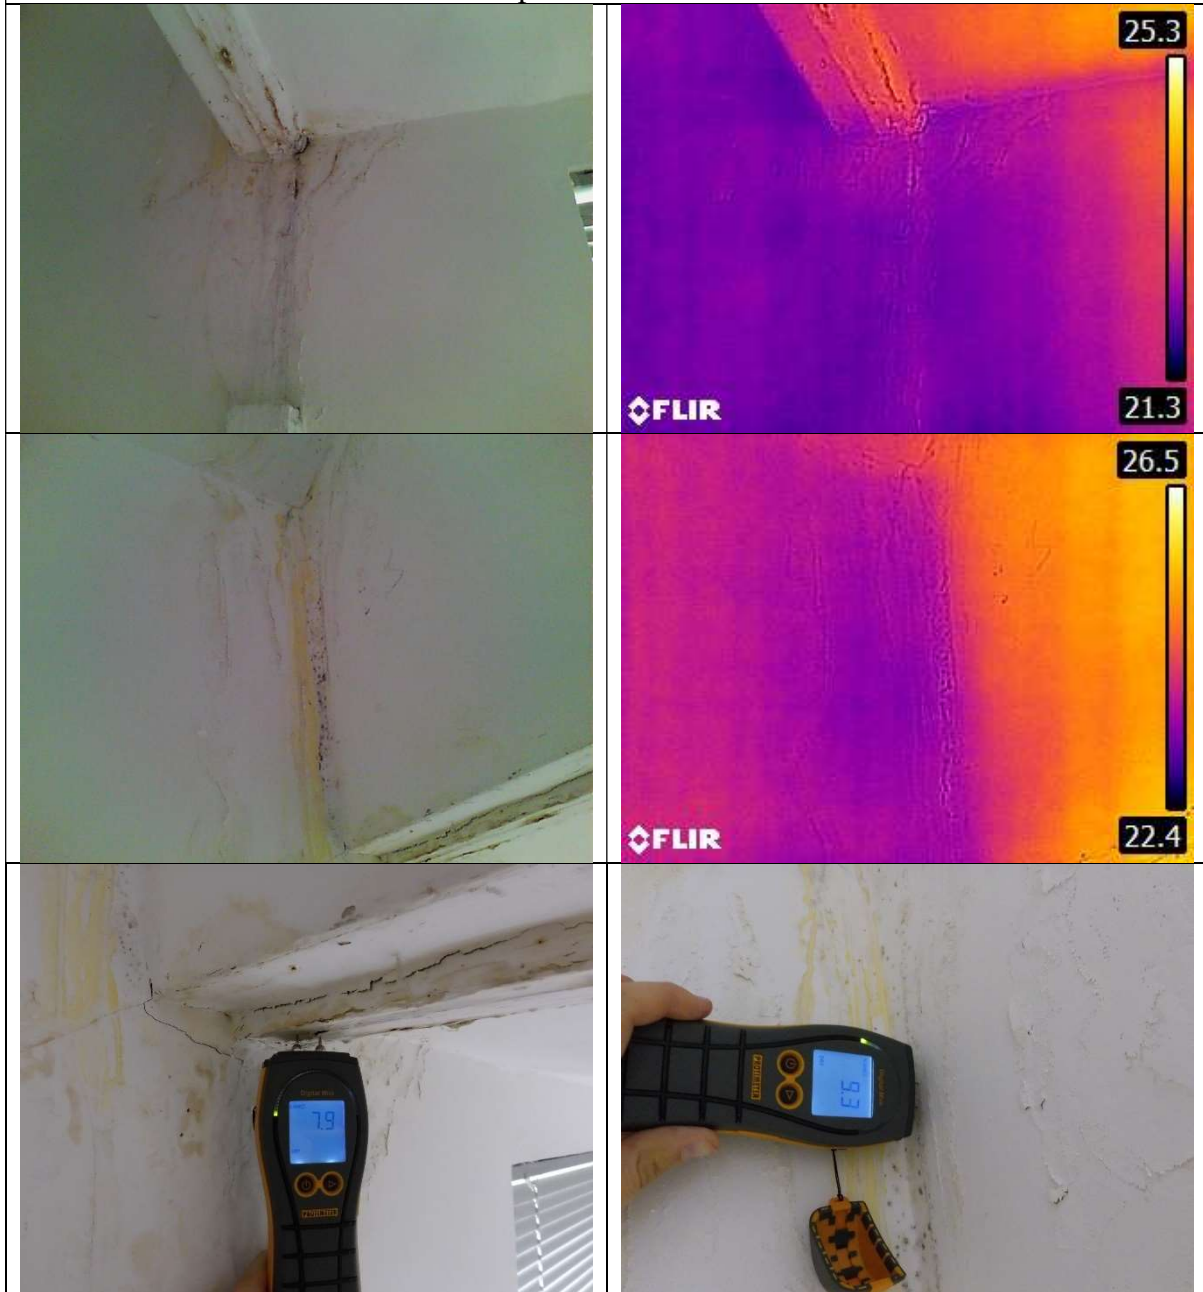
First-floor landing – there is evidence of moisture-related damage on the rear elevation, this is likely as a result of a historic gutter leak. The surface was dry to the touch at the time of our inspection and there was nothing unusual on the thermal imaging or electronic resistance meter. The area will need repair and redecoration.

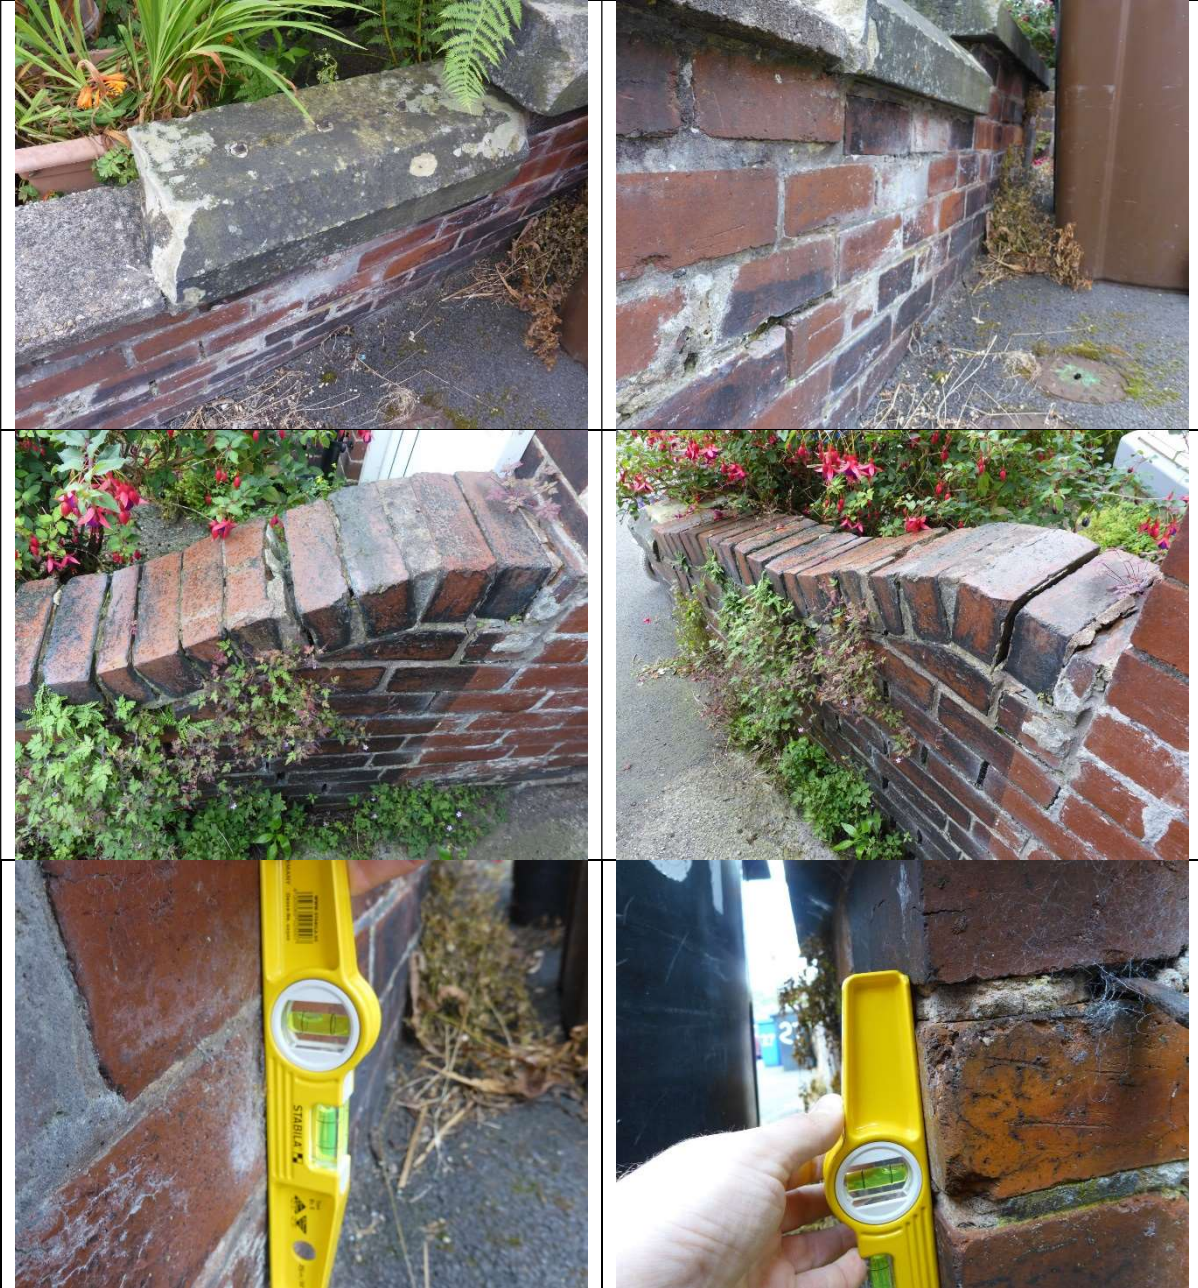
We have included some example photos below.

Ferrous fixings should be removed as they will continue to expand and jack the wall as they corrode.

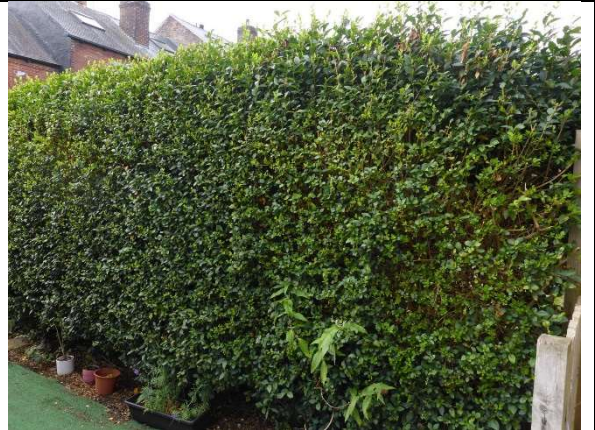
This hedge is close to the rear elevation and the main drainage run. The hedge must be kept well managed to mitigate against root damage to the drainage and house.

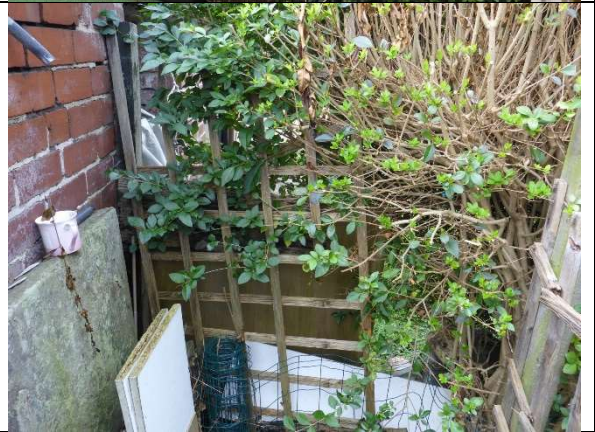
At the rear of the right-hand boundary in front of the outhouses, there is a piece of trellis used to close the gap where the hedge is thin – this is in poor condition and will need to be replaced in the short term to maintain a secure boundary.

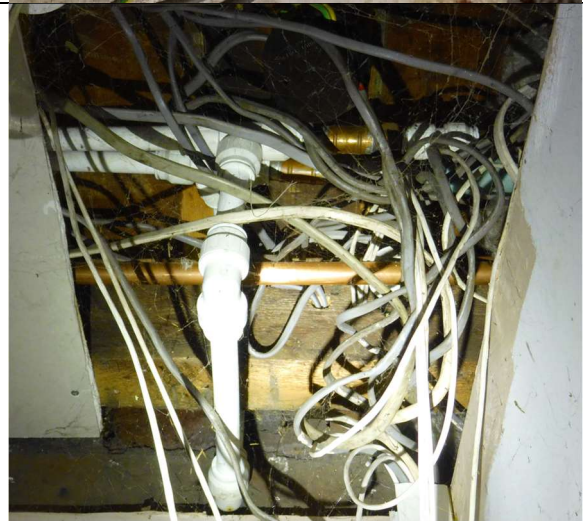
Cellar head – example of the poor organisation of the electrics. These should be tidied up by a suitably qualified electrician when the electrics are tested.

Also, note in this picture that the central heating pipework is not insulated. We recommend it is insulated to improve its efficiency.

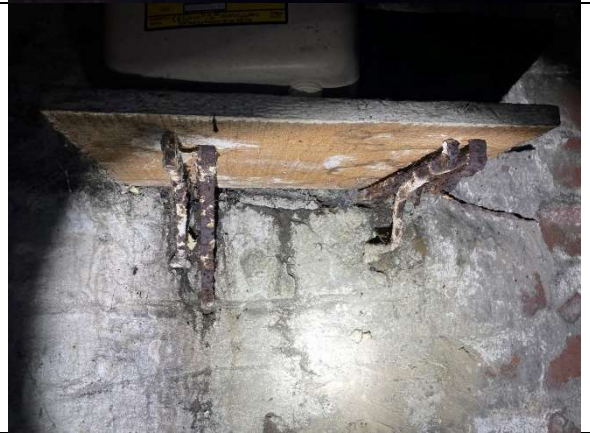
The brackets under the gas meter are corroded and may need to be replaced.

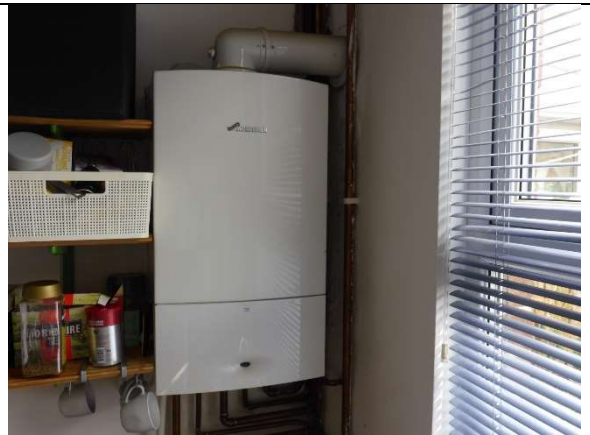
Note that none of the pipework we could see has been insulated. We recommend pipework be insulated to improve efficiency.
