Level 3 Building Survey

Report prepared by Simon  
Hollis MRICS

31<sup>st</sup> August 2023

## Building Survey Report

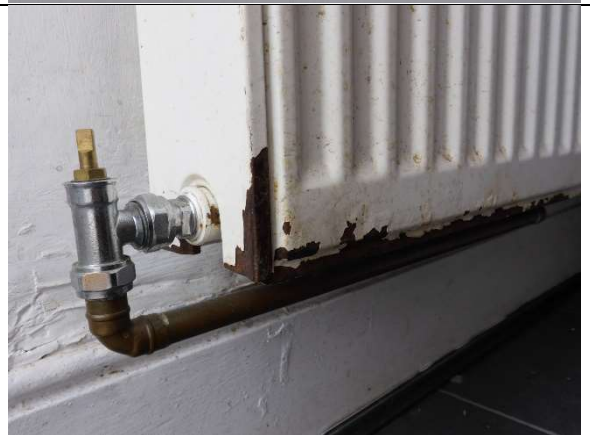
The kitchen radiator is in poor condition, likely as a result of being used to dry clothes etc.

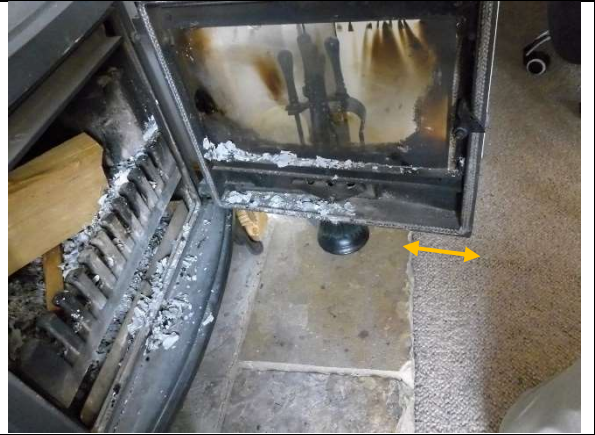
Wood-burning stove - the hearth does not project as far as the door when it is opened to 90°. We think that the hearth should project at least as far as the door to catch any stray embers when the door is opened.

We recommend inspection by a suitably qualified HETAS contractor.
