## **Historic Building Survey**

**Thorpe Salvin**

**FOR AND BEHALF OF  
Simon Hollis Limited  
30<sup>th</sup> June 2021**

## Building Survey Report

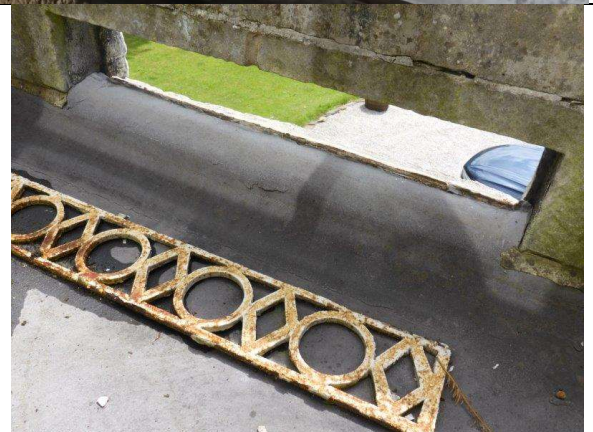
The top rail of stone has eroded over time and lost some of its profile detail. It would benefit from having the lichen cleaned off it in the medium term. This needs to be done with a nylon type brush, ferrous metal brushes are not suitable for use on stonework as their bristles get trapped, start to corrode and damage the stone.

There are cracks in the stone on the right-hand upright and on the top and bottom rails of the central panel. This is again likely as a result of ferrous pins buried in the stonework jacking the stone and causing cracking. See our comments on this above.

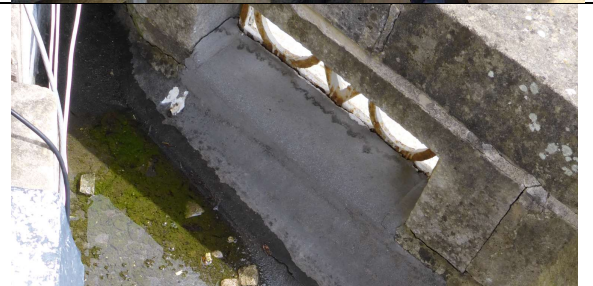
We assume that the outlet for the bay window is on the right-hand side. This looks to be blocked and there is some ponding on the roof. We recommend that this is unblocked as soon as possible and the debris cleared.

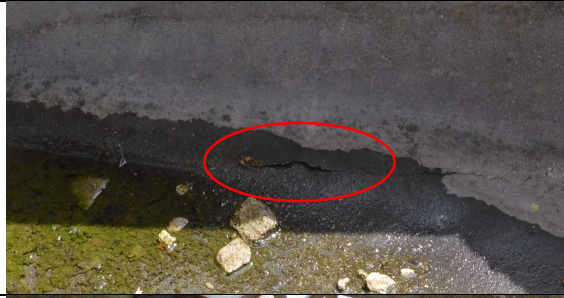
There is a small gap where the upstand and the main roof finish meet. This should be repaired as soon as possible to prevent water ingress to the dining room ceiling below.

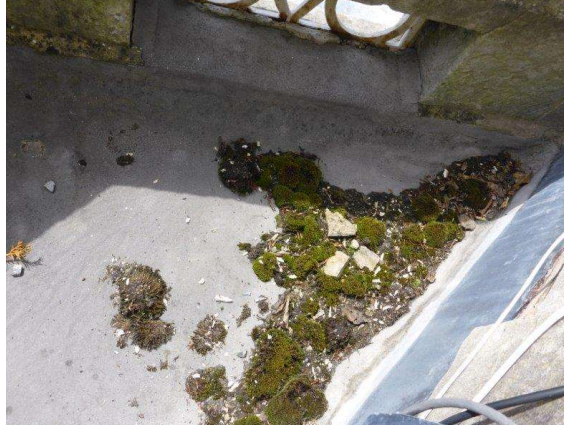
Debris should be cleared off the roof regularly to prevent it from blocking up the outlet and the drainage system beyond.

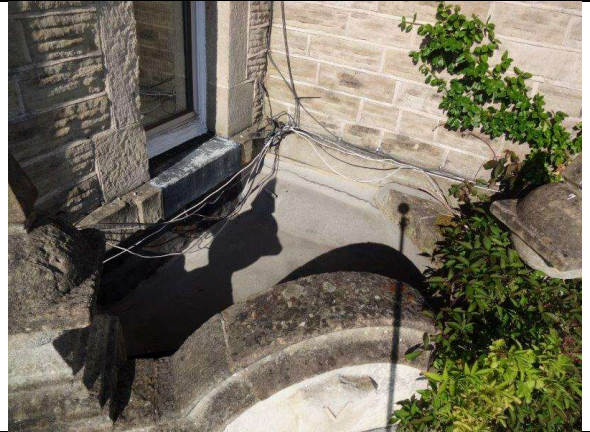
The mess of wires on the roof above the front door should be tidied up or at least properly clipped back.

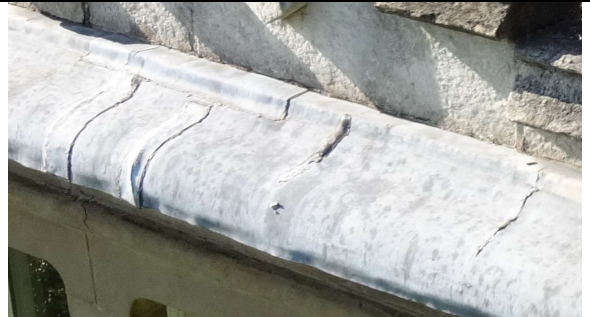
Previous repairs to the lead apron detail.

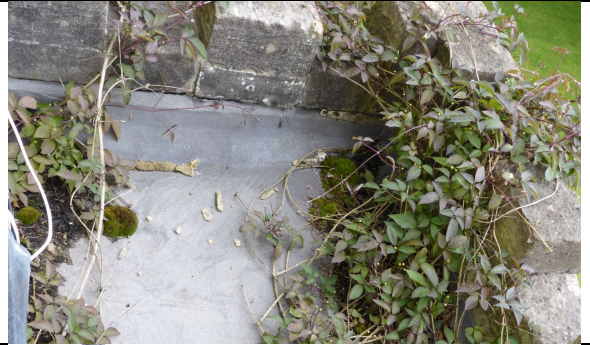
Climbing plants should be removed as they affect the evaporation cycle and can block rainwater outlets and drainage.

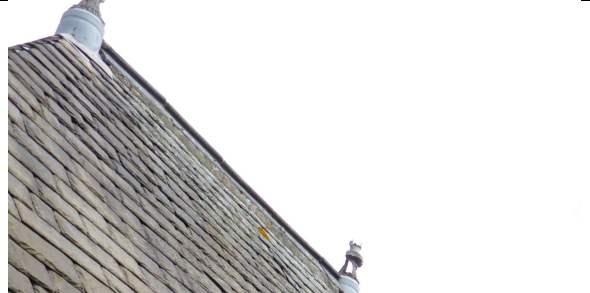
The final details on top of the kitchen roof area look to have all but disintegrated.

These should be inspected close-up and appropriate replacements sourced.

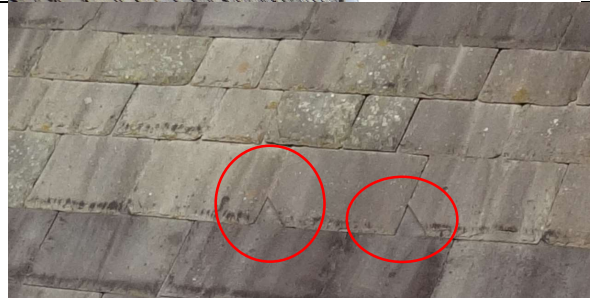
An example of some chipped slates on the main roof (above the front bedroom/store).

A suitably skilled roofer should be able to replace these with matching ones and use these ones to make smaller slates for use higher up the pitch.

We recommend that all chipped slates be replaced in the next year.

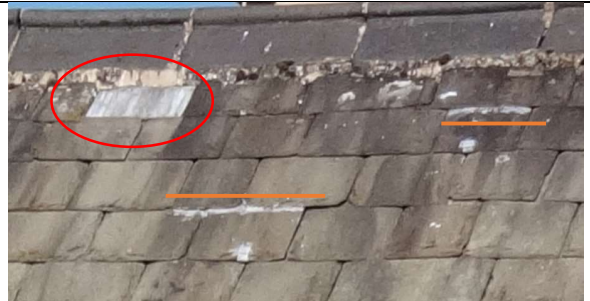
Again, above the front bedroom/store, a missing slate has been replaced with a sheet of lead. This should be replaced with a matching slate in the short term.

Also note that where two other slates have been replaced/reattached, beads of a Leadmate type product have been used. This is inappropriate and should not be needed if the roofer is confident in their repair.

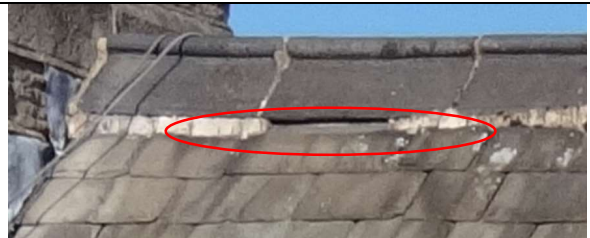
An example of a missing section of ridge pointing.

The ridge pointing is in varying conditions around the property. In places, there is lots of moss and algae growing on it. Missing sections could be repaired; however, we would consider it prudent to budget to have the ridge repointed in its entirety in the next two years.

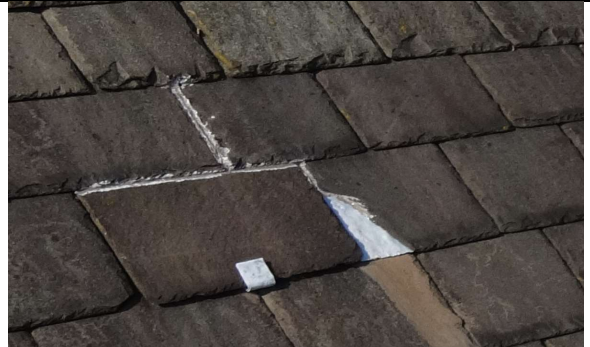
The slate has correctly been reattached with a lead tingle, however, the slate to the right should also be replaced as opposed to the missing section getting filled with lead. Also, patination oil does not appear to have been used which has resulted in lead oxide staining the slate below. The Leadmate type seal should also not be required as noted above.

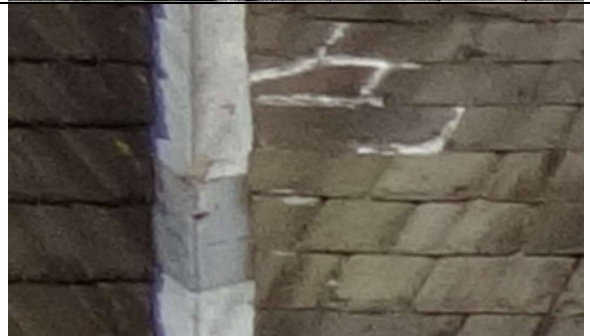
An example of where Leadmate has been used to stick slates to the pitch. This is inappropriate.

Also, note the repair to the valley.

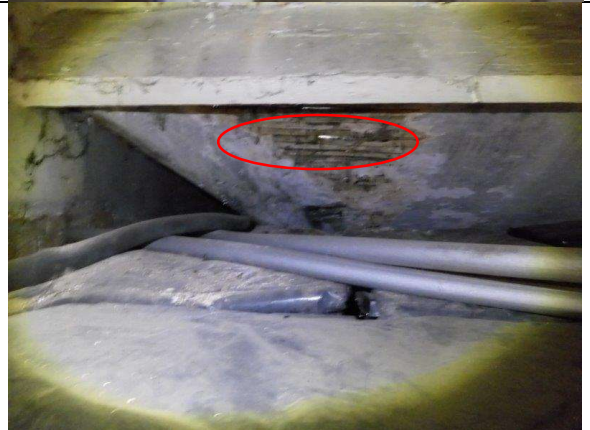
Daylight is visible in the store under the abovementioned roof pitch.

The damaged slate should be replaced in the short term.

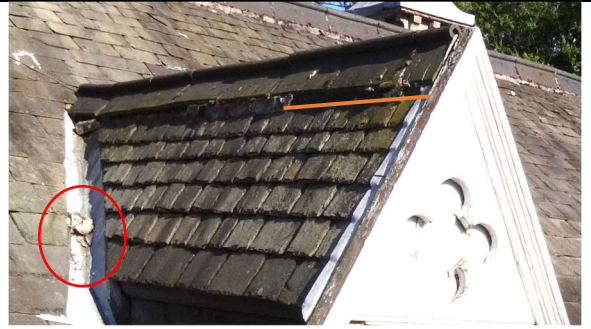
Left-hand front dormer – the front three ridge tiles look to not be sat square on the ridge. This could be because there is a defect with the timber underneath or as a result of poor workmanship. The area should be inspected close-up.

Most of the ridge pointing has also dropped off and there is debris in the valley gutter which should be removed in the short term.

Due to the sun, we could not properly see the cheeks.

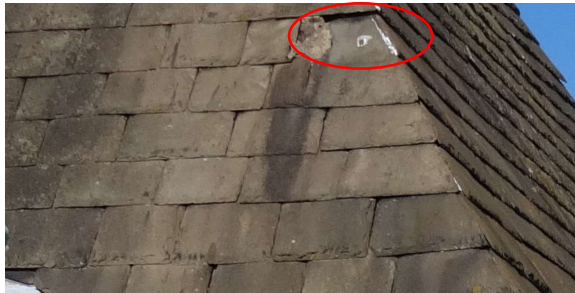
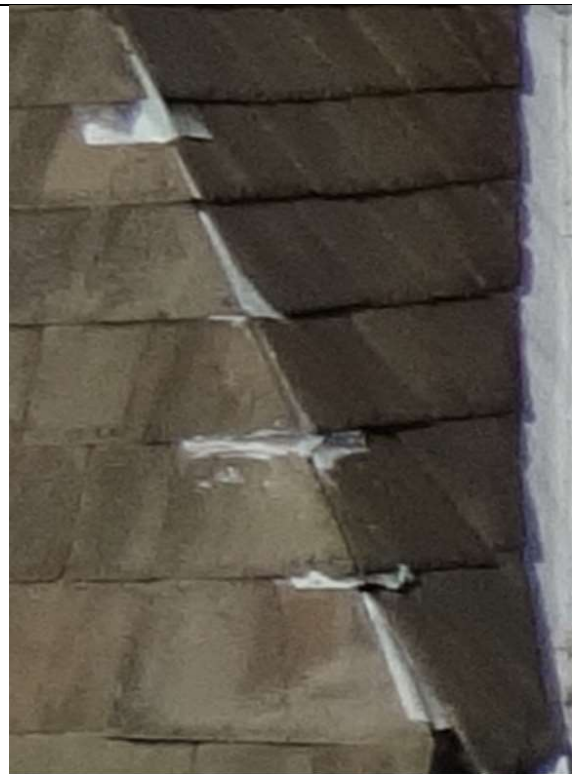
Above the kitchen, the hipped pitch is very steep. Some of the repairs on this section are not the best. Note the missing slate on the photo below and the repairs on the photo on the right-hand side – again done in lead sheet and Leadmate. You should plan to have these repairs properly executed in the short term.

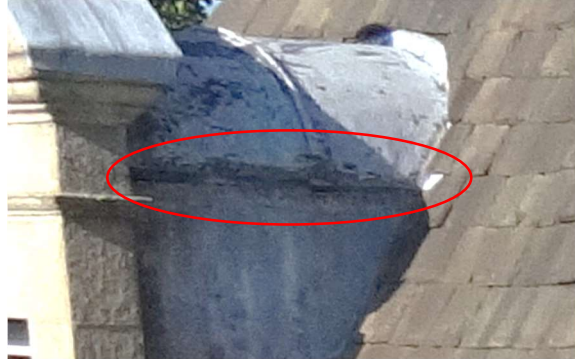
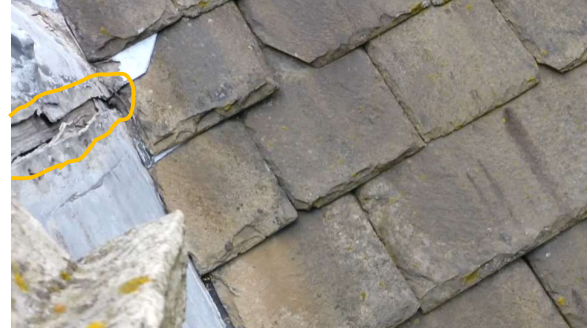
Left-hand rear dormer – the cheeks of the dormer are dressed in lead. There is a split in the covering on the right-hand cheek – this may be because of the size of the sheet, complicated design and expansion and contraction issues noted above.

Apologies we could not get better photographs of this. The left-hand photo below shows the area of the defect – where the upright sheet joins the roof sheets. The right-hand photo was the best we could get taken out of the window and shows there the joint has come apart.

A temporary repair should be affected as soon as possible whilst you find a craftsman able to undertake a permanent fix.

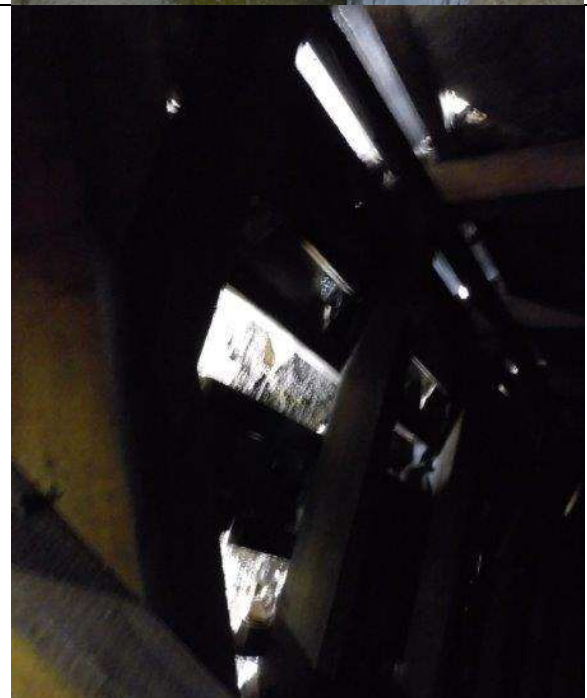
Daylight is visible from the roofspace accessed via the large attic storeroom.

The covering looks to have been disturbed to make access for the solar water heating infrastructure. We recommend that this area is inspected close-up and any dislodged roofing components repaired/replaced. This should be undertaken in the short term.

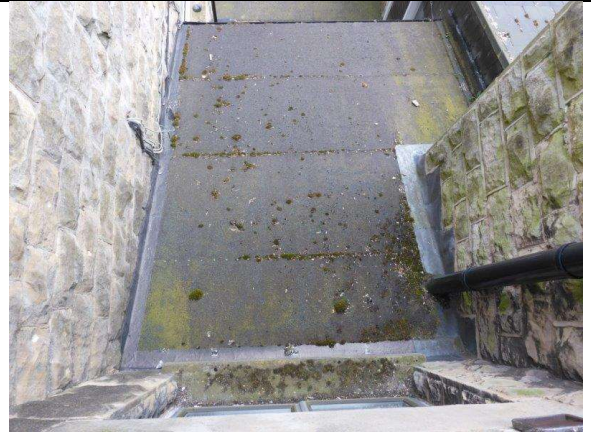
The infill extension at the rear has a mineral felt roof. This is likely reaching the end of its economic life (20 – 25 years) and it would be prudent to plan to replace this before any future leaks cause damage to the timber below and the job becomes a bigger one.

The lead detailing to the right-hand side still looks good and could likely all be reused subject to employing a contractor with enough skill. The flashband on the rest of the roof is inappropriate for the building and job.

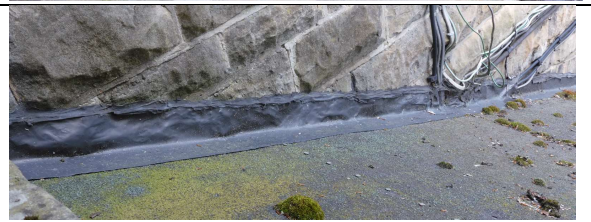
Flashband looks to have been diagonally cut into the stonework.

This is totally unnecessary on coursed stone and causes permanent damage.

Replacement detail should be in stepped lead flashings and soakers.

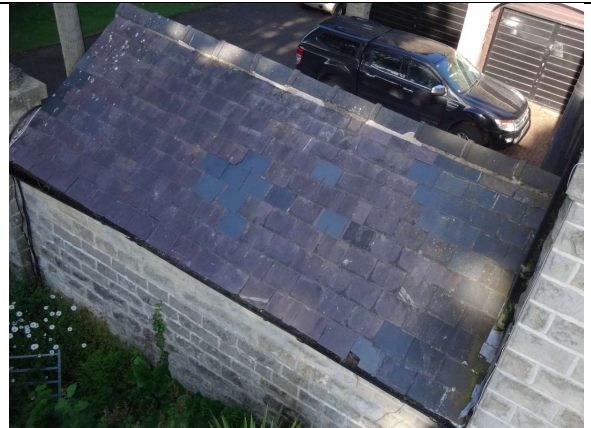
Stables – a number of slates have been replaced on the roof and some are chipped or missing.

The proportionally large number of slates that have been replaced or require replacement suggest that there may be some problems with nail corrosion.

We recommend that the damaged or missing slates are all replaced as soon as possible and that it may be necessary to budget to replace the roof in the next five or so years if the fixings are corroding and failing. The other side is in better condition and the damage could have been caused by climbing plants for example.

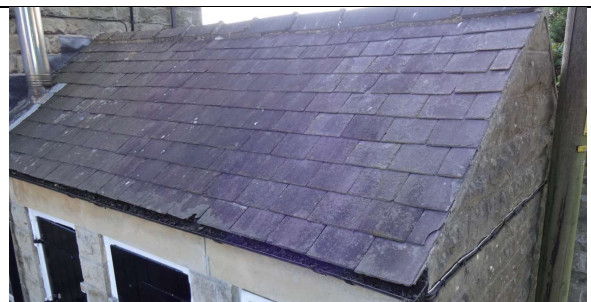
The other side of the pitch is in much better condition and only a couple of damaged slates need replacing.

Note that the verge detailing is done in slate, half slate, slate, half slate etc. whereas it should be done in slate and a half, slate, slate and a half, slate etc. There is no economical fix for this and this roof is not considered to be particularly exposed so it can be left until the time comes to re-roof.

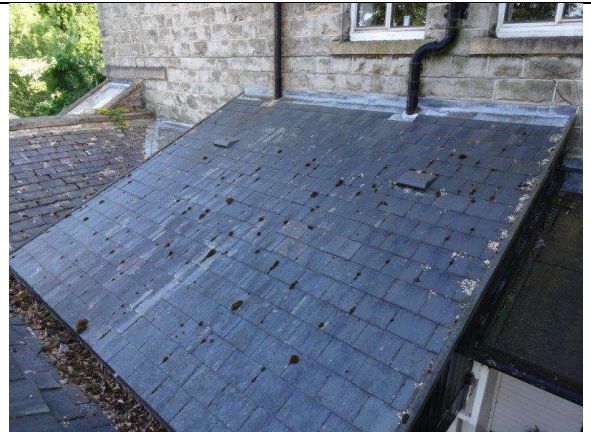
We could not access the roofspace above the store building. From an external inspection, the roof looked square.

As noted above, the slates on the verges are incorrect, however, they are protected with weatherboards so this is not of immediate concern.

Two ventilator tiles are a good start, four would be better.

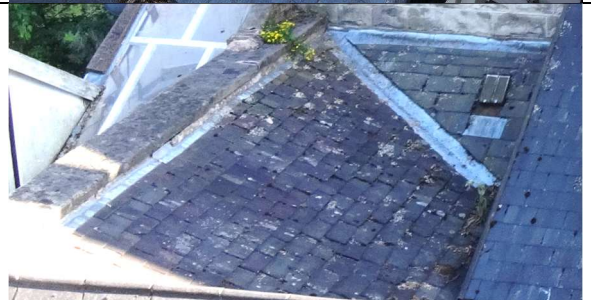
In the area beyond the abovementioned area, there is debris trapped at the side of the wall/roof abutment and some weeds on the parapet wall which should be removed as soon as possible.

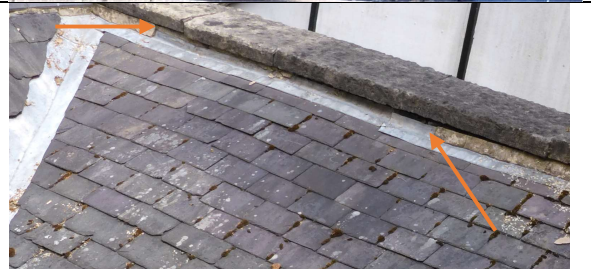
The fillet pointing that appears to be holding the lead soakers in place is missing in sections. The lead should ideally be packed with lead wedges as opposed to held in with a fillet.

The fillet should be replaced as a temporary measure.

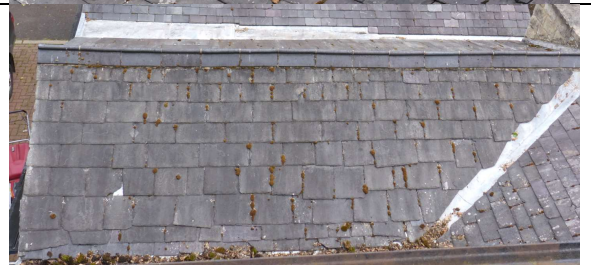
The proportion of slipping slates on the near-house pitch of the garage roof suggests the fixings are corroding and the roof will require an overhaul in the next couple of years. Internally, there looks to have been a leak in this area.

The slates look in acceptable condition, and many could likely be reused.

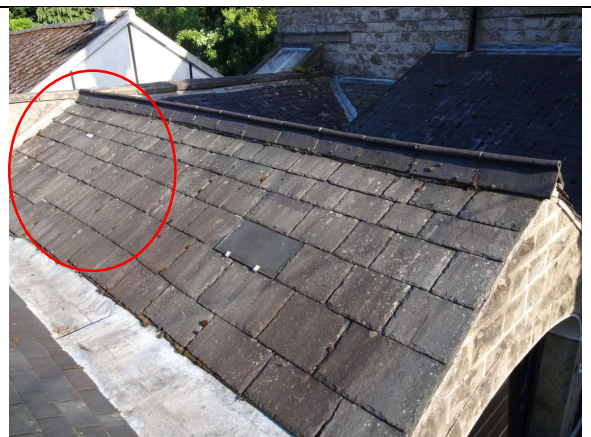
Towards the rear of the garage closest to the house, the coursing and side lap of the tiles becomes a little inconsistent.

This could be because the fixings are starting to corrode or that the quality of the original workmanship was not the best. We recommend that the area be monitored and an overhaul budgeted for in the next five or so years.

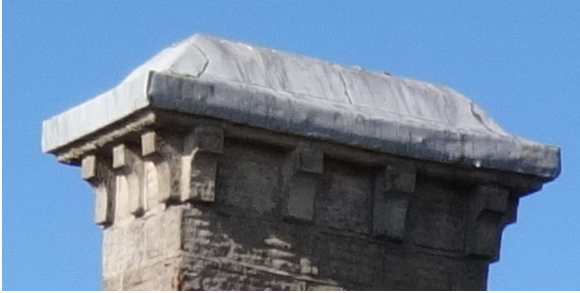
<p>The central front stack has been dressed in lead from the corbelling up.</p> <p>Whilst this prevents rainwater ingress to the flues, there does not appear to be any ventilation.</p> <p>We recommend that redundant flues are opened up and fitted with pots and capped vents.</p> <p>There does not look to be a saddle piece of lead flashing where the ridge abuts the stack (not shown).</p>

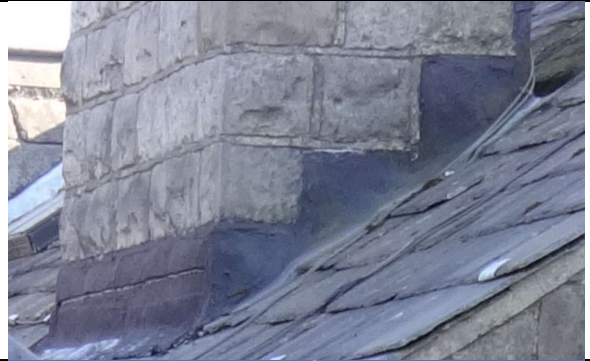
Left-hand dining room stack.

The stack has been dressed in lead from the corbelling up. From what we can see, both terracotta pots look to be intact. We recommend that a vented cowl is put on the rear pot to allow it to still be used, whilst reducing the amount of rainwater entering the flue.

Note that a section of the lightning conductor is corroding and likely needs replacing. The corrosion is beginning to stain the stonework.

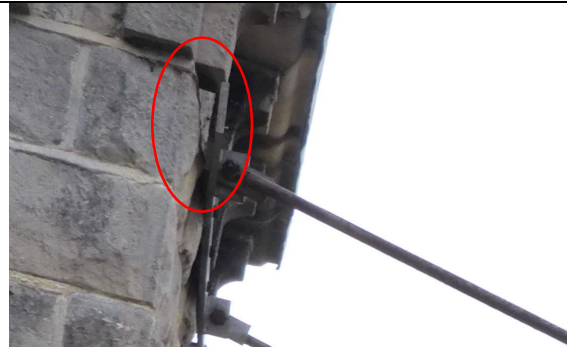
The bracing plate on the rear of the chimney looks to be cracking some of the stone.

The fixings could be corroding and blowing the stone apart, the fixings may have been over tightened causing them to blow the stone apart or the chimney may have moved slightly.

We recommend a close-up inspection of this area by a suitably qualified roofer. Fittings may have to be replaced and we recommend this is done in stainless steel. This should be looked at within the next year.

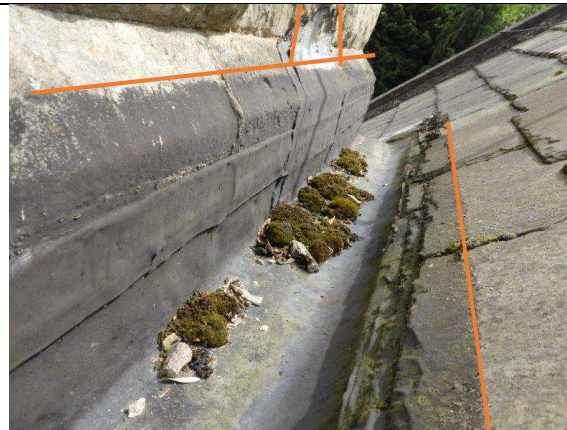
Note that the area has been covered in a paint on type leak sealant.

The back gutter should be cleared of debris in the short term.

We recommend that this is removed and any leak found to be active is properly repaired with the correct materials (lead and slate).

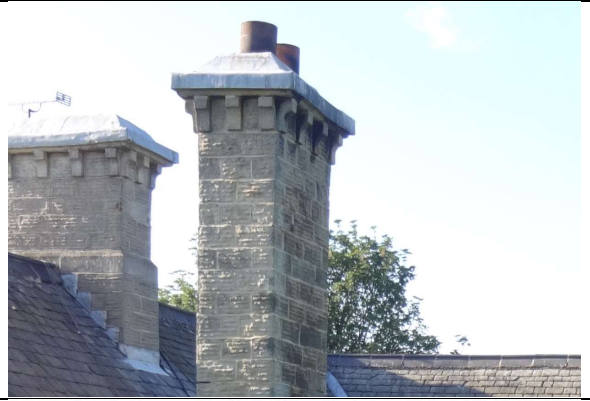
Right-hand side lounge stack. The stack looks to have a very slight lean on it which we recommend you monitor before taking any further action.

The stack has been dressed in lead from the corbelling up.

The stack looks to have two flues, both open. We recommend that vented cowls are put on each pot.

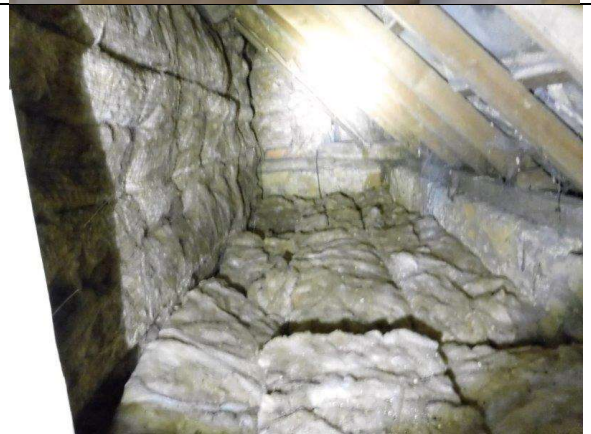
This is the only accessible area of roofspace which is off the front storeroom.

All the timber we could reach was sound including wall plate, purlin, rafter and batten.

WME 11.4%, no signs of condensation noted, no signs of corroded fixings on the batten.

We noted two different types of droppings on the top of the insulation batt, likely bat and rat.

Bats are a protected species, see section 6.4 for more details.

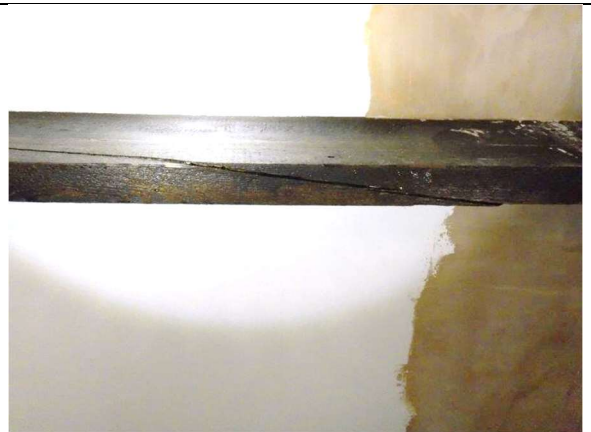
There is a crack along this purlin in the front storeroom. We do not consider this to be significant however it should be recorded and monitored. If it is progressive, it may need to be strapped in the future.

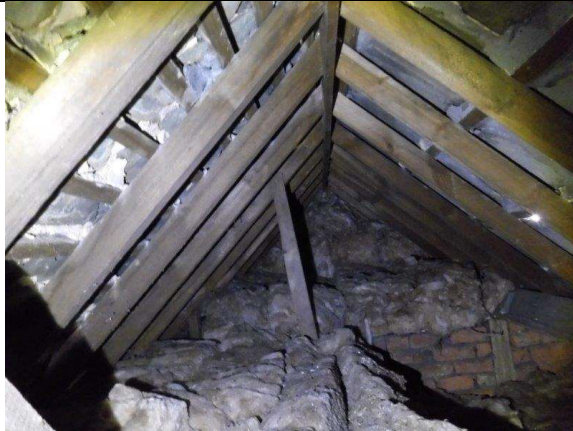
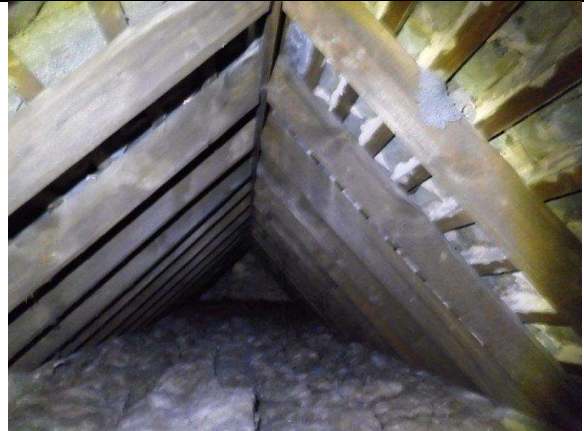
Photograph of the roofspace running from the access hatch in the larger second-floor storeroom towards the front of the house (left photo) and along to the gable end in line with the long room (right photo). The timbers we could reach from the hatch were all sound. There are a couple of areas of very minor white roof mould, we are not concerned about this.

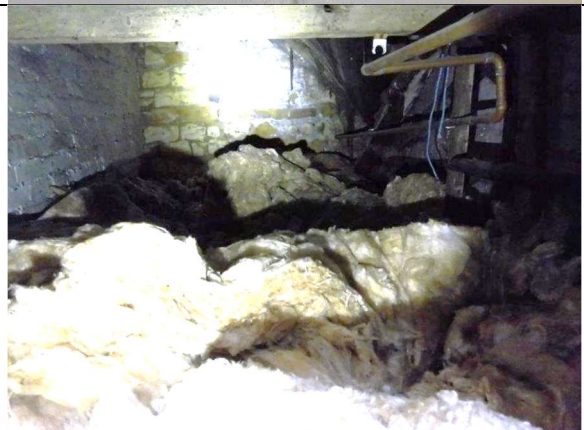
This is the area under the cold-water storage tanks – note that the insulation is uneven and in areas looks like it has been piled up/thrown in.

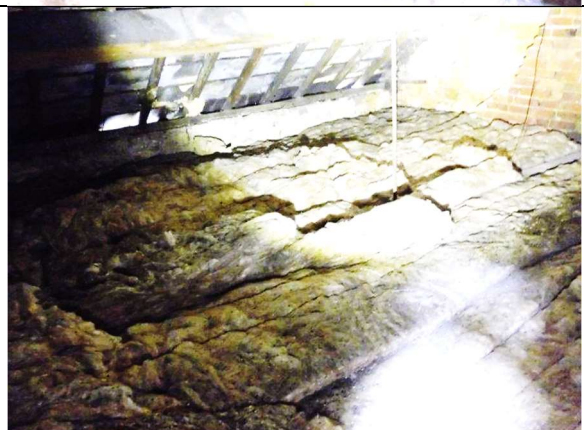
We started to inspect the roofspace above bedroom three, accessed off the tank room. We had to stop as we found bats present (flying around and likely nesting) in the room.

As bats are a protected species and it is nesting time, we cannot disturb them.

The insulation is covered in bat droppings and so appropriate protection should be worn should you decide to access this area. Note our comments on bats in 6.4.

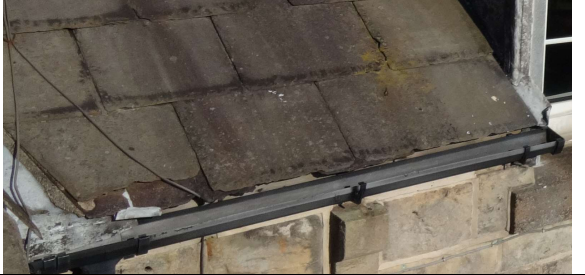
<p>Sections of the original cast iron guttering have been replaced with uPVC at some point. This is becoming sun-bleached in places.</p>

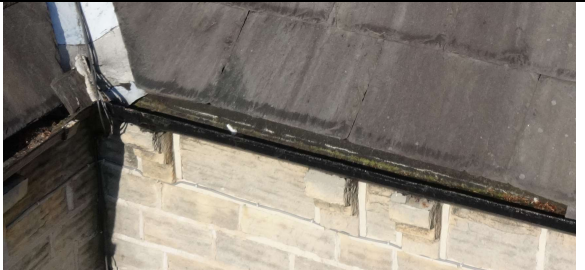
<p>Areas of the cast iron guttering are corroding.</p>

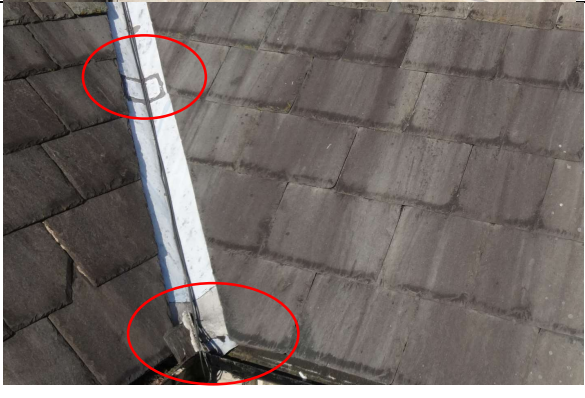
<p>The valley gutter above the front door has been repaired twice.</p> <p>Once with a patch in the centre and once with a paint on type product (maybe Flexacyrl) at the base. We do not consider pain on type products suitable for the historic nature of the property.</p> <p>Note also that there is a slipped piece of slate at the base of the valley which should be removed as soon as possible.</p>

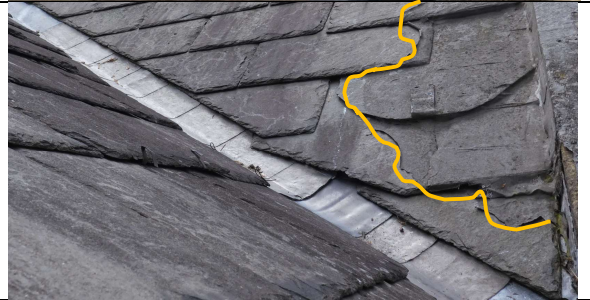
A closer view of the abovementioned area taken from the bedroom window.

Note the numerous replacement leaves of lead and the paint on product that has been used on the slates behind the parapet wall (yellow line).

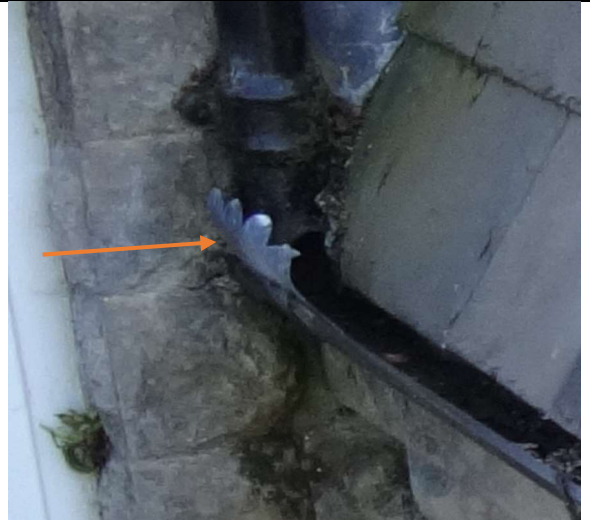
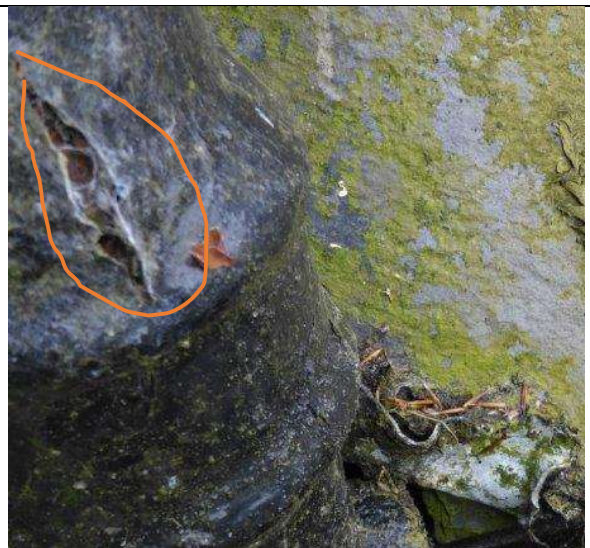
The abovementioned pipe also looks to have a crack just above the 90-degree boot. This needs to be repaired as soon as possible if the section of pipe is not replaced.

Water running down the pipe under centrifugal pressure will often fire out of cracks under pressure.

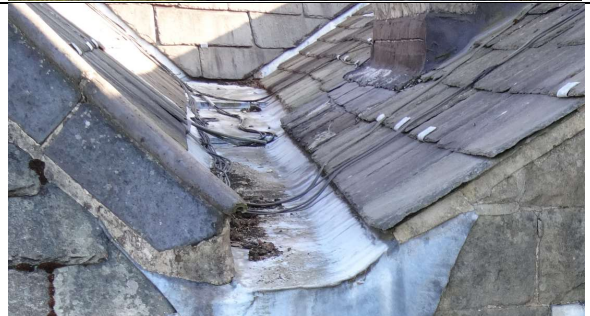
We could not get right into the centre of the roof due to the overhead cables. From what we could see, we recommend that the debris is cleared out of the valley and if possible, the cables re-routed.

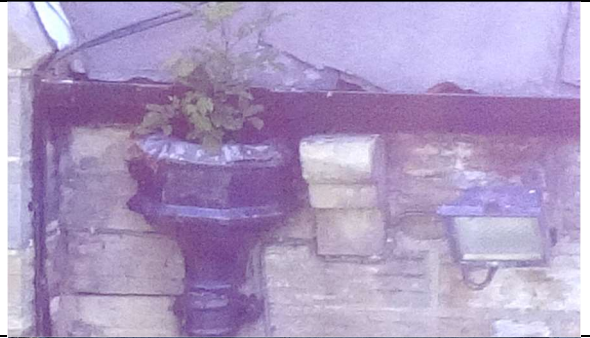
Rear hopper above the lounge – vegetation is growing from the hopper. This should be removed as soon as possible to prevent it from blocking the drainage system and/or water from overflowing onto the stonework.

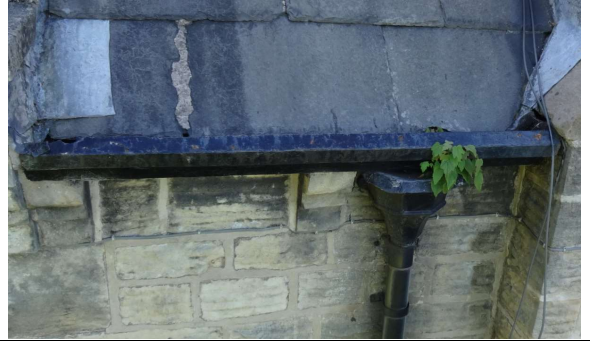
Front hopper above the lounge – vegetation is growing from the hopper. This should be removed as soon as possible to prevent it from blocking the drainage system and water from overflowing onto the stonework – see below.

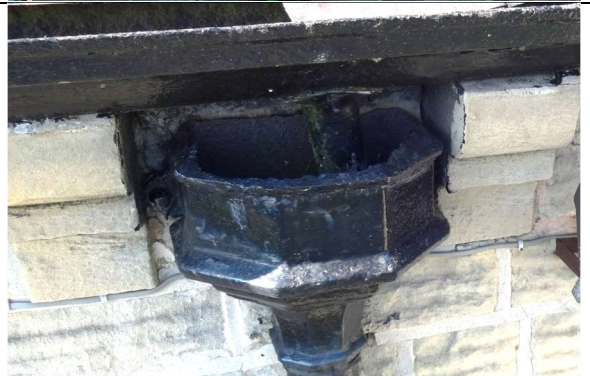
Front elevation – we cannot see how this hopper is affixed to the house; it may be just supported on the fall pipe.

We recommend it is inspected close-up to determine.

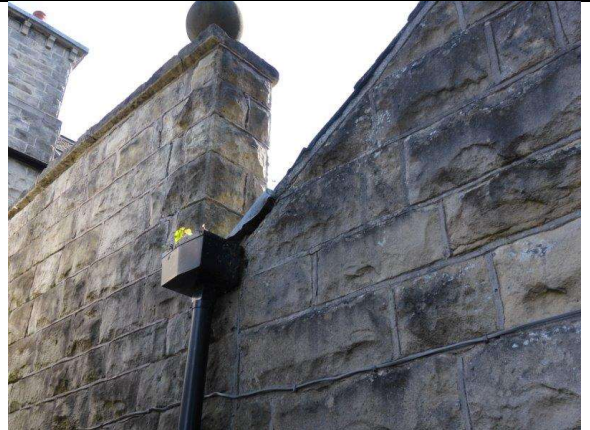
Hopper at the rear of the garage buildings has vegetation growing in it and needs to be cleaned out as soon as possible.

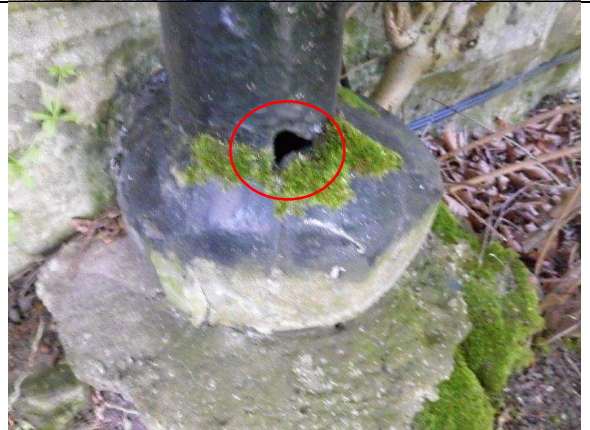
The base of a fall pipe on the right-hand elevation has a large hole at the bottom.

This should be repaired or replaced as soon as possible.

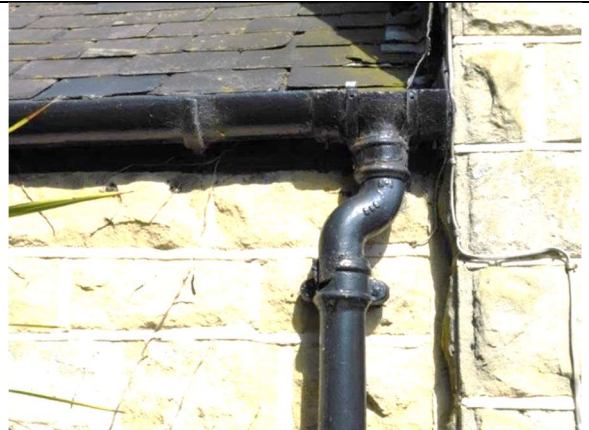
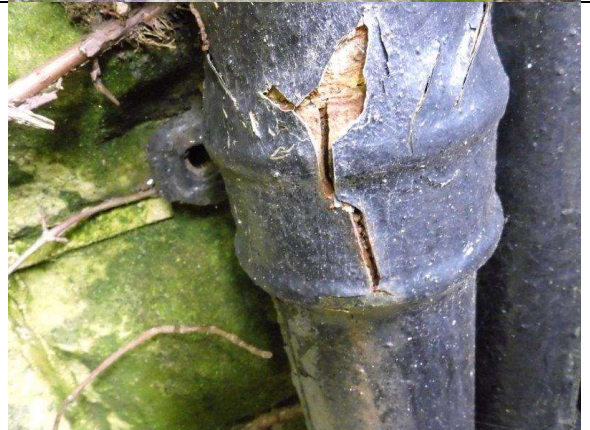
The two photos below show further cracks in the fall pipes which should all be repaired or replaced as soon as possible.

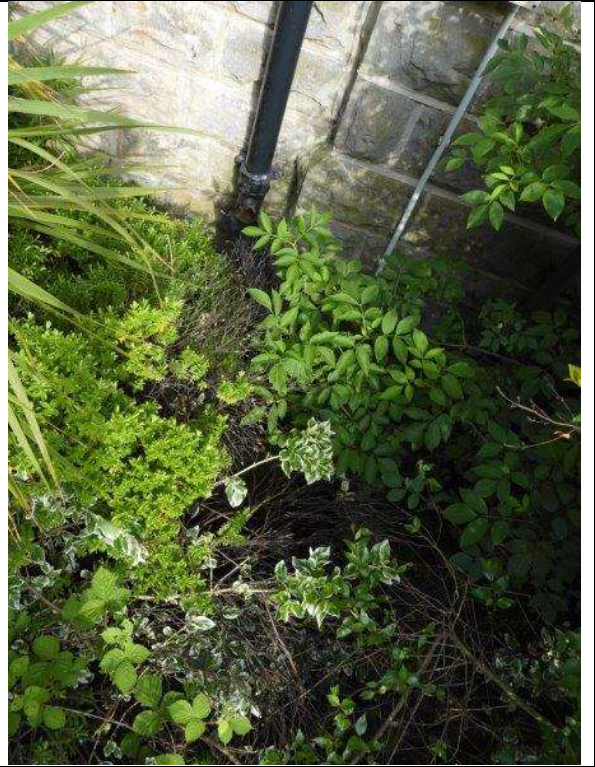
The vendor advised us that there is a soakaway in the garden area on the left-hand elevation.

There are lots of plants in this area and we could not undertake a full inspection without the chance of damaging them.

If this has been there since the property was built, it is likely that it will be silted up and need cleaning out.

We recommend that some of the vegetation is pruned and the soakaway found.

This should be investigated within the next year. It is important that rainwater is efficiently discharged away from the property.

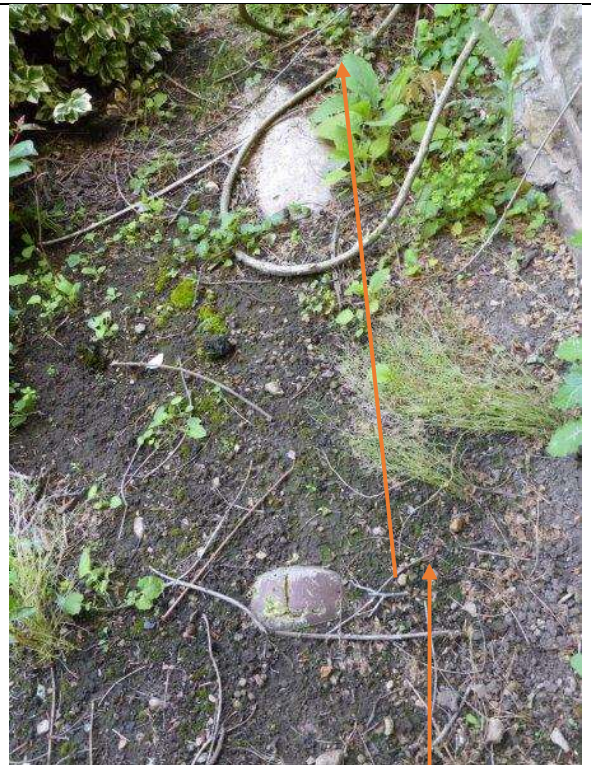
This is the clay drainage pipe that runs under the office window.

It is obviously very close to the surface so care should be taken when working in this area and should you need to erect a scaffold for example, contractors should be made aware of this.

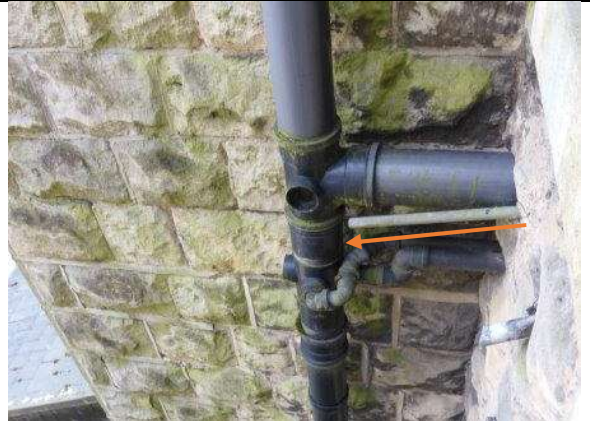
One of the connections on the abovementioned pipe may also be leaking as there is a lot of moss and algae around the branches and bossing.

Note that the moss and algae could also be caused by a leaking overflow in the foreground (orange arrow).

The pipe should be observed under load and any leaks repaired as soon as possible.

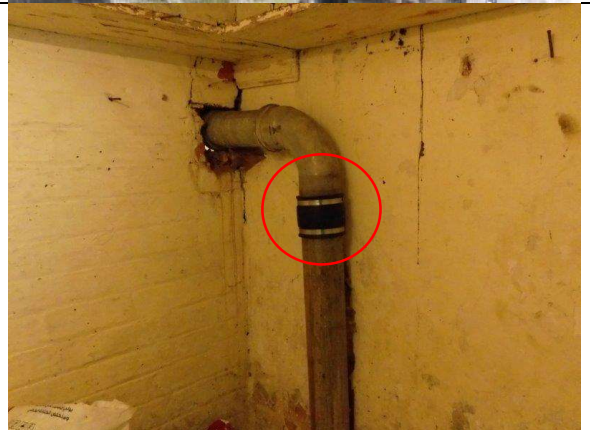
The vendor advised that the section of the soil vent pipe that runs through the outhouse has blocked before, hence the coupling.

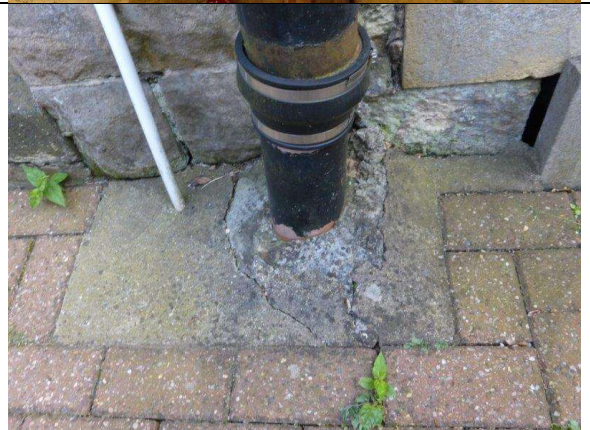
On the rear of the utility room wall there looks to have been a problem with this soil pipe - the concrete has been broken out around the base and a coupling fitted above.

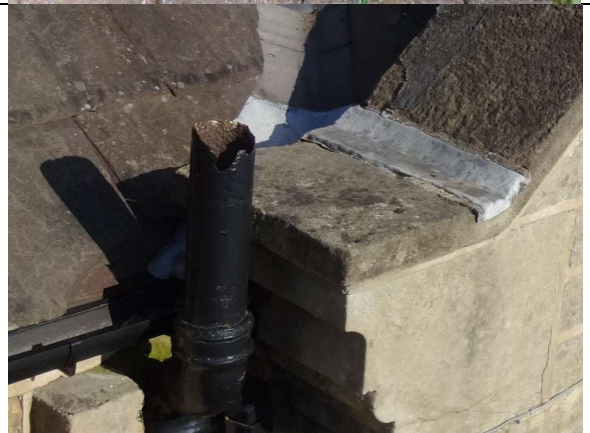
This soil vent pipe in between the dressing room and the stairs is corroding.

Consideration needs to be given to whether to begin a programme of refurbishment of the remaining cast-iron goods or to replace them with modern alternatives, subject to Conservation Officer approval.

In the meantime, a birdcage should be fitted to the top of the pipe to prevent birds from nesting and dropping debris into the drainage system.

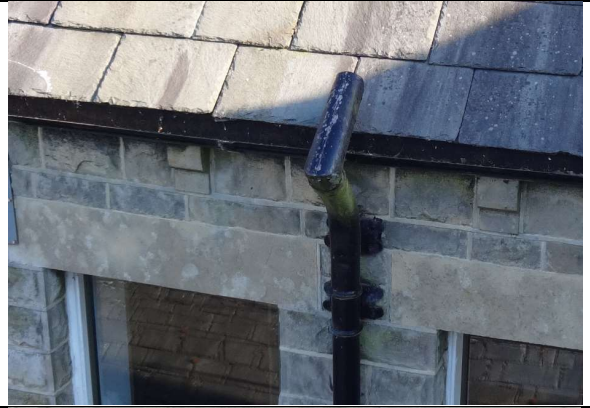
Soil pipe at the rear of the property requires a birdcage fitting to the top for the reasons noted above.

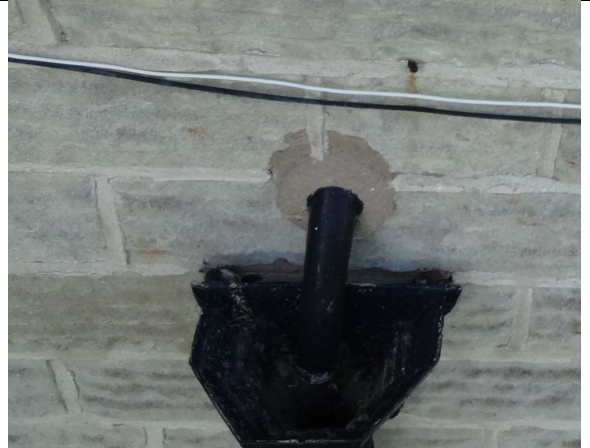
Front of bedroom two - we could not determine what this pipe/hopper is discharging. Maybe an old sink?

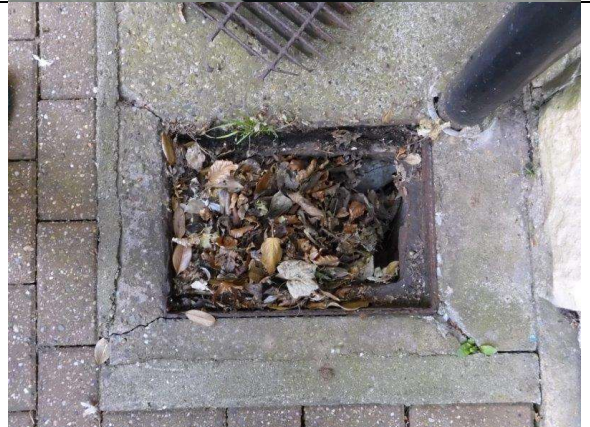
The gully next to the stables at the rear of the property is full of leaves and silt and requires unblocking as soon as possible.

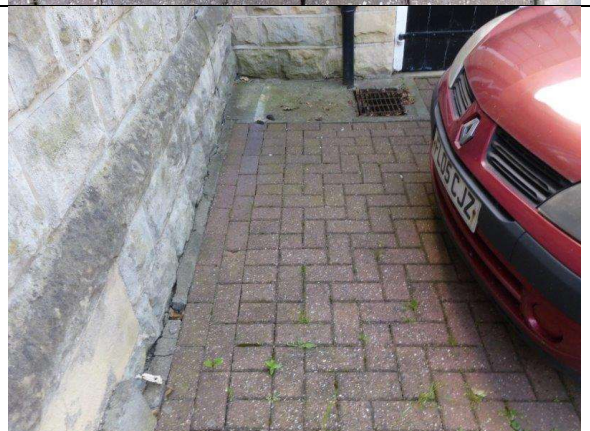
The gully outside the rear door is full of leaves and silt and requires unblocking as soon as possible.

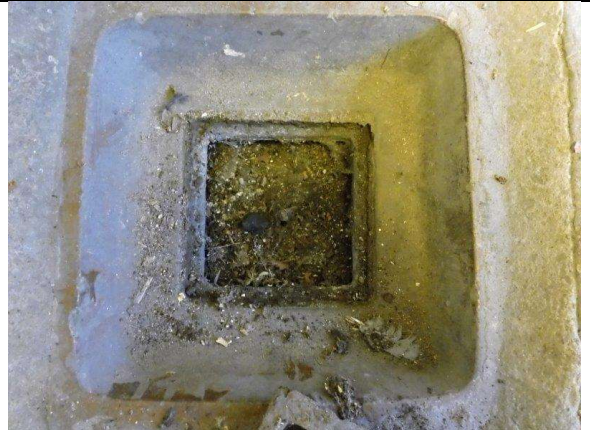
This gully around the side of the garage is full of debris and should be cleaned out as soon as possible.

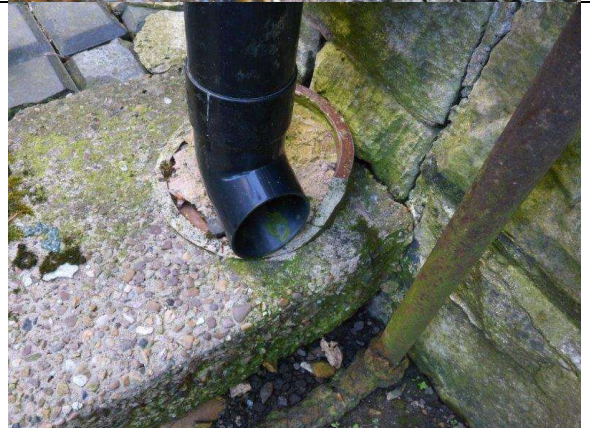
Again, this fall pipe is discharging rainwater straight to the foot of the wall.

We recommend that the gully is reinstated in the short term.

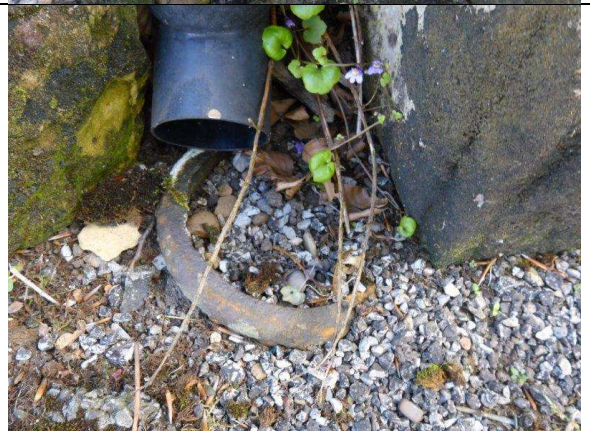
Around the right-hand side of the house, several gullies have been filled in with mortar. We are unsure as to why and recommend that the gullies are reinstated in the next year.

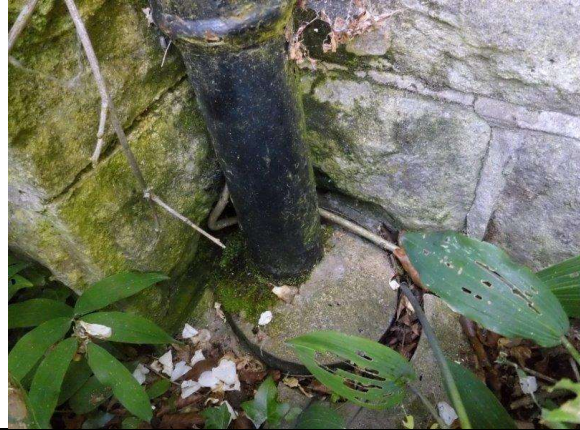
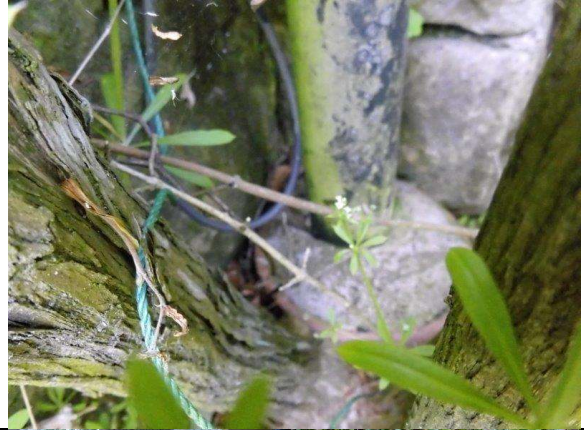
We have not been able to get to the bottoms of all of the fall pipes to inspect them due to the vegetation present. This one is outside the lounge.

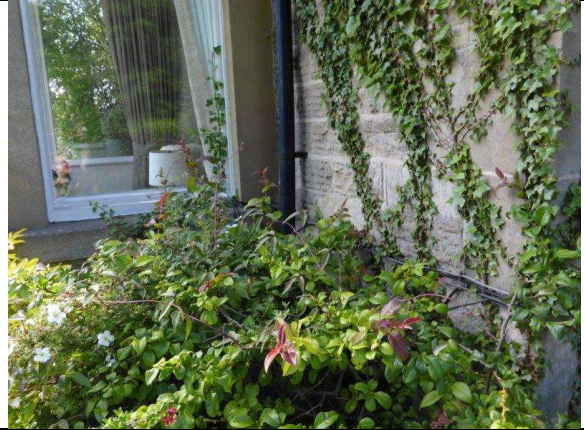
On the left-hand elevation next to the dining room there are a number of pipes discharging into a silted-up gully.

We recommend that the gully is cleaned out as soon as possible and the pipes observed under load to ensure that all of the water is getting sent down the gully. Any pipes creating splashback or not discharging straight into the gully should be amended to do so.

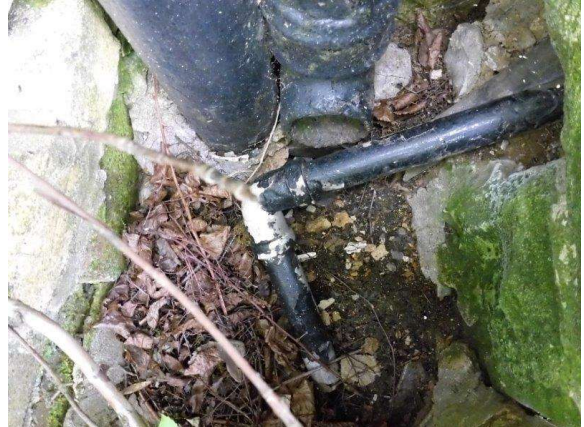
Gully under kitchen window – debris should be removed as soon as possible and vegetation cut back so that it does not enter the drains.

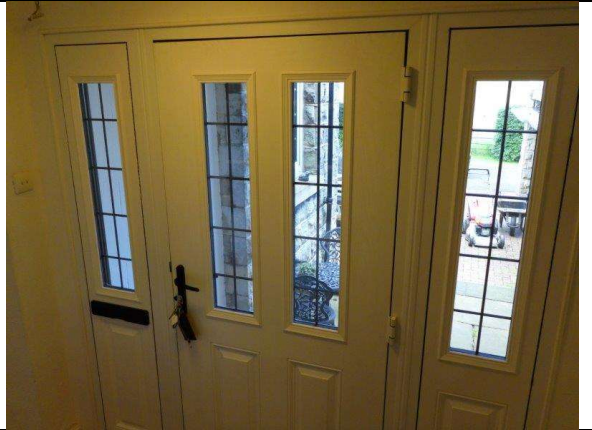
A number of double-glazed panels have failed.

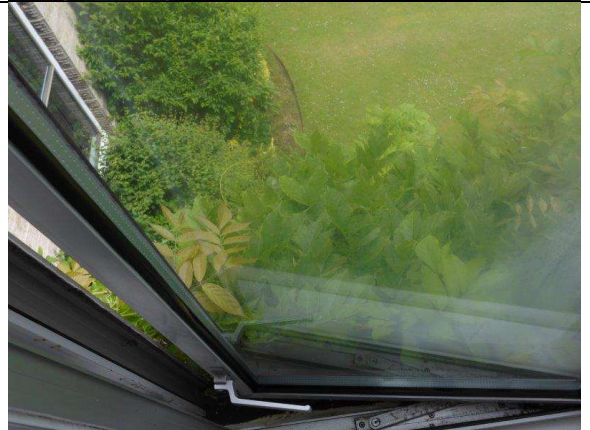
There is an older window in the ground floor W.C. We did not attempt to open this as it was covered in vegetation externally.

We recommend that the vegetation is cut back and some spray-on lubricant is applied to the moving parts before attempting to open it.

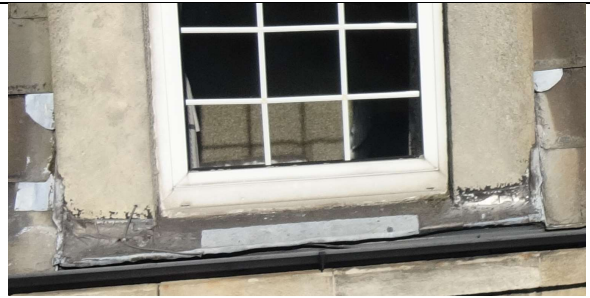
Rear attic storeroom (above the kitchen) – there have been numerous attempts to repair the leadwork around the windowsill

with a Flashband type product. This is inappropriate for a historic building and is only a temporary fix. We recommend that the Flashband is removed, the problem investigated and a suitable repair made in lead as soon as possible.

Holes appearing in the flashband in the abovementioned windowsill.

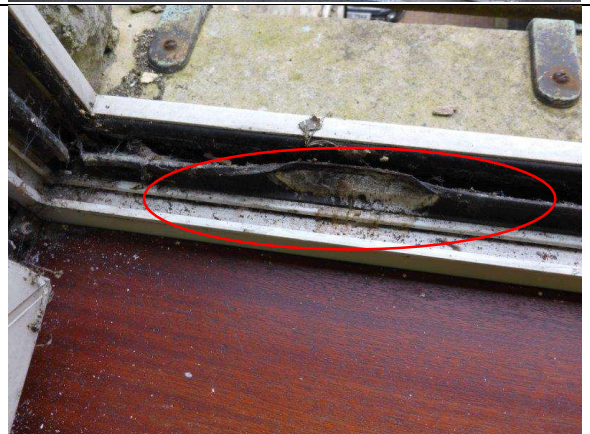
The front attic room window has dropped a little and is now difficult to close. This should be eased.
