## **Historic Building Survey**

**Thorpe Salvin**

**FOR AND BEHALF OF  
Simon Hollis Limited  
30<sup>th</sup> June 2021**

## Building Survey Report

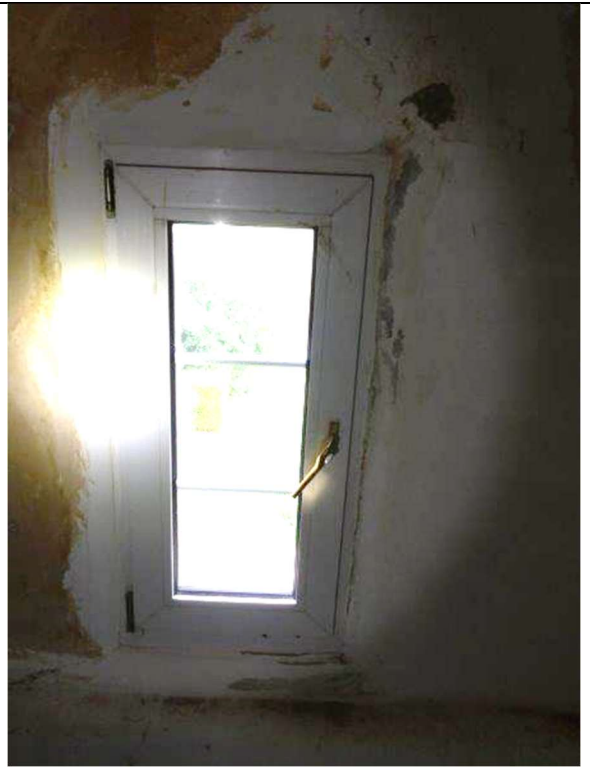
Windows generally need a good clean and their mechanisms lubricating with a suitable lubricant.

This should then be reapplied periodically.

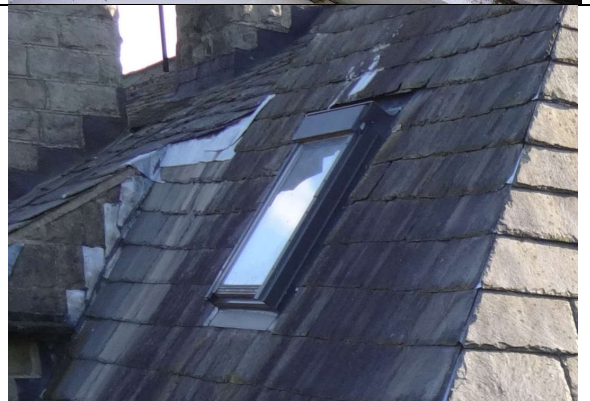
Nor are the two in the larger attic storeroom.

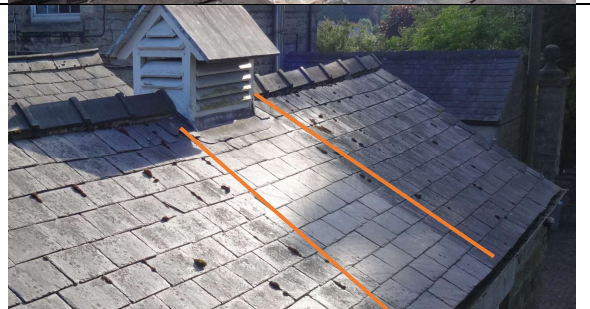
Patination oil should be used on the lead to prevent lead oxide from washing onto the slates below as can be seen in this photo.

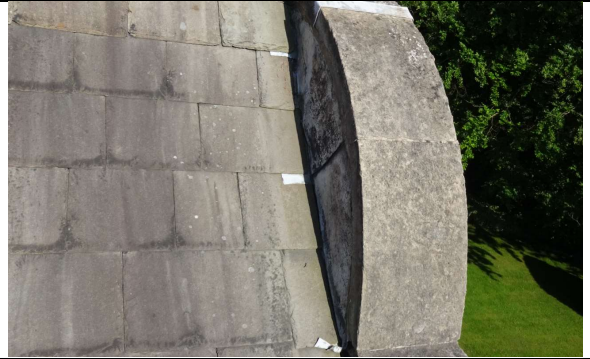
Lead detail dressed the horizontal mortar joints.

One of the strips has been folded back on itself above bedroom three. This should be dressed back into place as soon as possible.

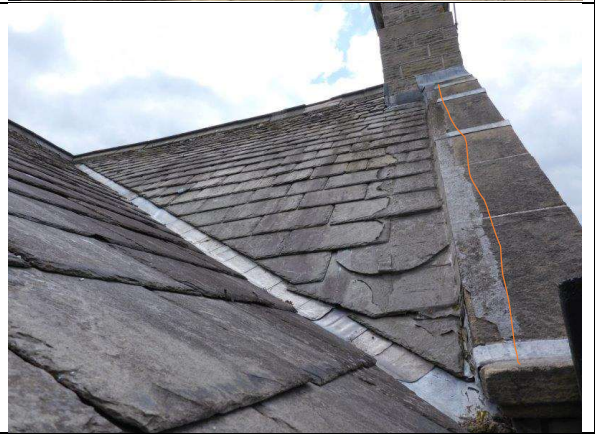
Above bedroom two - note the absence of the lead detailing on the joints between the coping stones.

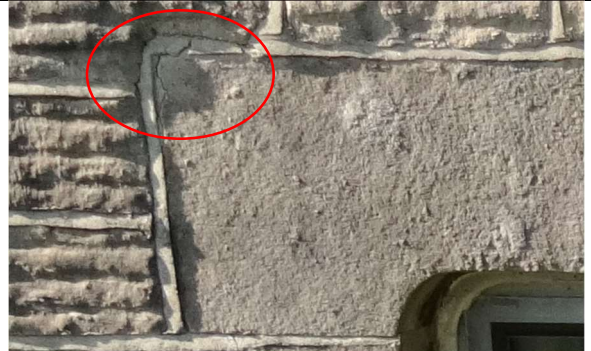
Dressing room - both the lintel and the sill are cracked.

Both cracks have a wethered appearance which suggests that they have been there for some time.

In the short to medium term, we recommend the cracks are recorded, repaired by a suitably qualified mason using a hot lime-based mix and then monitored each season going forwards.

As detailed further 5.2.2, we recommend a drainage survey is carried out as immediately below this window, foul and surface water drainage is present.

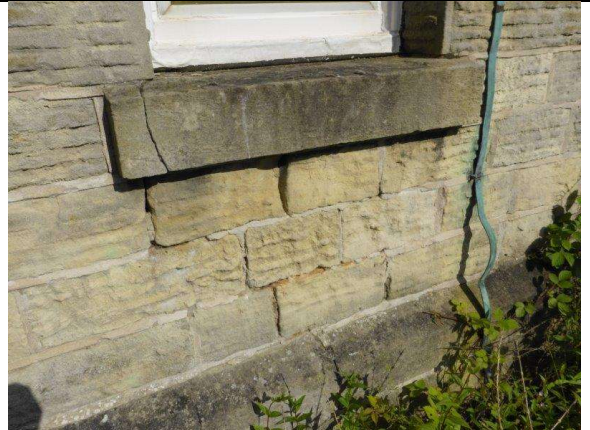
Two stones under the cold water storage tank overflow are cracked.

The cracks are wethered and they should be recorded and repaired as detailed above.

This area is also close to the rainwater drainage, comments on this above.

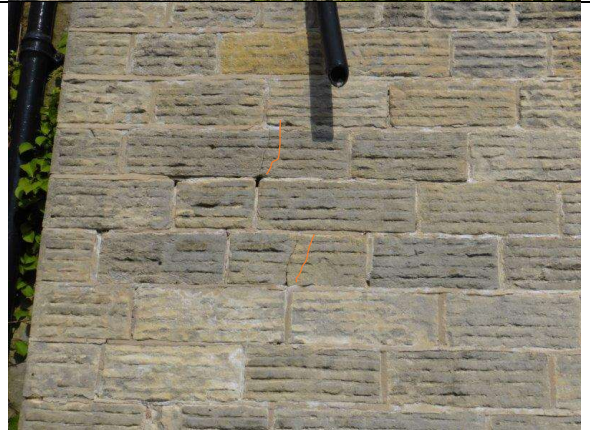
One stone cracked to the left of the dressing room window.

The crack is wethered and should be recorded and repaired as detailed above.

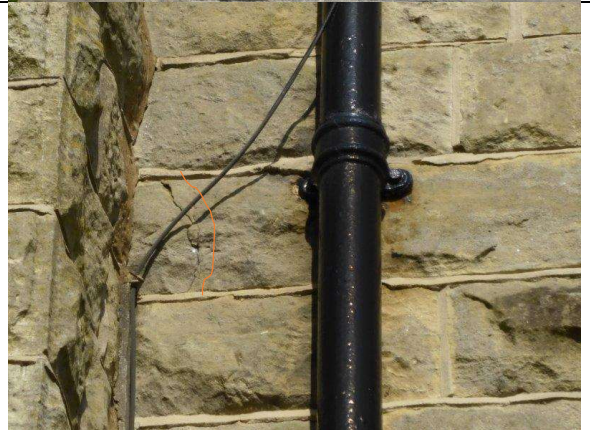
To the left-hand side of the left-hand elevation kitchen window, there is a hairline crack to the lintel, we cannot determine if this is just where the mortar and lintel abut or if a sliver of the lintel has cracked where it bares onto the wall. The sill also has a crack through it. The crack is wethered and should be recorded and repaired as detailed above.

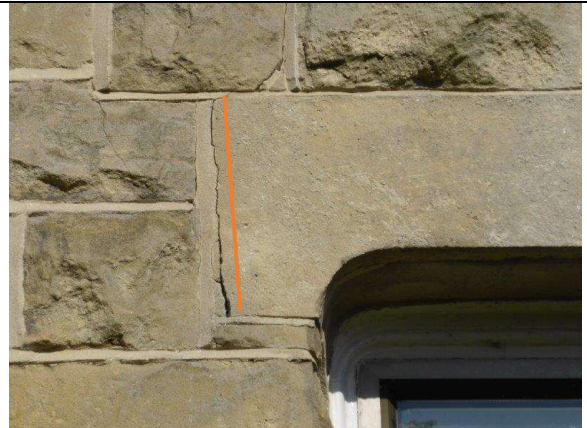
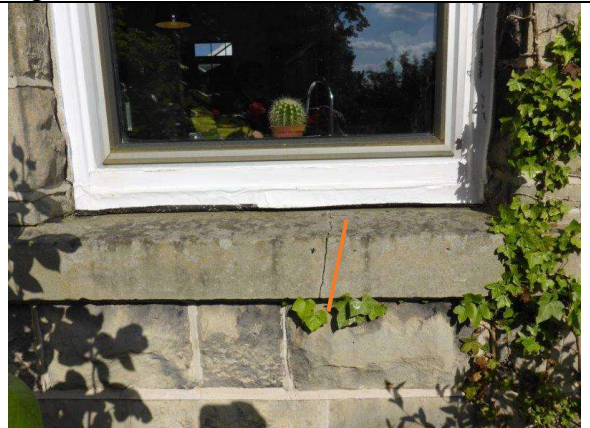
Rear LHS bedroom – there is a hairline crack on the corner of the stone that the lintel is bearing on.

Again, the crack is wethered and should be recorded and repaired as detailed above.

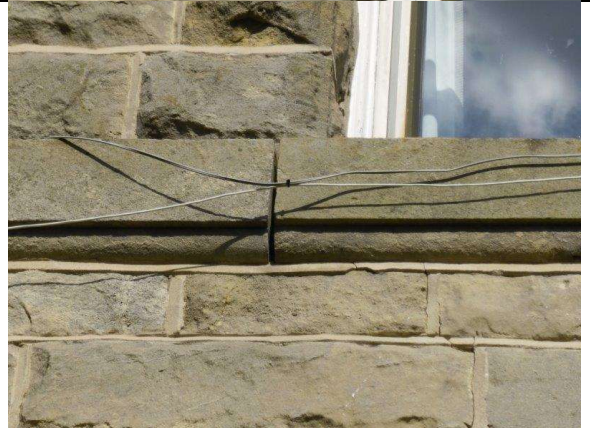
Rear elevation – there is a crack to the corner of the master bedroom lintel which is picked up again at the base of the opening and runs down to the kitchen window head and from the base of the opening to the ground. The vendor advised that they had not noticed the crack.

All sections of the crack are wethered and do not look to be above 5mm which is where BRE Digest 251 advises that repairs should be considered.

As noted above, there may be a defective drain running along the base of this wall, and we recommend that this is investigated further.

The chimney stack is also bearing down over the bedroom window, which has likely lost some of its strength due to the window replacement detailed above.

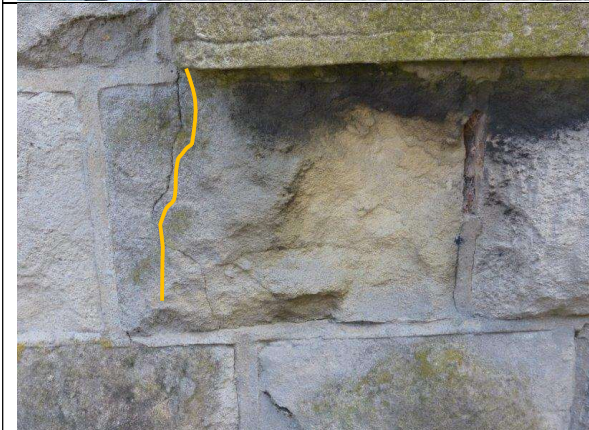
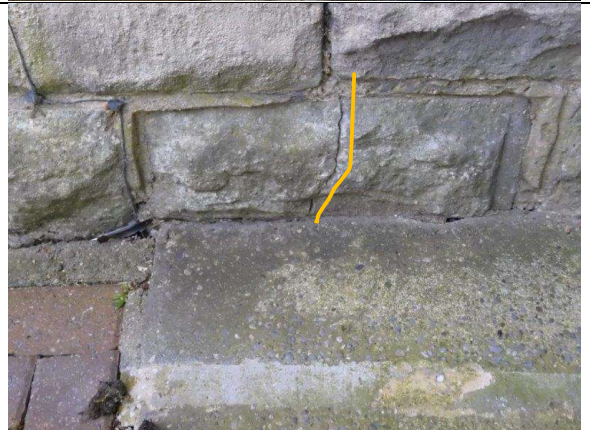
A hairline crack to the bottom right-hand corner of the lintel on the kitchen window outside the back door.

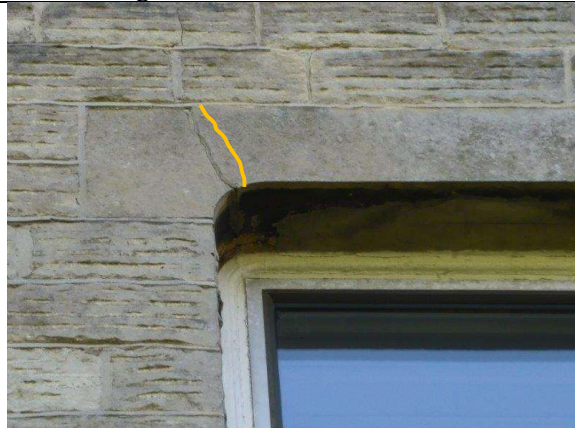
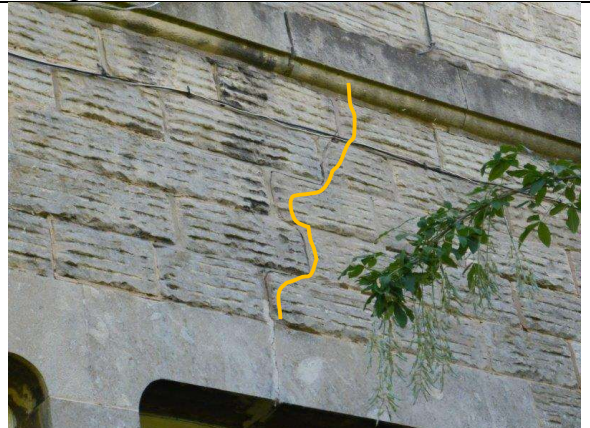
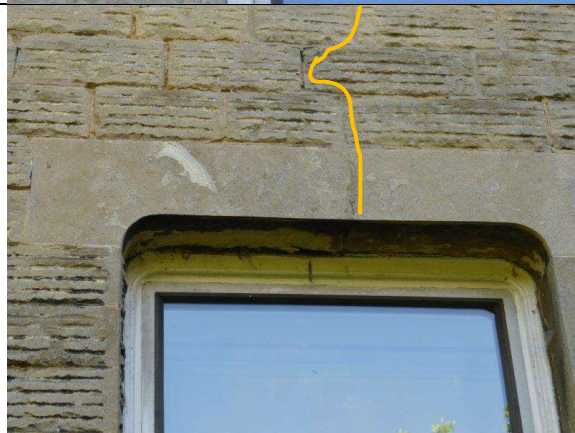
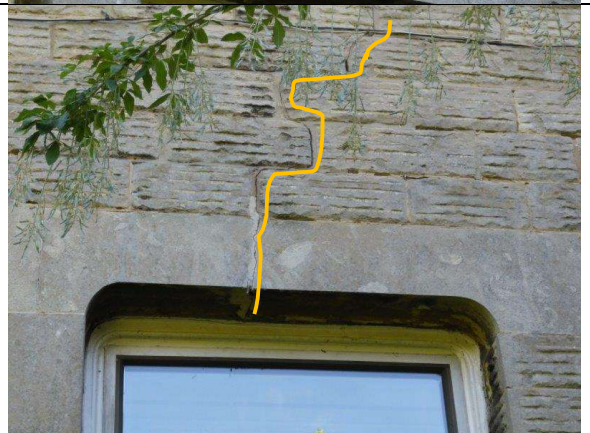
Bedroom two down to the drawing room – front elevation – the bedroom lintel has a horizontal crack through it. Horizontal cracks are more unusual and difficult to diagnose at a single point in time. This should be recorded, repaired and monitored. If you replace this window, we would recommend the lintel is either replaced or strengthened. The drawing room lintel has a vertical crack through it. This should be recorded, repaired and monitored.

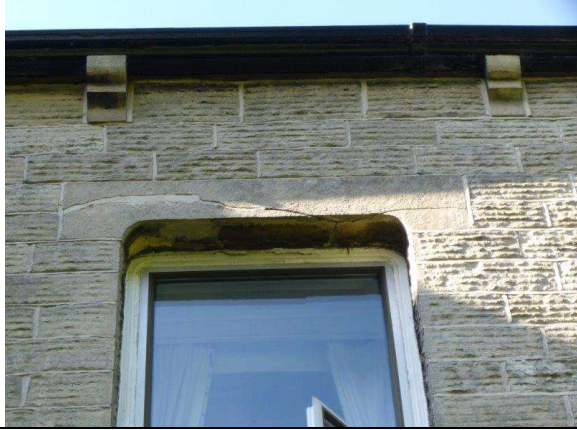
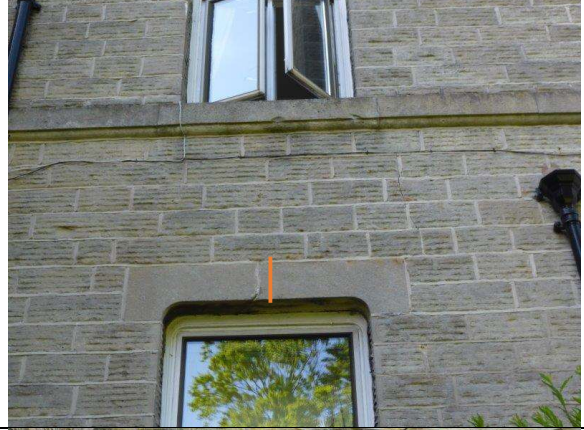
Drawing room door – the lintel above has a hairline crack through it. This should be recorded and monitored.

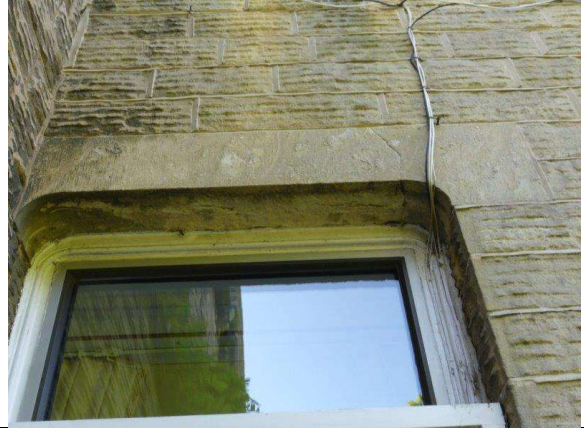
The ground floor office window has a vertical crack through it. This should be recorded and monitored.

This crack is a little larger and repair if the window is replaced should be considered.

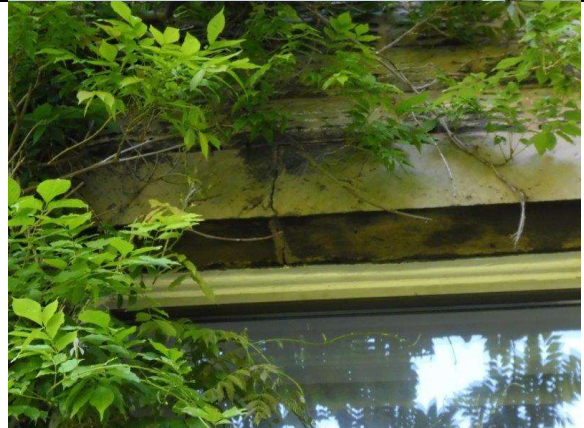
The lounge window has a hairline crack through it. This should be recorded and monitored.

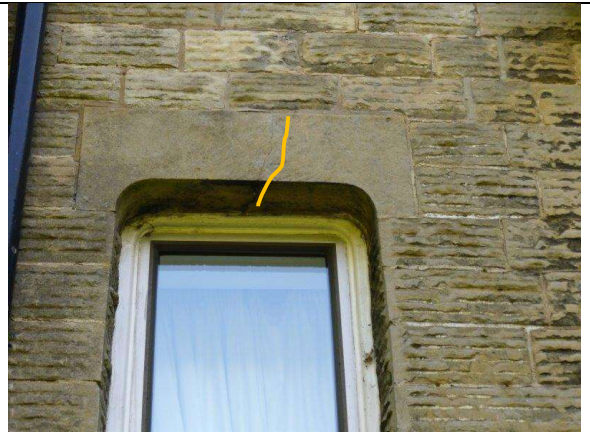
Lounge bay window – there is a very small area of spalling/crack to the stone where it is carved at the window head and a tiny crack to the bottom left corner of the stone lintel.

Both of these look historic and are not of concern to us.

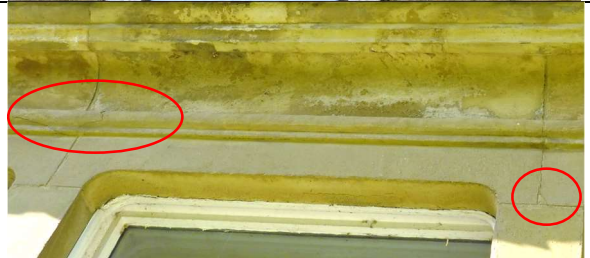
An area has been pointed over on the right-hand side of the lounge bay window.

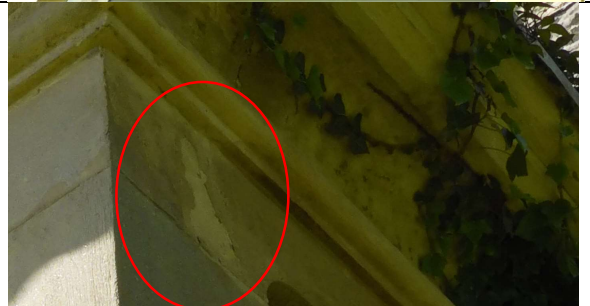
An area of spalled stone has been pointed over on the dining room bay window to the left of the front door.

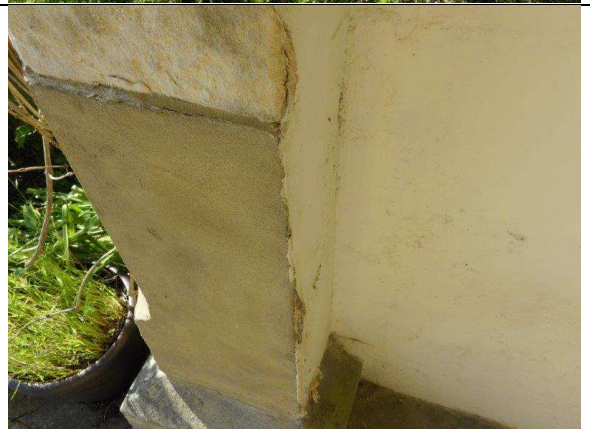
A few chips to the edge of the rendering in the porch area. These can be patched up if desired.

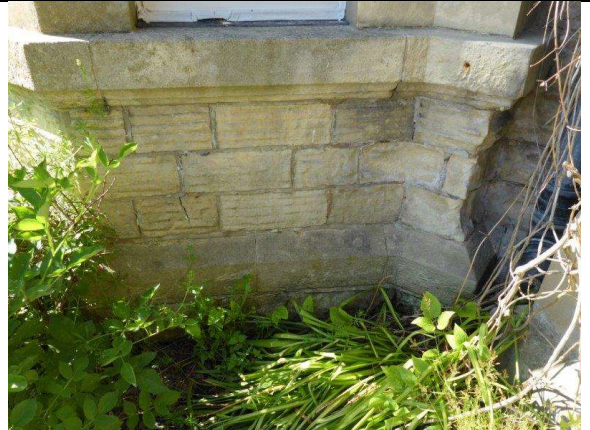
There is some light stone decay under the dining room bay window. Loose grit should be brushed off and the area repointed in a hot lime-based mix in the next two years.

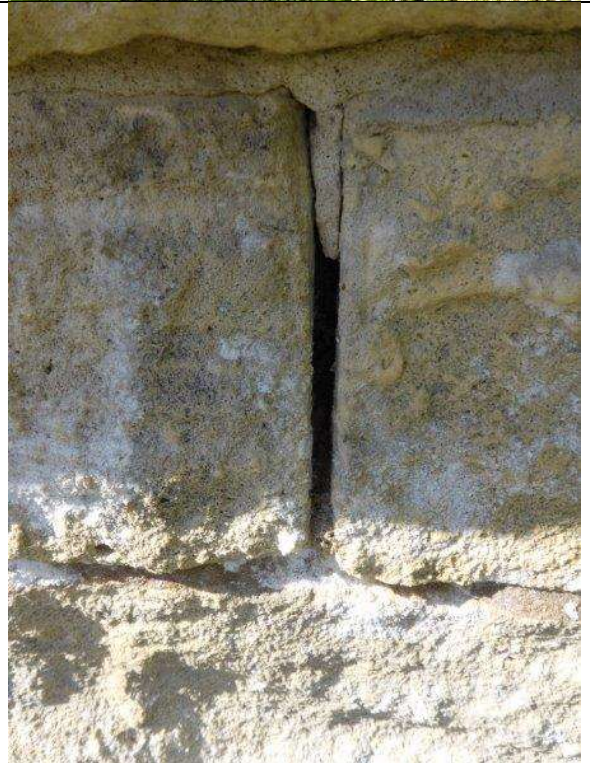
Joints that have no pointing should be re-pointed in a hot lime-based mix.

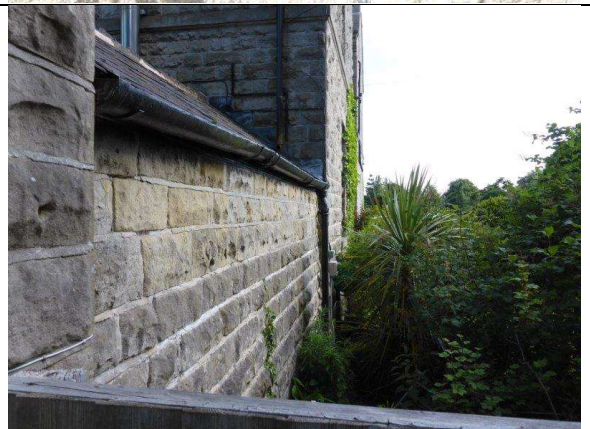
The top three courses on the rear of the stable block look different to the lower courses.

They may have been cleaned up or partially deconstructed and rebuilt to allow the kerosene tank to be installed?

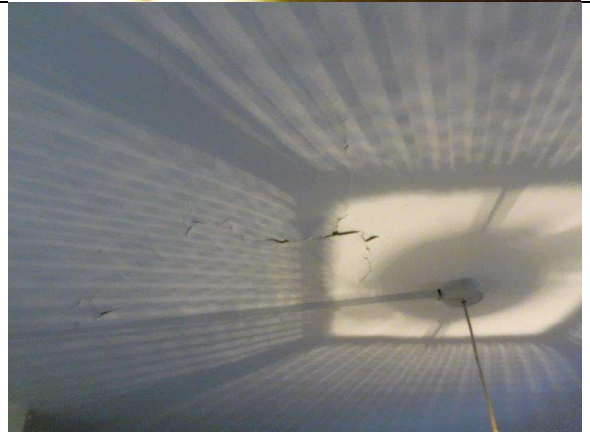
Office ceiling – some peeling paint, likely as a result of a historic leak.

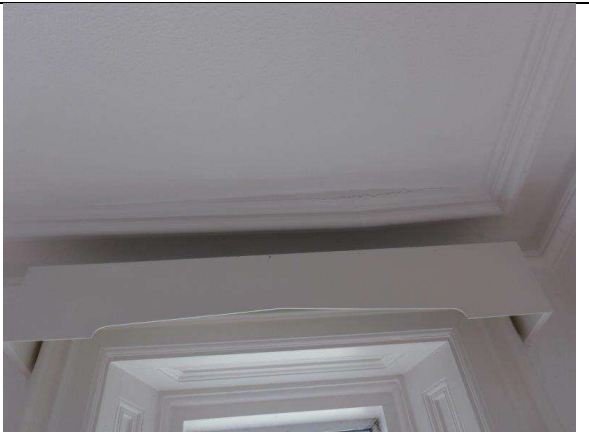
The coving in the bedroom three en-suite has sunk a little. No surface cracking was seen and this looks to be historic.

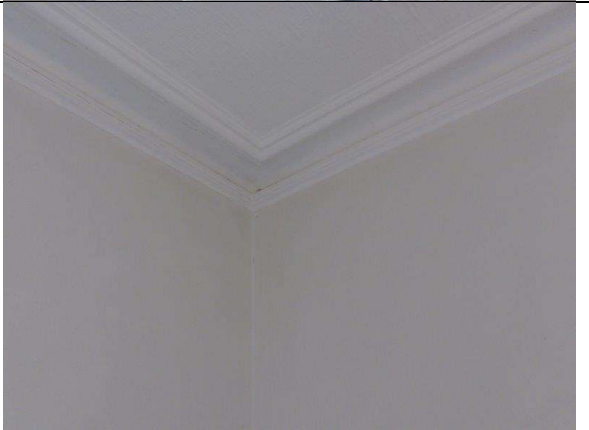
In the corner and along the right-hand wall of bedroom four, the paint is a little flaky. This may be poor quality workmanship or a historic leak. Nothing was picked up on the thermal imaging of this area.

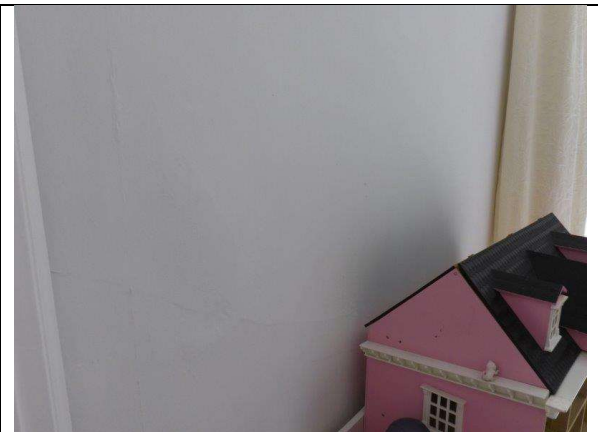
There is a large area of plaster that has lost its key in bedroom three next to the door to the en-suite.

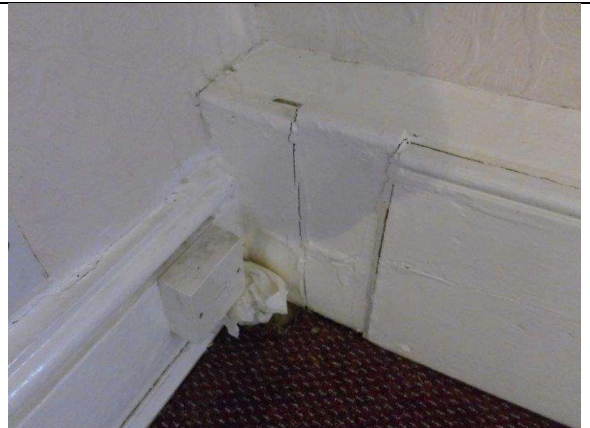
Some of the skirting board detail on the second floor is not the best. This example is in the left-hand rear bedroom.

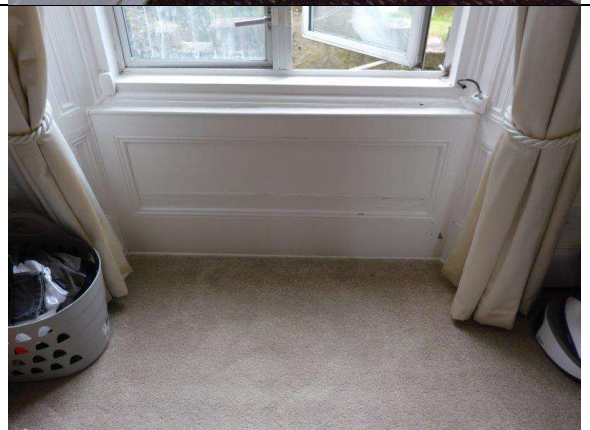
In bedroom four the timber panel under the window has some paint flaking off it. We examined the area and did not note any decay.

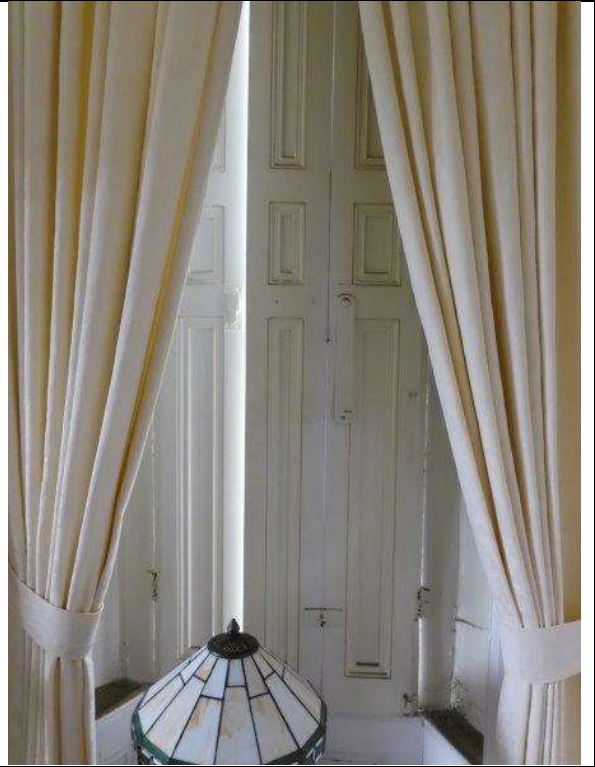
Dining room shutters are stiff, but with some use and light lubrication should function correctly.

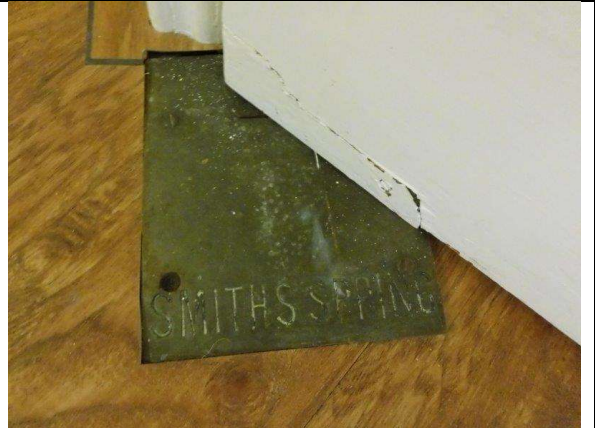
The hallway door is binding a little. It is on a spring mechanism that may require adjustment by a suitably qualified contractor.

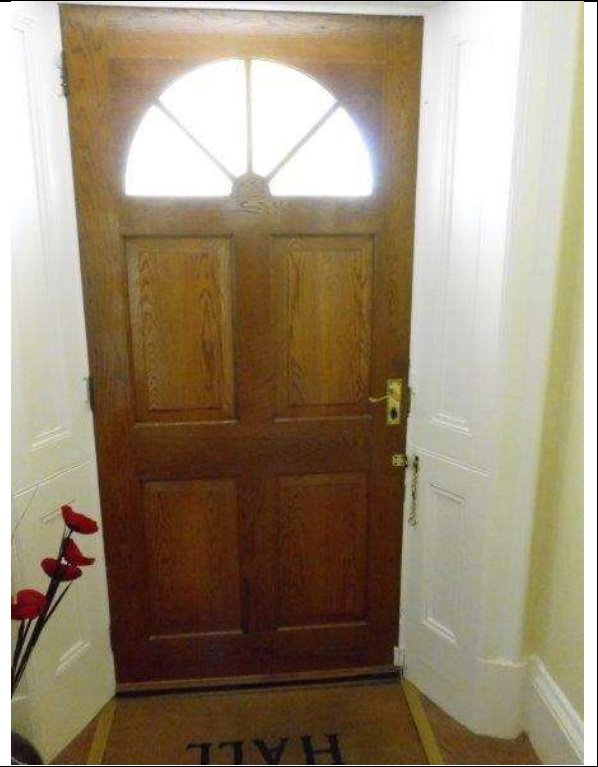
The front door binds a little and could do with some adjustment.

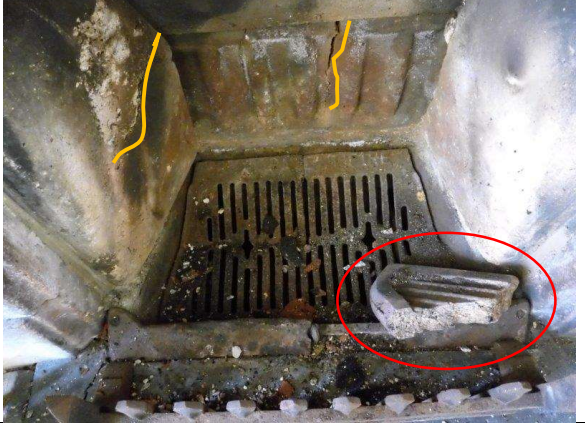
<p>Baxi Burnall fire in the dining room.</p> <p>The Vermiculite liner board is damaged in various places. Consideration should be given to its replacement.</p>

A photograph showing the interior of a fireplace. A metal grate is visible, and a red circle highlights a component on the right side. The surrounding walls appear to be made of a light-colored material, possibly vermiculite liner board, which shows signs of damage and discoloration.
<p>From what we could see of the flue, it did not look to be pardged.</p>

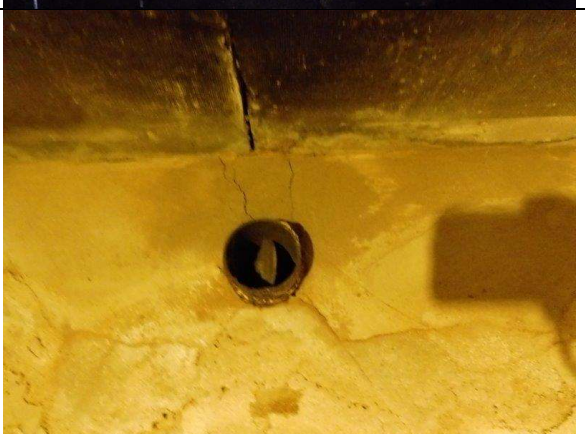
A photograph showing a dark, narrow flue passage. The walls are dark and appear to be made of a solid material, possibly brick or stone. The lighting is dim, highlighting the texture of the walls.
<p>The air intake in the cellar storage room.</p>

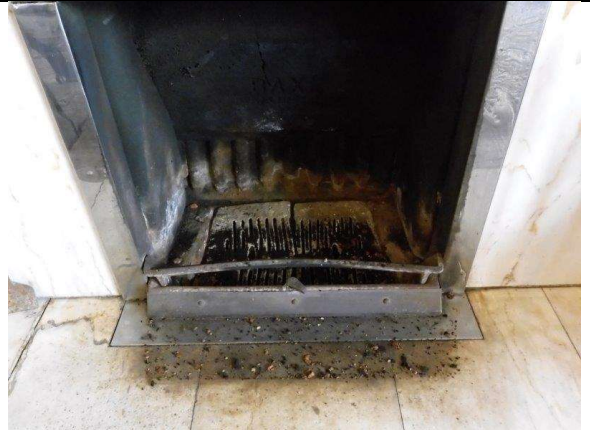
Baxi Burnall fire in the lounge.

Some of the Vermiculite liners are damaged.

Consideration should be given to its replacement.

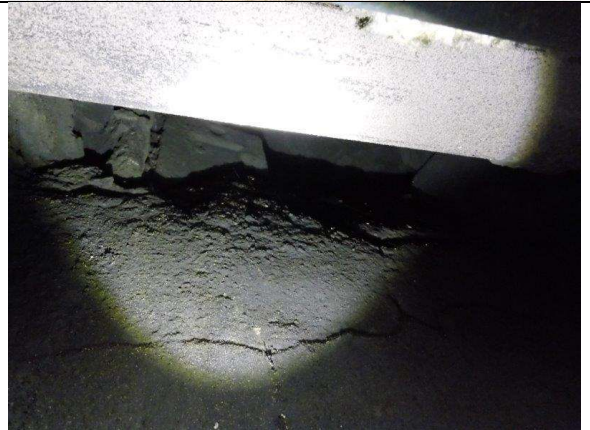
From what we could see of the flue, it did not look to be pardged.

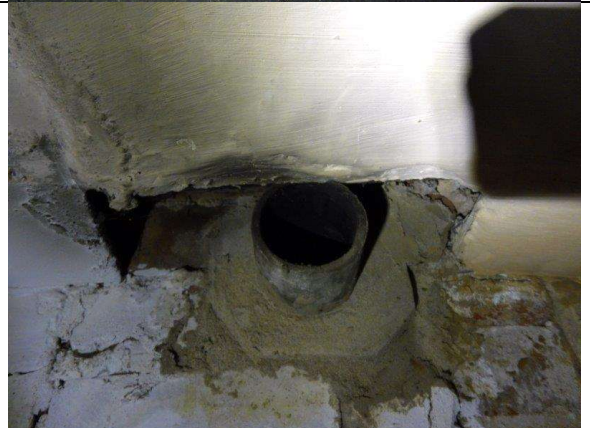
The air intake in the wine cellar.

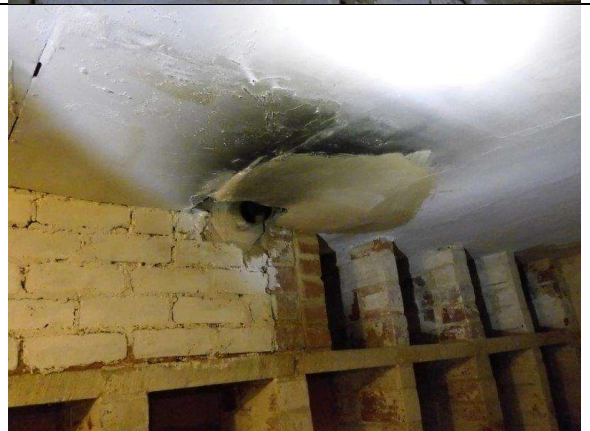
Soot staining to the ceiling around the air intake.

This suggests there may be problems with back flow. We do not recommend that you use the fires until they have been inspected by a suitably qualified member of HETAS.

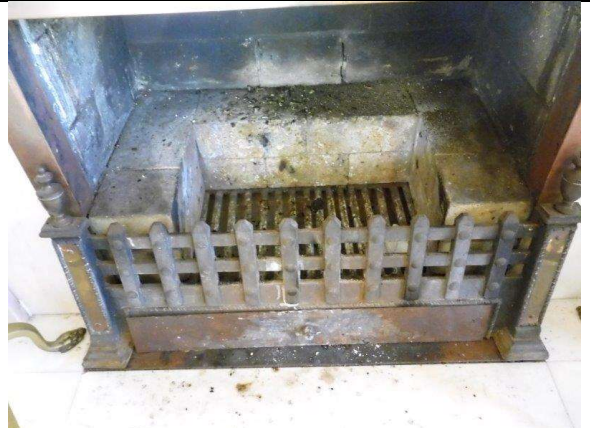
Fire grate in the drawing room. We could not see a maker's mark.

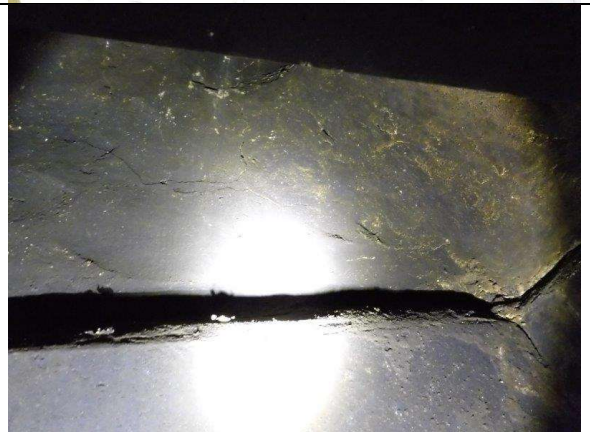
We could not see very far up the flue.

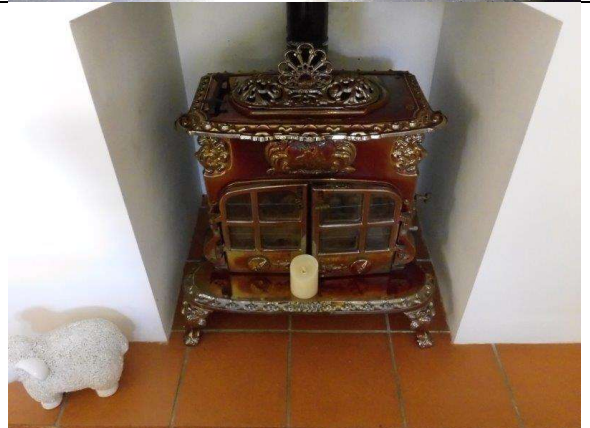
Modern wood-burning stove in the breakfast room. The vendor advised that this flue is capped and they constructed the boxing in from ply wood.

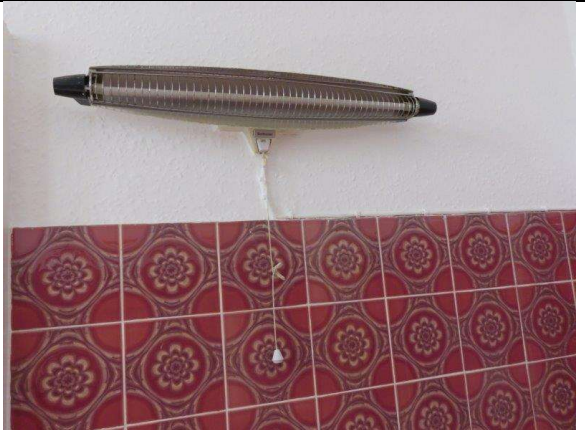
The heater in the bedroom three en-suite does not look to be suitably IP rated.

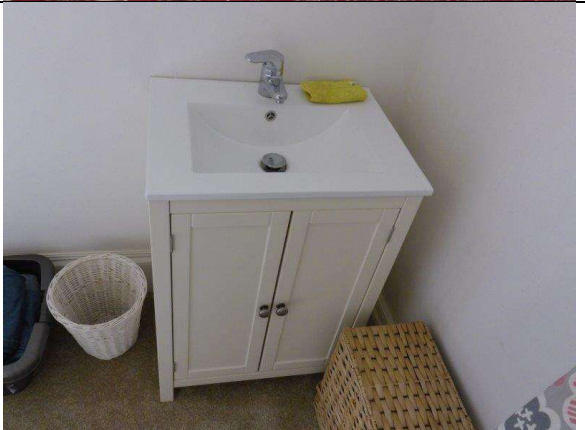
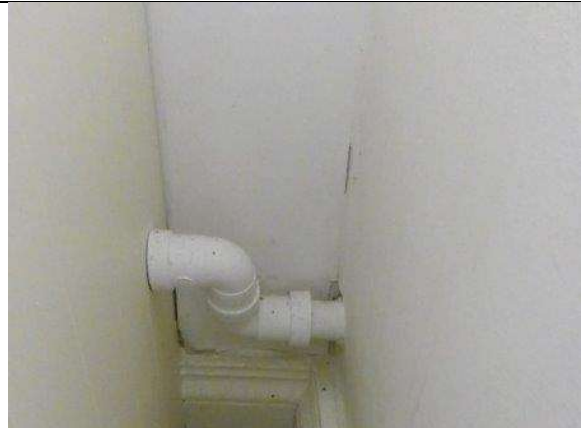
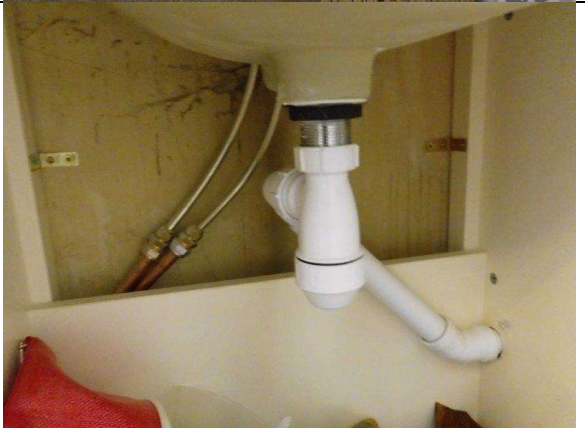
It is not immediately clear where the drainage from the sink in bedroom four goes.

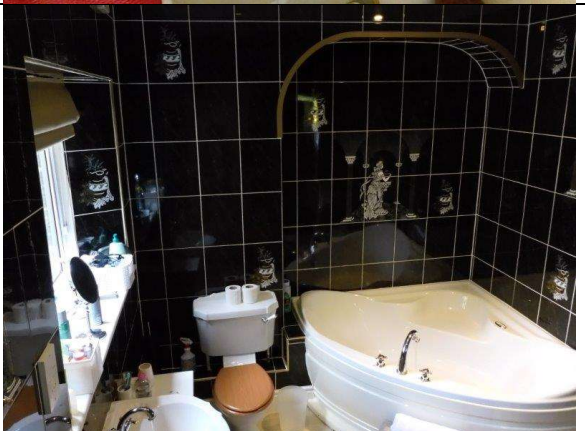
Specialist tiles will likely be hard to replace if needed.

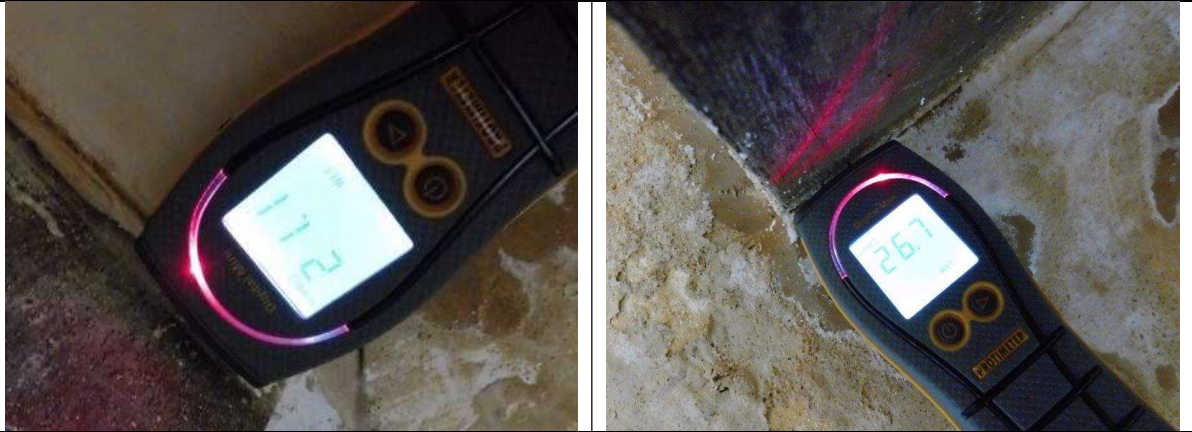
For the sake of completeness, we tested the timber purlins with an electronic resistance meter. The WME readings were 26.7% and 21.1%. We do not consider these readings to be accurate as the timbers are full of salt and other impurities that would have been soluble in the moisture coming through from the roof/wall and have been deposited on the surface when this moisture evaporated into the room.

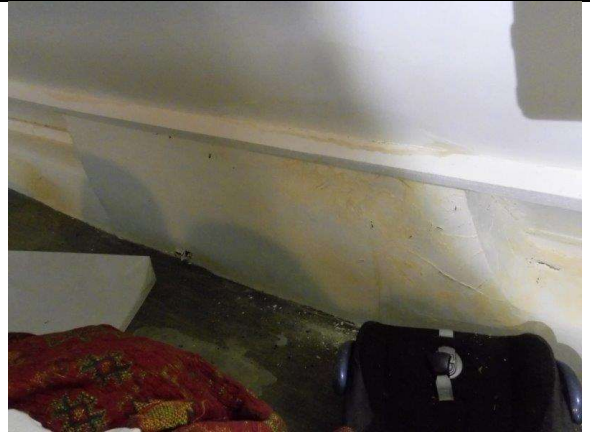
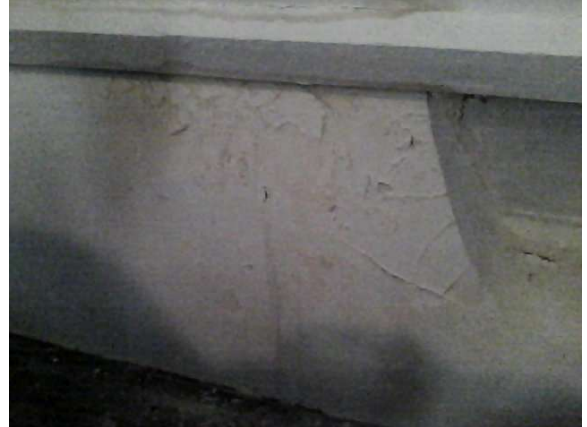
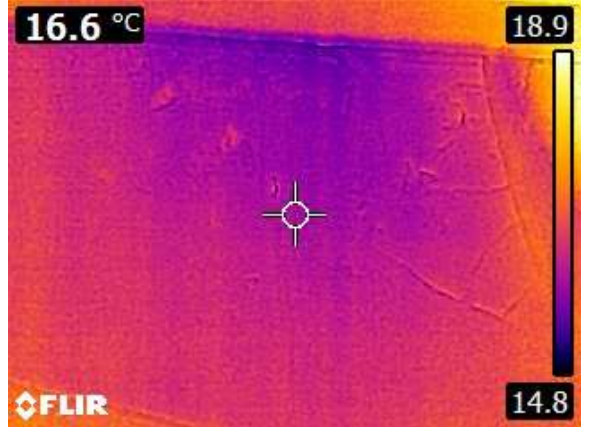
Also in the front storeroom, there is some staining and impurities on the right-hand wall where the chimney stack is.

The thermal imaging picked up a cool area here.

This staining is likely caused by rainwater in the chimney flue and the resulting salts and impurities it is dragging through. The vented cowl recommended in 5.1.1 should stop most of the rainwater from entering the flue, however, it may take years for the salts to stop being a problem.

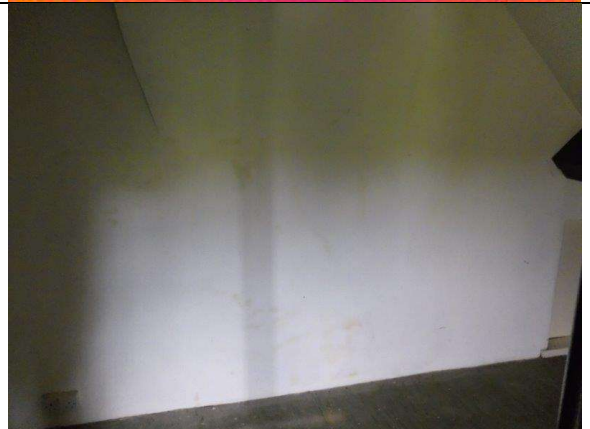
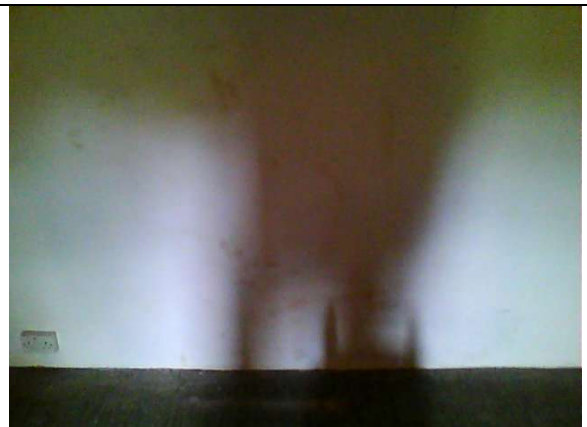
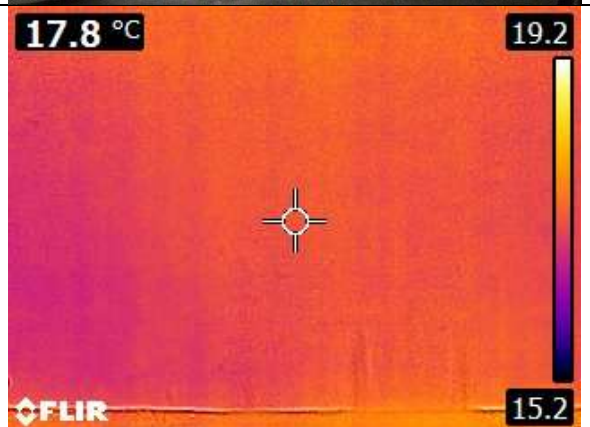
On the rear wall of this room where the chimney breast passes through, there is some light staining to the surface finishes. Again, this is likely to be caused by salt and impurities coming through from the chimney flues. Ventilating the flues and room should reduce this.

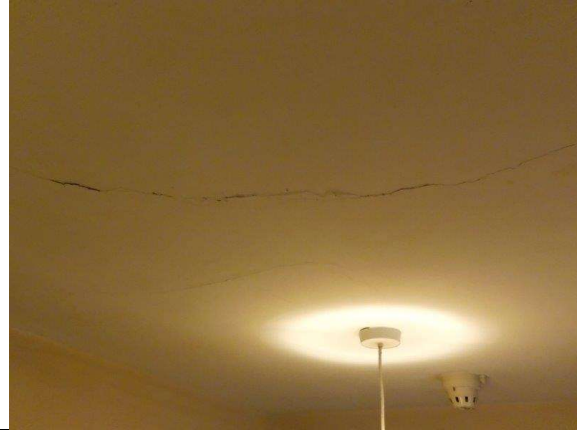
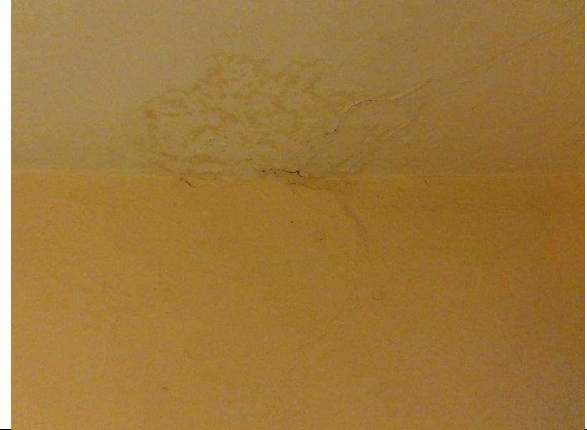
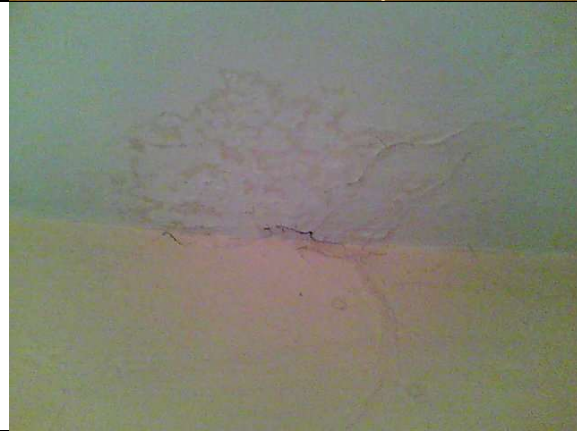
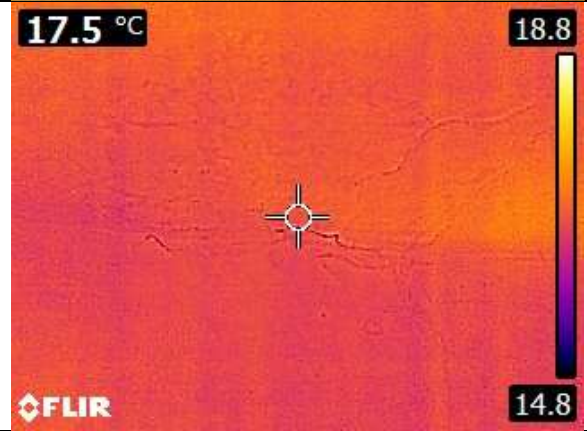
On the second-floor front landing, there is evidence of a historic leak and a crack in the ceiling plaster. The thermal imaging did not show up any cooler areas. The ceiling should be repaired prior to any redecoration of this area.

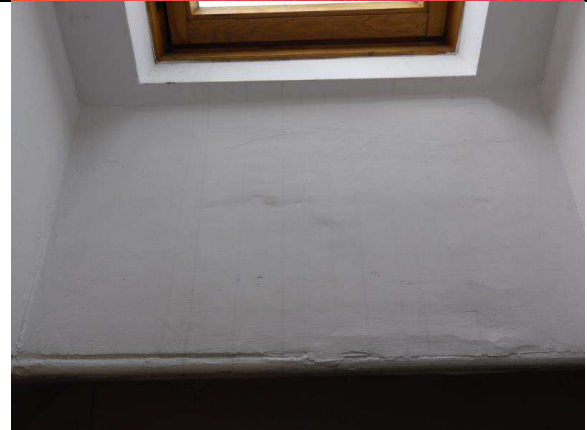
Central store/attic room – there are some faint water stains below the Velux window. These look historic and nothing was picked up on the thermal imaging camera. We recommend that the area is monitored going forwards following heavy rain.

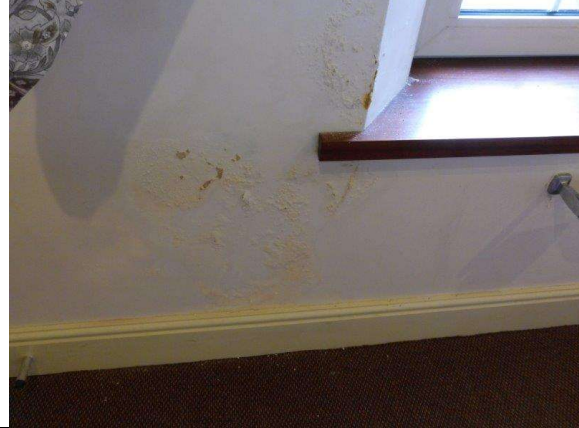
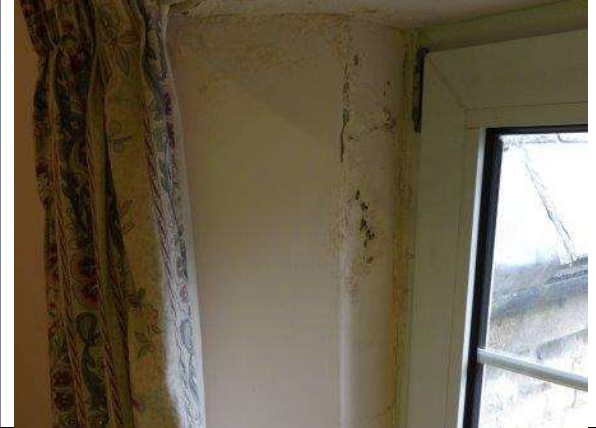
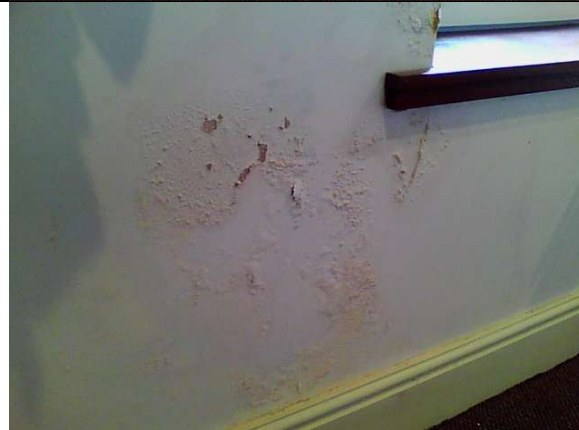
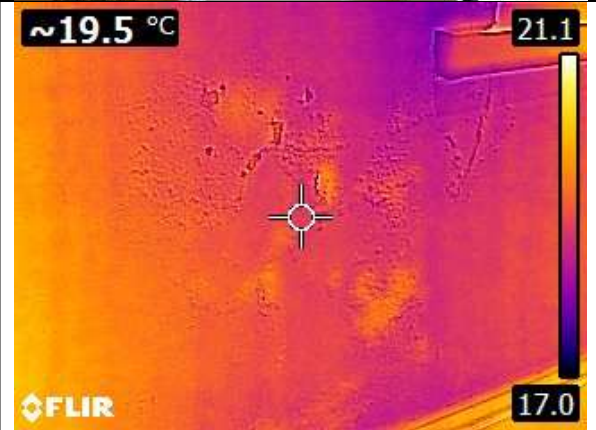
Second floor bathroom – note our comments in section 5.2.1 about the defective rainwater goods on the outside of this area. The walls look to be drying out; however, we recommend the area is monitored during and following heavy rainfall. The finishes can likely be sanded down and repainted once confirmed they have dried out. We recommend that clay or earth based paints are used throughout the house as oppose to modern plastic based paints as these reduce the permeability of the walls.

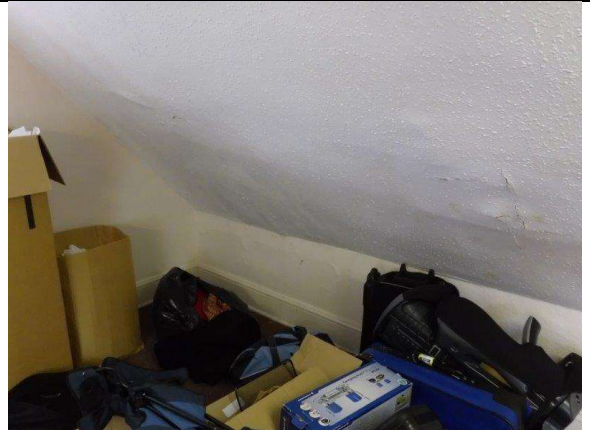
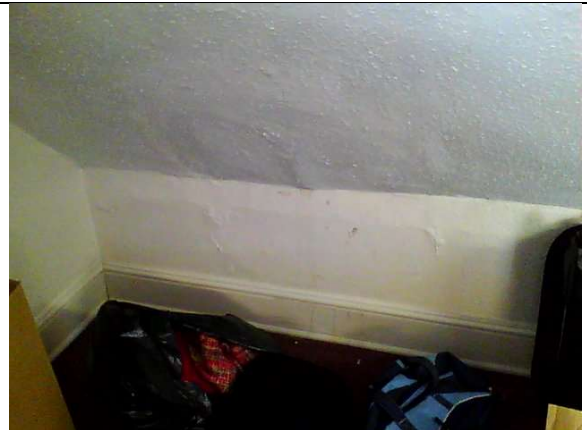
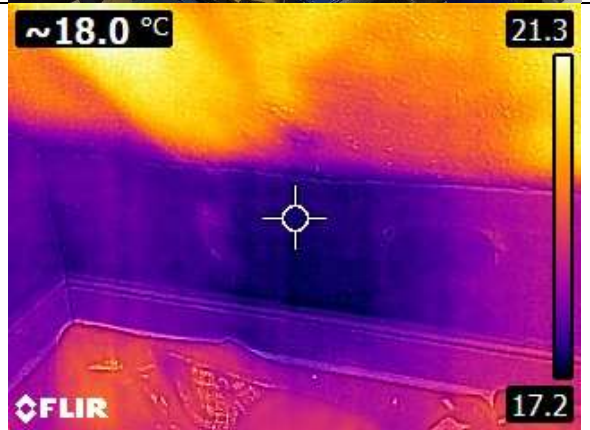
Large attic room – there has been water ingress on the front right-hand area. This could be as a result of the solar water heating leak, roof leak or joint in the guttering.

There is a lot of bleed on the thermal imaging from the roof void so it is hard to tell if this is an ongoing problem.

It should be monitored during and following heavy rainfall.

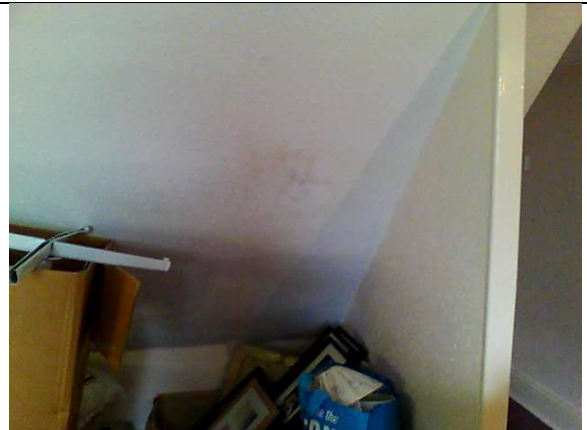
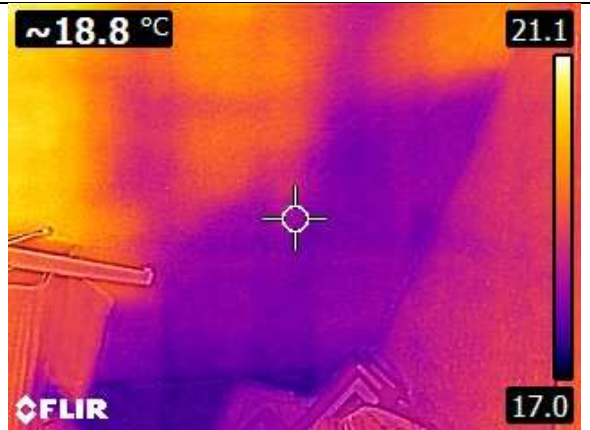
Large attic room – there is water staining on the front wall. This is directly under where the infrastructure for the solar hot water penetrates. The cooler areas on the thermal imaging are likely the valley boards. The area felt dry to the touch but there is no harm in monitoring it.

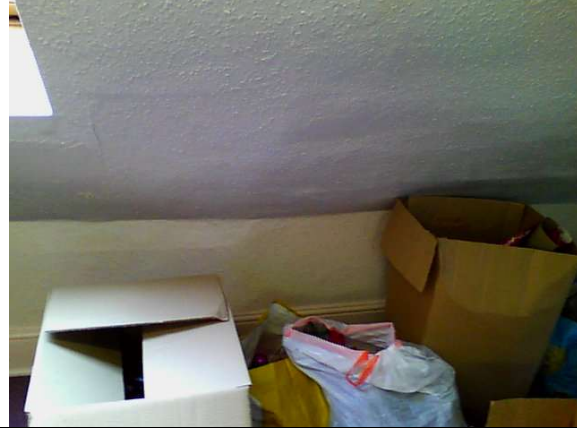
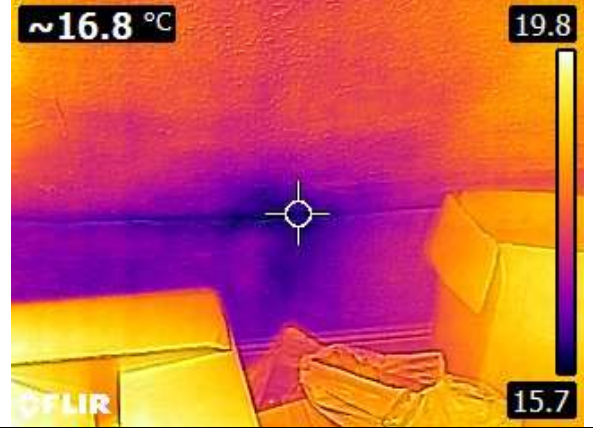
There is some staining and cooler patches under where the rear chimney stack is – this is the area that has had a paint on repair as detailed in 5.1.2. The area felt dry (however it has been warm preceding the inspection). We recommend heating and ventilation to the room should be increased, the chimney and roof abutment inspected close-up and any required repairs undertaken in traditional materials.
