## **Historic Building Survey**

**Thorpe Salvin**

**FOR AND BEHALF OF  
Simon Hollis Limited  
30<sup>th</sup> June 2021**

## Building Survey Report

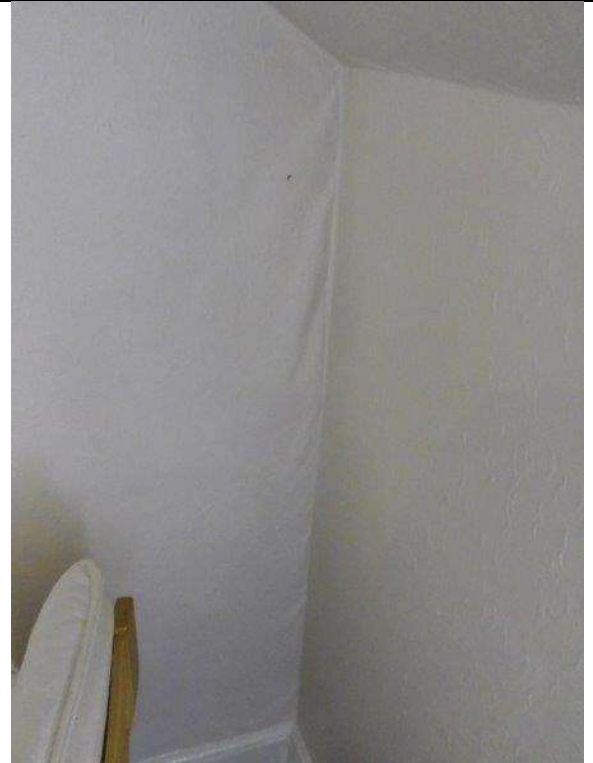
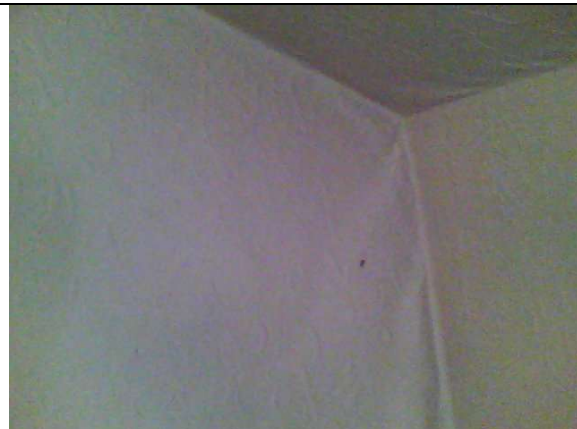
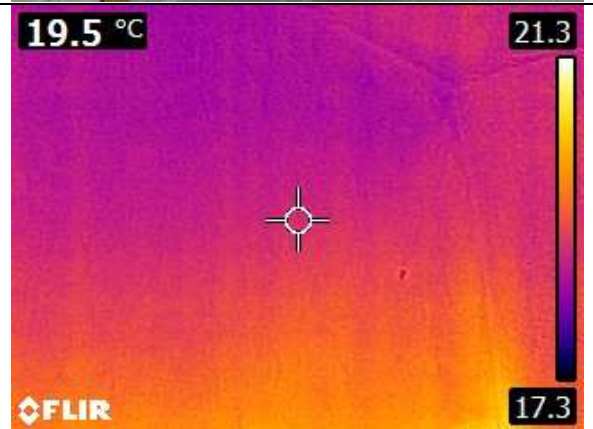
In the left-hand centre office room on the second floor, there is some blown wallpaper to the left of the window. The area is roughly located where two sections of guttering meet and where there has been a previous repair to the valley as detailed further in 5.1.1 and 5.2.1.

The repair looks to be holding and the area felt dry.

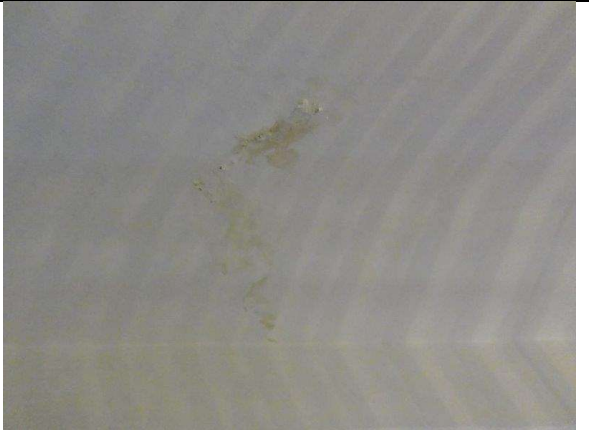
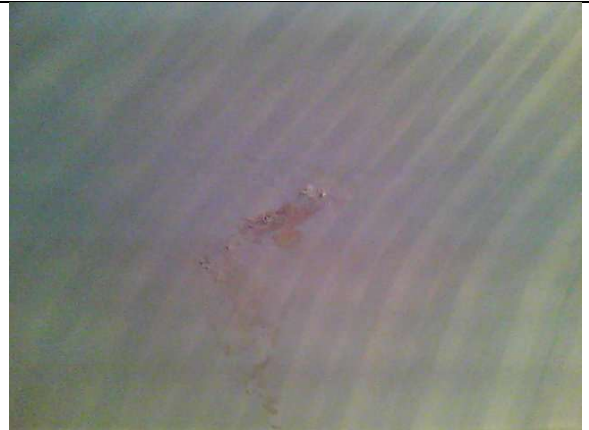
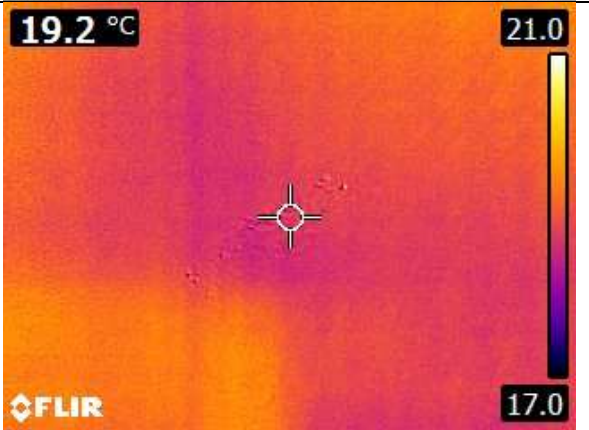
There is some water staining on the ceiling in the central office room. This is likely as a result of a roof leak.

The thermal imaging did not show anything untoward.

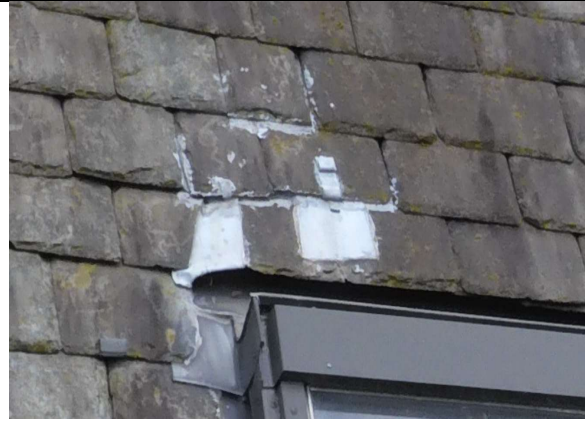
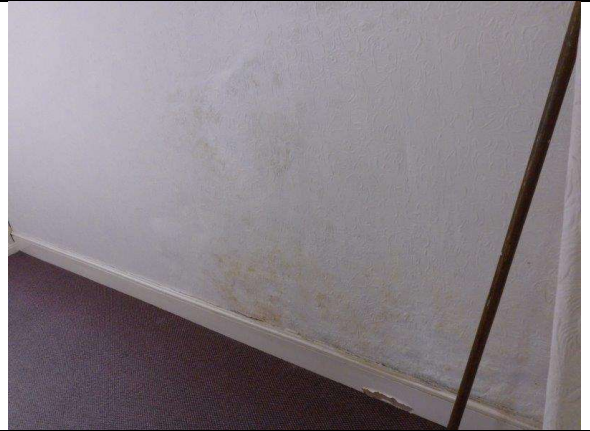
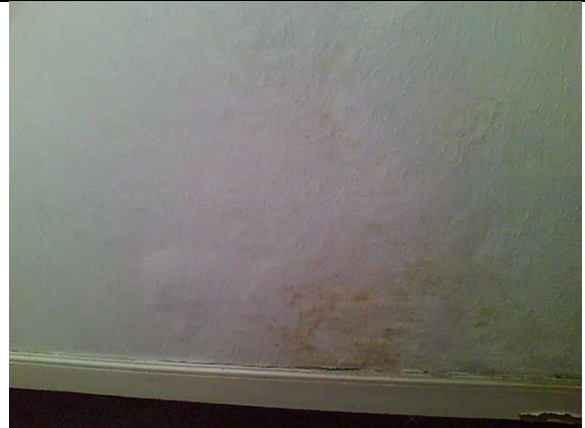
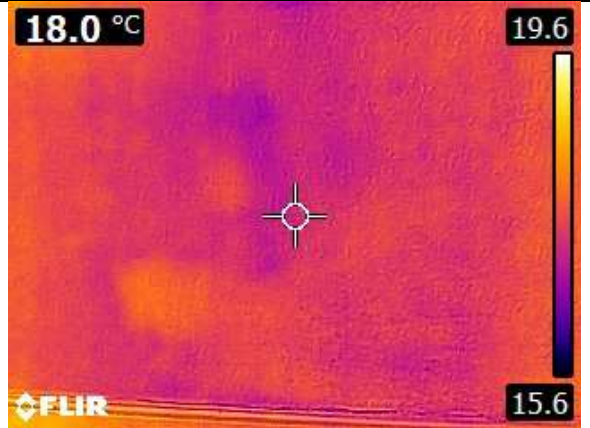
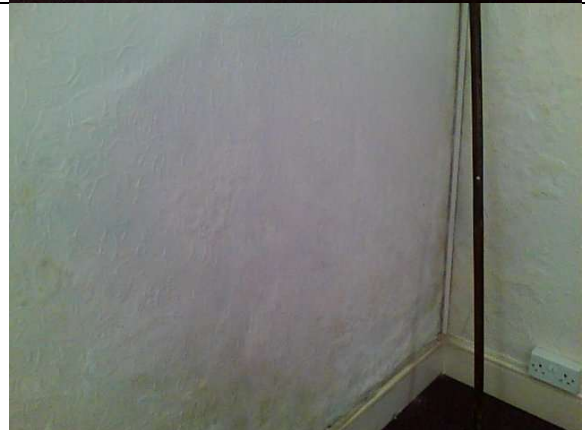
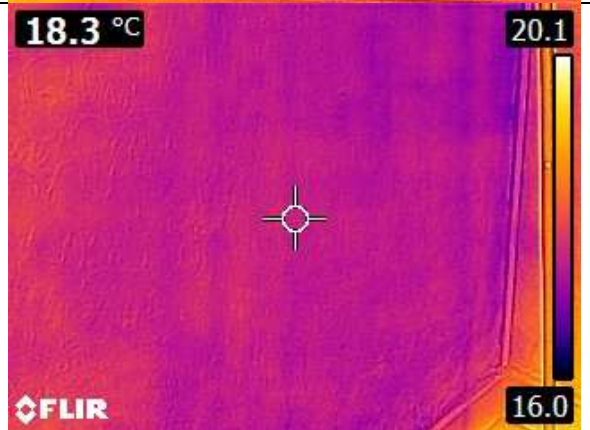
On the rear second-floor landing area, there are two adjoining areas of wall with water staining on. The areas felt dry to the touch, however, the thermal imaging showed some cool spots suggesting the walls may not quite have finished drying out. Externally is the area with the defective guttering we detailed in 5.2.1. There has also been a repair above the rooflight as per the photograph below.

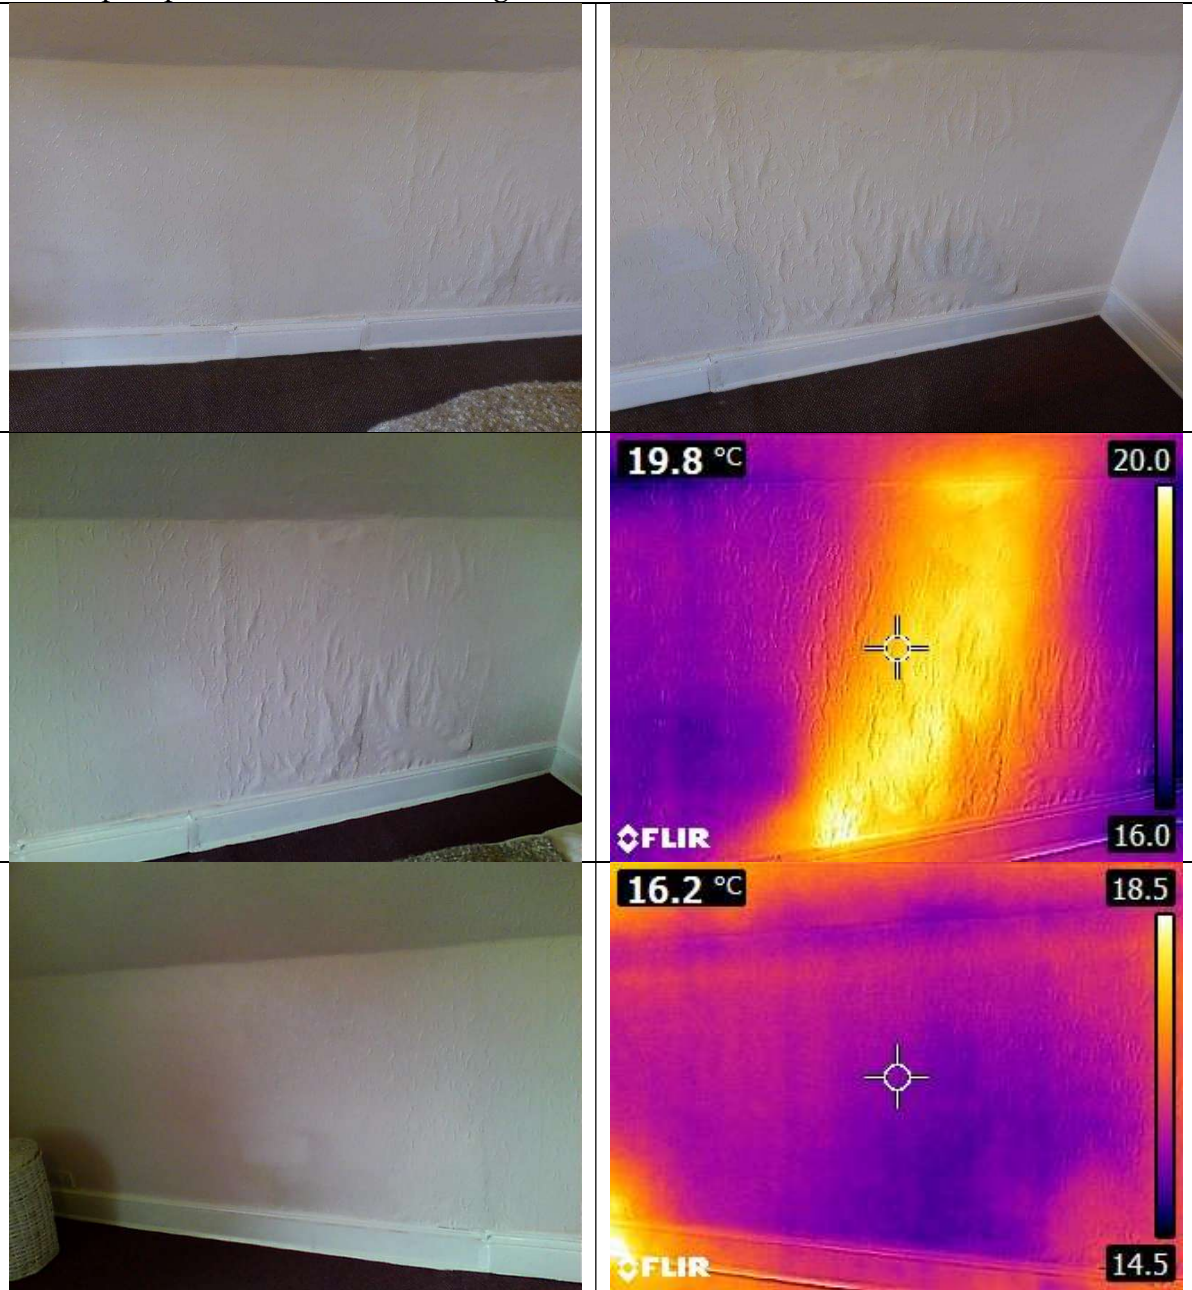
There is some damage to the decoration in the rear left-hand second floor room. It is hard to determine what is going on here due to the bleed from the AGA flue. At worst this is likely to be a defective piece of lead flashing/back gutter on the chimney stack above. An external close-up inspection should be able to get to the bottom of this.

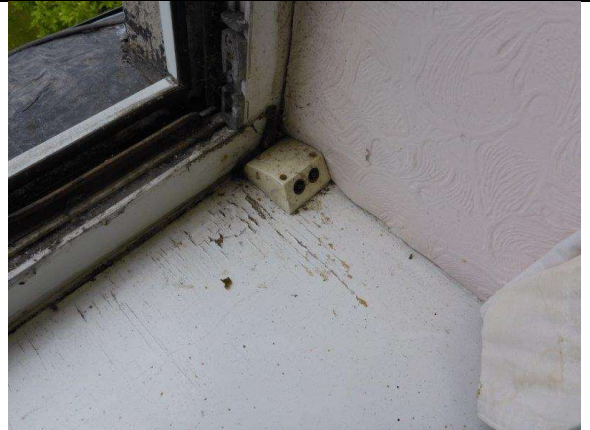
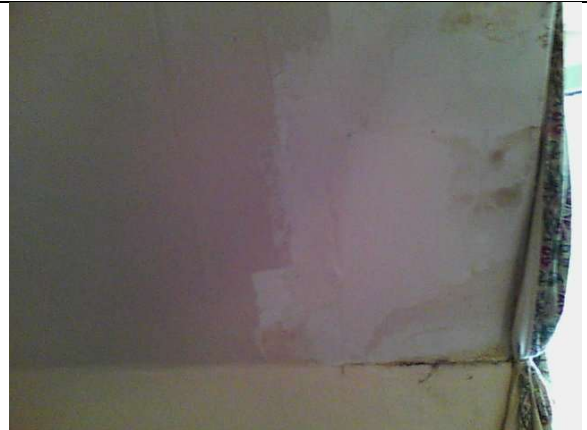
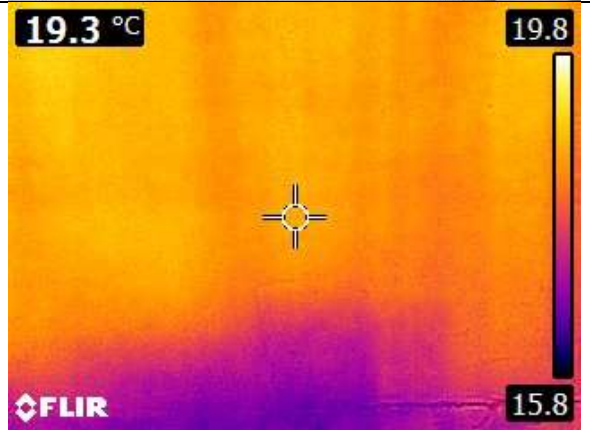
There is water ingress around the window in this room too. As noted in sections 5.1.1 and 5.3.1, there are defects with the lead dressing and window detail that need to be addressed.

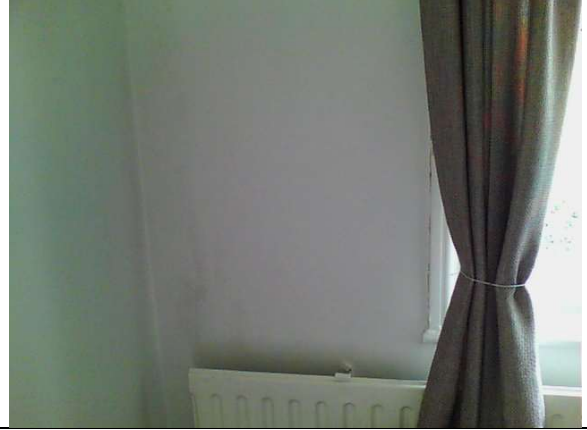
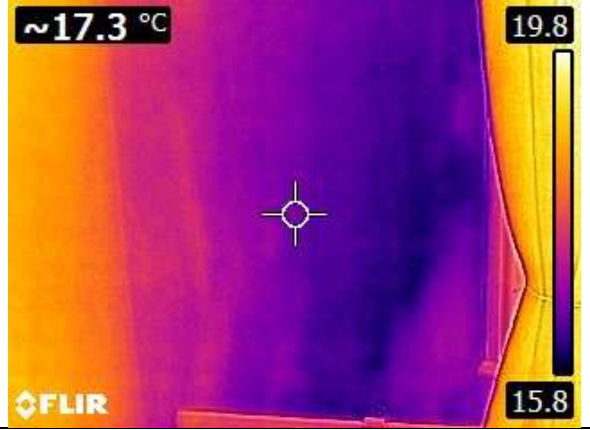
There is an area of light staining on the exterior wall in the dressing room. Externally, there is a fall pipe in this area that may be cracked (due to vegetation, we could not inspect up close). We recommend they are observed during heavy rain and any cracks repaired or the pipes replaced.

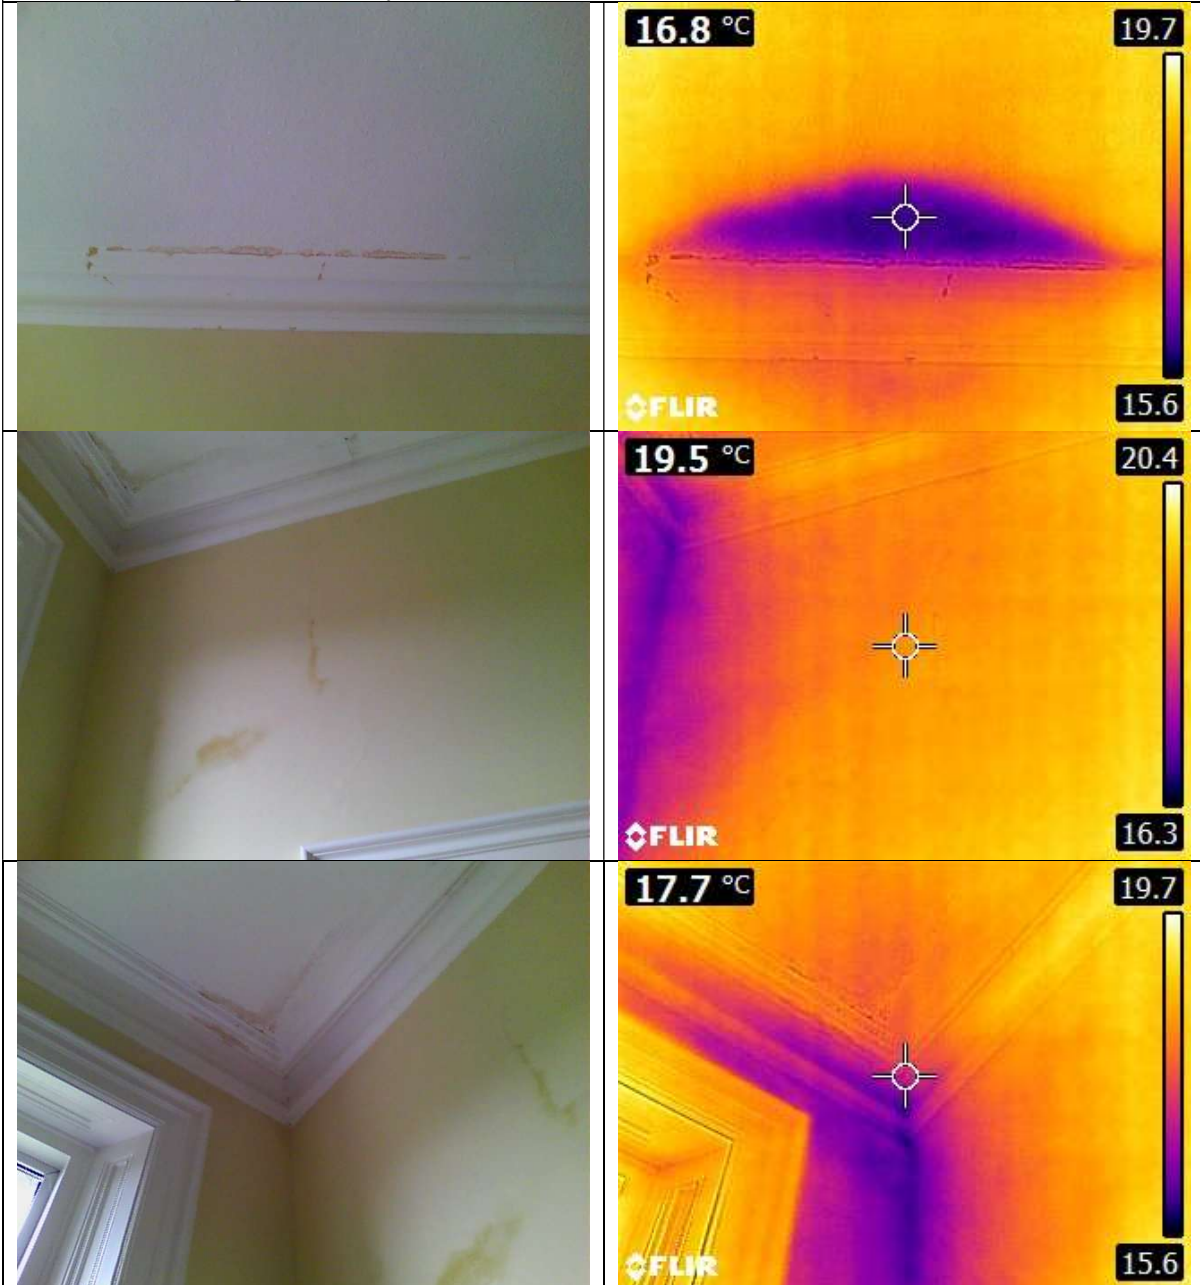
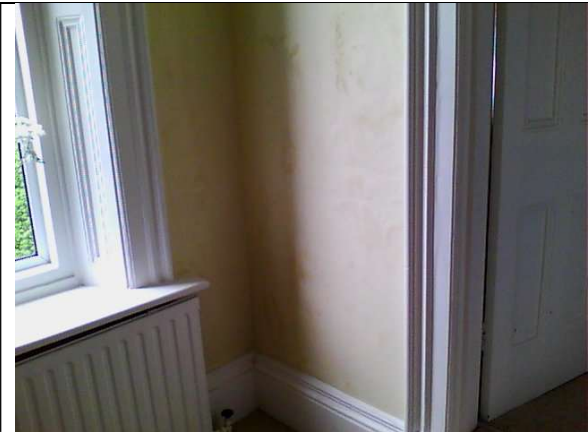
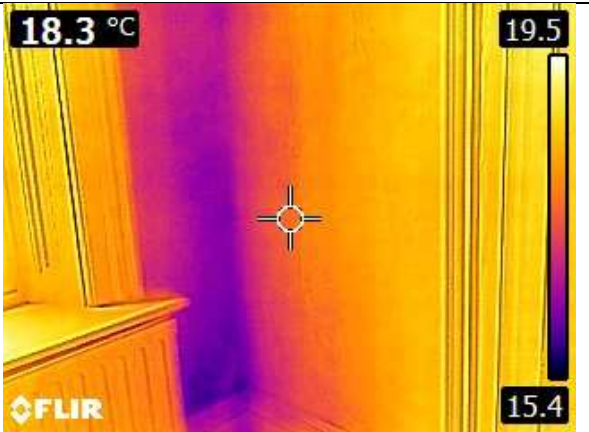
On the main staircase next to the abovementioned area in the dressing room, there is also some staining on the walls and the abutting ceiling. These may not be related as the walls look to have dried out but there is still a cooler spot on the ceiling. This could be as a result of the weep on the cold water storage tank perhaps? Due to the amount of mineral wool on the floor of the tank room, we could not access the area above. We recommend that the area is further investigated when you move in.

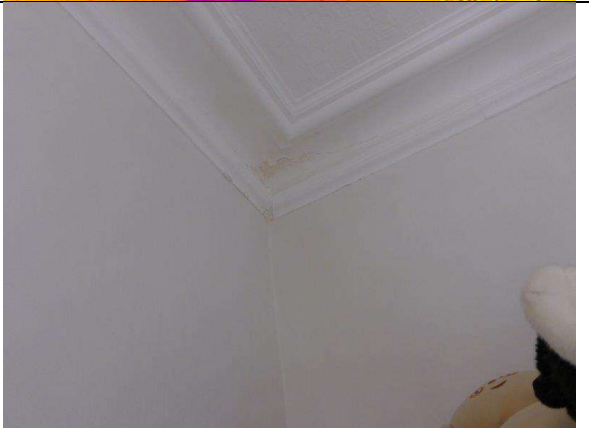
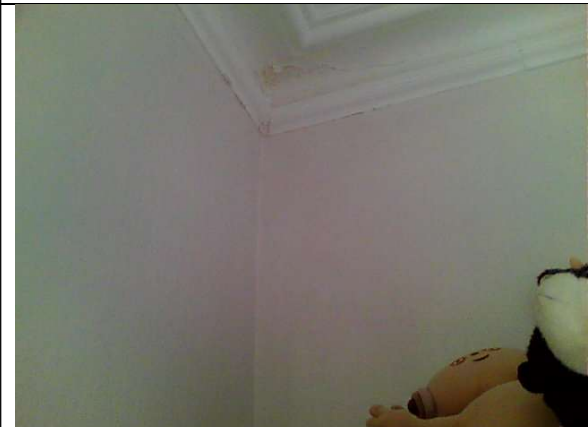
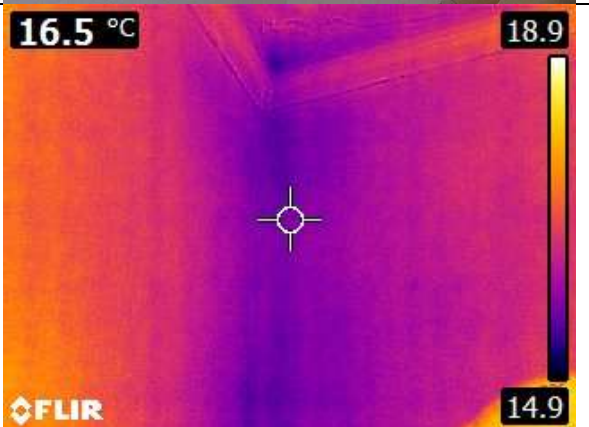
Bedroom three – there is a small stain on the front left-hand corner of the room. We examined the area with the thermal imaging camera but did not pick up anything untoward (it is normal for the internal corners of the room to be cooler than the centre of walls, as shown here in the photos below).

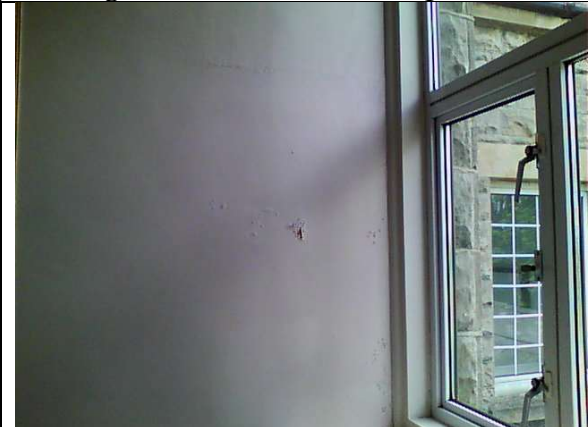
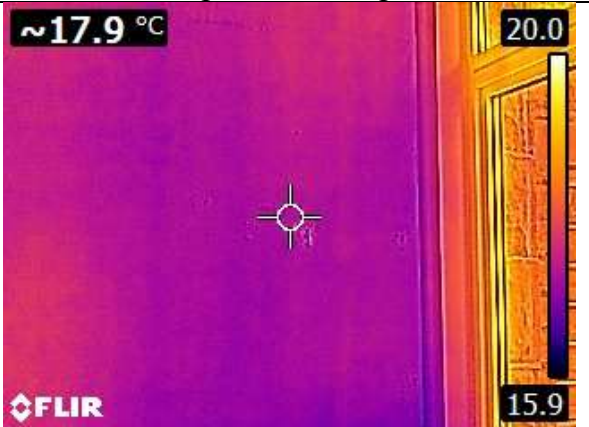
There was some minor blistering on the surface finishes in the Jack and Jill bathroom. The thermal imaging did not pick anything up and this is likely to be from a little condensation forming combined with the temperamental nature of modern plastic-based paints.

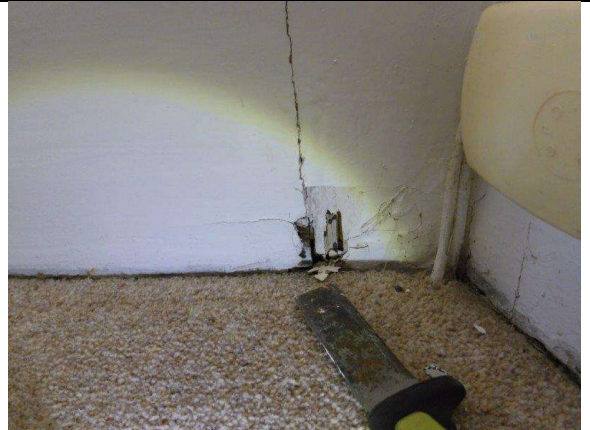
Underneath the side window in the dining room, there is some timber decay at the base of the wooden panel.

Despite trying, we could not get the carpet to pull back to examine the floorboards below.

The cellar below here is damp and there is timber decay to the floor structure underneath this area.

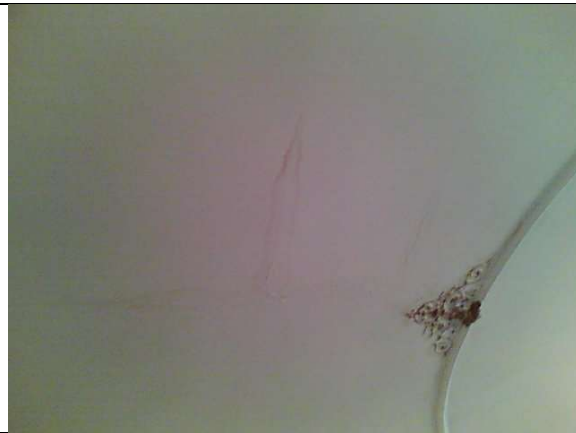
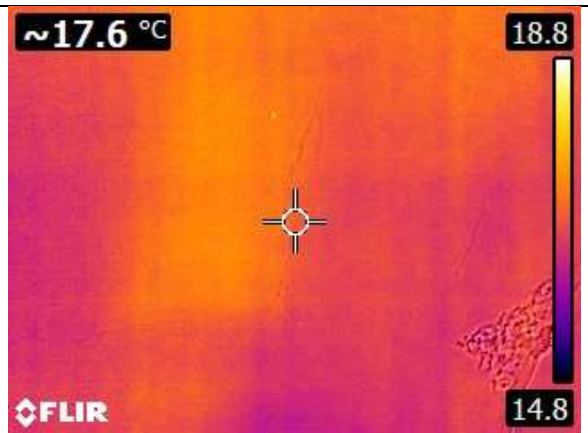
There is some light staining on the drawing room ceiling. Nothing is showing on the thermal imaging camera and this is likely to be from a historic leak in the Jack and Jill bathroom above.

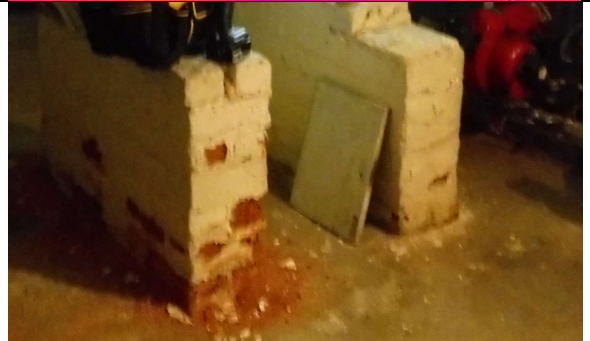
Some decay to the bricks in the boiler room. Likely as a result of ground moisture being driven up them as it cannot permeate the floor slab. This moisture is then getting trapped behind the modern paint and slowly decaying the bricks.

The pier with the most damage does not appear to be serving a purpose so could be removed. We recommend removing the paint of the other pier to aid evaporation.

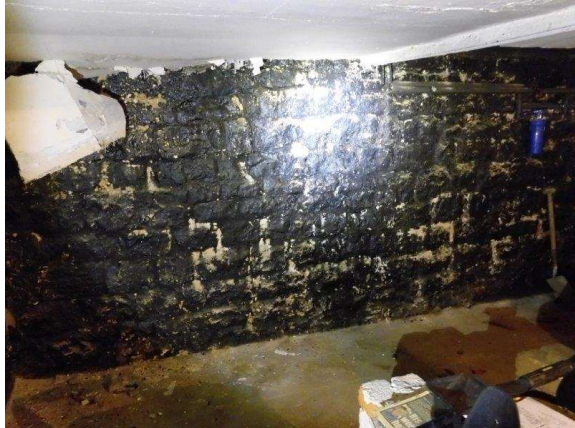
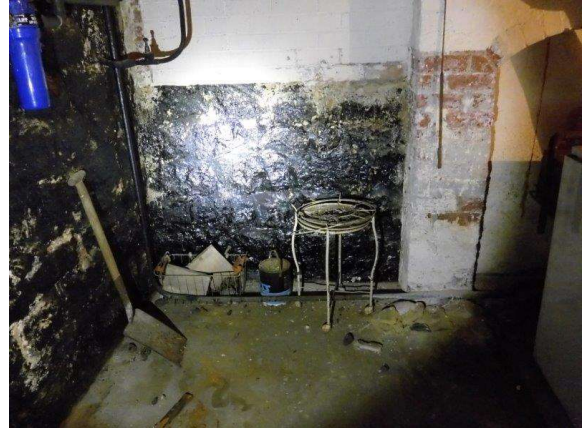
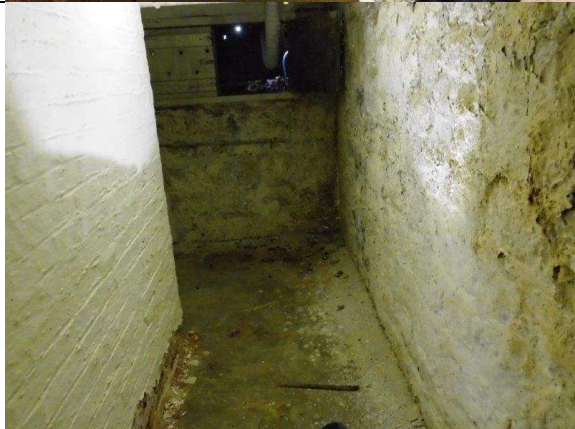
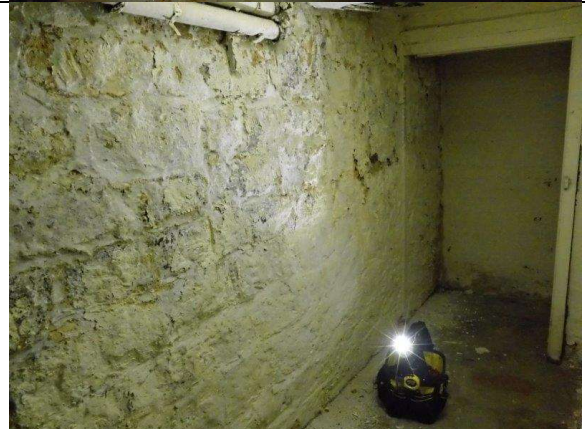
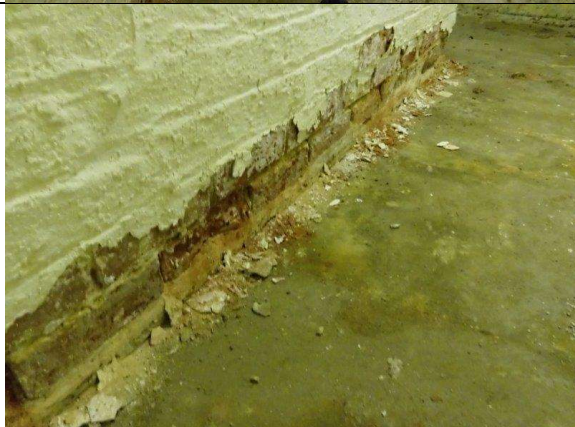
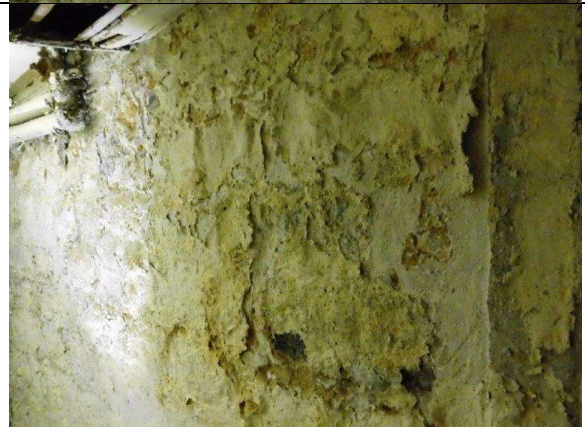
Boiler room and adjoining cellar room – bitumen and plastic-based paints will trap moisture against the stonework and eventually cause it to start decaying. We recommend plans are made for its removal with a specialist DOFF or TORK machine.

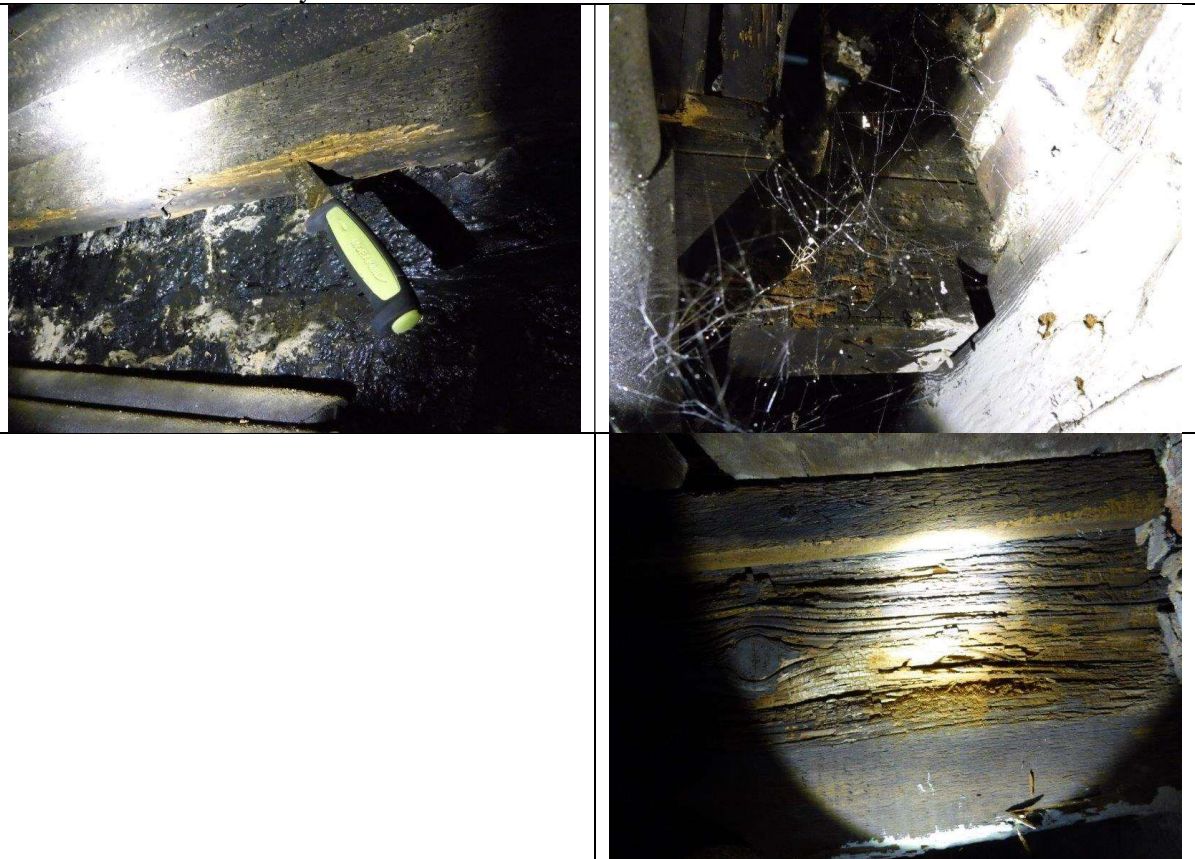
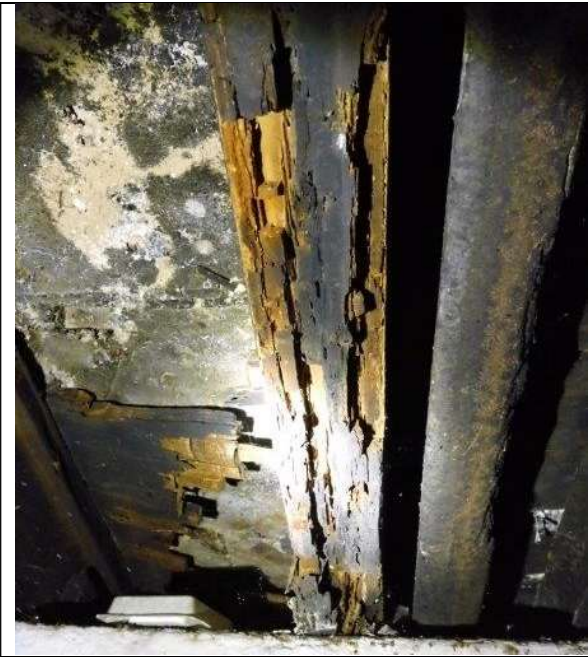
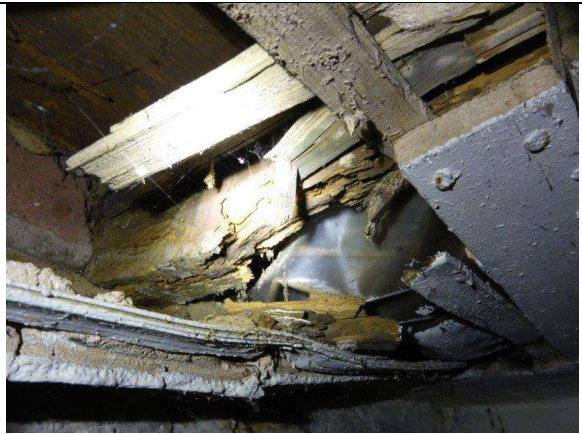
Boiler room and adjoining cellar – the exposed timbers are black, likely soot-stained presumably from old coal-fired boilers/fires?

This soot staining is hiding lots of areas of timber decay. Part of the ceiling in the boiler room and the ceiling in the adjoining room are both underdrawn so we cannot see the full extent of this decay. Further, the floors above are all tiled so we cannot properly check for deflection.

The decay has been caused as there is virtually no ventilation to the areas now the flue is not being used. This needs permanently addressing as a priority to prevent the situation from getting any worse.

We have included some photos of the timber decay below, however, this should not be considered a full survey of all the timbers in this area.

Once adequate ventilation has been installed, serious consideration should be given to removing the underdrawing (lath and plaster) so that the timbers can be properly examined and a plan made for replacing timbers that are no longer structurally sound or that would cause the floor to drop. Subject to the extent of the decay and your plans for the rooms above, it may be more economical to consider replacing the floors. There is no point in doing any works of this nature until the ventilation issue is addressed.

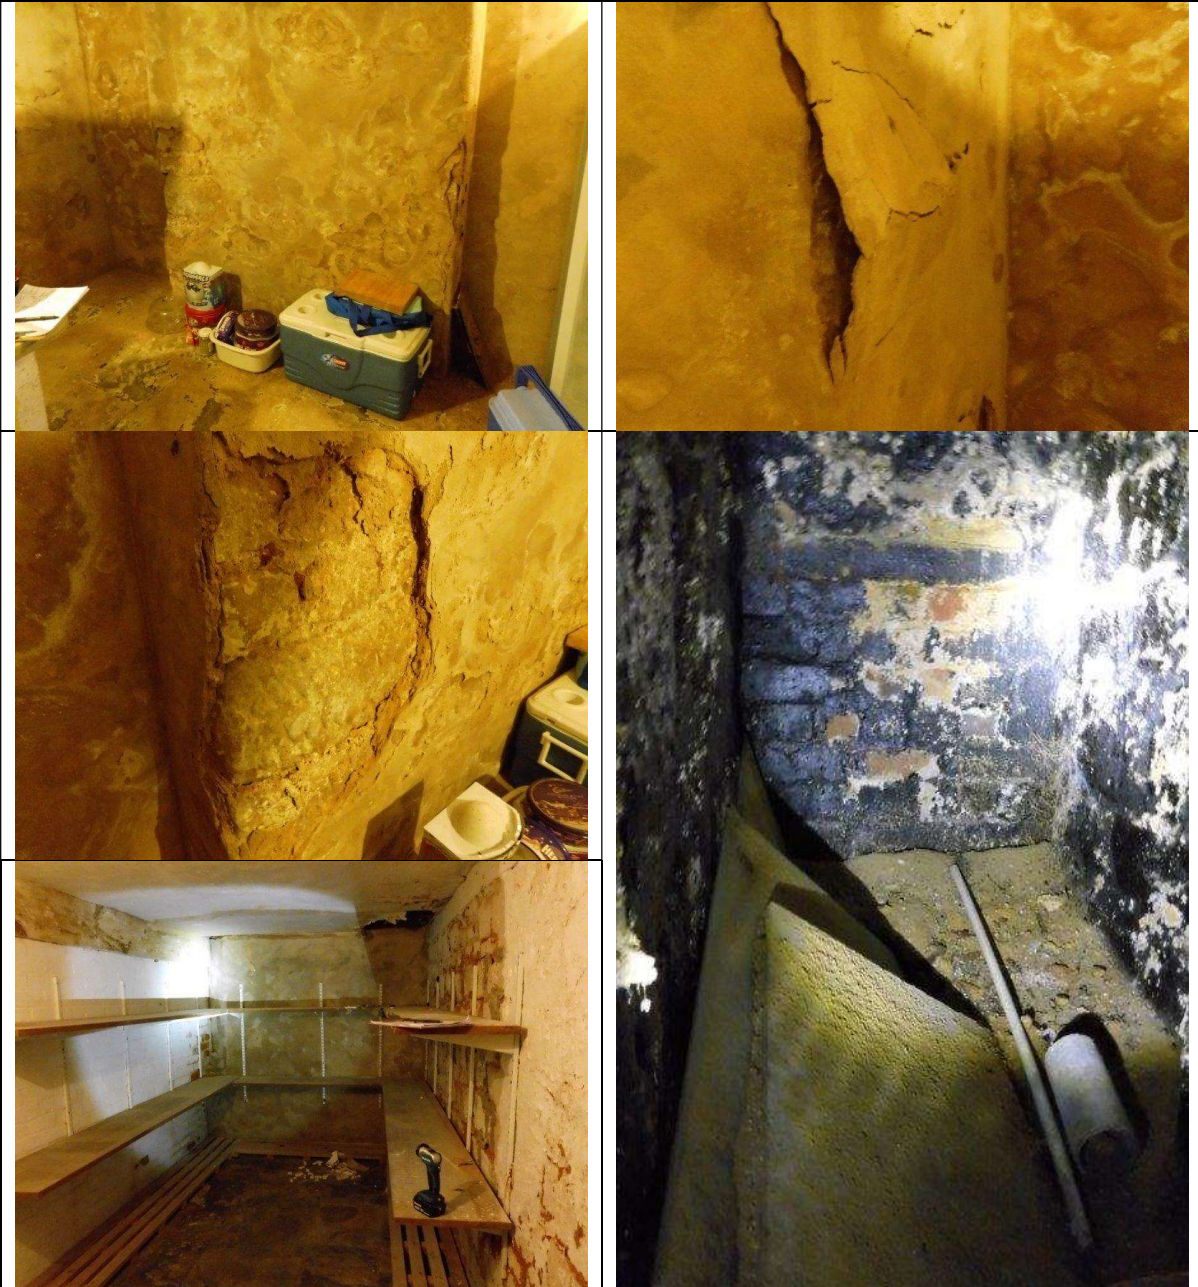
As with the rear cellar, the front cellar is lacking in any ventilation. To compound this problem, areas of masonry have been rendered with an impermeable mix, likely to be cement-based. This is trapping moisture against the stonework and causing it to spall and decay in areas. The render is also being blown off the walls by moisture and salts. We recommend that all the render and paint is removed from the walls and they are allowed to dry out in their own time once the ventilation to the sub-floor area has been improved. During this time, further investigation into the timber decay can be undertaken and a plan formed for remedial works. The bricked-up door could also be investigated at this time.

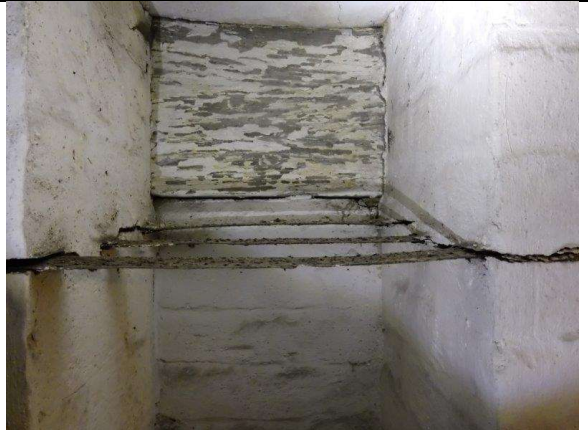
The cast/forged iron wine rack shelves need to be monitored. They are corroding and as they do, they will delaminate and expand which will start to jack the masonry around them.

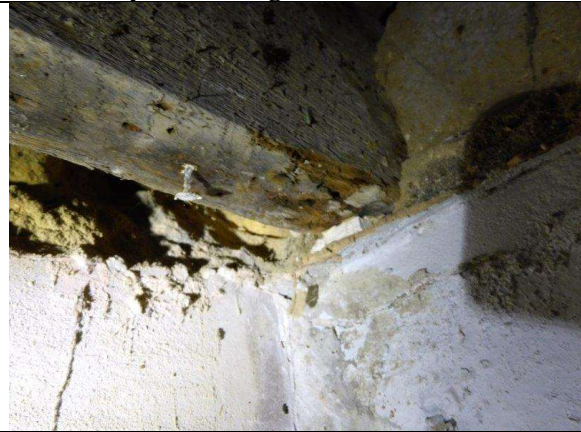
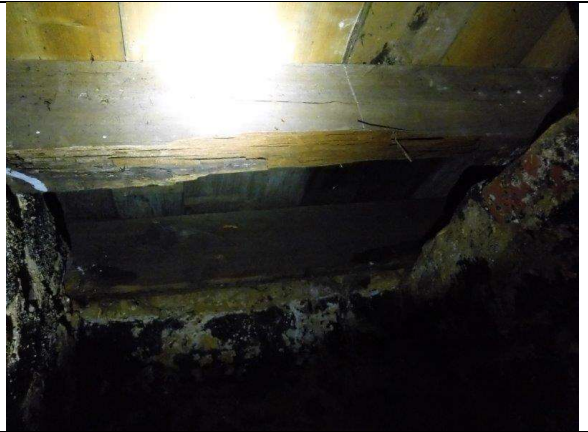
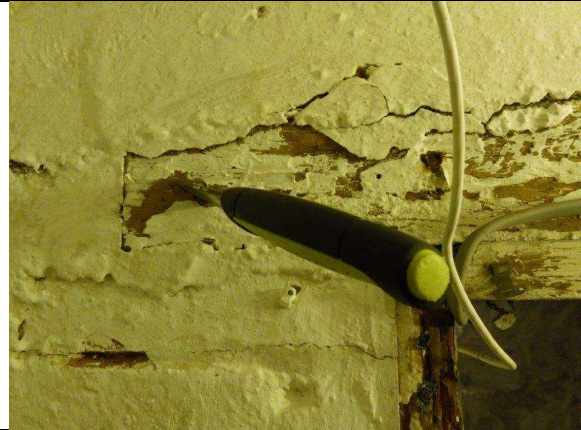
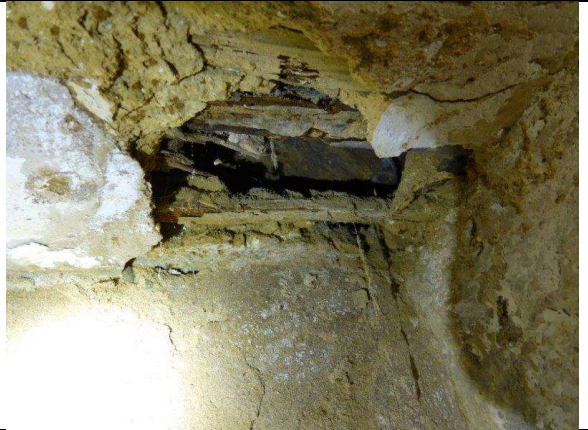
Whilst the main joist across the larger storeroom has managed to remain sound, various other timbers are feeling the moisture and have succumbed to decay and insect attack. Again, the underdrawing really needs to come down, the renders need to come off the walls and then an examination of the timbers needs to take place to see what is sound and what needs to be replaced/sistered. A plan for improving ventilation needs to be put together before any works begin.

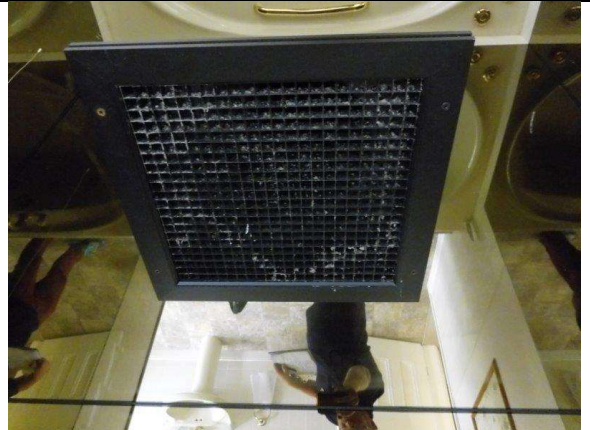
Extractor fan in the Jack and Jill bathroom.  
This looks like it needs a good clean out.

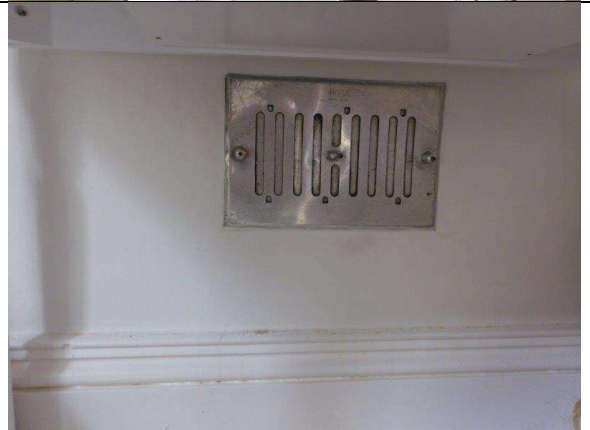
Hit and miss vent in the chimney breast in bedroom three.

The atmospheric conditions in the flue were:

Relative Humidity: 52.8 %

Absolute Humidity: 8.41 g/m<sup>3</sup>

We consider these to be acceptable bearing in mind the external conditions.

This was closed at the time of our inspection; it should be kept open to vent the flue and the room.

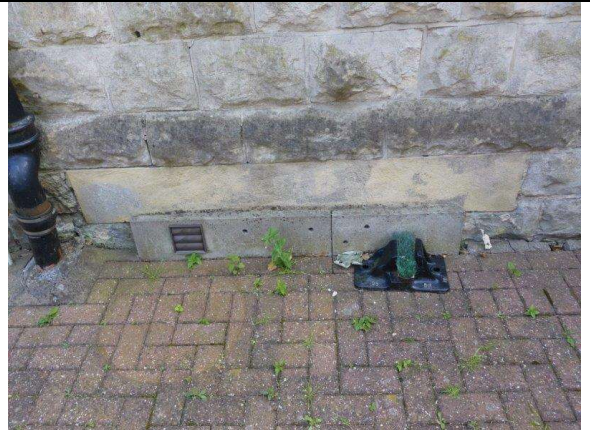
There was likely a door/window into the rear cellar, which has since been filled in. The plastic vent is for the dryer in the laundry room above.

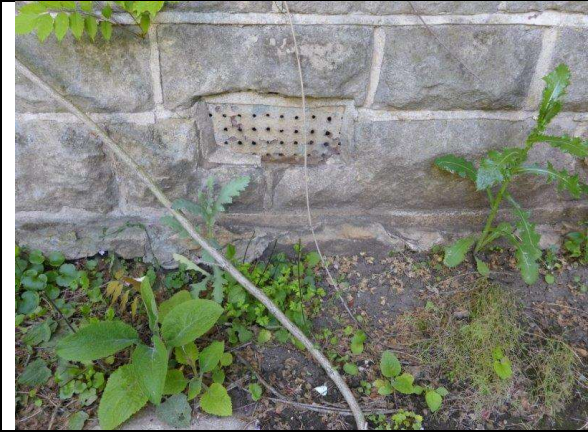
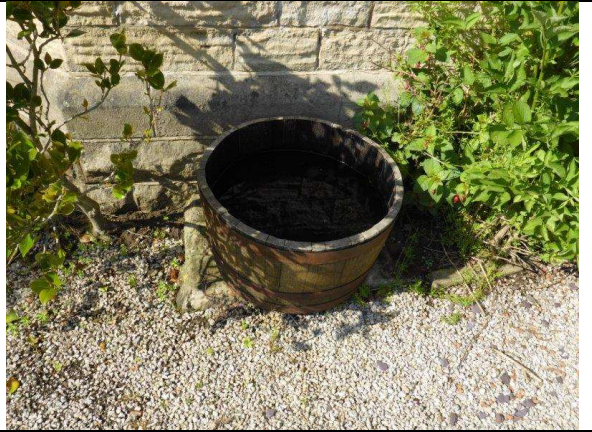
Below, there is one subfloor vent in the right-hand elevation. We think there is a vent in the front elevation under this planter. It is likely providing no ventilation in its current set-up. There may be other vents under the vegetation, but these are likely blocked.

Sub-floor – As detailed above, we could only find one sub-floor vent in use on the right-hand side of the property. Vegetation may be blocking others. This is wholly inadequate and urgently needs addressing.

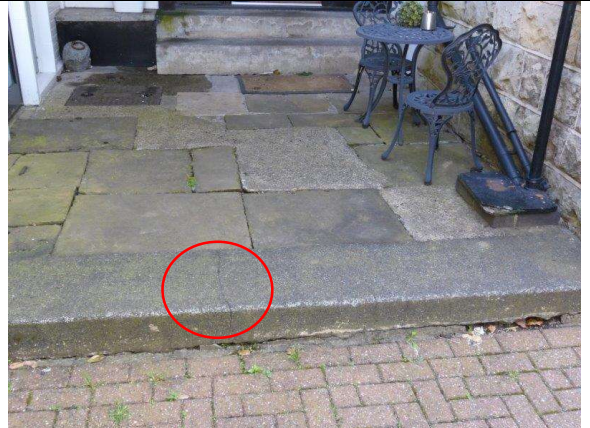
Various parts of the rear step area have been previously dug up and infilled with concrete.

There is also a crack in the step (red circle).

As detailed above, we recommend a drainage inspection to include this area.

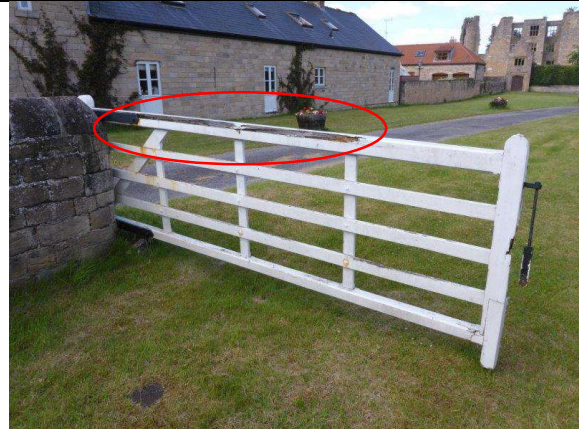
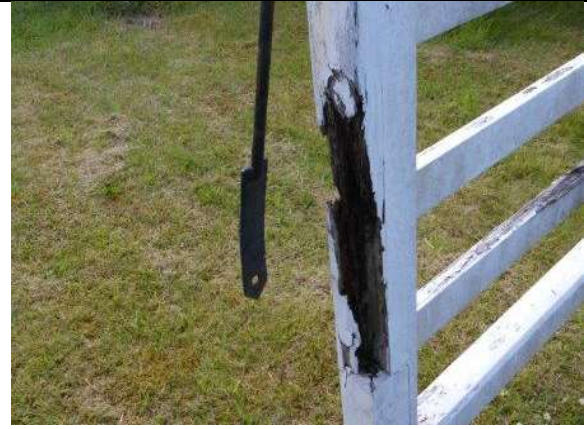
Below are photographs of the front gate. There are areas of timber decay that should be repaired as soon as possible.

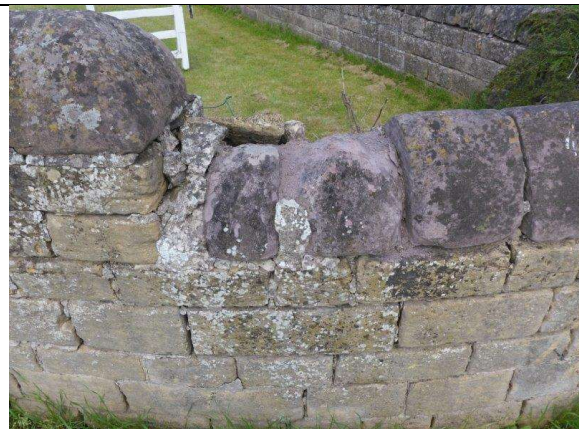
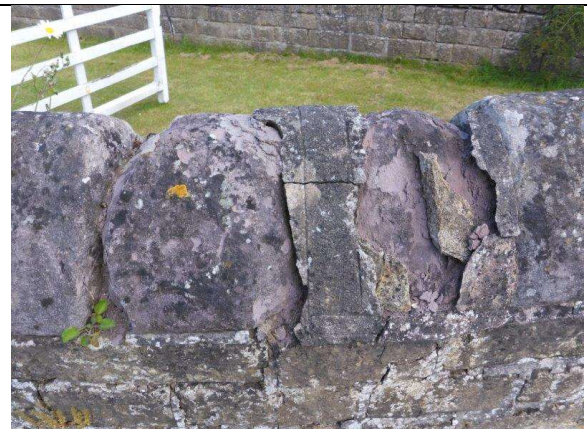
A very hard, likely cementitious mortar has been used to repair some sections of the wall. This is causing the stone to decay and should be removed as soon as possible and replaced with a hot lime-based mortar.

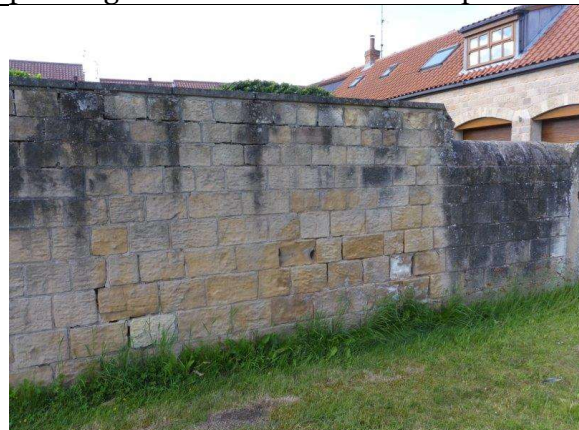
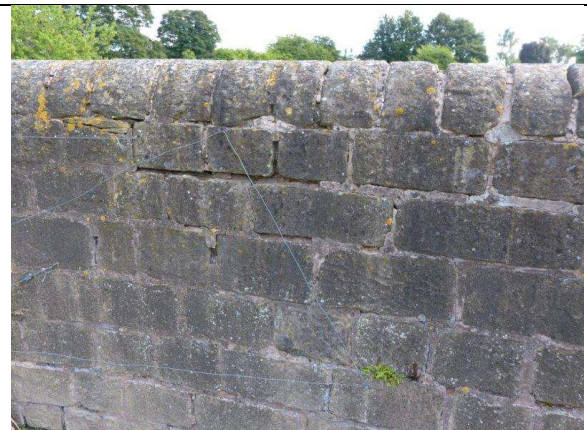
Some areas of the side walls going along the drive have missing pointing. Cementitious pointing should be removed and replaced with a hot lime-based mix.

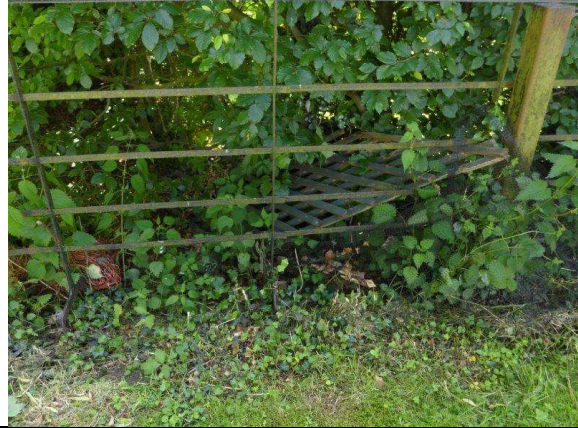
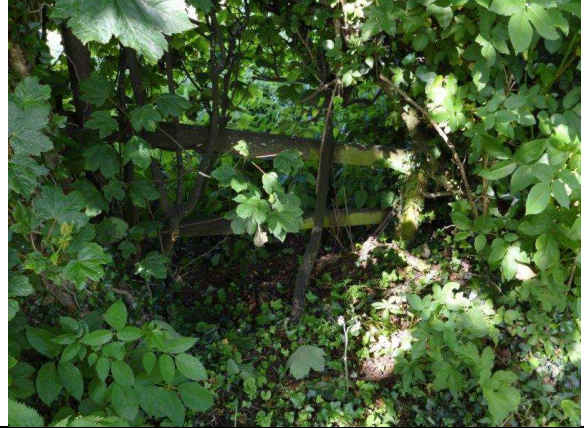
Some fencing that runs along the drive is in a poor state of repair. Some sections will need replacing and others cleaning up and repainting.

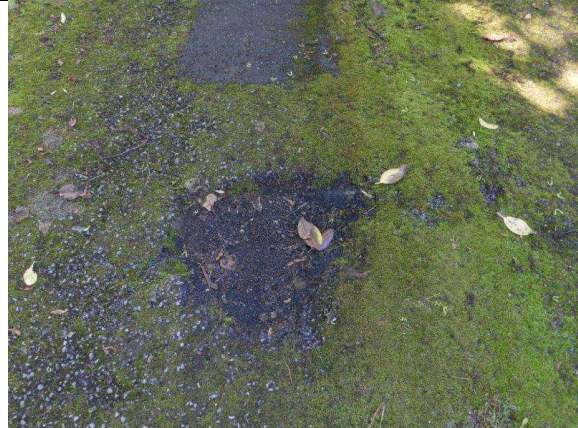
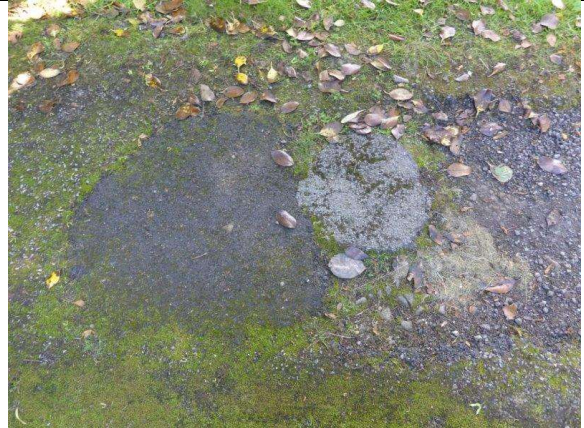
The surface is in relatively good condition in comparison to a lot of properties we see. Some minor potholes should be dealt with as soon as possible to prevent them from getting worse. This process will likely be ongoing.

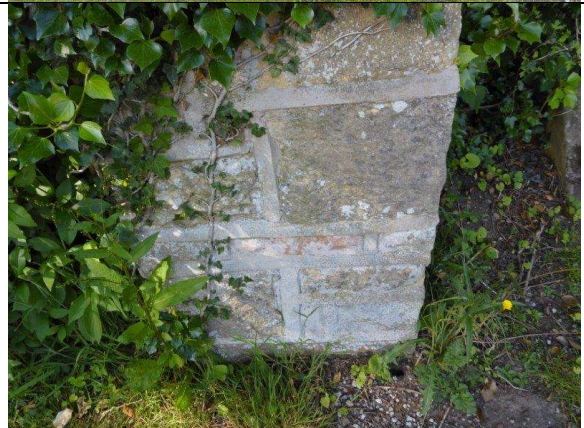
The gate posts at the house end of the drive have been pointed in hard, likely cementitious pointing. You should plan to remove this and replace it with a hot lime-based mix in the next couple of years.
