## **Historic Building Survey**

**Thorpe Salvin**

**FOR AND BEHALF OF  
Simon Hollis Limited  
30<sup>th</sup> June 2021**

## Building Survey Report

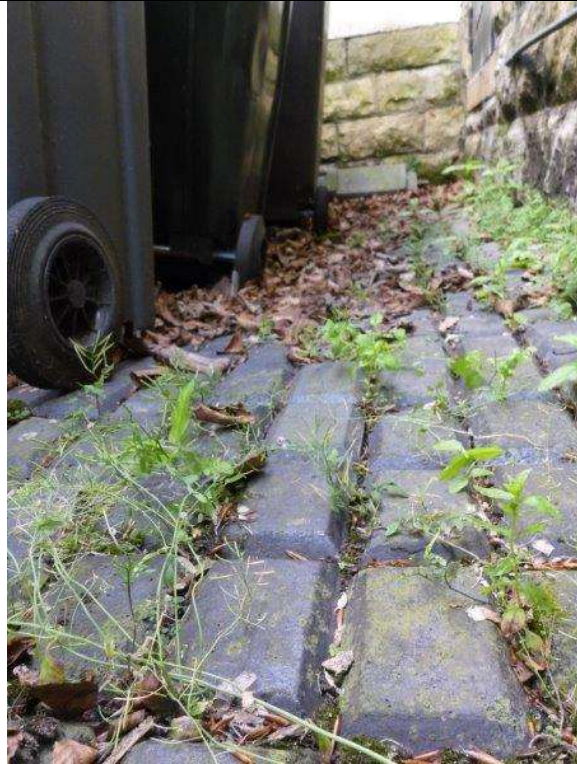
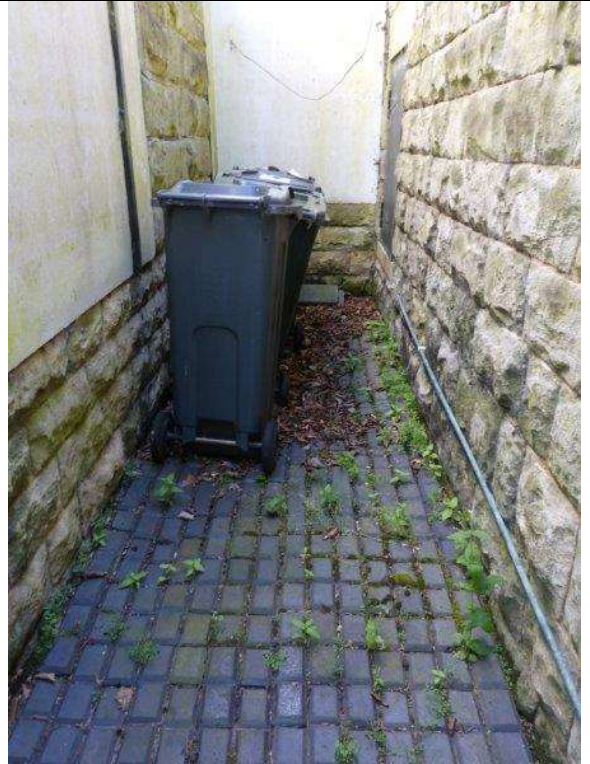
The pathway to the rear of the garages/games room sinks a lot in places. This may be down to a problem with the drains. We recommend that a drainage survey is undertaken to see if there is a drain in this area and if so if it is still functioning correctly. If it has collapsed, some excavation works may be necessary.

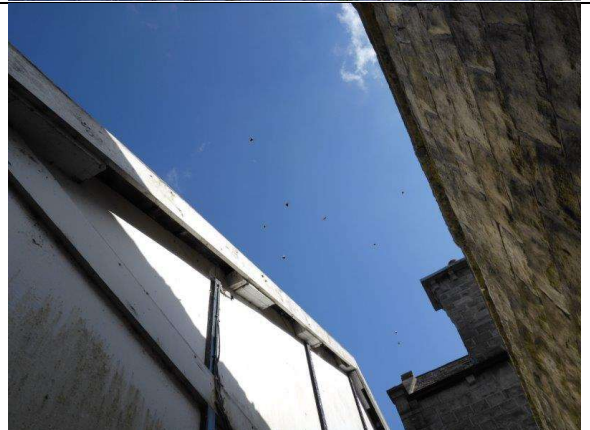
The games room is not part of this instruction; however, we feel it prudent to advise you that there appears to be a sizable bee's nest present.

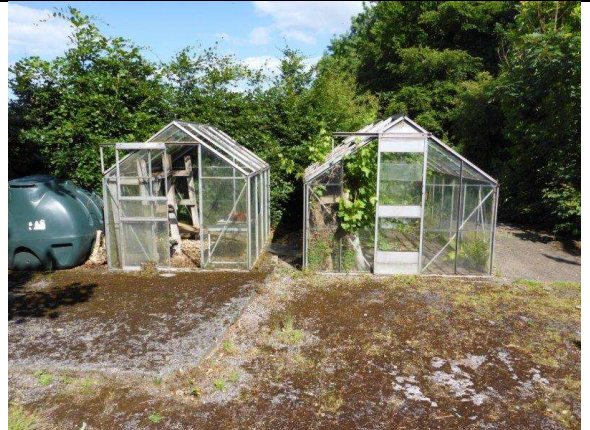
The greenhouses are dilapidated and present a danger to children.

We recommend that the area is cordoned off as soon as possible.

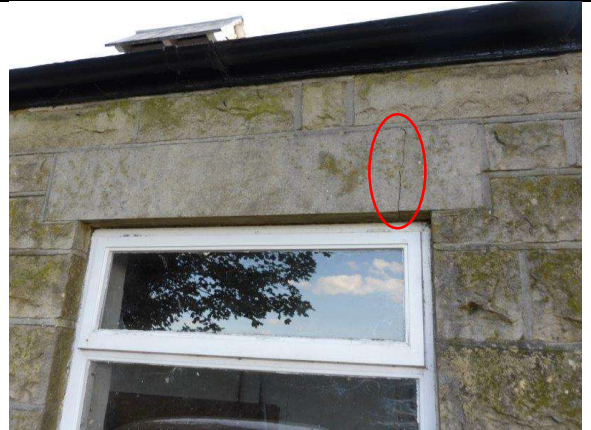
There are a couple of hairline cracks in the rear garage walls – these should be recorded, repaired, and monitored.

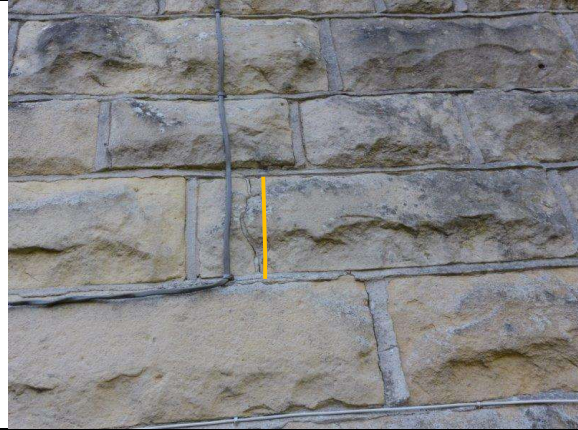
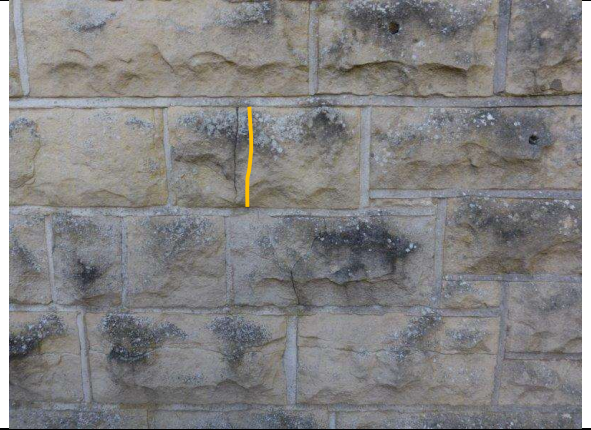
Coal hole – rear door – we cannot determine whether this fine line is a hairline crack or not – we kept being attacked by bees when we were in the area.

We recommend monitoring in the short term.

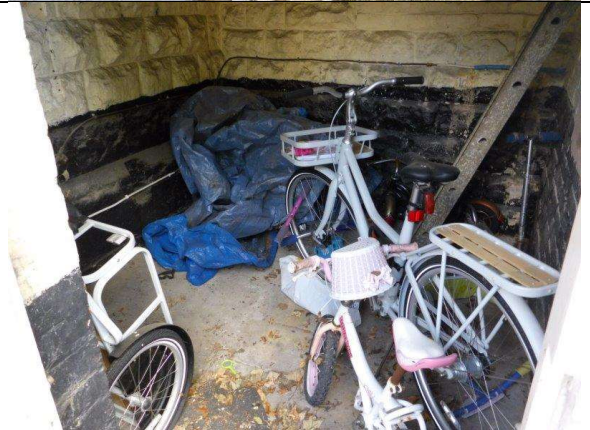
There is an extraction outlet and a vent into the kitchen in the stable closest to the house. This may not be the best idea when there are propane tanks in the room, although in theory, the gas should sink to the floor.

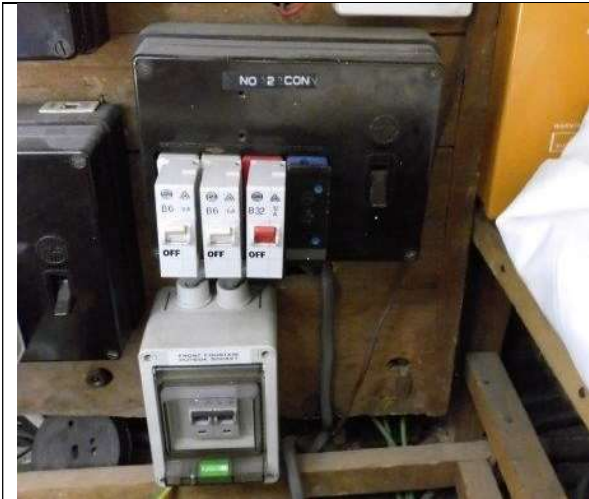
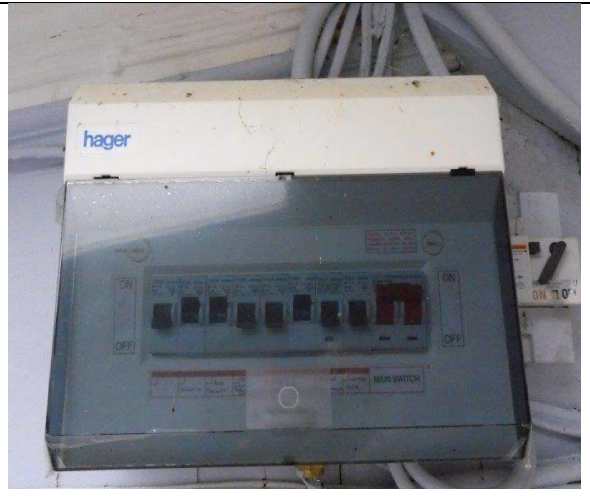
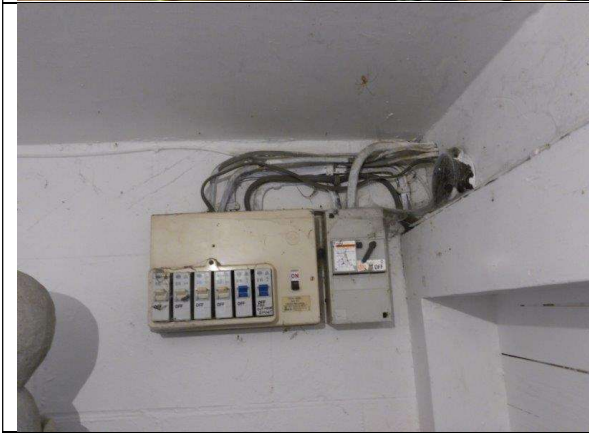
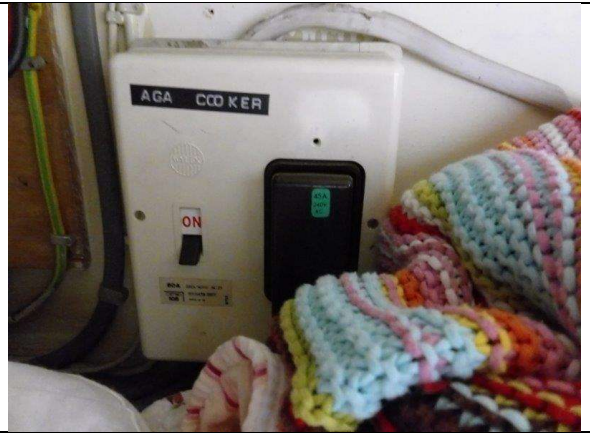
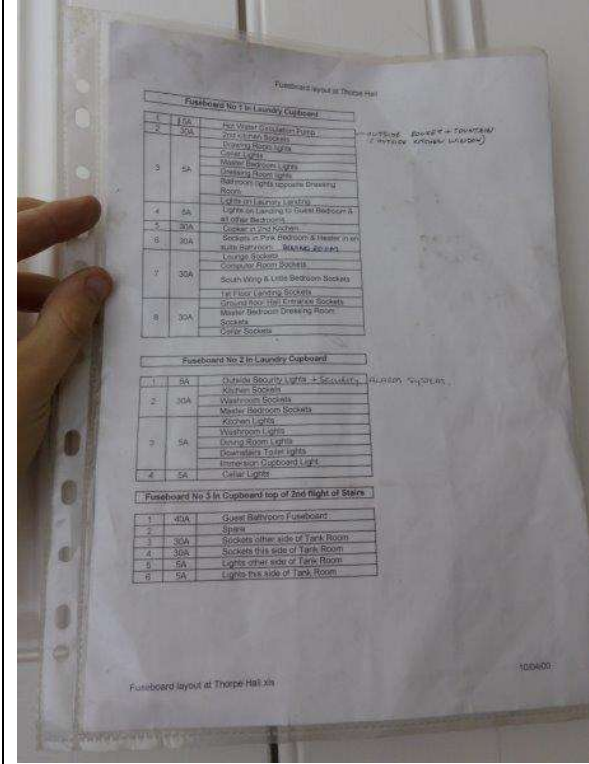
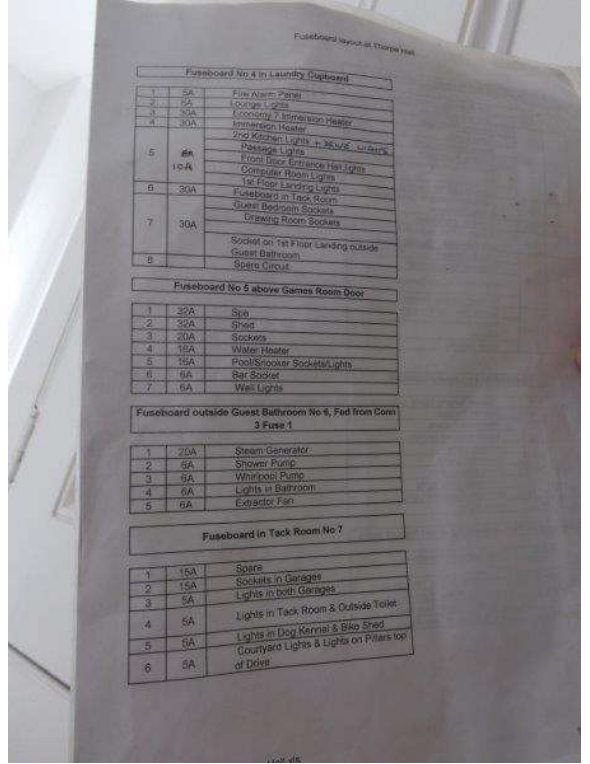
You have advised you plan to replace the electrics so we have not gone into detail on this. We have included photos of the various meters and distribution boards below. The main feed comes into the property on the first-floor rear landing.

We do not recommend using the outside of the property for running cables unless this absolutely cannot be avoided.

Cable penetrations need to be properly detailed, preferably with a conduit and cowl.

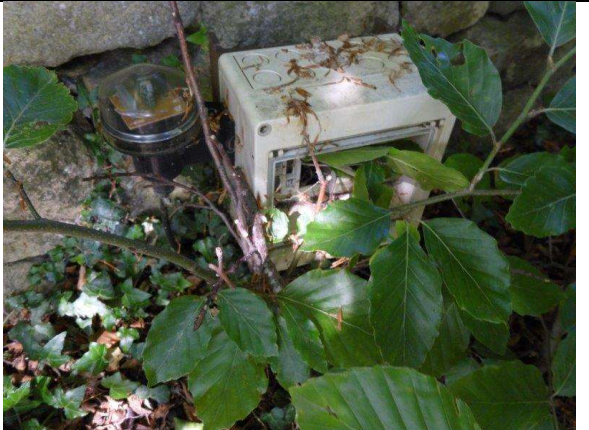
The distribution board in the garden – looks in a precarious condition.

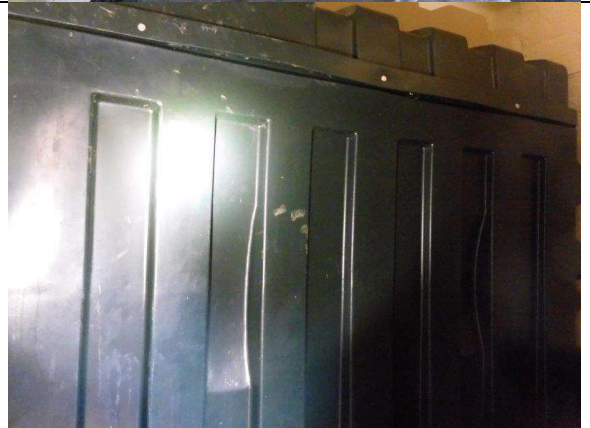
Substantial kerosene tank in the stables. This is obviously very close to the house and there is a small or kerosene in the air.

We recommend that this installation is inspected as soon as possible.

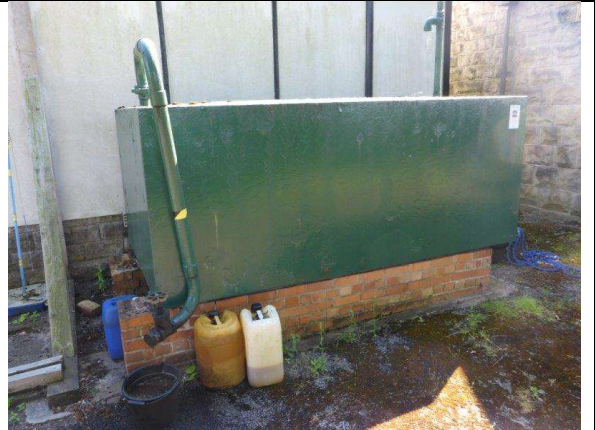
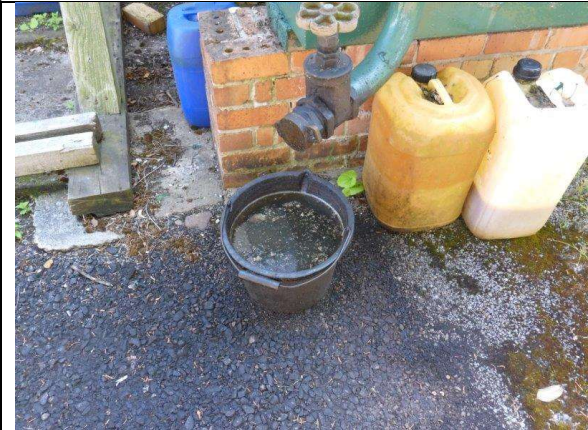
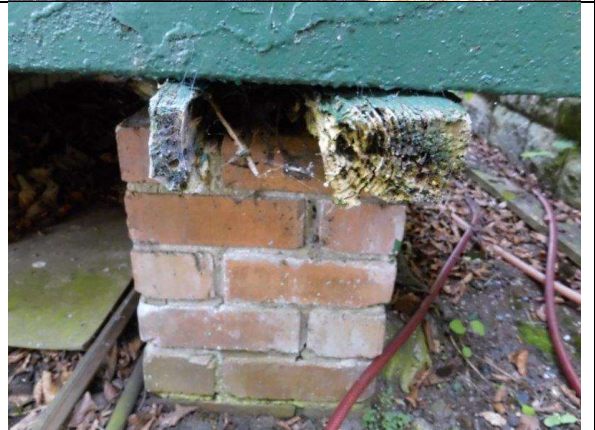
Heating oil tank behind the games room.

There is a bucket under the filling pipe to catch backflow. We are not experts in this area but this doesn't seem like the best system for doing this.

Also, note that the timber bales that the tank is sat on are decaying. Plans need to be made to address this as soon as possible.

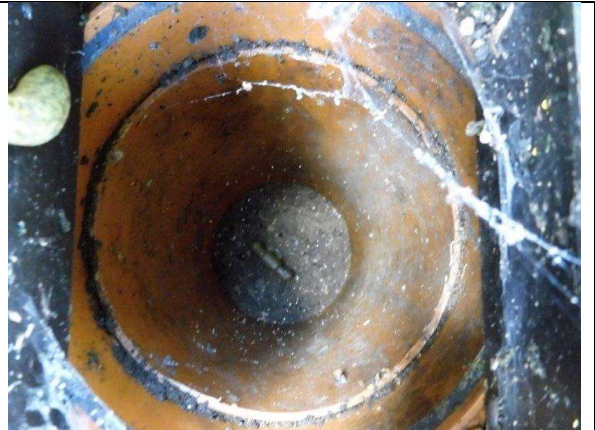
External stop tap located near the electricity pole.

Note that the insulation bung is missing.

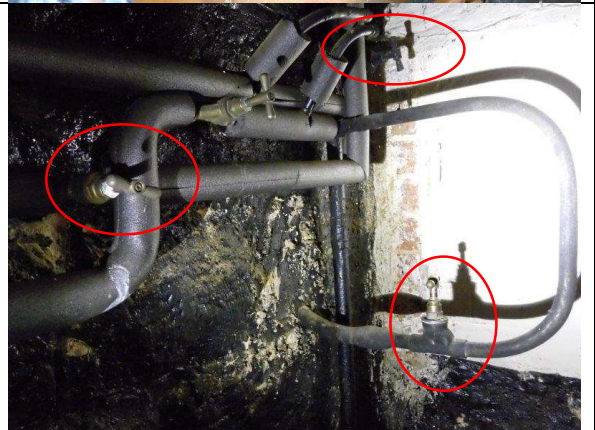
There are three stop taps in the boiler room. The water main is lead.

You should familiarise yourself with what each of these tap's controls so you know what to shut off in an emergency.

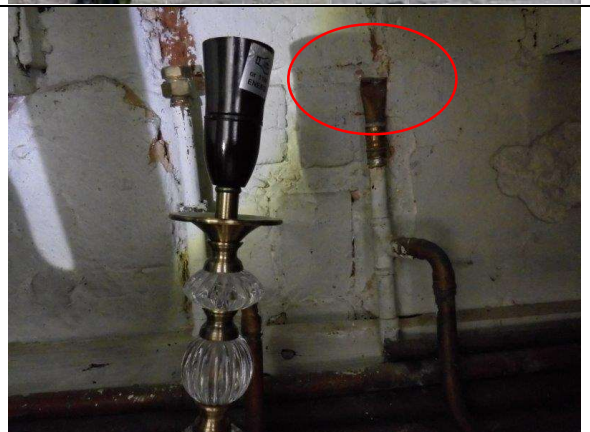
Underneath the sink on the rear of the first-floor landing, one of the supply pipes just looks to be crimped as opposed to capped off.

The pipe should be properly terminated.

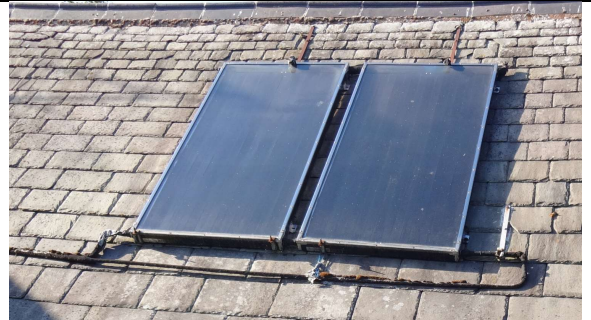
The vendor advised that the solar hot water system was no longer operational due to a leak caused by frost damage.

We could not access the roofspace below to see if the structure had been strengthened to take the additional weight of the panels and infrastructure.

If the panels will not be replaced, consideration should be given to removing them and their infrastructure from the roof.

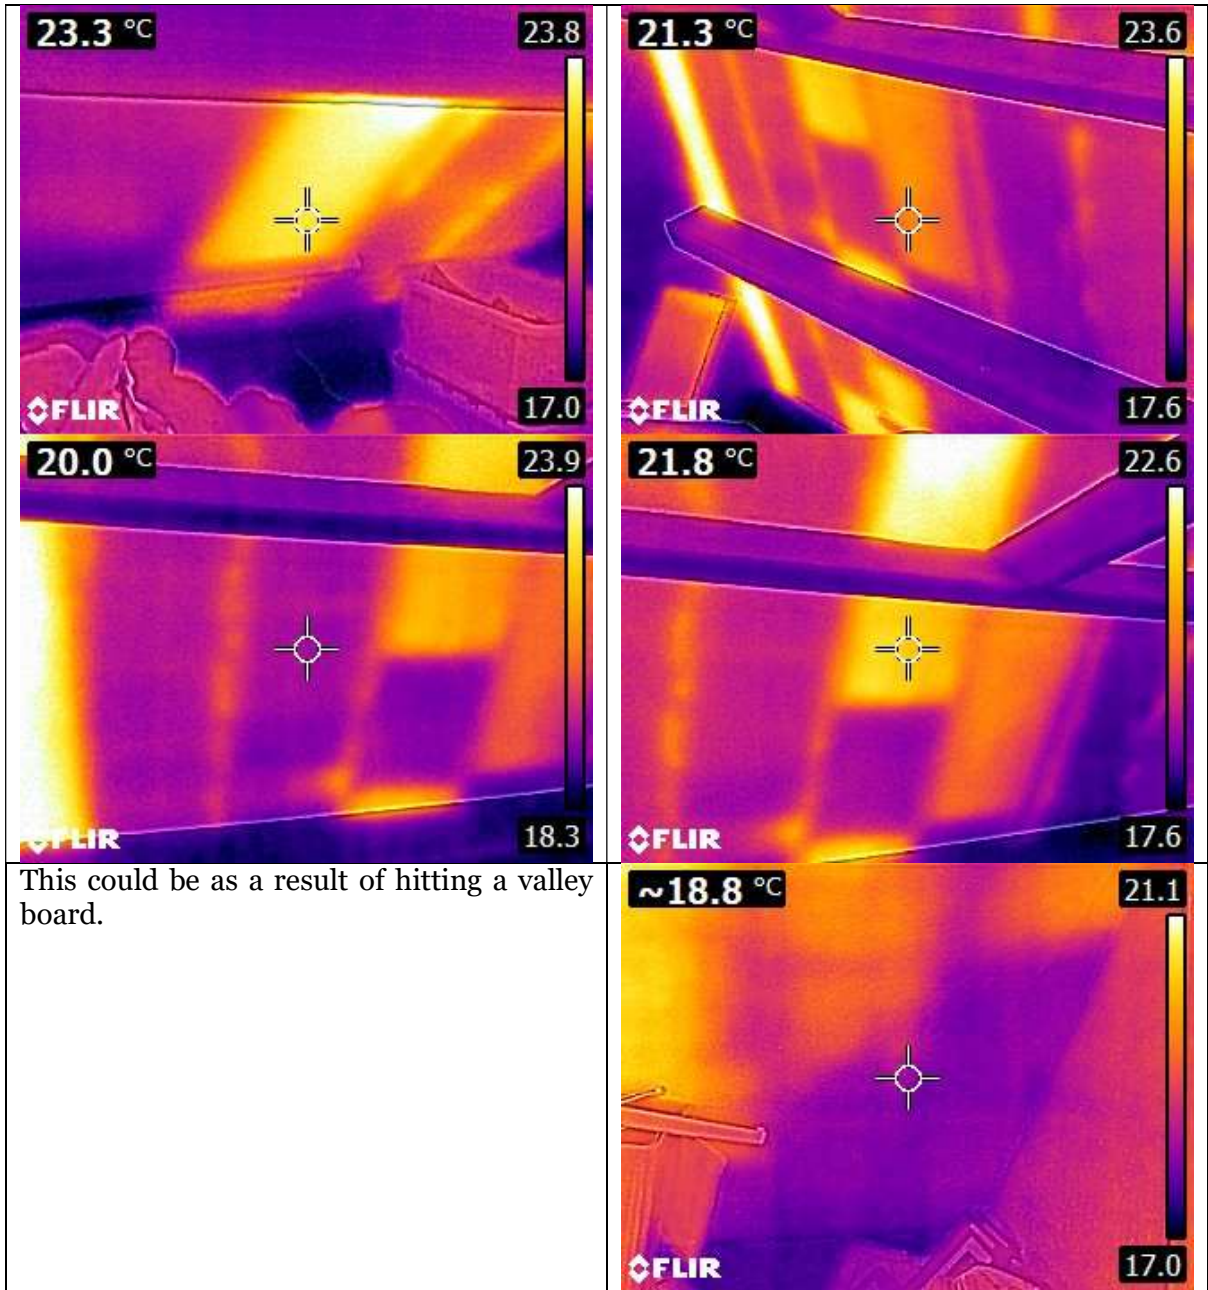
The vendor advised us that they have had parts of the roofspace insulated during their ownership. We have used a thermal imaging camera in places – note the inconsistency in some of the insulation installed in the photographs below. You should ask your legal advisor to obtain paperwork for this install in case there are any future problems i.e., insulation pushed up against timber, trapping moisture and causing decay.

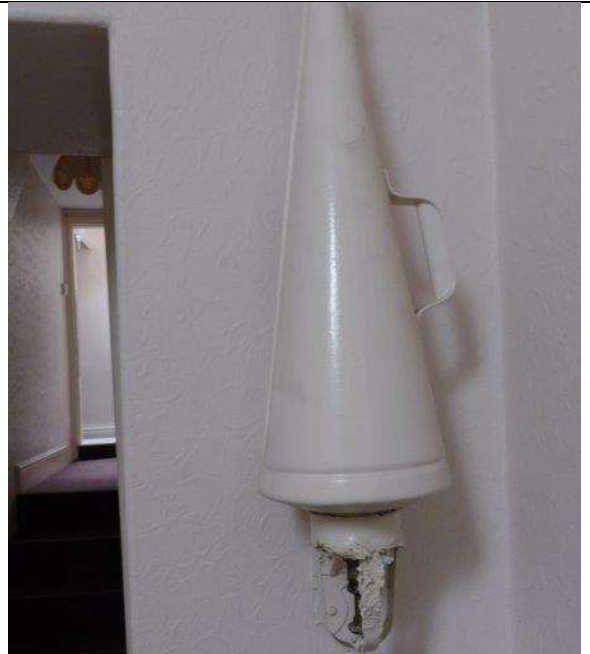
This is likely pressurised and may be dangerous if used.

It should be investigated further as it is outside of our area of expertise.

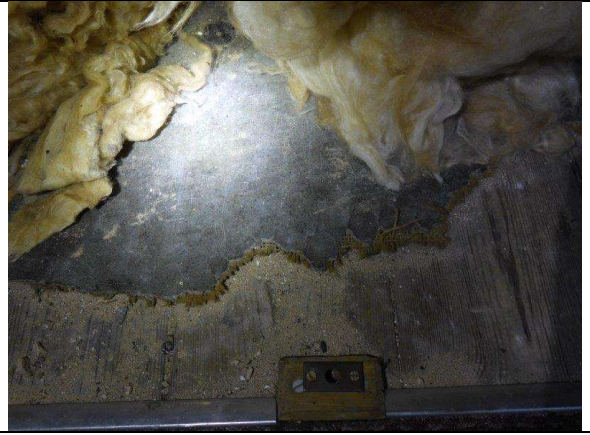
Possible asbestos in the tank room floor tiles.

This survey does not include an asbestos inspection and falls outside The Control of Asbestos Regulations 2012. Given the age of the building, asbestos may be present. A Refurbishment or Demolition survey should be undertaken before carrying out any repair or refurbishment work to the property.

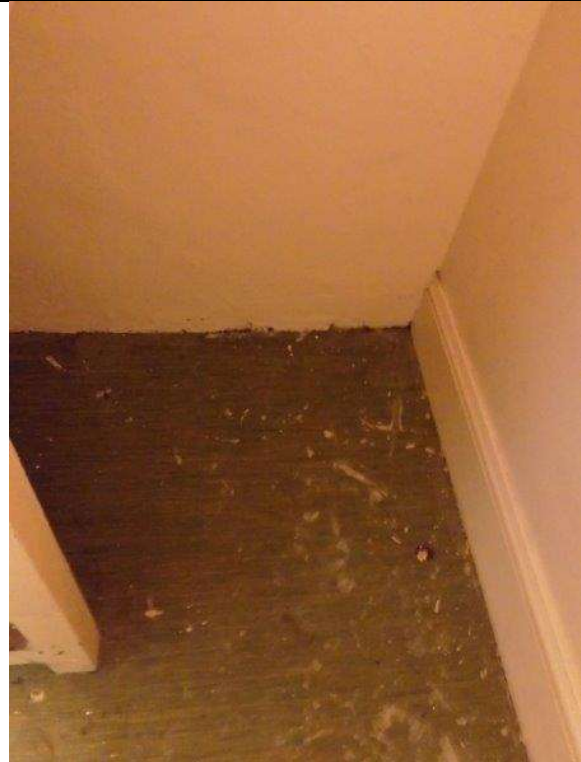
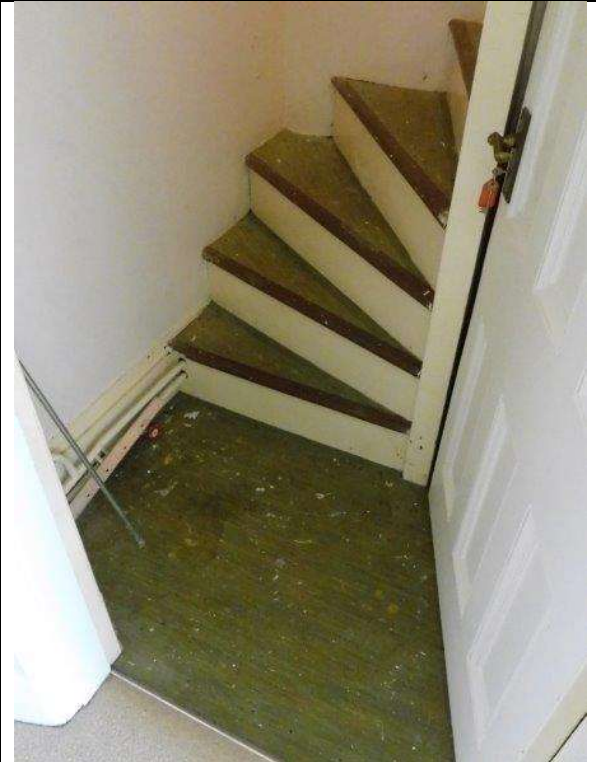
The floor tiles on the first to second-floor staircase at the front of the property may contain asbestos.

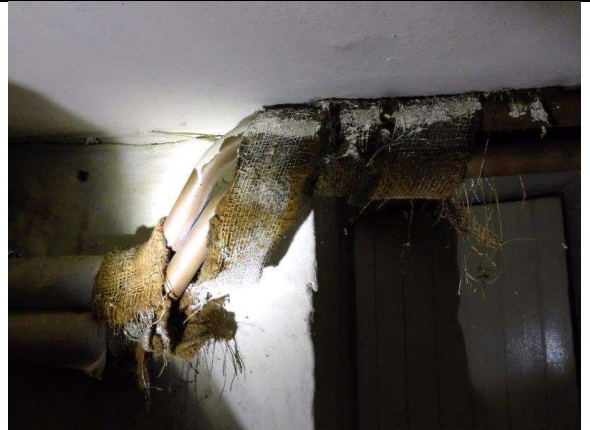
Pipe lagging in the boiler room possibly containing asbestos.

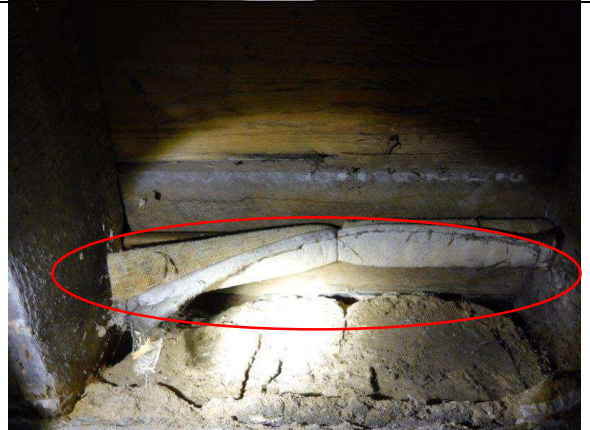
Possible asbestos lagging in the front right cellar.

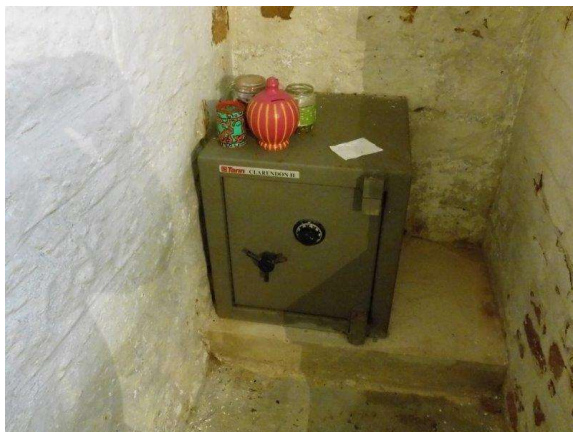
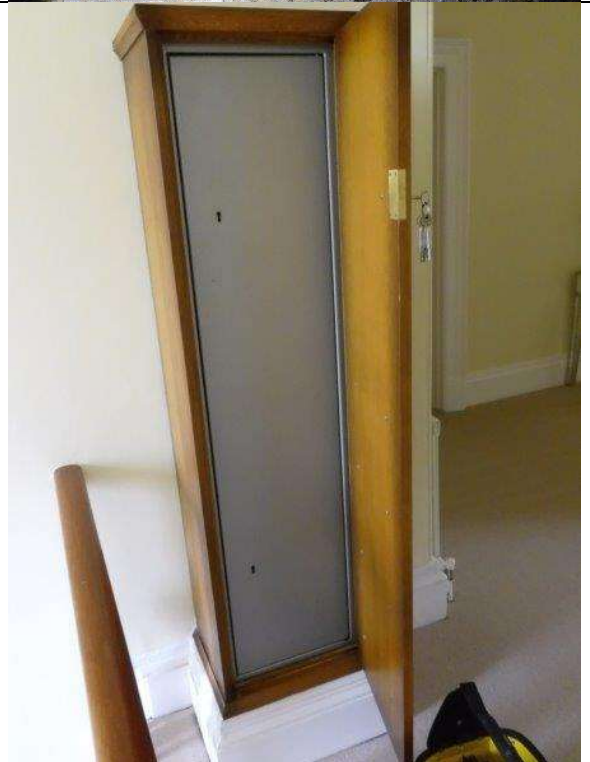
We noted two safes during our inspection. A gun safe built into the landing joinery and a second safe in the front cellar.

Old safes can contain asbestos so should be checked before they are disturbed. You should also ensure that the vendor leaves the keys for these if they do not take them with them.

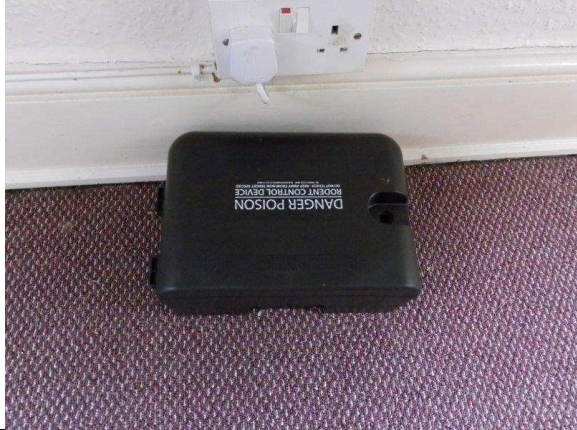
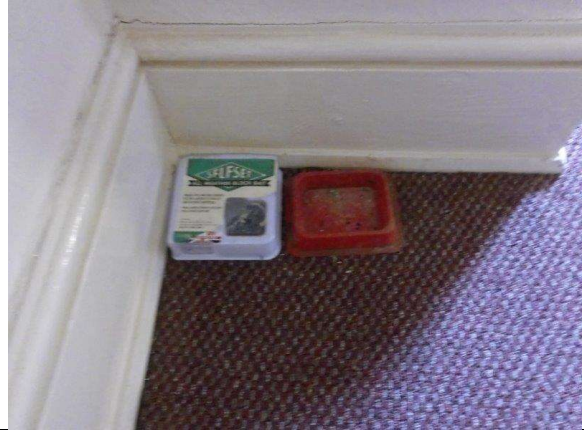
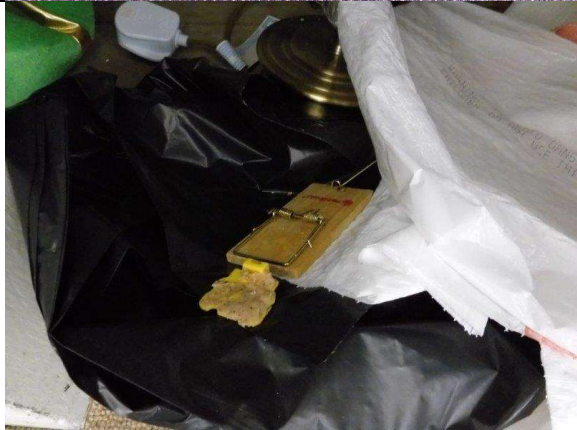
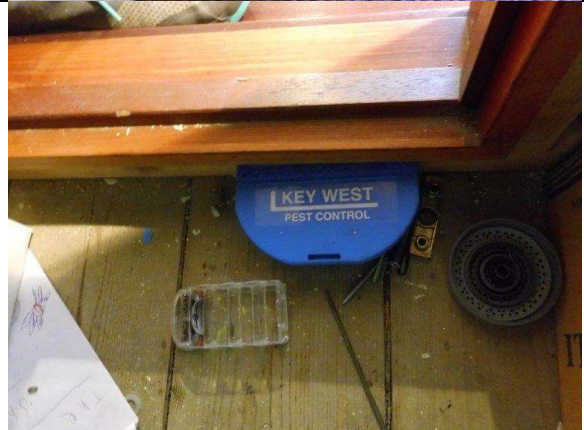
There are rodent boxes throughout the property, suggesting there is a sizable problem. We recommend that these traps and bait boxes are refreshed and monitored.
