Inspection Summary

Halifax

Report produced by Simon Hollis MRICS

7th September 2021

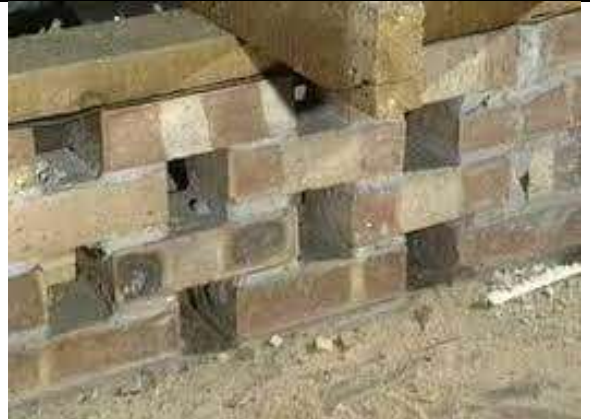
Underneath the left-hand of the two inspection hatches, there is an area of dry rot, note the yellow tinges to the fungus.

Whilst the timber is still wet, it is not possible to determine the extent of the damage. At the moment, the timbers still look in acceptable condition; however, they may distort and crack as the timber dries out and some cutting back/support may be necessary.
