Roof Inspection Report
In respect of:

**Report produced by Simon
Hollis MRICS**

Drone Inspection Report - Summary of Findings

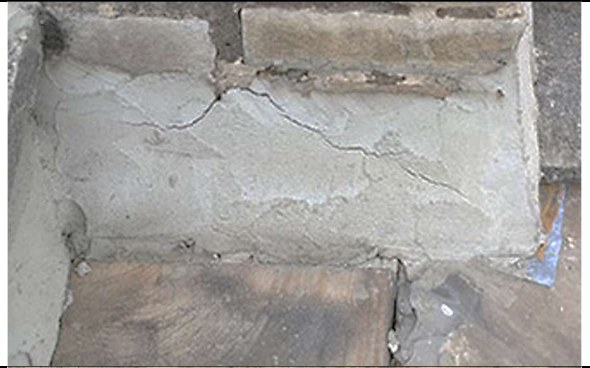
From the construction photos, it looks like there may be more than one layer of mortar at the base of the stack as this photo shows cracked mortar.

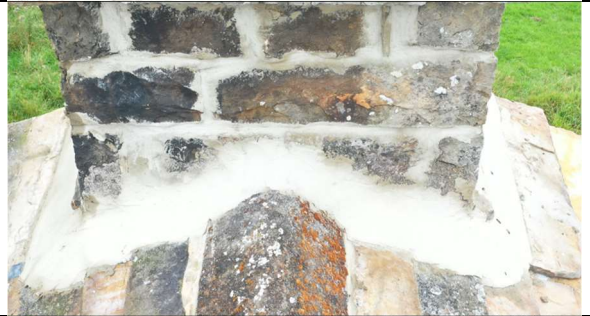
There should be a stepped lead flashing and soaker detail and a saddle piece here.

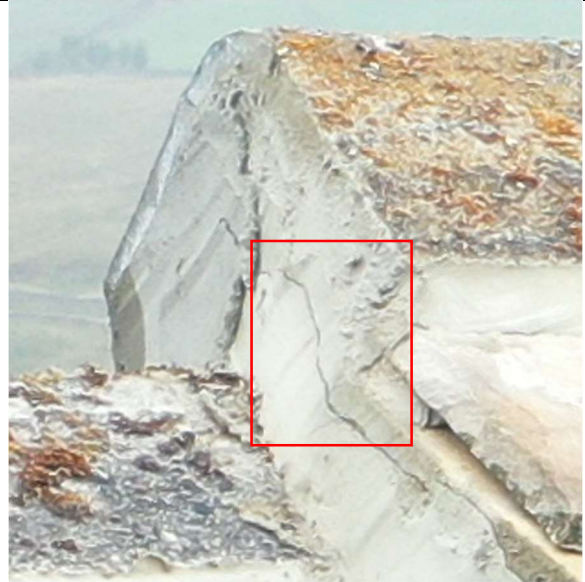
Where the roof steps, we can see two different strengths of mortar have been used.

There is already a hairline crack in the front section.

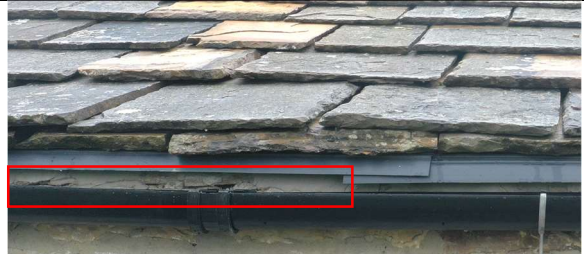
Several sections should be monitored during heavy rain to ensure that the eaves trays deflect rainwater into the guttering and not onto the wall head.

This could also be tested with a hosepipe.

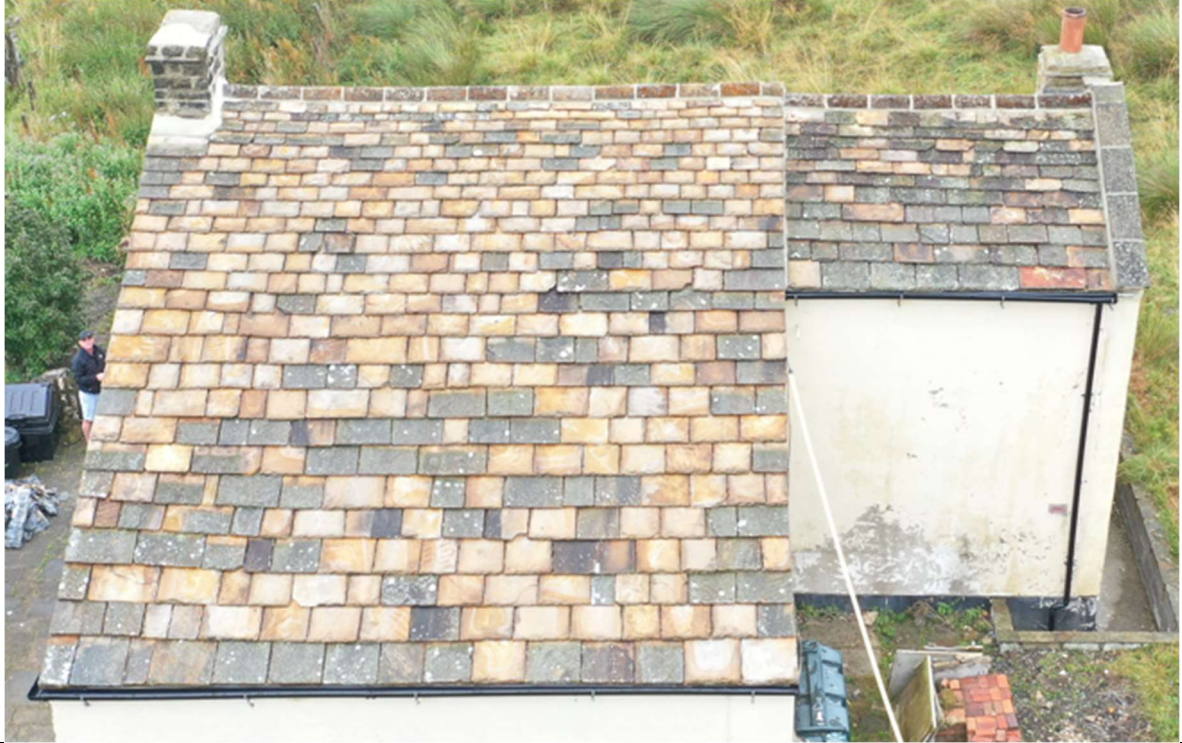
Ridge – example of a hairline crack to the pointing detail.

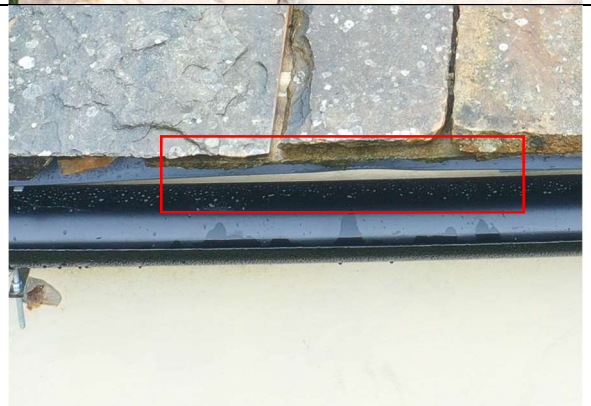
It looks like the eaves tray may not deflect rainwater into the gutter properly.

This should be tested with a hosepipe.

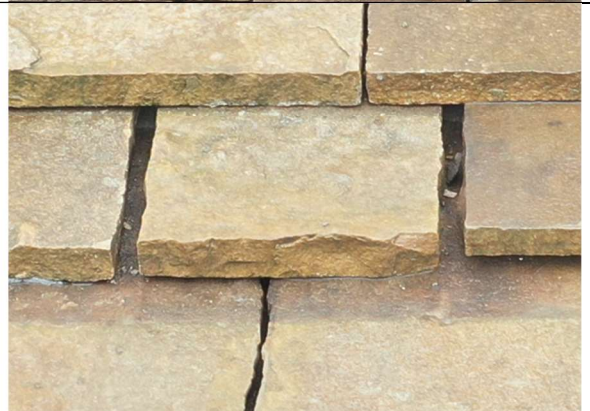
Poor bonding detail and inconsistent tooling of the side of the slate.

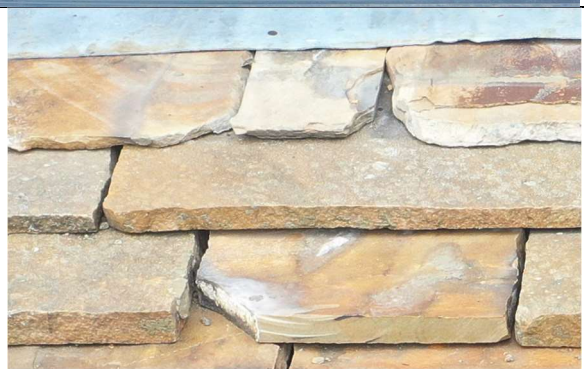
Chipped slates should be tooled to a smaller size.

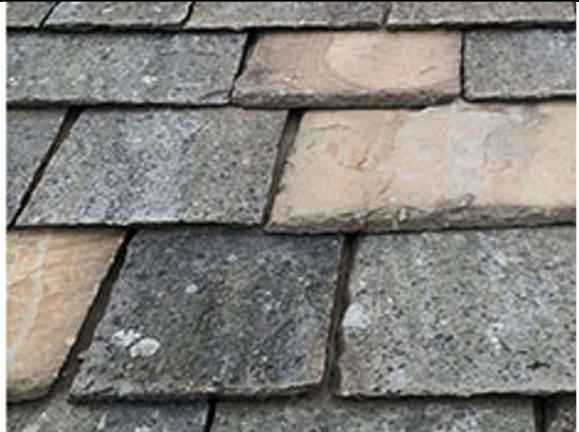
The gaps created by the shoulders on the slates illustrate why it is important for the slates to be well bonded and square.

The slates should be squared up prior to being laid so that the bond is close.

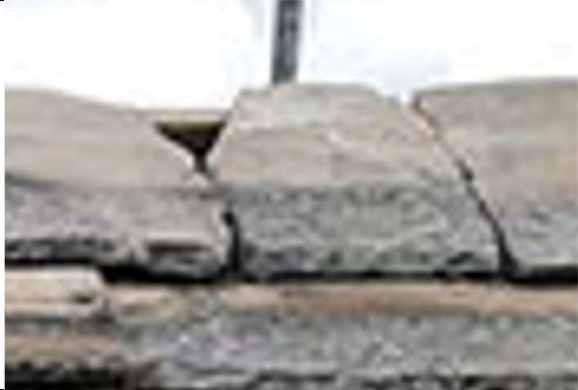
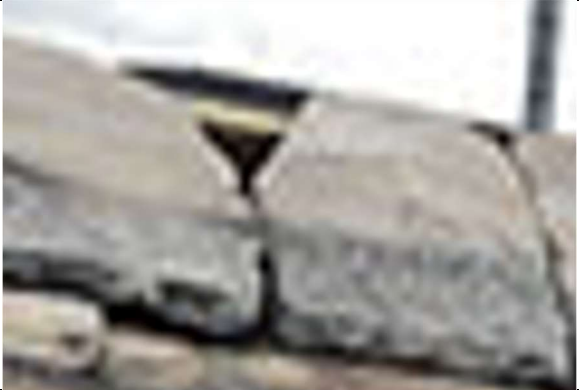
Back Roof - 2

The photos below show the inconsistent edge profile of some of the slates. In places, this is causing a gap in the bond of up to 40 mm.

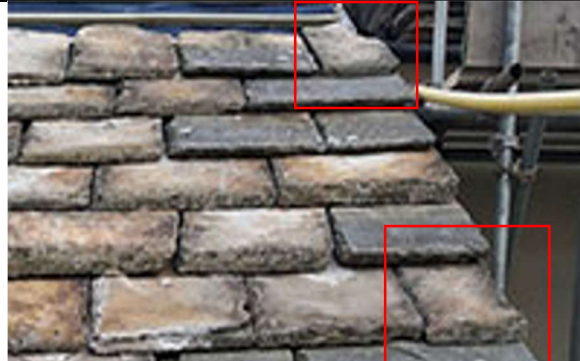
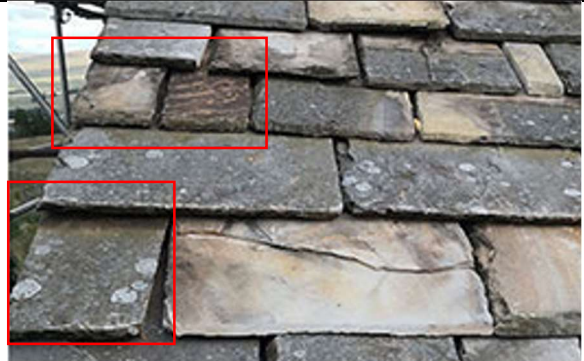
Main Roof

Having lots of small slates on the verge of the roof is far from ideal due to problems with wind lift.

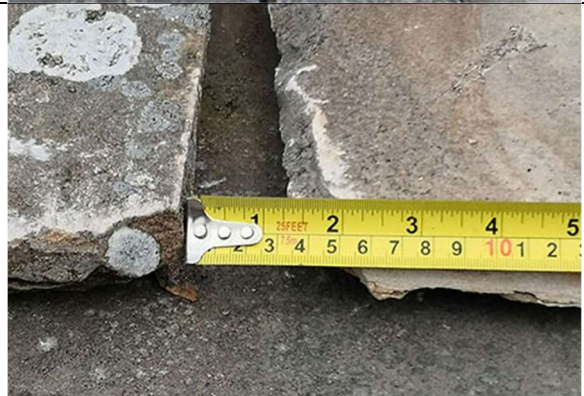
As detailed above, the slates are not square/do not sit square with each other.

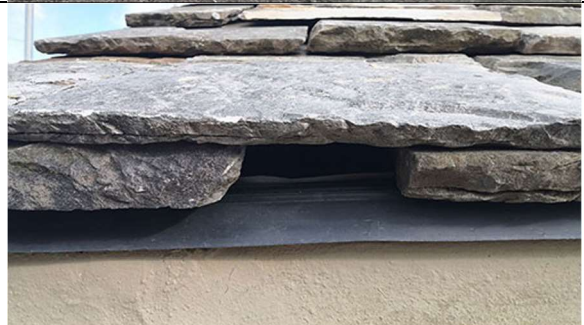
Gaps on the under course at the eaves.

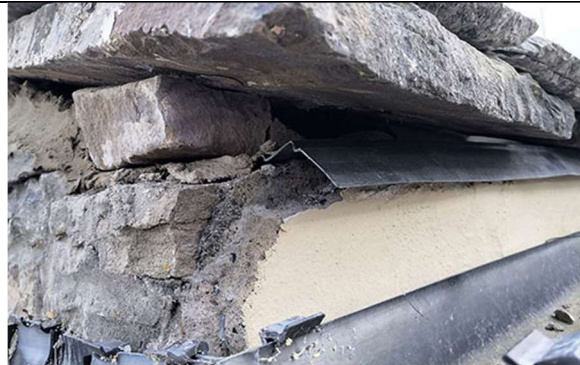
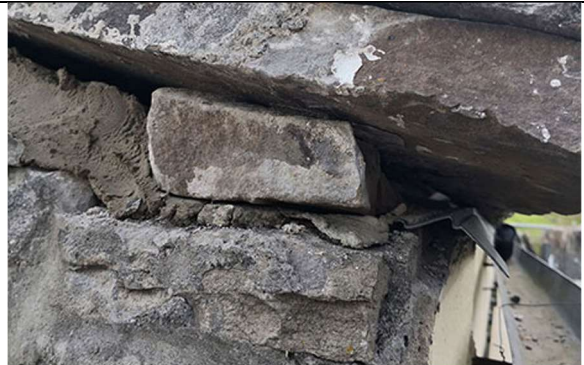
An eaves tray has been used along this section. This looks to have been incorrectly fitted as it looks like it has been squashed into place and the edge is now kicking up and forming a trough.

There also looks to be no projection on the verge. There should be a projection of at least 50 mm.

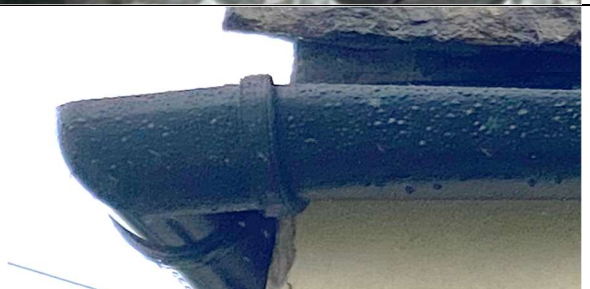
The two sections of guttering do not sit square in the elbow.

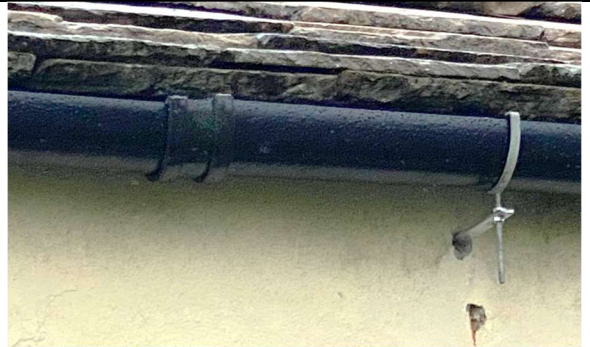
The sections of guttering do not look to sit square in the union. The bracket should likely also be closer to the union (although we would need to check the manufacturer's installation instructions to confirm this).

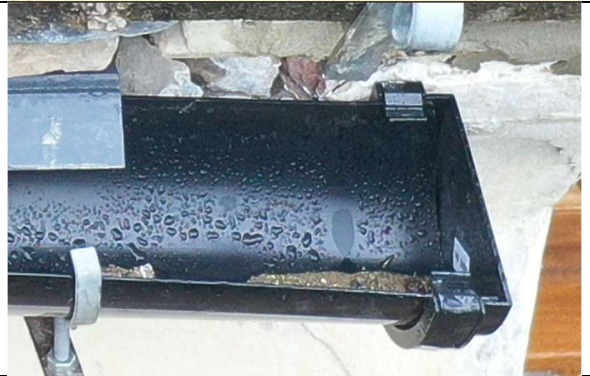
Extension – the guttering is warped.

From the collection of debris at the stop end, which is at the opposite end to the outlet, it looks like the guttering has been laid to the incorrect fall (although we would need to check the manufacturer's installation instructions to confirm this).

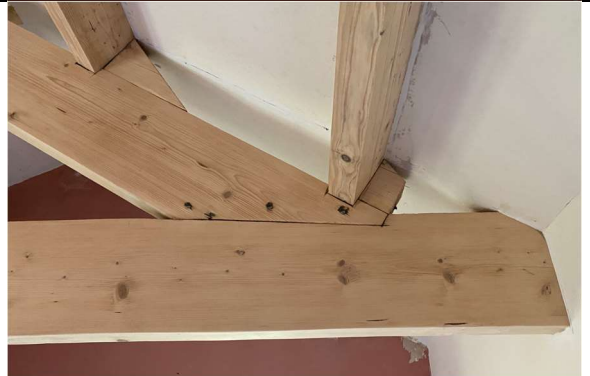
In our opinion, these timber elements should fit together with a better tolerance than this and the purlins should be trenched deeper into the truss [however, we have not seen the designs].
