# Roof Inspection Report

Report produced by Simon Hollis MRICS

22<sup>nd</sup> December 2022

Drone Inspection Report - Summary of Findings

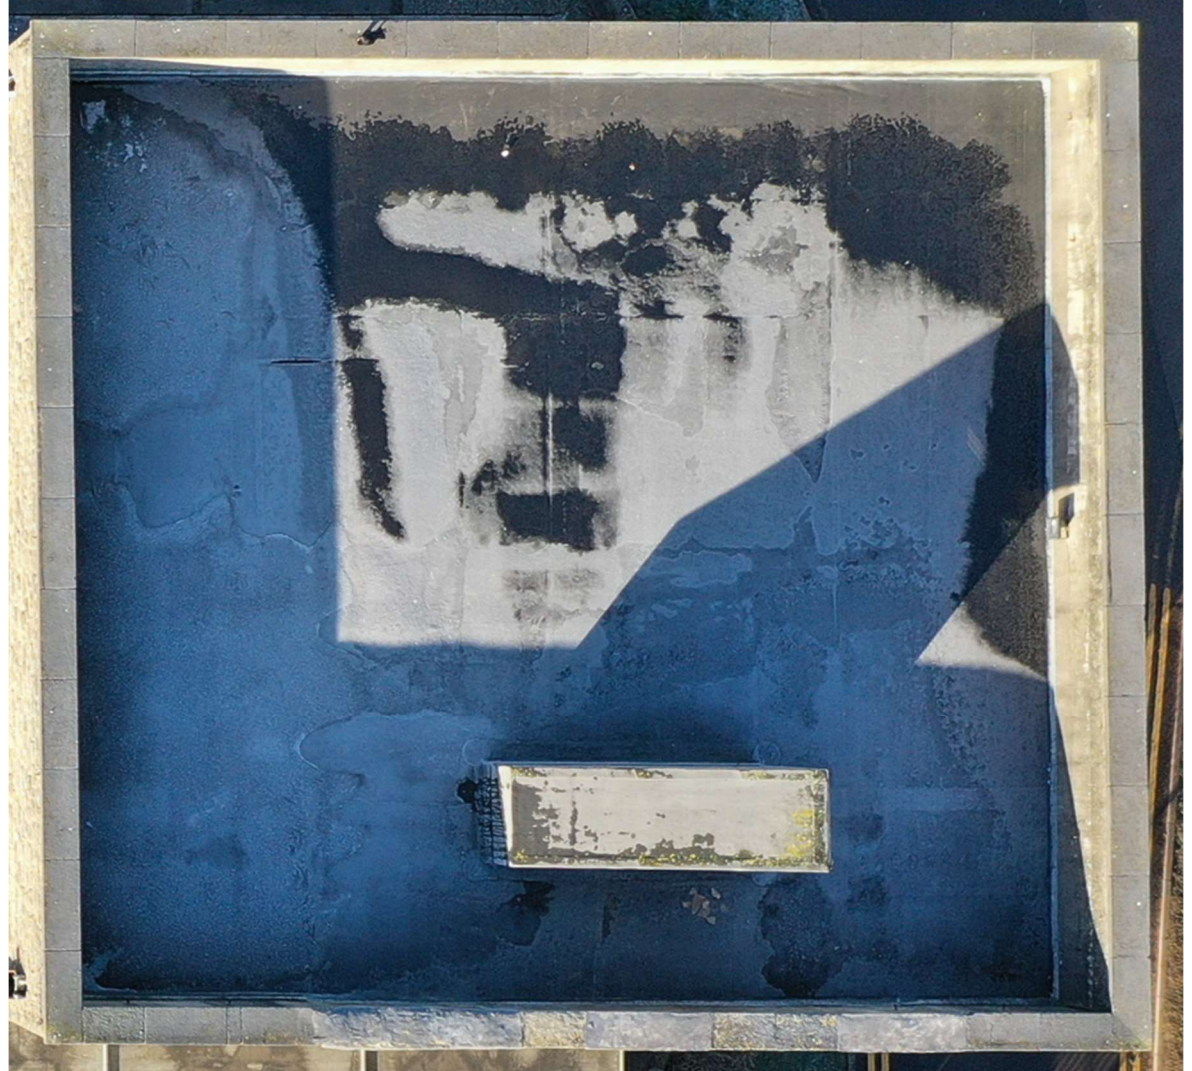
Overhead photo of the tower roof.

The frost and build-up of ice have somewhat restricted our inspection of this section. From some of the detail, this looks like a singly-ply membrane covering/over-covering.

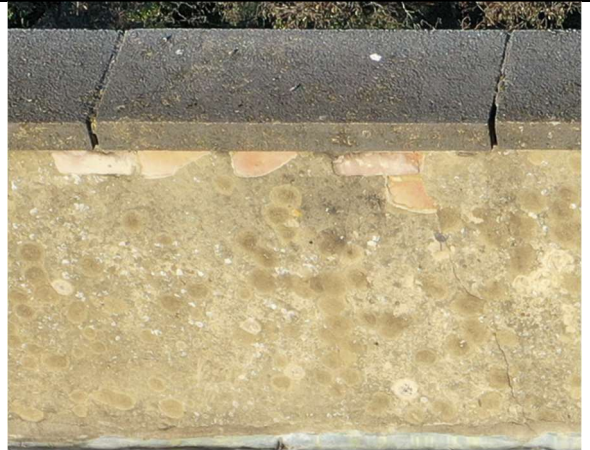
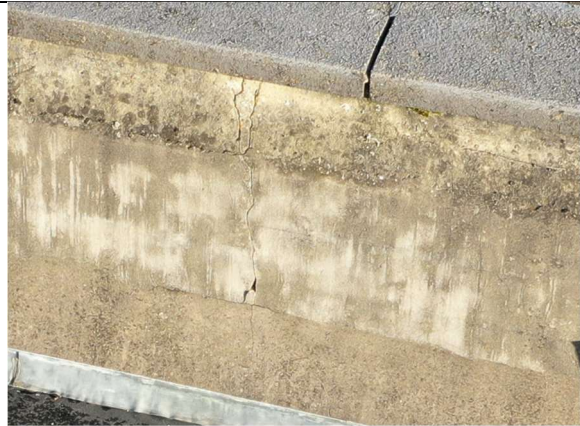
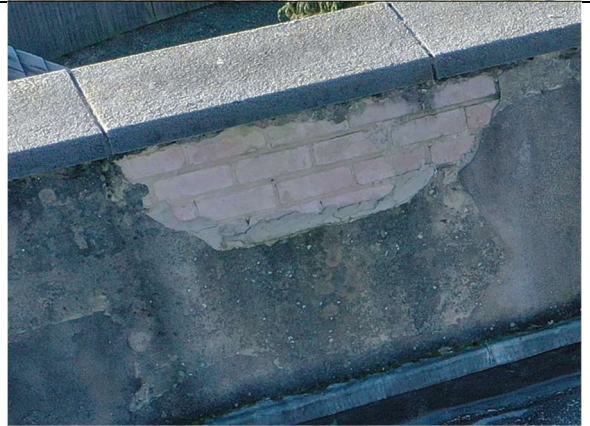
This is cracking and falling off in places and there are no expansion joints in the detail.

The render should be repaired/replaced in a more appropriate mix for the location.

This work should be undertaken in the spring/summer.

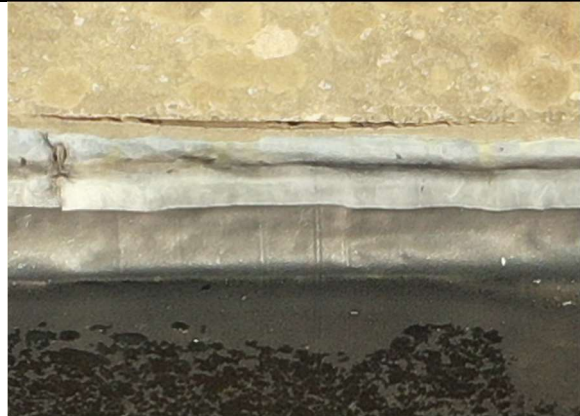
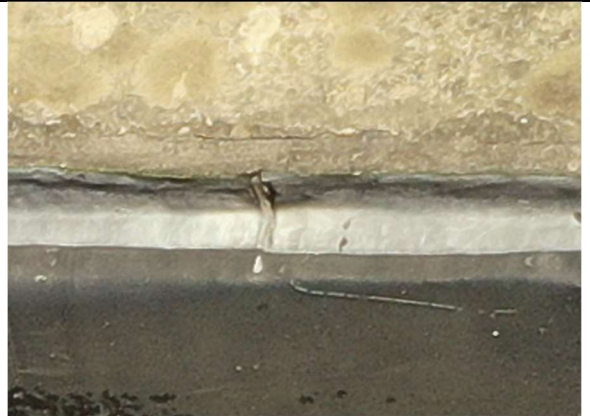
Where the upstand meets the render, there is a lead flashing detail. The design/fitting of this is questionable in places. This should be inspected close-up in the spring and any required repairs actioned.

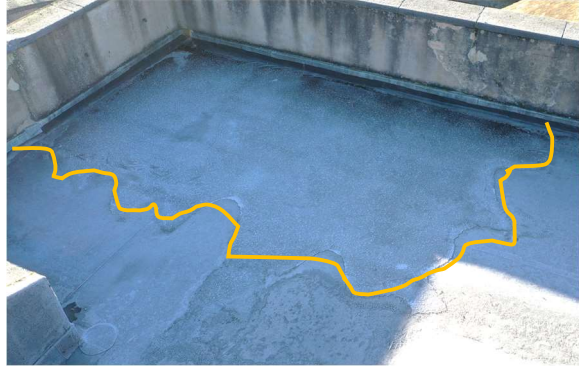
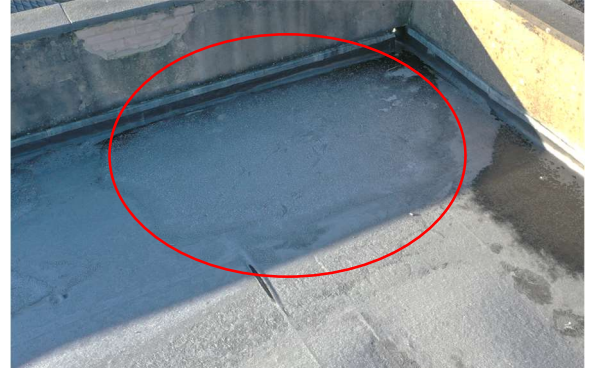
There are large areas of ice on the covering in front of both of the outlets. This suggests that the outlets are not set at the lowest point/the fall of the roof has been incorrectly cut. This is going to be a complicated defect to remedy.

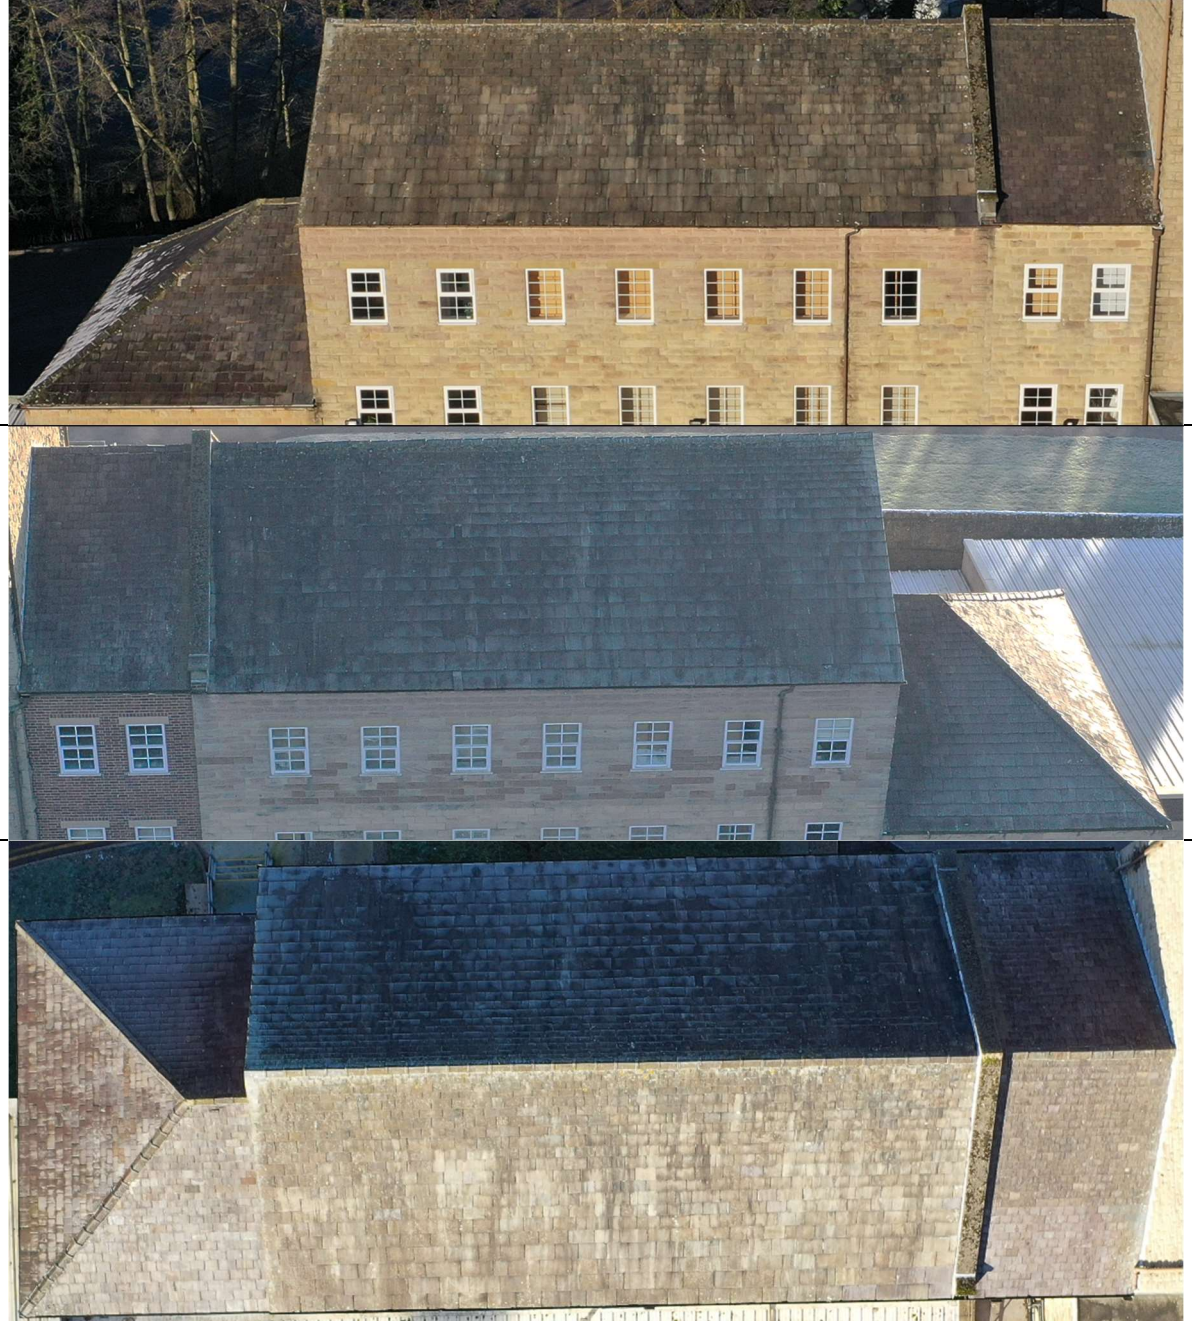
Side-on and overhead photos of the roof.

The main roof is covered in natural slate in diminishing courses. A parapet wall divides the sections of the main area and there is a separate hipped section to the left-hand side. The covering is in generally acceptable condition, with only some minor repairs required.

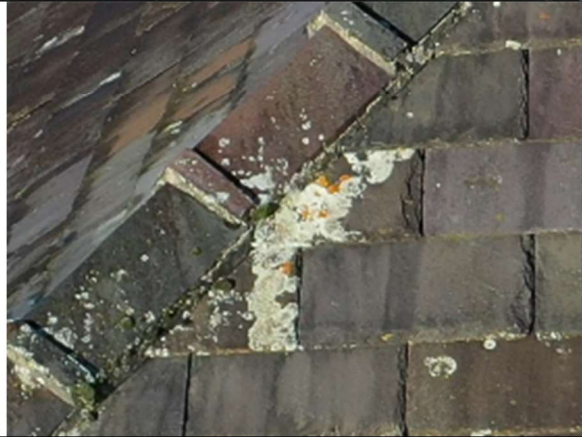
An example photo of where lichen is building up. This should be cleared off in the spring.

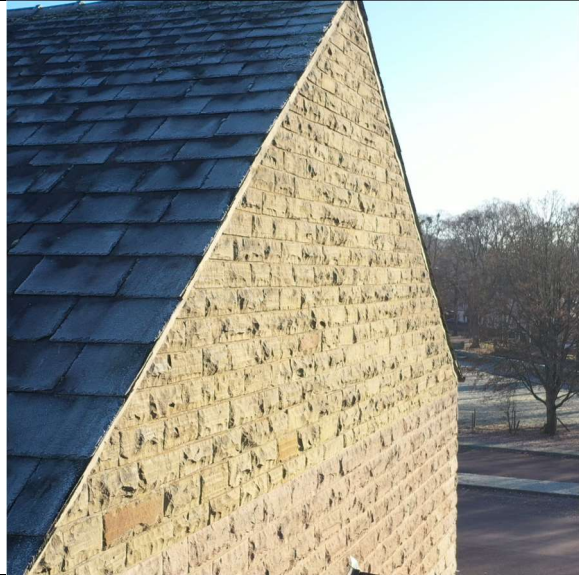
Here, the detail is slate, half slate, part slate etc. Problems can occur if there is only a single fixing in the smaller slates as they are subject to increased wind lift on the verge.

There is no economical way of addressing this, but it should be considered if and when the building is re-roofed.

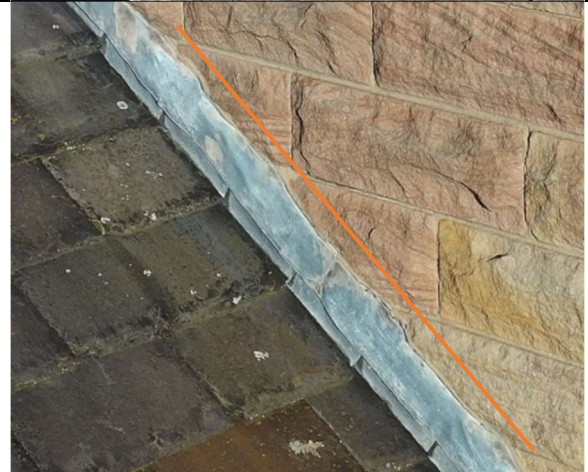
Front and rear pitches, abutment detail – a diagonal cover flashing has been cut into the stone.

A stepped detail would have caused less damage and is a more reliable way of detailing this.

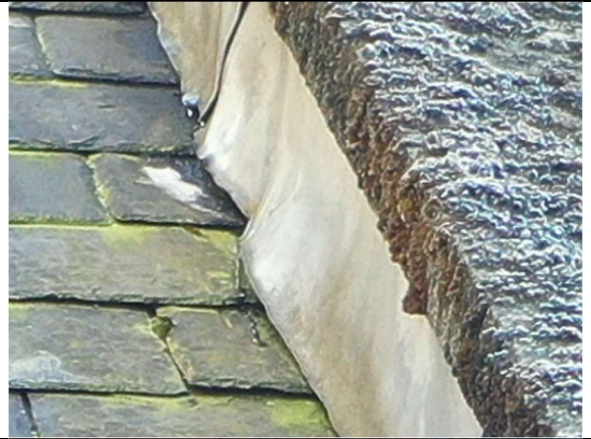
Front and rear pitches, parapet wall – the lead detail is ruckling in several places along the parapet, likely as a result of the individual sections being too long to accommodate adequate thermal expansion and contraction over the summer months.

The lead should be tamped back into place.

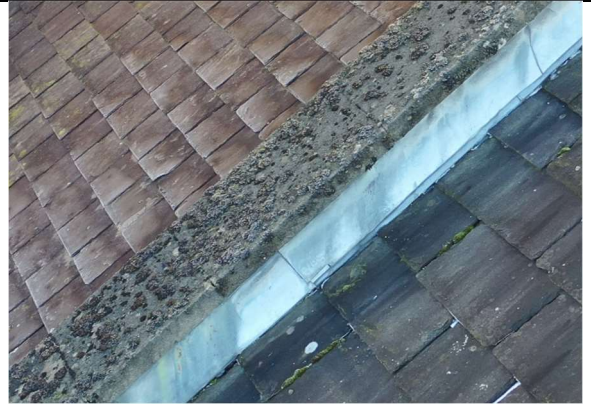
Front and rear pitches, parapet – moss is building up on the coping slabs. This should be killed and cleared off in the spring.

An anti-fungal wash could be considered to mitigate against this in the future.

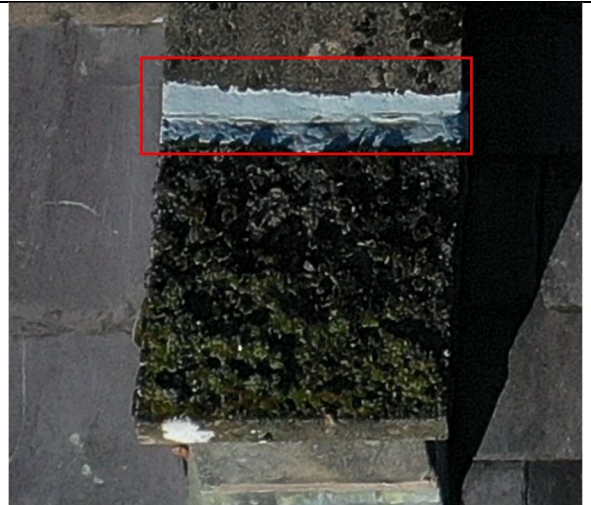
Front and rear pitches, parapet – the abutment of the pitched and flat coping stones have been sealed with a temporary waterproofing paint-on-type product (Flexacyrl, Chromapol etc.).

This is not appropriate for this job. The paint should be removed and lead used to detail the abutment.

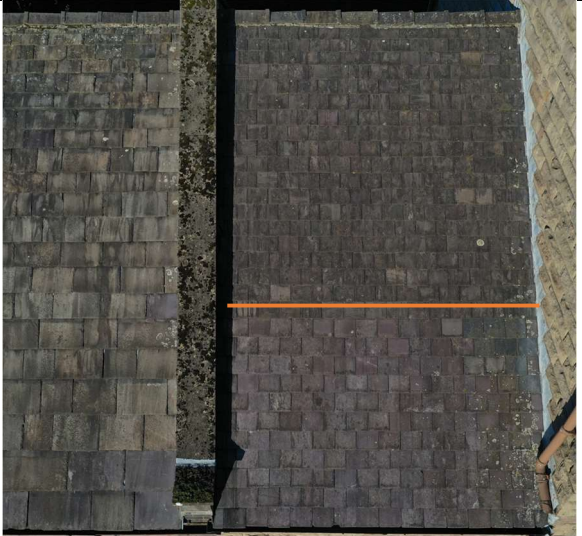
Front Pitch

Covering – it looks like part of the pitch has been covered with reclaimed slate and part new.

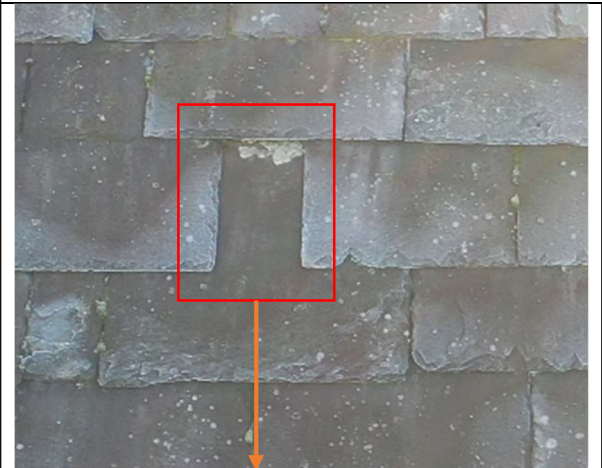
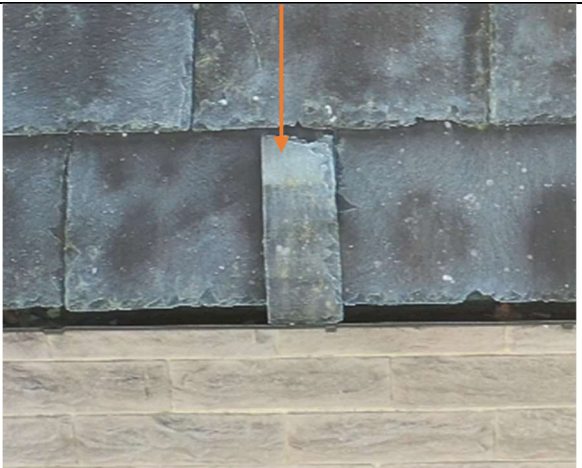
Rear Pitch

A small slate has snapped and slipped down the pitch. This should be replaced as soon as possible and the missing section should be removed from the guttering so that it does not fall and hurt someone.

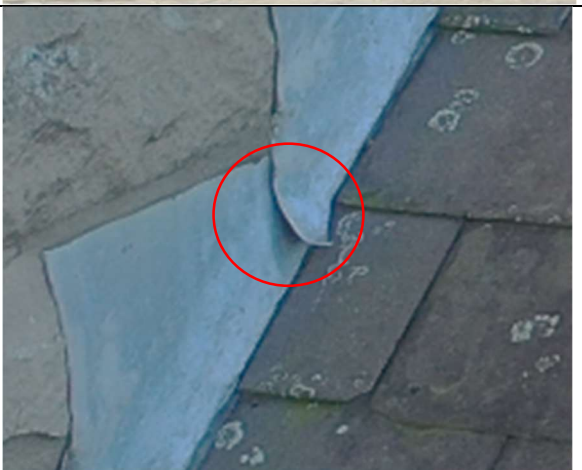
A couple of the stepped cover flashings need tamping back down. This should be done in the spring.

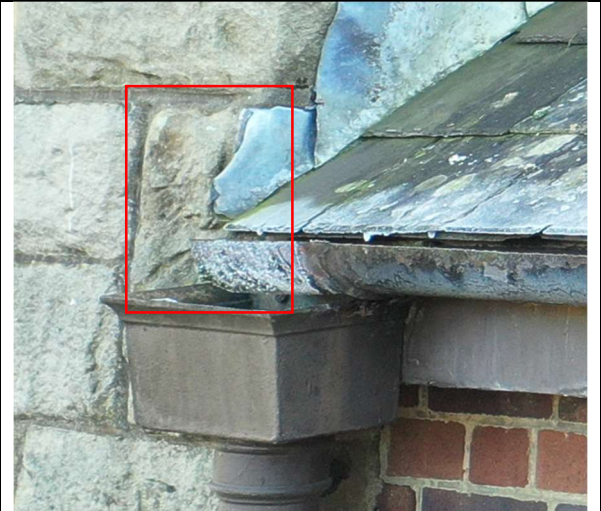
This flashing detail is incorrect and should be changed to the correct detail in the spring.

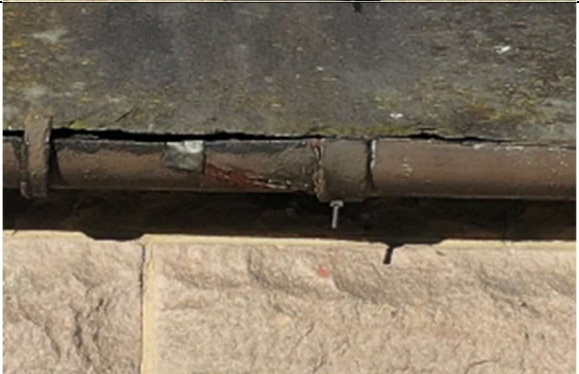
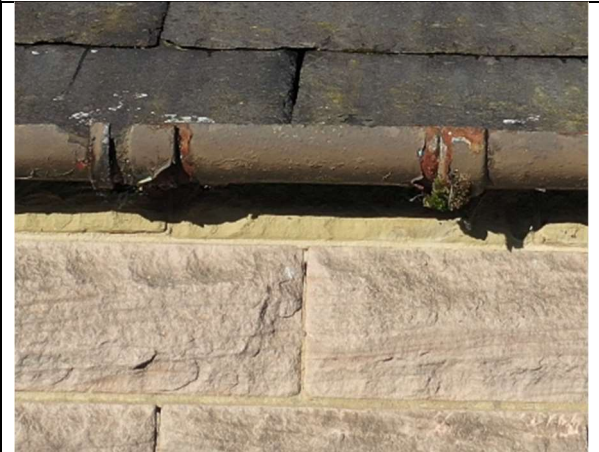
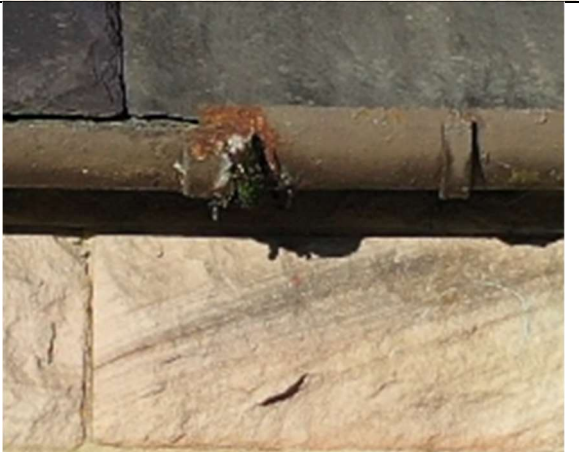
<p>Most of the joints are leaking and there are many examples of corrosion and some cracking in the guttering.</p> <p>These things all need to be addressed as soon as possible/in the spring.</p> <p>We have included some example photos below as opposed to a photo of every defect.</p>

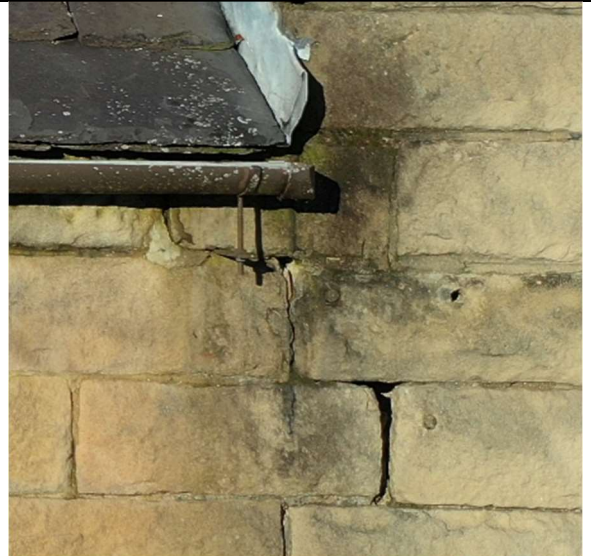
There is no stop end in the left-hand section of the guttering. One should be fitted straight away.

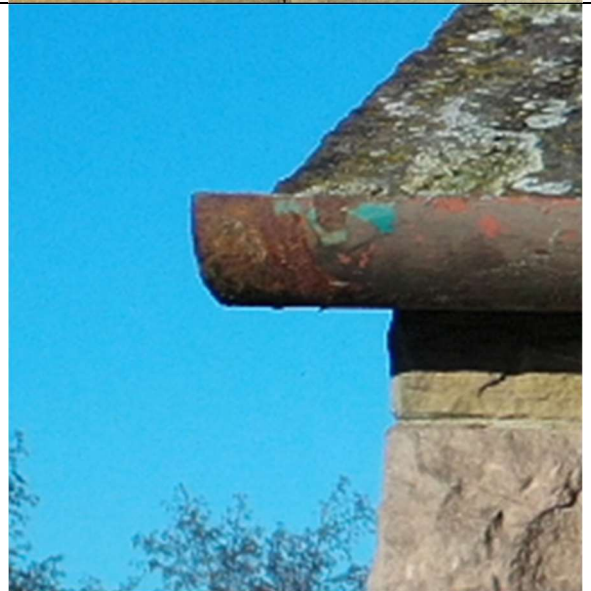
The guttering runs on the hipped section of the roof sit too far from the foot of the roof. It looks like an attempted resolution to this has previously been attempted in felt.

With the rise and fall brackets, it should be easy to adjust the run to a 1:60 fall and bring the guttering closer to the slates, so the slates sit halfway across the run.

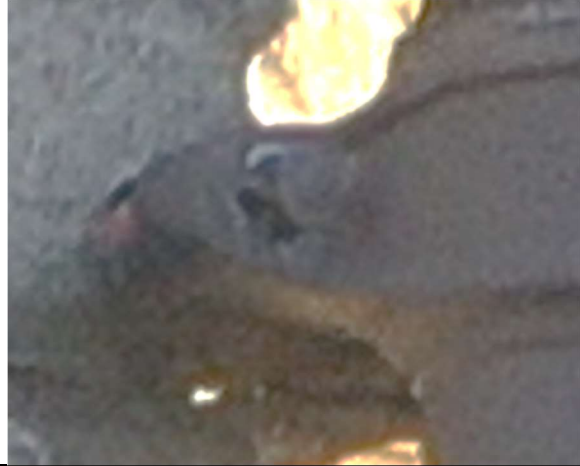
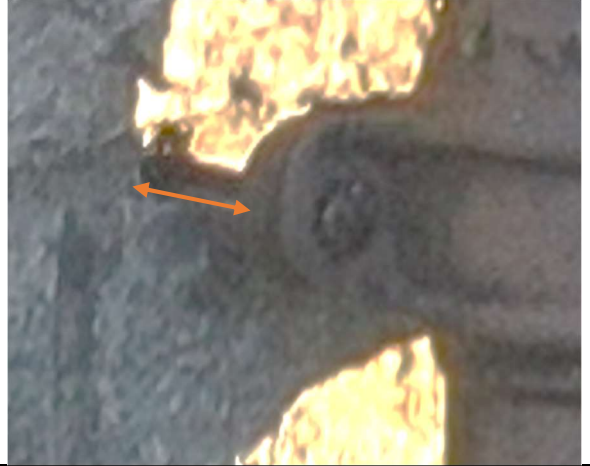
Fall pipe below the abovementioned hopper – it looks like the timber packers have decayed to nothing and the pipe clips are now likely rattling on their fittings.

This should be made safe now and permanently addressed when the rainwater goods are refurbished.

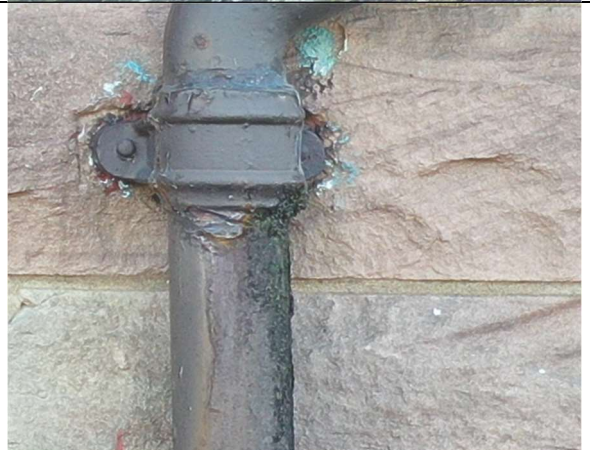
Rear elevation – the fall pipe is leaking under the swan neck.

This should be addressed in the short term.

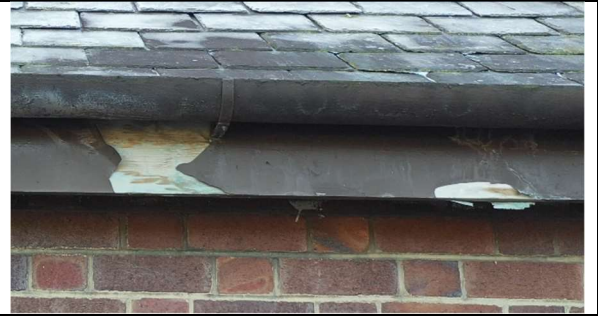
Facia board – the paint is peeling off along this run.

The facia boards should be rubbed back, prepared and redecorated.

All timber should be redecorated in a linseed oil-based paint.

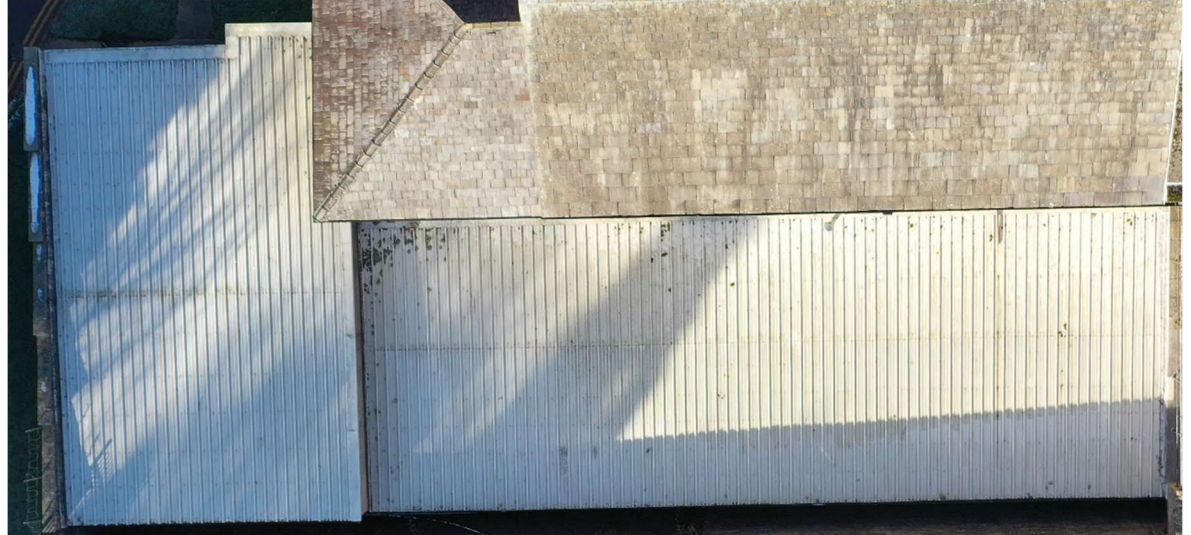
Overhead photo of the roof.

The lean-to roof is constructed from profiled sheet cladding sections, joined in the centre. The detailing is not the best around the edges and there is cut-edge corrosion across the length of the horizontal joints and at the foot of the roof.

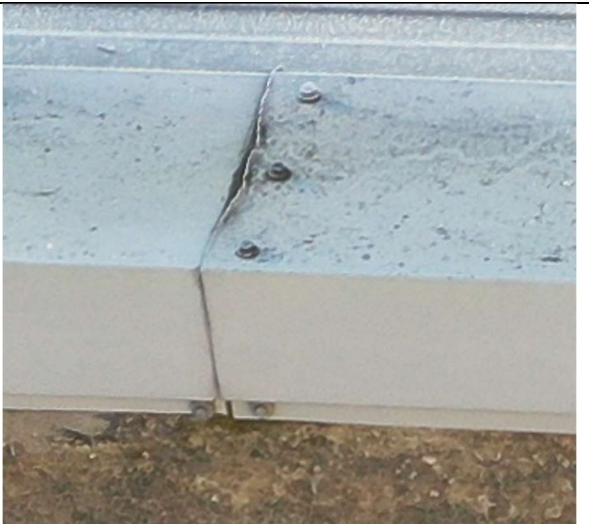
Example of cut-edge corrosion along the cappings. This should be prepared and treated at the same time as the main roof sheets.

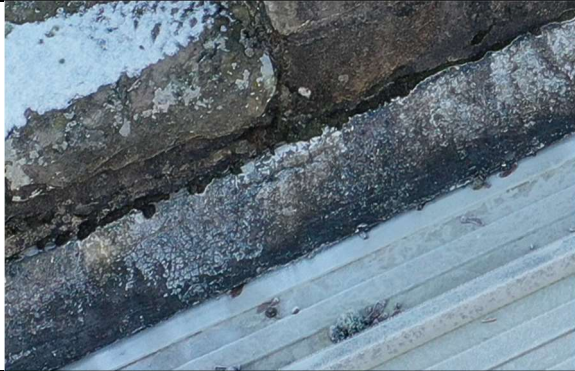
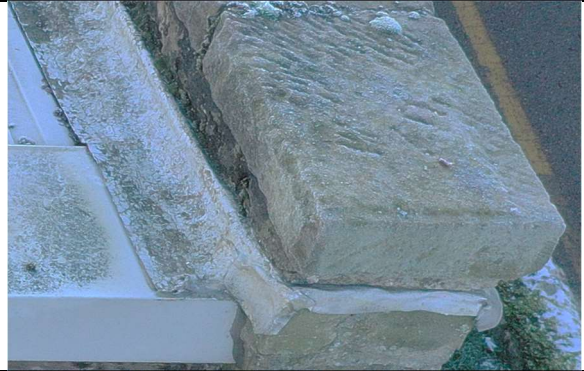
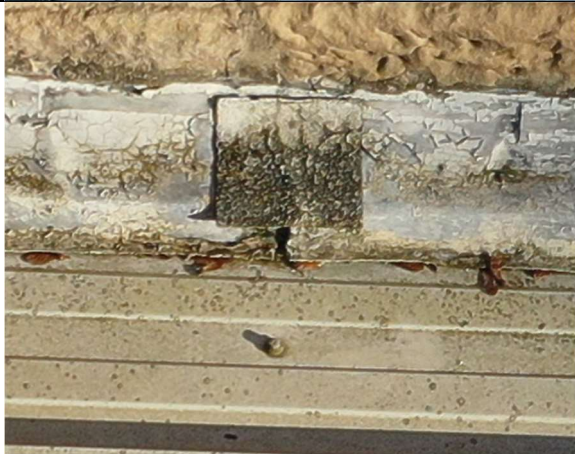
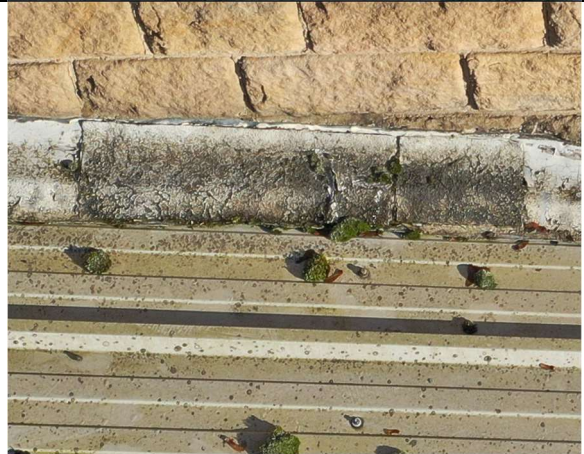
Some of the upstand details have been poorly designed and all are in poor condition and look to have been over-painted and repaired several times. We have included some example photos below. A plan should be made to replace the detail in these areas before they fail again.

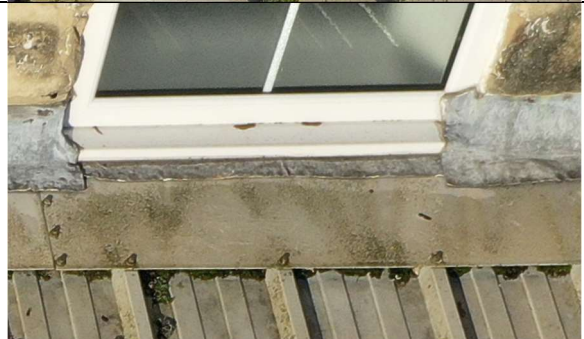
Example photo of poor flashing detail around the window penetration/reveal.

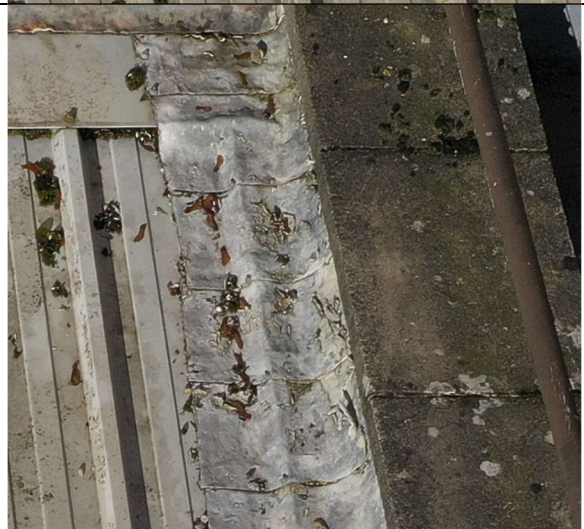
Walkway abutment – this detail has been poorly formed. It should be replaced with a more appropriately designed detail.

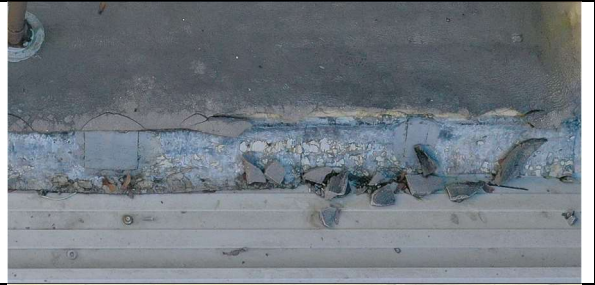
The detail is in poorer condition further down the path abutment.

It looks like asphalt has been incorrectly detailed here. This may be complicated to repair as asphaltting roof detail is somewhat of a dying art.

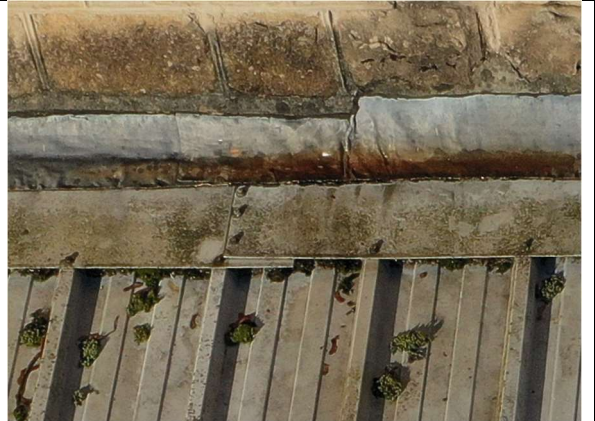
Example of where the leaking guttering is staining the flashing.

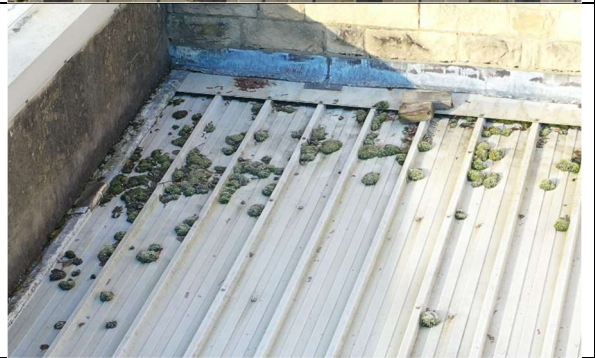
Moss and debris should be cleared from the roof before it is cleaned and the cut-edge corrosion treated.

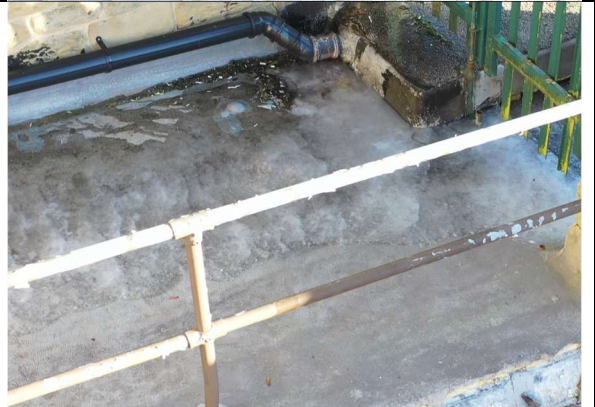
Thick ice is building up along the path.

The source of this needs to be established – is it from a leak in the pipe or ponding rainwater?

If it is from a leaking pipe, this should be repaired.

If it is from rainwater ponding, the pitch/cut needs to be altered.

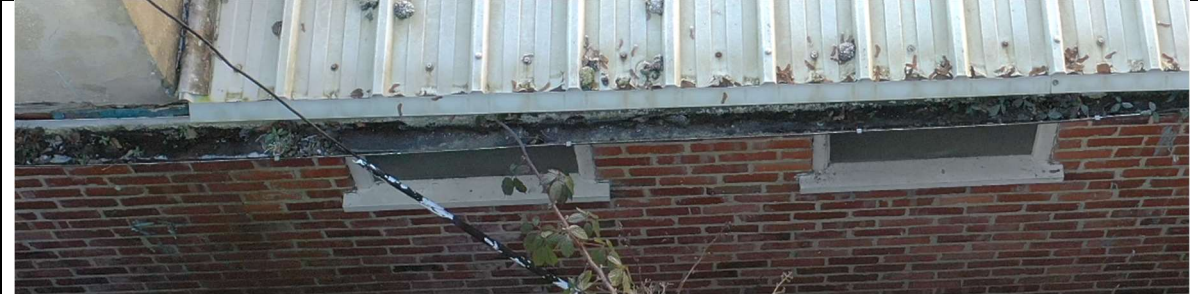
Guttering detail – this is full of debris and warping along the runs. The guttering should be cleared out as soon as possible and additional brackets added to try to correct the warping.

The runs are both set far down from the foot of the pitch. Consideration should be given to fitting an additional drip detail to take water from the foot of the pitch into the guttering or raising the position of the run.

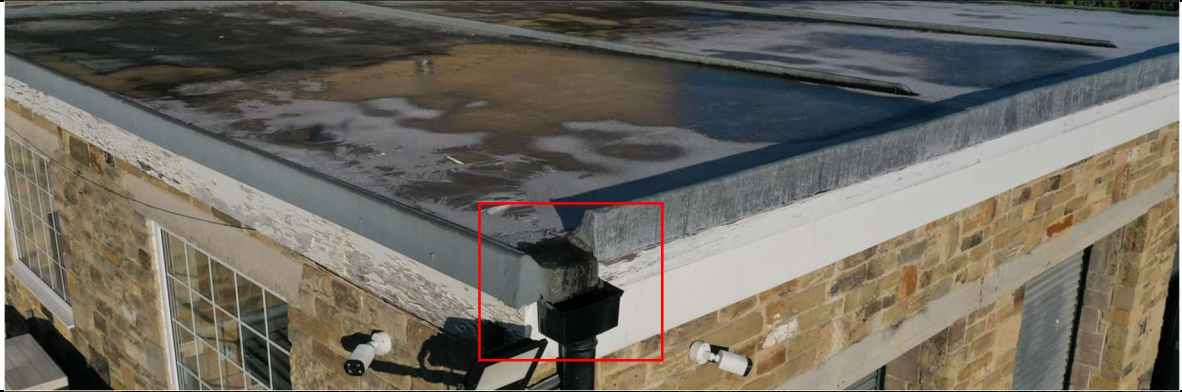
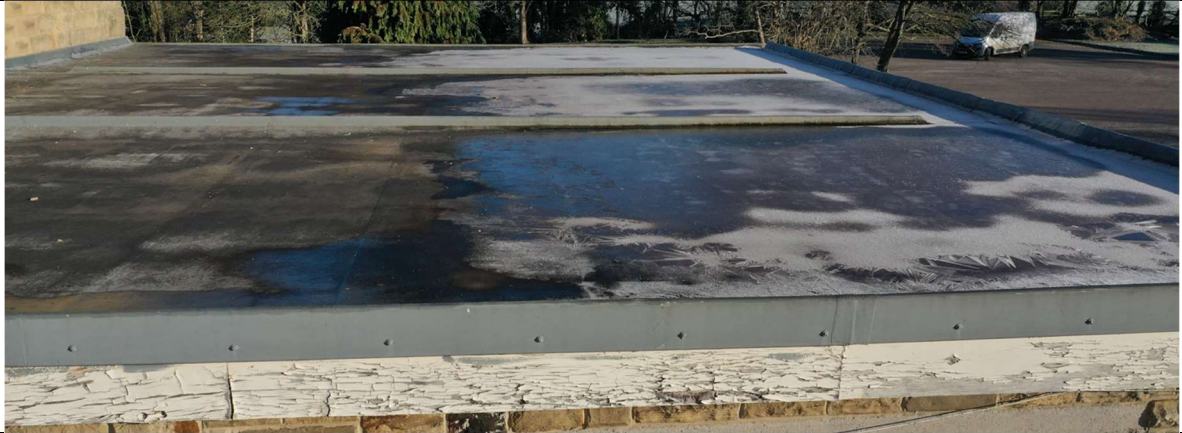
Red box – this is now the only outlet for this pitch. In the second photo, note the amount of water that has built up on the roof that is not making its way to the outlet. This is going to be a complicated problem to address and a plan should be made in the short term. Please let us know if you need any further advice on this.

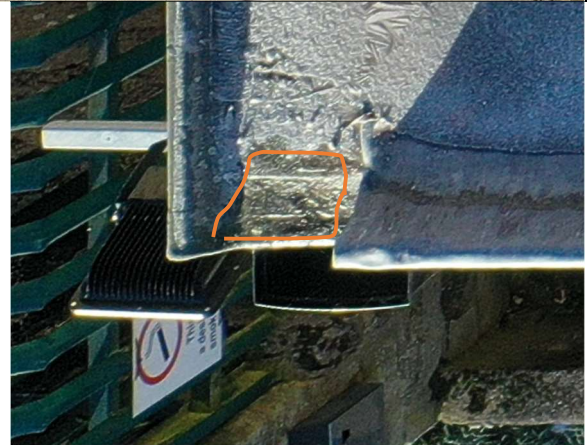
Close-up of the outlet overhead – note that there is no ice in the orange area suggesting that it is set higher than the surrounding covering.

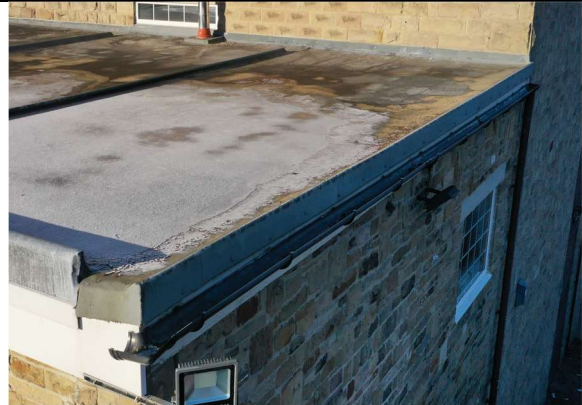
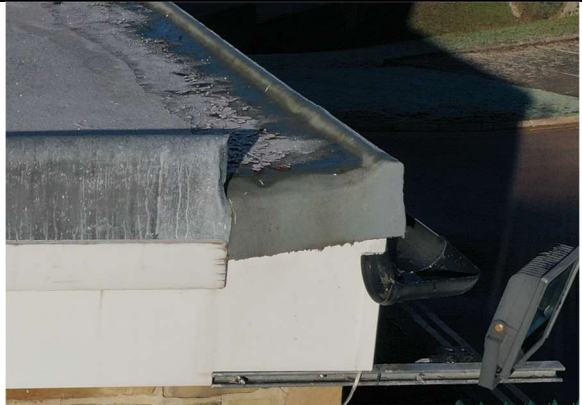
It looks like the roof was originally designed to fall to this elevation as there is a full run of guttering. A capping detail looks to have been added and therefore the design of the roof has been changed – does a contractor have any design liability for this?

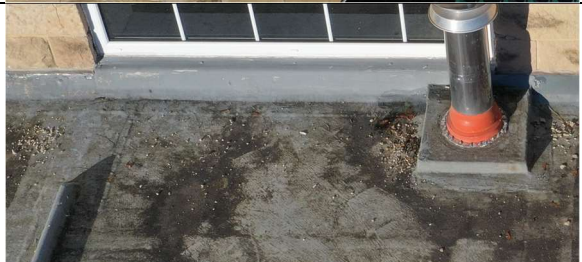
Poor detailing around the window reveal.

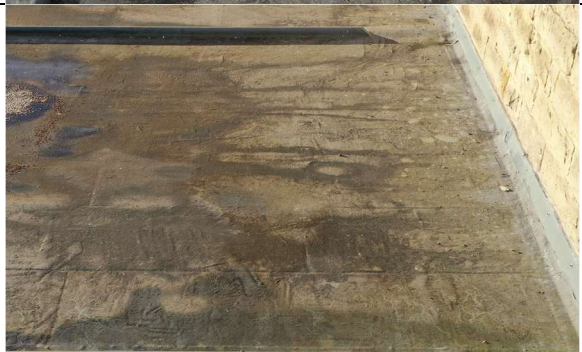
Photo of an area of the roof not covered by ice.

The material looks to be ruckled up/blistering suggesting that there may be moisture building up in the substrate.

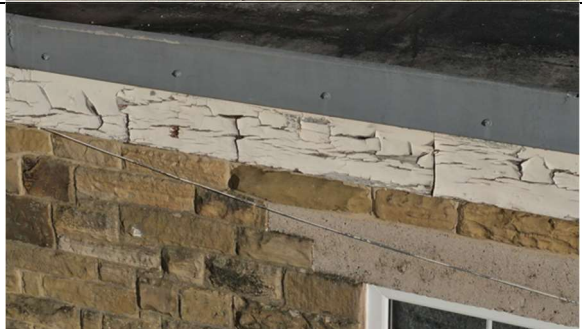
The fascia boards are in poor decorative condition. They should be rubbed back, prepared and redecorated in a linseed oil-based paint next year.

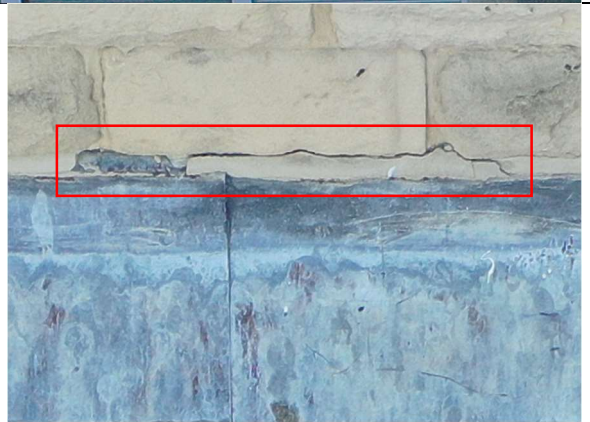
Some of the pointing is coming away where the cover flashing is detailed into the chase.

There are no restraint straps under the cover flashing.

The defective pointing should be removed and the chase repointed in the spring.

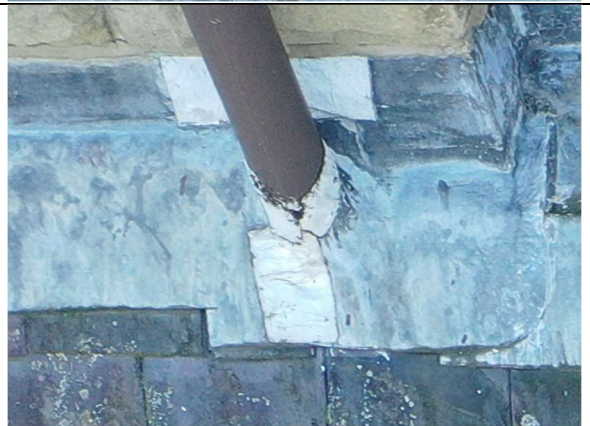
Penetration – this has been poorly detailed in a 'Flashband'-type product. This should be monitored.

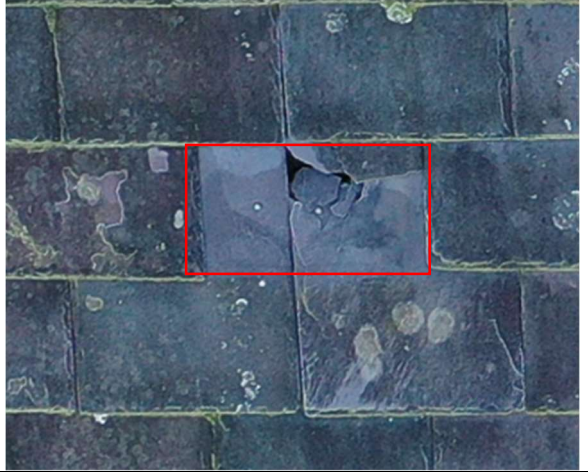
The missing slate should be replaced as soon as possible.

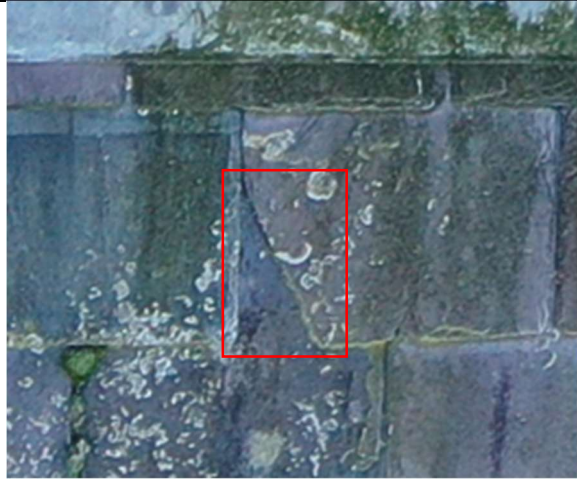
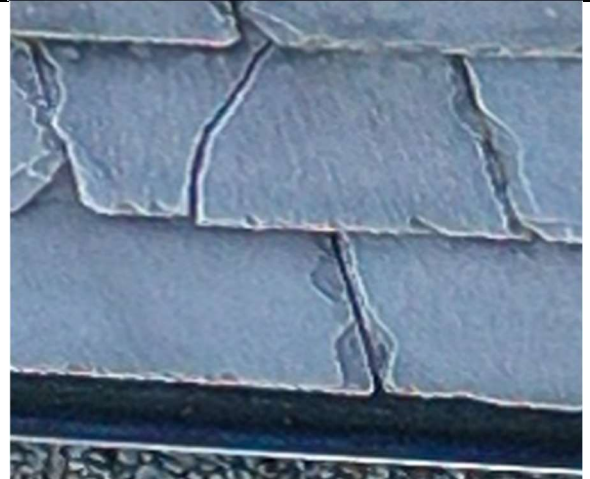
The lesser damaged slates should be replaced in the spring.

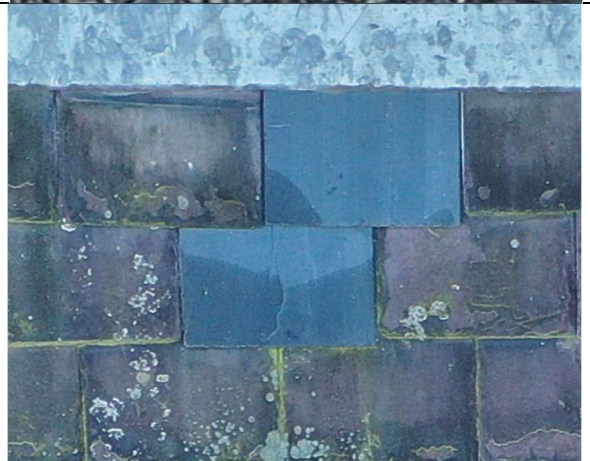
Repairs should be undertaken in like-for-like slates. These mismatched slates should be swapped for matching ones in the spring.

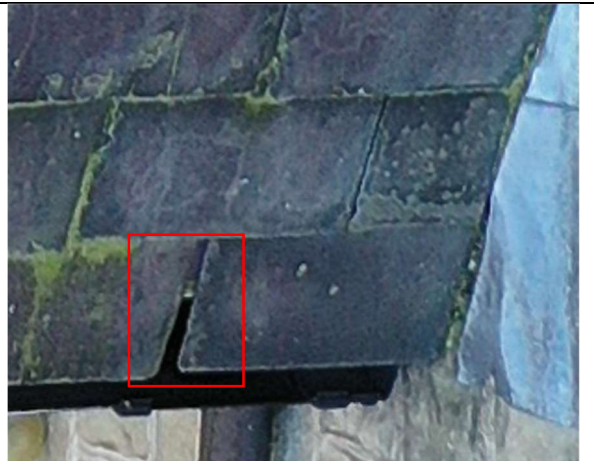
It looks like the eaves course of slates is missing.

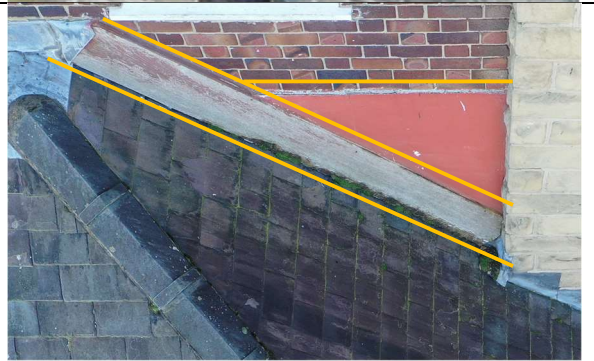
We do not know how this verge/abutment detail has been designed to function.

Instead, it looks like a piece of timber has been used.

There should be a stepped lead flashing and soaker detail along this abutment.

This area should be monitored for leaks and a plan made to replace the existing detail with the correct detail.

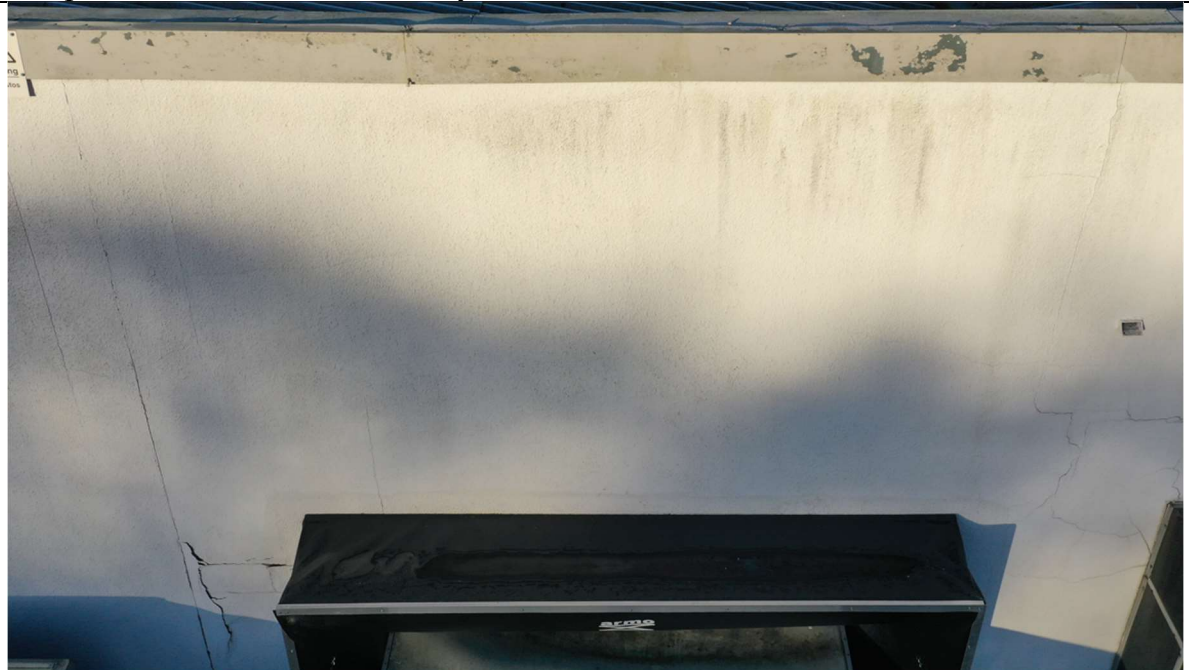
General comment, applicable to the whole building – the parapet capping detail is in poor condition all the way around the building. Paint is flaking off, sections appear to be affixed in an ad-hoc fashion and the render on the elevations below is cracked in all areas, and there are some sections that are missing.

There are no fall pipes for the gutters to discharge into, the outlets just stop as they clear the elevation. This is not ideal and a plan should be made to take all of the rainwater into the mains surface water drainage.

We recommend that consideration is given to undertaking repairs to the render before any more sections fall off. It should be made safe as soon as possible.

The cappings can be replaced/repainted at the same time as the roof works.

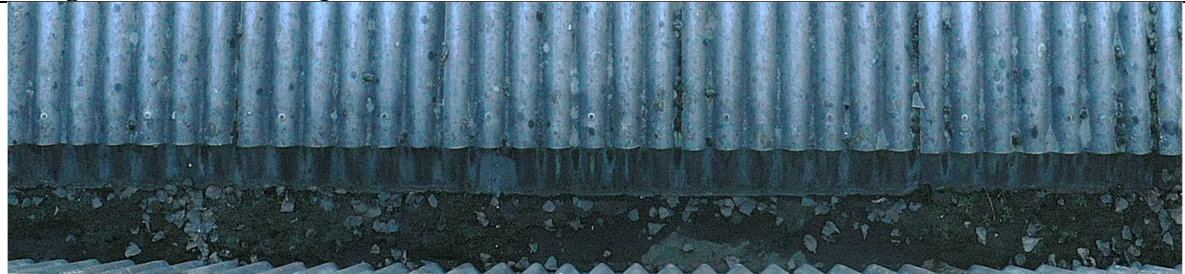
Box gutter – the build-up of debris should be removed in the short term.

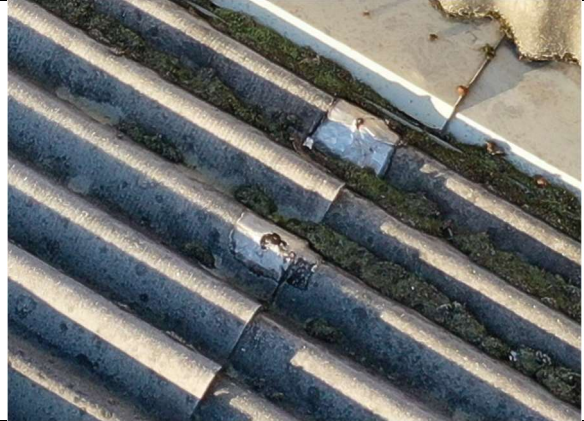
Examples of short-term repairs to the cladding around the fixing holes.

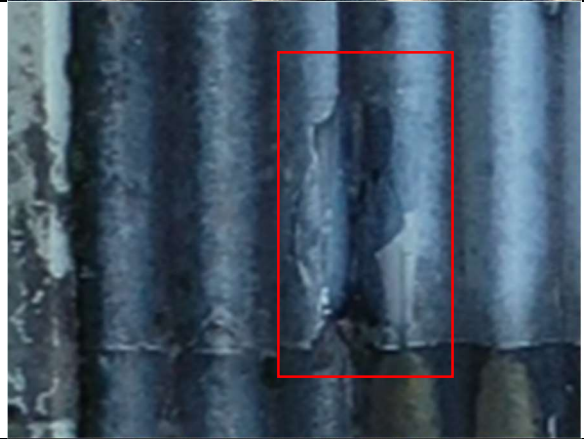
Example of a damaged section of asbestos sheet.

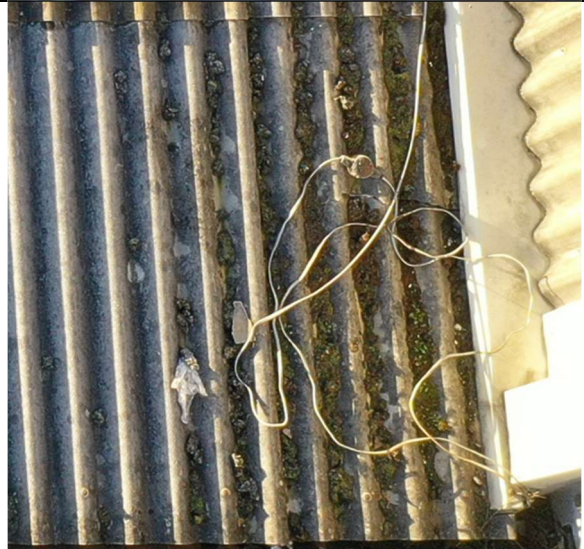
Example photo of the debris building up on the pitch. This should be cleared away in the short term.

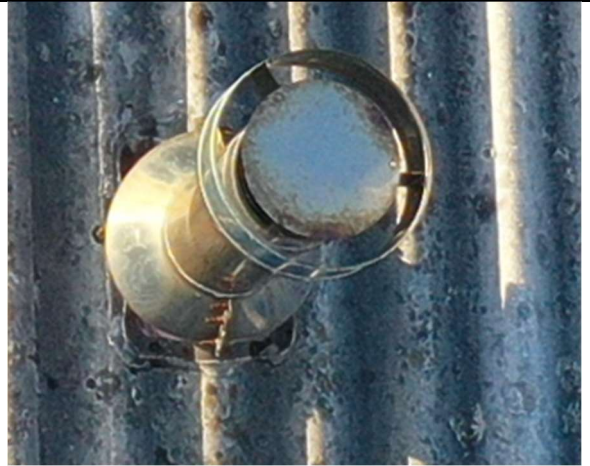
We could not see how this penetration was detailed.

It should be inspected internally for leaks and if necessary, a modern rubber gator boot-type flashing should be used.
