# Roof Inspection Report

Report produced by Simon Hollis MRICS

22<sup>nd</sup> December 2022

Drone Inspection Report - Summary of Findings

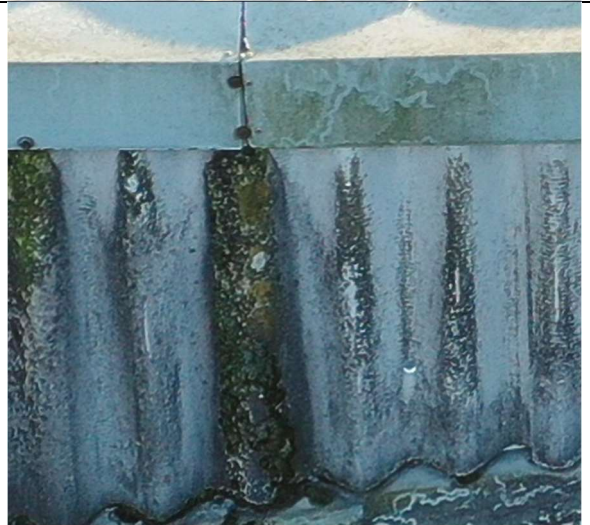
Parapet – the right-hand piece of capping has not been cut/affixed square and this is increasing staining on the sheeting below.

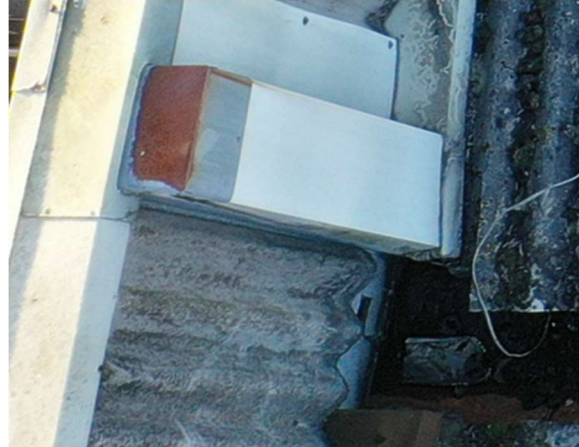
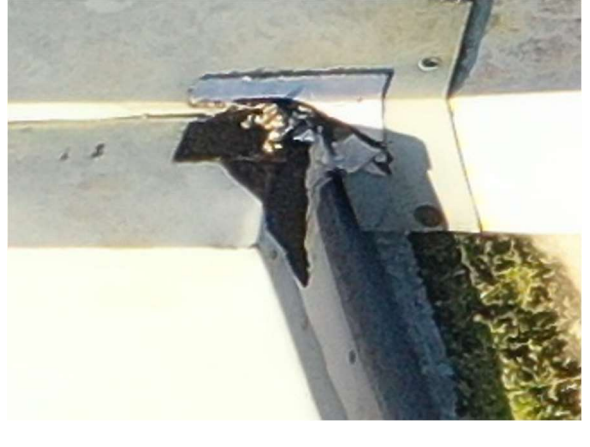
Parapet – the front upstand is corroding and the rear has been poorly repaired with a 'Flashband'-type product. These should be properly repaired in the short term.

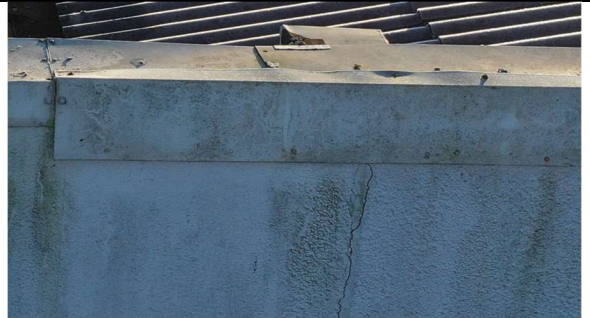
Rear elevation – this capping piece has been poorly affixed to what looks like an uneven surface.

It should be properly positioned and reaffixed.

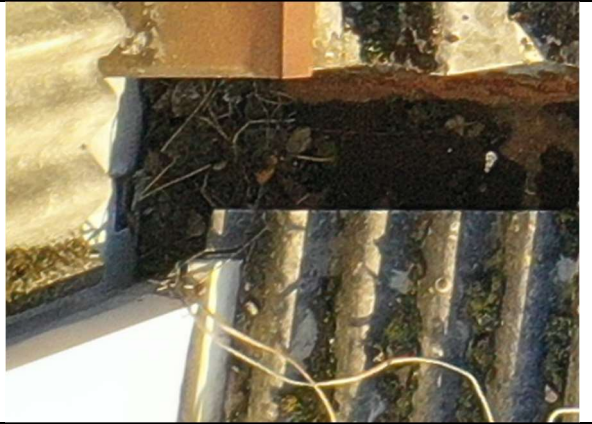
Valley gutter between bays 2 and 3 – this should be cleared of debris in the short term.

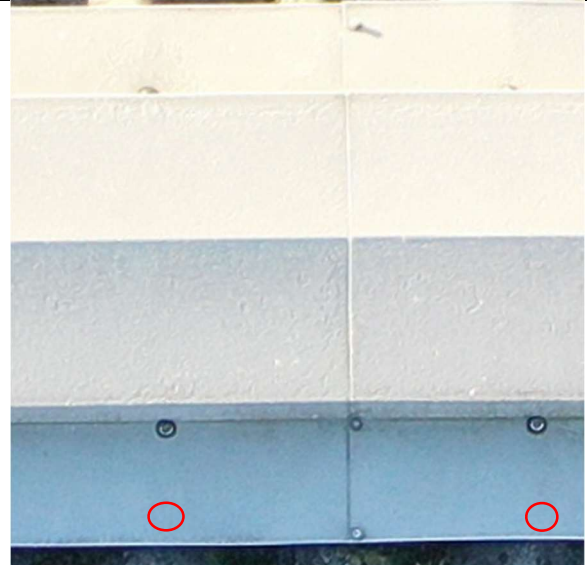
Ridge capping – this looks to have been replaced in the not-too-distant past.

Without knowing the manufacturer's details, we do not know the specification for the fixings, however, there should likely be some closer to the edge of the sheet e.g., where the red circle is.

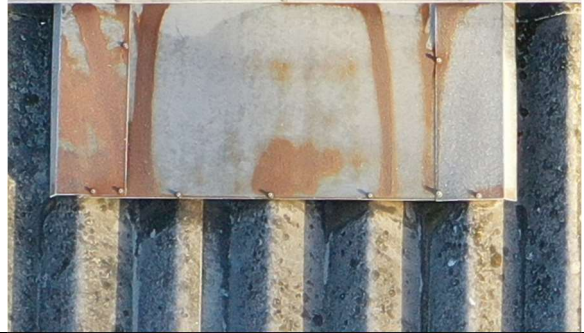
Corrosion is building up around the infill above the extractor.

A plan should be made to replace/treat these sections next year.

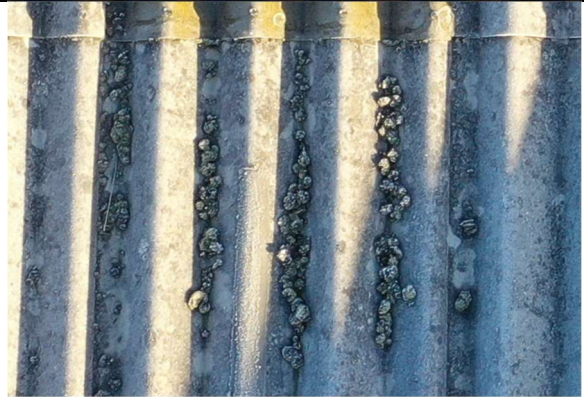
Moss is building up across most of the roof.

This should be killed and cleared off the pitch in the spring.

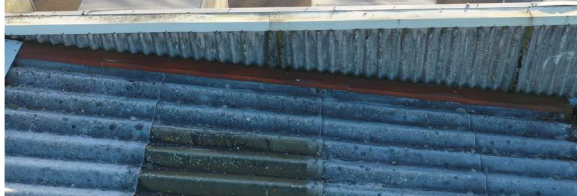
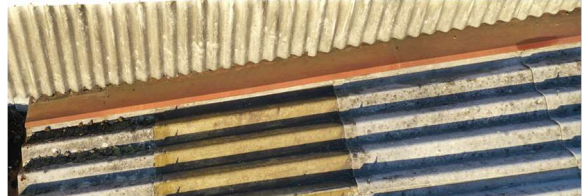
The abutment detail at the front and rear of the bay has corroded. The section still appears to be in one piece so preparation and treatment may be successful, however, the manufacturer would need to be appraised of the condition first.

If it cannot be treated, the sections should be replaced.

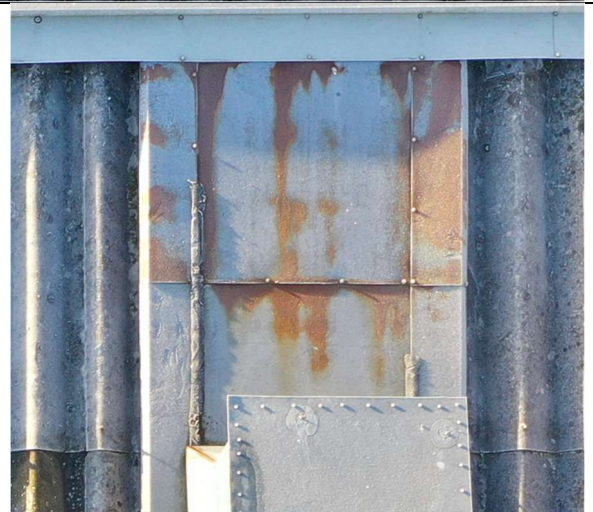
Corrosion is building up around the infill above the extractor.

A plan should be made to treat/replace these sections next year.

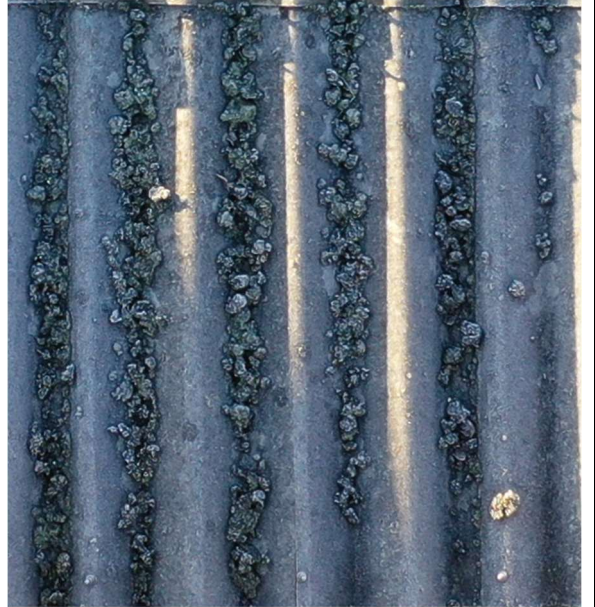
Moss is building up across most of the roof. This should be killed and cleared off the pitch.

The opposite is an example photo of the level of moss build-up.

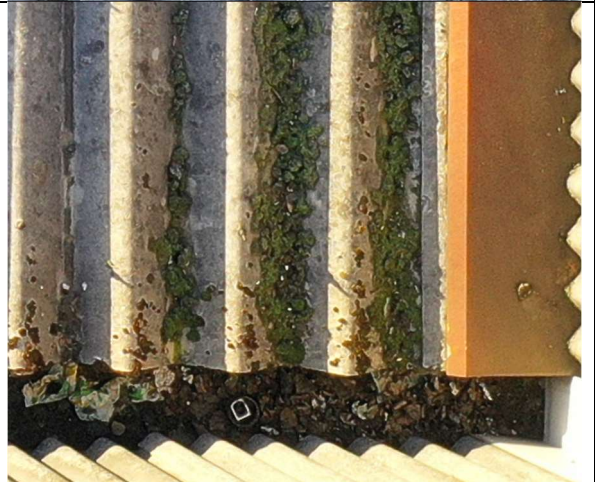
Guttering – example photos showing the amount of debris building up in the guttering run. This should be cleared out as soon as possible.

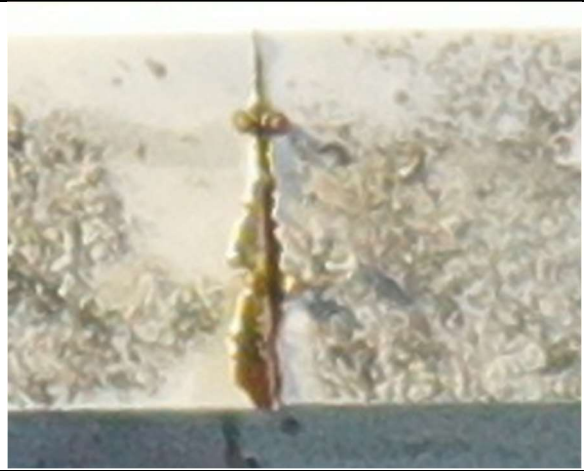
Example photo of cut-edge corrosion to the parapet capping detail.

All of the areas affected by this need to be prepared and treated to prevent them from decaying further.

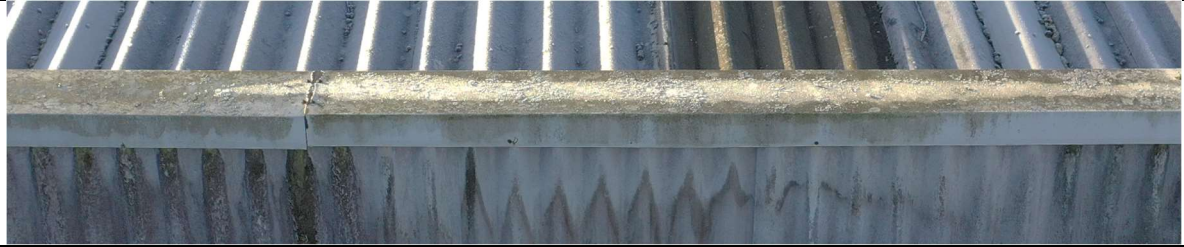
Example photo of the general condition of the parapet cappings.

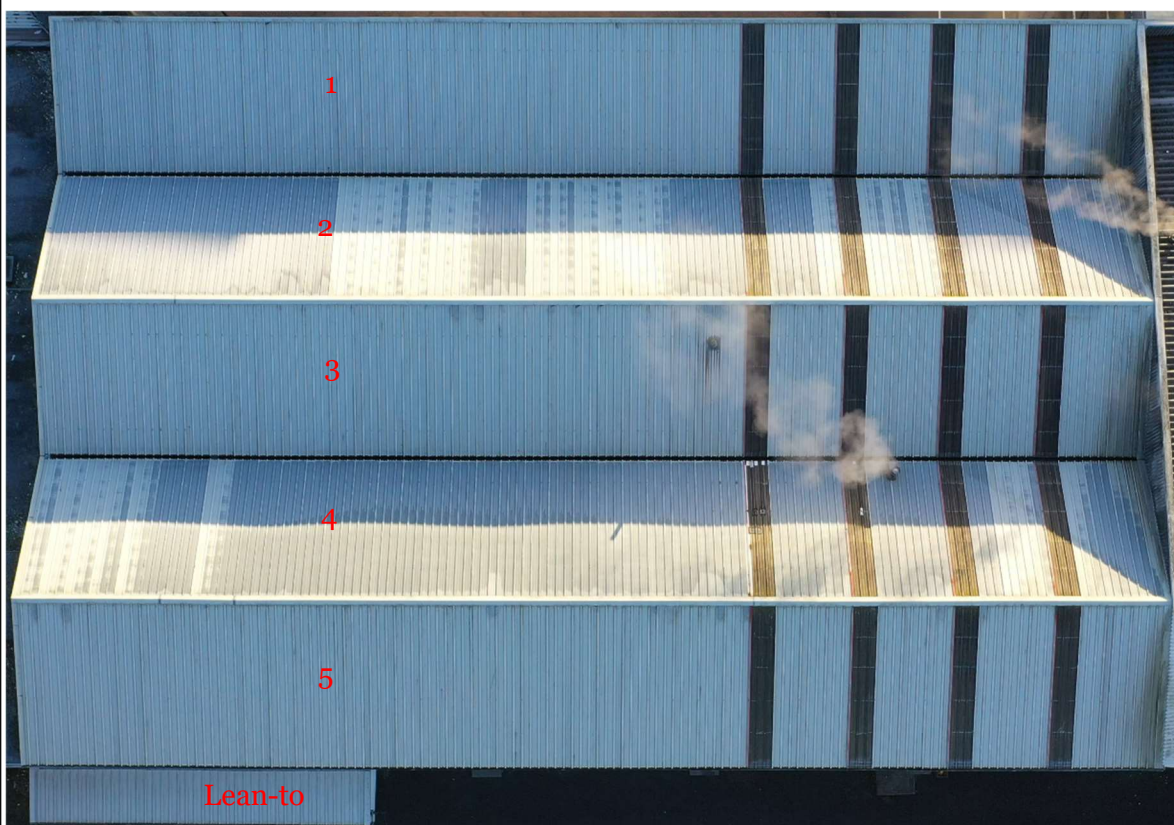
Example photo of the general condition of the cladding where Roof B and Roof C abut. The cladding is quite heavily stained.

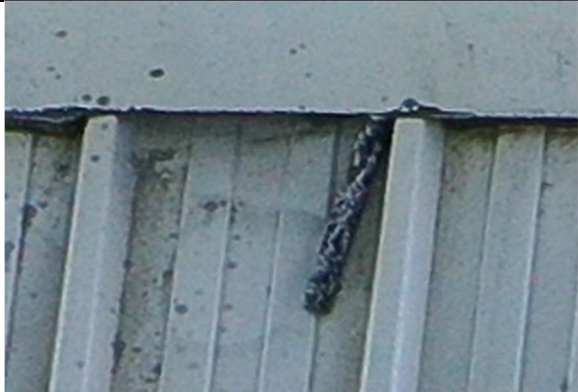
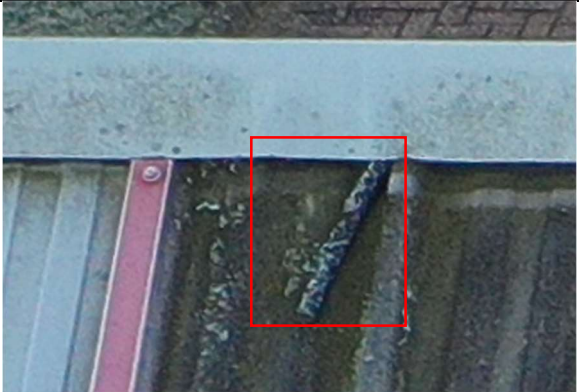
Ridge – examples of where the weather strip is slipping down the ridge. This should be replaced in the short term; we noted five areas of this happening.

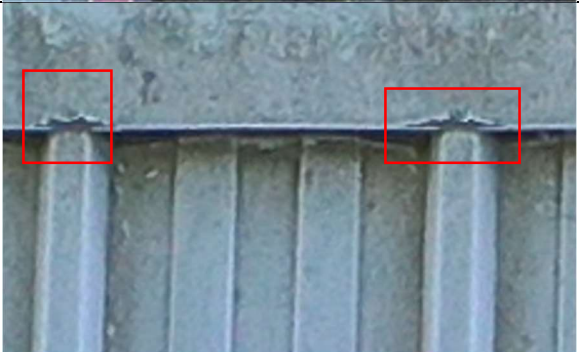
Example of the early stages of cut edge corrosion on the ridge capping. This runs the length of the ridge.

This should be cleaned up and treated.

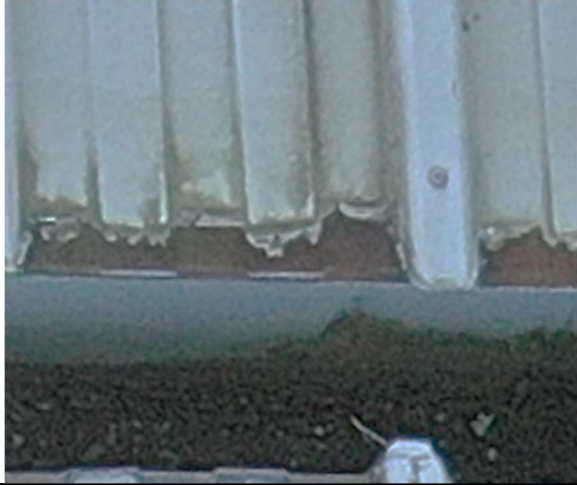
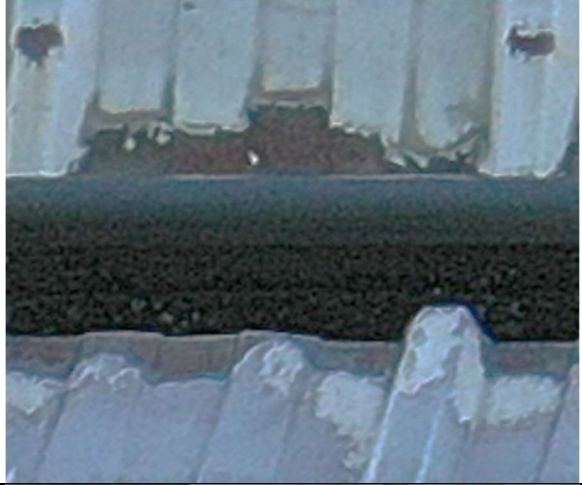
Example of cut edge corrosion at the bottom of all of the profiled sheets. A plan should be made to clean this up and treat it in the short term.

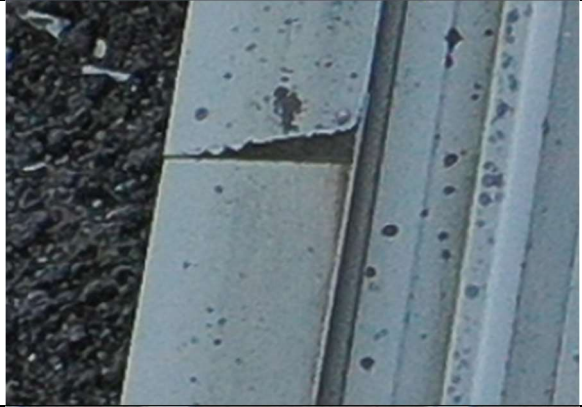
Example of corrosion on the perimeter capping detail.

These areas should be cleaned up and treated in the short term.

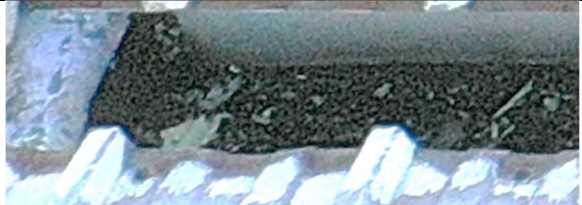
Box gutter – example photo of debris building up in the box guttering. This should be cleared out in the spring.

We cannot make out the outlet detailing as the bridge sun put this area in shadow.

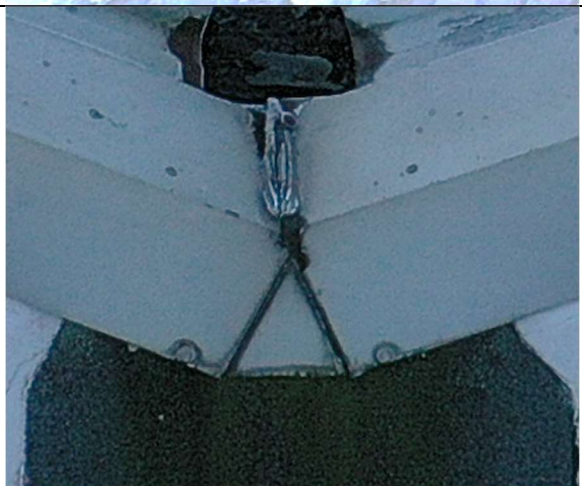
Parapet abutment of bay 1 and bay 2 – there is corrosion forming around the abutment.

This area should be cleaned up and treated.

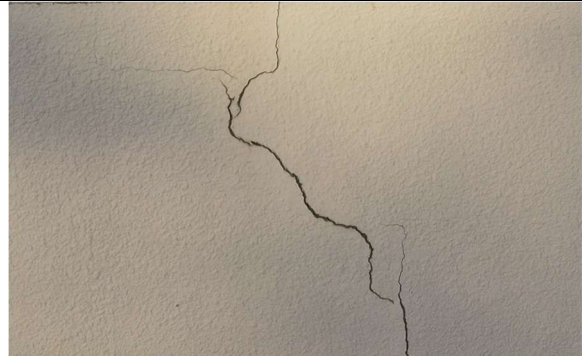
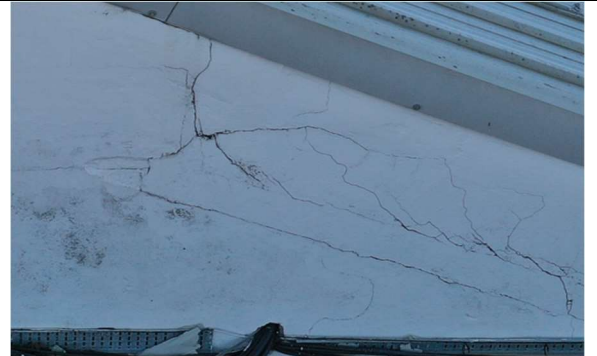
Although the elevations do not form part of this inspection, we noted that the render on the front and right-hand elevations of Bay 1 and 2 & 3 and 4 & 5 was cracked in a similar fashion to the cracks on Roof B.

These should be inspected and defects repaired as appropriate.

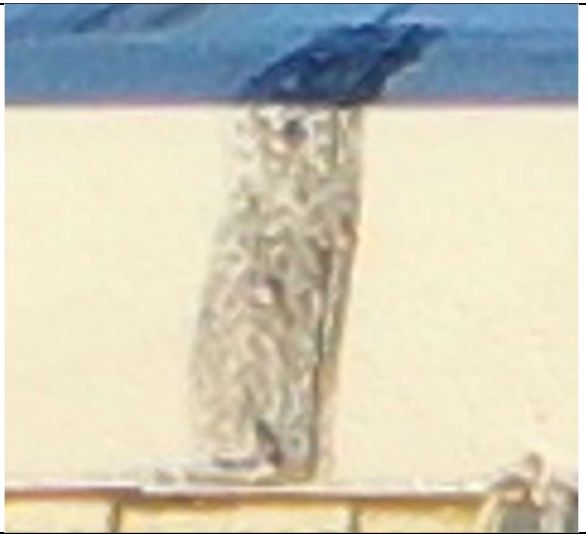
Bay 2	
<p>Ridge – it looks like there is corrosion treatment around the lap.</p> <p>This should be cleaned up and re-treated in the spring.</p>

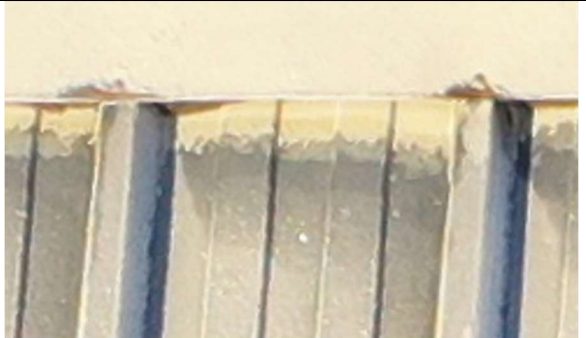
<p>Example of the early stages of cut edge corrosion on the ridge capping. This runs the length of the ridge.</p> <p>This should be cleaned up and treated.</p>

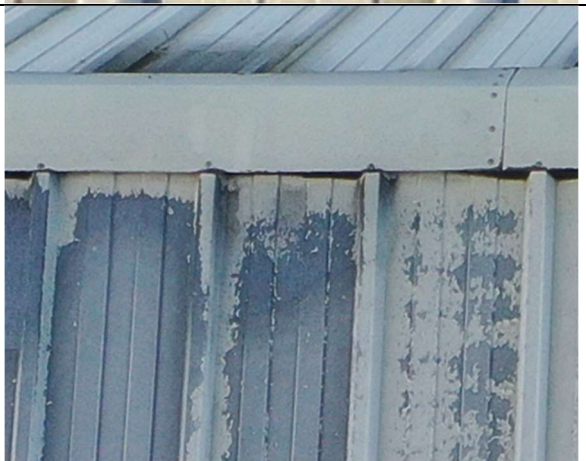
<p>From the different colours present on the five pitches, it looks like this roof may have been treated before, however, as the coating does not appear to be uniform, it will likely need retreating in the short term.</p> <p>You should see if any guarantees are in place for the last treatment.</p>

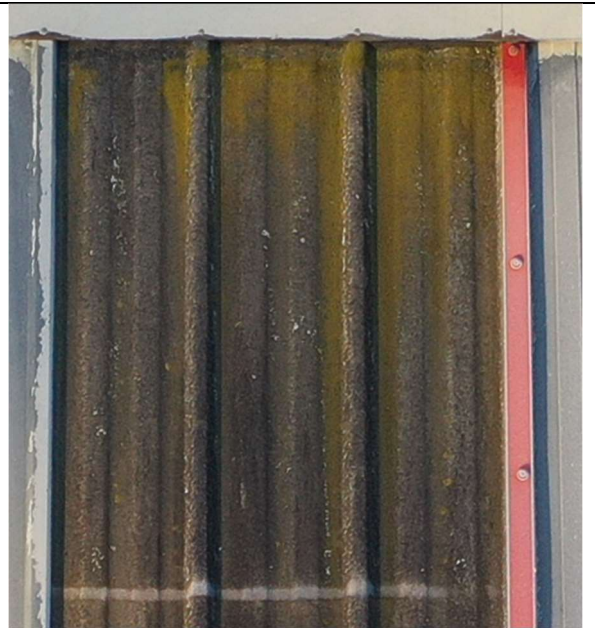
Example photo of where the rooflights have lost their transparency.

The rooflight sheets can be replaced independently of the rest of the covering.

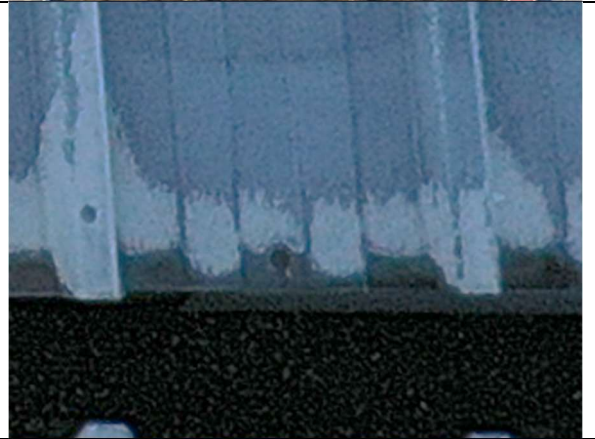
Example of cut edge corrosion at the bottom of all of the profiled sheets.

A plan should be made to clean this up and treat it in the short term.

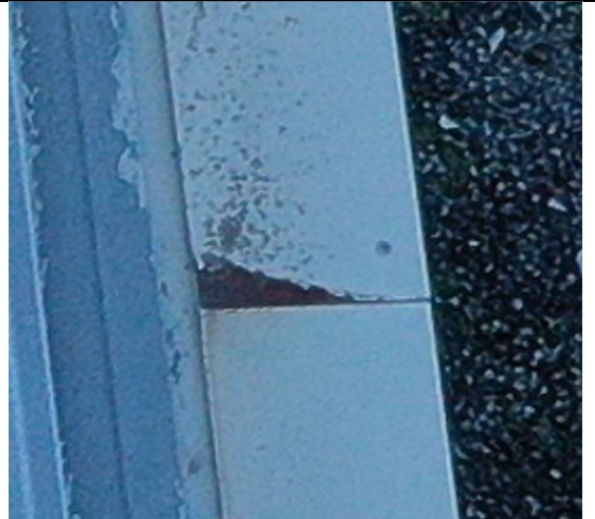
Example of corrosion on the perimeter capping detail.

These areas should be cleaned up and treated in the short term.

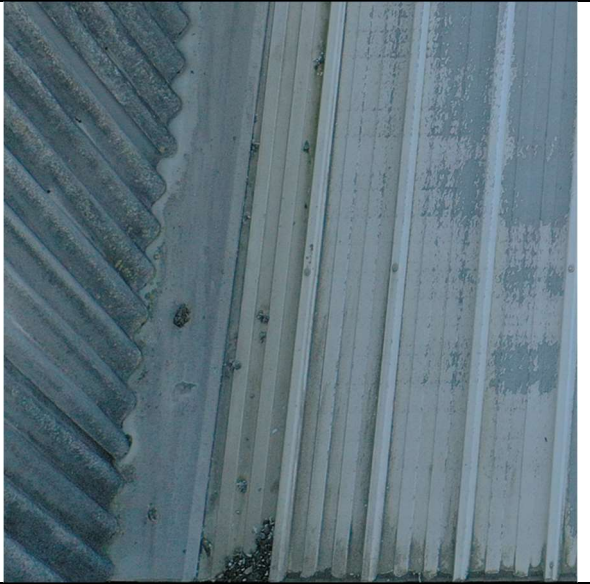
Example of staining to the covering from the capping on the adjoining Roof B.

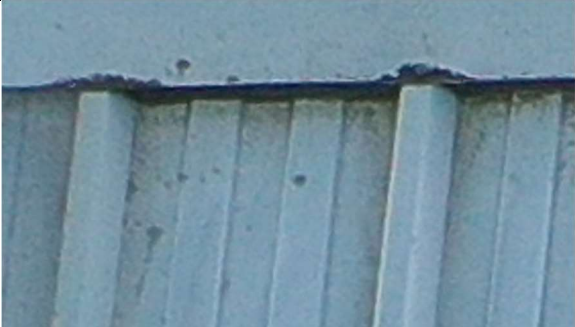
Bay 3	
<p>Example of the early stages of cut edge corrosion on the ridge capping. This runs the length of the ridge.</p> <p>This should be cleaned up and treated in the short term.</p>

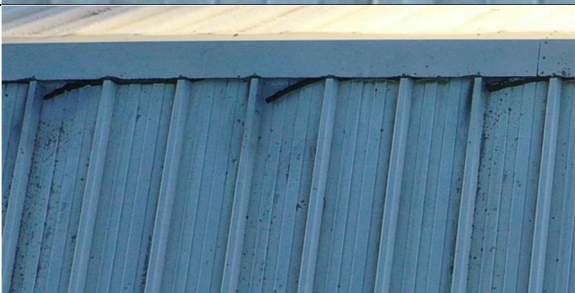
<p>Ridge – examples of where the weather strip is slipping down the ridge.</p> <p>This should be replaced in the short term; we noted three areas of this happening.</p>

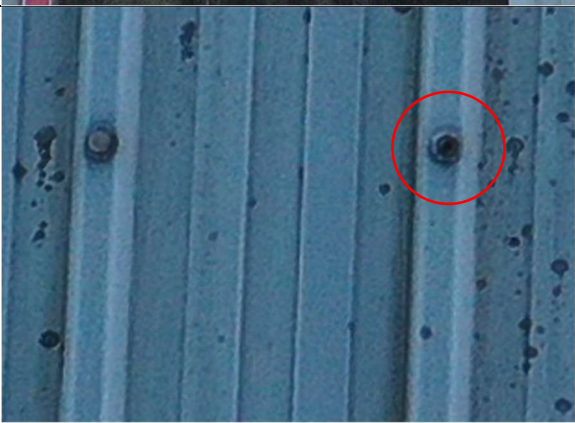
<p>Example of where it looks like a fixing has lost its head (red circle).</p> <p>Compare this to the left-hand fixing.</p>

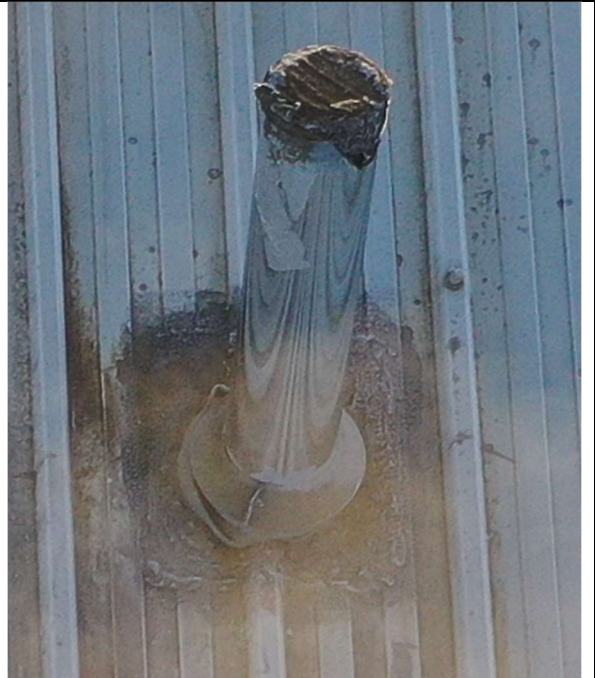
This penetration looks to be redundant. It has been poorly detailed where it comes through the sheet.

If it is redundant, it should be removed and the covering sheet overlaid.

If it is to be retained, a proper gasket boot should be fitted.

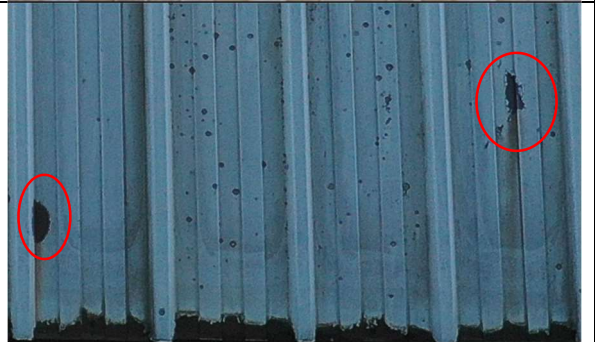
Isolated areas of corrosion need cleaning up and treating.

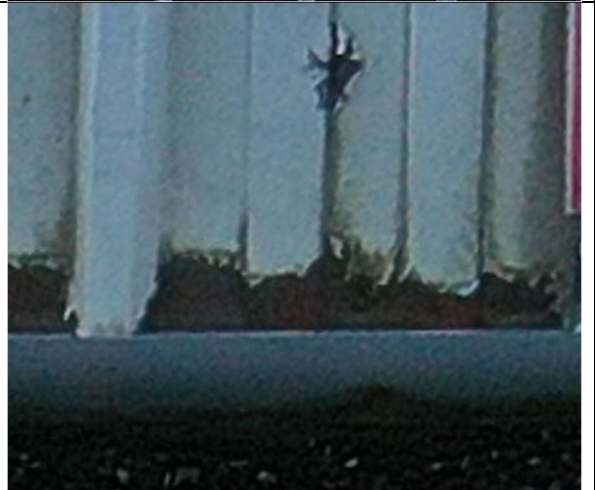
Example of cut edge corrosion at the bottom of all of the profiled sheets.

A plan should be made to clean this up and treat it in the short term.

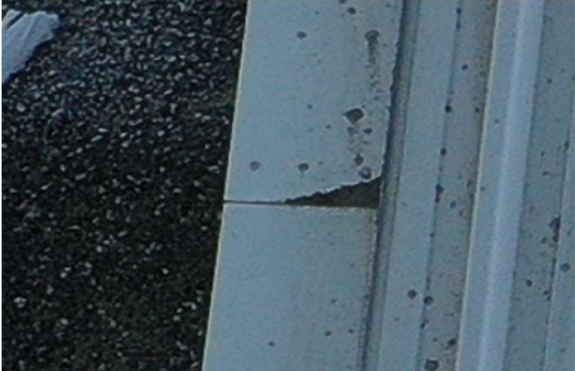
<p>Example of corrosion on the perimeter capping detail.</p> <p>These areas should be cleaned up and treated in the short term.</p>

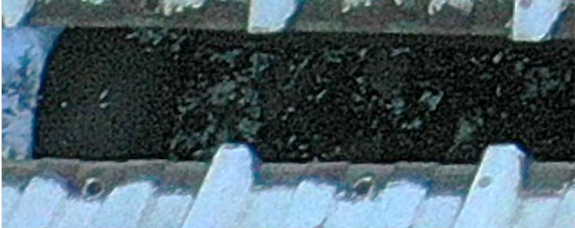
<p>Box gutter – example photo of debris building up in the box guttering. This should be cleared out in the spring.</p>

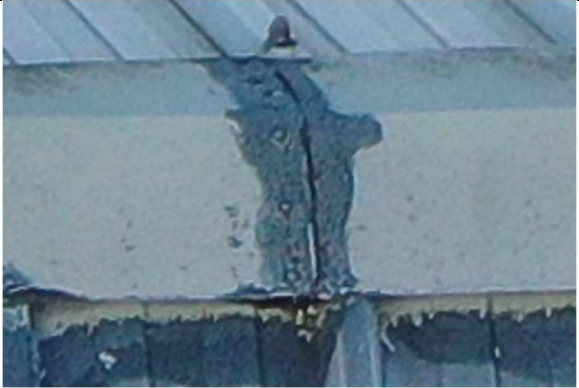
Ridge – previous corrosion treatment to the ridge is failing.

The area should be cleaned up and treated again in the short term.

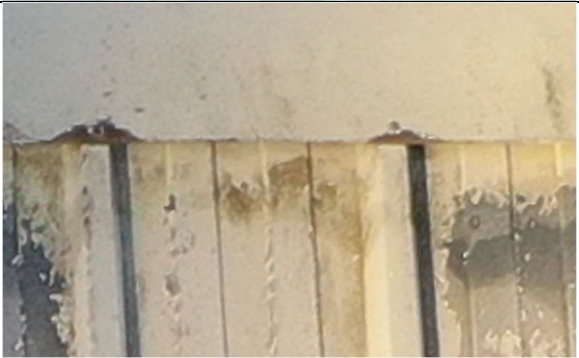
Example of the early stages of cut edge corrosion on the ridge capping. This runs the length of the ridge.

This should be cleaned up and treated in the short term.

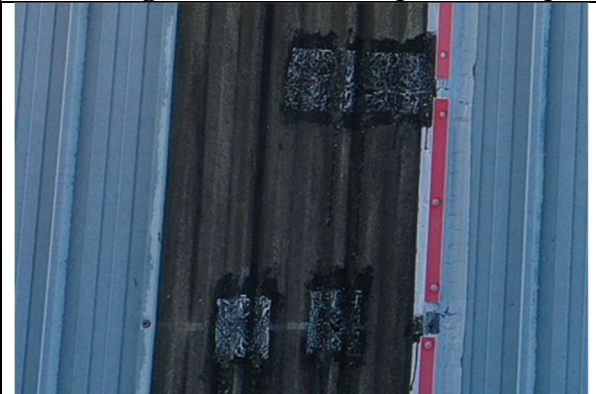
Example photo of where the rooflights have lost their transparency.

This one also has several repairs along the sheet including all of the way down the right-hand side and at the base, likely a sign of how brittle it is.

The rooflight sheets can be replaced independently of the rest of the covering.

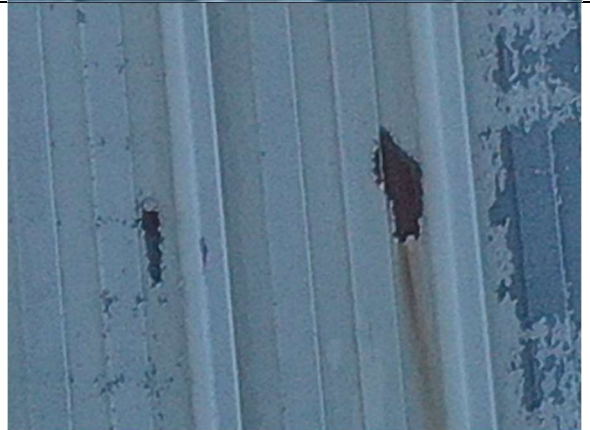
Example of cut edge corrosion at the bottom of all of the profiled sheets. A plan should be made to clean this up and treat it in the short term.

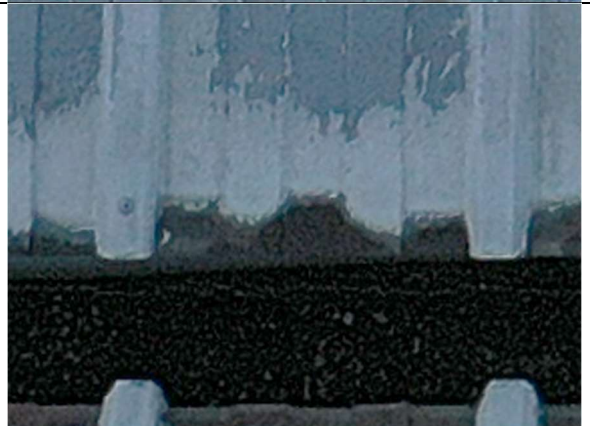
Example of corrosion on the perimeter capping detail.

These areas should be cleaned up and treated in the short term.

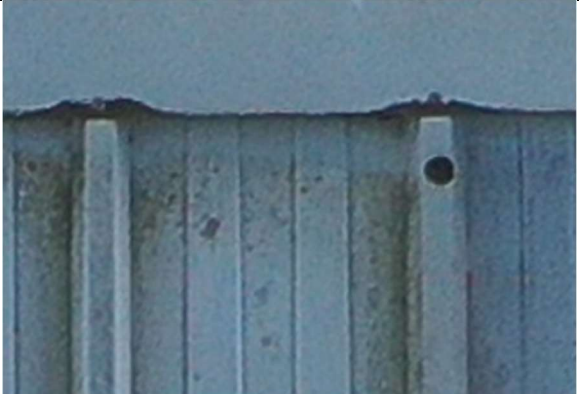
Bay 5

Example of the early stages of cut edge corrosion on the ridge capping. This runs the length of the ridge.

This should be cleaned up and treated in the short term.

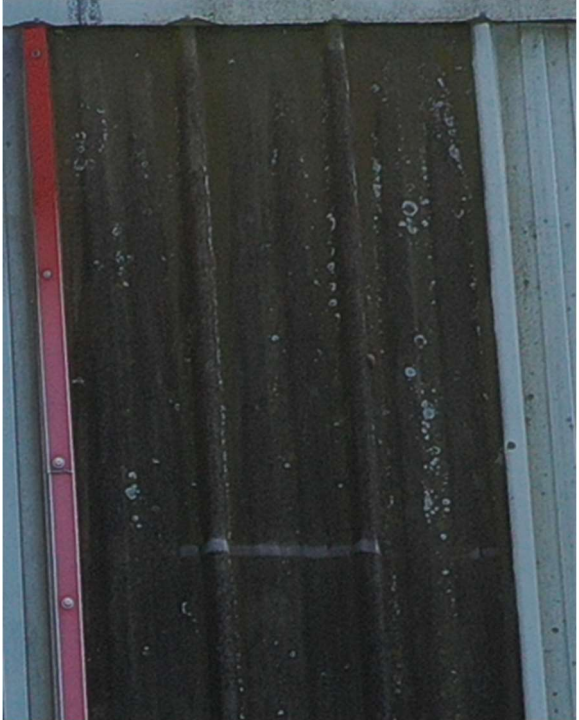
Example photo of where the rooflights have lost their transparency.

The rooflight sheets can be replaced independently of the rest of the covering.

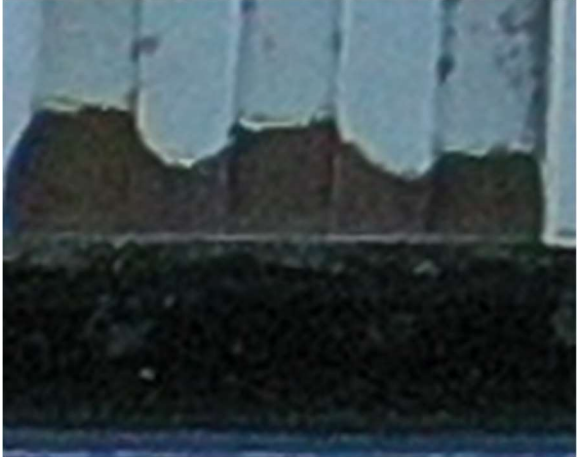
Example of cut edge corrosion at the bottom of all of the profiled sheets. A plan should be made to clean this up and treat it in the short term.

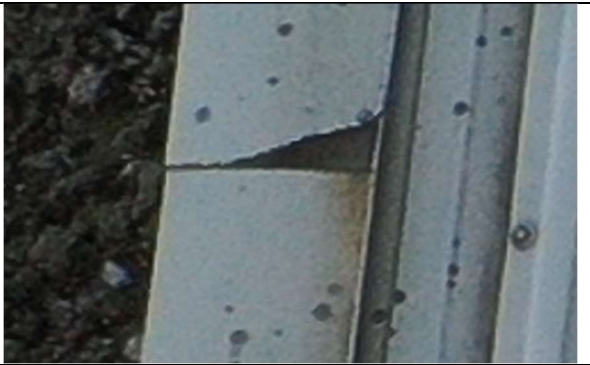
Example of corrosion on the perimeter capping detail.

These areas should be cleaned up and treated in the short term.

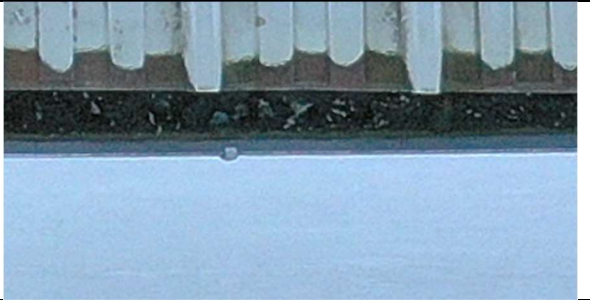
Example of cut edge corrosion at the bottom of all of the profiled sheets.

A plan should be made to clean this up and treat it in the short term.

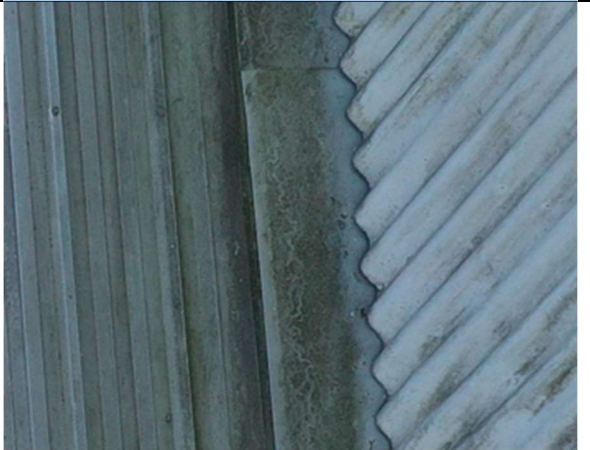
Example of staining to the covering from the capping on the adjoining Roof B.

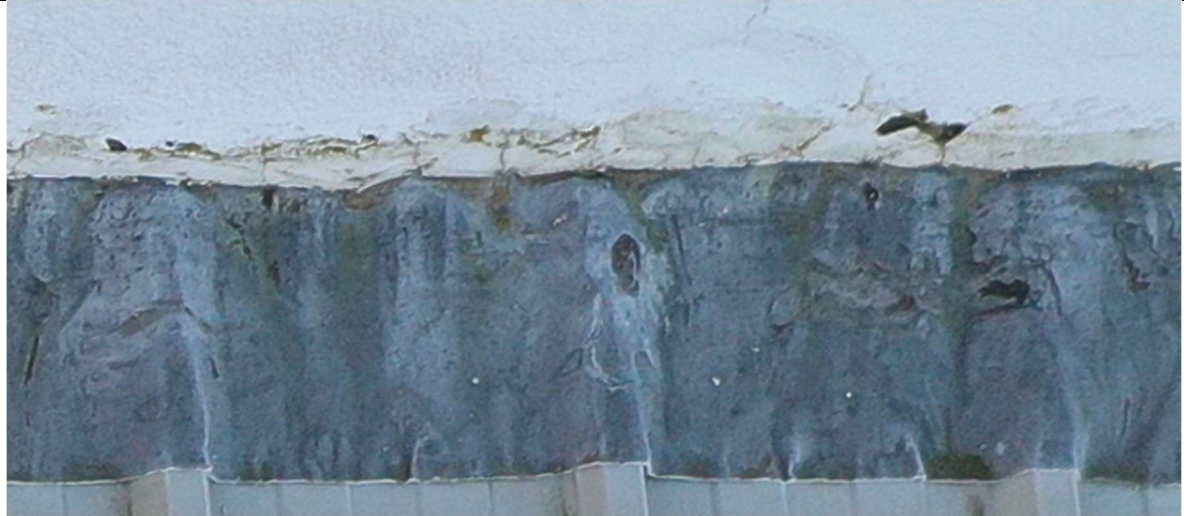
Lean-to

Flashing – the flashing detail appears to have no upstand and has been poorly detailed into the rear elevation of bay 5.

The sections also look to be too long, they should be no longer than 1200 mm.

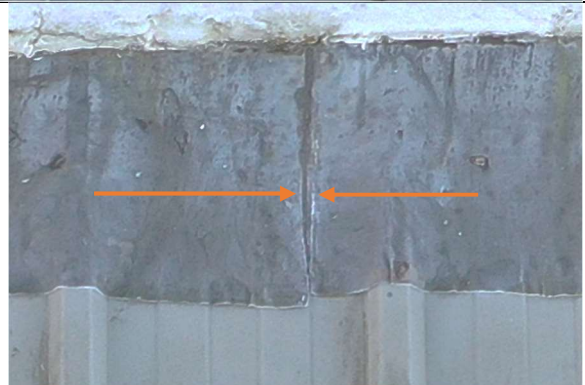
There is no lap detail where the flashing sections abut each other.

Lead is an odd choice of material to use for this job FYI.

The two sections should overlap by at least 150 mm.

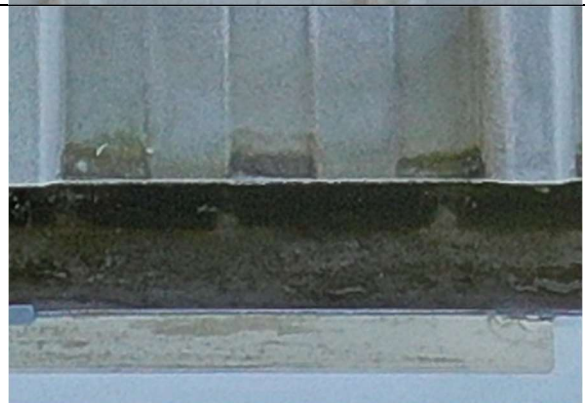
Early signs of cut-edge corrosion at the foot of the panels.

This should be treated in the short term to prevent it from getting worse.

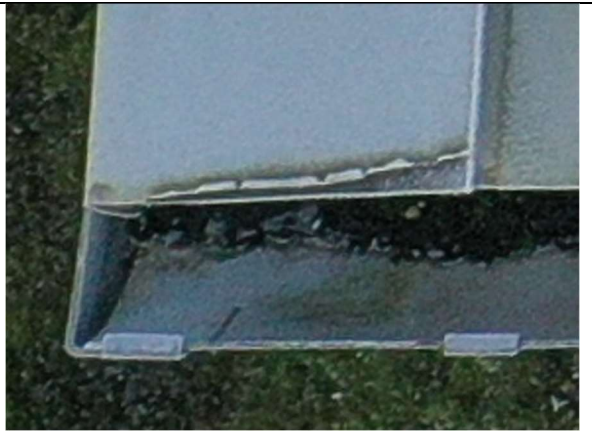
Verge cappings – the coating is peeling off the panels – these areas should be cleaned up and treated before corrosion takes hold.

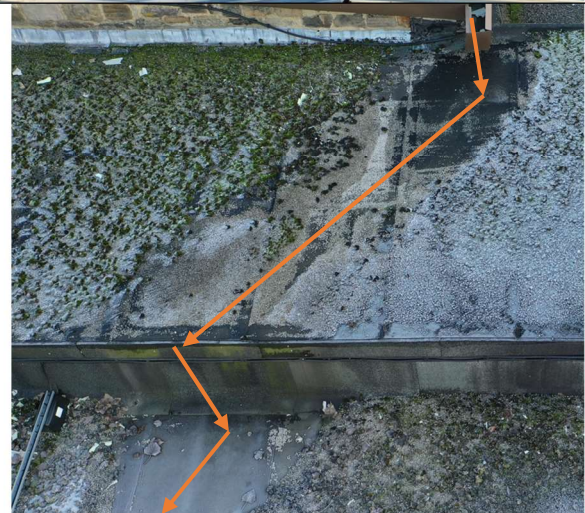
Rainwater is discharging from the guttering of Roof G onto Roof D and in doing so, is displacing the solar reflective chips and accelerating the decay of the felt.

A suitable run of fall pipes should be added to the Roof G guttering run to take the rainwater to the guttering run at the edge of Roof D.

The missing chippings can then be replaced.

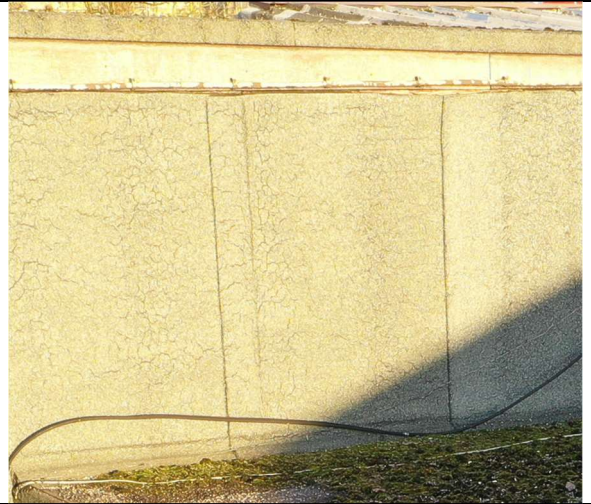
Upstand detail with Roof F – this looks to have been detailed in mineral felt which is not suitable for this detail.

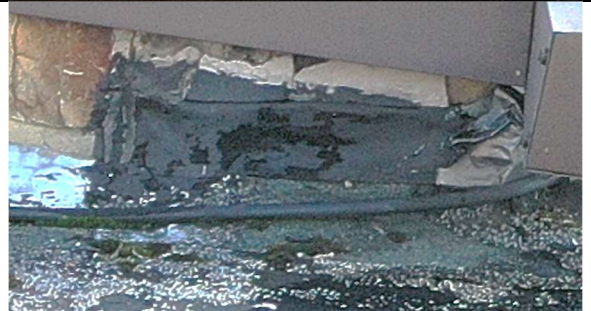
The upstand detail where Roof D abuts Roof G is in poor condition and should be reformed in lead in the short term.

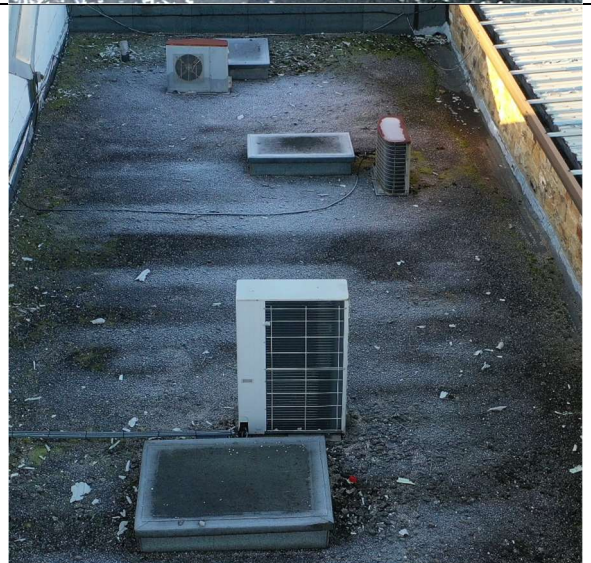
Plant – the weight of the plant can cause the roof to deflect where it is sited.

Any leaks of refrigerant can also cause chemical decay to the covering.

Any redundant plant should be removed in the short term and any plant in use should be checked for leaks.

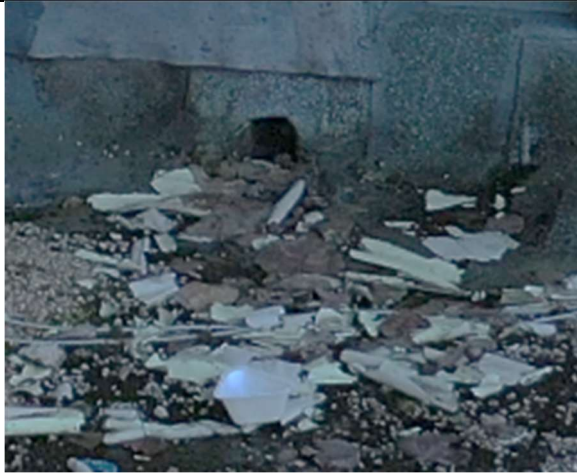
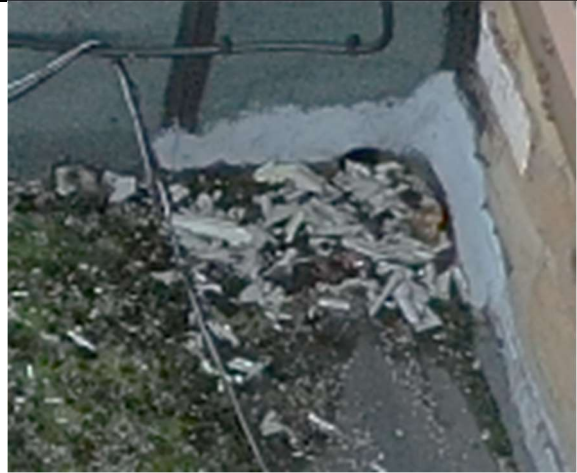
Rainwater outlets – these are choked with debris and should be cleared out and tested in the short term. Once the moss and debris are cleared, service media should be properly affixed and the roof should then be dye tested to check that it discharges rainwater correctly.

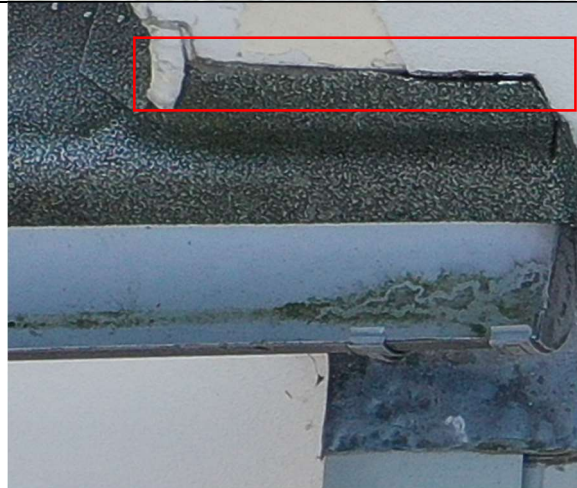
Rear left-hand upstand – the upstand does not look to be detailed into the elevation and rainwater will likely get behind here and may cause problems with penetrating dampness internally.

The upstand should be correctly detailed in the short term.

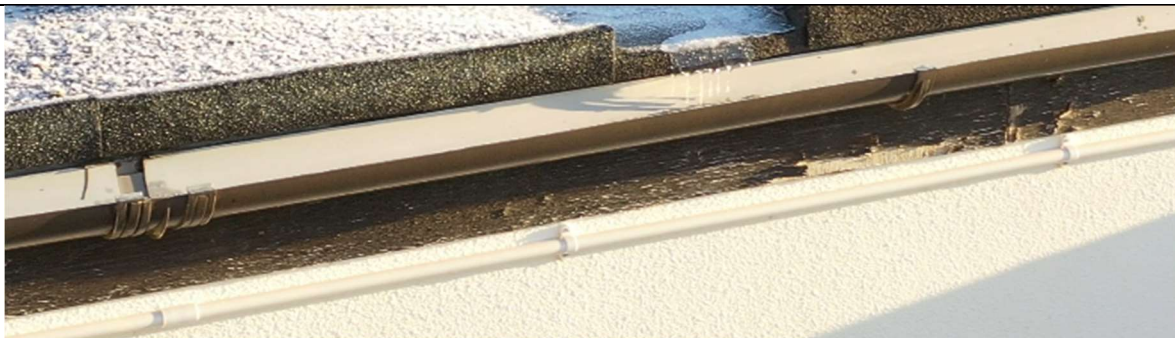
Guttering – there is only a small amount of debris in the guttering. This should be cleared in the spring. Paint is peeling off the timber fascia board holding the guttering.

This should be prepared and redecorated in the spring. Linseed oil-based paint should be used to decorate timber.

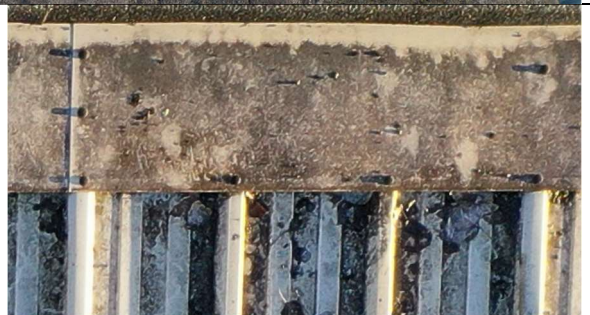
Ridge capping – this is in poor condition and should be cleaned up and treated in the short term to prevent further decay.

If the sheets have become too brittle to safely put fixings through without the wind tearing them out, then the cappings will need to be replaced.

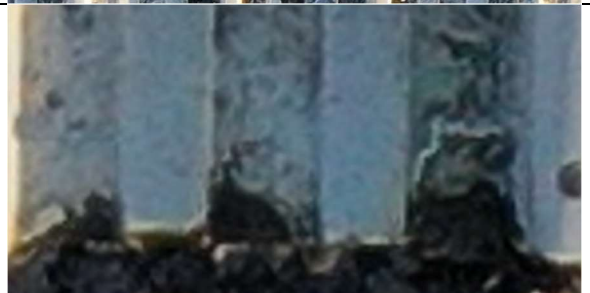
There is cut-edge corrosion along the length of the foot of the sheets.

This needs treating in the short term to prevent further decay of the sheets.

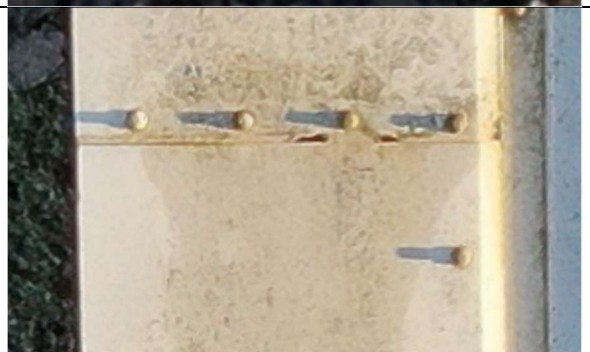
Perimeter cappings – an example of the early stages of corrosion. These areas should be cleaned up and treated to prevent further decay.

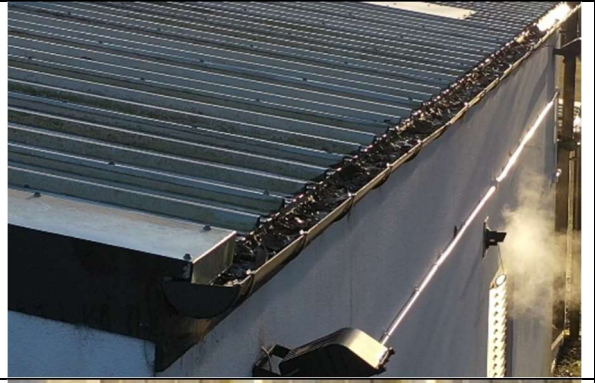
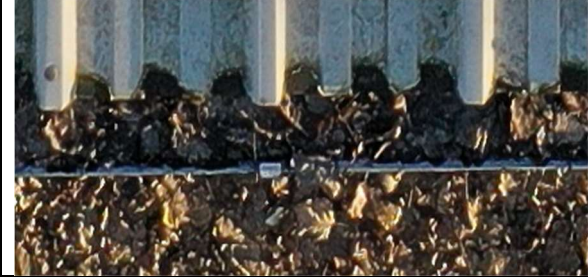
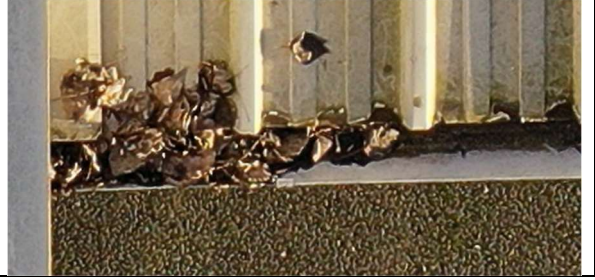
Guttering – the main and off-shot guttering runs are blocked with leaves. These should be cleared in the short term and on a regular basis thereafter.

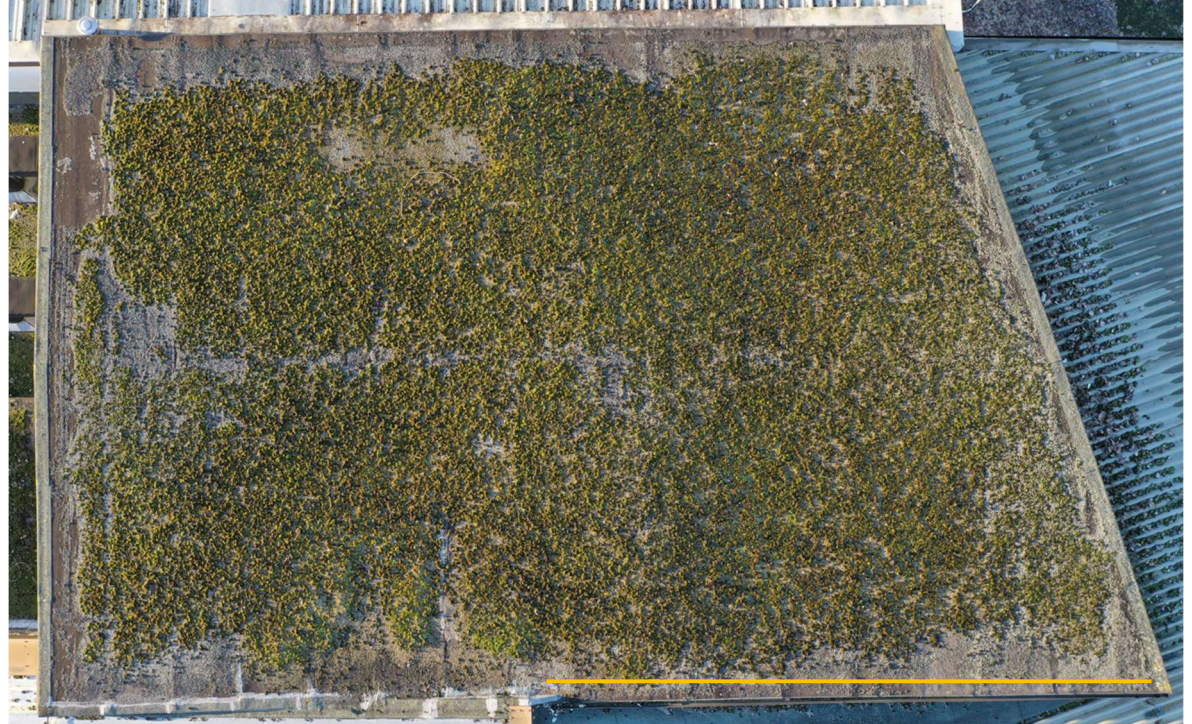
Overhead photo of the roof. Virtually all of the roof is covered in a thick layer of moss. This is a sign that the roof is not draining properly and that it is permanently wet. The moss needs to be killed and removed in the spring and the roof should then be reinspected for defects.

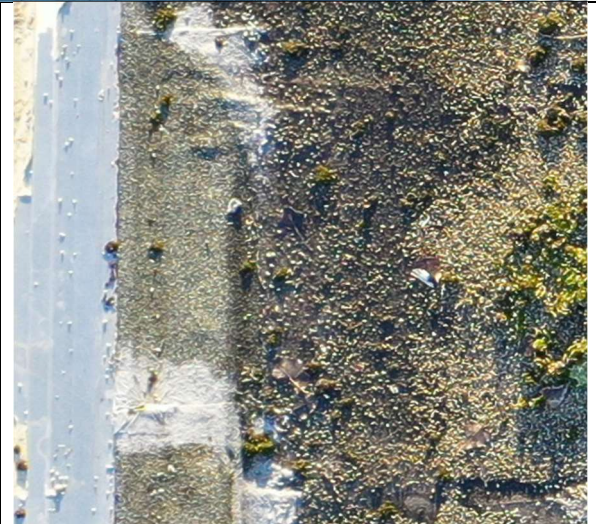
Example photo of 'paint-on'-type repairs. These should only be considered short-term repairs.

The defect should be permanently repaired in the spring.

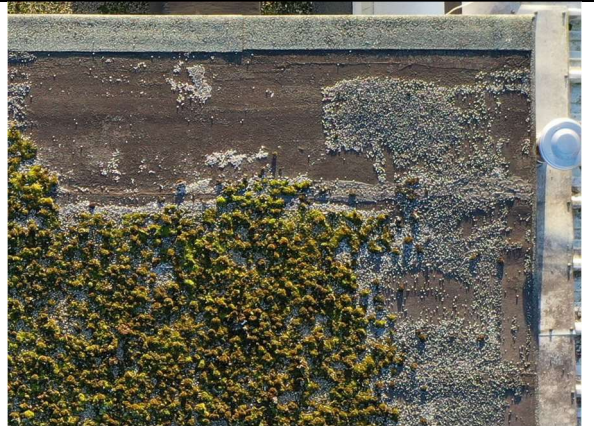
An example photo of where the solar reflective chippings are missing.

Where the chips are missing, the UV will accelerate the decay of the felt.

These areas should be re-covered in chippings once the moss has been removed.
