# Roof Inspection Report

Report produced by Simon Hollis MRICS

22<sup>nd</sup> December 2022

Drone Inspection Report - Summary of Findings

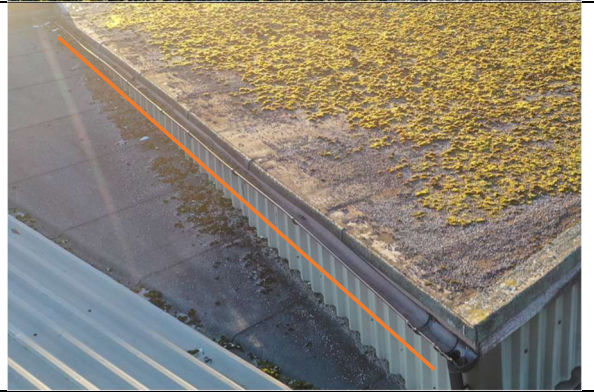
Guttering run – the fall of the pitch should be tested to see if it adequately discharges rainwater into this run.

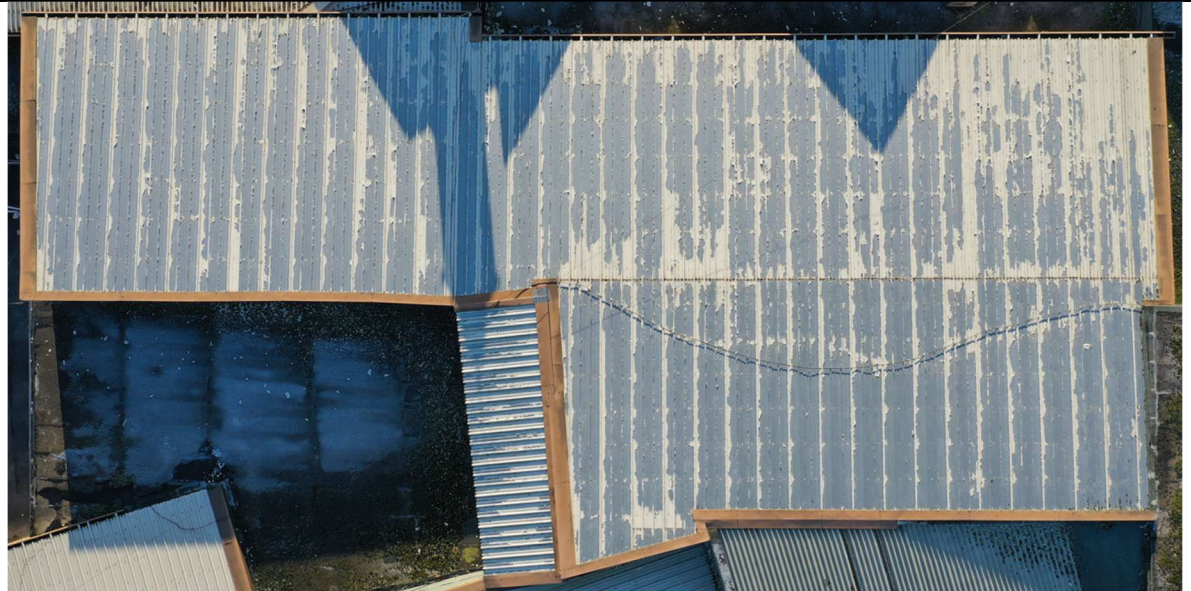
Overhead photo of the roof pitches.

It looks like the roof has been overcoated before, however, this is now peeling off across all of the covering. A plan needs to be made to address this before more serious corrosion sets in.

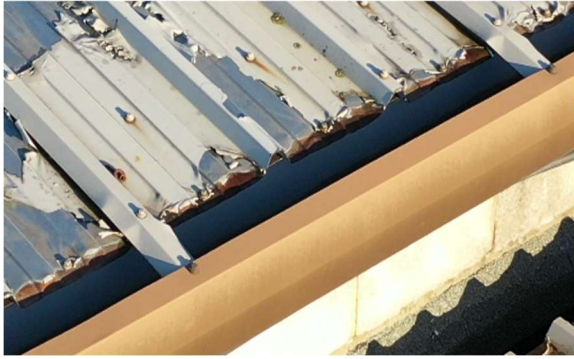
Example photos of the poor condition of the profiled sheets. There is cut edge corrosion all along the foot of the roof and all along where the sheets abut.

Urgent action is required to address this.

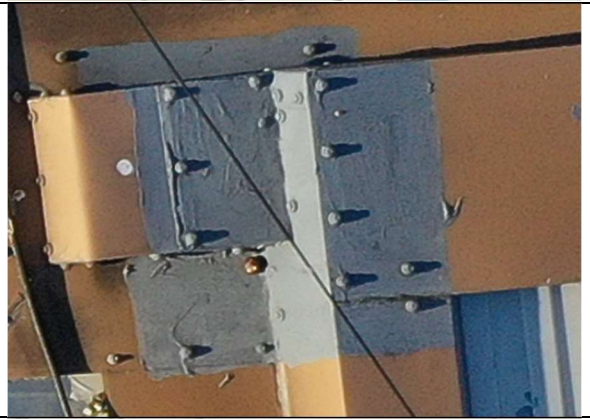
A 'paint-on'-type product has been painted over several of the capping pieces, presumably due to a leak in the area.

This is only a short-term solution and the defect should be located and appropriately repaired permanently.

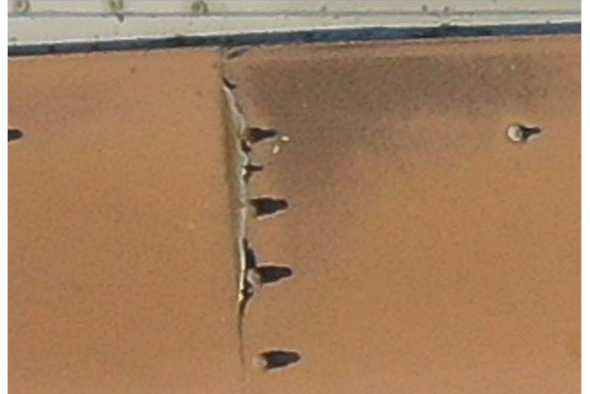
An example photo of the coating beginning to peel off the capping sections.

These areas should be cleaned up and treated in the short term to prevent further decay.

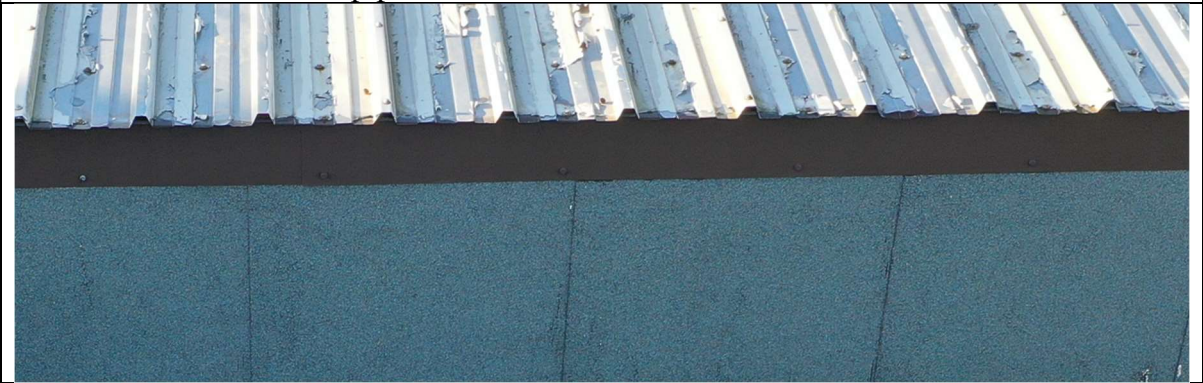
Guttering – there is no guttering under the smaller section of roof at 90° to the main pitch.

A suitably sized run of guttering should be added together with a fall pipe to take the rainwater to the main fall pipe.

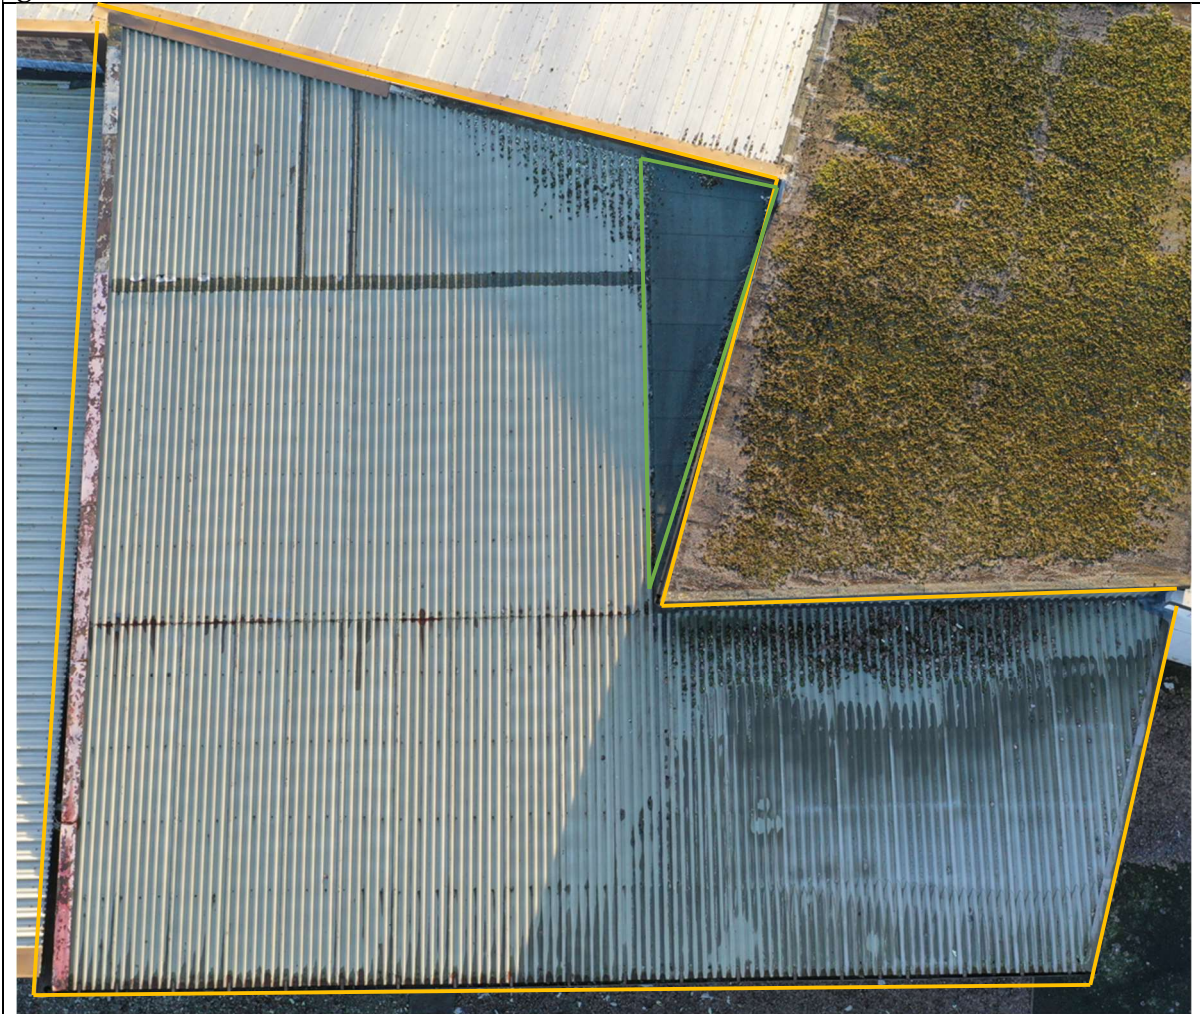
Overhead photo – the main pitch is outlined in orange and the mineral felt area is in green.

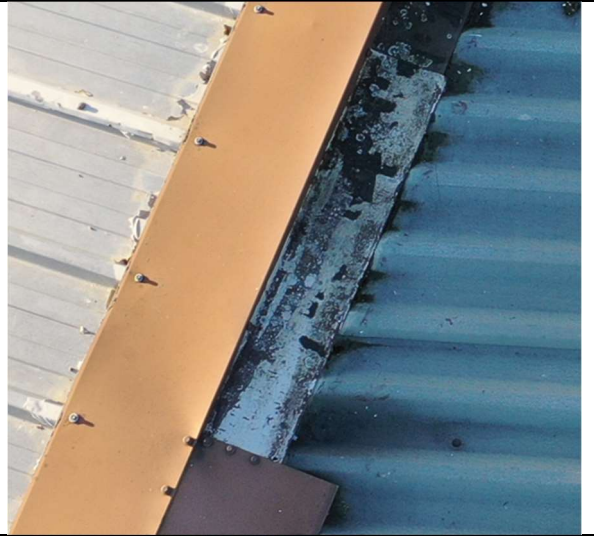
Ridge – the ridge detail with the adjoining pitch is inconsistent in its detail.

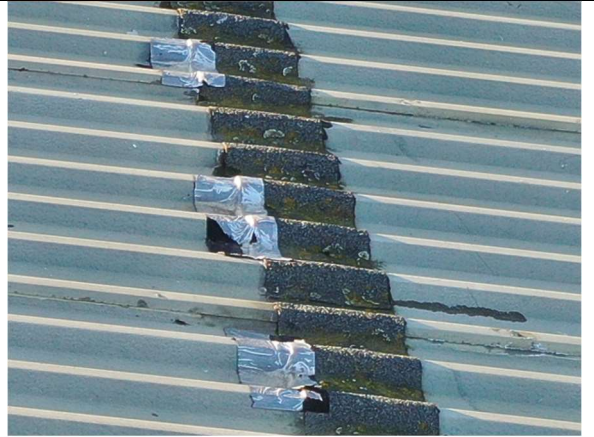
Example photo of where two sheets have had mineral felt applied across the abutment. The sheets are likely to be corroding under this.

Several other repairs have been undertaken in Flashband above (to the left in the photo).

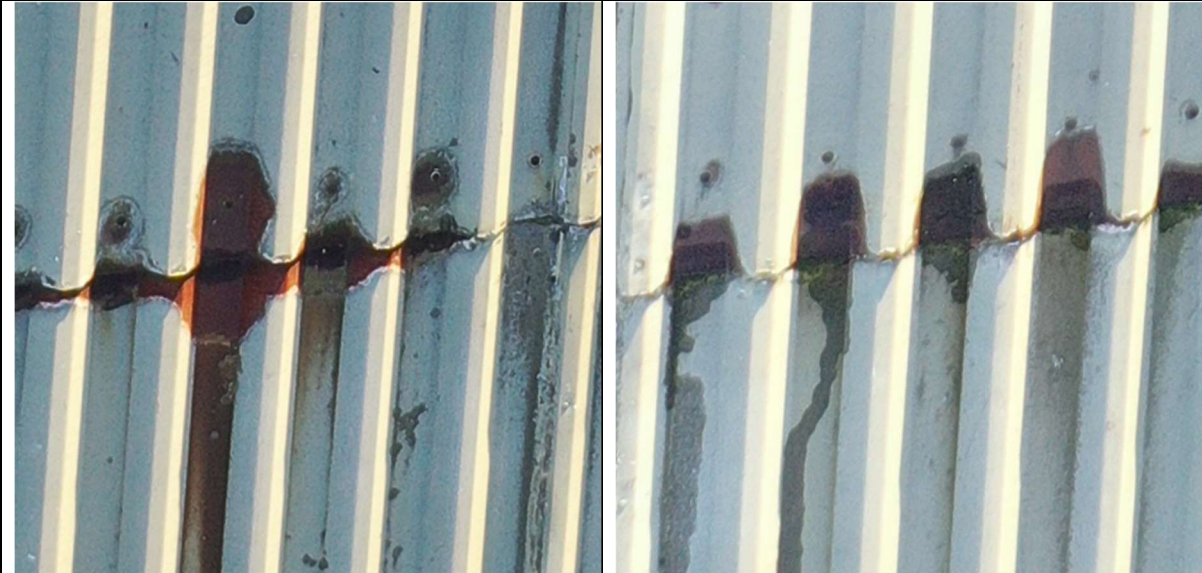
Example photos of the cut edge corrosion where the sheets abut. This needs cleaning up and treating in the short-term.

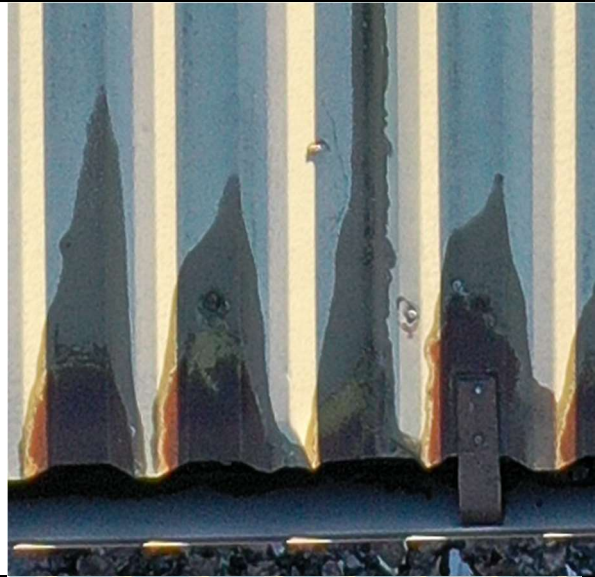
Example photo of the cut edge corrosion at the foot of the sheet.

This needs cleaning up and treating in the short-term to prevent further deterioration of the sheets.

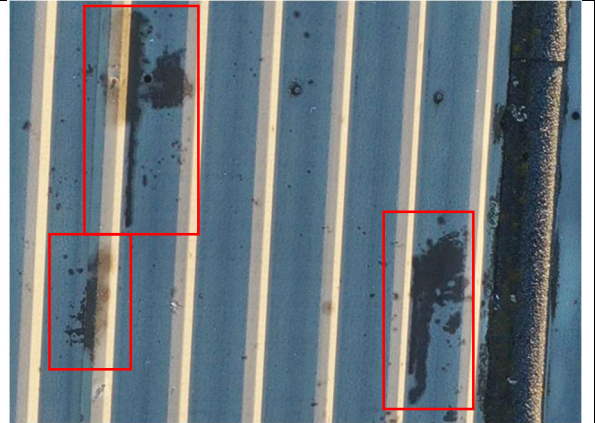
Example photo of isolated areas of corrosion.

This needs cleaning up and treating in the short-term to prevent further decay.

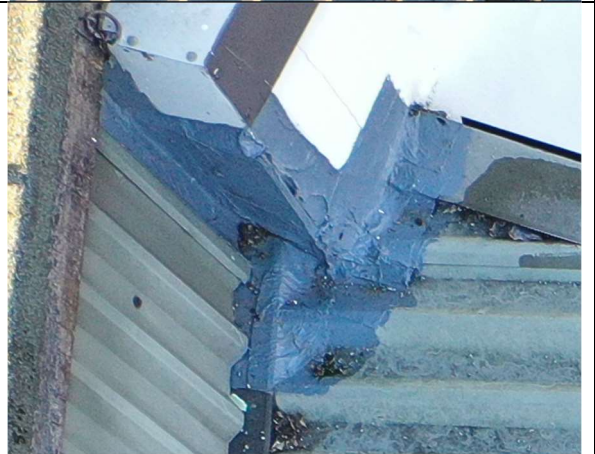
The rear of the pitch – a paint-on type product has been daubed all over the covering and upstand.

A permanent repair should be affected in the spring.

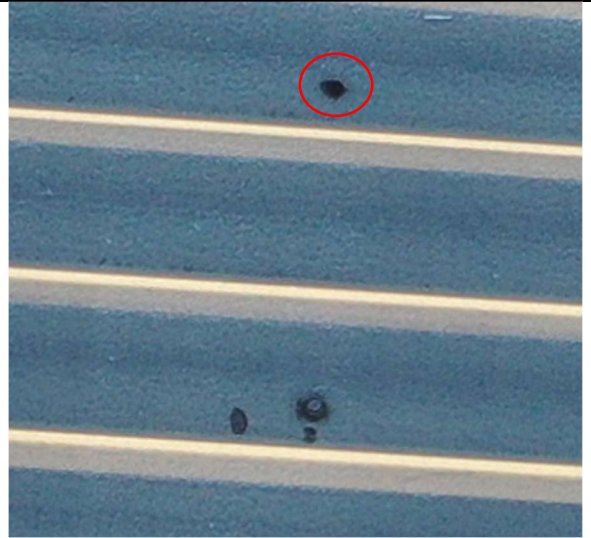
Red circle – an example of where it looks like a fixing head has come away. There are several fixings like this across the pitch.

They should be checked in the spring and any defective fixings replaced with suitable non-ferrous ones.

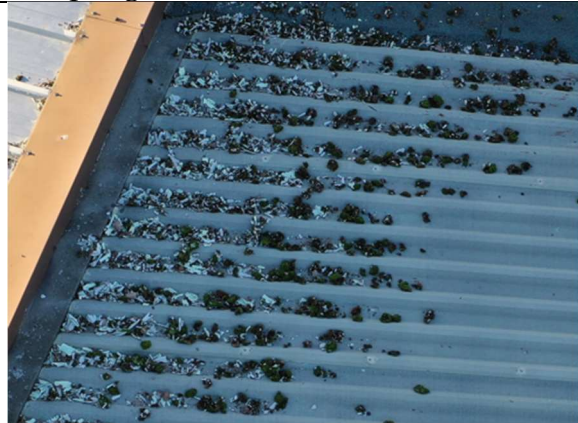
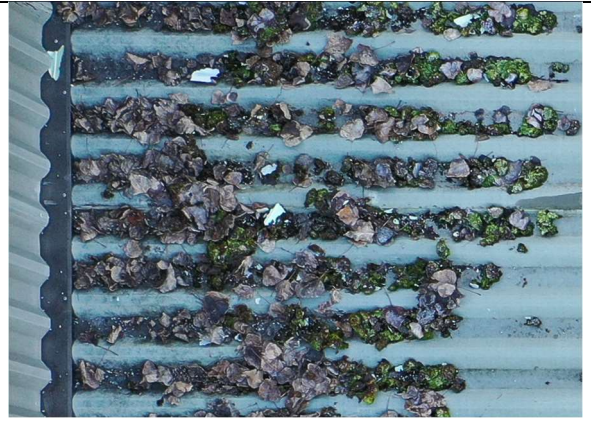
Example photos of debris building up across the pitch. This should all be cleared away in the spring.

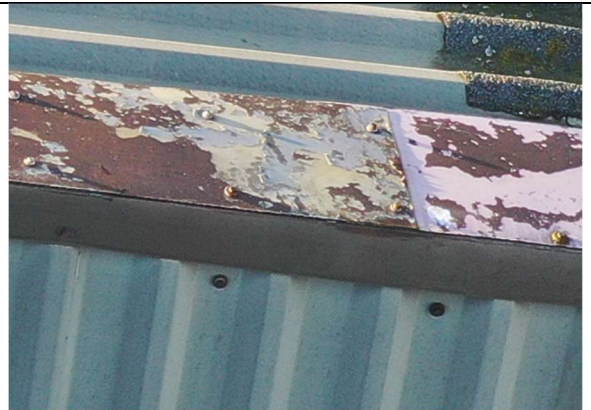
Example photo of corrosion along the verge cappings.

These are likely past the point of being treated now and may need to be replaced.

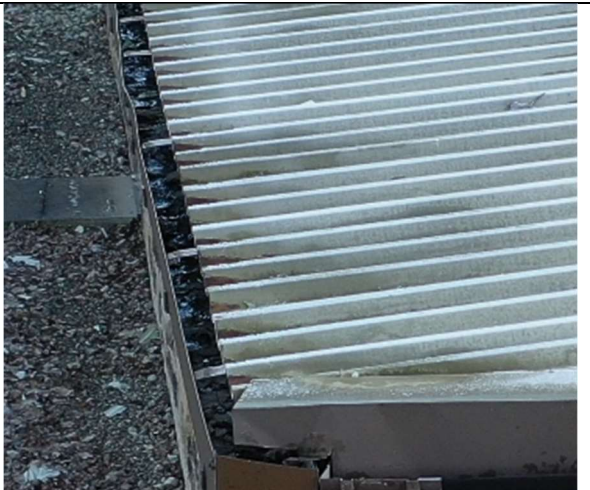
Guttering – the debris in the guttering should be cleared out in the spring.

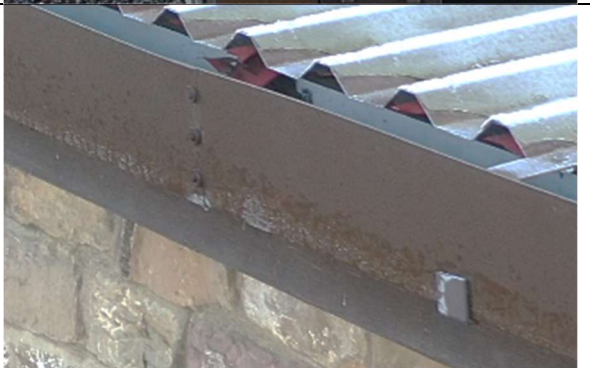
Guttering – the finish is flaking along the bottom edge. This should be treated in the spring.

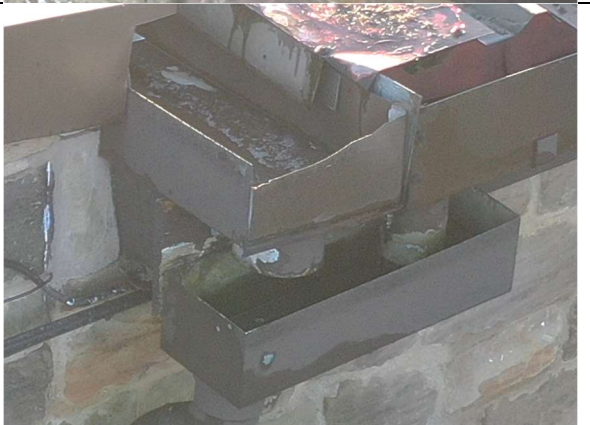
Guttering – there is corrosion around the end of the box gutter runs. This should be repaired in the spring.

The outlet from Roof I should be taken further down into the hopper.

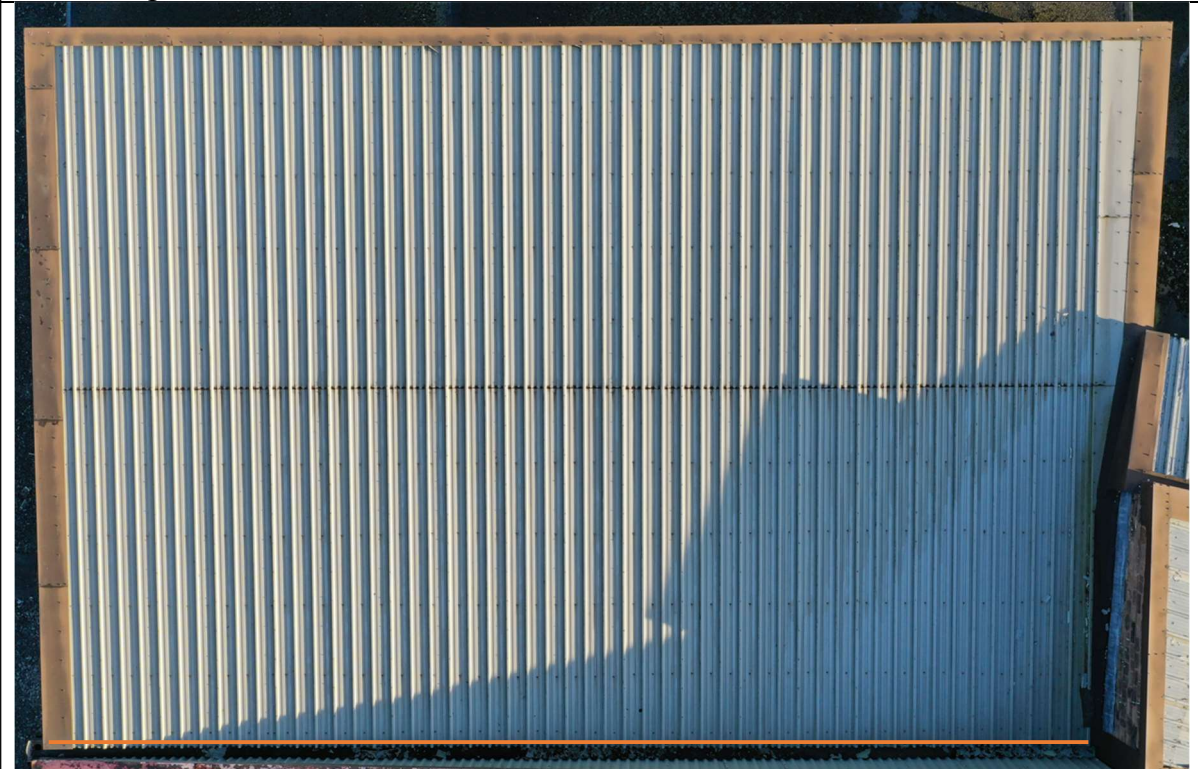
Overhead photo of the roof.

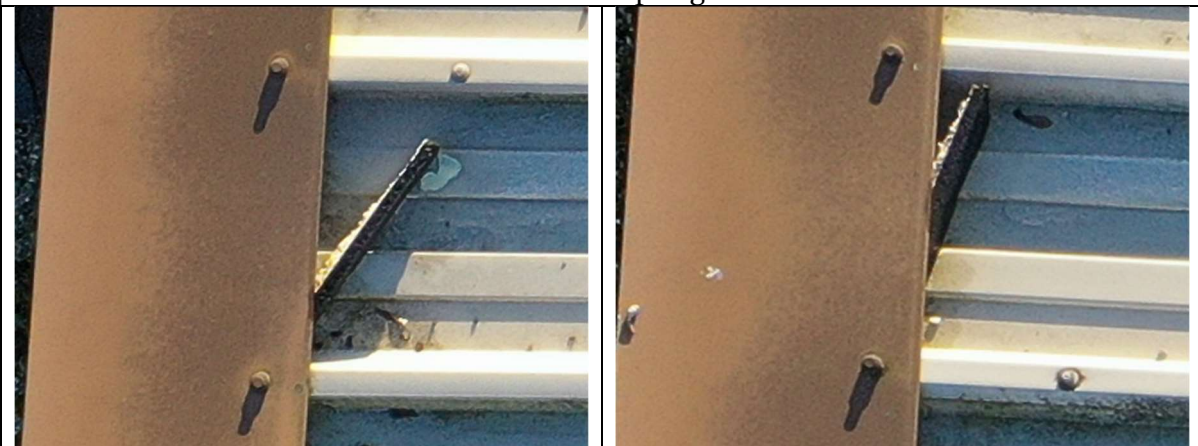
Example of the weather strip coming away from under the capping detail. This should be reaffixed and the other sections checked in the spring.

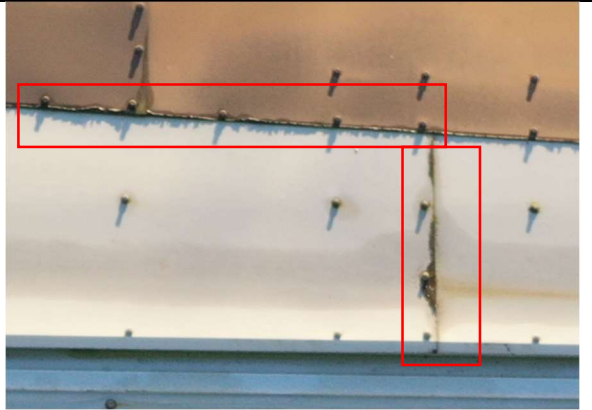
Example of corrosion on the verge capping sections.

This should be cleaned up and treated to prevent further decay.

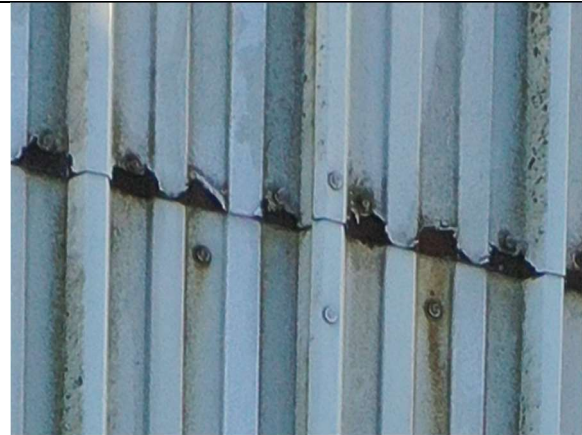
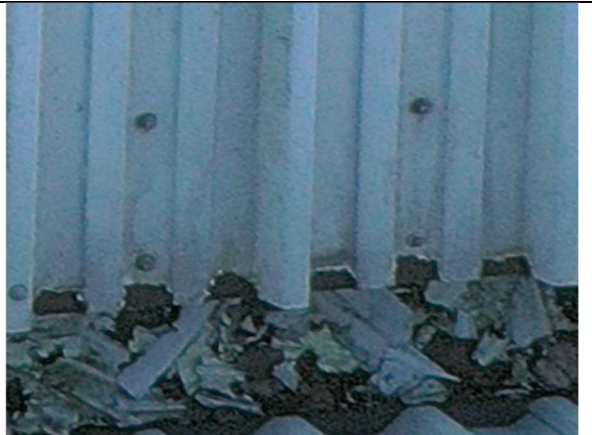
Example of cut edge corrosion where the roofing sheets abut each other and at the foot of the sheets. This needs cleaning up and treating in the short-term to prevent further deterioration of the sheets.

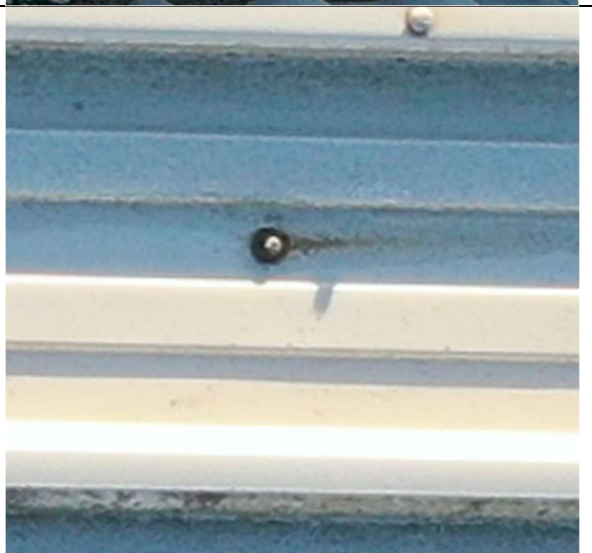
Example photo of corrosion staining around the fixings. This needs to be monitored and the fixings may need to be replaced, non-ferrous fixings should be used.

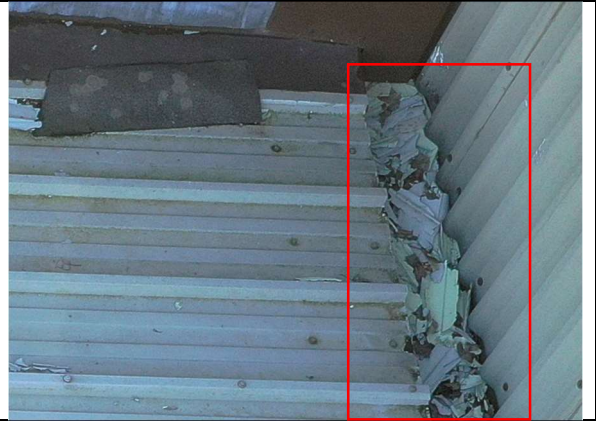
Example of debris building up in the guttering. This should be cleared in the spring.

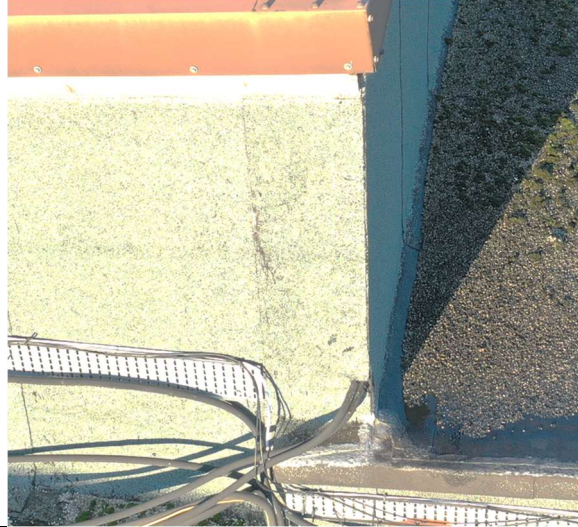
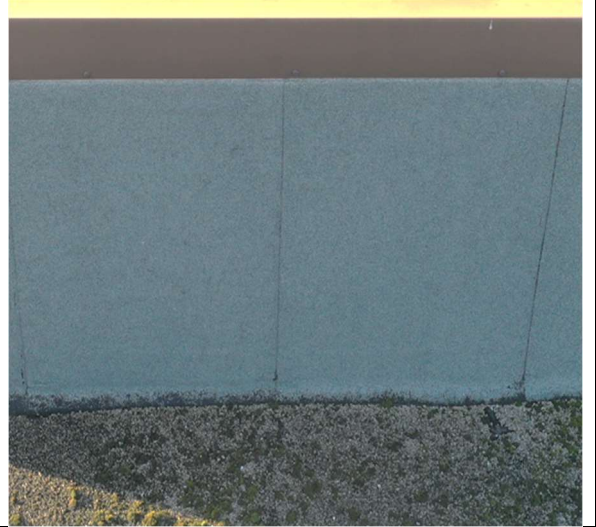
Example photos of where the upstand around the Roof J abutment has been detailed in mineral felt. This is not appropriate and a suitable cladding material should be used.

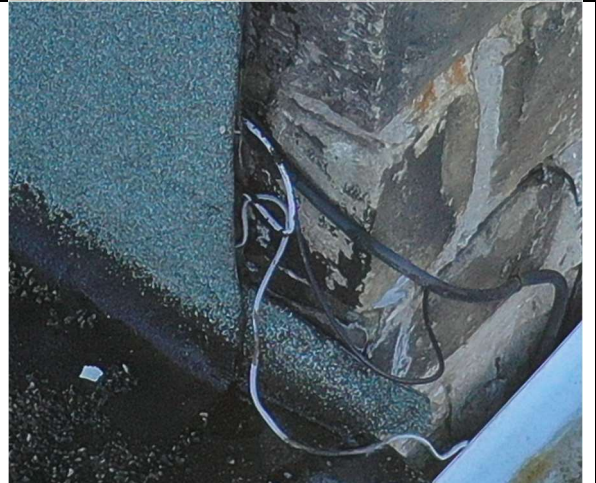
At the end of the mineral felt upstand, there is no detail where this meets the corner (e.g., a cover flashing).

Cables are also being run behind the felt.

It is likely that wind-driven rain will be getting in behind here.

If the mineral felt upstand is to be retained, a suitable flashing with cable detail should be added.

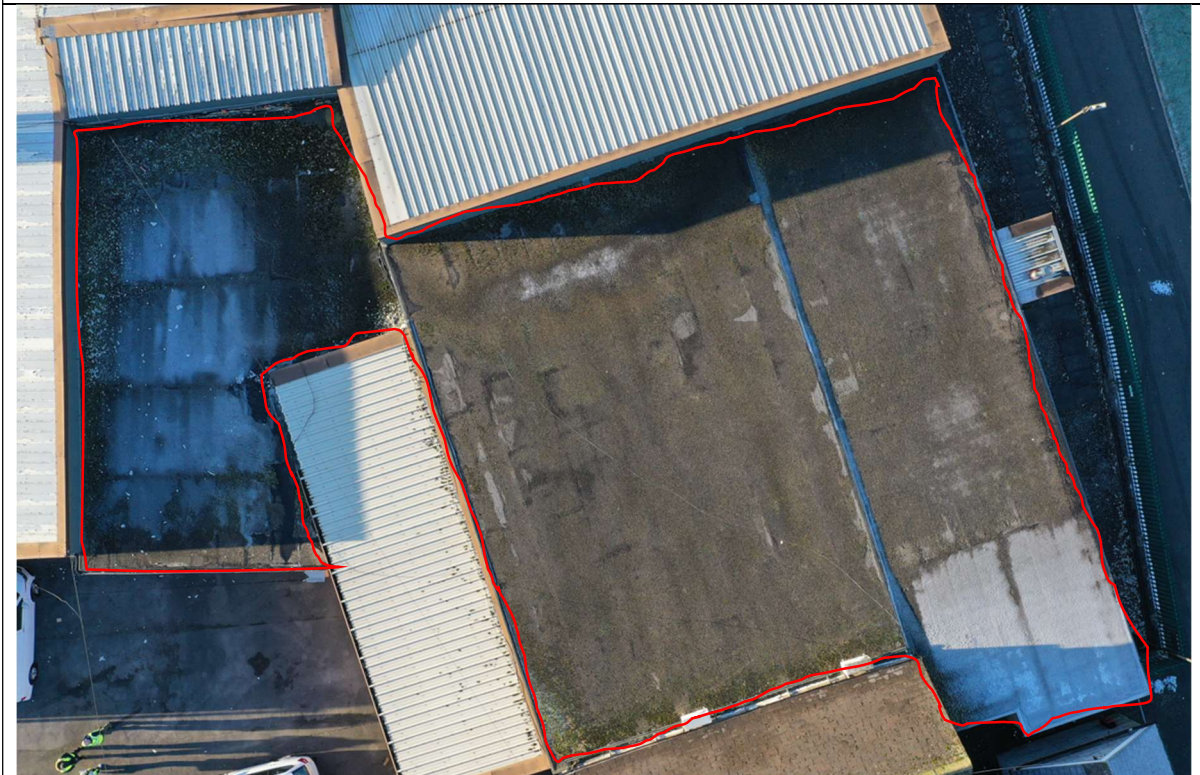
Overhead photo of Roof J – this is made up of the two areas outlined in red which meet between Roof G and Roof K.

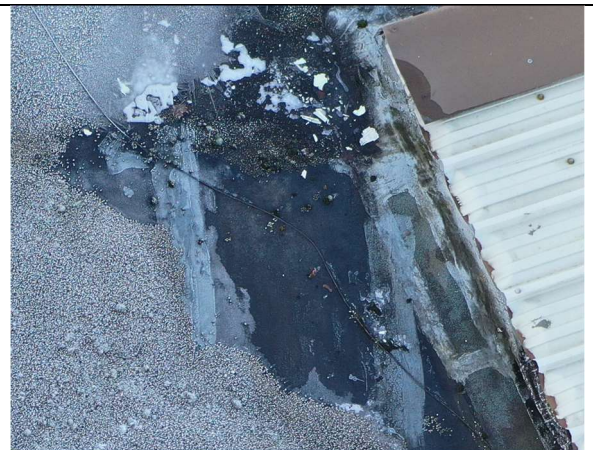
Example of several short-term repairs that have been poorly undertaken.

The defects should be properly repaired in the spring.

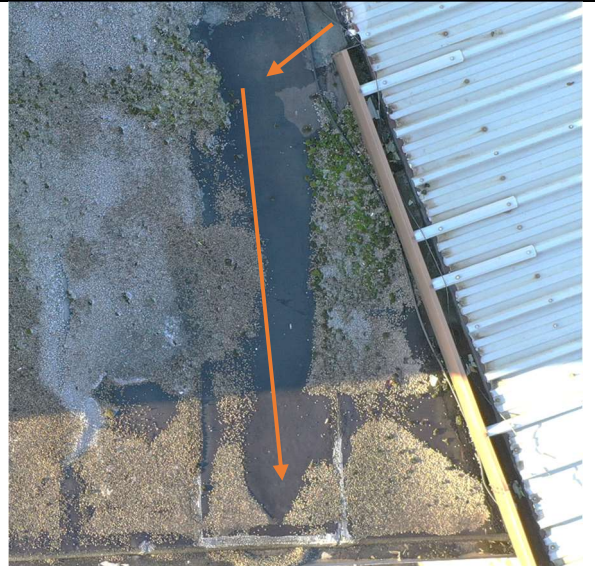
Rainwater discharge has washed away the solar reflective chippings on the left-hand section of the roof.

A fall pipe should be added to the guttering run to take the rainwater to the guttering/vertical fall pipe.

Once this has been done, the solar reflective chips can be replaced.

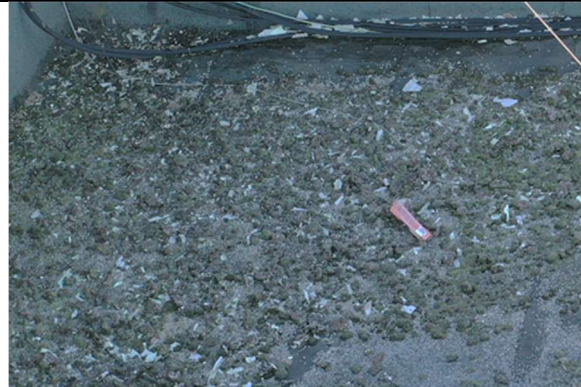
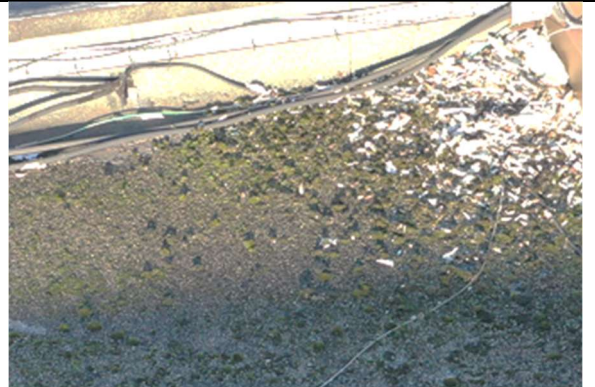
Left-hand section – there is a heavy build-up of moss towards the rear of the roof which has restricted our inspection. The moss should be killed and cleared in the spring and the roof re-inspected for defects once the moss has been cleared.

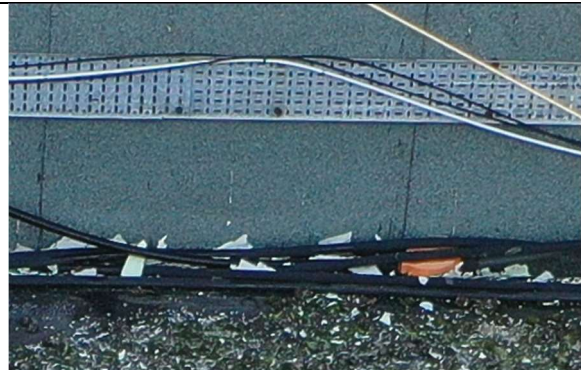
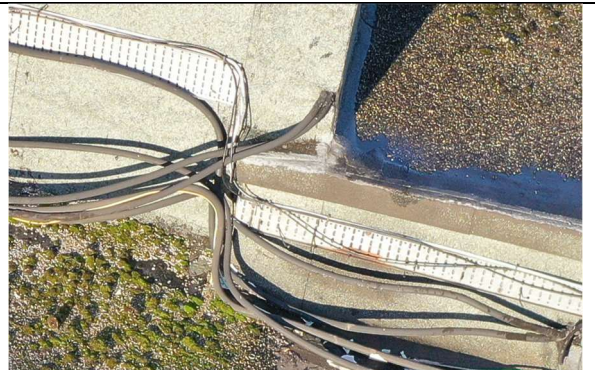
The service media has come away from the cable tray all of the way around this section. This should be re-affixed in the short term.

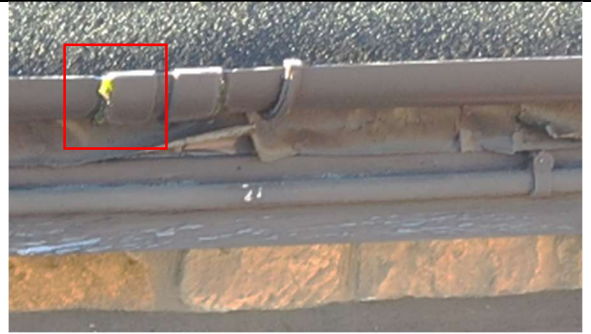
Guttering – the union looks like it is leaking on the left-hand side. It should be repaired as soon as possible.

Facia – there is paint peeling all along the fascia board. This should be prepared and redecorated in the spring using linseed oil-based paint.

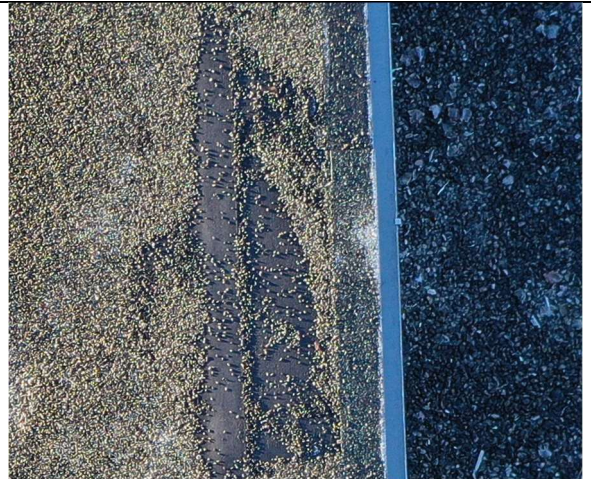
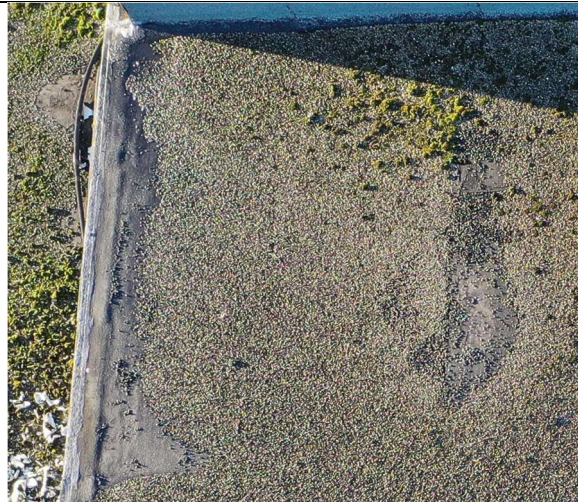
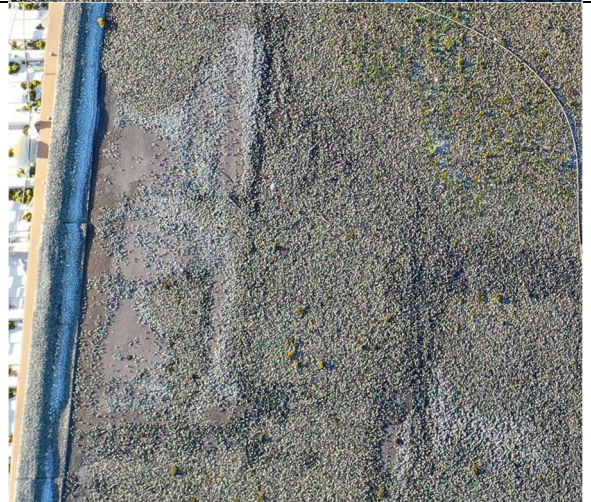
The solar reflective chips are missing across several areas of the roof, we have included some example photos opposite and below.

These should be replaced in the short term to mitigate UV degradation of the covering.

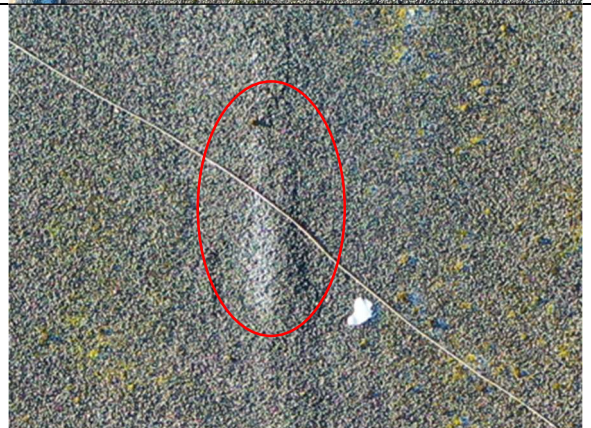
Example of an area of blistering in the covering. This suggests that the covering has debonded from the substrate, likely as a result of moisture ingress.

This should be recorded and monitored.

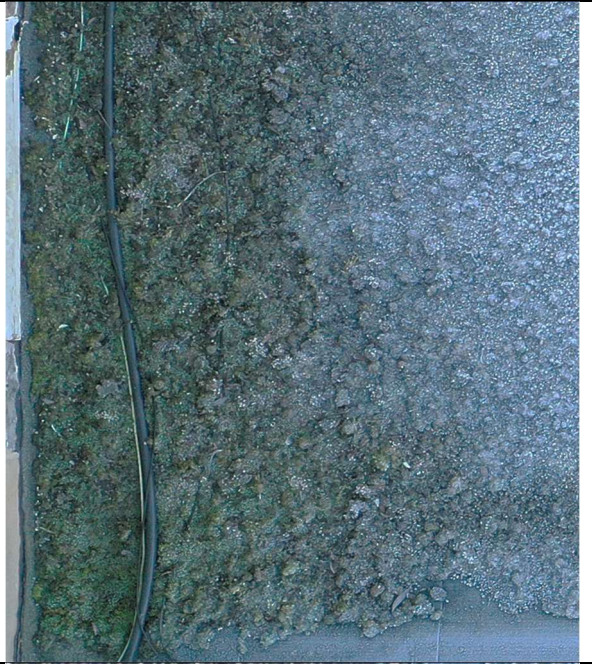
Moss is building up in areas. This should be killed and cleared in the spring.

The areas underneath should then be reinspected for defects.

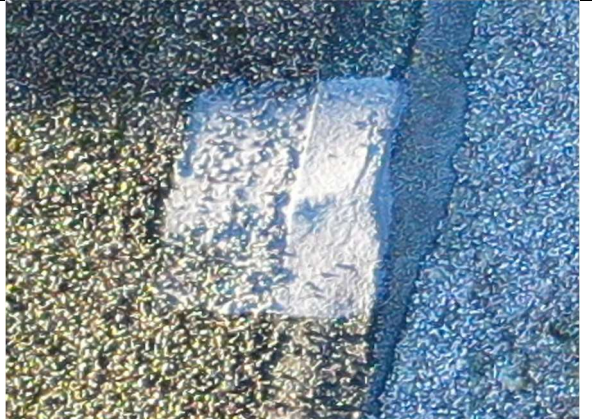
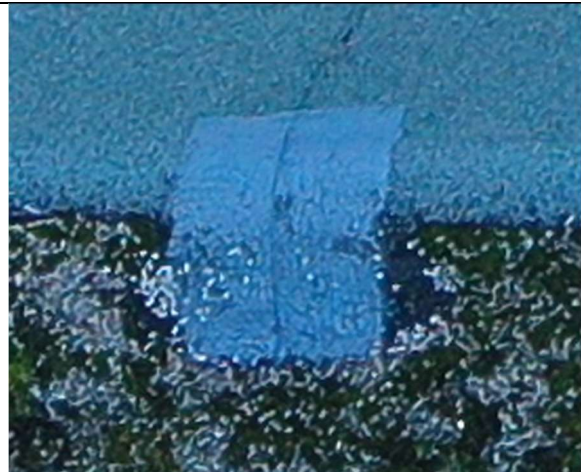
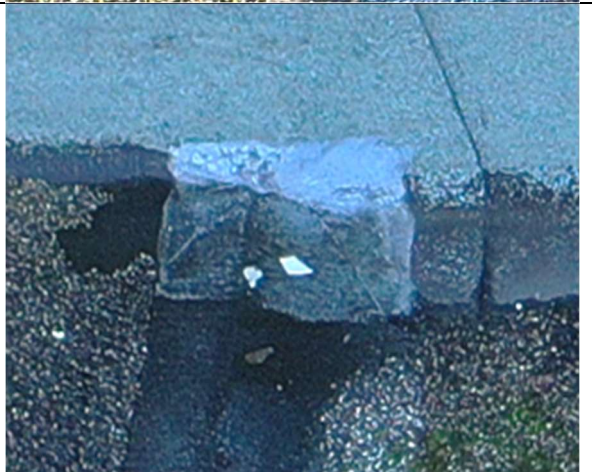
Examples of where there have been some temporary 'paint-on'-type repairs to the covering.

These defects should be permanently repaired using appropriate repair materials in the spring.

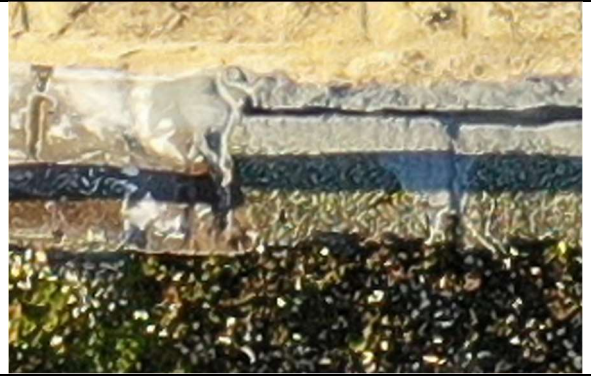
Upstand detail to the Roof M abutment – this has been daubed over with a paint-on-type product. This is not suitable for this type of repair and will also damage the stone substrate.

It should be cleaned off in the spring and replaced with an appropriate lead cover flashing detail.

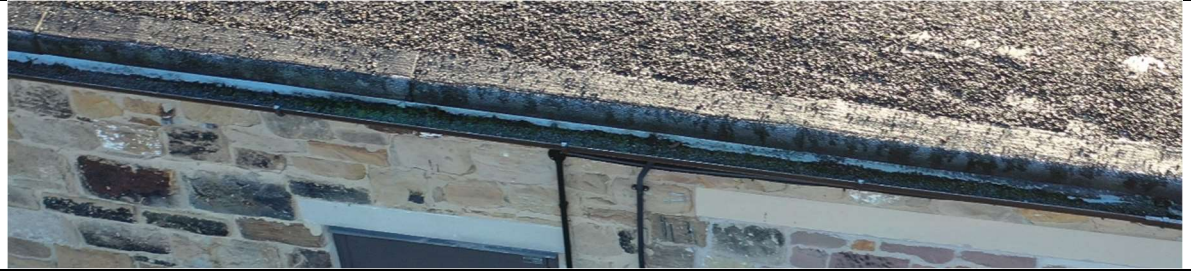
Right-hand guttering runs – these should be cleared of debris in the short-term.

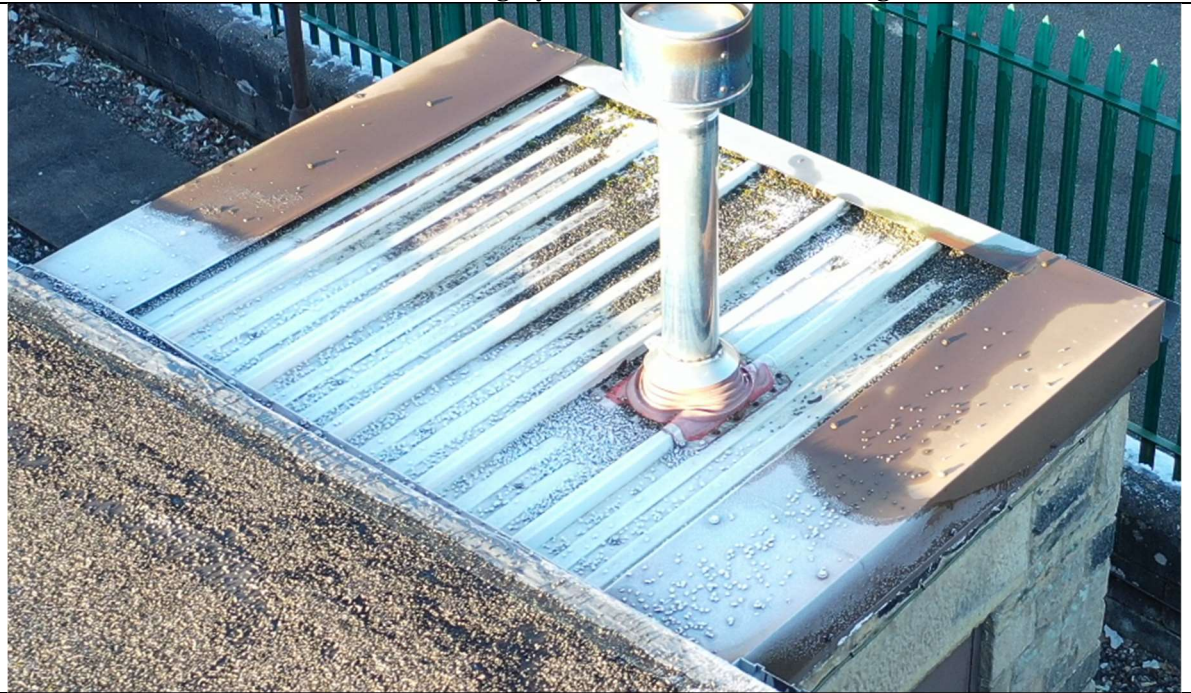
The boiler house – the debris should be cleared from the covering. We could not determine from the imagery how rainwater is discharged from this section.

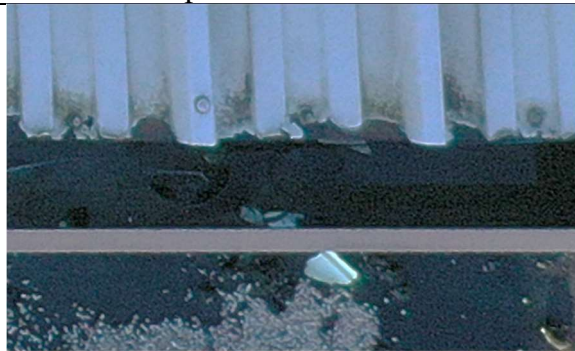
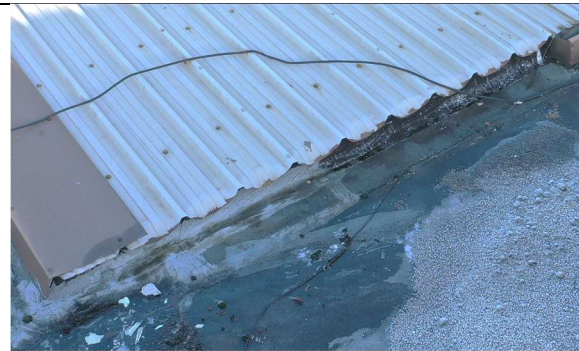
Example photos of cut edge corrosion at the foot of the roof. This should be treated in the short term to prevent further deterioration of the sheets.

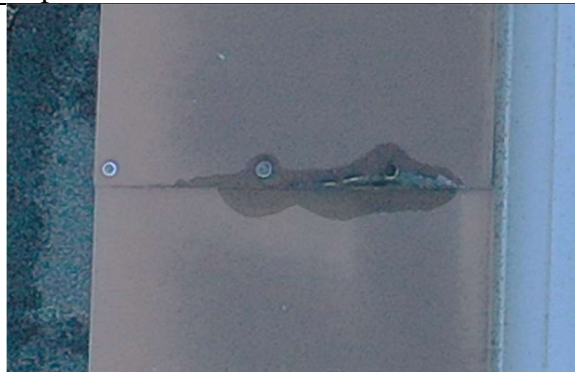
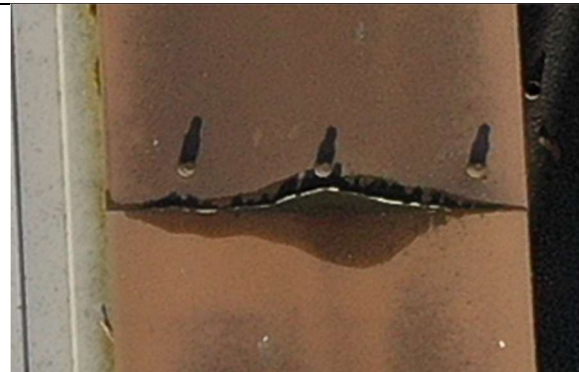
Example of some light corrosion on the cappings. This should be treated in the short term to prevent further deterioration.

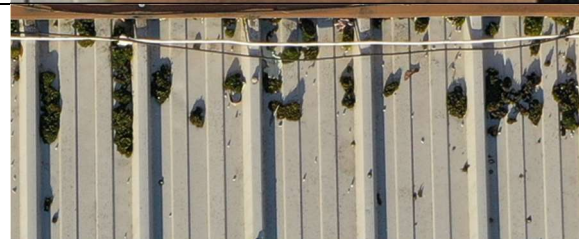
The light covering of moss should be cleared in the spring.

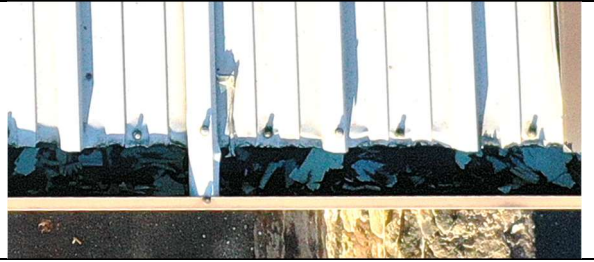
Guttering – debris building up in the guttering should be cleared in the spring.

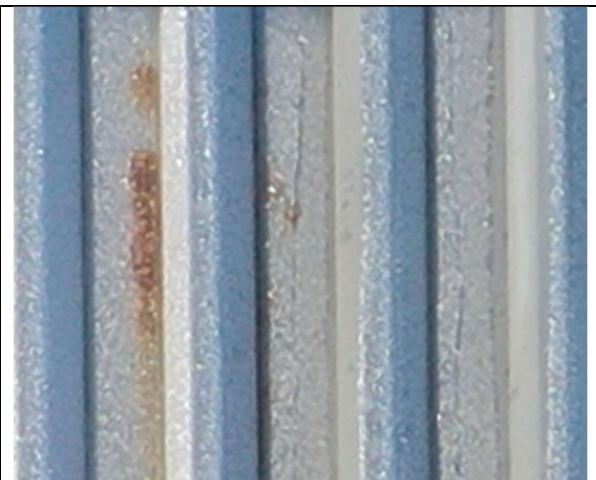
An example photo of an isolated area of corrosion on the pitch.

These areas should be cleaned up and treated in the spring.

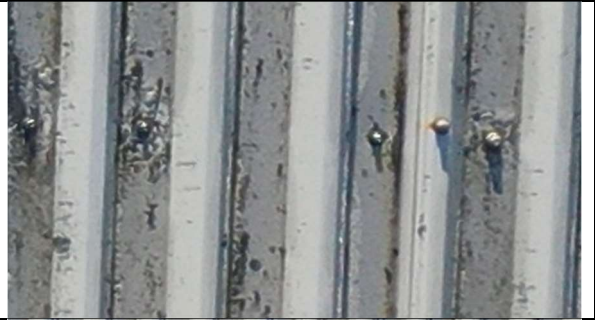
Example photo of some disturbance to the coating around the fixings.

These areas should be cleaned up and treated in the spring.

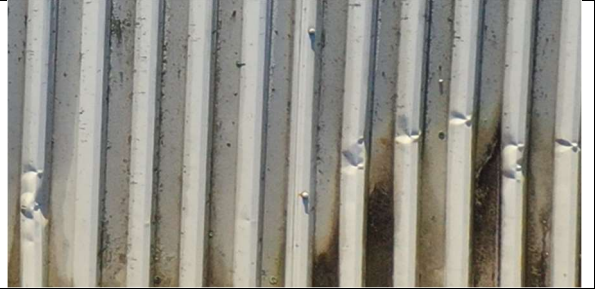
Where the pitch abuts Roof G, there are lots of dents across the covering.

This is likely to have damaged the coating and these areas should be monitored for corrosion.

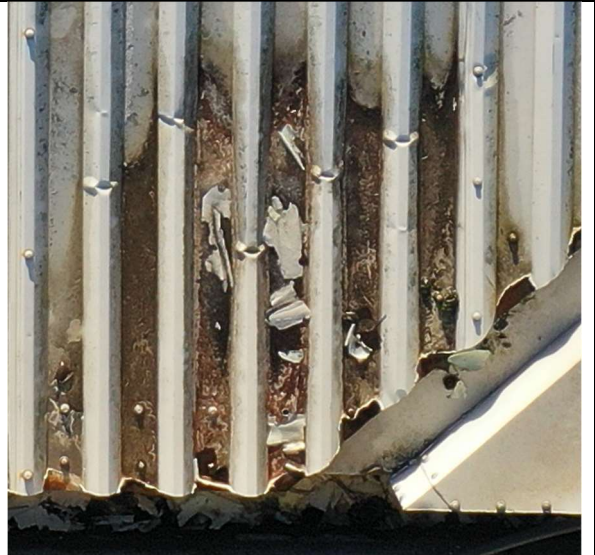
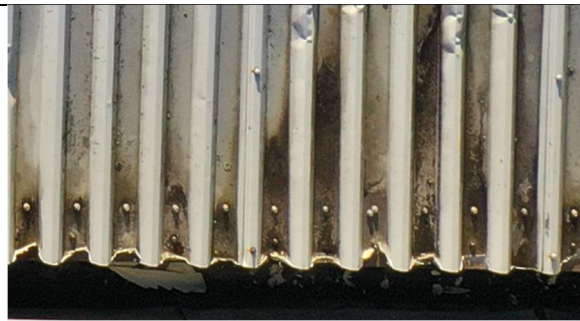
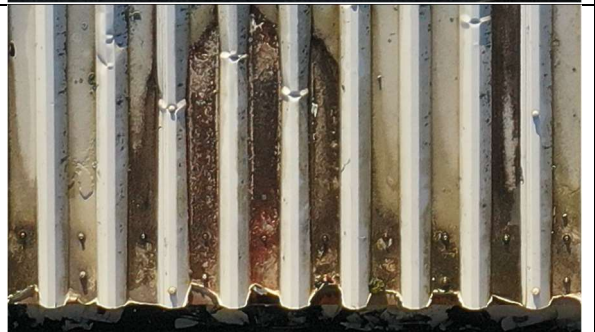
The foot of the pitch – the foot of the pitch is suffering from corrosion and cut edge corrosion all the way along.

This should be prepared and treated in the spring to prevent further deterioration of the sheets.

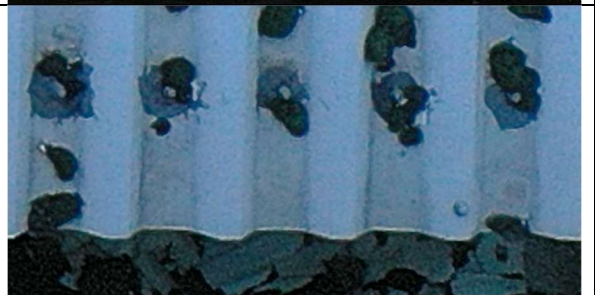
Example photo of some fixing heads that have been treated for corrosion.

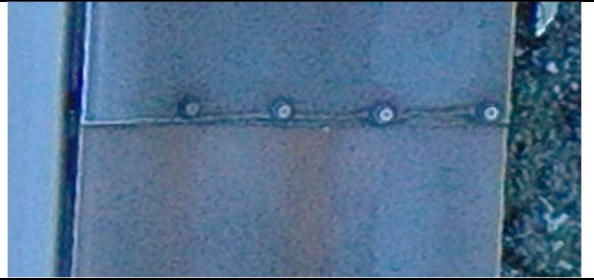
Capping – early signs of cut edge corrosion to the capping sections.

These areas should be cleaned up and treated in the spring.

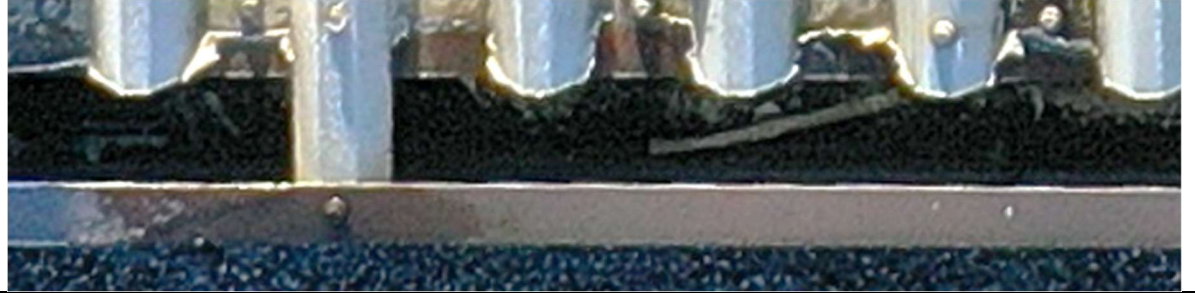
Guttering – debris should be cleared from the guttering in the spring.

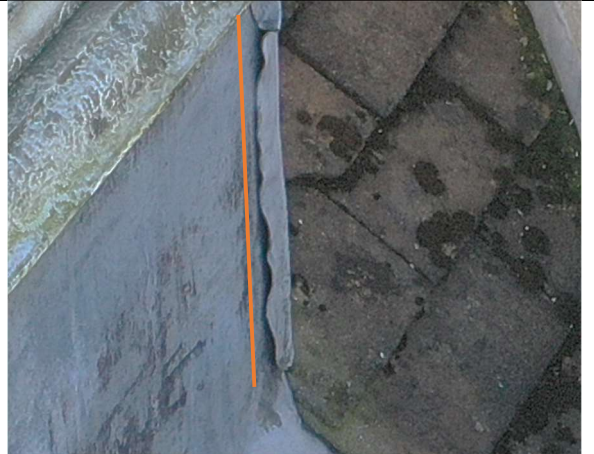
Clocktower – the lead detail should be tamped back down where it is lifting (orange line).
