# Roof Inspection Report

Report produced by Simon Hollis MRICS

22<sup>nd</sup> December 2022

Drone Inspection Report - Summary of Findings

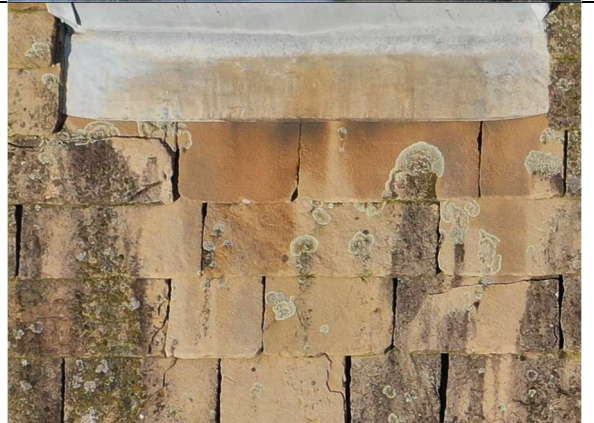
Clocktower – patination oil should be used on all leadwork to prevent it from oxidising and staining the roof covering below.

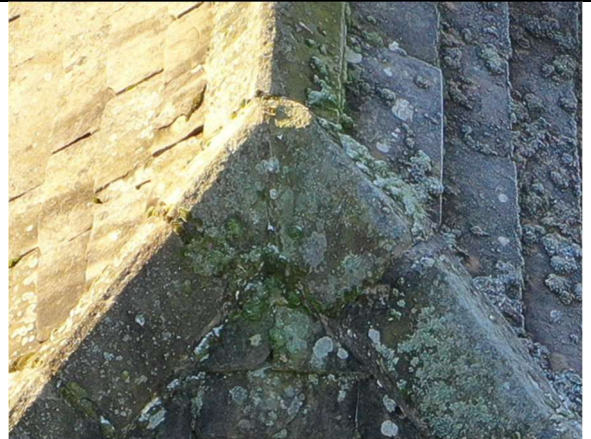
Ridge and hip detail and roof covering – there is a build-up of moss and lichen. This should be killed and scraped/brushed off in the spring.

A stiff nylon brush and scraper should be used for this.

A wire brush should not be used.

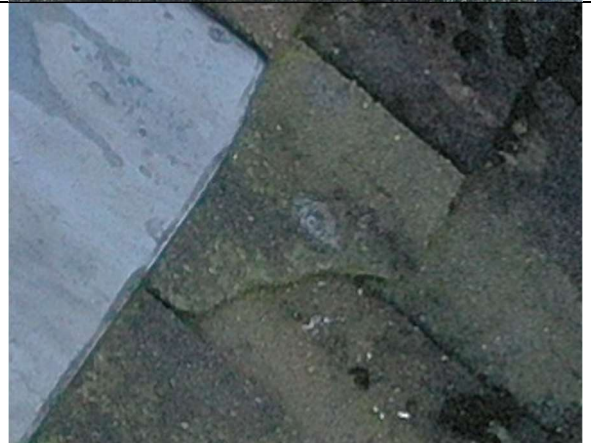
Rear pitch – the damaged slate should be replaced in the spring.

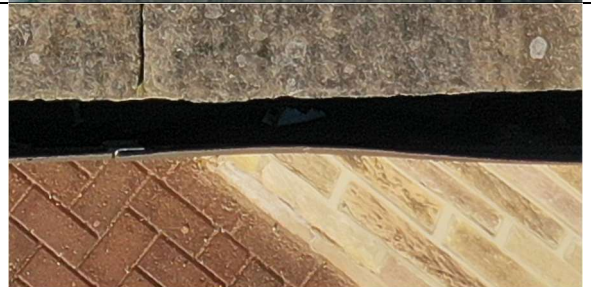
Front guttering run – this is deflecting in places, likely a combination of insufficient clips and UV damage.

Additional clips should be fitted to try and bring it back into shape.

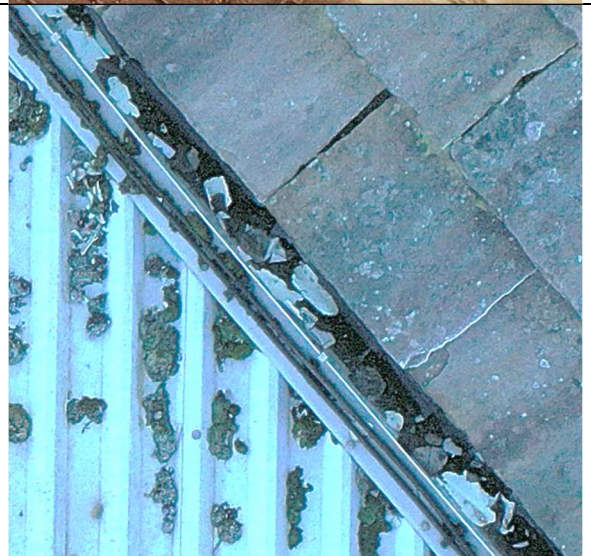
The front, side and rear guttering runs are full of debris and should be cleared out in the short term.

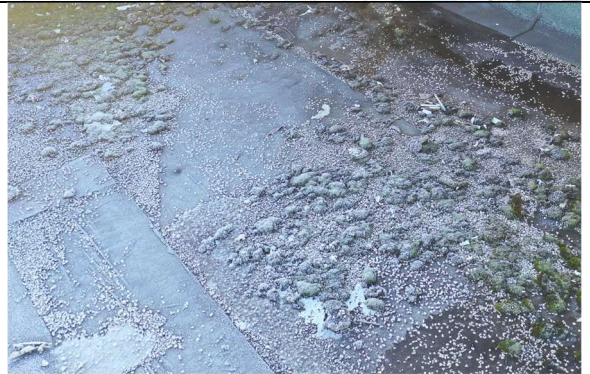
The mineral felt is in generally poor condition.

The build-up of moss should be killed and cleared away in the spring and the roof reinspected for defects.

The areas of missing chippings will need to be reinstated, or another sheet of capping felt added if the roof can be made dry enough.

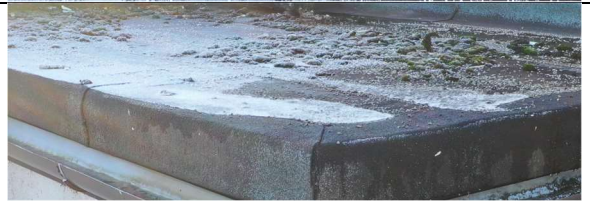
It looks like additional sections of felt have been added around the perimeter of the roof. This is now making the main deck lower than the perimeter and causing rainwater to pond. Once the ice has melted, this should be tested with a hose pipe. If this is the case, the fall of the roof will need to be re-cut and the roof recovered.

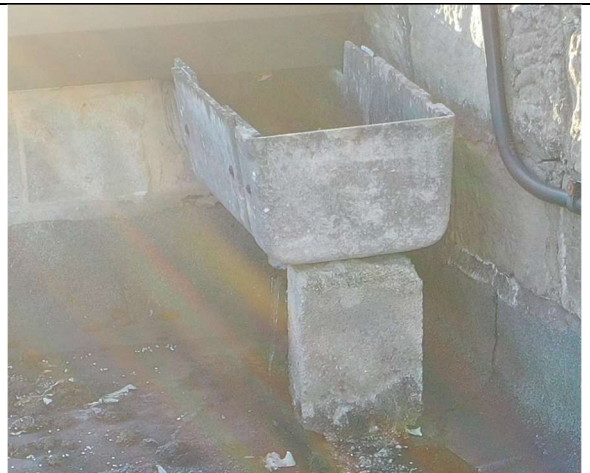
Having the outlet from the large section of the roof discharge onto this roof is not ideal and is likely the principal reason for the washing away of the chippings.

Having the outlet supported by a brick is also less than ideal!

The rainwater goods should be redesigned to better manage this rainwater into the mains drainage.

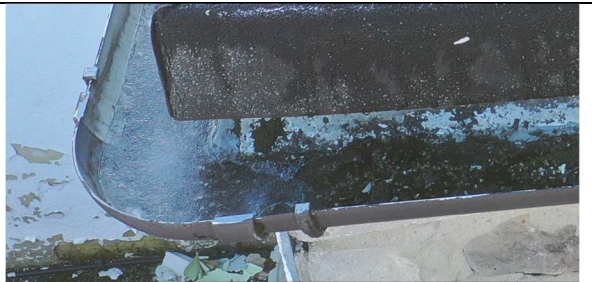
Ice building up in the guttering indicates that the run is not set to the correct fall.

The guttering should be set to the correct fall in the spring. This run handles a lot of rainwater so needs to be operating efficiently.

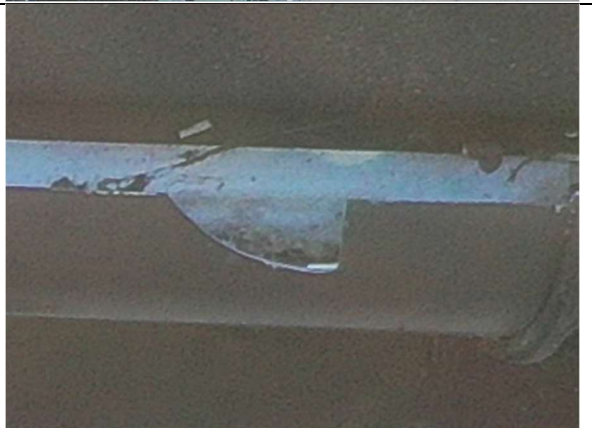
The damaged section of guttering should be replaced in the spring.

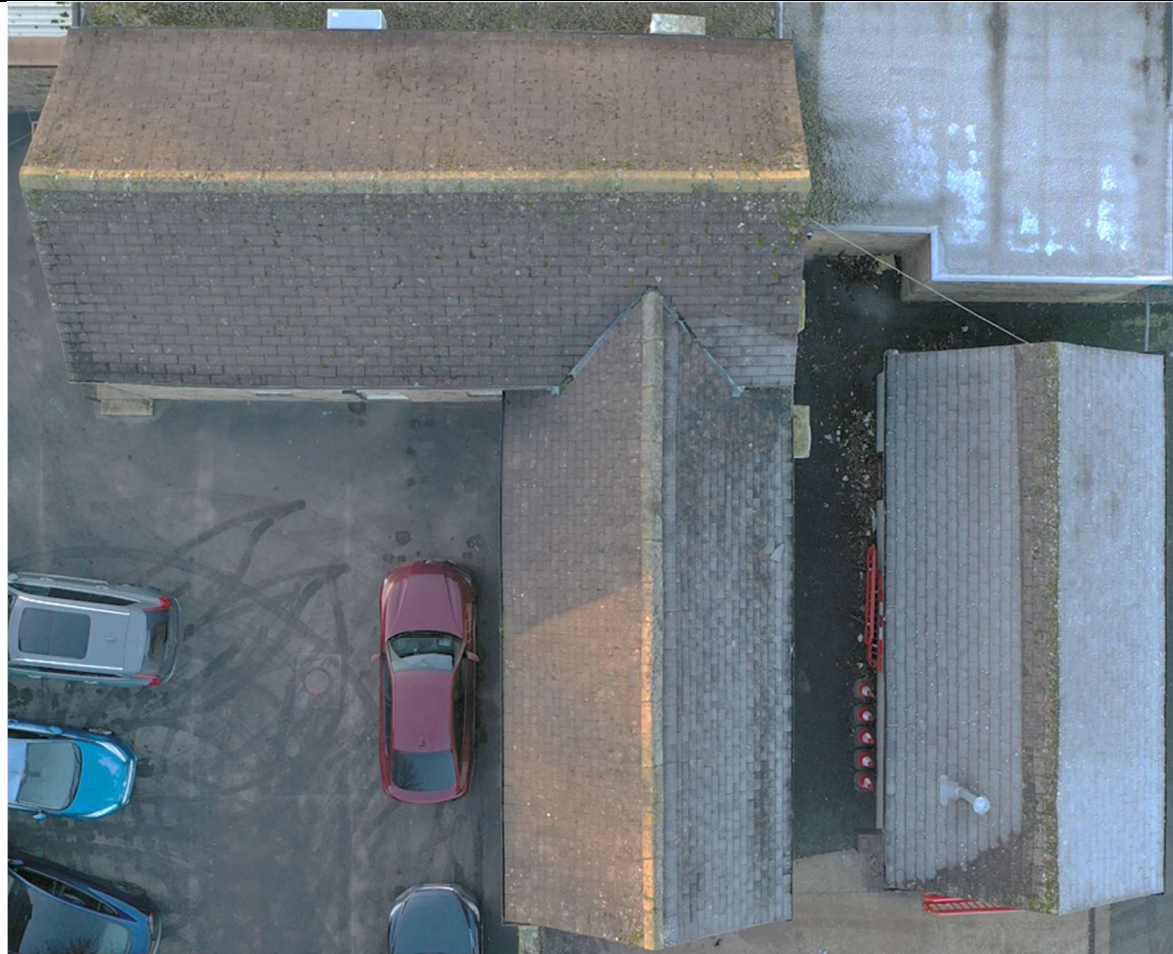
Both roofs are covered with concrete interlocking tiles. Moss build-up and frost restricted our inspection of some of the areas.

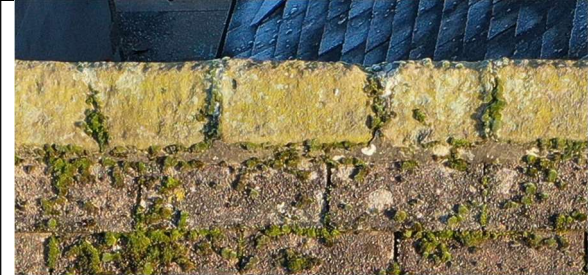
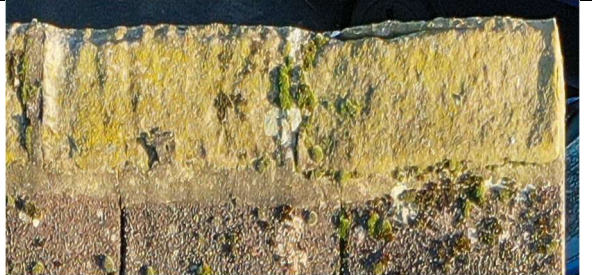
Ridge, main building – the ridge tiles are decaying, likely in part as a result of the moisture stress being placed on them by the use of an incorrect mortar mix. Once the moss and lichen have been cleaned off them, they should be reassessed to see if they are salvageable or if replacement needs to be planned for. Example photos are below.

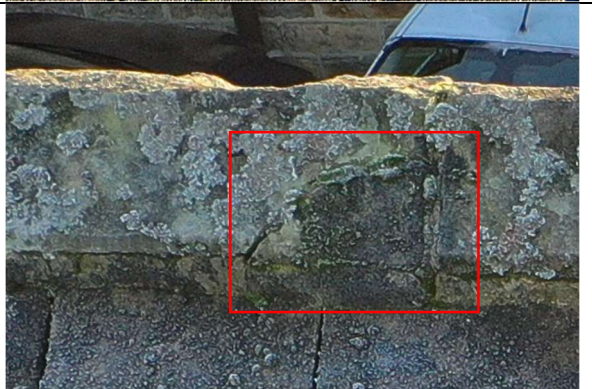
Ridge – cracked tile should be appropriately repaired with a suitable repair compound.

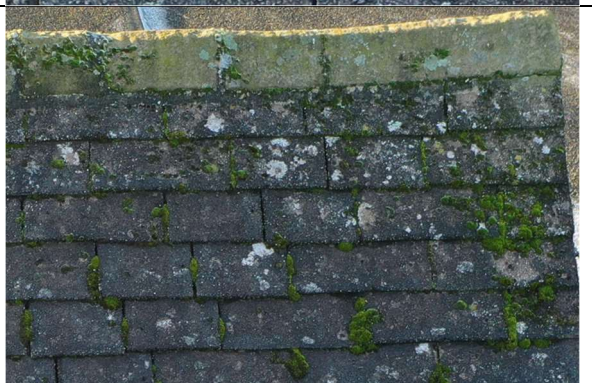
Moss and lichen build-up needs to be cleared off all of the pitches.

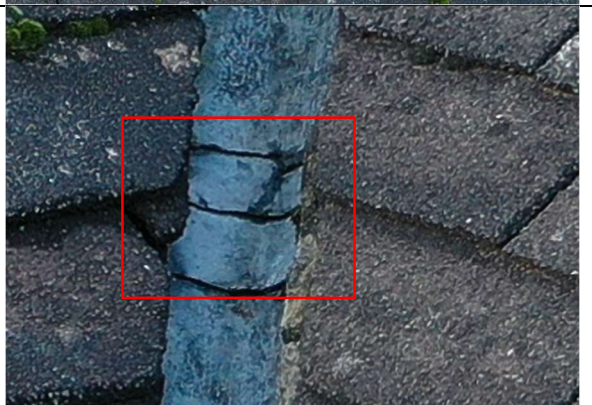
Example of a repair that has been undertaken to the front valley gutter.

This should be monitored internally for leaks.

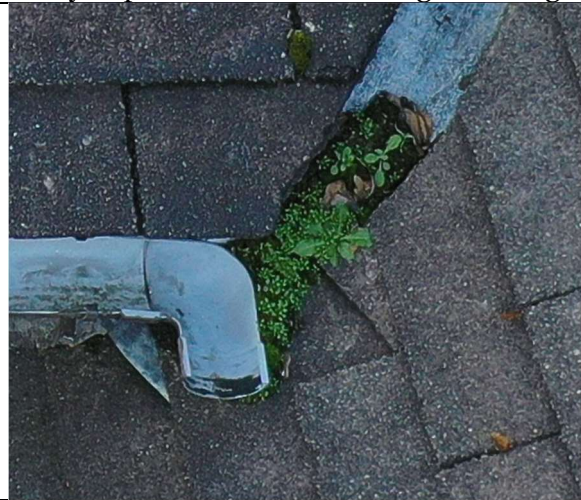
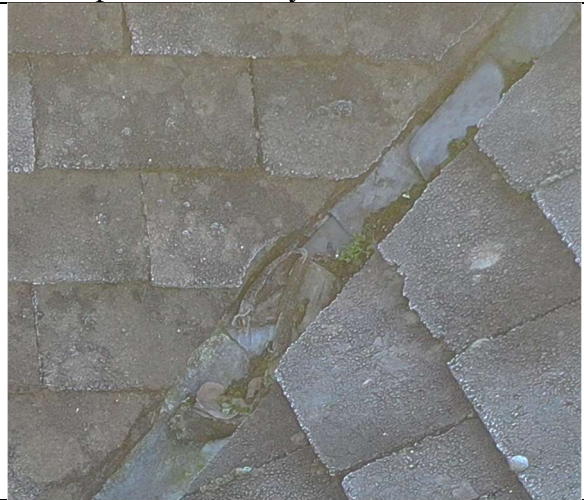
Both valley gutter runs are blocked with debris. These should be cleared out as soon as possible. Consideration should be given to redesigning the plastic guttering adjacent to the front valley to prevent it from creating a blockage further up the lead valley.

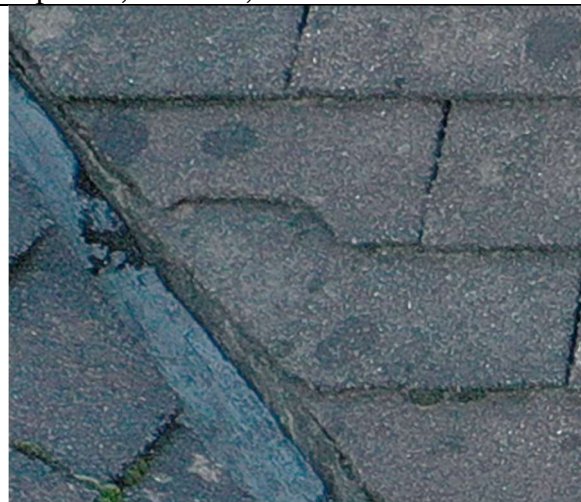
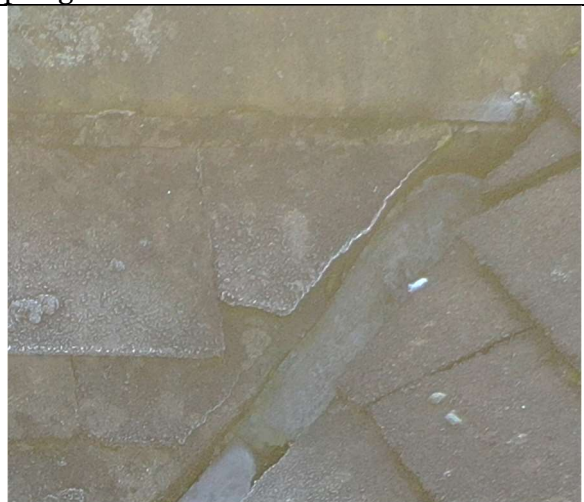
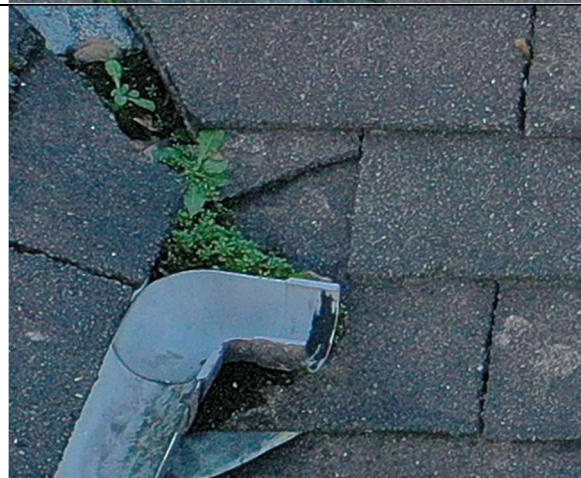
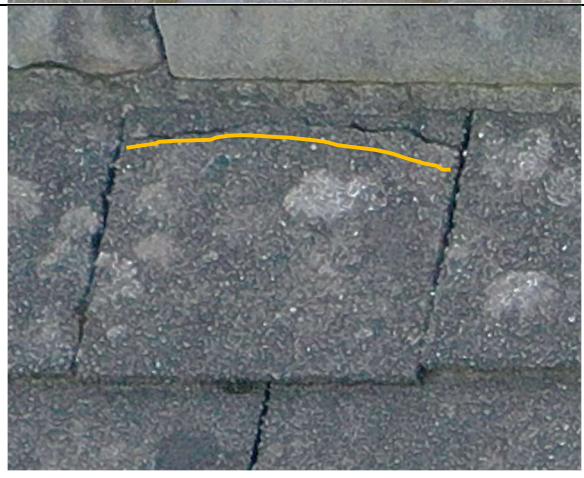
There are damaged tiles on the off-shot part of the building. These should all be replaced as soon as possible. Photos below. There are also several chipped tiles that should be replaced; however, these could wait until the spring.

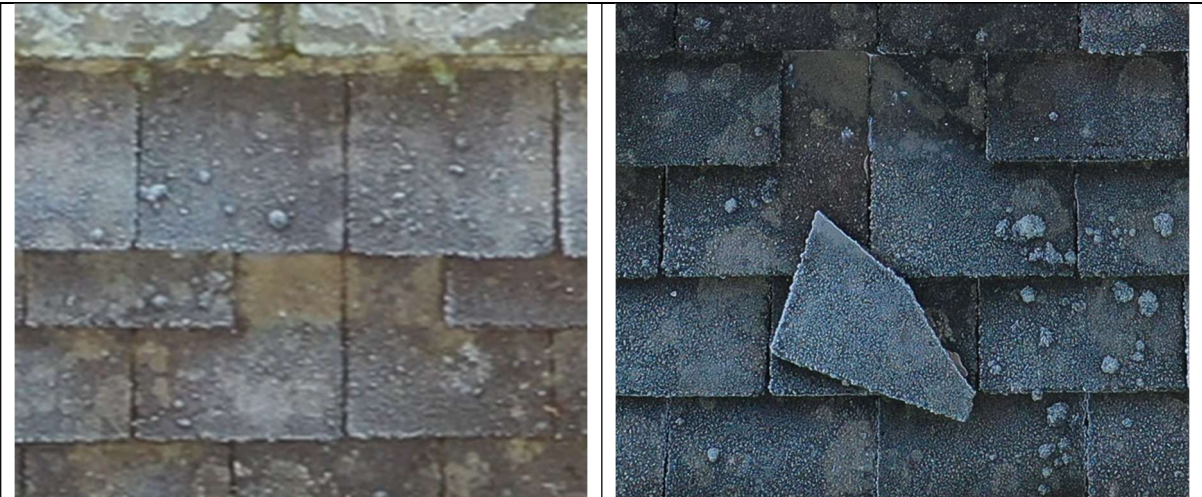
Verge detail – the verges should be detailed as they are in the left-hand photo – tile, tile and a half, tile, tile and a half.

Some of the verges are detailed as in the right-hand photo – tile, half-tile, tile, half-tile.

This arrangement makes it more likely that the smaller verge tiles will be subject to wind uplift and therefore failure.

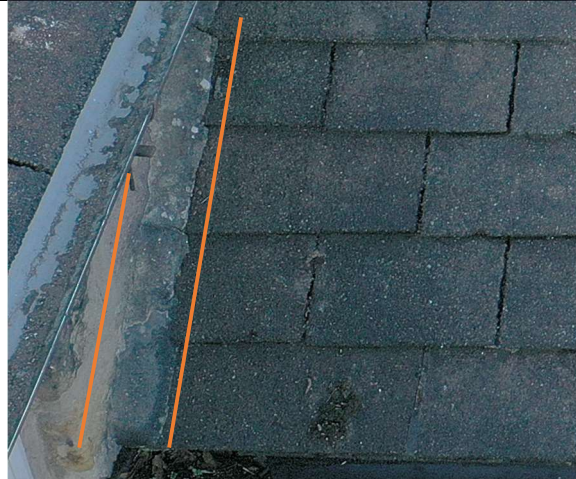
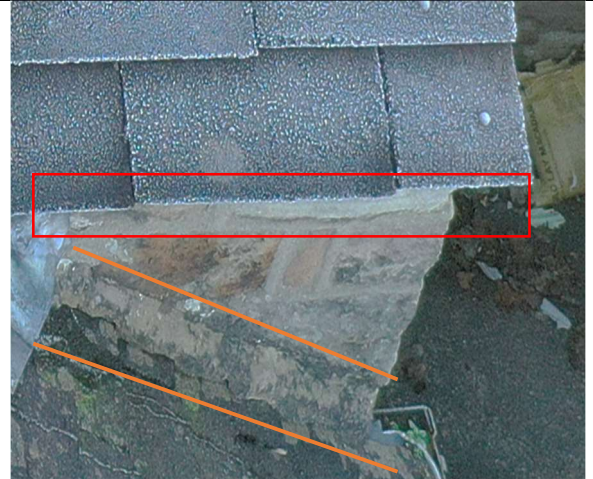
On the rear of the abovementioned area, there needs to be a wrap-around flashing added as part of the lead detailing.

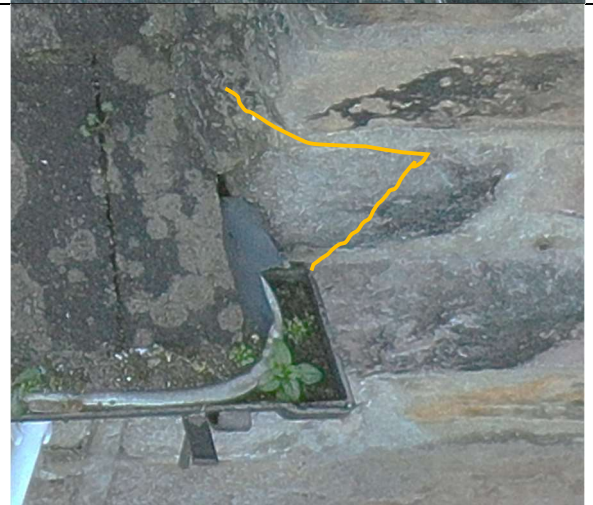
Guttering – front of the main building – the guttering run is either bowing or, the wallhead is deflecting. This should be checked and monitored.

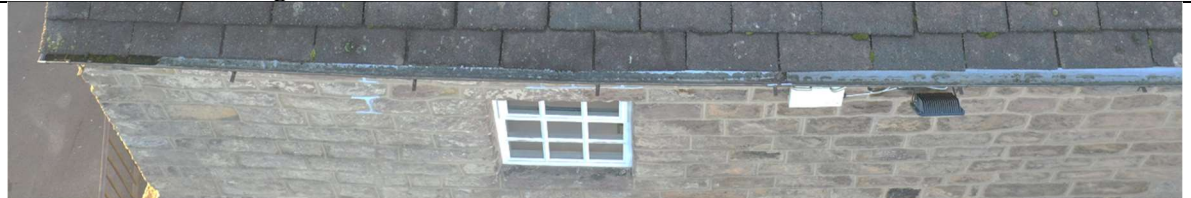
Guttering – front of the main building – the guttering run should be set to a fall of c. 1:60. Here, it is set to a much greater fall – note the distance from the tiles to the guttering on the left compared to the right.

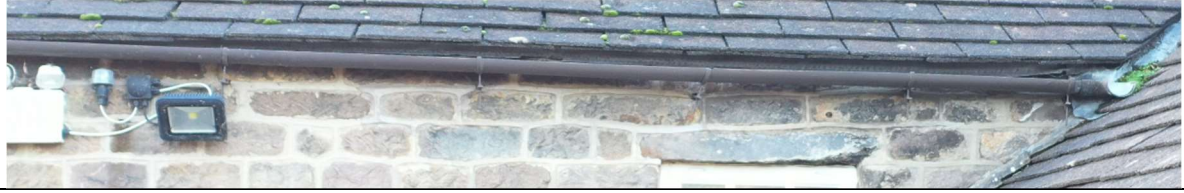
There is a lot of debris building up in the off-shot guttering. This should be cleared in the next month.

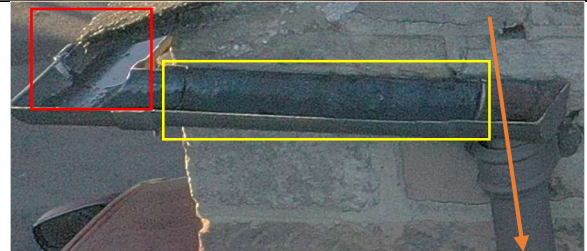
The rear of the off-shot – there is a lot of debris built up in the guttering. This should be cleared out as soon as possible.

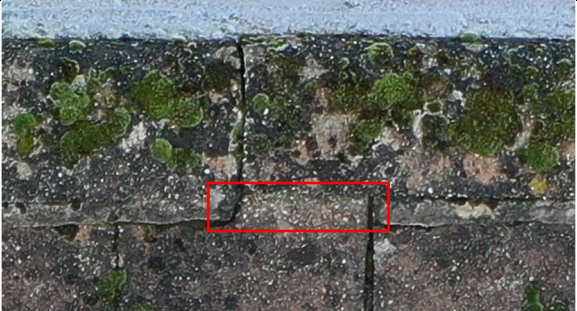
<p>The damaged tile on the eaves course should be replaced in the spring.</p>

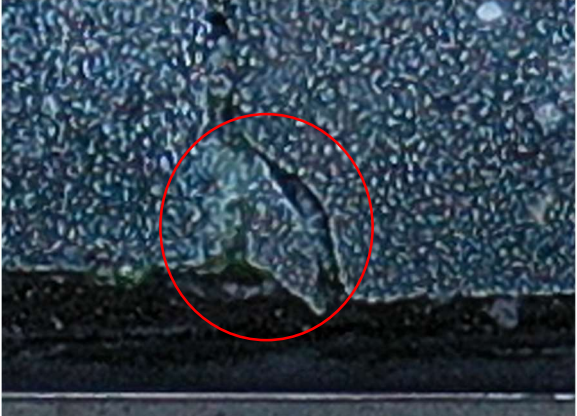
<p>Rear corner – we are not sure what is sticking out of the rear corner; however, it is unlikely that it should be there.</p> <p>It should be inspected close-up and removed as necessary.</p>

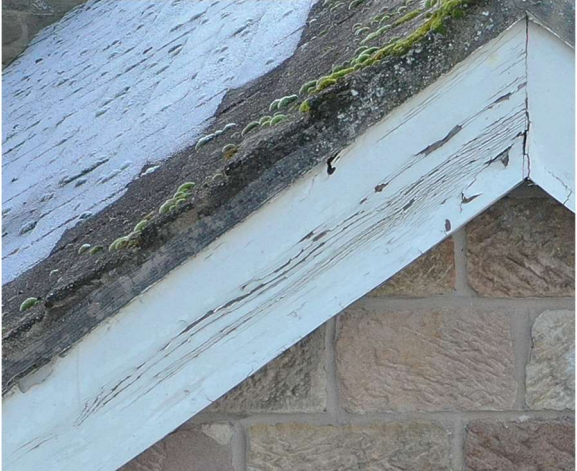
Guttering – red box – ice is building up in the guttering run.

Also, note the poor condition of the timber barge boards, fascias and soffits in the right-hand photo. These will need to be repaired and redecorated in the short term.

The guttering run should be reset in the spring.

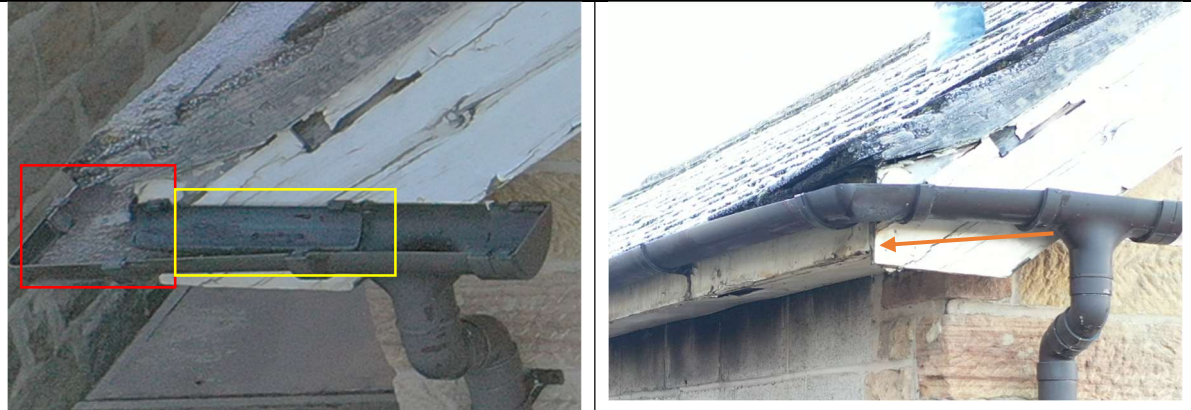
The debris building up in the guttering runs should also be cleared in the short-term.

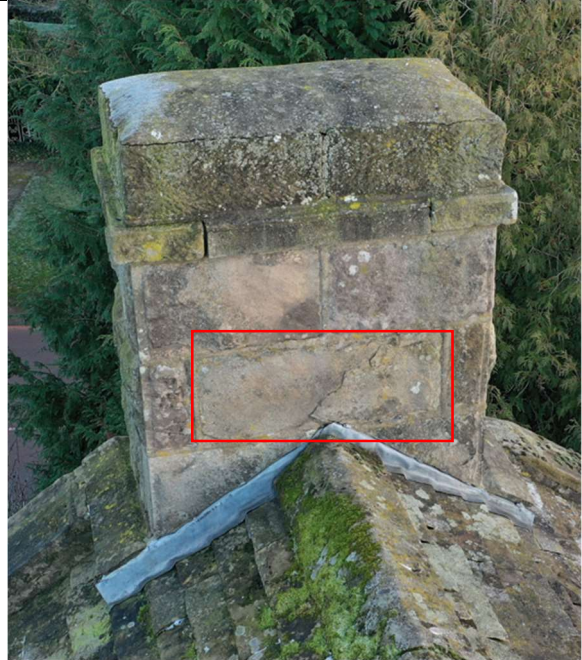
Flashings – this design of cover flashing is only appropriate if there are soakers or secret gutter running underneath it.

This should be checked next time roof works are being undertaken.

Red circle – there is no saddle piece where the ridge and stack abut. One should be added next year.

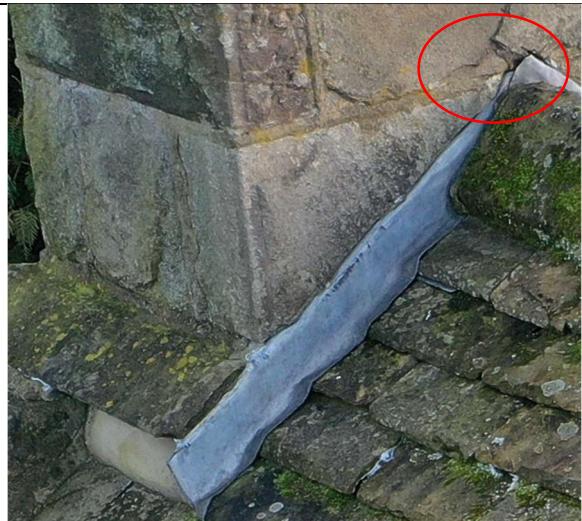
Red circle – there is no saddle piece where the ridge and stack abut. One should be added next year.

This should be checked next time roof works are being undertaken.

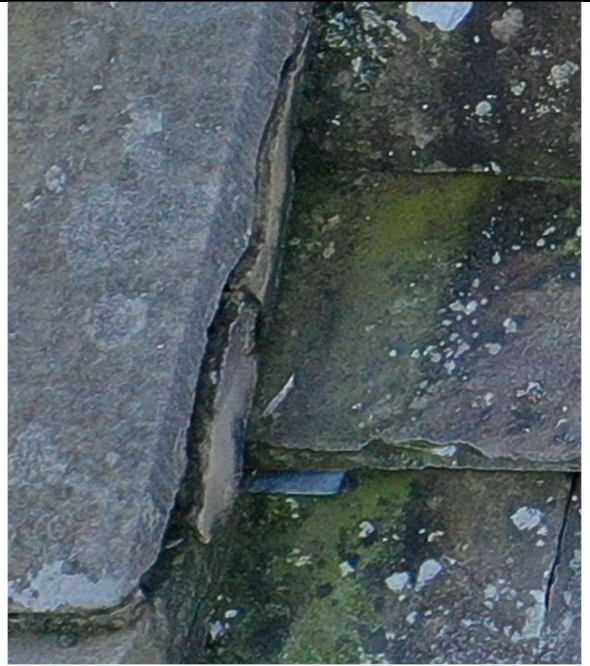
Left-hand parapet – staining of the wallhead (and likely some internal water penetration) where there is missing pointing on the coping stones.

If the abovementioned upstand detail is to be corrected, it would make sense for a lead damp proof course to be designed to work with this which would reduce the reliance on the mortar joints between the stones (this applies to all of the parapet wall/coping stone details).

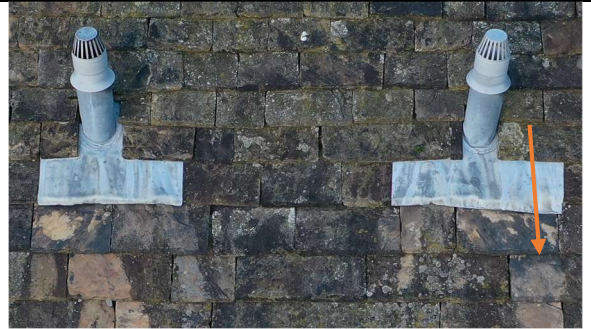
There are no restraint straps on the flashings. The right-hand flashing looks like it is slipping down the pitch and it should be re-secured. Restraint straps should be added to both flashings.

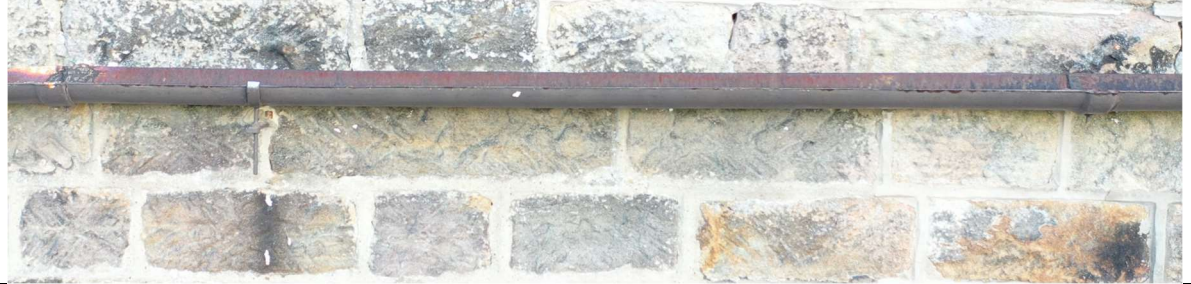
The rear and right-hand guttering runs are in need of refurbishment in the next year. This is specialist work.

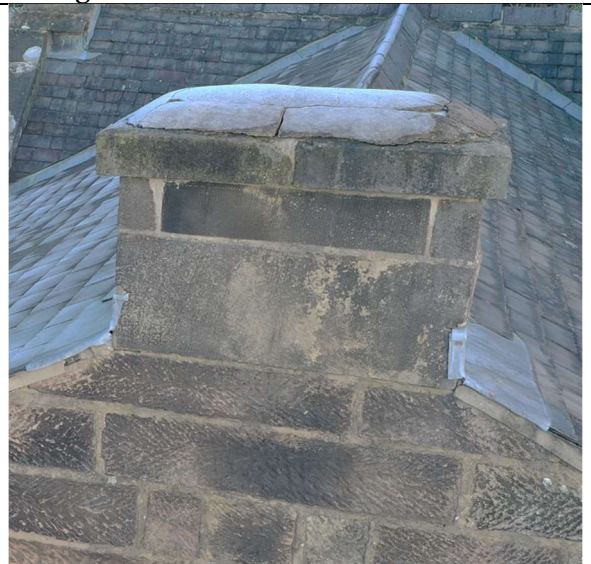
Photo of the flaunching.

This is cracked all over and if these sections are loose, they could be subject to wind displacement.

The stack should be checked for loose mortar as soon as possible.

If pots are not to be added (as advised above) the flaunching should be replaced with an appropriate mortar mix.

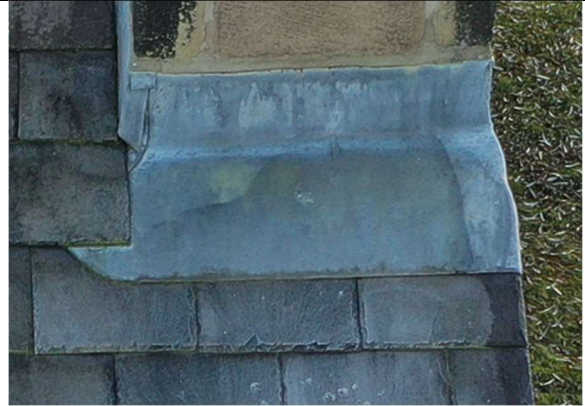
Pitch - this design of cover flashing is only appropriate if there are soakers or secret gutter running underneath it.

This should be checked next time roof works are being undertaken.

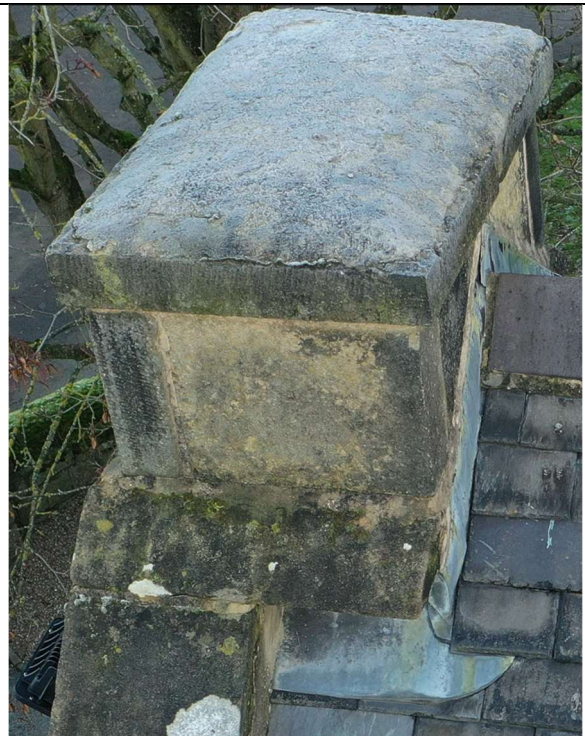
This design of cover flashing is only appropriate if there are soakers or secret gutter running behind it.

This should be checked next time roof works are being undertaken.

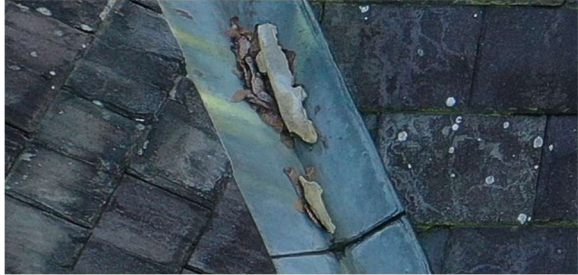
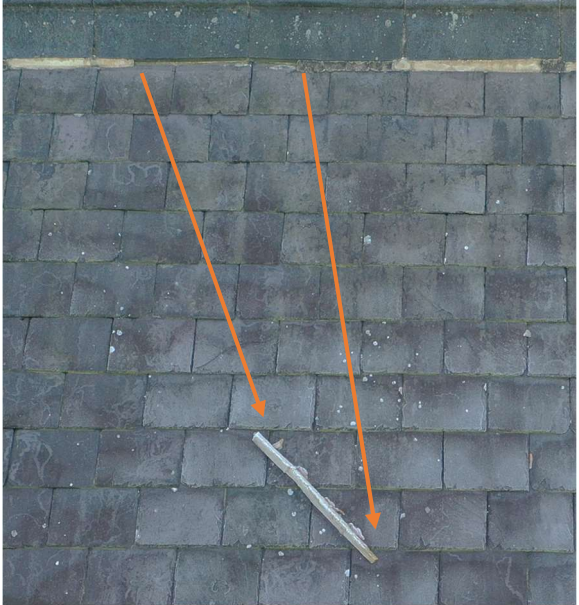
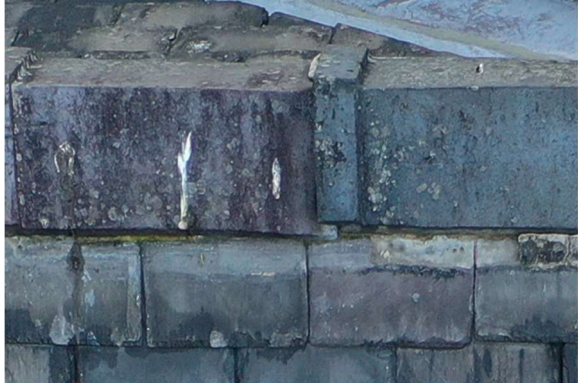
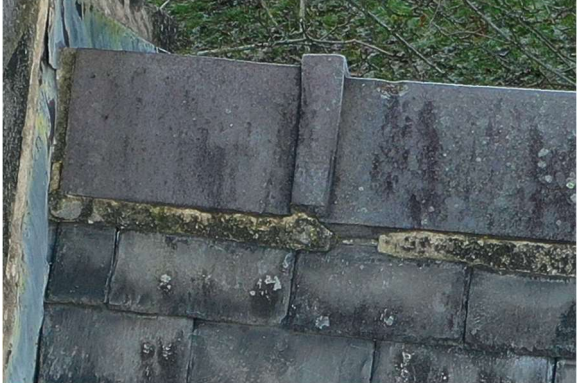
There are no restraint straps on the front aprons. These should be added when the detail is replaced (there is no need to replace this at the moment).

Ridge - main and left-hand pitches – the ridge pointing is failing and sliding down the pitches/into the valley gutters in sections.

A plan should be made to remove the defective pointing and re-point the ridges next year. An appropriate mortar mix should be used for this i.e., not a cementitious one.

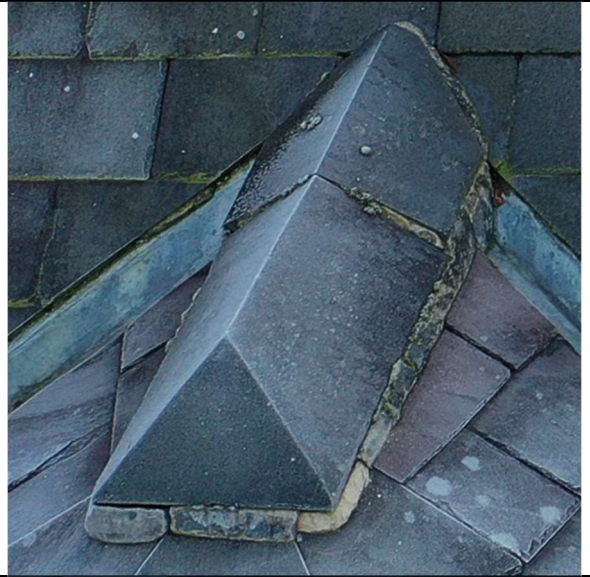
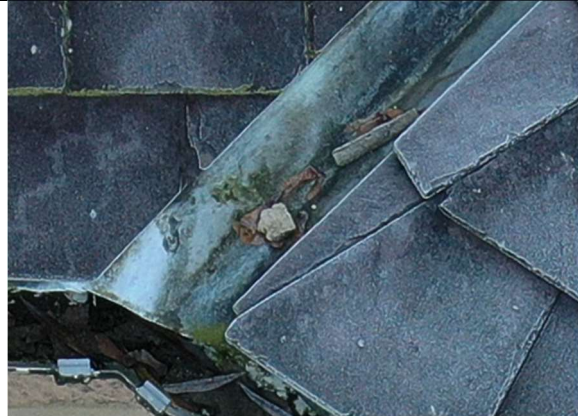
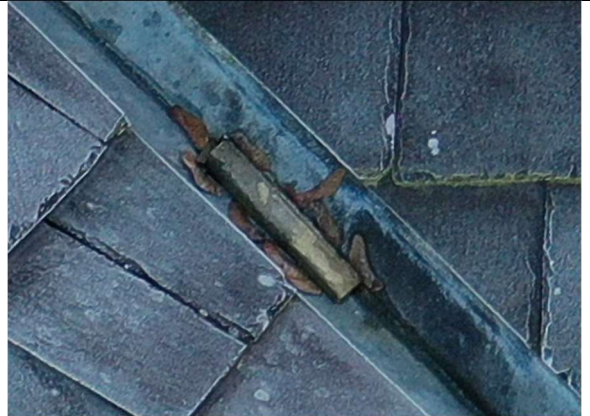
Front bay window ridge – the pointing is also failing in this area and slipping down to block the valley gutters.

The valleys should be cleared in the short term and the ridge repointed at the same time as the main roofs.

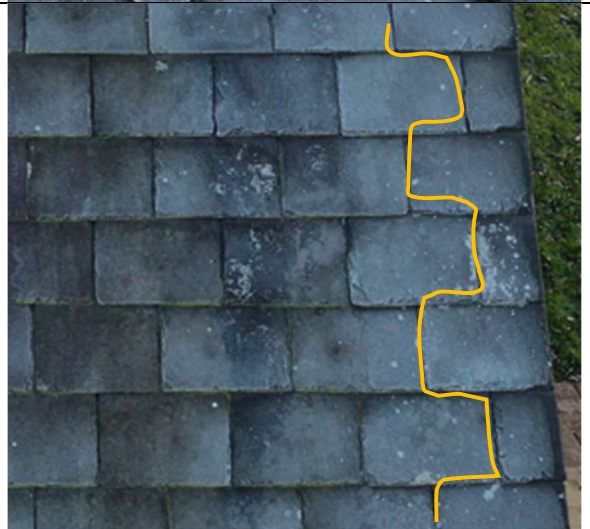
Front and rear pitches – the verge detail is incorrect – the slates should run:

The half slates will be subject to wind lift and as a result, failure. There is no economic way to address this now, but it should be considered when the building is ready for a re-roof (which is not needed at present).

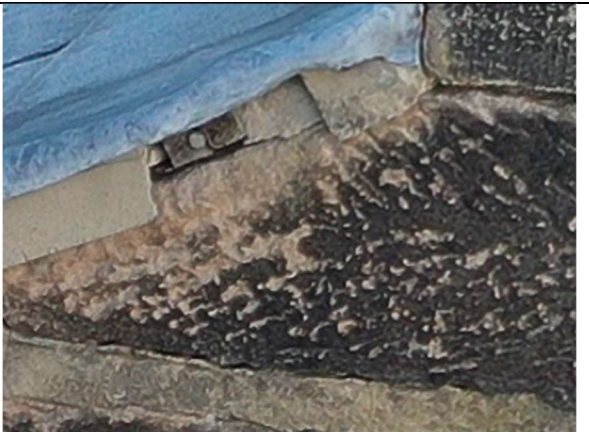
Verge – there looks to be inadequate projection on the verge detail – the slates should project at least 50 mm from the elevation. There is no economic way of addressing this now.

There are a couple of areas where sections of the verge pointing are missing. These areas should be repointed in an appropriate mortar mix in the next couple of months.

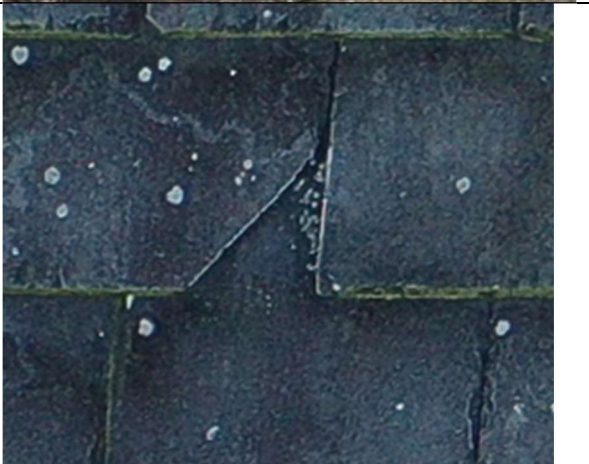
There are a couple of damaged slates across the pitches which should be replaced in the spring.

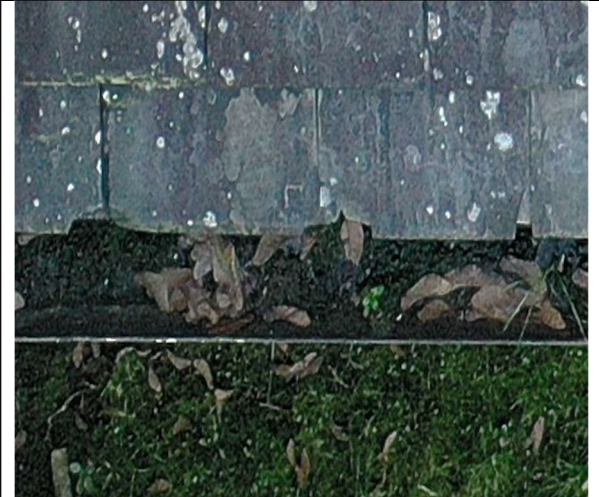
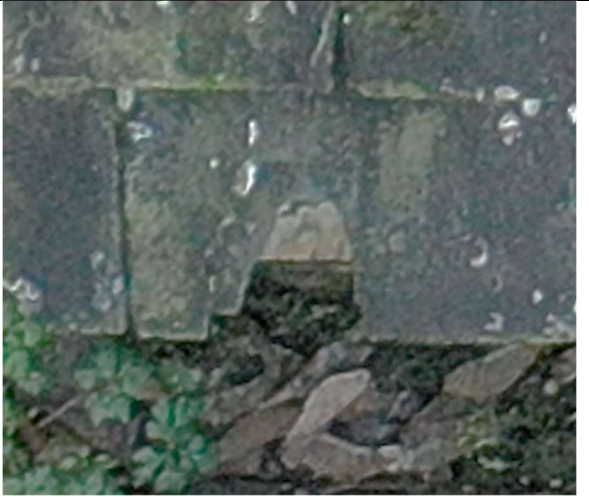
Left-hand pitch – there are several damaged slates along the eaves course. These should be replaced in the next month or so.

Also, note that this run of guttering is full of debris and should be cleared as soon as possible.

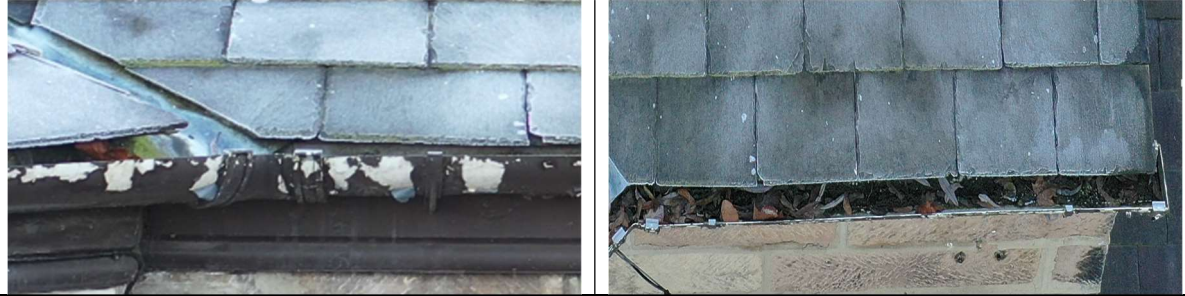
Front guttering run – this is in poor decorative order and full of debris. The debris should be cleared out in the next month and a plan made to redecorate the guttering next year. Example photos are below.

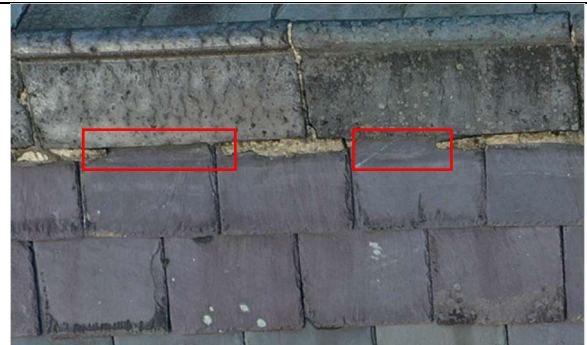
Sections of pointing are missing from both sides of the ridge.

The ridge should be repointed in the next year. An appropriate mortar mix should be used.

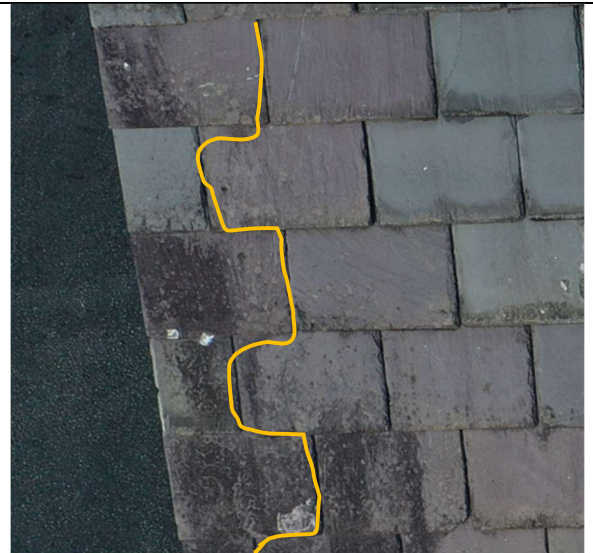
Front and rear pitches – the verge detail is incorrect – the slates should run:

The half slates will be subject to wind lift and as a result, failure. There is no economic way to address this now, but it should be considered when the building is ready for a re-roof (which is not needed at present).

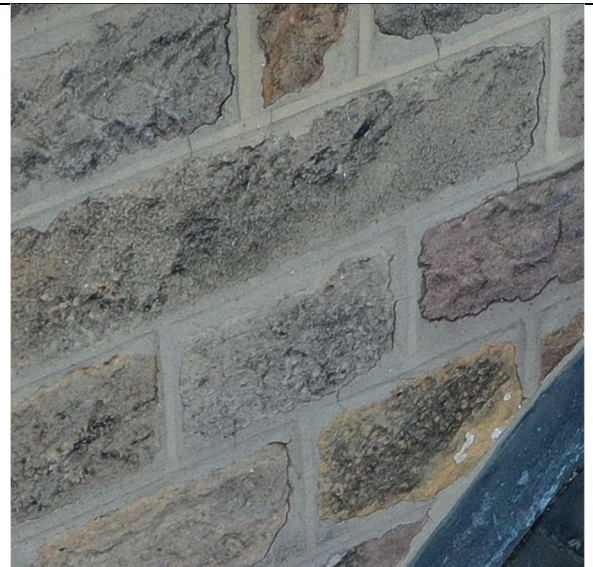
Not related to the roof survey we have undertaken, but worth mentioning – the stone on these buildings has been over-pointed with an incorrect mortar mix, likely cementitious. This is causing moisture stress on the stone and accelerating its decay.

If you are planning to undertake work to the stone buildings in future, we would be happy to assist/review proposals.
