Level 3 Survey in Respect of:

Report prepared by Simon
Hollis MRICS

18th July 2023

Building Survey Report

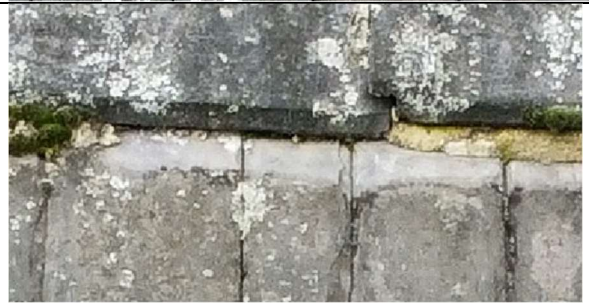
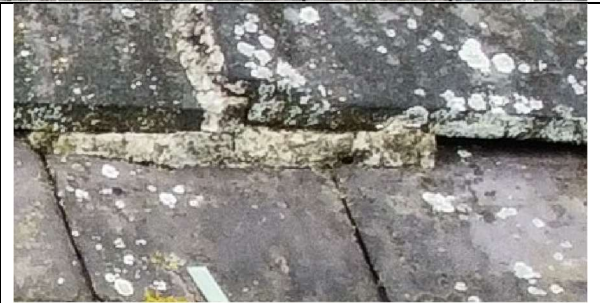
Ridge – there are several sections of the ridge pointing that are missing. The defective pointing should be raked out and replaced before winter. We have included some example photos below.

Side-on photo of the ridge – note the missing pointing between the tile abutments.

Note that the ridge tiles are not sat square along the ridge.

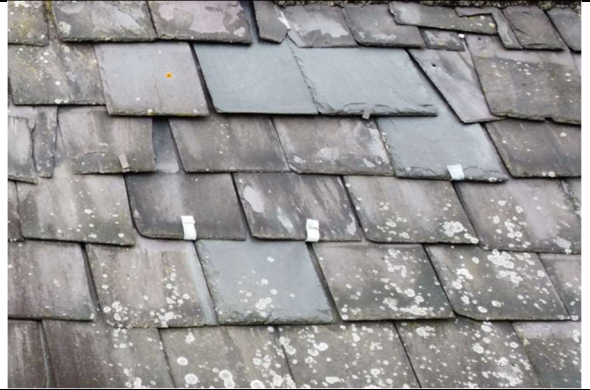
Example photo of where an area of slates has been replaced, but more slates are slipping.

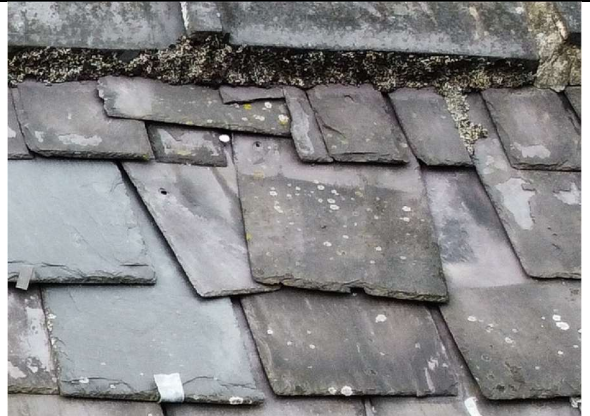
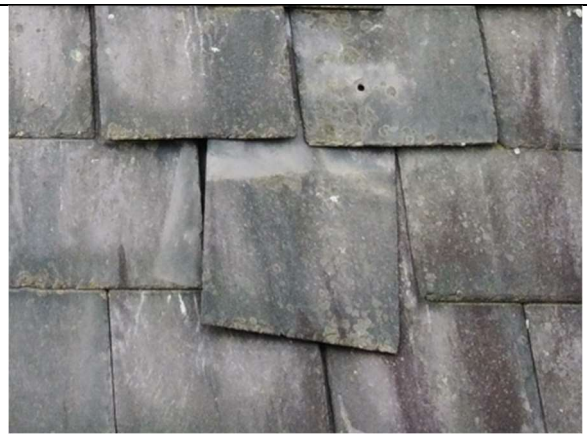
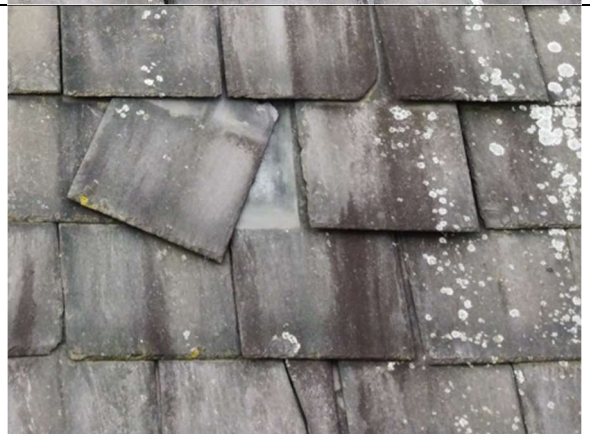
Example photos of where slates are slipping and immediate repair work is required.

Note that there are areas of moisture ingress around the chimney on the front pitch in line with where the slates are slipping.

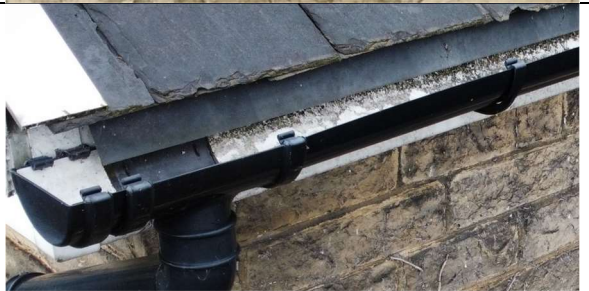
The slates should sit halfway across the guttering run, here, the guttering has been replaced and the slates do not sit far enough over. An eaves tray has been added to mitigate this.

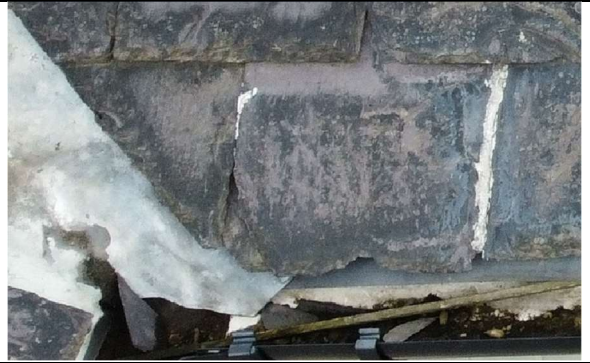
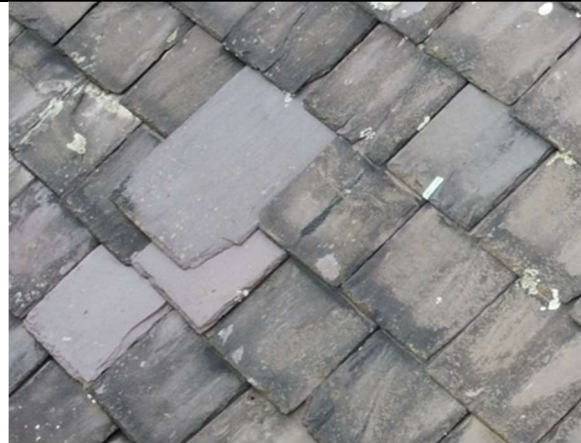
Example photos of slipped and damaged slates – all of these should be replaced before winter.

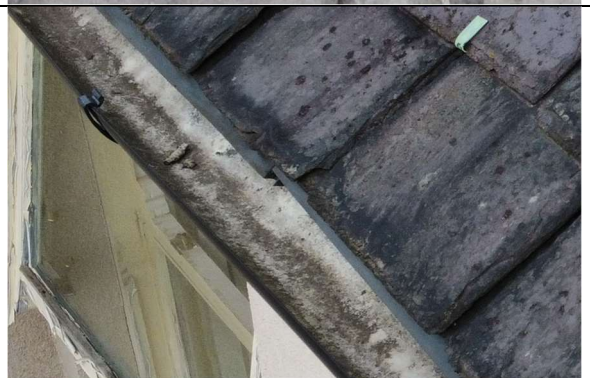
The slates should sit halfway across the guttering run, here, the guttering has been replaced and the slates do not sit far enough over. An eaves tray has been added to mitigate this.

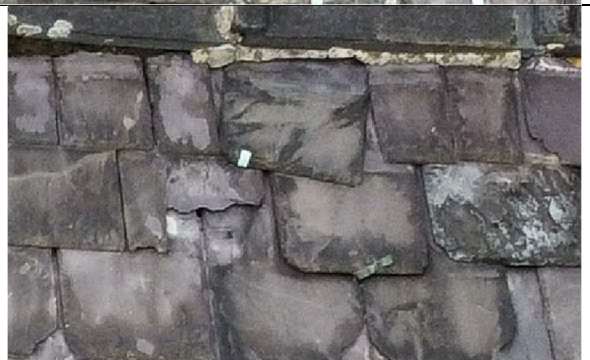
The areas of slipped, missing and damaged slates need to be repaired immediately. Example photos are below.

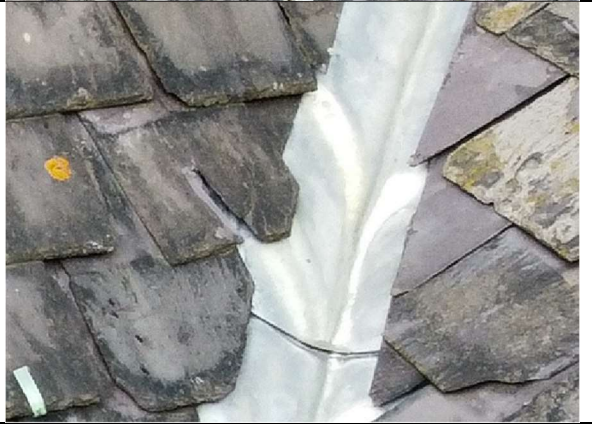
Valley – the slipping and missing slates along the valley should be replaced before winter.

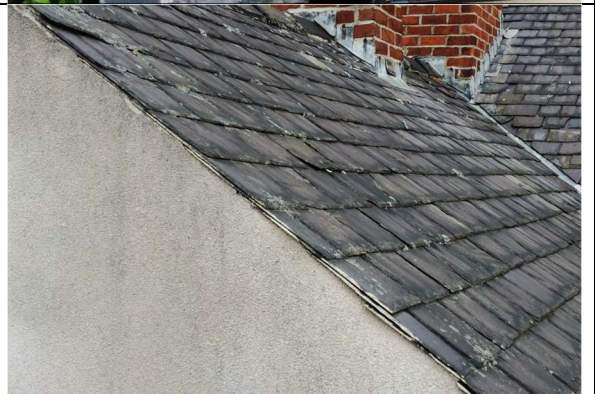
Verge – the slate line along the verge should project at least 50 mm from the elevation below. Here, the slates are flush with the elevation which may cause problems with rainwater run-off into the wallhead.

This is a complicated, uneconomical problem to remedy.

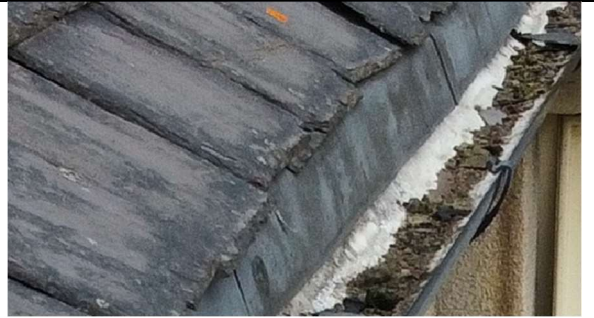
Eaves - the slates should sit halfway across the guttering run, here, the guttering has been replaced and the slates do not sit far enough over. An eaves tray has been added to mitigate this.

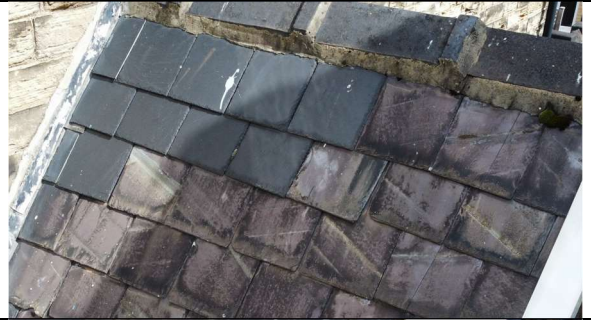
Some of the slates have been replaced and others are cracked.

The cracked slates should be replaced in the short-medium term.

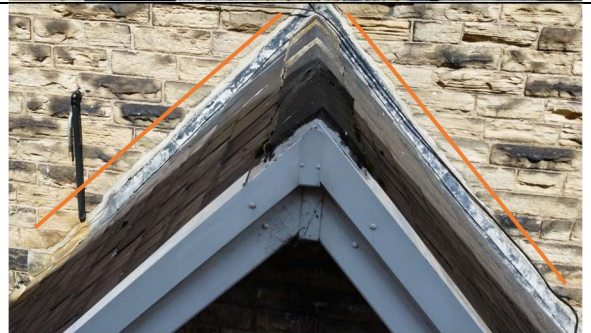
Flashing – this should have been done in a stepped lead flashing and soaker detail, here, a one-piece cover flashing has been used.

This is functional, so there is little point in correcting this for the time being.

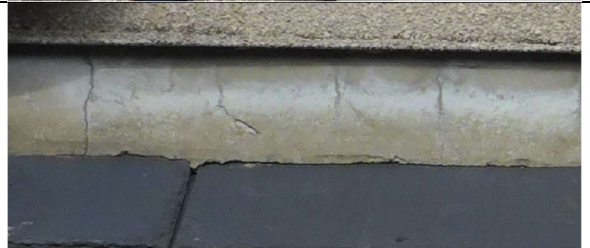
Kitchen lean-to – it looks like the flashing detail has been mortared over. This is starting to crack and should be monitored, repairs will likely be needed in the medium term.

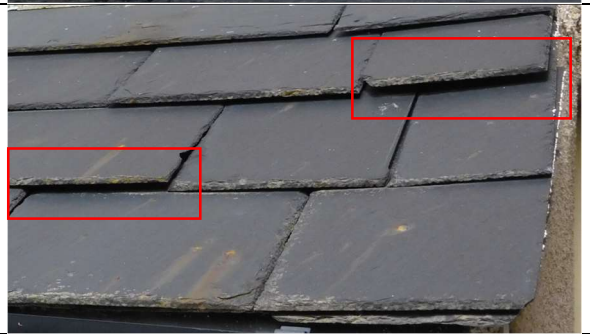
Kitchen lean-to - examples of where the slates do not sit flat on top of each other – this could cause problems with wind-driven rainwater ingress.

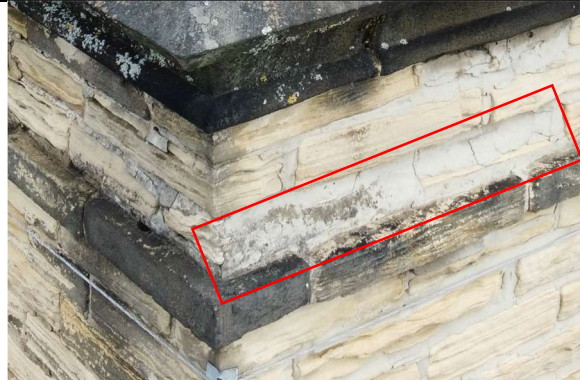
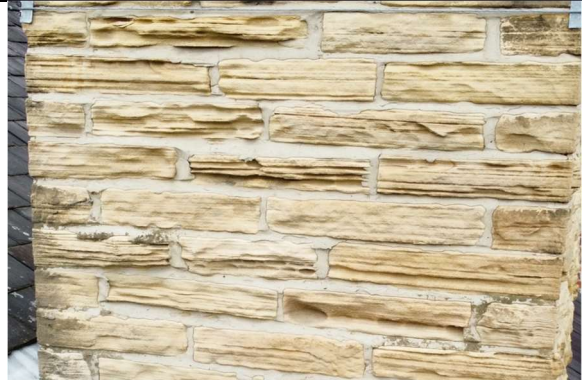
Two example photos show the decay of the stone forming the stack. The red box shows where mortar has been inappropriately used to try to 're-face' some of the stones. Based on the colour of the mortar, this looks to have been repointed with a cementitious mix. We recommend that this is removed, the stones repaired and the stack repointed in the short-medium term. Please see our comments above on stone repair and mortars.

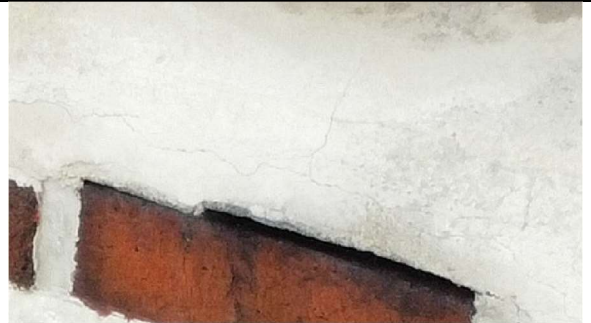
Flaunching – there are some minor hairline shrinkage cracks in the mortar and an area where the mortar is missing.

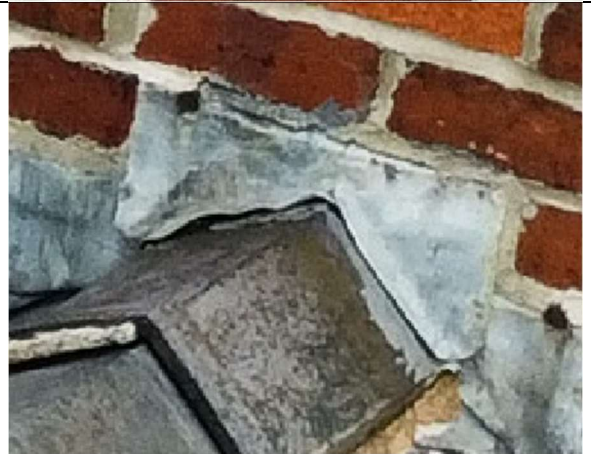
The lead saddle piece should be dressed under the ridge tile as opposed to over it. This should be amended when the ridge is repointed.

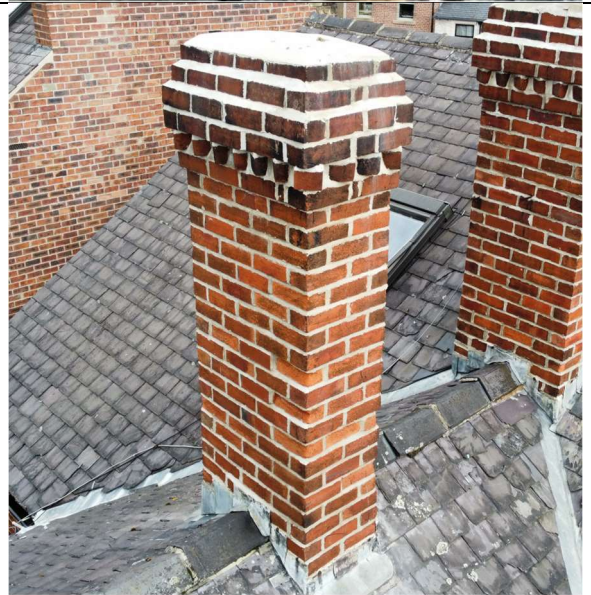
The lead looks to be the original lead (based on its colour and condition). This will likely last a few more years until it needs to be replaced.

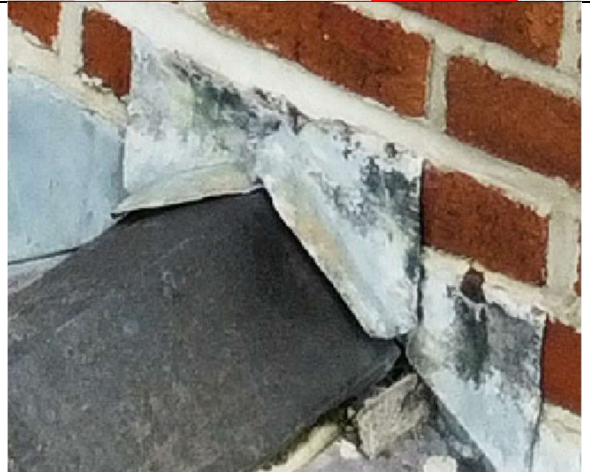
The lead saddle pieces should be dressed under the ridge tiles as opposed to over them – this applies to both sides of the stack.

This should be amended when the ridge is repointed.

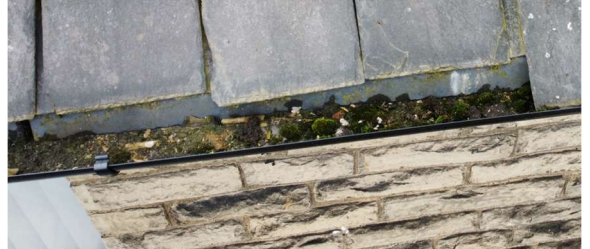
Example photo of the debris – this should be cleared out before winter.

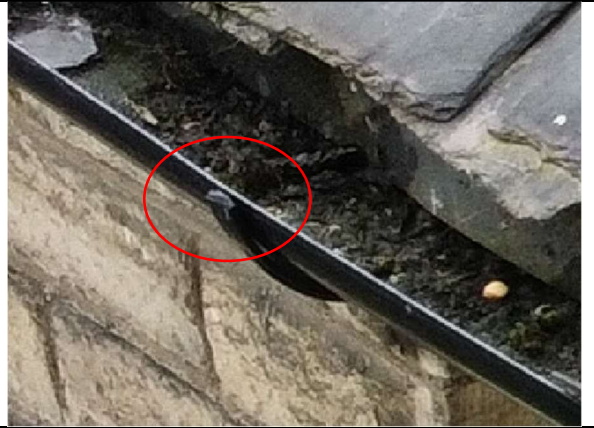
The clip has snapped off the top of this guttering bracket, the bracket should be replaced before winter.

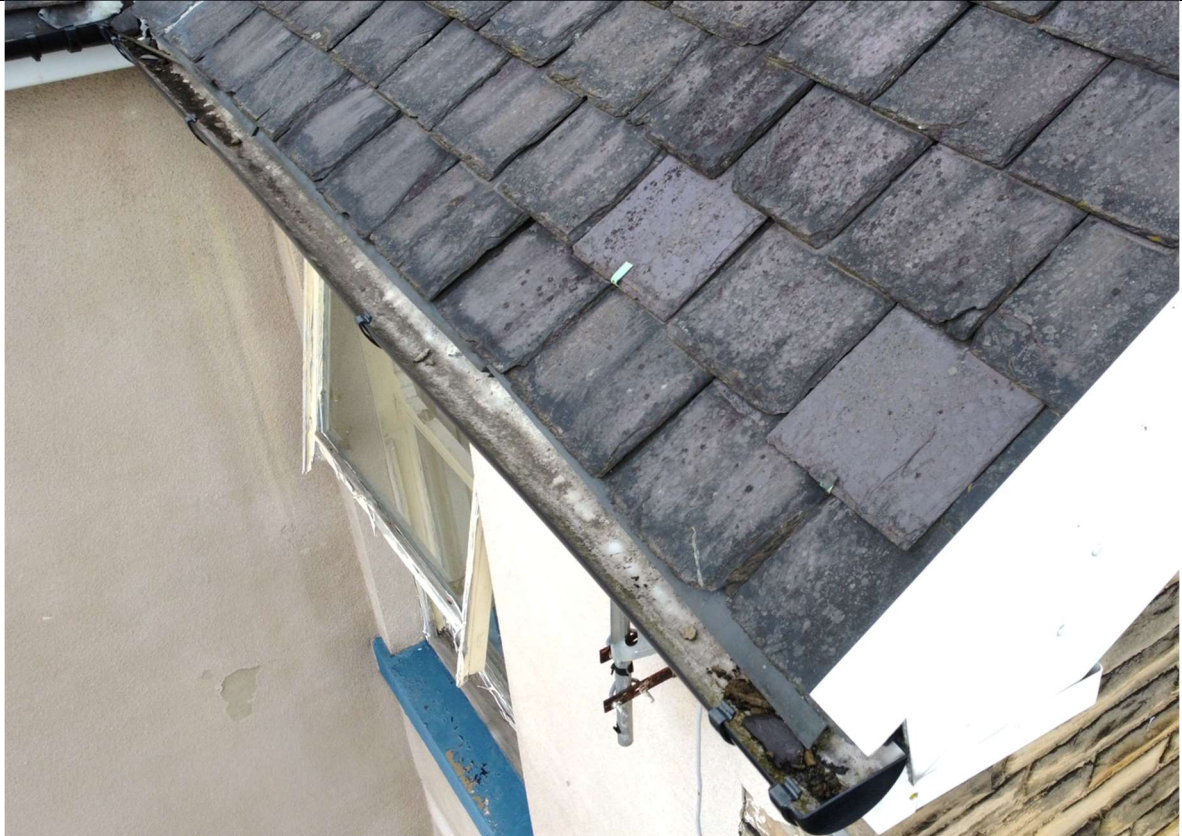
Overhead photo of the rear run.

There is debris trapped at the left-hand side of the run, away from the outlet, this is likely as a result of the guttering not being set to the correct fall.

The debris should be removed before winter and consideration given to re-setting the guttering.

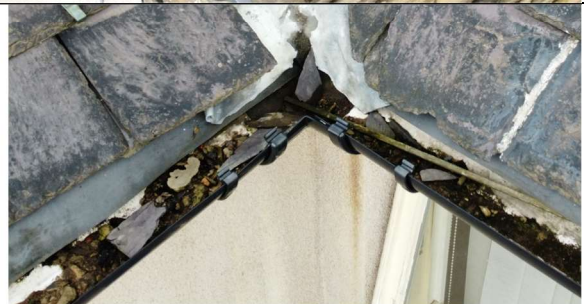
Off-shot guttering – the debris should be cleared before winter and consideration given to re-setting the run to the correct fall.

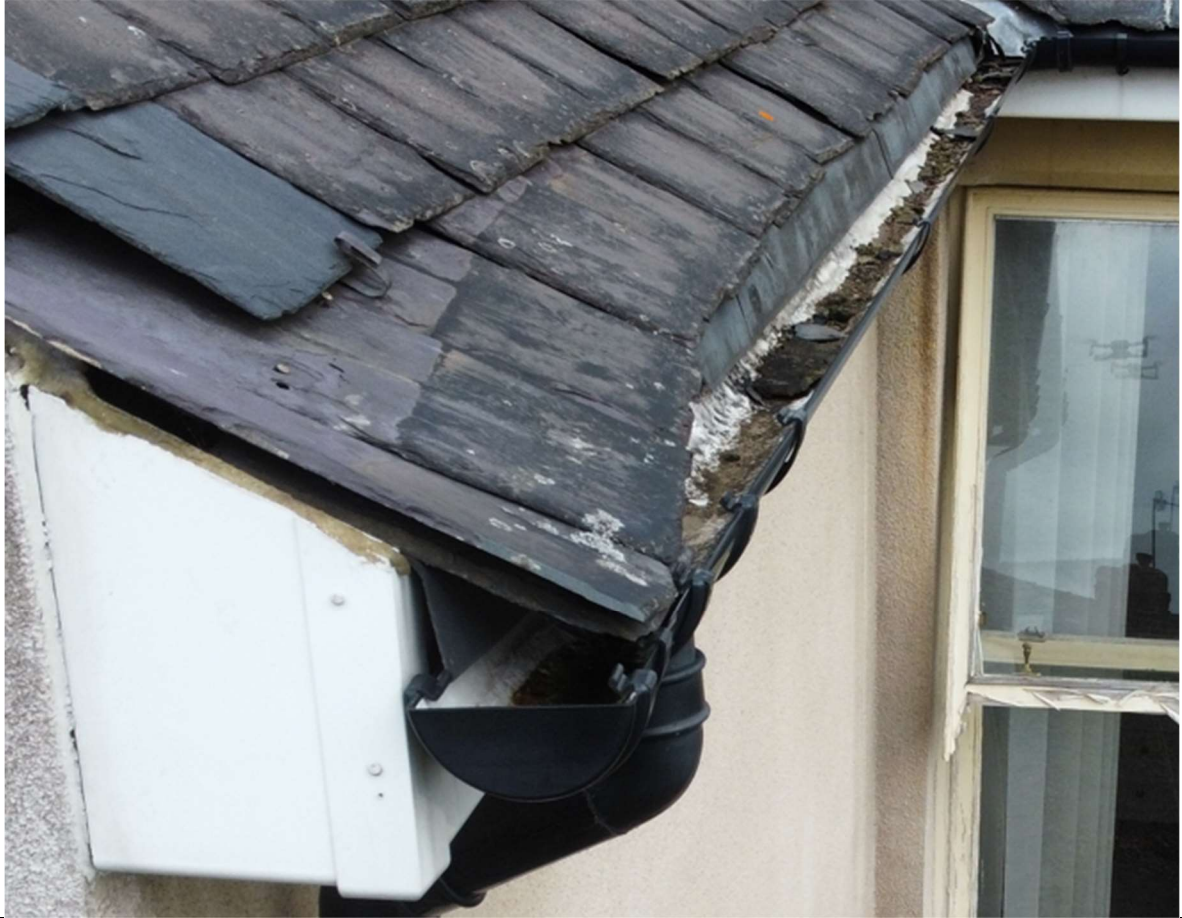
Kitchen lean-to – the guttering is not fitted close enough to the eaves course. As with the other sections, an eaves tray has been added to try and mitigate this.

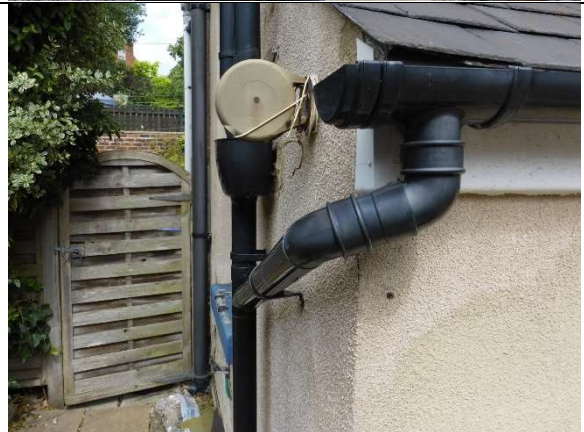
<p>Kitchen – we could not see what this pipe serves internally. If it is redundant, it should be appropriately terminated to prevent insect etc. infestation.</p>

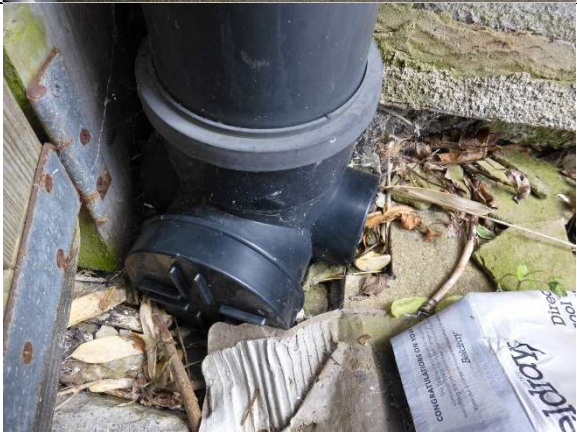
Rear elevation – the pipe boots should be better directed into the centres of the gullies, the areas of damaged mortar should be repaired and the gullies cleared out with the grills re-set in the short term.

These should then be tested to ensure water is correctly discharging into the gully and not escaping.

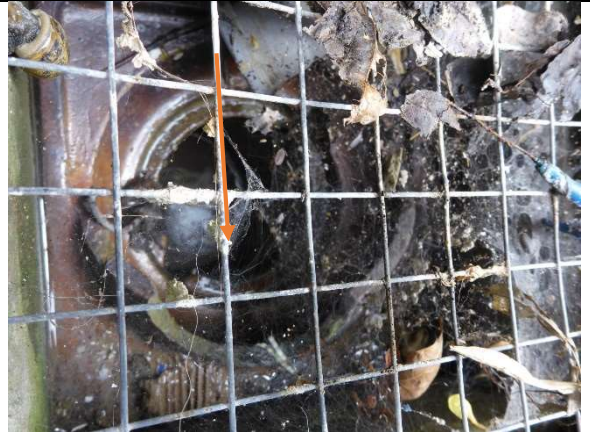
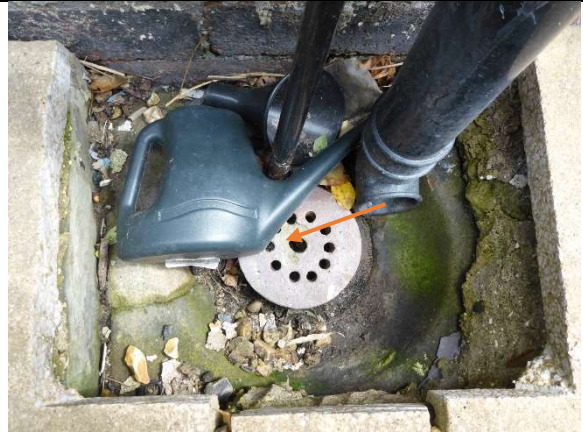
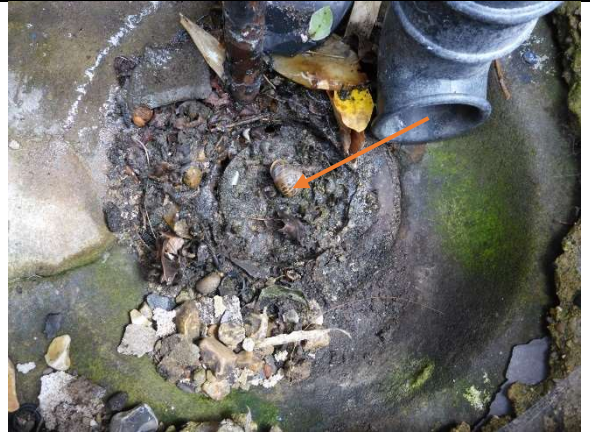
Gully to the rear of the porch – this needs clearing of debris in the short term, and then inspecting for damage. There may have been some movement in the porch and it is essential that the drainage is in repair before monitoring begins.

A boot should be added to the bottom of the fall pipe to better direct water into the centre of the gully.

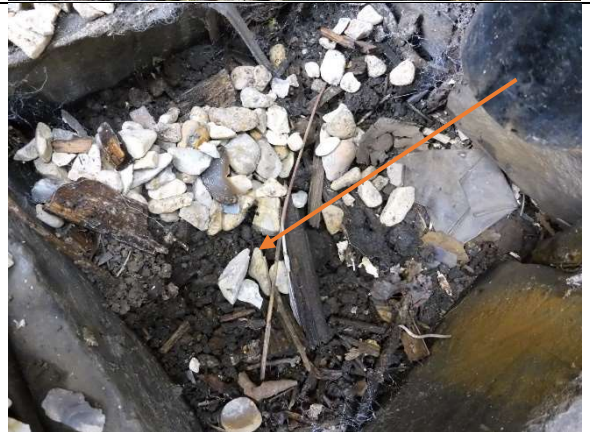
Front gully – this was full of debris and the fall pipe goes below ground level.

This should be cleared out and inspected in the short term and a grille/grate added to the gully and boots to the base of the fall pipes.

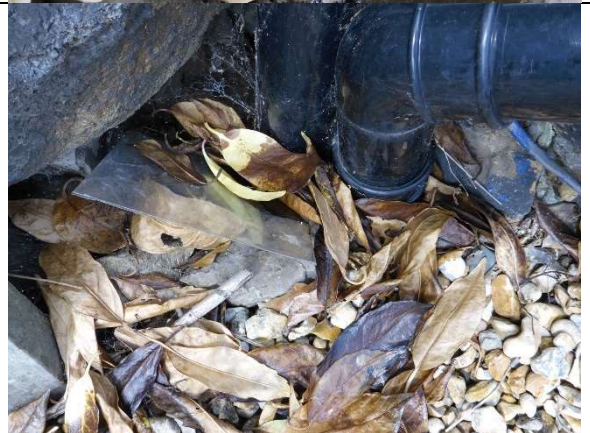
Left-hand front gully – this needs to be unblocked and reinspected in the short term.

The cracked section should be replaced in the short term and a grille/grate added to prevent debris from entering the trap.

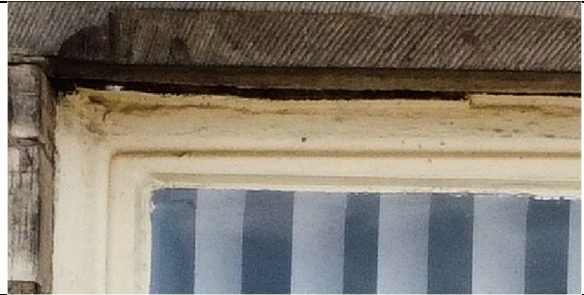
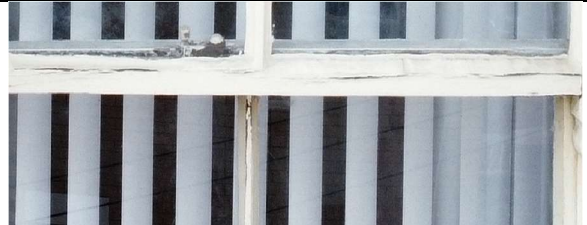
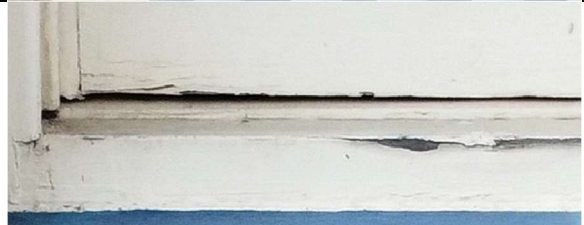
First-floor, right-hand bedroom window – there is some damage that should be repaired before the areas are prepared and redecorated. We recommend this work is undertaken in the next year.

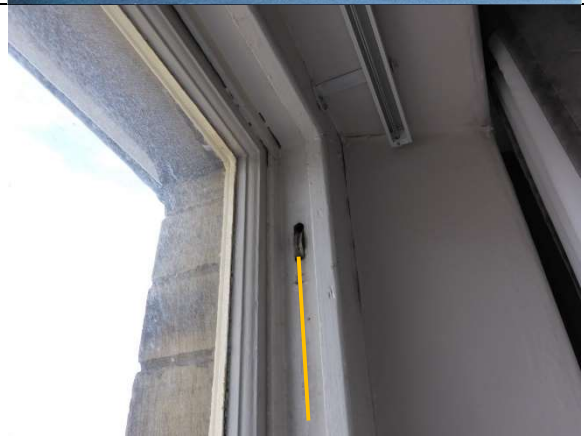
This window has no sash ropes and does not open. It should be repaired so it functions correctly.

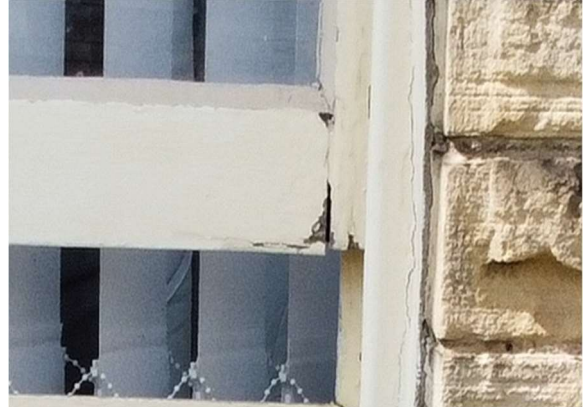
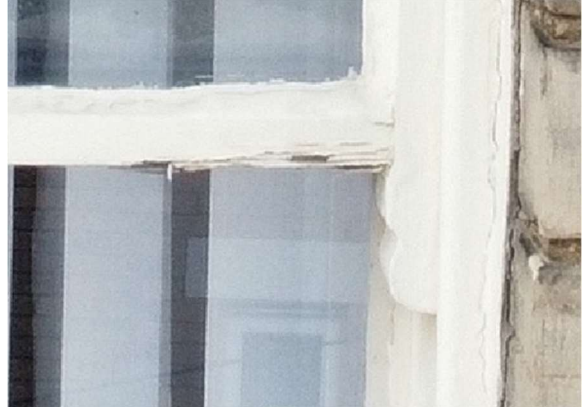
First-floor, left-hand bedroom window – there is some damage where the bottom rail connects to the stud on the upper and lower window sections – these areas should be repaired, prepared and redecorated in the next year.

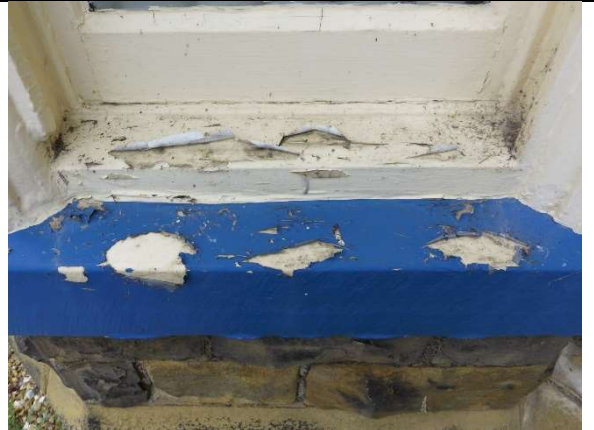
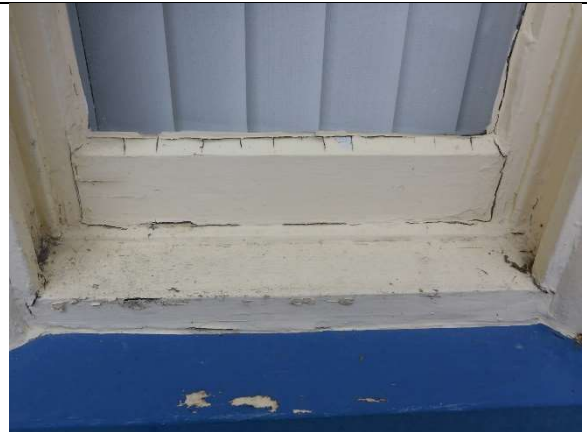
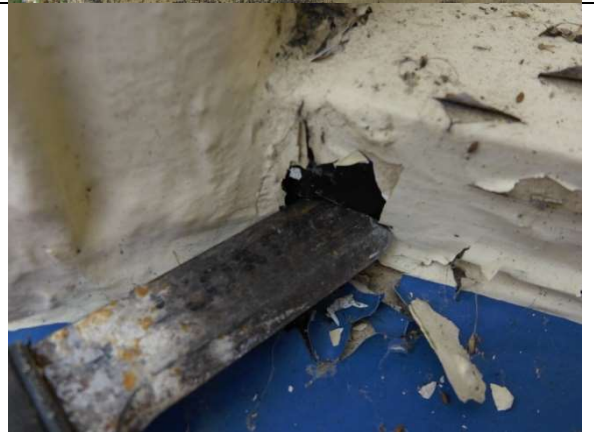
Front bay window – the vendor advised that the windows do not function. They are in poor decorative condition and there are areas of failing putty and decay to the timber.

We have included some example photos as opposed to photos of all of the defect areas.

Refurbishment will be required to bring the windows back into functioning condition.

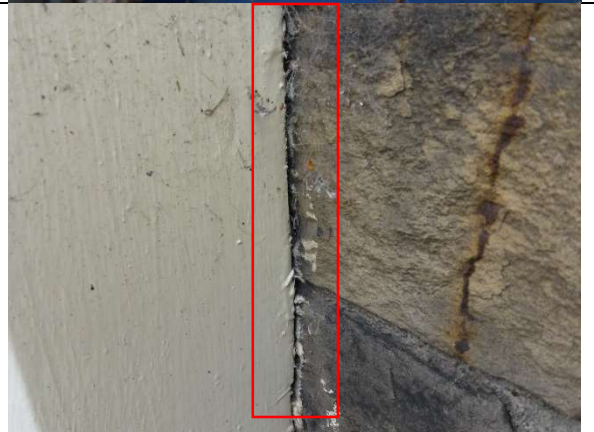
Front bay window – there is no seal at the abutment with the front elevation. We recommend both sides are cleaned up and sealed with burnt sand mastic as part of the refurbishment process.

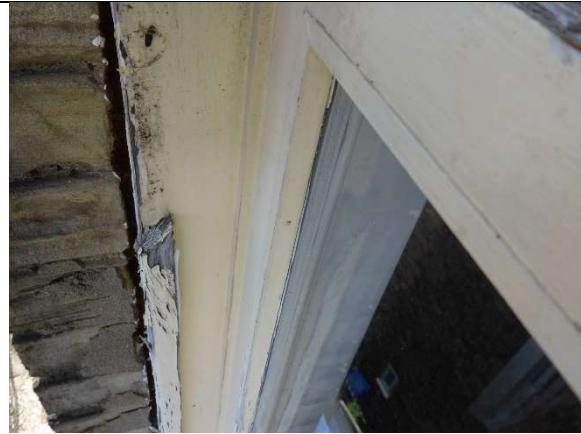
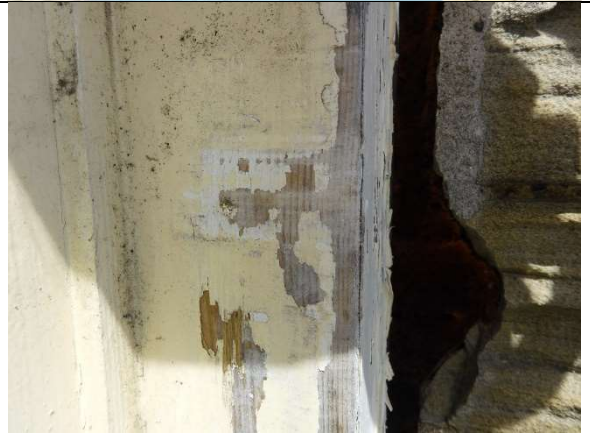
Second-floor window – the frame is in poor condition, repair, preparation and redecoration are required; we recommend before winter. Where the frame abuts the reveal, it has been sealed with expanding foam and there is a large gap. This should be sealed with burnt sand mastic before winter.

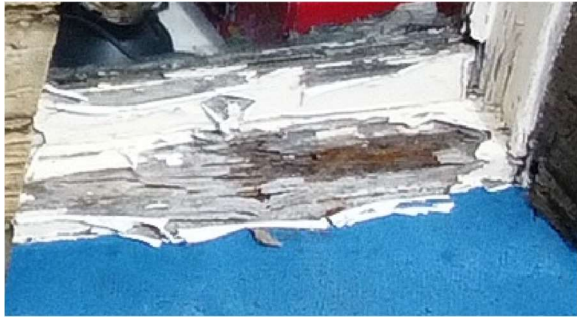
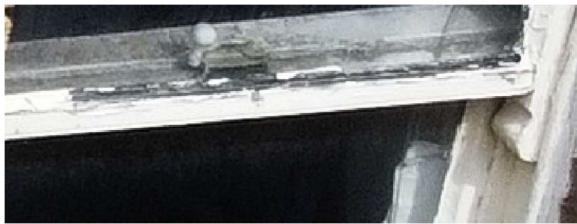
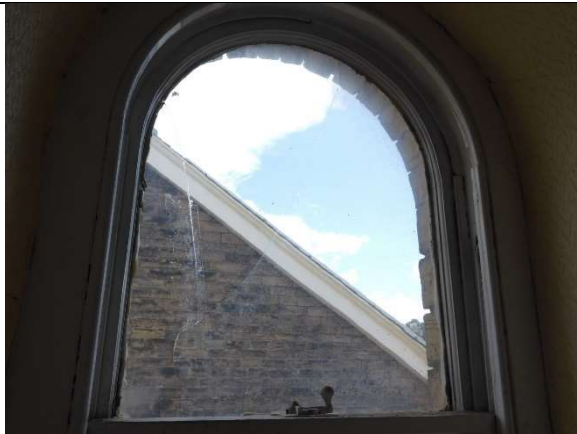
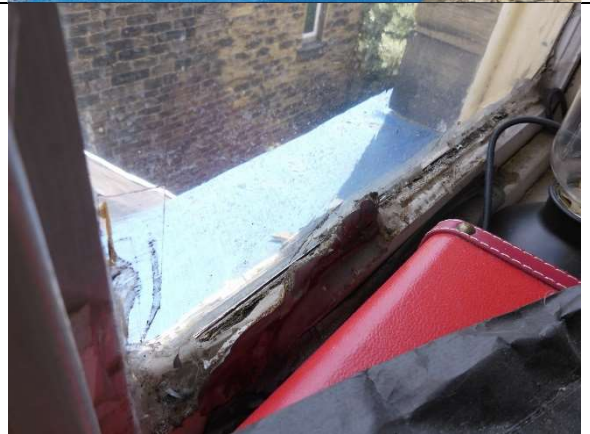
First-floor window – this is in poor condition and the glazing is cracked. The window should be repaired/replaced in the next year or so.

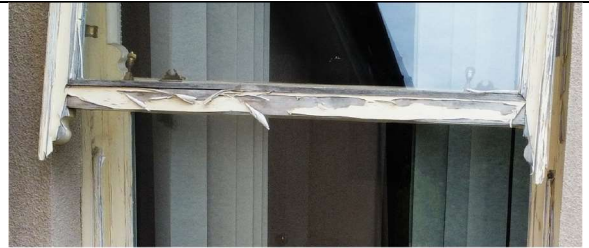
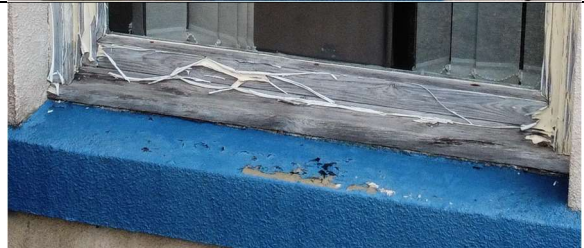
First floor, rear bedroom – the frame needs preparation and redecoration, we recommend that this is undertaken before winter.

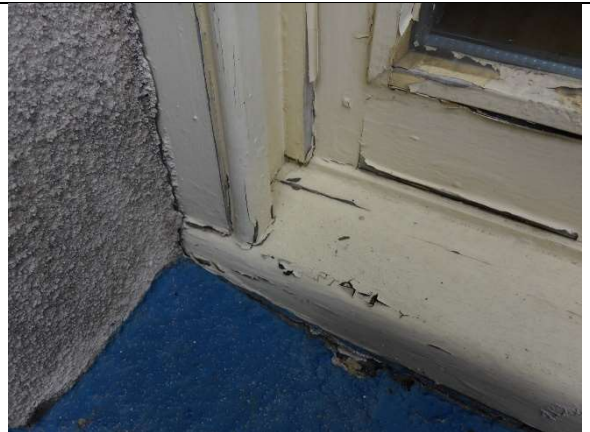
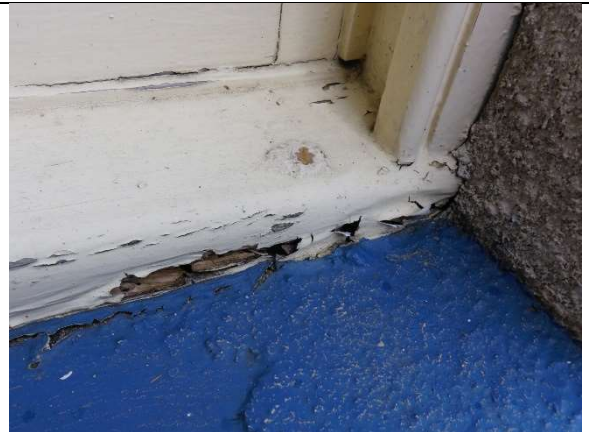
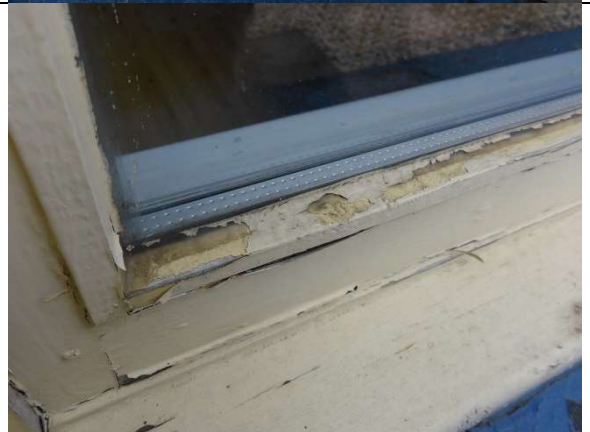
Dining room window – the sill is rotten and the window is in generally poor decorative condition. The sill needs to be repaired/replaced and the window prepared and redecorated.

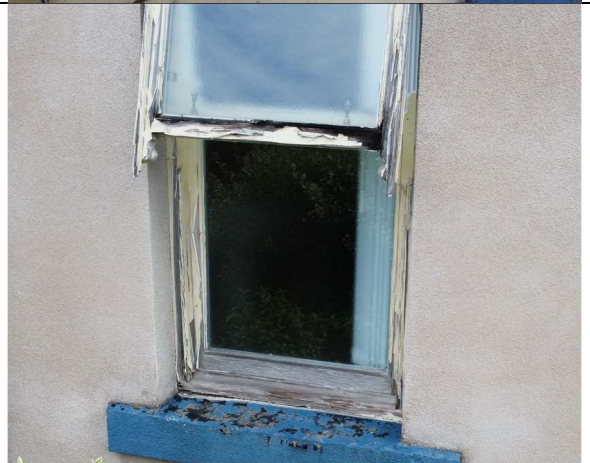
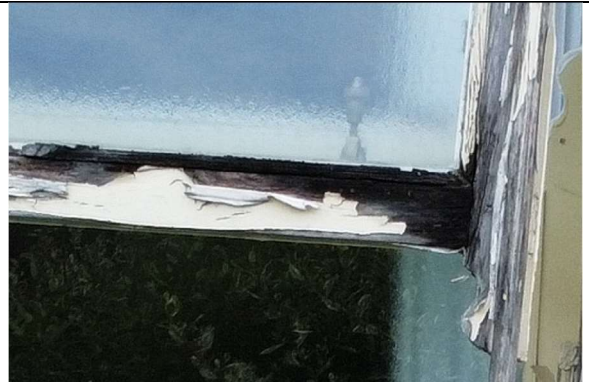
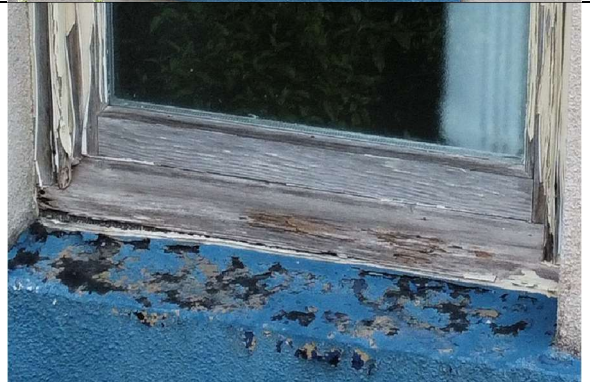
Bathroom – the window frame is in poor condition, this could be repaired and redecorated, however, replacement may be more economical.

The lower rail in the opener is in particularly poor condition and looks like it may fail soon.

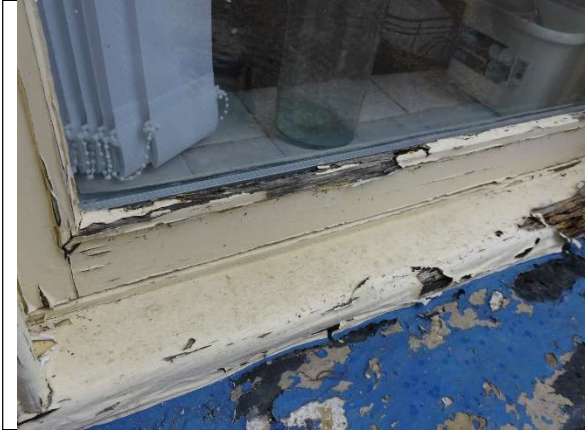
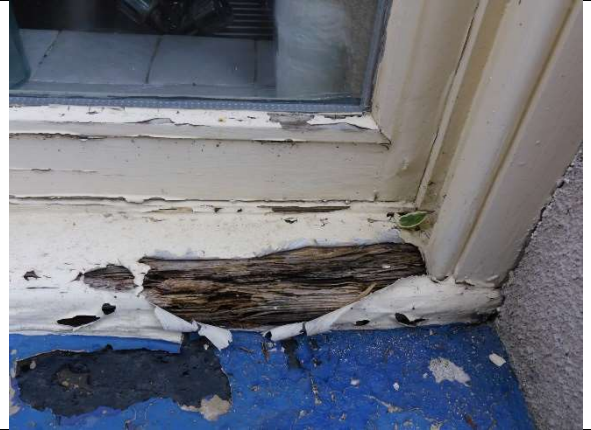
Kitchen window – this is in generally poor order, and repairs are required before preparation and redecoration. It may be more cost-effective to replace the window.

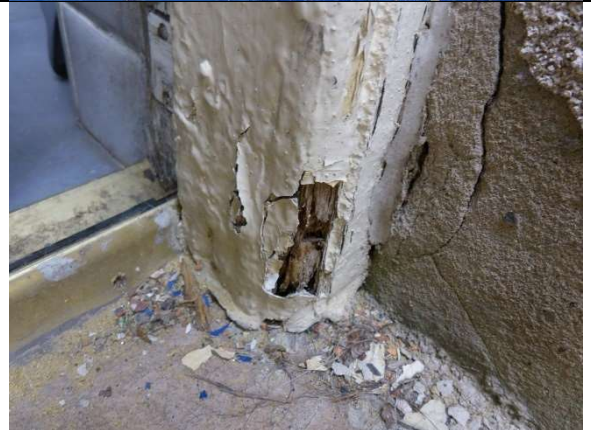
Rear (Kitchen) door – there is decay around the bottom of the frame. This needs cutting out and fresh timber splicing in. The frame will then need preparation and redecoration.

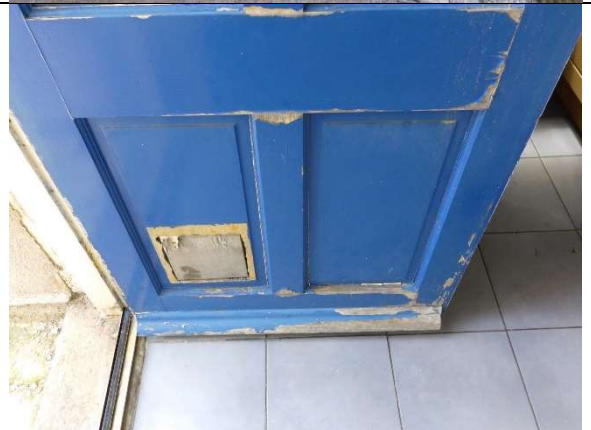
Rear (Kitchen) door – this needs preparation and redecorating. The door does not fit particularly well in the frame and binds in areas.

Note that there is a cap flat hole in the door.

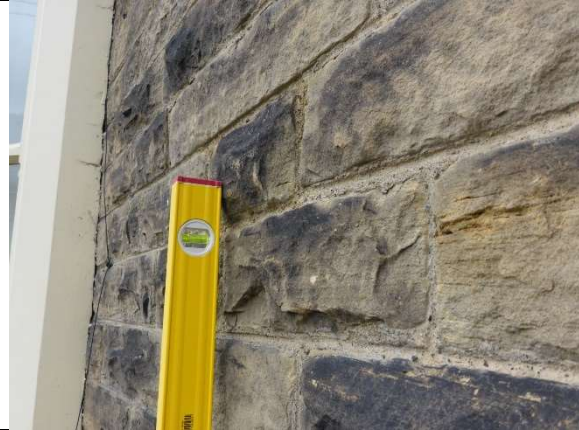
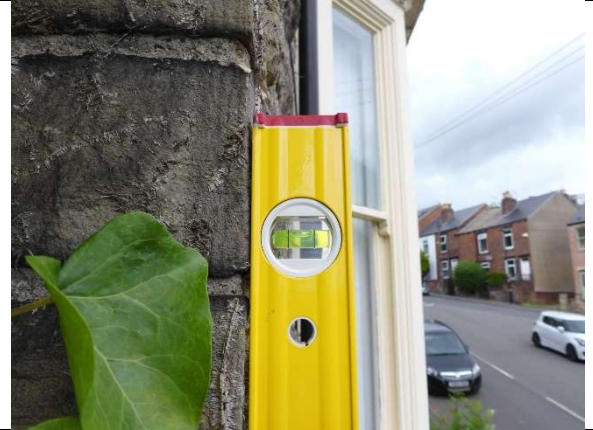
Where the stone does not have a flat face, we have not been able to use the level to spot-check the plumbness of the walls. On the corners, the stone has been dressed to a 90° arris and we have been able to use the level to check for plumbness and found these areas to be plumb.

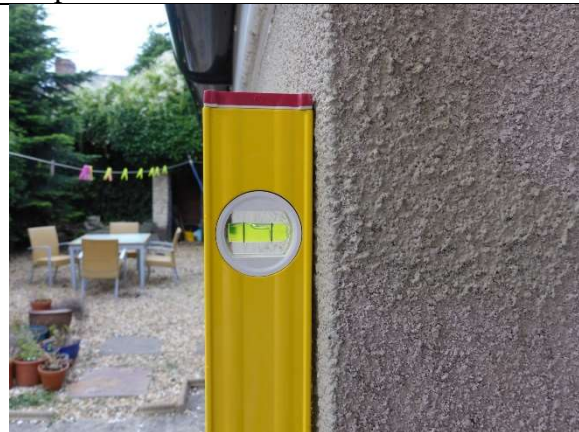
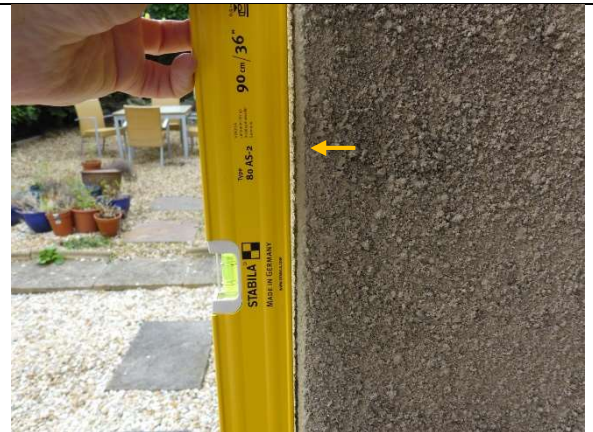
Where the walls are rendered, the finish is textured and in places, it is not flat (note the gap at the back of the level), so we have been unable to use the level to spot-check these walls for plumbness.

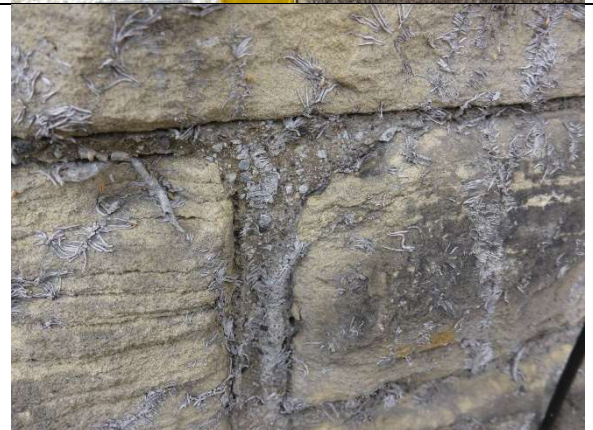
A close-up photo showing where ivy has been growing up the front elevation. This is likely responsible for some of the damage detailed below.

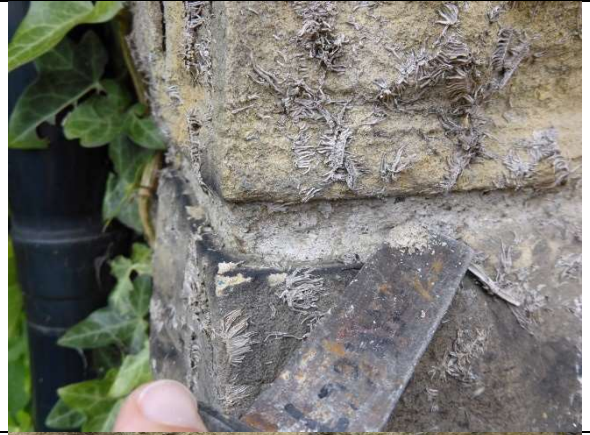
An example of the soft, lime-based original mortar.

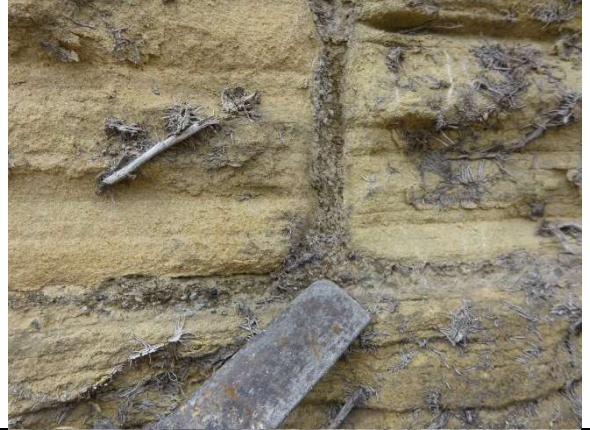
An example of a harder, likely cementitious mortar that is inappropriate for a traditionally constructed house.

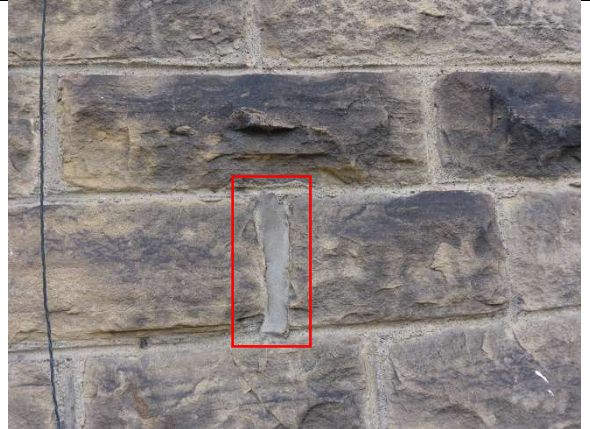
Example of inappropriate re-pointing style and material.

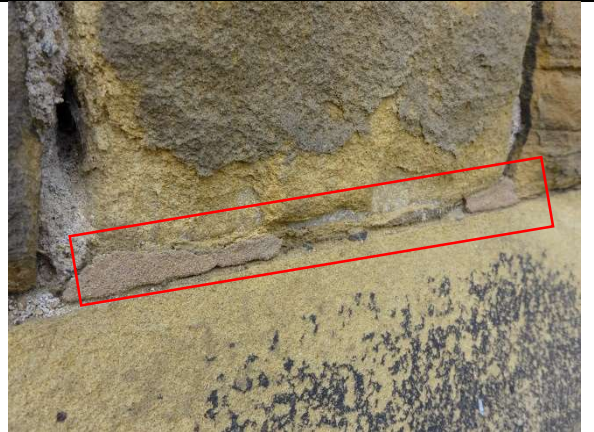
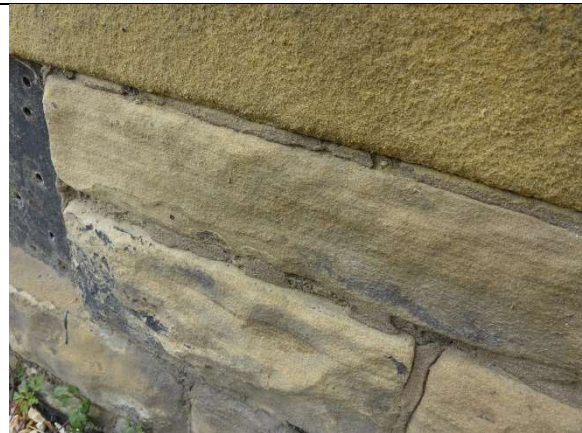
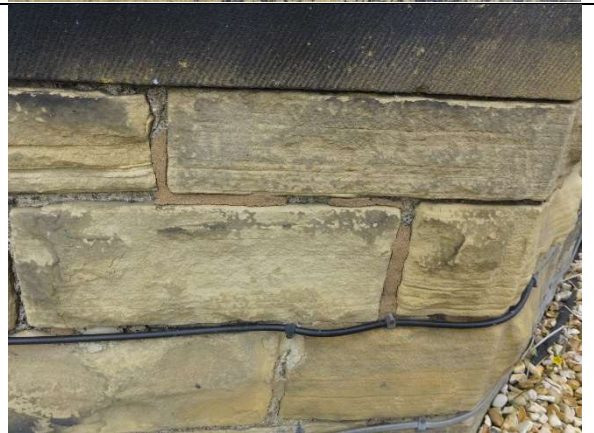
An example of where the elevation has been 'overpointed' and the cementitious mortar has caused some decay to the stone.

The inappropriate mortar needs to be removed, and the stone needs to be defrassed and repaired if necessary and the area then needs to be repointed.

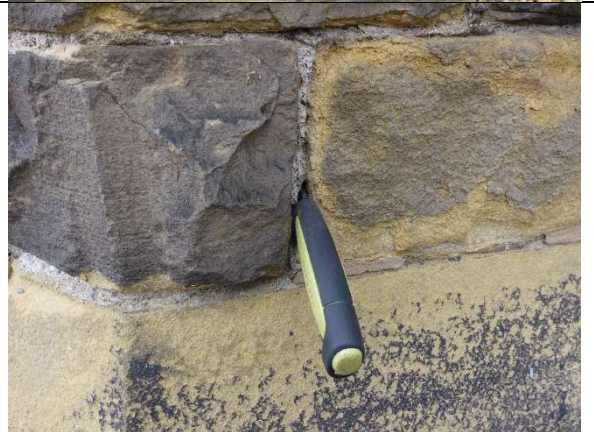
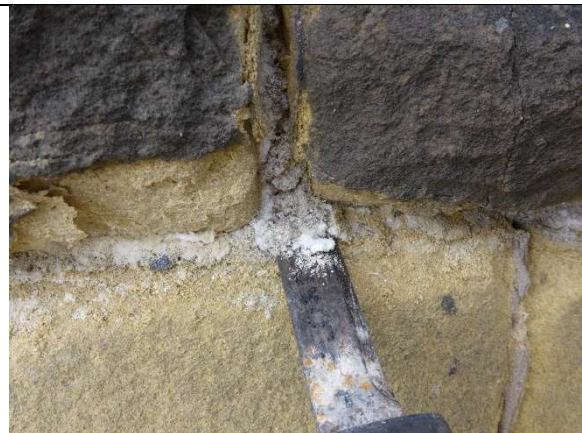
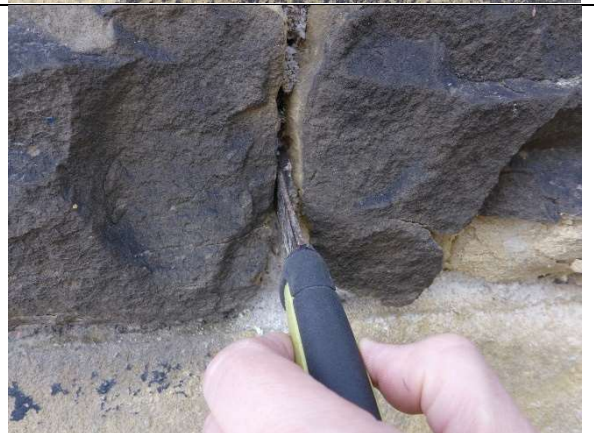
Examples of where there is no mortar in the perp joints. These need to be properly raked out and repointed before winter.

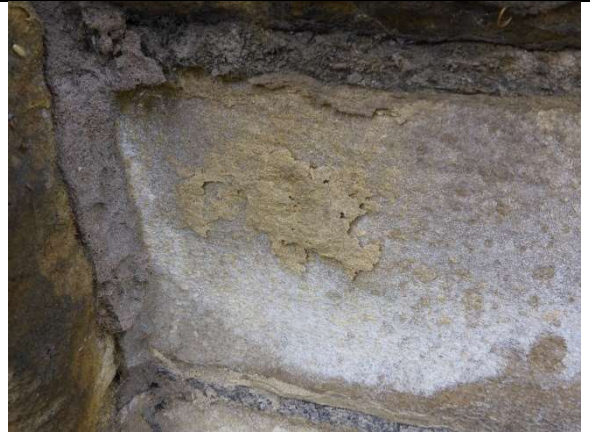
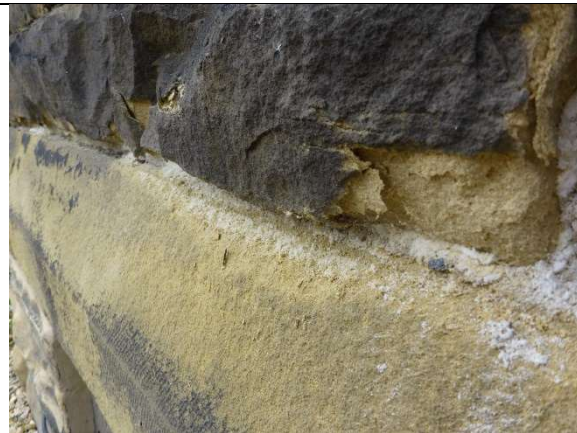
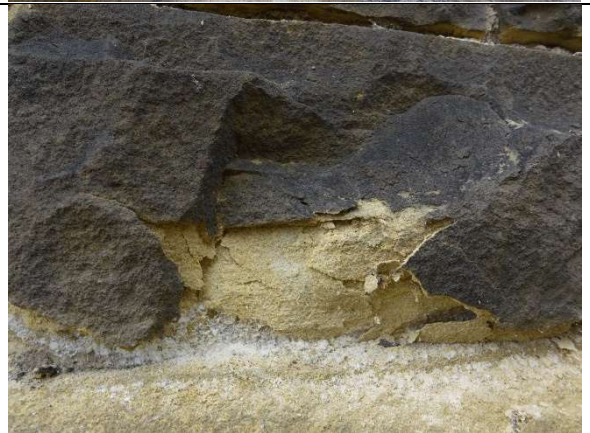
Examples of areas that have been repointed in an inappropriate cementitious mortar mix which has then caused the stone to decay.

The inappropriate cementitious mortars should be removed, the stones defrassed/repared and the areas repointed in a more appropriate mortar mix.
