Level 3 Survey in Respect of:

Report prepared by Simon
Hollis MRICS

18th July 2023

Building Survey Report

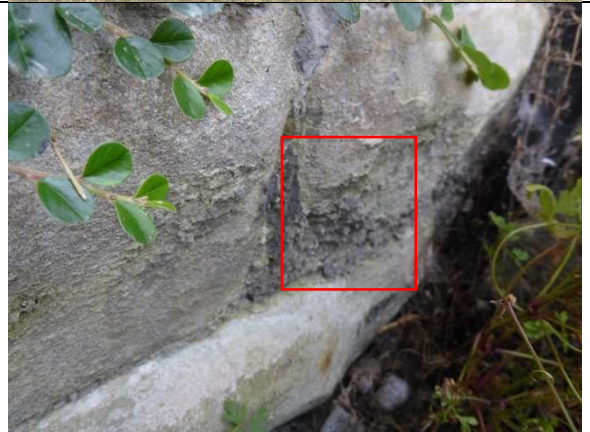
Example of some surface decay to the lower stones – these should be defrassed in the next year.

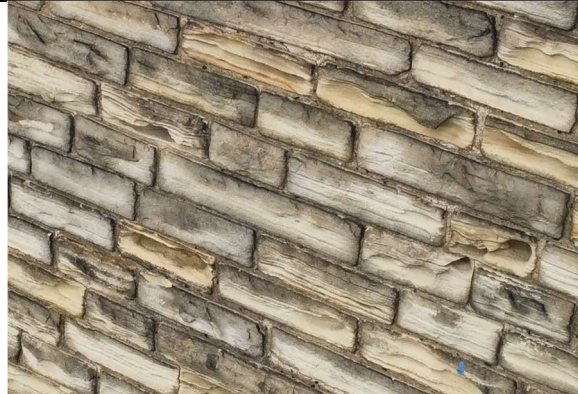
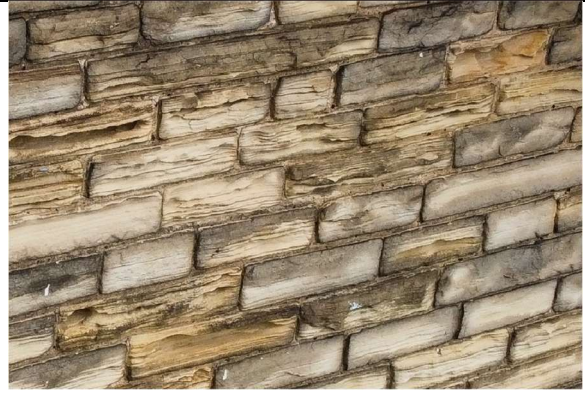
Left-hand elevation – some examples of stone decay. Some of the stones that are worse affected will need to be replaced in the medium term. A matching stone should be sourced in advance of the works. There are perhaps 25 – 35 stones that will need to be replaced, many of these are at high level and a scaffold will be required.

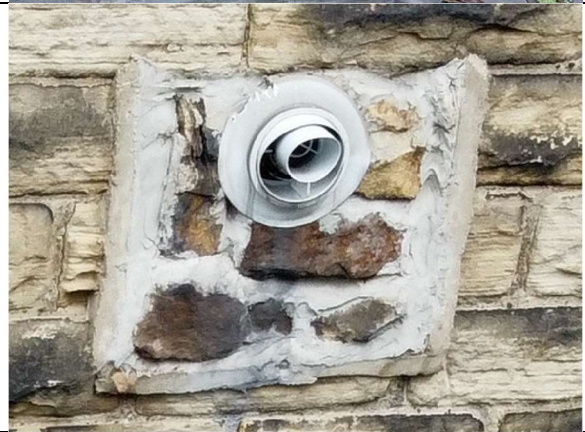
The wall has been poorly repaired where the boiler flue penetrates.

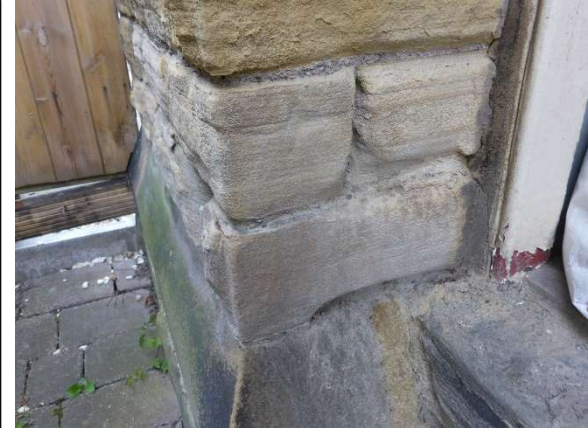
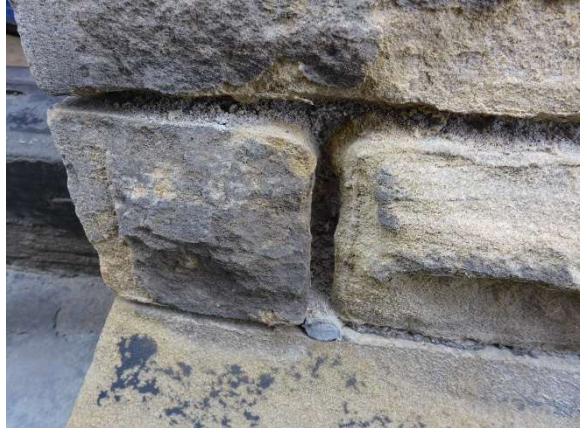
Porch – example photos of weathering and some decay to the stone and washed-out mortar joints which need properly raking out and repointing. We recommend the stone is defrassed and the joints re-pointed before winter.

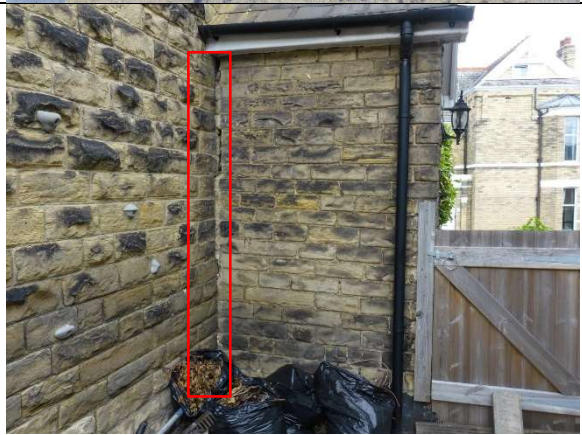
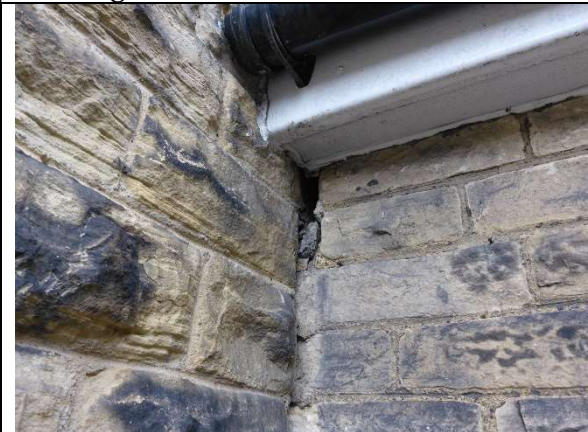
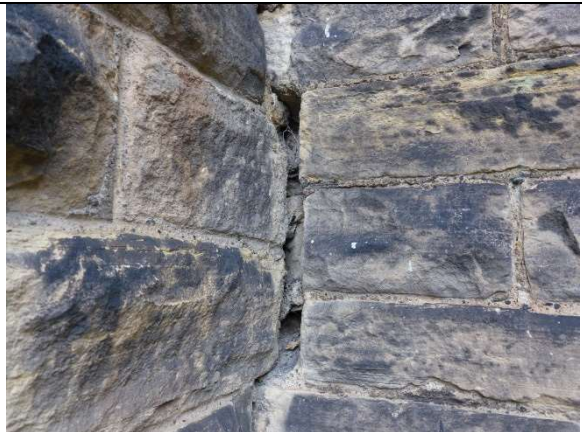
On the rear side of the porch, there is a larger gap where the stone is toothed into the left-hand elevation.

The upper outer edge of the wall is c. 20 mm out of plumb, however, there were no cracks to the mortar joints or stone.

We recommend that this is recorded, repaired and monitored with the seasons going forward. If it is established that there is some active movement, some tying back may be required. There was no internal cracking in this area.

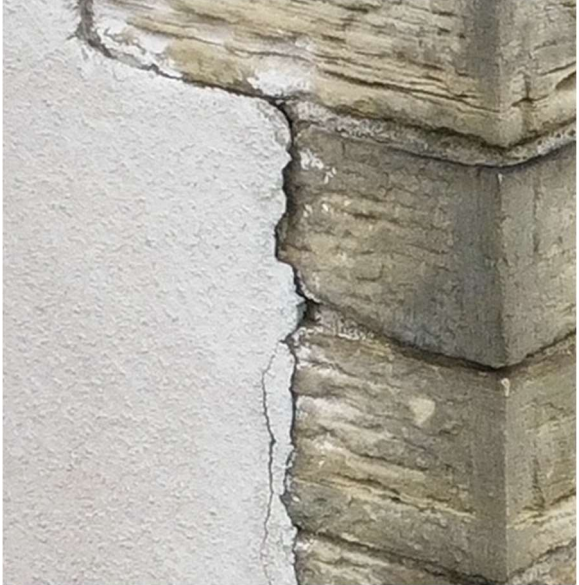
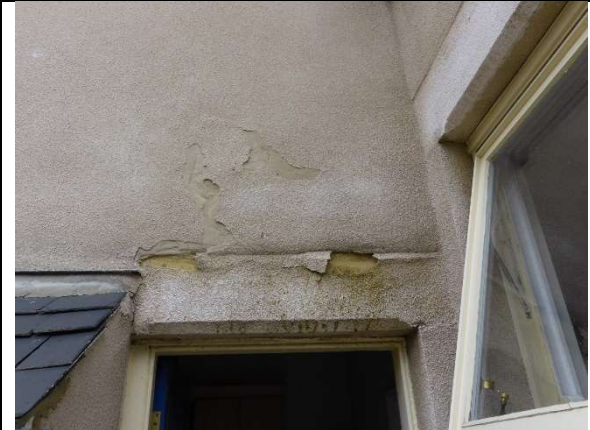
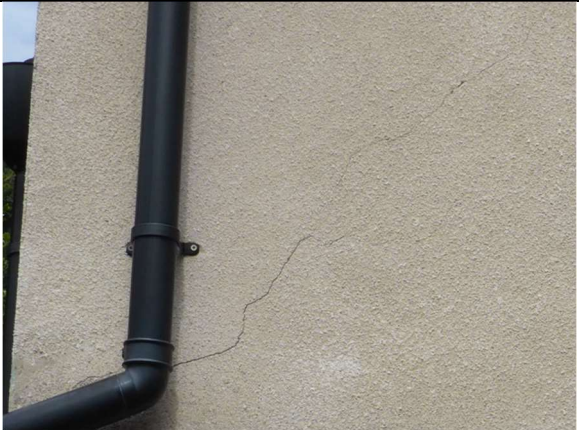
The render is cracking and coming away from the substrate in some areas. This is likely a cementitious mix and is not original to the house. We have included some example photos of the defects below.

The cracks will allow rainwater to penetrate the render and this will likely cause problems with freeze-thaw weathering, damage to the substrate and penetrating dampness.

In the not-too-distant future, the render should be removed and the substrate assessed before a plan can be made to either retain and repair the substrate and have this as the external face, or, re-render in a more appropriate mix.

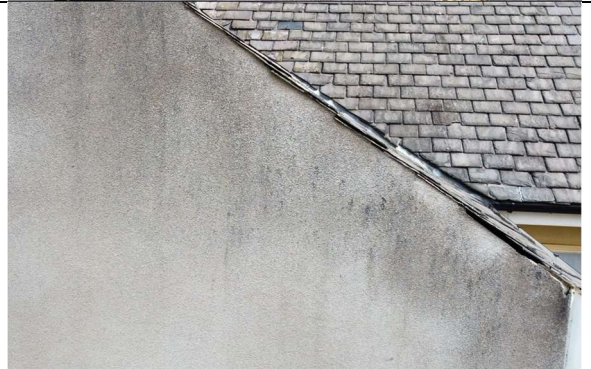
Off-shot, rear elevation – the verge line is stained due to the abovementioned lack of projection on the verge slates.

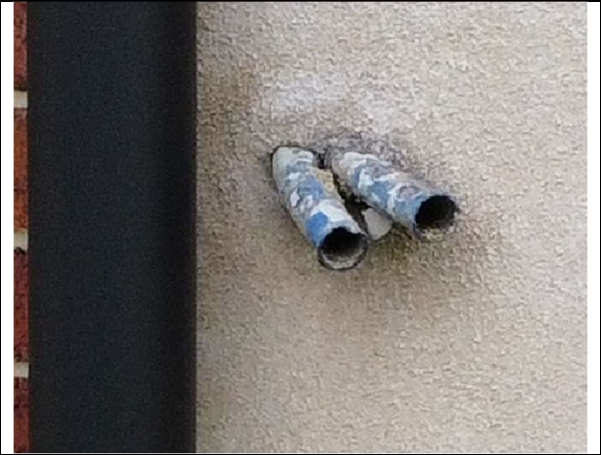
Off-shot, rear elevation – these look like redundant service penetrations, they are not visible internally.

If they are redundant, they should be removed.

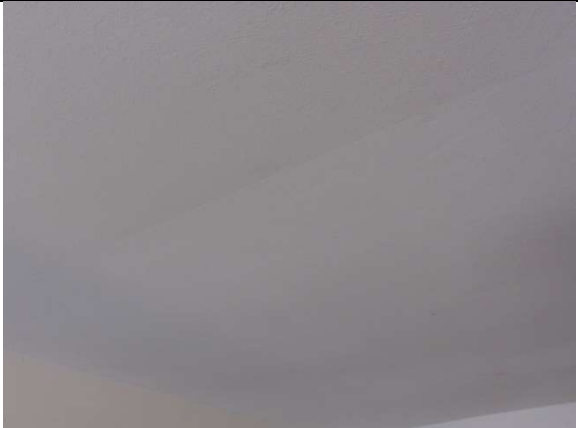
<p>Second floor – some of the plasterboard joints are visible through the plaster.</p>

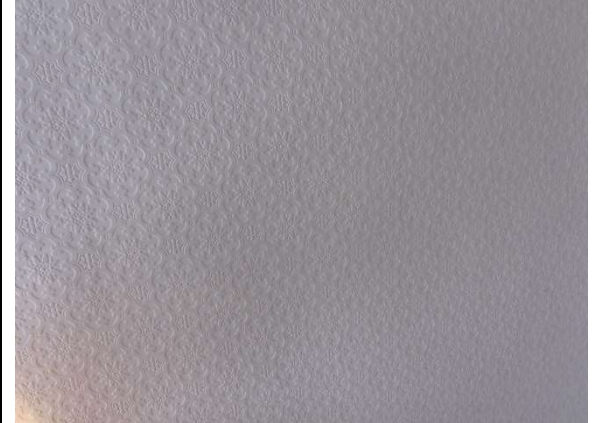
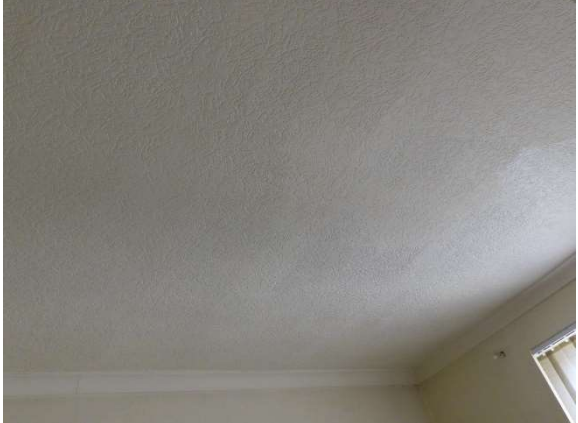
<p>Front and rear bedrooms – the ceilings have blown vinyl paper on, which may be difficult to remove and cause damage to the substrate.</p>

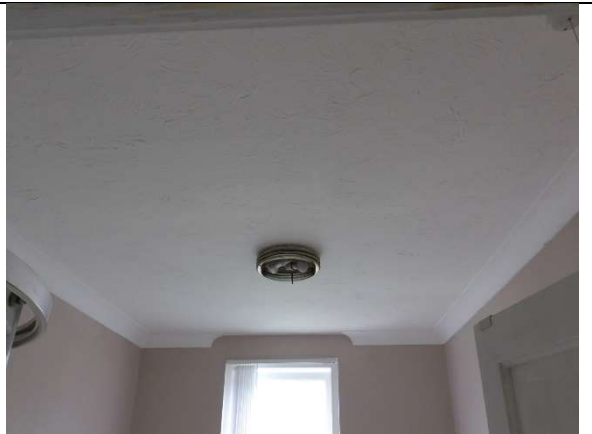
Bathroom – there is a textured coating on the ceiling. This should be checked for asbestos before it is disturbed.

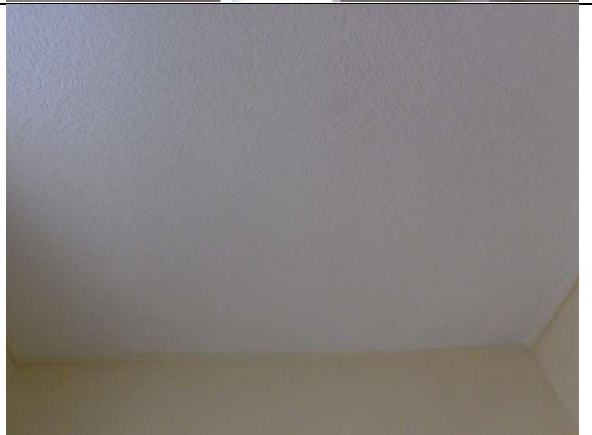
Hallway – textured/blown wallpaper on the ceiling.

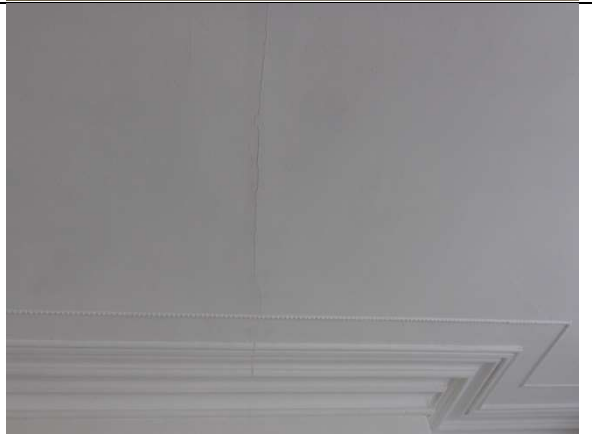
Living room – there is a side-to-side hairline crack in the ceiling emanating from the centre of the chimney breast.

This could be cut out and filled during the course of redecoration, however, it may reappear with time.

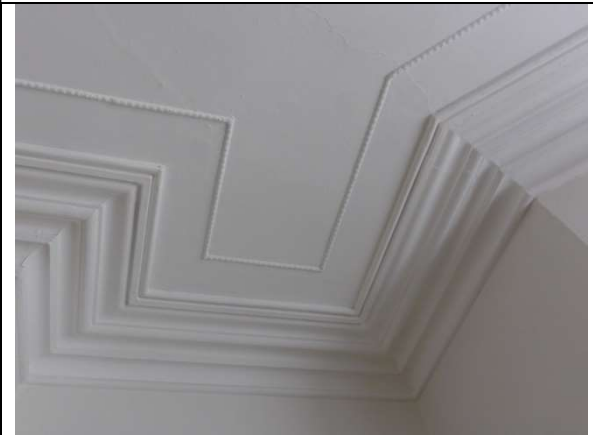
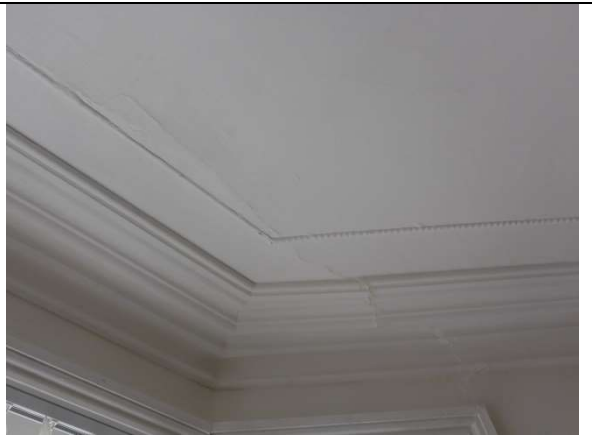
Living room, bay window area – there are some hairline cracks around the bay window, see comments above.

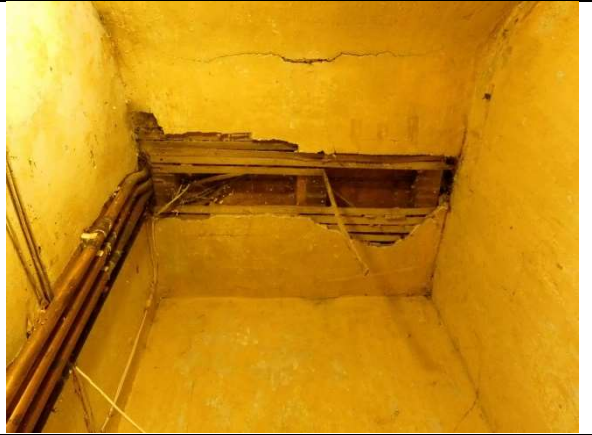
Cellar head – a section of the lath and plaster ceiling has failed. This should be repaired or taken down and plaster boarded to ensure it is safe.

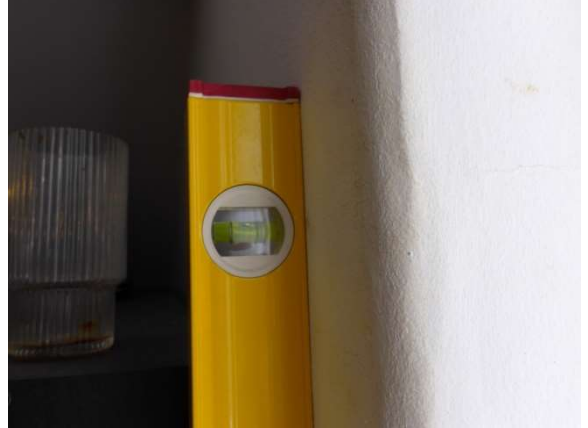
<p>Second-floor – an example of where the surface finish is not flat.</p>	 
<p>Second-floor – to the front side of the window, the wall is out of plumb, there was no cracking in the areas we could see, however, there was a wardrobe in front of this area of the wall.</p>

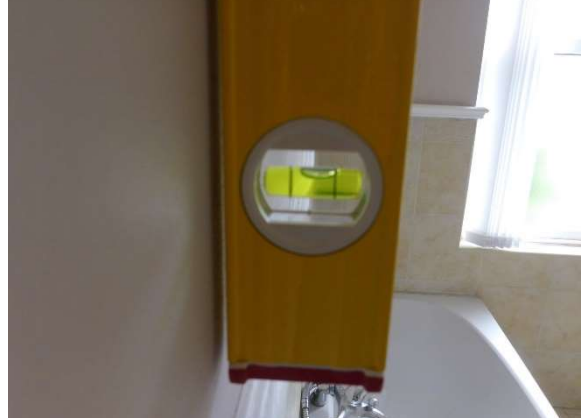
<p>Bathroom – the surface finishes are not flat. There was no cracking in the plaster.</p>

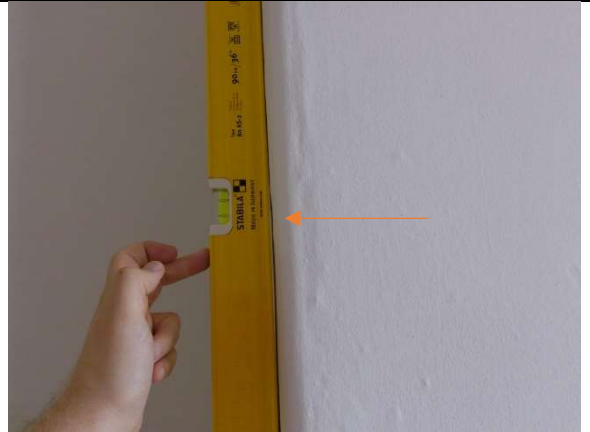
Front bedroom – the walls are generally plumb; however, the surface finishes are not all flat.

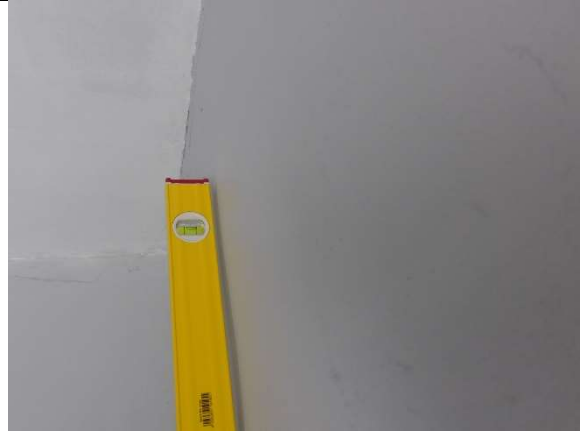
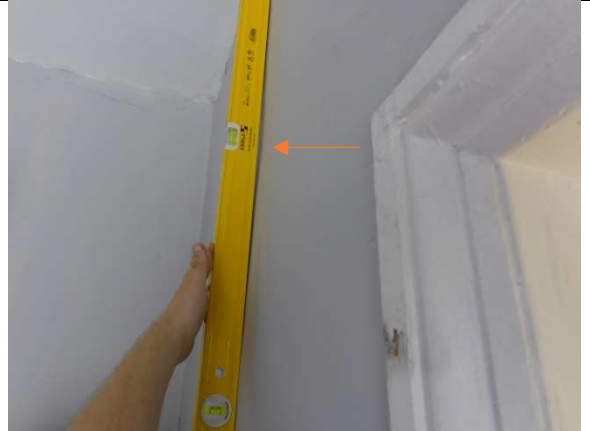
Kitchen, dining room wall – the wall is out of plumb; however, the surface finishes are also not flat.

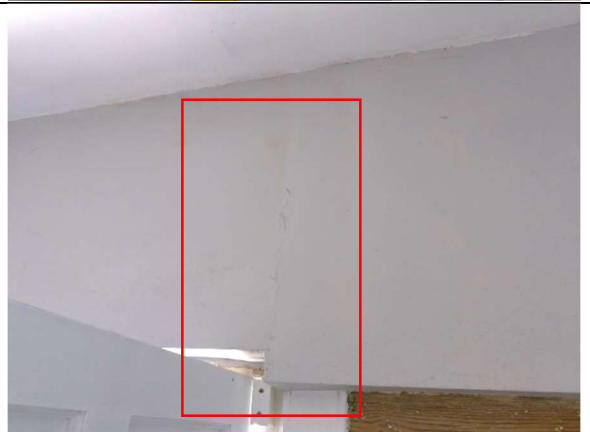
Kitchen – there is a small area of vertical cracking around the door/lean-to confluence.

There is no record of this work on the Building Control portal. The beam is level.

The area is tiled and clad below and there was no visible damage to the surfaces below.

This should be investigated further when the room is next redecorated.

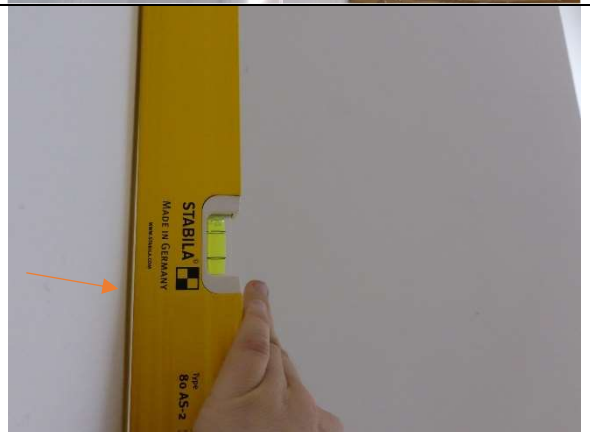
Dining room – the walls are generally plumb; however, the surface finishes are not flat.

The plaster was hollow in places.

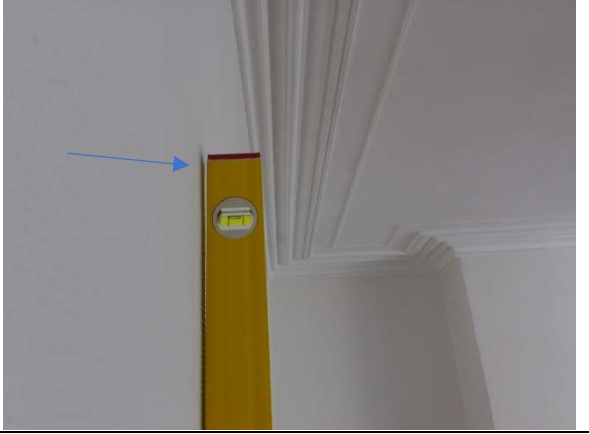
Living room – the walls are generally plumb; however, the surface finishes are not all flat.

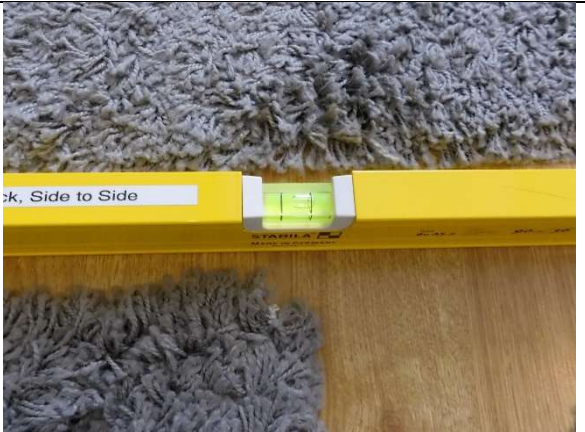
<p>Second floor – the floor is out of level by c. 5 mm front to back and side-to-side.</p>

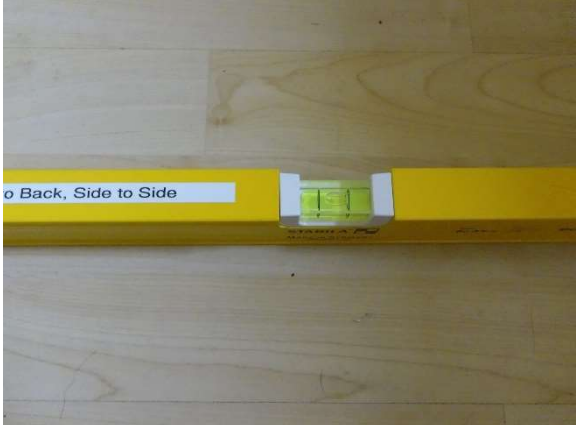
<p>Rear bedroom – the floor is out of level by c. 5 mm front to back.</p>

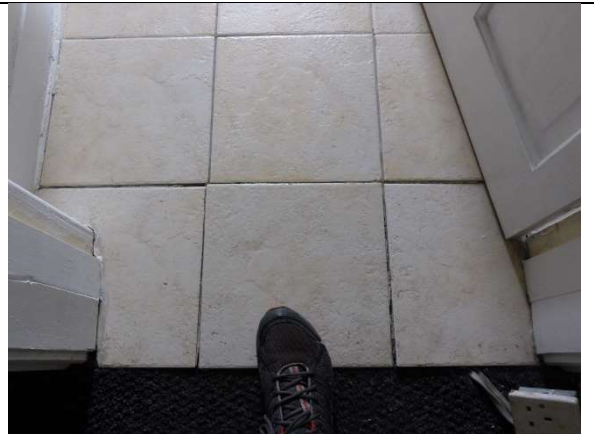
Bathroom – the tiles around the door are loose and should be affixed back into place and re-grouted to maintain water tightness.

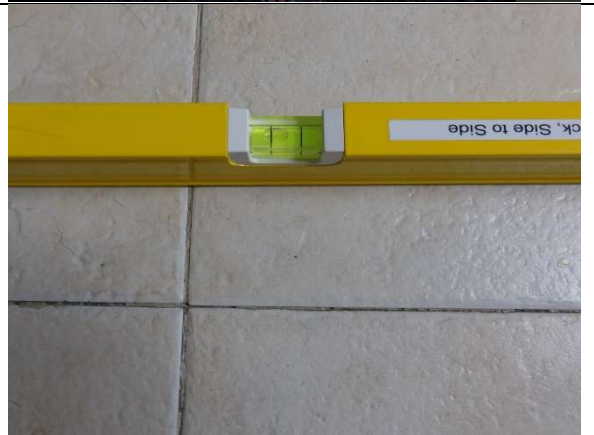
Bathroom – the floor is out of level by c. 10 - 15 mm front to back.

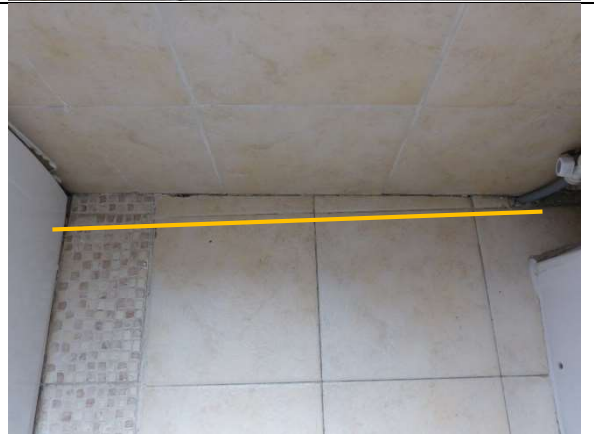
Bathroom – the tiling/room are not square.

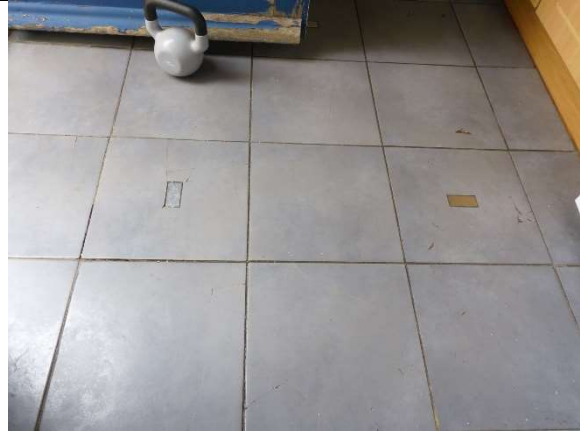
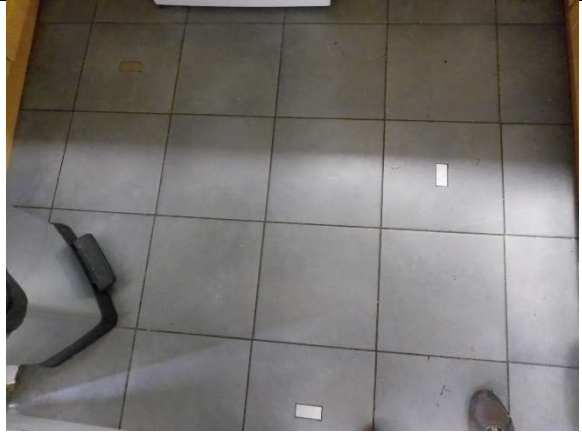
Kitchen – most of the floor tiles were cracked.

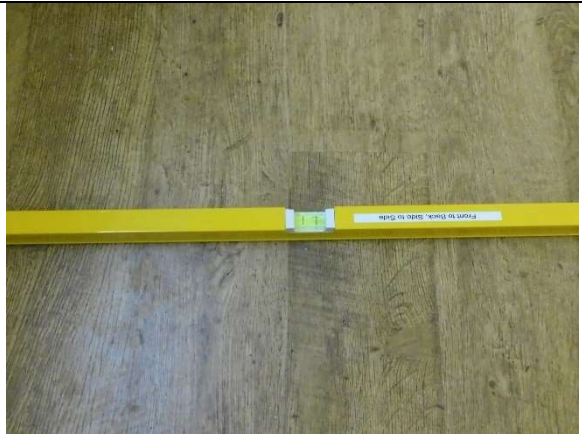
Hallway – the floor is c. 30 mm out of level in the side doorway area.

There is no access to this area from below to check the condition of the joists and we have not been able to find a hole to put the thermo-hygrometer probe down.

If the laminate flooring in this area is lifted, this should be investigated further as the floor timbers may be decaying.

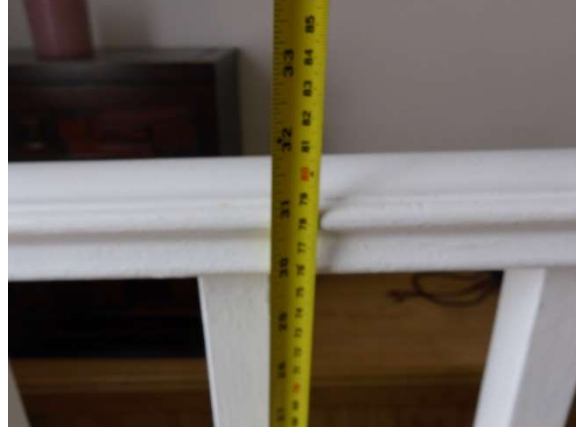
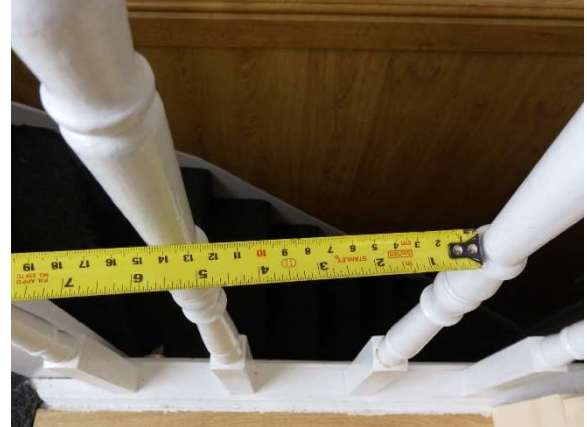
Second floor – note that the balustrade is c. 790 mm from the floor, current regulations are 900 mm, and the spindles are c. 130 mm apart, current regulations state that a 10 mm sphere should not be able to pass between spindles (there is no requirement for retrospective compliance).

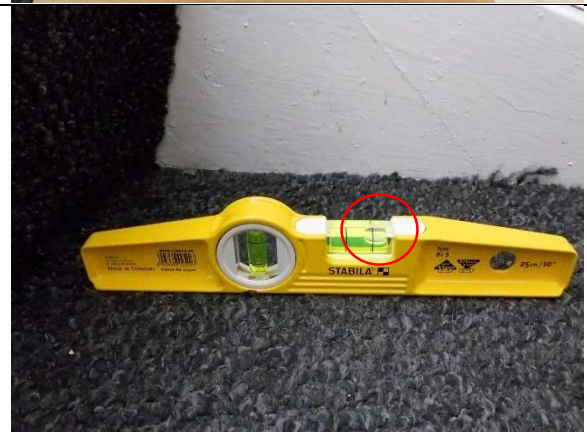
Second-floor staircase – the top steps are not level. The staircase should be repaired before the room is in regular use.

Repairing staircases can be tricky work and a suitably experienced carpenter should be employed.

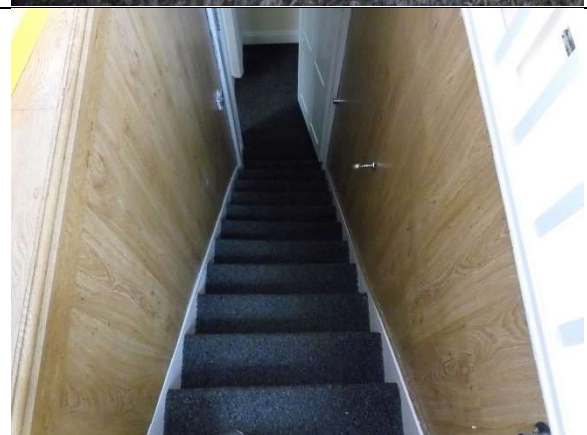
Second-floor staircase – there is no handrail. We recommend a handrail is added if the room is in regular use.

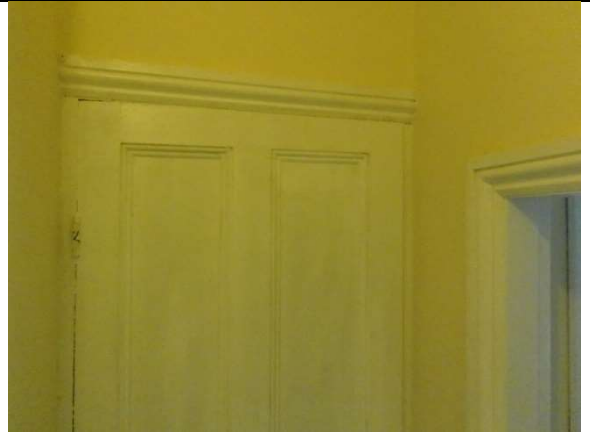
Second-floor door – the door is not square in the frame.

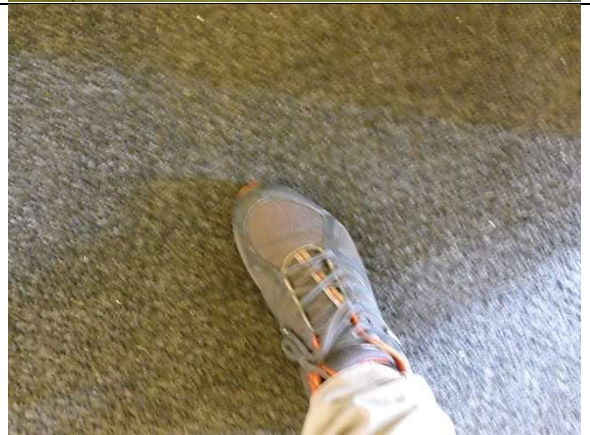
Landing floor – there are areas of undulation across the floor.

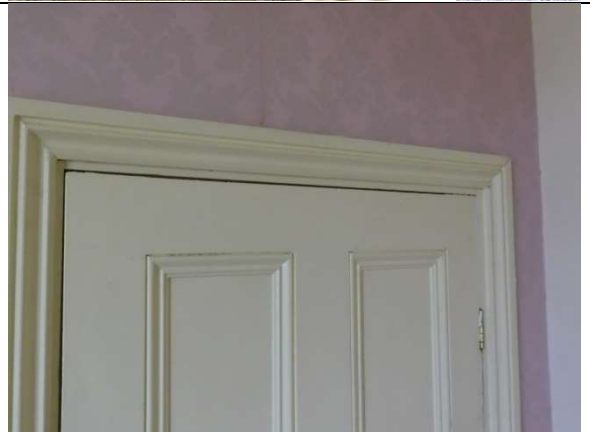
Back bedroom – the door does not sit square in the frame.

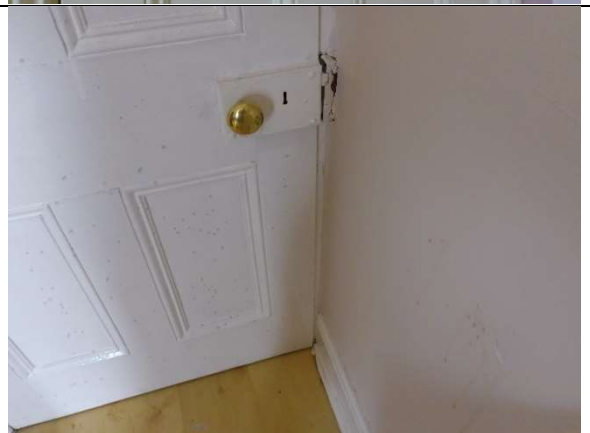
Front bedroom, cupboard – the door does not sit square in the frame.

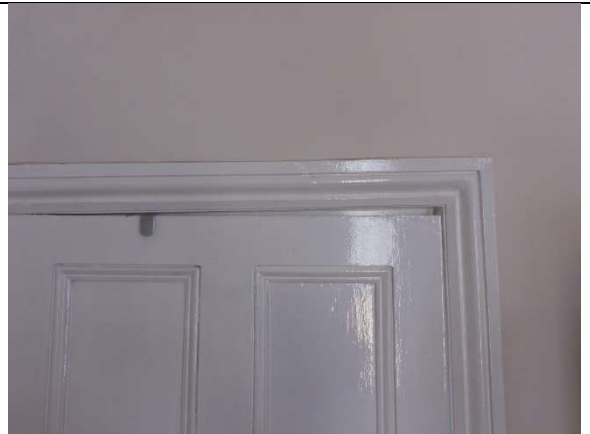
Dining room – the kitchen and hallway doors did not sit square in their frames.

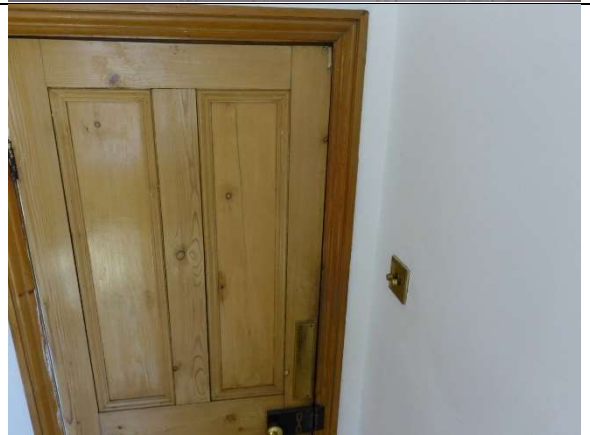
Living room – the door does not sit square in the frame and does not stay closed.

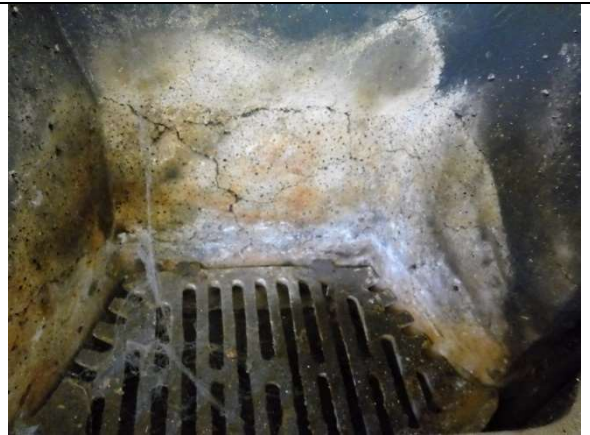
Dining room – the inset is cracked and should be replaced if the fire is to be used (following a satisfactory inspection by a HETAS-certified contractor).

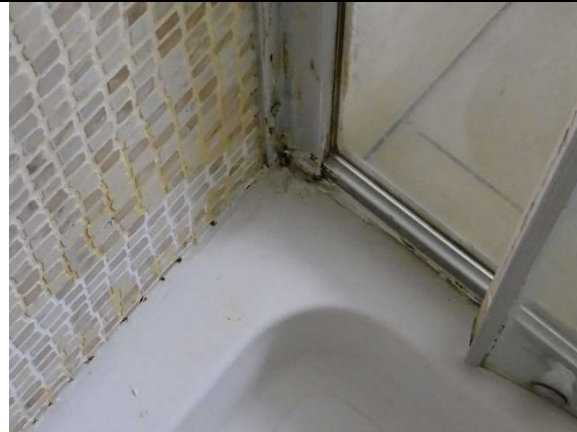
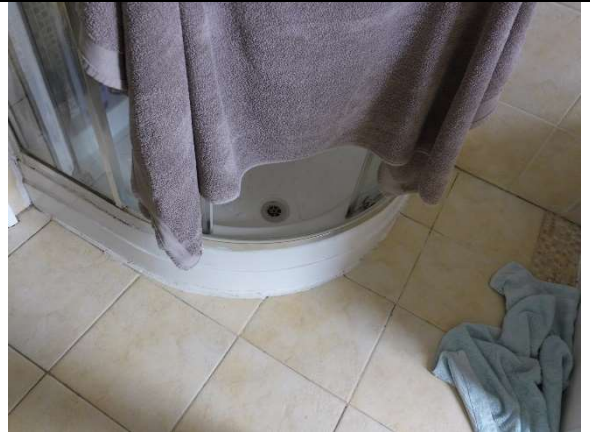
Bathroom – the silicone detail around the inside and outside of the shower is not the best. From the staining on the ceilings and walls below, it looks like this has been leaking.

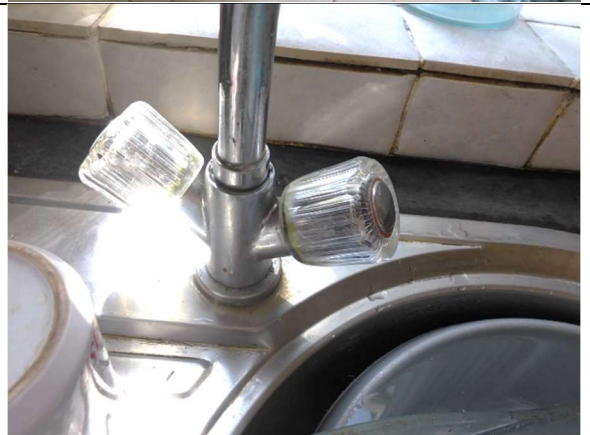
Kitchen – the hot and cold taps are back to front, the hot should be on the left.

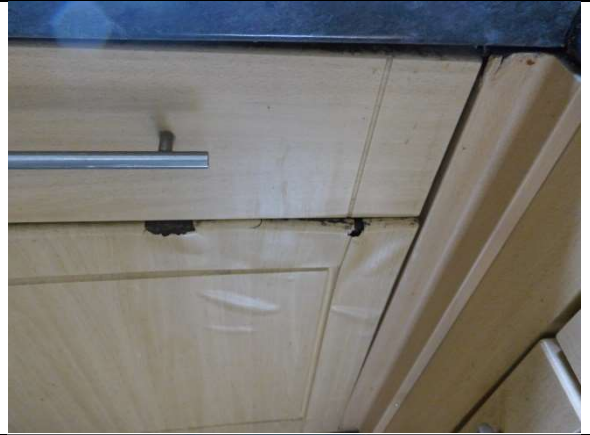
Kitchen – some of the kitchen units are damaged, particularly under the sink.

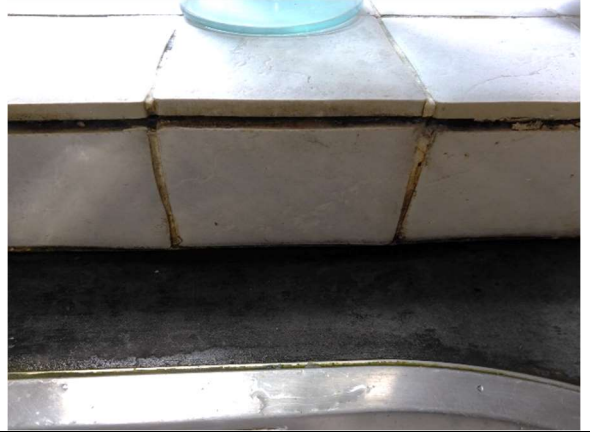
Kitchen – some of the tiles are coming away around the sink.

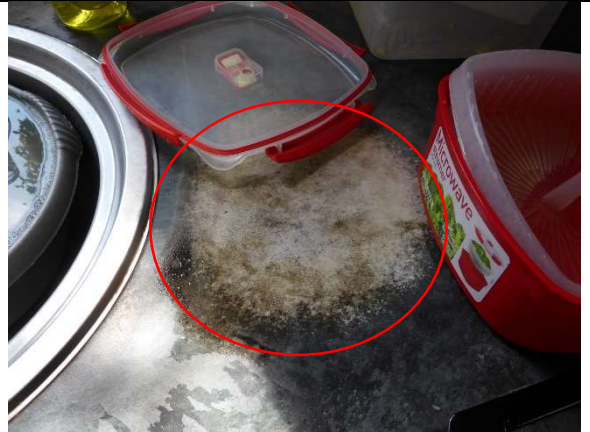
Kitchen – example of damage to the worktop.

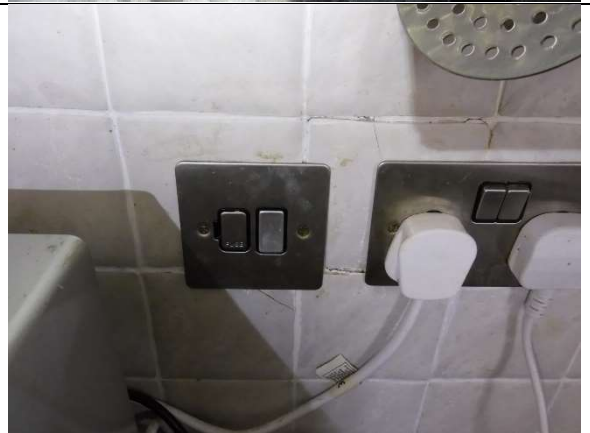
Kitchen – example of some cracked tiles around the sockets.

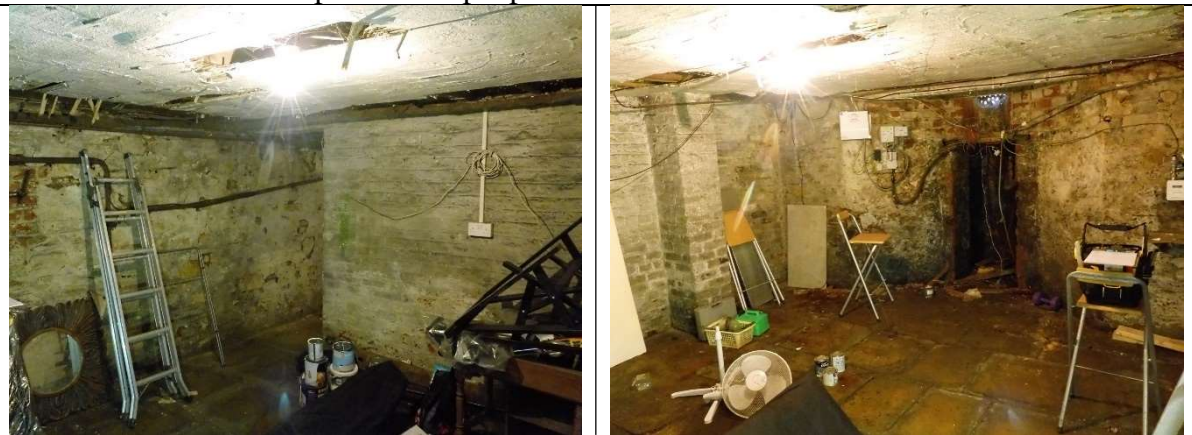
The ceilings are underdrawn; however, the lath and plaster are in poor condition and areas are failing (or have already been removed), with decaying laths and areas of insect attack. We recommend that the underdrawing is removed to improve air circulation.

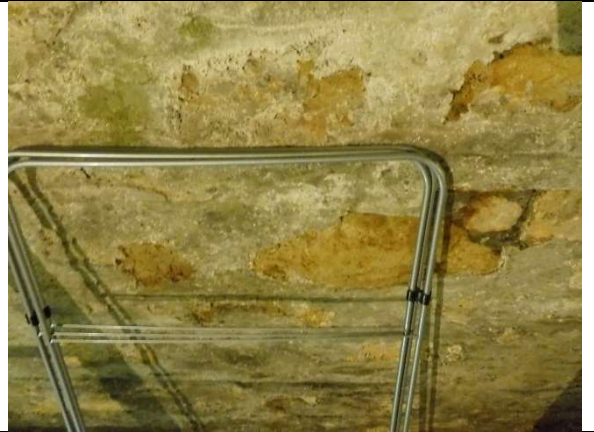
Walls – these have been limewashed and painted, and the surface is beginning to fail in some areas.

The damaged areas should be scraped back, the stone defrassed and fresh limewash applied.

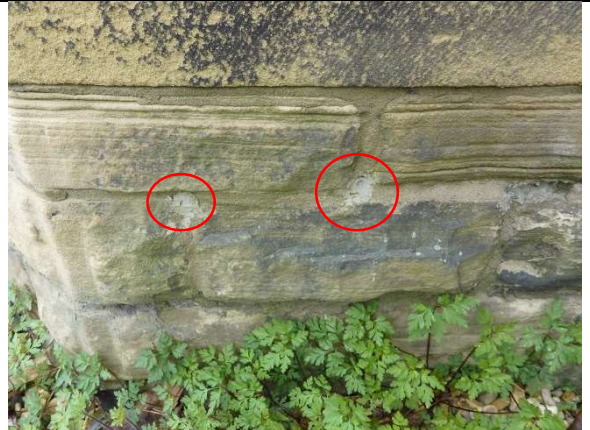
Front elevation – there are some drill hole marks that may be from a chemical injection damp proof course.

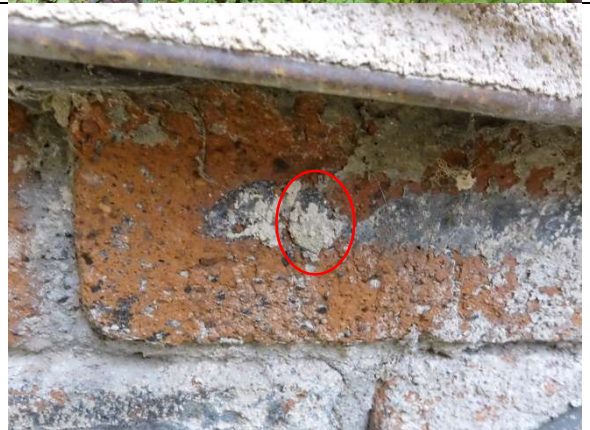
Kitchen lean-to – there are some drill hole marks that may be from a chemical injection damp proof course.

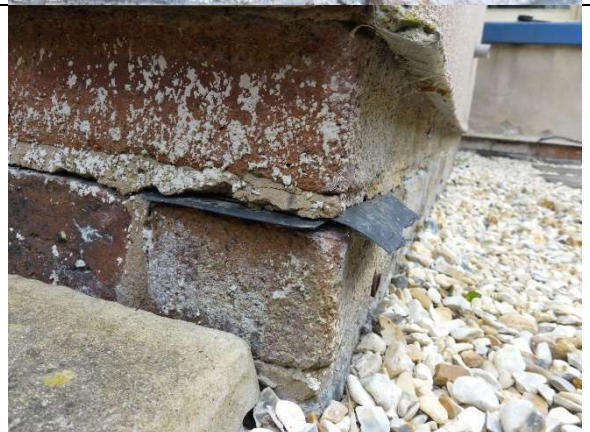
Kitchen lean-to – there is a damp proof course visible around this structure.

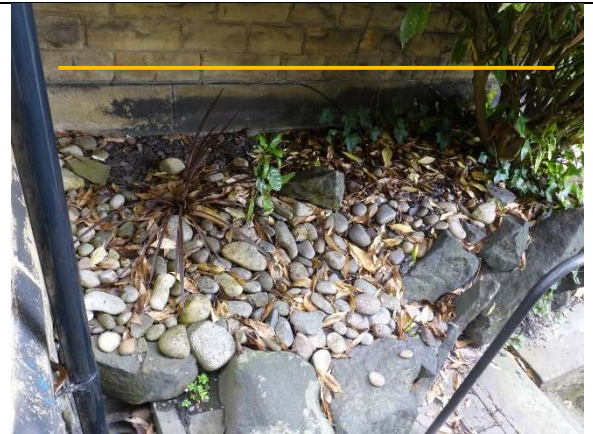
Left-hand elevation – the ground has been built up to form a raised bed against the side of the house. This is likely responsible for the internal moisture issues detailed above and below.

We recommend that this bed is removed and hopefully, the original sub-floor ventilation grill can be exposed and brought back into use. We recommend that the area closest to the porch is removed this year and the large bush in the front portion is gradually reduced over the next couple of years to minimise chances of ground heave

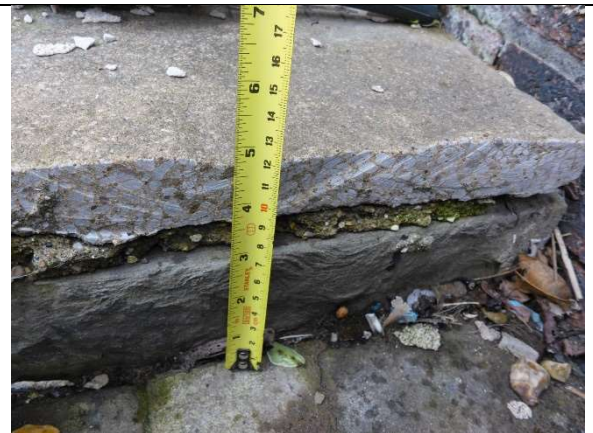
Rear elevation – the ground levels have been increased around the rear, a good measure of this is that the gullies would have originally been set at ground level and now the ground is c. 120 mm above the gully height. We recommend that plans are made to reduce the ground levels in the coming year.

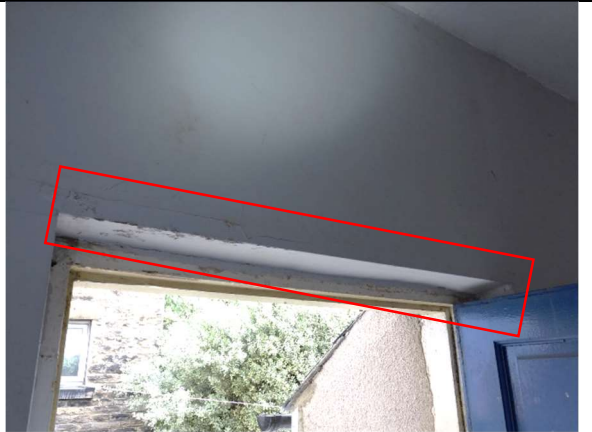
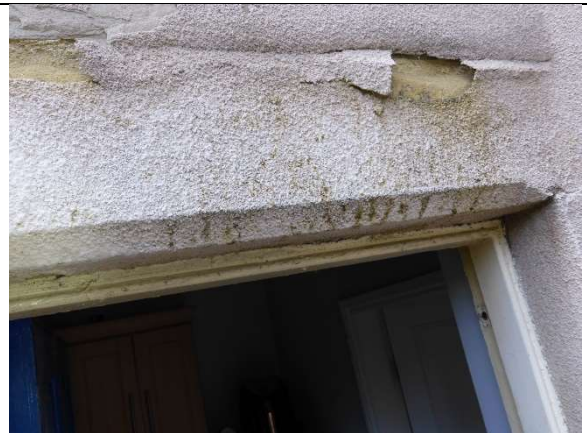
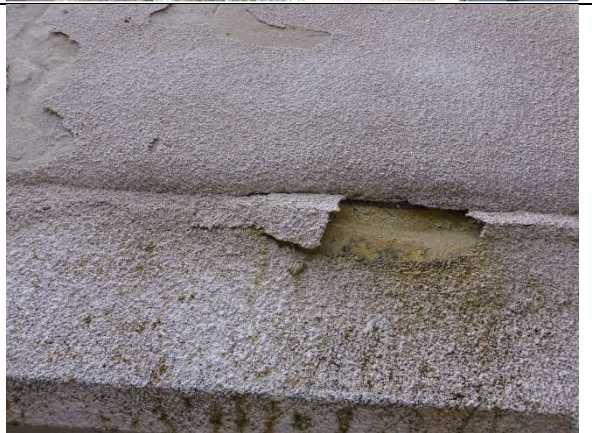
Kitchen – there is a crack along the plasterboard bead and some corrosion staining coming through.

This will likely need cutting out and replacing once the shower has been thoroughly leak tested and the external render repaired.

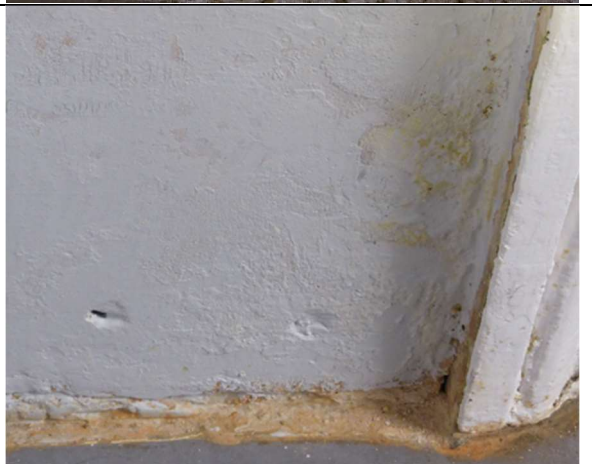
Kitchen – there is a small area of light paint peeling and impurity staining, likely a little moisture getting up the side of the slab, or from the dining room sub-floor.

Hopefully, this can be brushed off and managed with improved ventilation to the subfloor and kitchen.

A lime-based plaster and clay-based paint would improve this area.

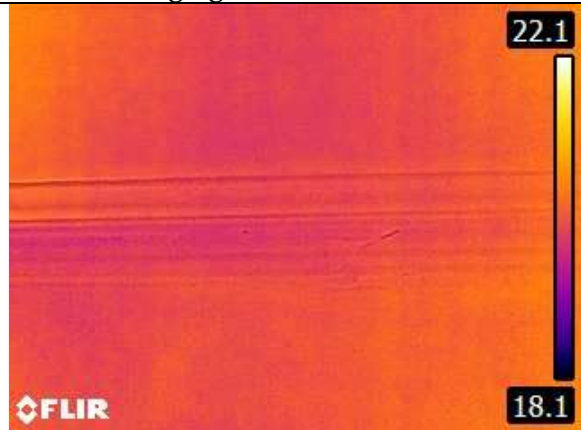
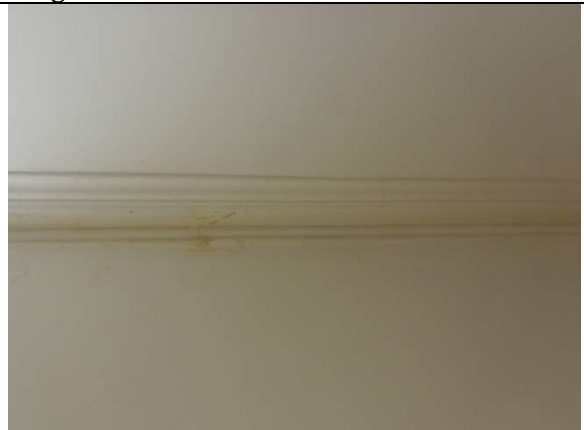
Dining room, kitchen wall abutment – there is some moisture staining around the coving on the reverse area of the abovementioned kitchen staining. We inspected this area with the thermal imaging camera and did not note anything unusual.

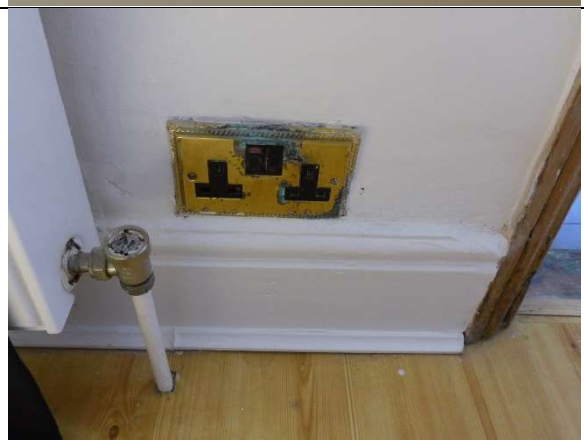
Dining room – there is corrosion to this socket on the cellar steps wall, this is likely as a result of moisture rising from the cellar. Once the sub-floor ventilation is improved, the socket should be replaced.

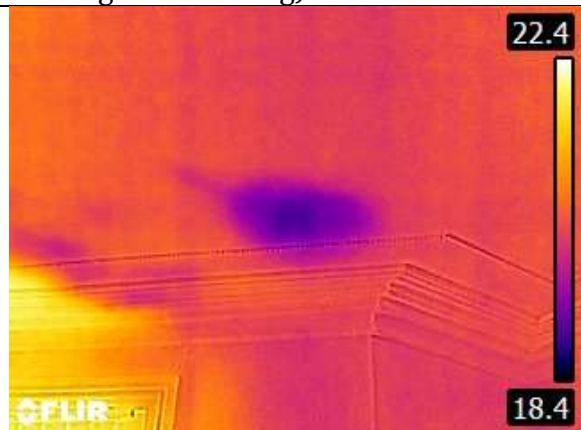
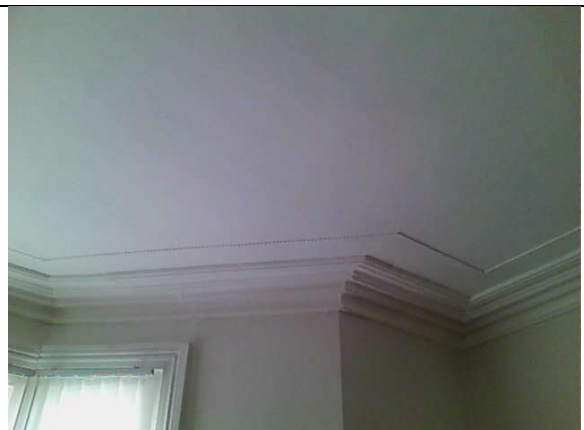
Living room bay window – there is a cool spot in the left-hand corner where the main room goes into the bay. This is likely a result of a historic water leak (as there was no moisture staining on the ceiling).

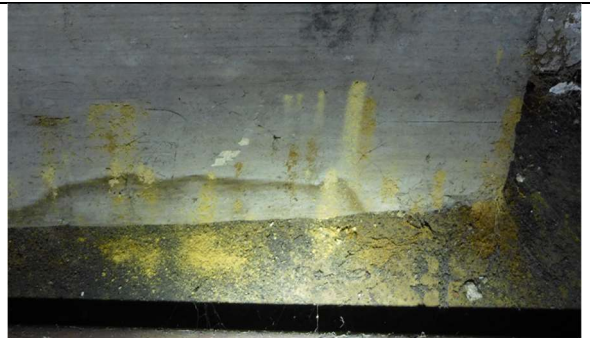
Cellar - example photo of wood boring insect attack in a piece of timber that is sat on the cellar floor.

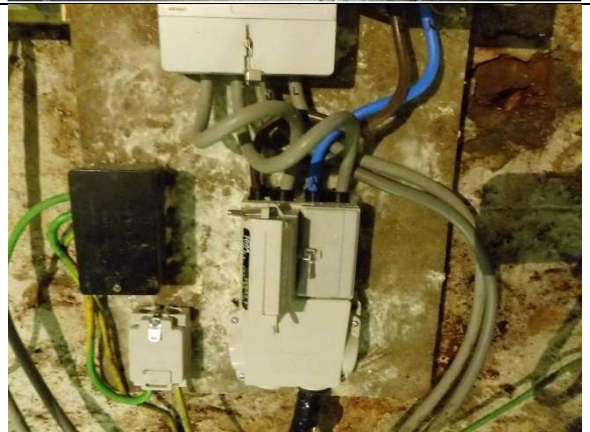
Example of white cellar mould building up on the meter backboard.

This is made of a particleboard hence it is taking on moisture quicker than softwood.

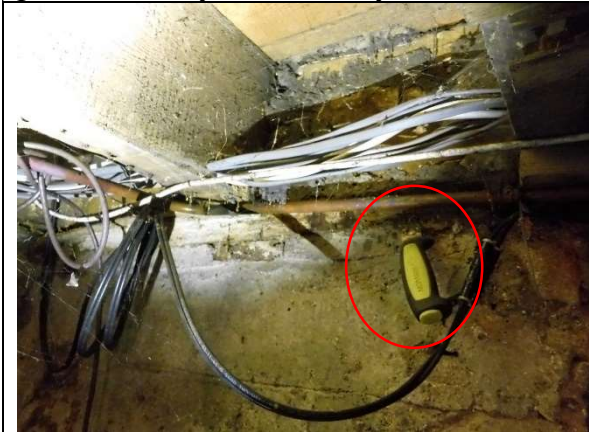
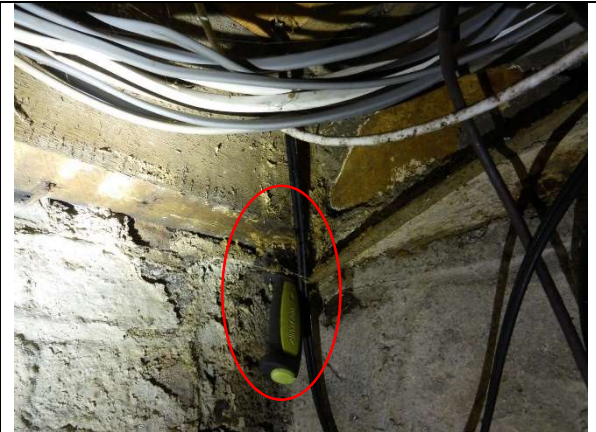
Ground floor timbers – along the external walls, the ground floor joists are sat on timber bearers/wall plates. These timber bearers and many of the joist ends are taking on moisture and softening as a result of inadequate sub-floor ventilation. Immediate action should be taken to address this. See our comments below on ventilation. Until this problem is brought under control and the timber has dried out, it is not possible to determine the full extent of the damage, however, we anticipate that there will need to be at least some sistering/strengthening of the floor joists and the smaller lintels that have already been replaced will again need to be replaced. Until the sub-floor ventilation is addressed, this will keep getting worse hence there is no point undertaking any remedial works until the ventilation has been addressed. We have included example photos below as opposed to photos of every area of decay.

In the meantime, we recommend that the cellar head door is left open all of the time, fans are put in both cellar rooms and a dehumidifier is used on a low setting to begin to dry the sub-floor atmosphere out so that it is in line with the external atmosphere. If no action is taken, the timber ground floor structure will continue to soften and the timber will decay and become susceptible to insect attack.

Once the atmospheric conditions have stabilised in the cellars, the timber should be reassessed and a programme of remedial work prepared. There is no point undertaking this now as the timber needs to be dryer before an appropriate reassessment can take place.
