Level 3 Survey in Respect of:

Report prepared by Simon
Hollis MRICS

18th July 2023

Building Survey Report

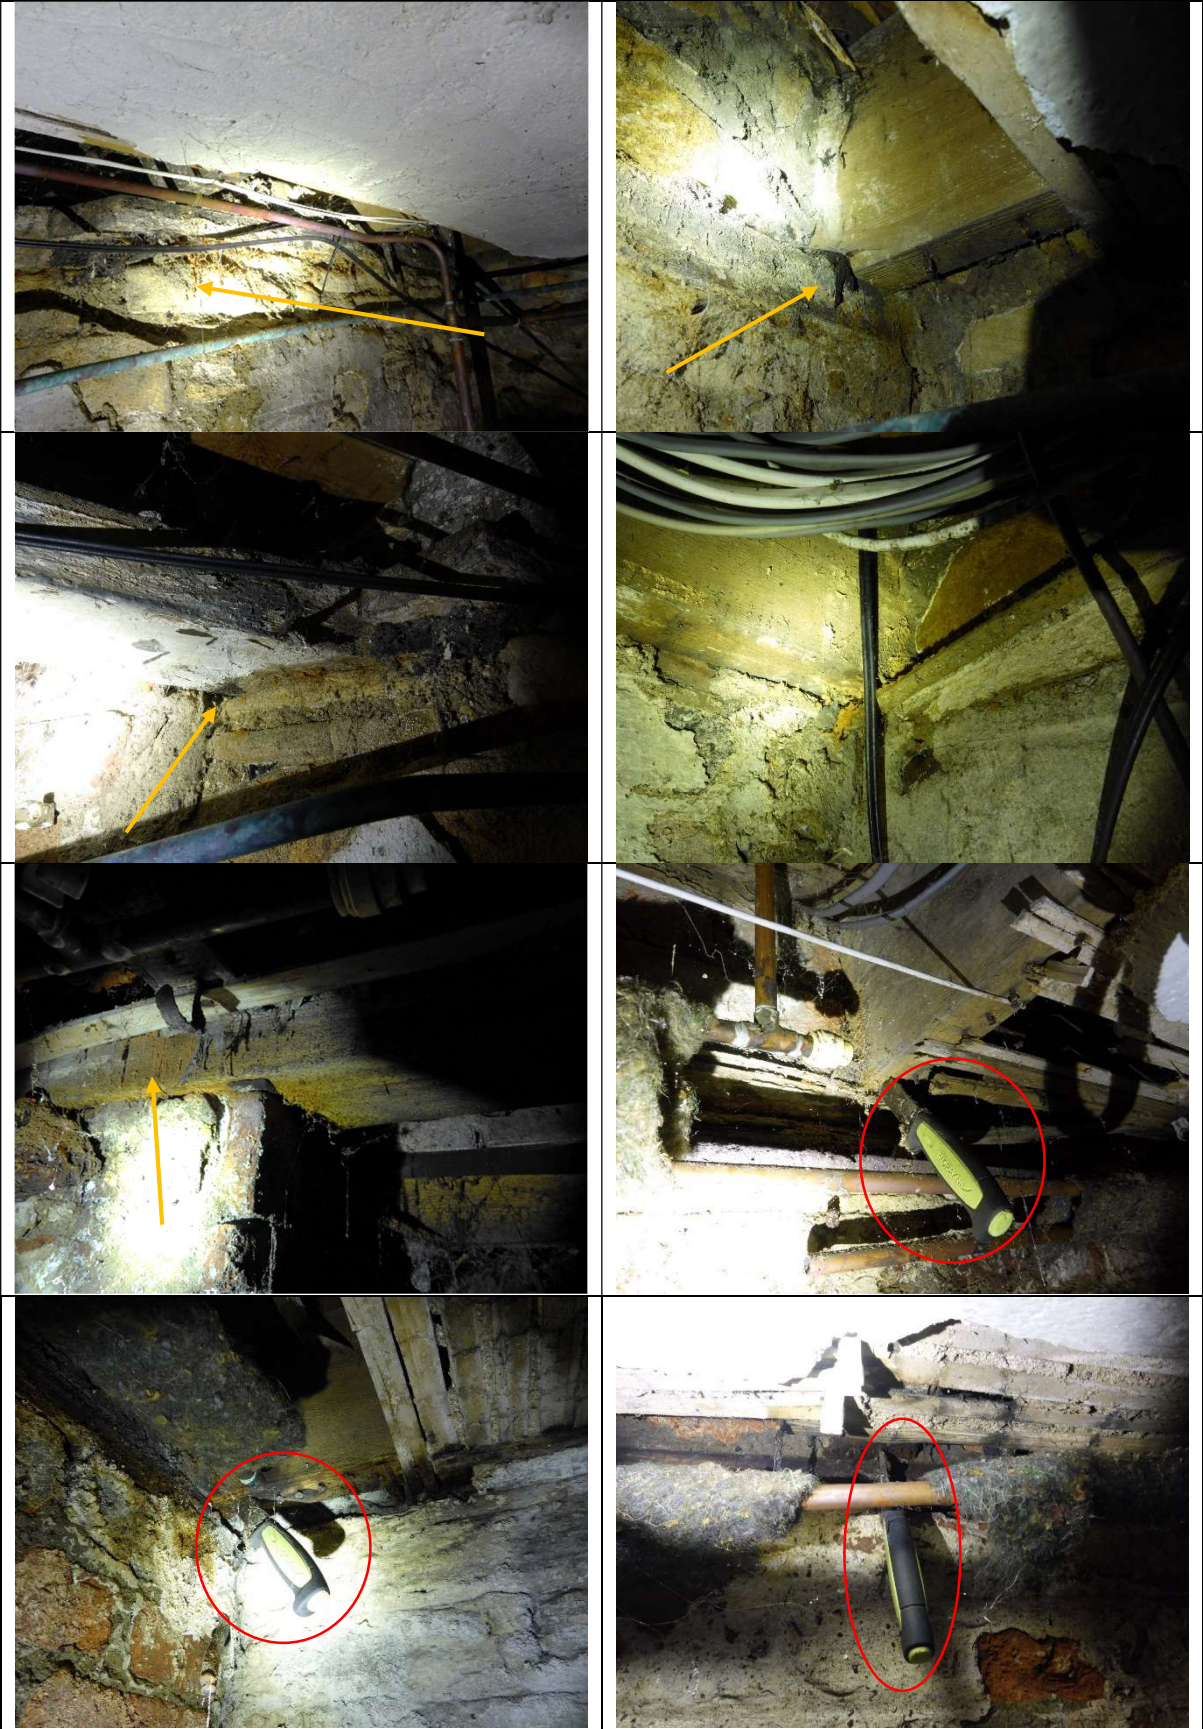
Left-hand sub-floor vent – as noted above, roots are growing through from outside all around this area. The two lintels have been replaced previously and the rear brick is cracked.

The replaced lintels have taken on a lot of moisture and are failing again.

A plan should be made to replace these once the sub-floor ventilation has been addressed, see below. The loose stonework above should be consolidated at the same time.

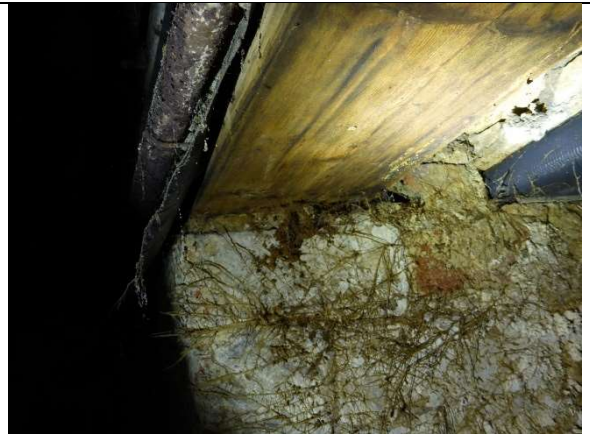
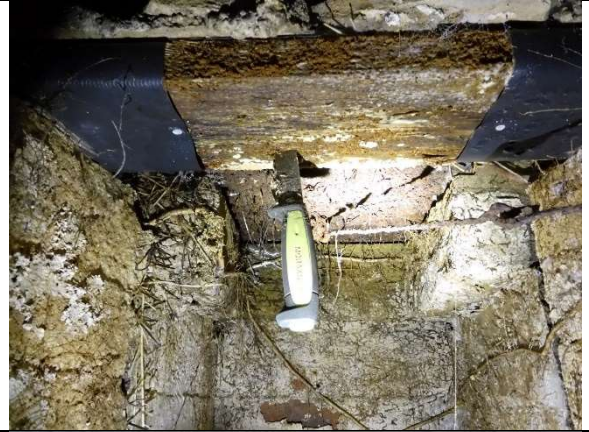
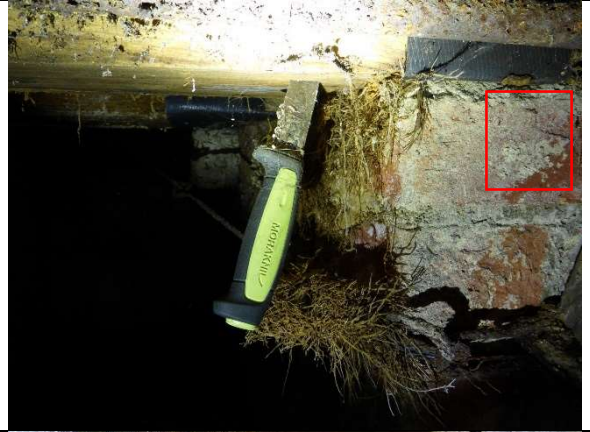
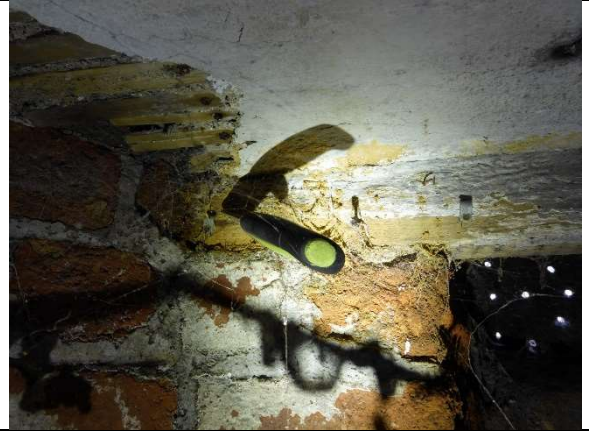
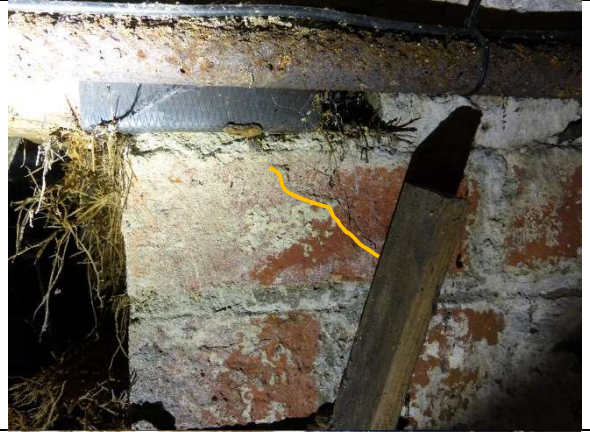
Ground floor timbers – along the external walls, the ground floor joists are sat on timber bearers/wall plates. These timber bearers and many of the joist ends are taking on moisture and softening as a result of inadequate sub-floor ventilation. Immediate action should be taken to address this. See our comments below on ventilation. Until this problem is brought under control and the timber has dried out, it is not possible to determine the full extent of the damage, however, we anticipate that there will need to be at least some sistering/strengthening of the floor joists and the smaller lintels that have already been replaced will again need to be replaced. Until the sub-floor ventilation is addressed, this will keep getting worse hence there is no point undertaking any remedial works until the ventilation has been addressed. We have included example photos below as opposed to photos of every area of decay.

Note the water droplets forming on the PVC enveloping at the end of the joist.

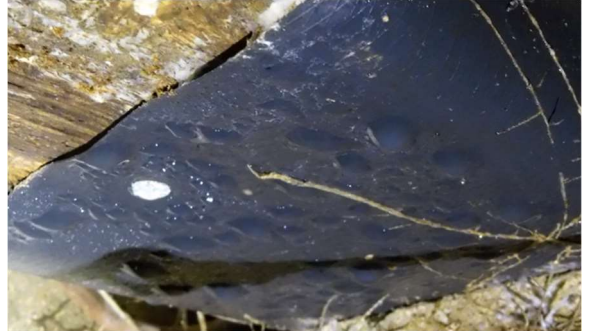
Water droplets forming on the PVC sheeting that is over the rear sub-floor vent.

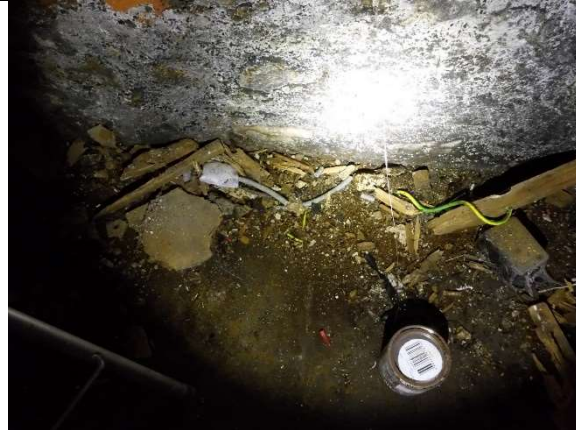
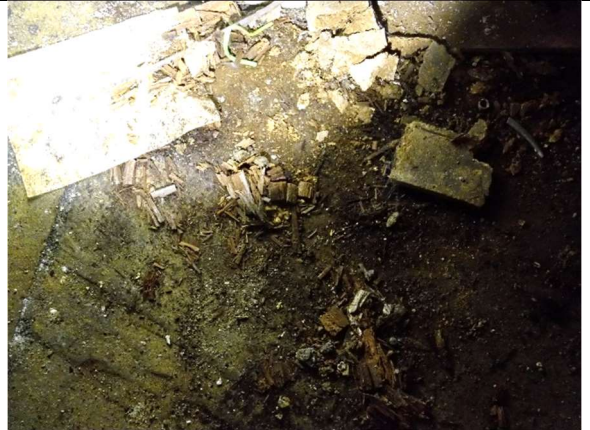
Examples of where lintels have previously been replaced. This replacement lintel has taken on a lot of moisture and is now failing again.

It should be replaced once the sub-floor ventilation has been addressed, see below.

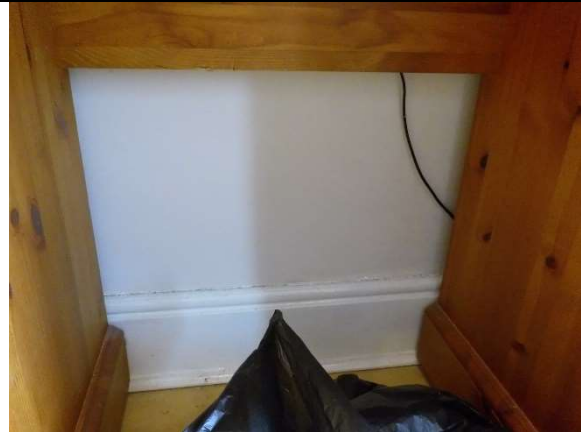
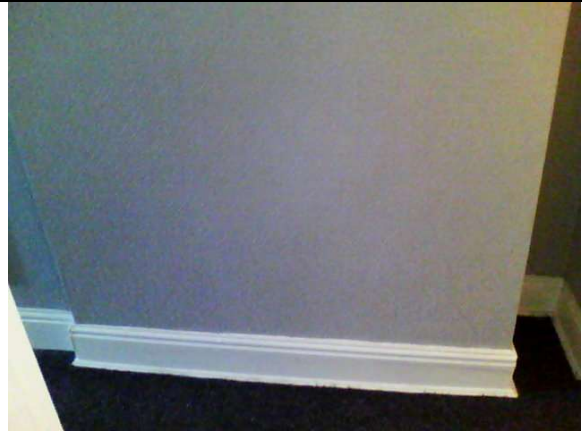
Front bedroom and landing – both flues have been blocked up. We recommend that these are adequately ventilated before winter.

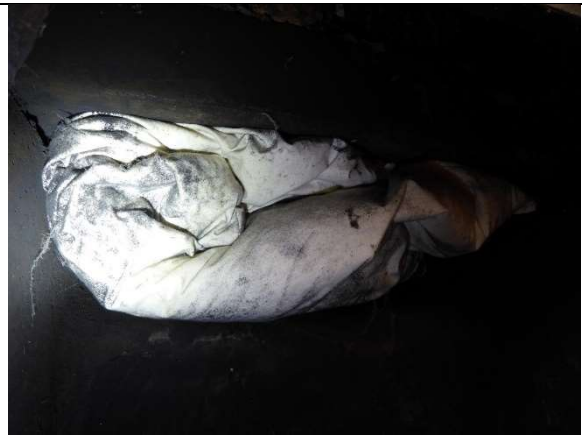
Dining room – the flue has been blocked with a blanket – we recommend that this is removed to allow ventilation to the room and the redundant flue.

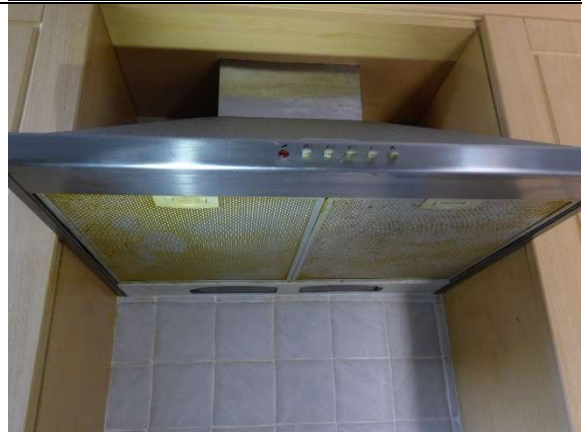
Kitchen – the recirculating extractor fan will not exhaust moist air externally to mitigate against condensation.

We recommend an externally exhausting unit is installed this year.

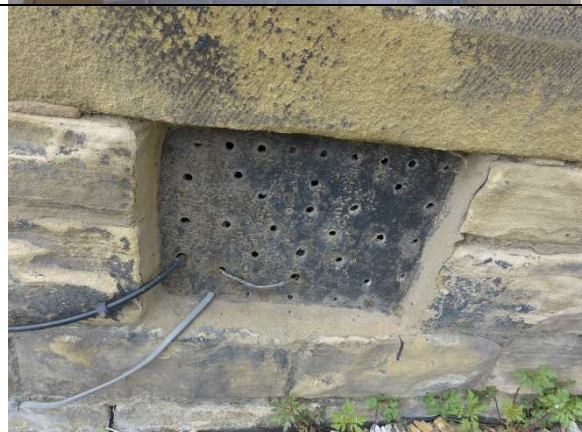
Sub-floor areas – this plate in the bay window is currently the only source of sub-floor ventilation. Urgent action is needed to improve sub-floor ventilation.

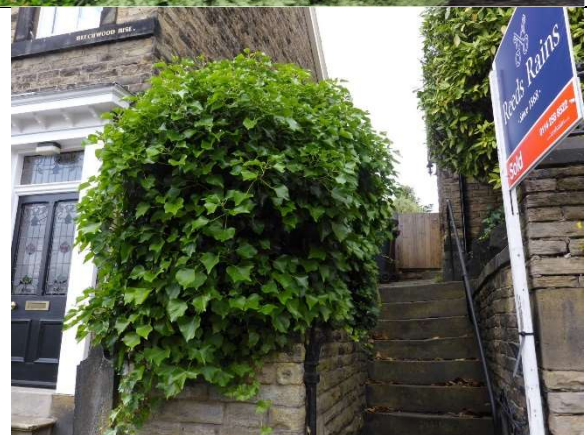
Front left-hand side – there is a bush that has been taken over by ivy all around the wall head and garden area.

We recommend that the ivy is killed and removed and the bush pruned so that the wall can be properly inspected.

Some repair work may then be necessary.

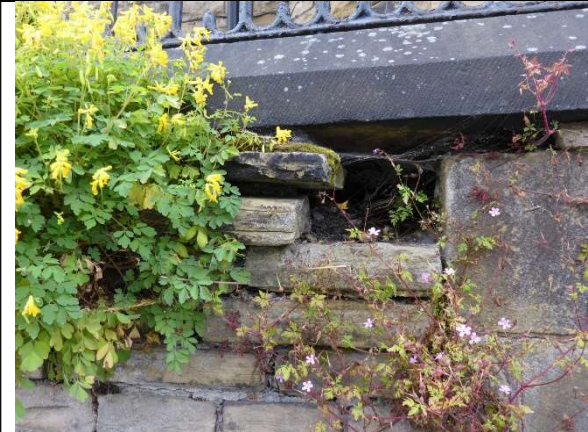
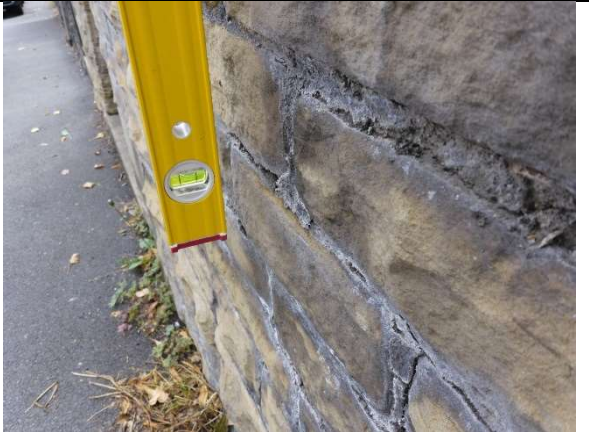
Front, retaining boundary wall – the wall head has been pushed out along most of its length, likely at least in part as a result of a large tree/bush. We have included some example photos below. At some point, the upper section of the wall is going to need to be taken down and rebuilt to correct this. The iron fencing is damaged in places and the capping stones are leaning back towards the house. We recommend the drains and soakaways are inspected prior to this work being undertaken as if the front gullies run into a soakaway in the front garden, this may need emptying and remaking at the same time. This work will likely require some of the pavement to be cordoned off. We have included example photos below.

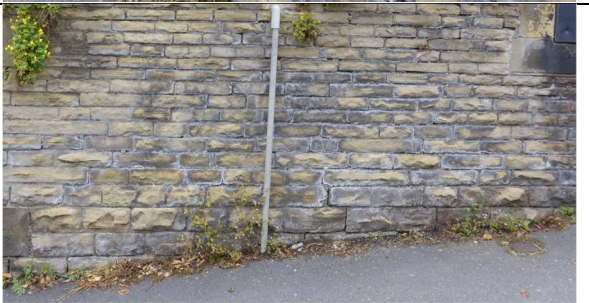
There are no weep holes in the wall which is likely causing hydrostatic pressure to build up behind the wall and causing moisture to penetrate through the stone, bringing with it impurities that are staining the wall, and which are particularly visible on the mortar joints.

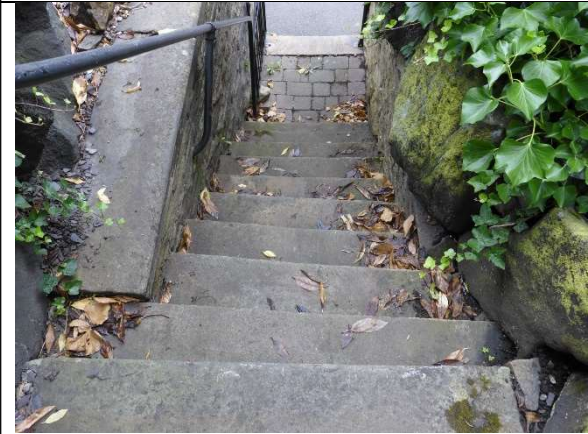
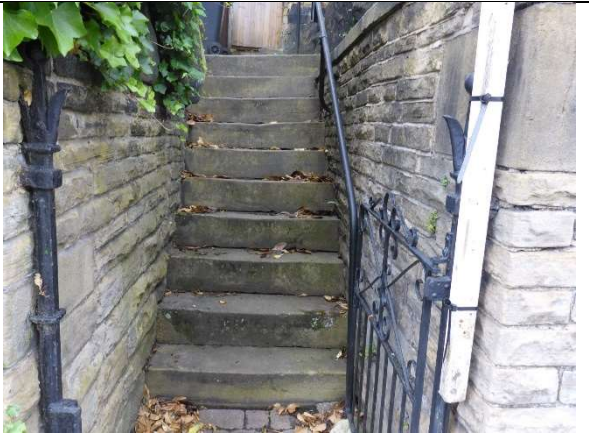
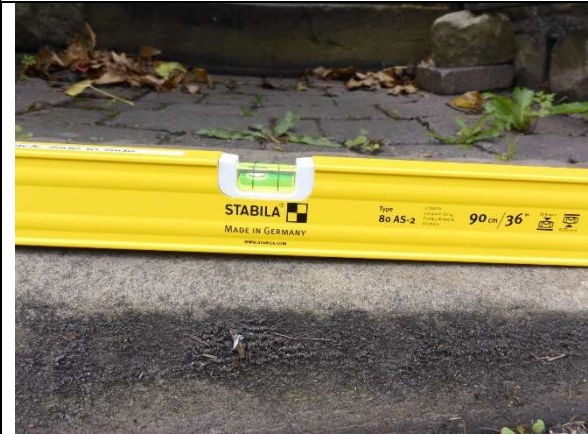
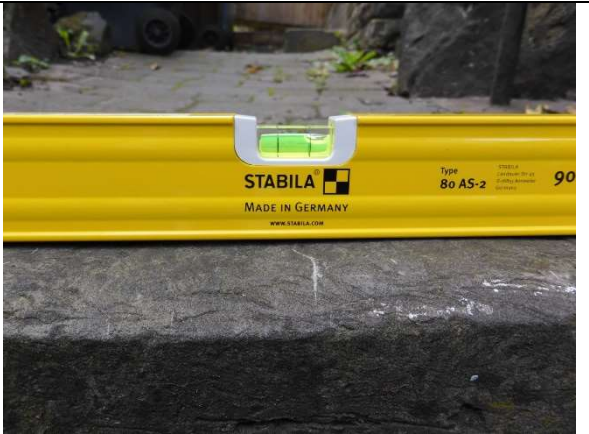
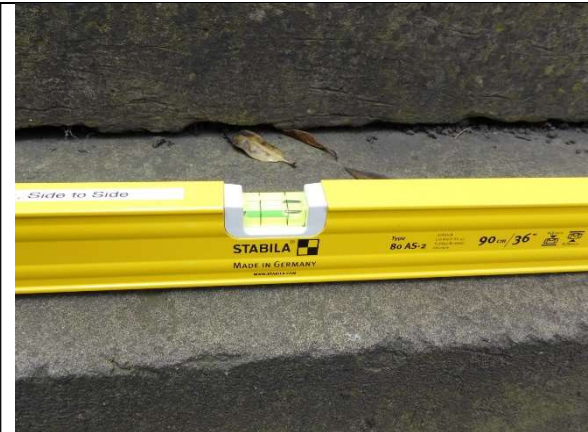
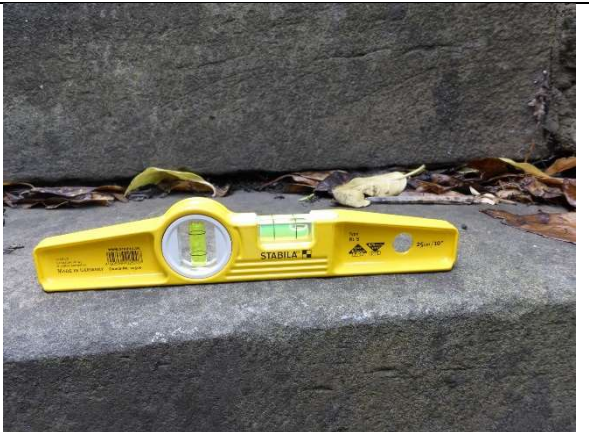
Front steps and pathway – the first larger step, the upper steps and the upper pathway are all over the place in terms of level. This could be as a result of inadequate bedding, tree root disturbance or rainwater erosion/leaking drainage. We have included some example photos showing these defects below.
We recommend the vegetation/bushes are gradually reduced to prevent excessive heave and that the steps and pathway are lifted, and suitably rebbed on a suitably compacted sub-base.

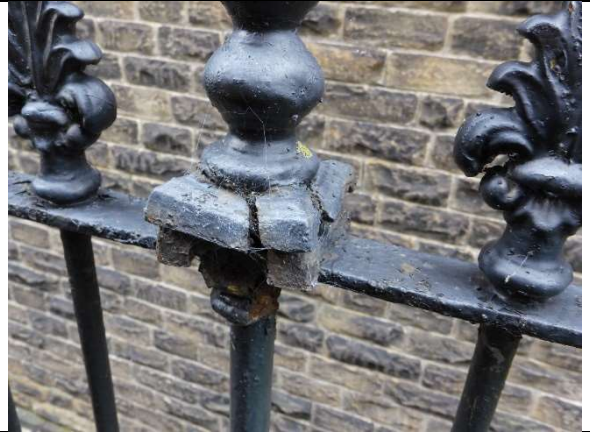
Example of corrosion damage to the left-hand fencing.

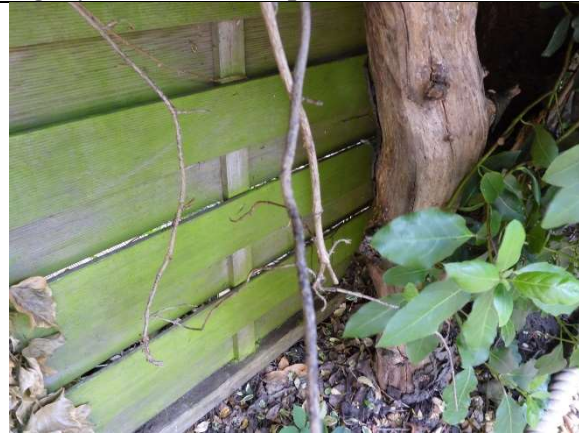
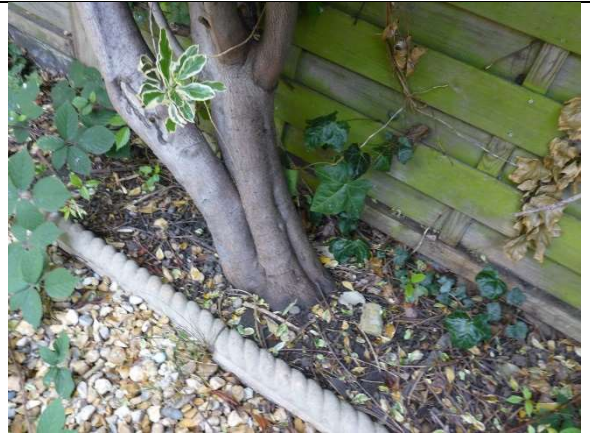
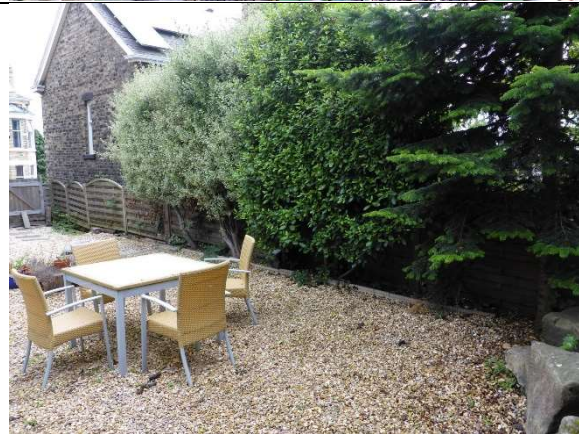
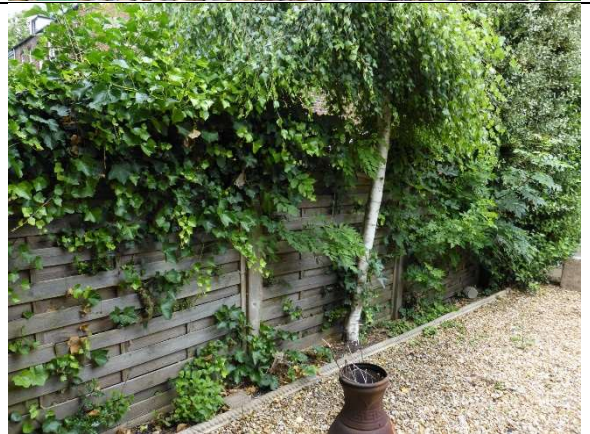
Left-hand (retaining) boundary wall – this wall is set significantly higher than the left-hand neighbouring property and there are several mature trees growing very close to the wall head which could disturb the structure. We have been unable to inspect this as it backs onto the neighbouring garden and there is a lot of vegetation around this. Your legal advisor must establish the maintenance responsibilities of this retaining wall as repairs are likely to be expensive. You should ensure you are happy with the maintenance arrangements before you legally commit to the purchase.

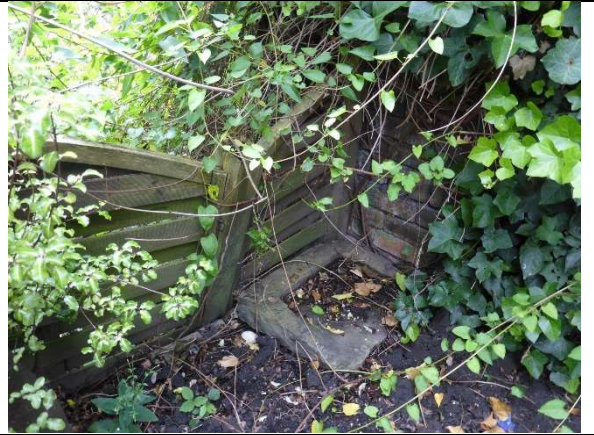
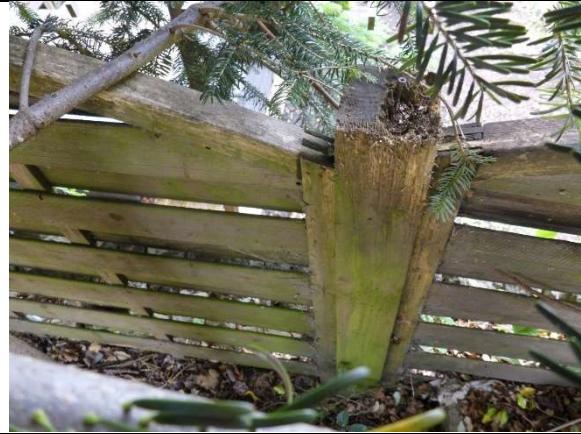
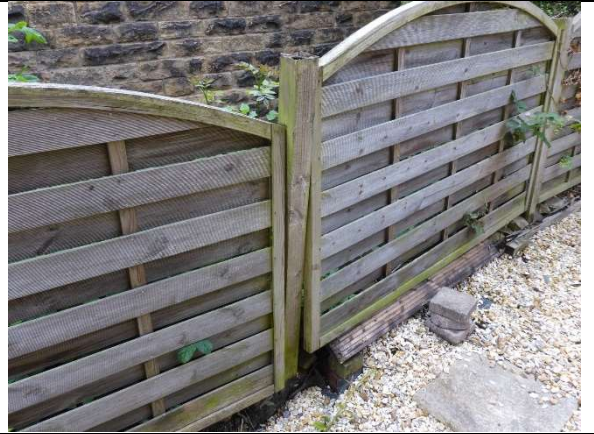
Left-hand boundary fence – this is in poor condition all of the way along – decay has set into many areas and some of the posts have completely rotten through. As there is a significant drop at the other side of this fence, arrangements should be made for repair/replacement in the short term.

We have included some example photos as opposed to photos of all areas of decay.

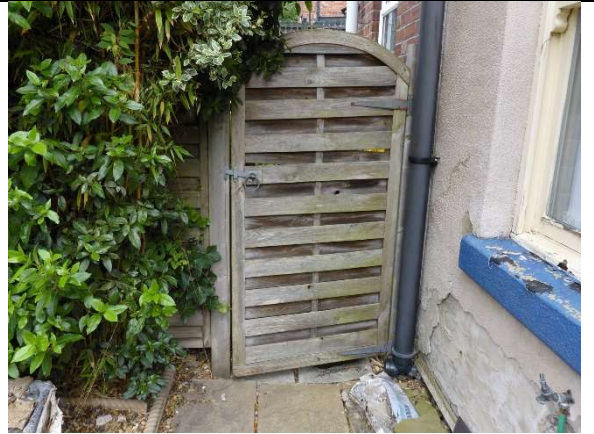
Rear right-hand boundary – there is a gate through to the neighbouring property. The vendor advised that there is no right of way across the property and your legal advisor should investigate this.

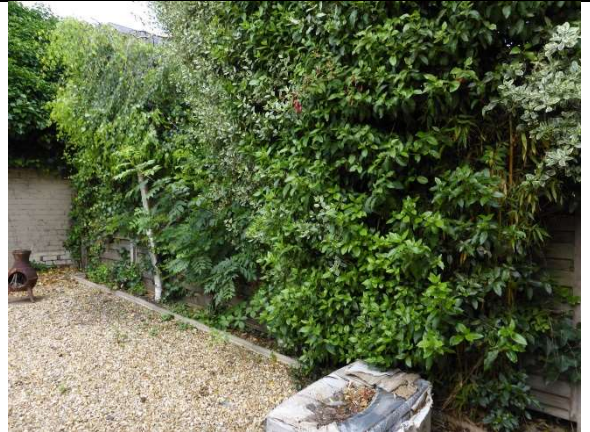
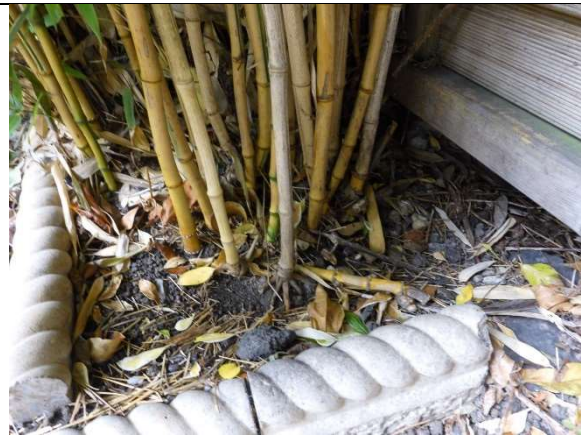
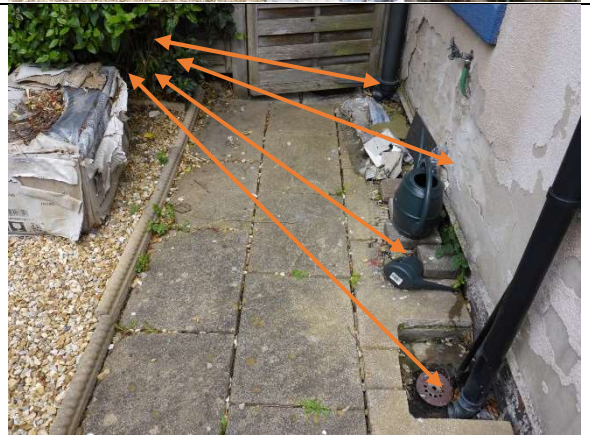
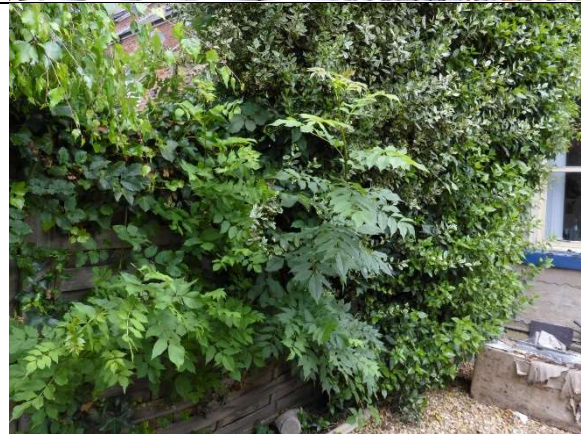
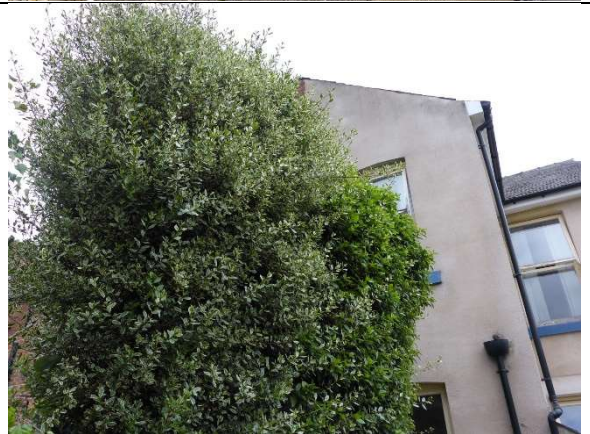
Rear right-hand boundary – there are several mature trees, including bamboo growing along the boundary. These could disturb the rear elevation, boundary and any drainage runs that are across the back of the property.

Most trees should be at least 1.5 x their height away from drainage and houses.

We recommend these trees etc. are gradually pruned/reduced to prevent ground heave.

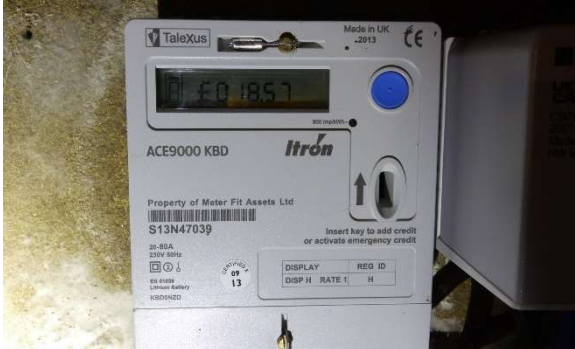
<p>Mains electricity is connected to the property and the electricity meter is located on the front wall of the cellar. The meter looks to be a pre-payment type.</p>

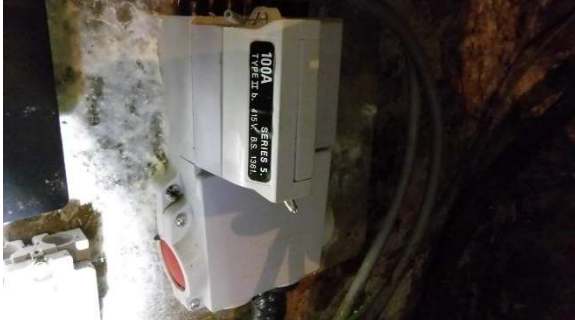
<p>The main incoming fuse has a sticker advising it is 100A</p>

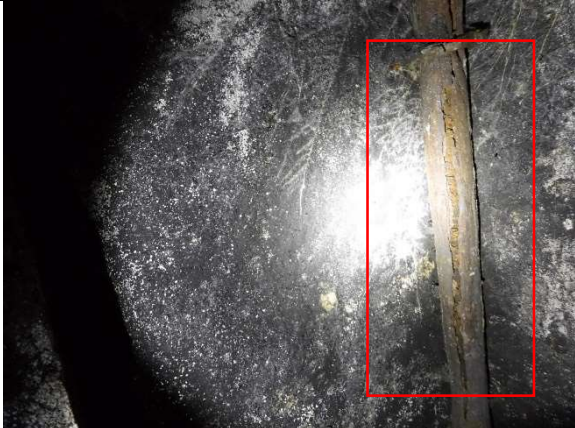
<p>The conduit around the incoming supply is badly corroding and has split along its length. You should arrange to have this inspected by the network supplier to ensure it is satisfactory.</p>

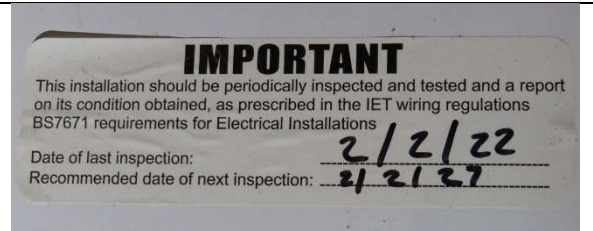
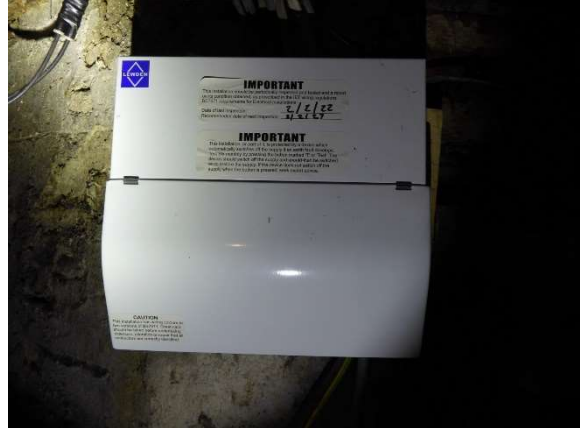
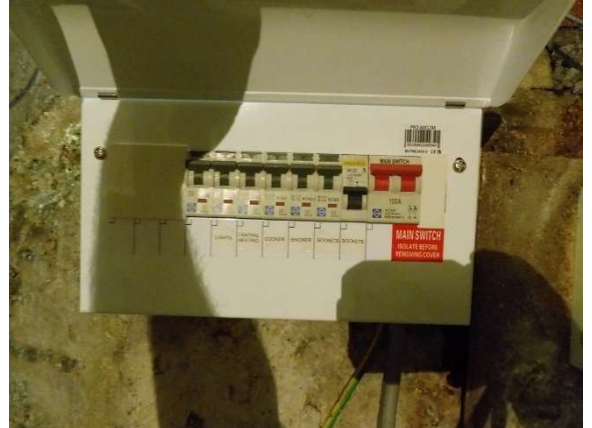
The distribution board is located on the front wall of the cellar. The sticker on the front advises the last inspection was on 2nd February 2022. Your legal advisor should obtain the installation and commissioning documentation for this replacement distribution board. Note that the board is not RCD protected.

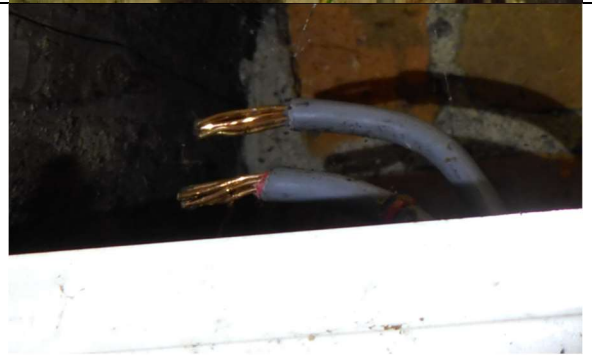
Cellar – the unterminated electricity cables should be correctly terminated straight away.

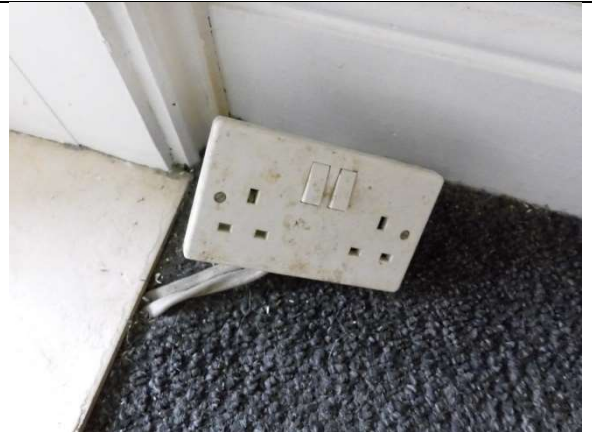
Landing – there is a socket hanging free in front of the bathroom.

This is unsafe and should be isolated and suitably relocated.

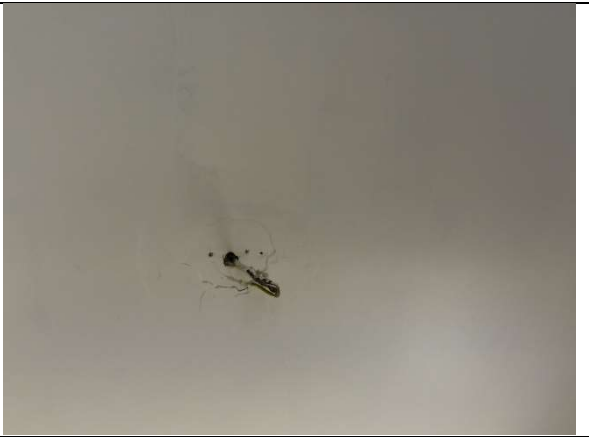
Kitchen - the unterminated electricity cables should be correctly terminated straight away.

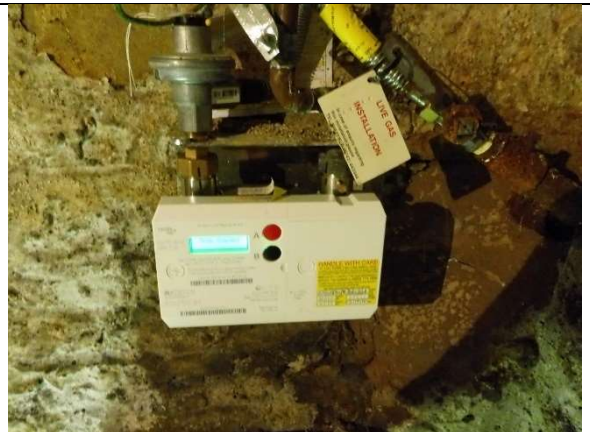
The property is connected to mains gas, the gas meter is located on the front wall of the cellar, this may be a pre-payment type meter.

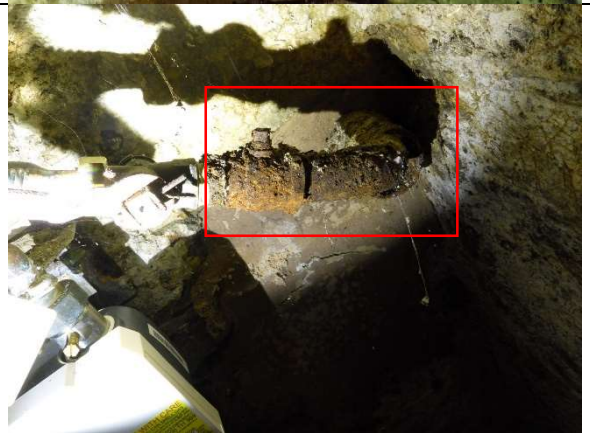
The incoming gas main is corroded and we recommend you ask the network operator to come and inspect this.

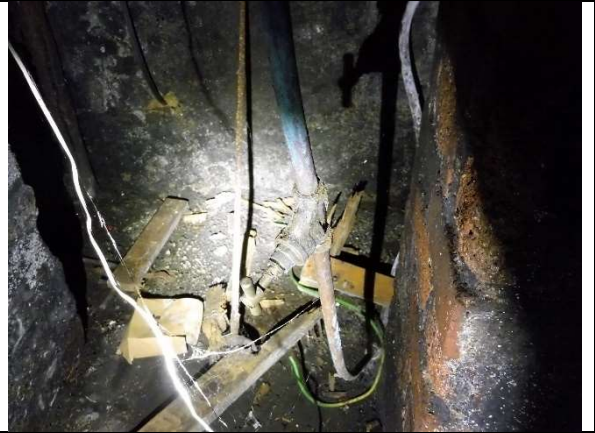
All of the supply piping should be appropriately lagged.

We recommend that this is clearly labelled and that occupants know where it is in case of emergency.

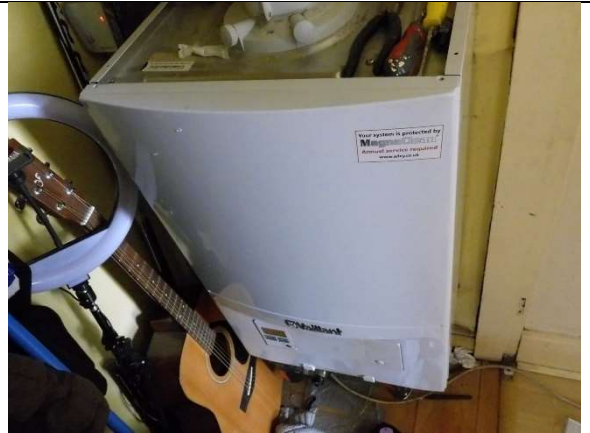
The boiler, a Vaillant combination system is located in the back bedroom cupboard under the second-floor staircase.

Your legal advisor should obtain a copy of the commissioning certificate that should have been issued when the boiler was installed.

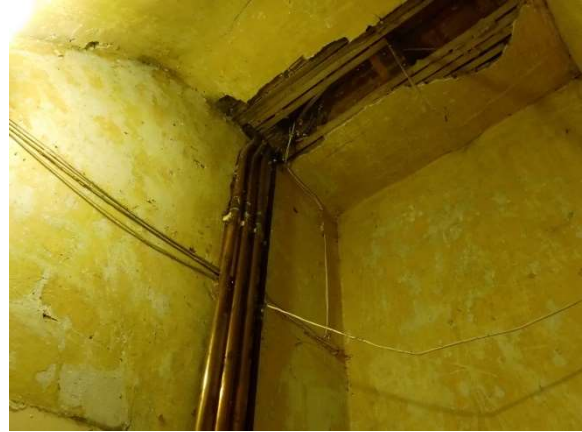
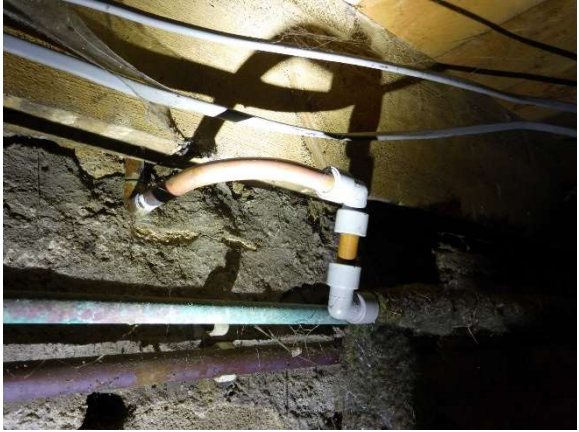
All of the central heating pipework should be appropriately lagged. Example photos showing un-lagged pipework are below.

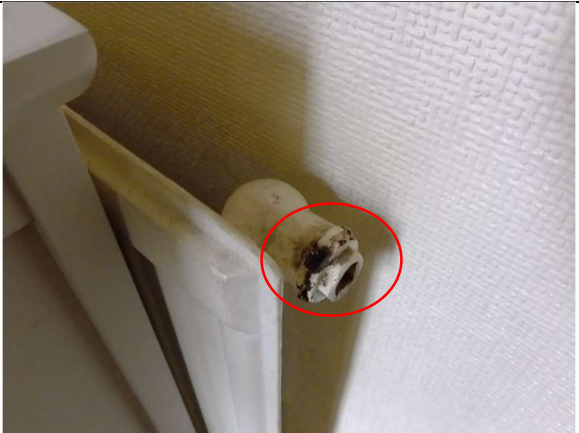
Example of some corrosion around the top of a radiator valve (back bedroom).

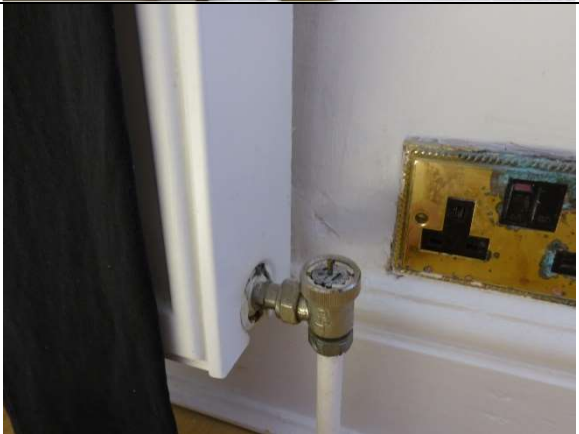
Example of a radiator (dining room) missing the TRV.

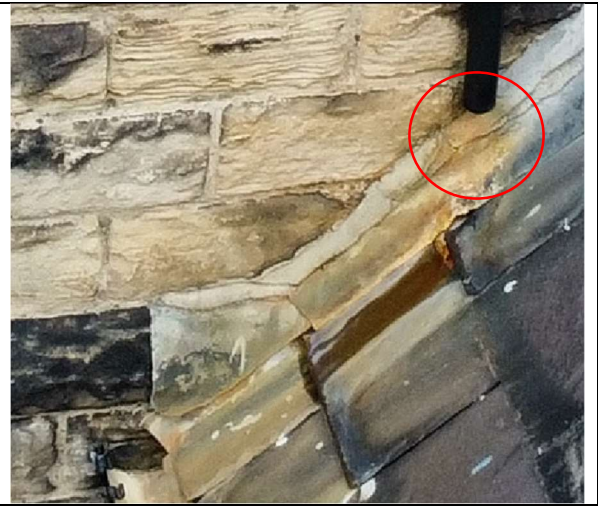
The condensate pipe from the boiler does not extend far enough down and there should be a boot on the end of the pipe.

The contaminants in the system are staining the surrounding area and are a sign that there appears to be some corrosion in the system.

Inspection by a suitably qualified heating engineer is recommended.
