Level 3 Building Survey

Report prepared by Simon  
Hollis MRICS

31<sup>st</sup> August 2023

## Building Survey Report

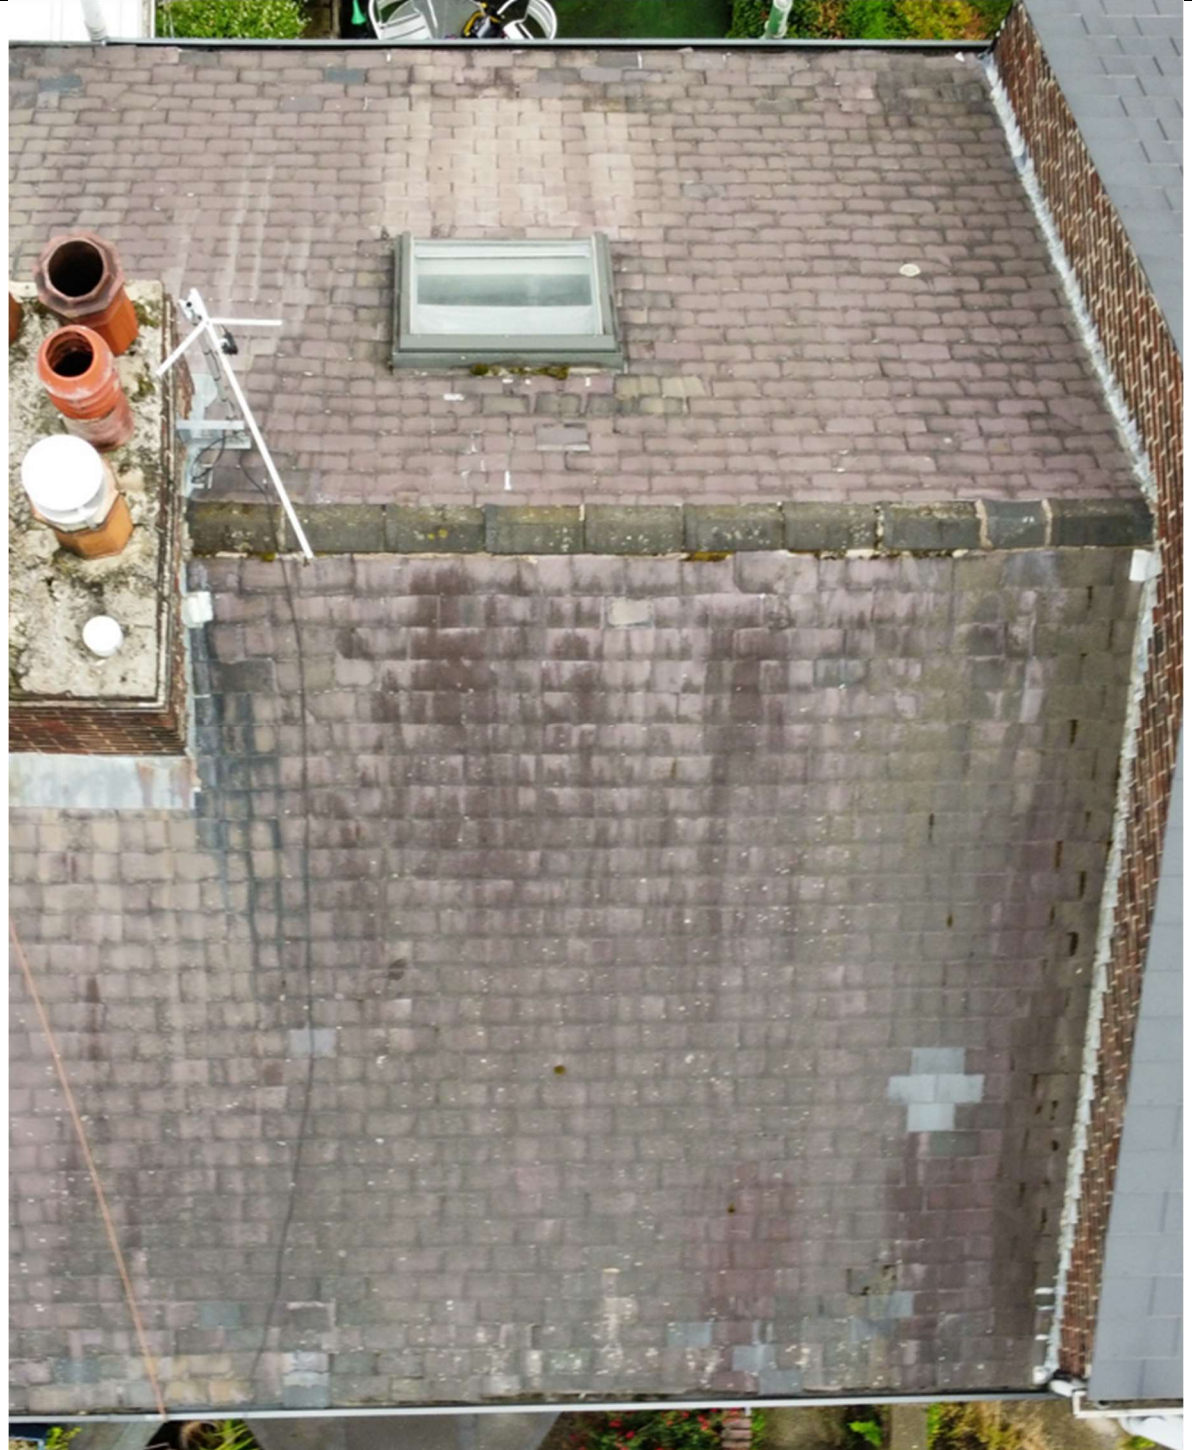
Overhead photo of the front roof pitch. Note the heavy staining to the slates.

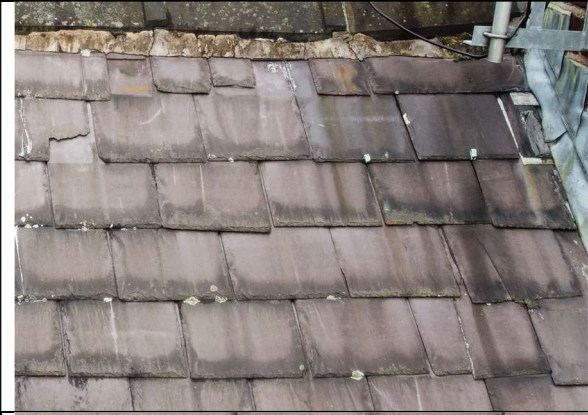
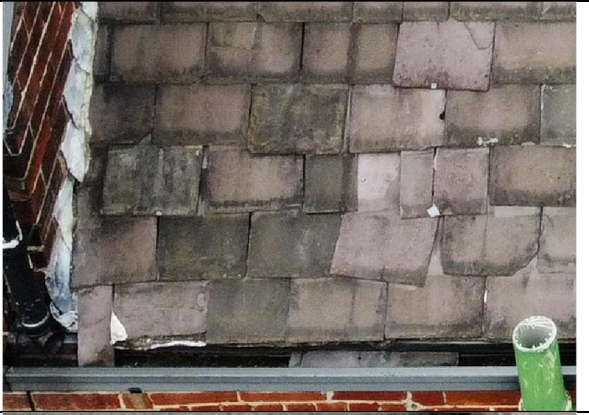
There are several areas of damaged slates across the pitch. All areas of damaged slates should be repaired/replaced as soon as possible. We have included some example photos of the areas below.

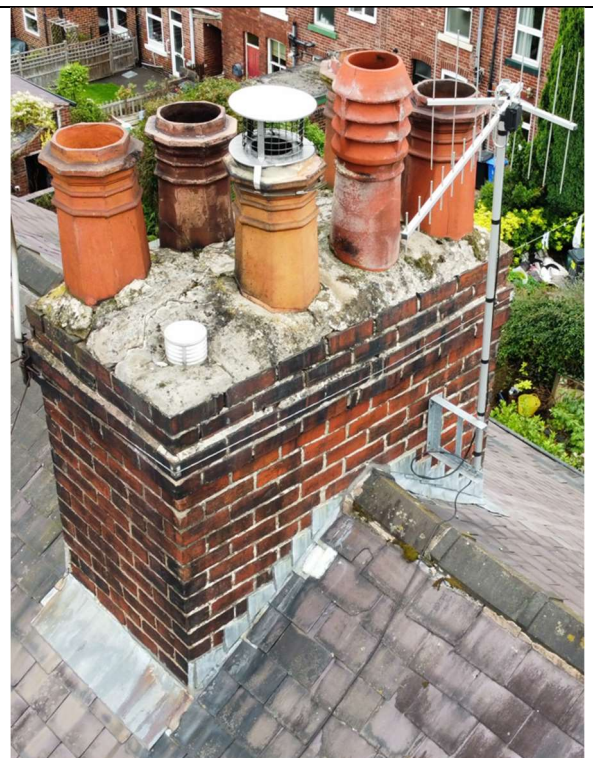
The front aprons are not set high enough up the stack and there are no restraint straps – see below.

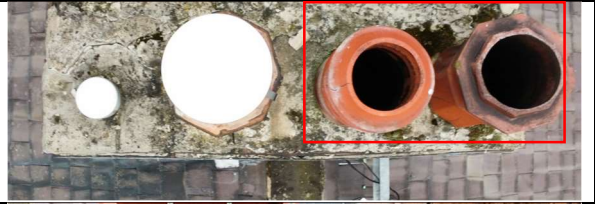
The rear two pots should have vented caps added to their tops.

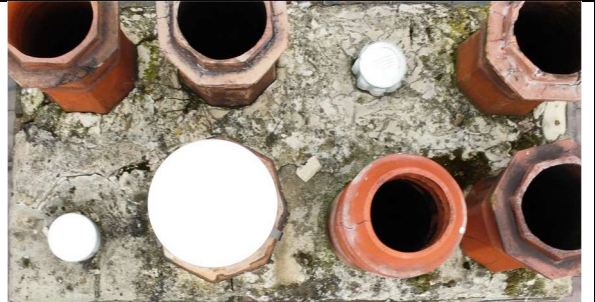
The centre rear and rear pots are both cracked.

The centre rear is badly damaged all around and needs to be replaced (and a vented cap added once replaced).

The flaunching on the subject property will probably last another couple of years.

The flaunching on the other side of the stack (the neighbouring side) is in poor condition and this may allow moisture into the subject properties side of the stack.

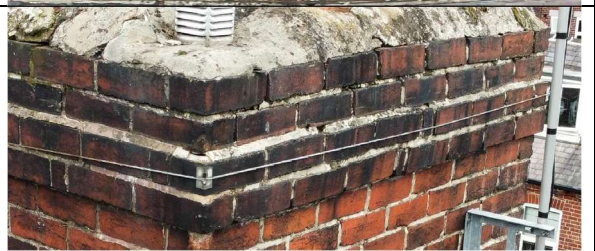
The pointing around and above the corbelling is in poor condition and needs to be raked out and repointed in the next year.

See our comments above on mortars.

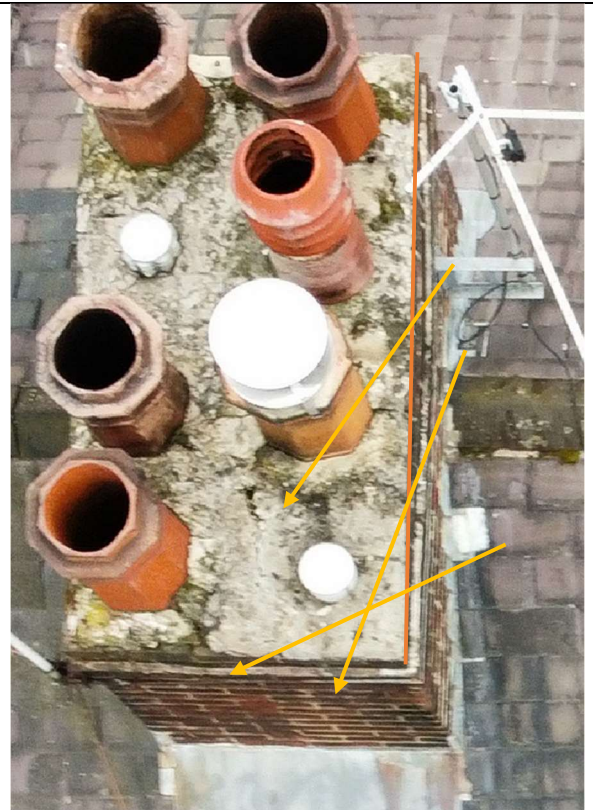
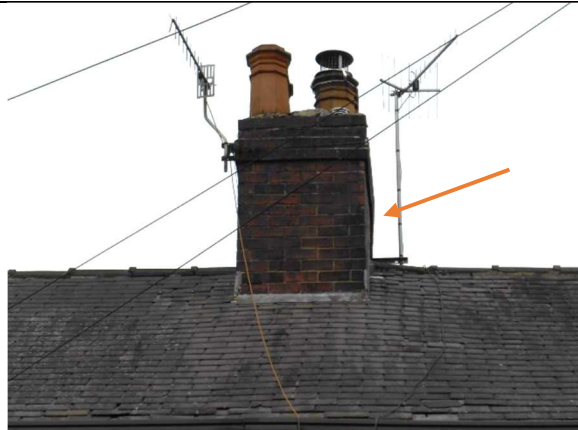
Stack – the stack has a twist on the right-hand side towards the centre twisting left.

This needs to be recorded and monitored to see if the twisting is active.

This can be done at the same time as the repairs to the courses at and above the corbelling.

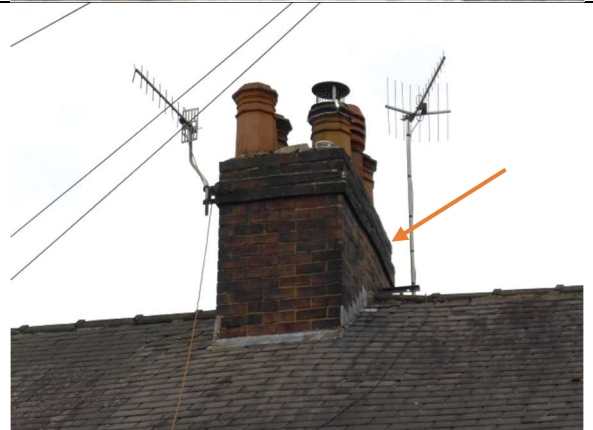
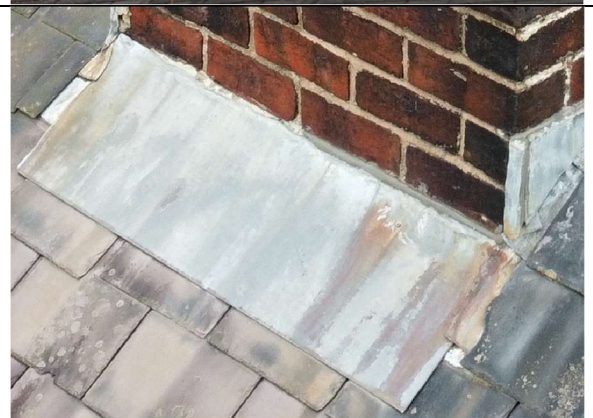
Front apron – the upstand on the front apron is not high enough – it should be 150 mm above the pitch.

There are also no restraint straps under the apron (to stop this slipping). These should be added next time high-level works are undertaken.

This is the same on the front and the rear of the stack.

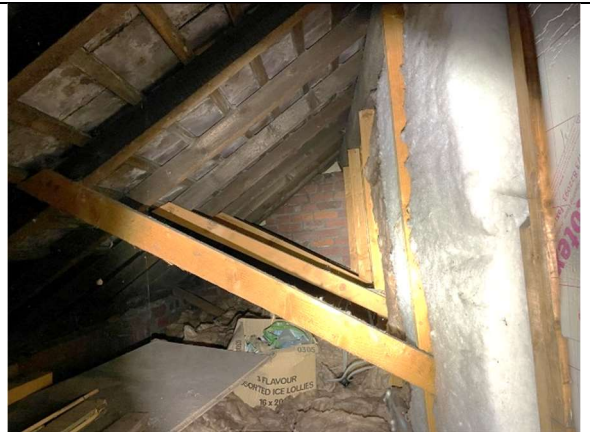
The attic room stud walls are braced to the rafters/vice versa.

The pitch appeared flat when we inspected it from the ground.

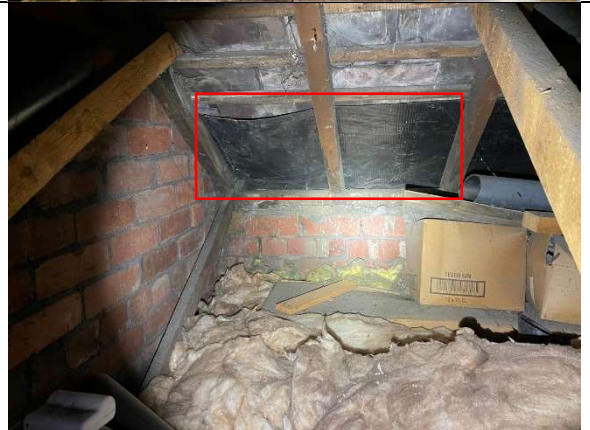
The underside of the original roof covering is visible in the front area.

At some point in the more recent past, an improvised eaves tray type arrangement has been added – see the red box.

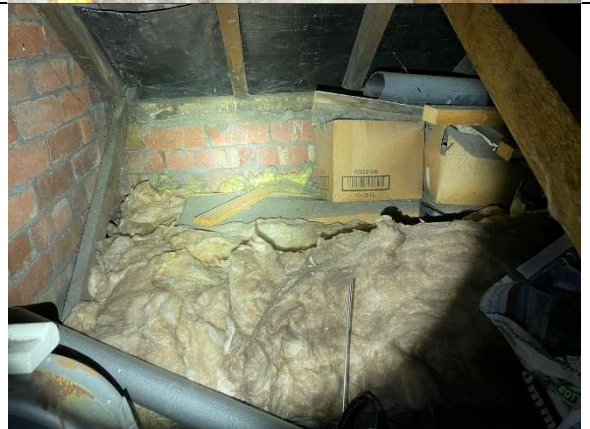
The fibreglass and mineral wool insulation that is laid across the first-floor bedroom ceilings can trap moisture.

Consideration should be given to replacing these with permeable insulation such as sheep's wool insulation

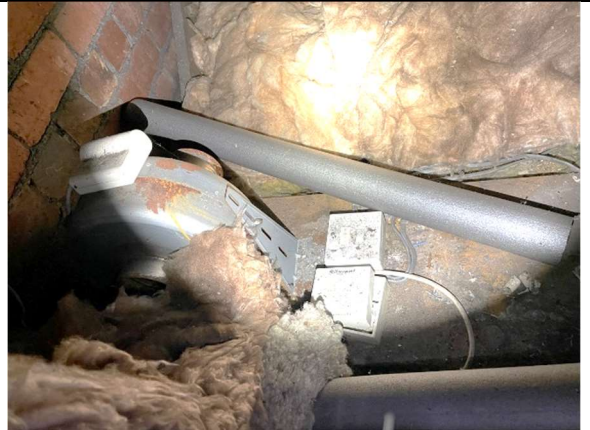
Front roofspace – there is a redundant fan and associated electrics in the roof void.

These should be removed.

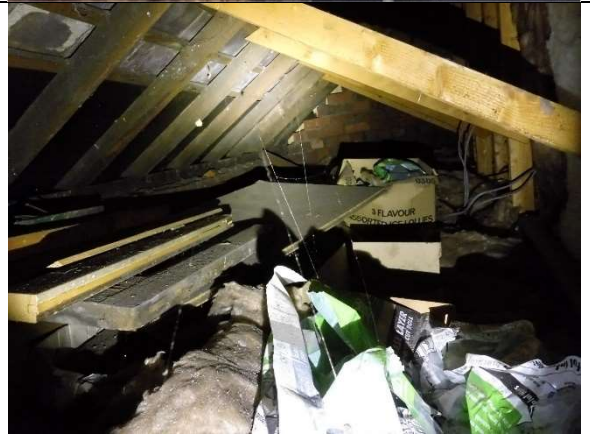
The building materials etc. in the roofspace should be removed.

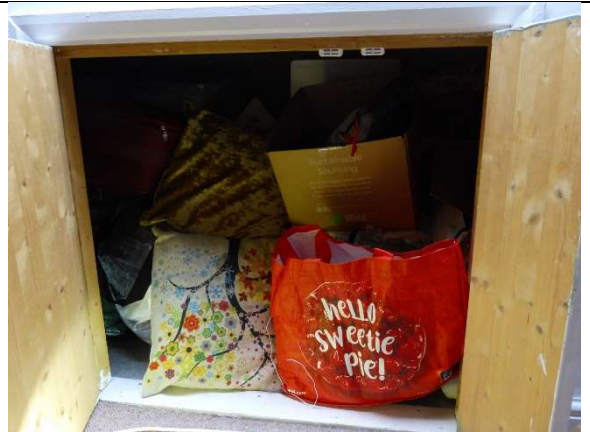
We have not been able to inspect the rear roofspace as this is underdrawn with plasterboard and was full of possessions.

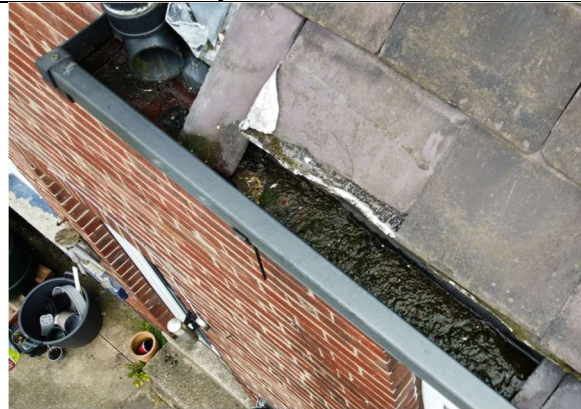
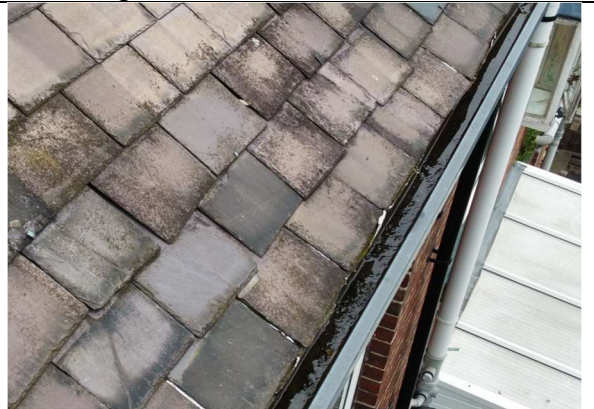
There is debris in the rear guttering run which should be cleared out before winter. There is also some minor ponding along the run which suggests that this is not set to the correct fall. A contractor may be able to correct this with the use of packers.

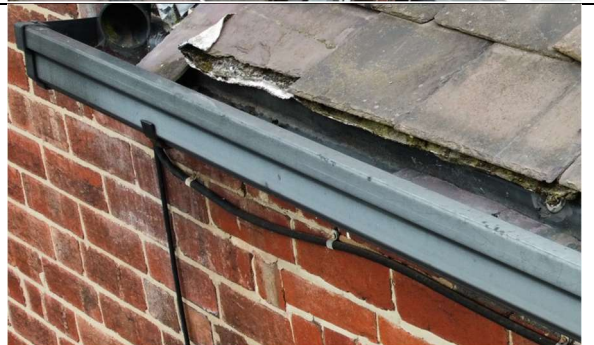
The rear guttering run is sun-bleached/UV damaged which will likely accelerate its failure.

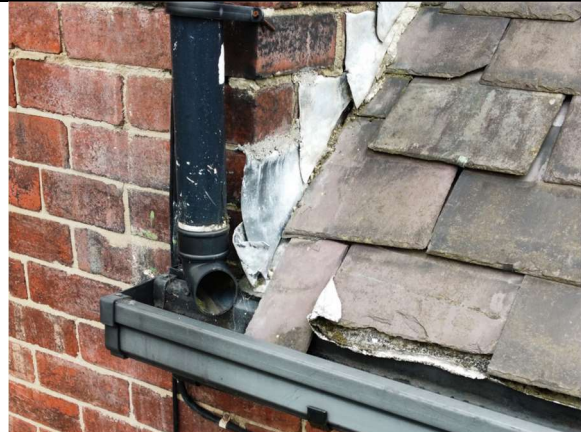
The two right-hand neighbours' guttering discharge into the subject property's guttering and the left-hand neighbour's guttering discharges into the subject property's fall pipe.

This is a lot of rainwater and any leaks could quickly cause moisture ingress-related problems.

Your legal advisor should ensure satisfactory documentation is in place for this arrangement.

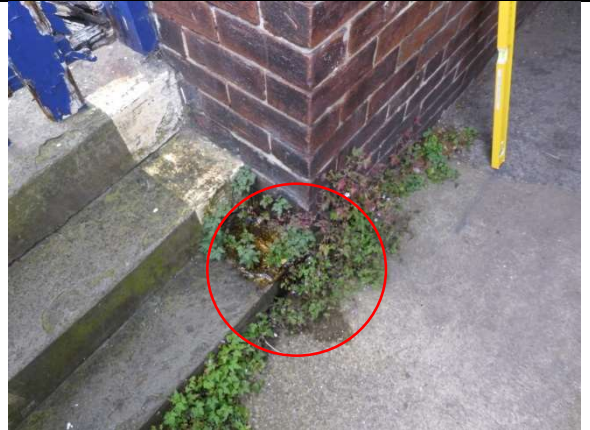
Water is leaking from the guttering – we cannot see if this is from the subject property or the neighbouring property.

This needs to be addressed regardless as this could cause heave or erosion and this pier supports the lintel over the passageway and thus the rear elevation of the houses.

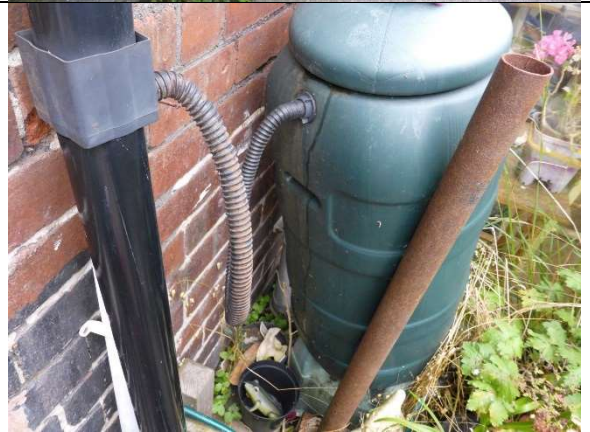
The rear fall pipe discharges into a water butt on the neighbouring property. This is full and leaking and could cause moisture and structure-related issues with the subject property.

We recommend speaking to the neighbour about this arrangement and fitting an overflow to the water butt that is directed into the mains drainage.

The lower section of the fall pipe is now unsupported and should be properly clipped back to the rear elevation in the short term.

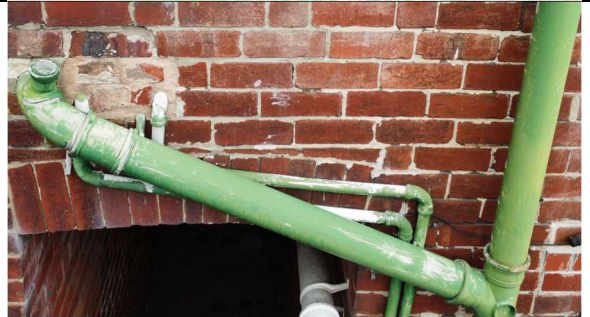
Rear elevation – we think that the green soil vent and waste pipes are redundant and that the bathroom used to be at the rear of the property before some reconfiguration took place. If they are redundant, they can be removed and the wall tidied up. If they are kept, additional pipe clips should be added to take the weight off the joints.

Note that a Dergo/air admittance will need to be added to the section that is in use.

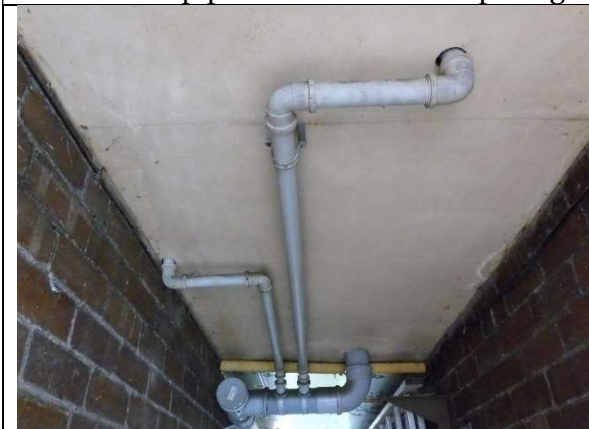
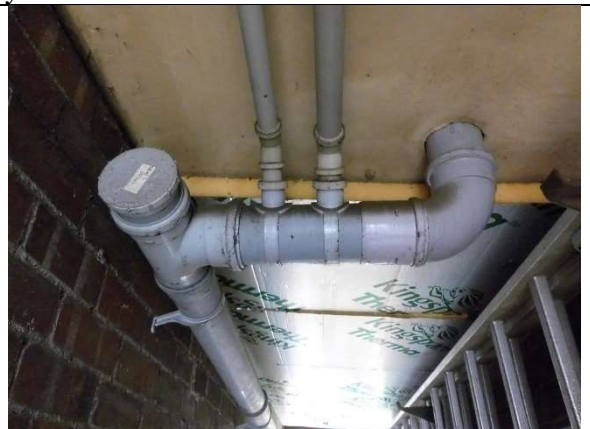
Passageway – pipe clips should be added to the bathroom waste pipes to take the pressure off the joints. This should be done in the short term.

Note that this run is particularly long and it would have been much easier to connect into the soil vent pipe at the front of the passageway.

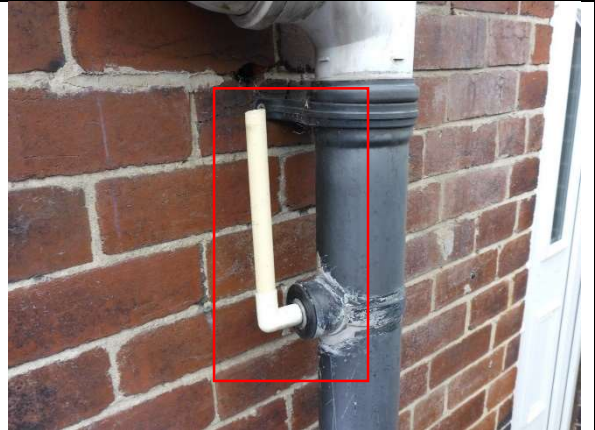
The redundant bossed pipe should be removed and the penetration properly plugged.

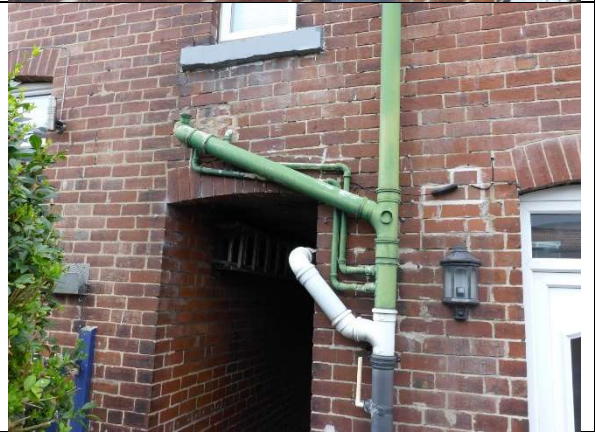
Note that the pipework in this area is all mismatched.

The top section of the soil vent pipe is not plumb and there are not enough pipe clips.

Additional pipe clips should be added in the short term if this section is to be retained.

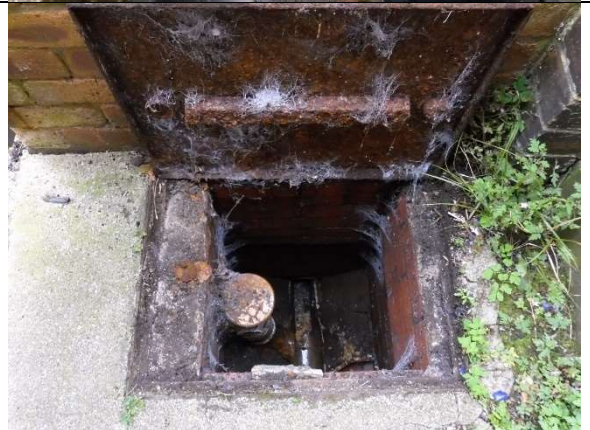
There is a plastic soil vent pipe in the inspection chamber – this is an unusual arrangement and is unlikely to comply with building regulations.

It likely belongs to the property on the left-hand side as when we ran some water through the waste pipe on the subject property, it did not come out of here.

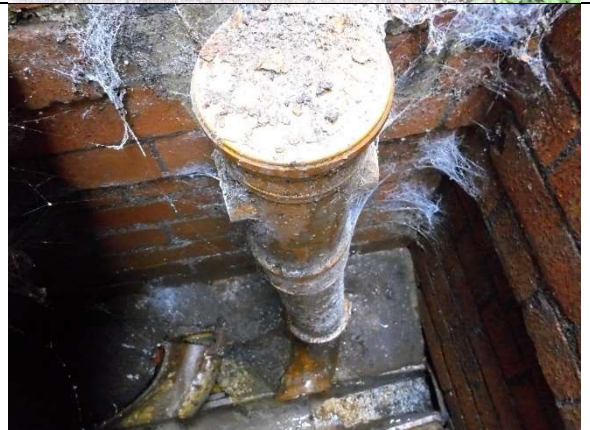
The inspection chamber is in poor condition, the benching is damaged and there are cracks/displacements in all of the pipework.

This could undermine the structural stability of the house if it is left.

This will leave sewage and waste water leaking into the ground below and **IMMEDIATE** action is required to address this.

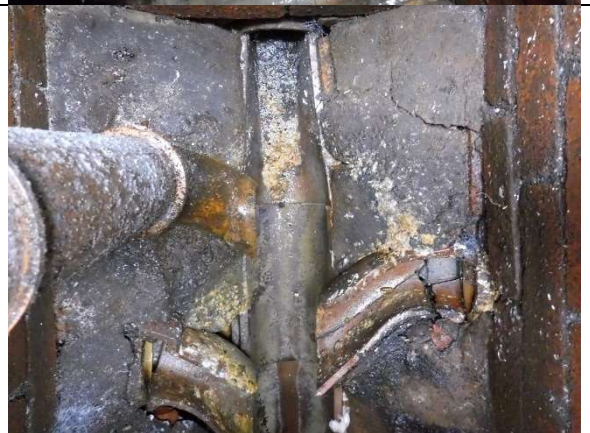
The pathway has collapsed along the route of this drainage run so it may be damaged and needs to be part of the drainage inspection.

There is no point in repairing the pathway until the drainage has been surveyed and any repairs have been undertaken.

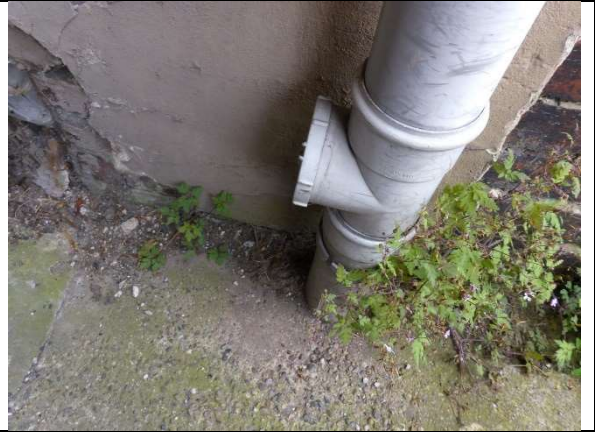
Note that the neighbour's soil vent pipe is located in the subject property's passageway.

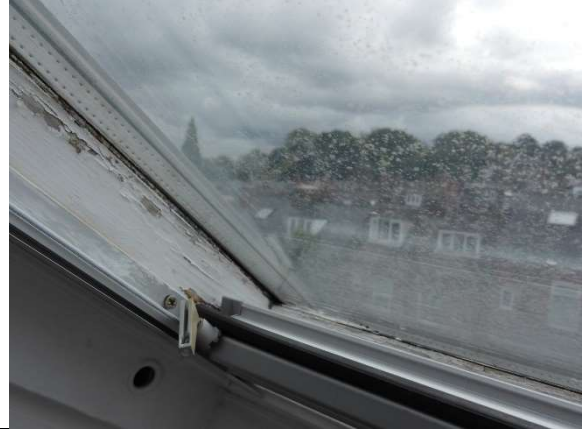
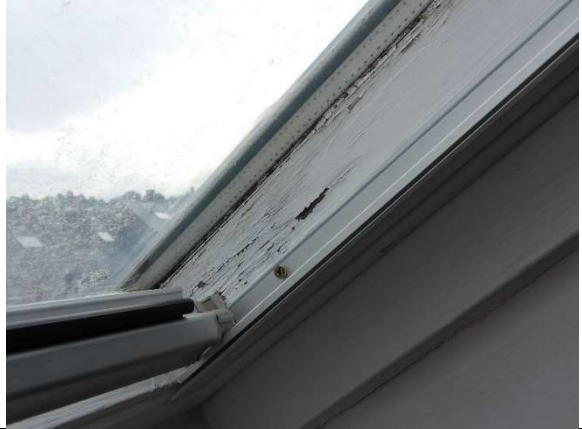
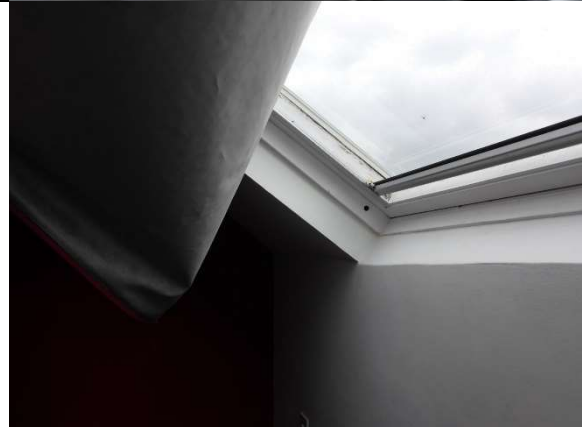
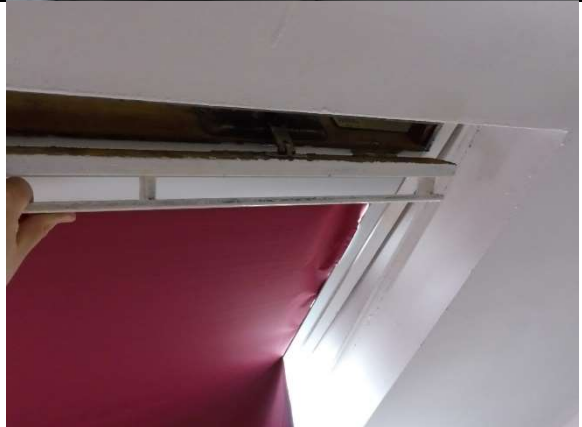
The Velux window on the rear roof pitch was in generally poor condition – the paint was blistering and flaking off, the blind was broken and the window did not open with reasonable force. It is usually challenging to find someone to repair these and replacement may now be the only option.

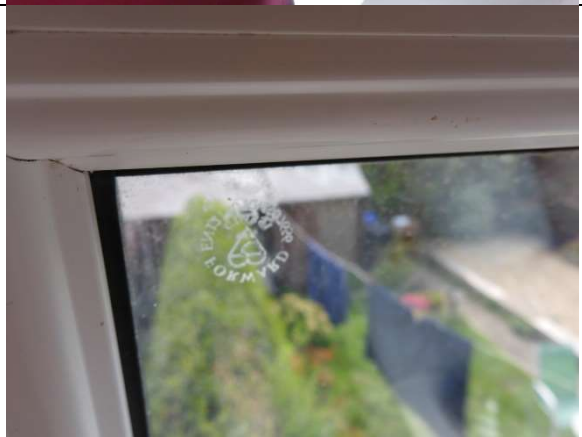
Rear landing window – this is etched EN 15120 for safety glass, as it should be as the window is 600 mm from the ground.

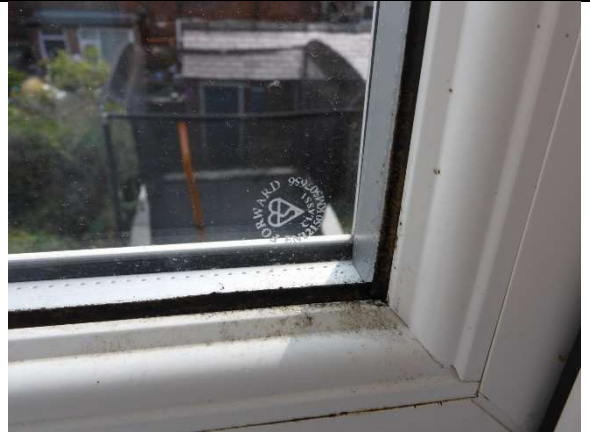
First floor Rear bedroom window – this is etched EN 15120 for safety glass, as it should be as the window is 700 mm from the ground.

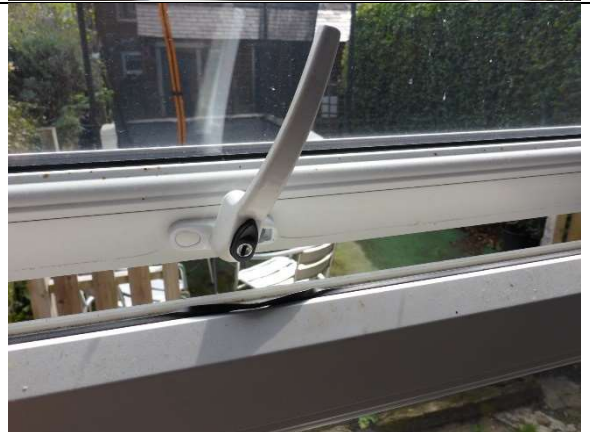
Living room – where glass is <800 mm from the floor, it should be safety glass. The glass in the living room is c. 560 mm from the floor and we could not see any safety glass markings etched into the glass.

Consideration should be given to replacing this with complaint glass.

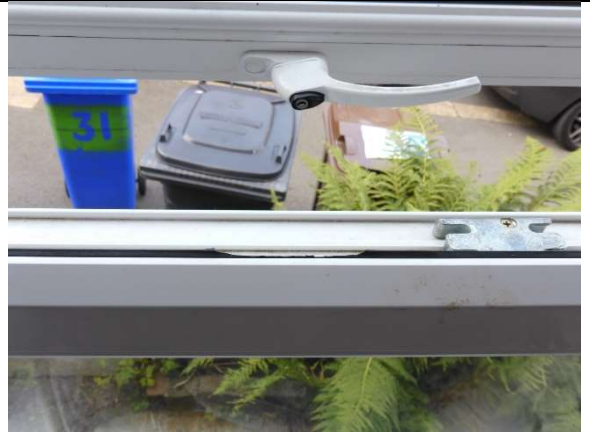
Living room – there is a small area of damage around the seal. This section should be replaced.

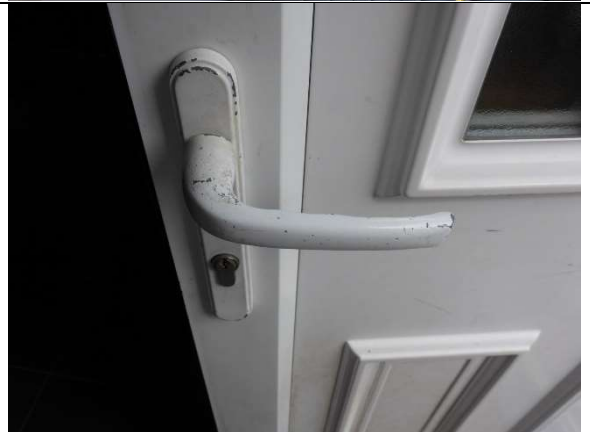
Kitchen door – the handle is worn and we could not get the door to stay closed on the latch without raising the handle to throw all of the multi-point locks.

This should be repaired in the short term by a suitably experienced contractor.

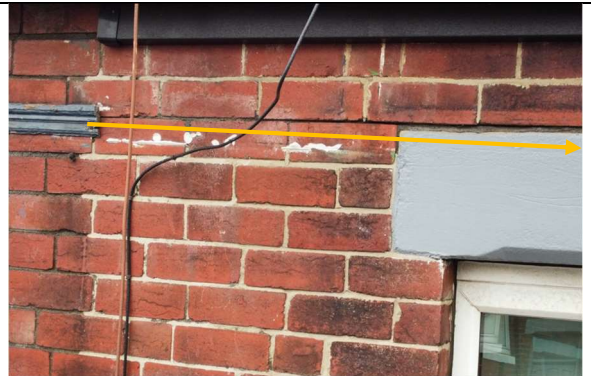
Front elevation – the decorative timber trim that is seen on the neighbouring houses is missing from this house, leaving only the shadowing across the brickwork and lintel.

You may wish to consider replacing this to cover the areas of shadowing.

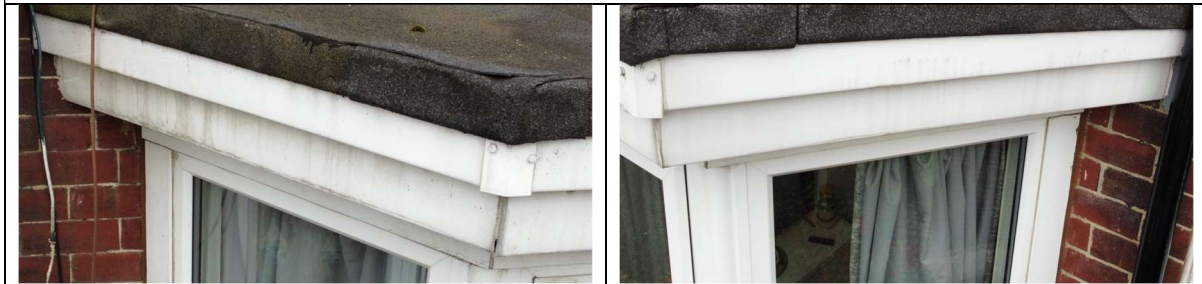
The original decorative timber around the bay window has been replaced with uPVC this is stained and there are a couple of areas where the seal is missing.

It would benefit from a clean and re-seal.

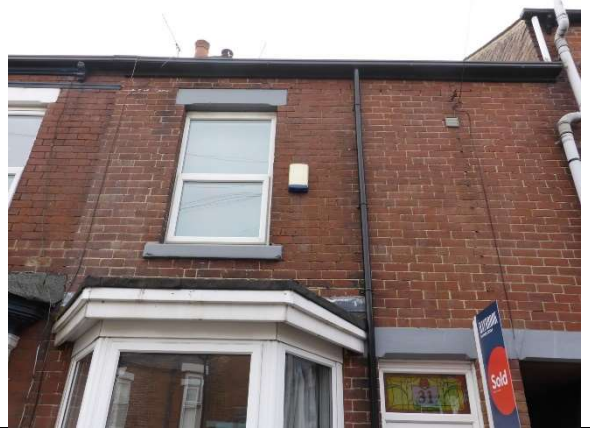
There has been some localised repointing to areas of the front and rear elevations. In most of the areas we inspected, an incorrect (hard and cementitious) mortar mix has been used.

This will need to be taken out and the areas repointed in a more appropriate lime-based mix. See our comments above in Section 1.7 on mortars.

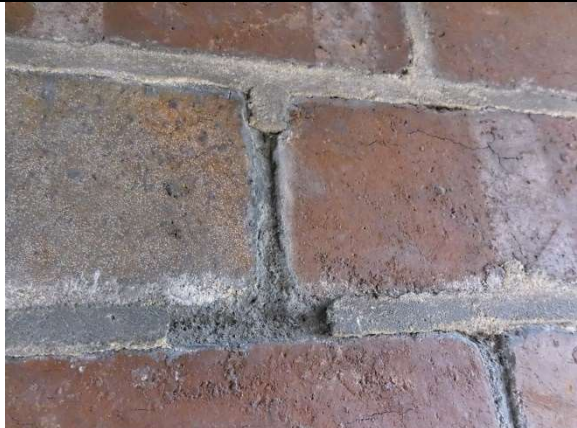
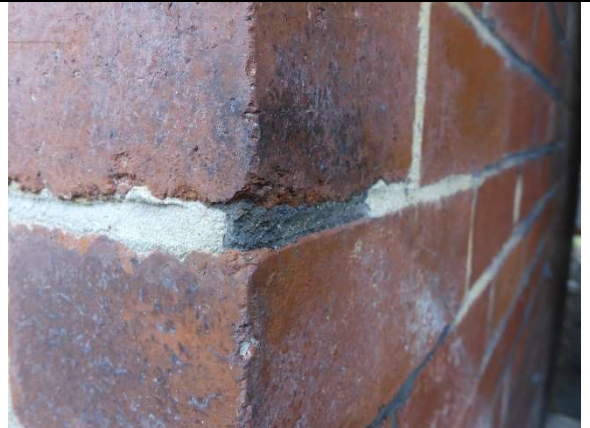
There are areas of overpointing, where mortar has been smeared over the existing mortar as opposed to the original mortar being raked back to 25 mm/twice the joint height and the exposed depth repointed.

This is poor practice.

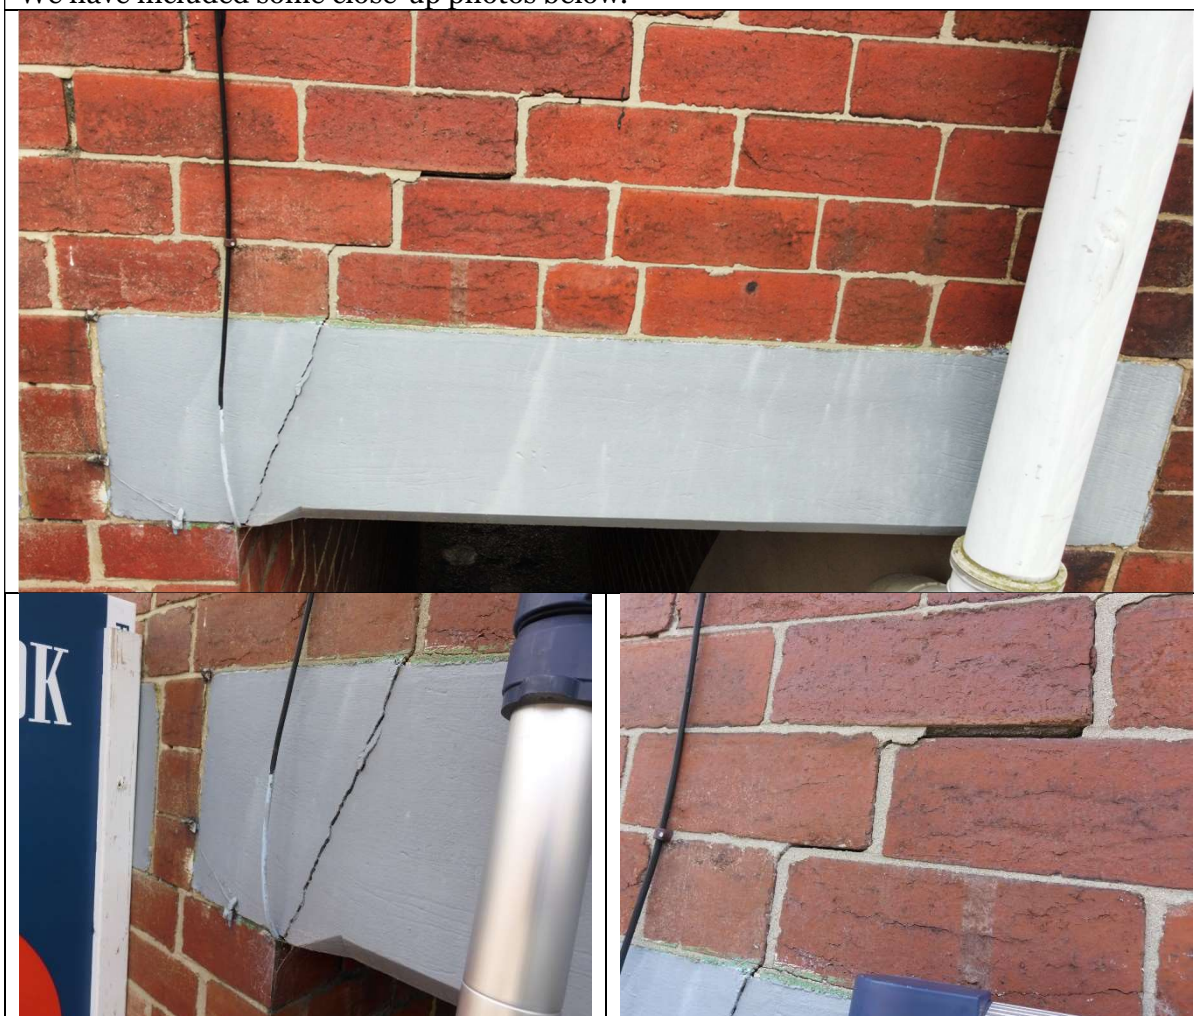
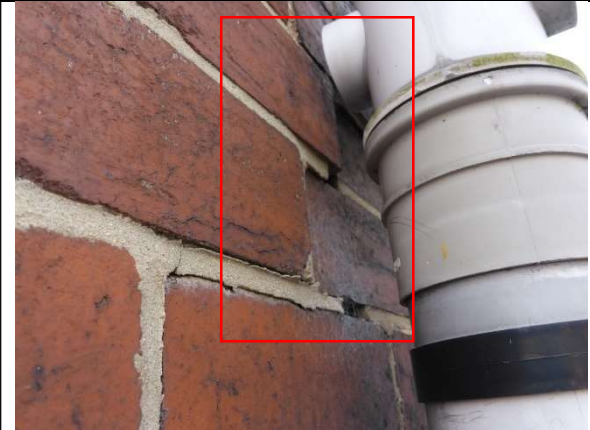
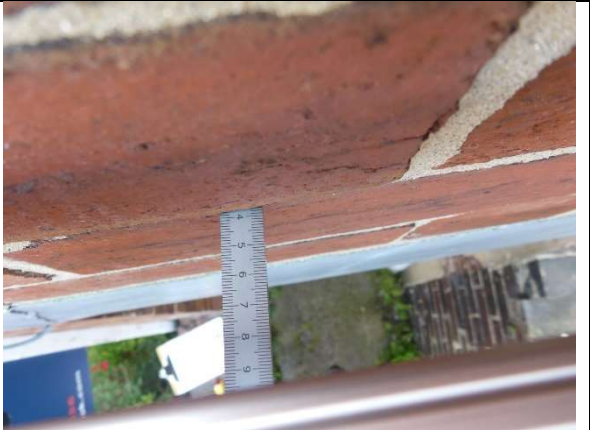
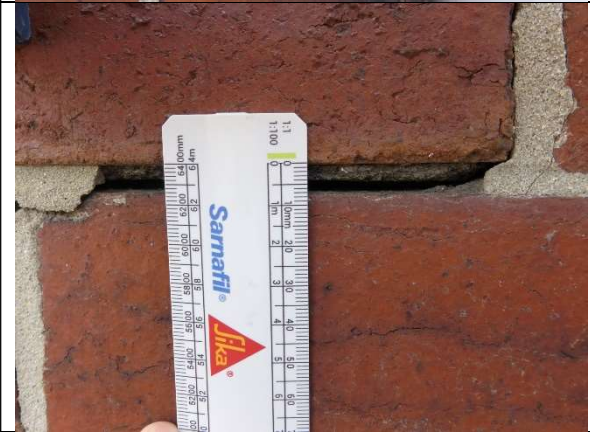
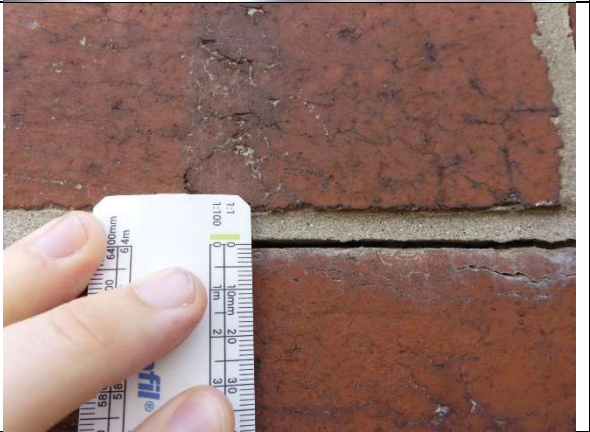
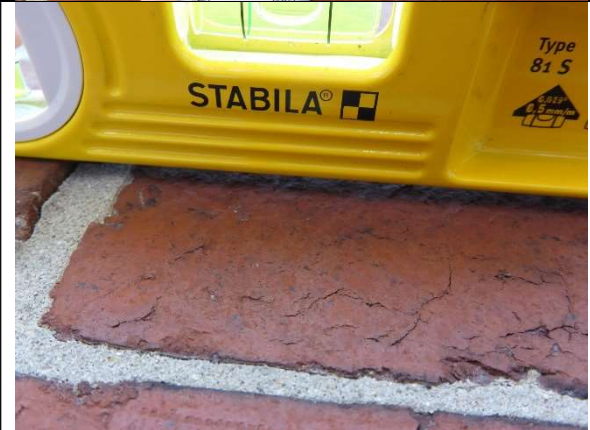
Passageway lintel and brickwork above – the stone lintel above the passageway has snapped where it bares onto the front elevation on the left-hand side of the passageway. The lintel has cracked all of the way through and there are c. 7 courses of brickwork above that have dropped by up to 4 mm and there is an area closer to the neighbour's soil vent pipe that is out of plumb and the brickwork is visibly displaced.

This is likely as a result of a combination of defective drainage, historic problems with leaking guttering and the fall pipe discharging at the base of the house as opposed to into the mains drainage. The drainage should be inspected and repaired and the fall pipe taken into the mains whilst the work to replace the lintel is planned in. As this is a shared combined sewer, the water authority should repair this, however, they are unlikely to deal with the fall pipe or the lintel/brickwork repairs free of charge.

The lintel should either be replaced or a steel lintel with a lip should be placed behind and underneath the lintel in situ (see example below). The brickwork should then be repaired. A structural engineer should be consulted as soon as possible.

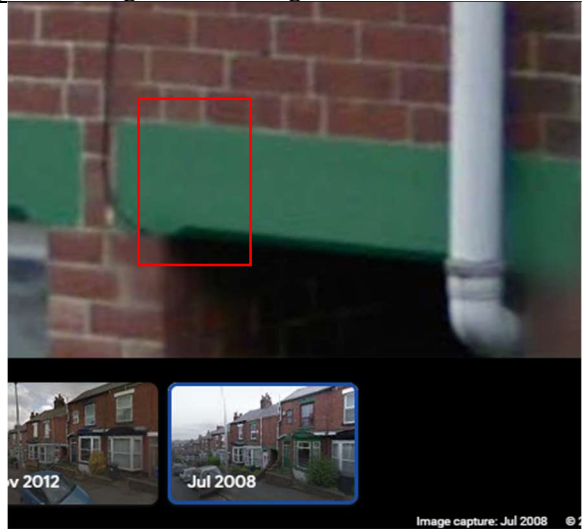
Google Street View July 2008 – there does look to be a line across the lintel in this photo, although it is not particularly pronounced.

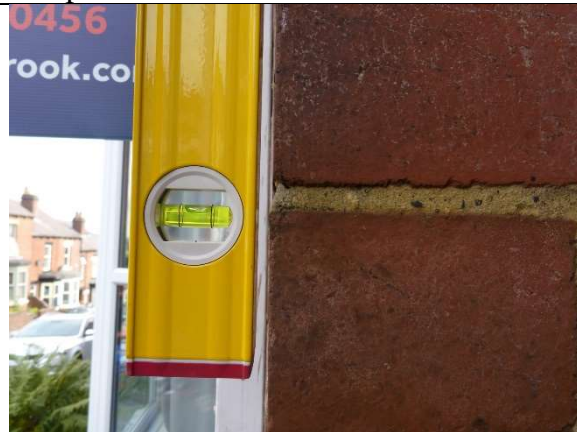
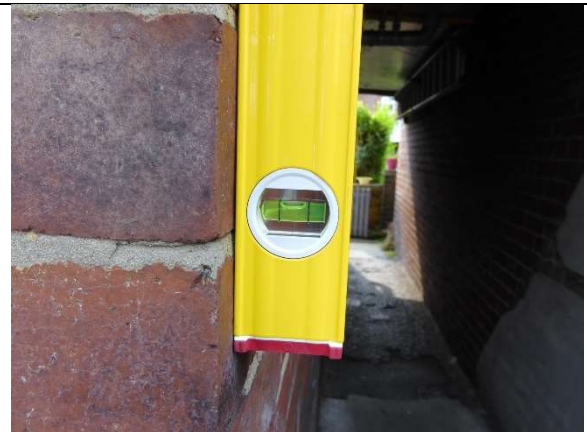
The front elevation below the lintel is c. 5 – 10 mm out of plumb. The passageway elevation was plumb.

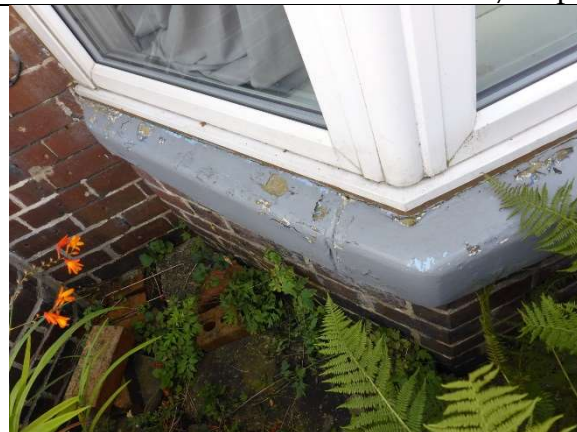
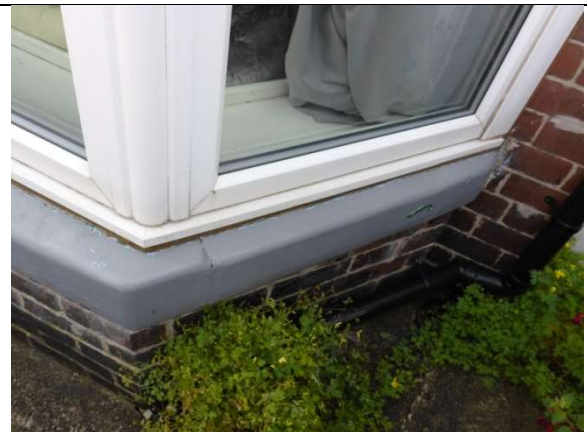
Bay window – we have not been able to inspect the lintel above the bay window as it sits behind the flashing upstand.

The paint is peeling around the bay windowsill. This should be prepared and redecorated. See our comments above in Section 1.7 on paints.

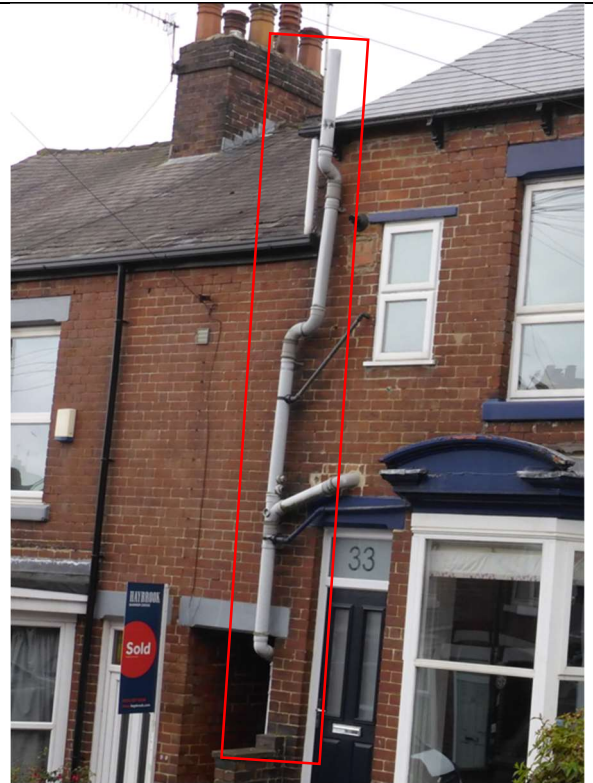
The neighbouring properties' soil vent pipe is affixed to the front elevation of the subject property – you should ensure you are happy with this arrangement before you commit to purchase and your legal advisor should ensure that there is satisfactory documentation in place.

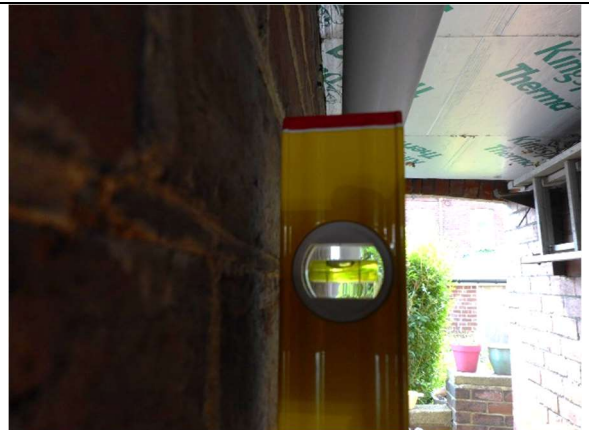
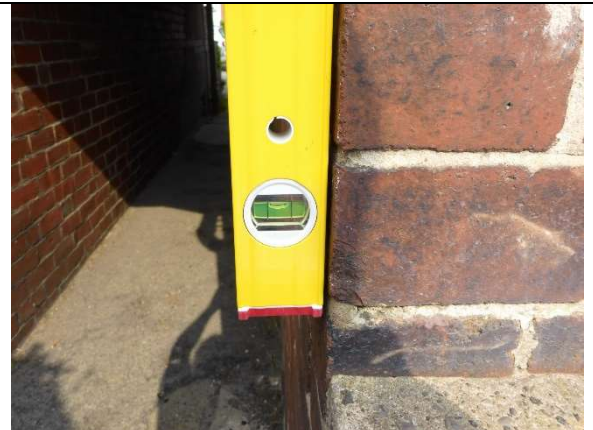
The wall along the passageway is generally a little out of plumb, however, there are some areas where the faces of the brickwork are not all in line. We did not note any areas of stress to the brickwork or mortar beds.

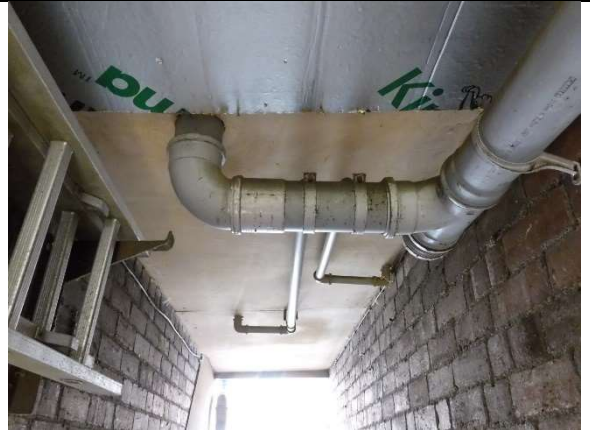
Note that only part of the passageway ceiling is insulated and there is no ventilation gap above the insulation that is there.

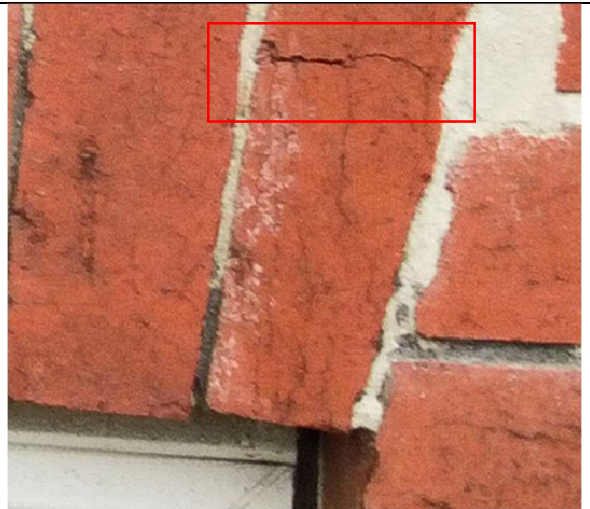
Landing/passageway arch – the left-hand brick is cracked.

This should be monitored.

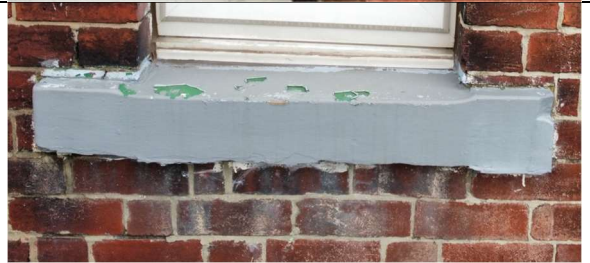
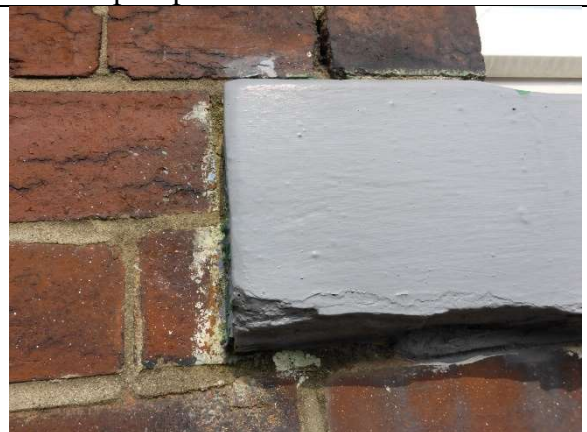
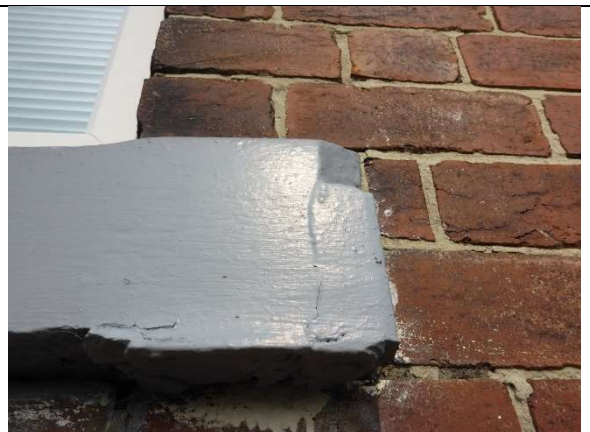
Landing/passageway windowsill – the lower arris/part of the windowsill has delaminated, likely as a result of a leak in the guttering above. Some close-up photos are below.

This should be repaired with a proprietary stone repair product.
