Level 3 Building Survey

Report prepared by Simon  
Hollis MRICS

31<sup>st</sup> August 2023

## Building Survey Report

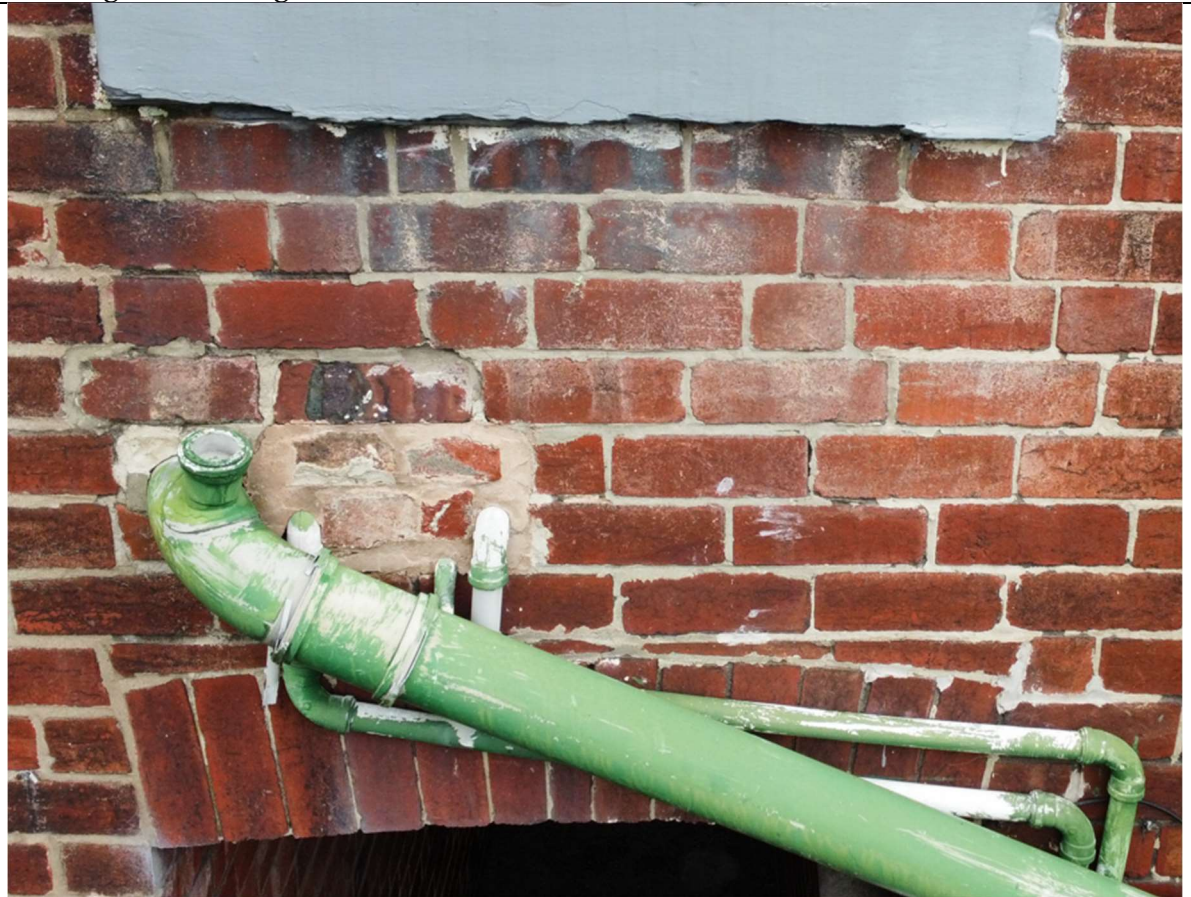
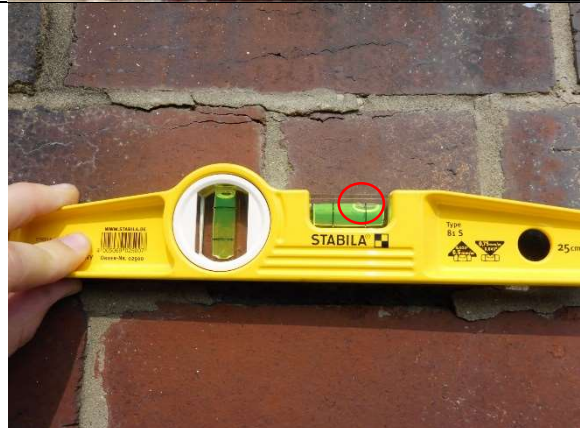
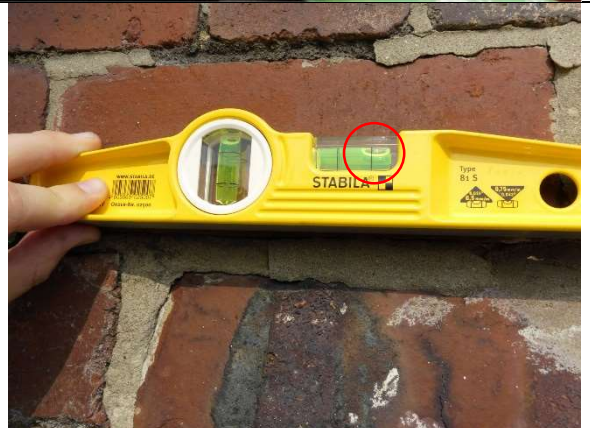
Close-up photo of the brickwork above the rear of the passageway. The arch is quite flat and the brickwork courses above are not level. The area around the drainage penetrations has been poorly detailed and some consolidation would tidy this up. See our comments above on the 'green' drainage items.

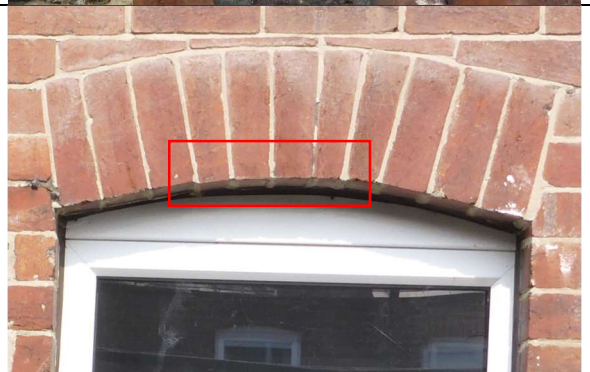
Kitchen door – there has been a slight drop in some of the gauged bricks above the kitchen door, likely as a result of replacing the timber with uPVC.

This should be recorded and monitored going forwards.

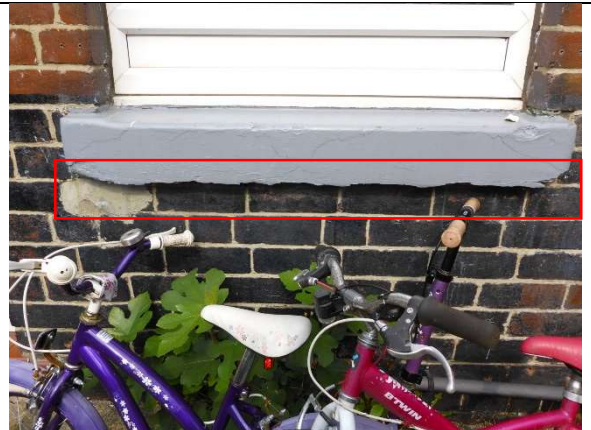
Kitchen windowsill the lower corners of the stone have been lost to delamination.

These areas should be repaired and the windowsill prepared and redecorated. See comments in Section 1.7 on paints.

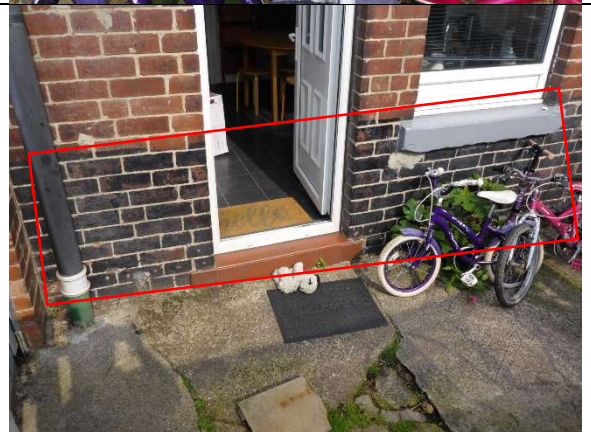
The lower section of the rear elevation has been painted – likely as a result of ill-advised damp-related works.

The remainder of this paint should be removed as it will likely trap moisture against the bricks causing accelerated decay.

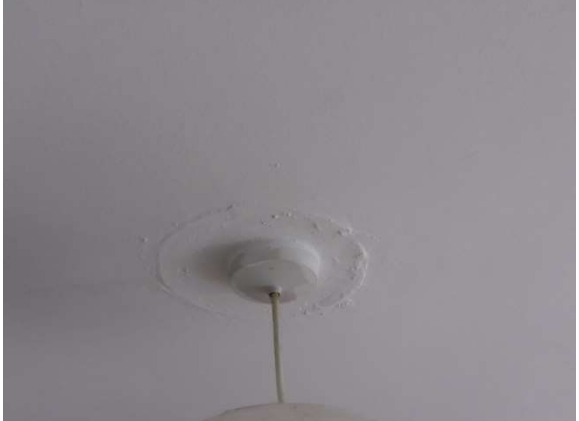
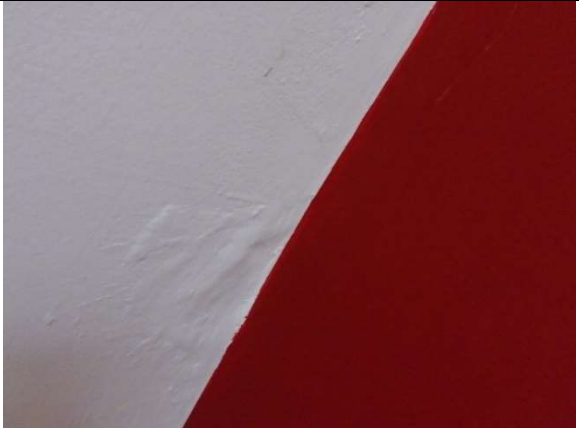
| <p>Attic room – the ceiling has been damaged where the light fitting has been replaced and there are some areas of hairline cracking and poorly finished paintwork.</p> <p>Example photos below.</p> | |

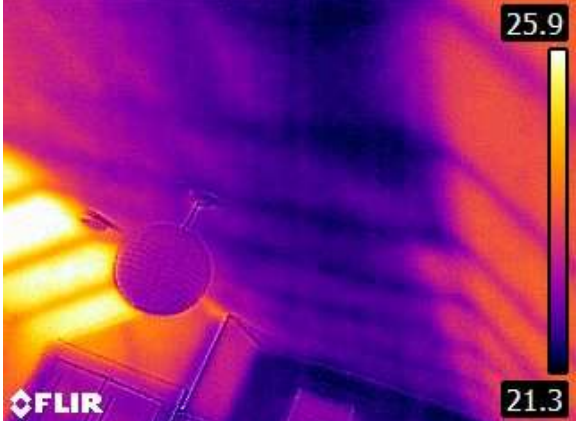
| <p>Attic room – the pitches do not appear to have been insulated.</p> | |

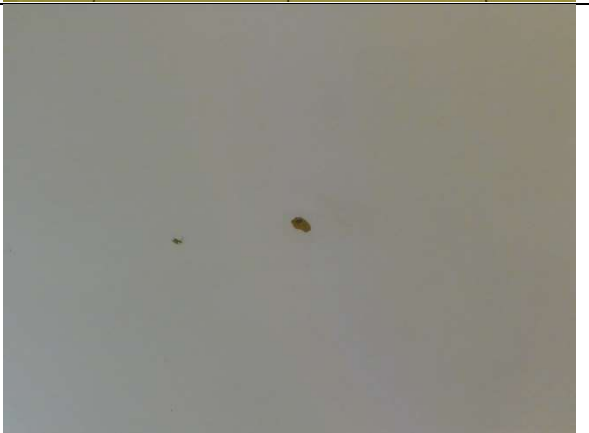
First-floor rear bedroom – there are some areas where the fixings have popped through the face of the plasterboard. These should be repaired.

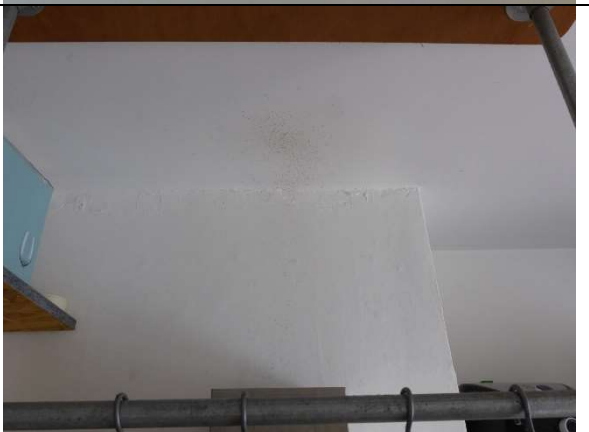
Kitchen – there is staining on the wall and ceiling above the extractor hood as this is not an externally exhausting model.

The filters need to be cleaned and the grease cleaned away.

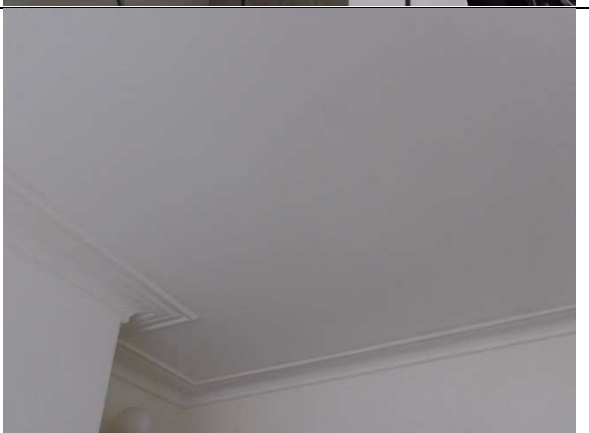
Living room – the ceiling has been overboarded and skimmed – this is not the best job and the outer profile of the covings has been lost in places.

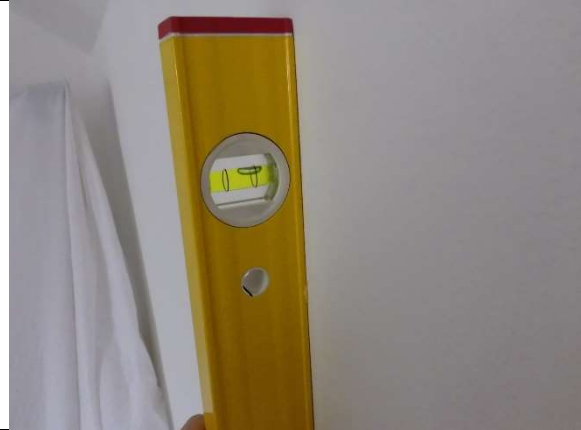
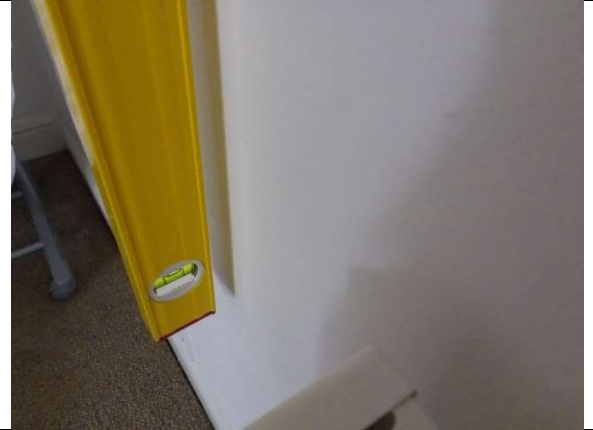
Attic room – the front stud wall is out of plumb in places. The other areas we inspected were generally plumb.

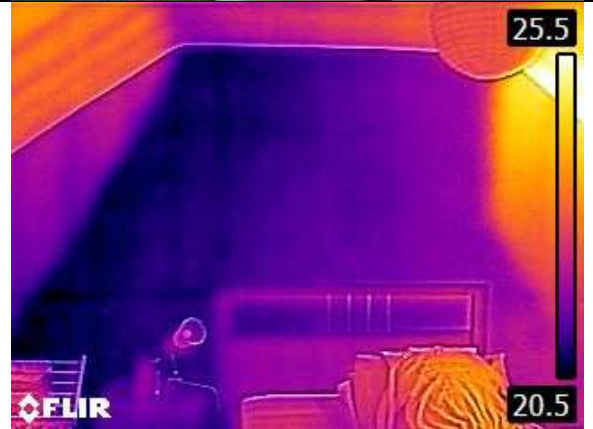
Attic room – the chimney alcoves have been boarded out and the wall skimmed – note the cooler area where the stack brickwork is and the lighter areas where it is stud.

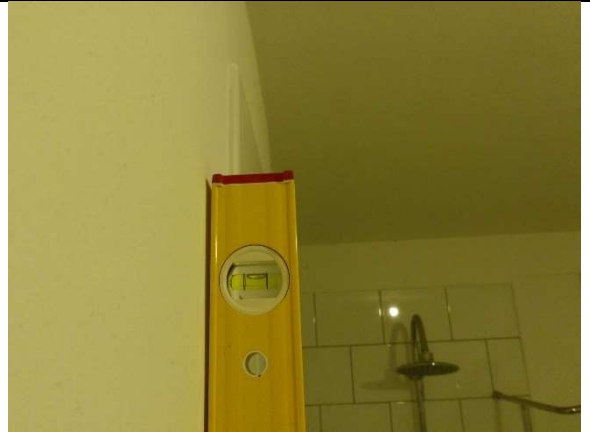
Bathroom – the walls are generally plumb; however, the surface finishes are not all flat, note the gap at the rear of the level.

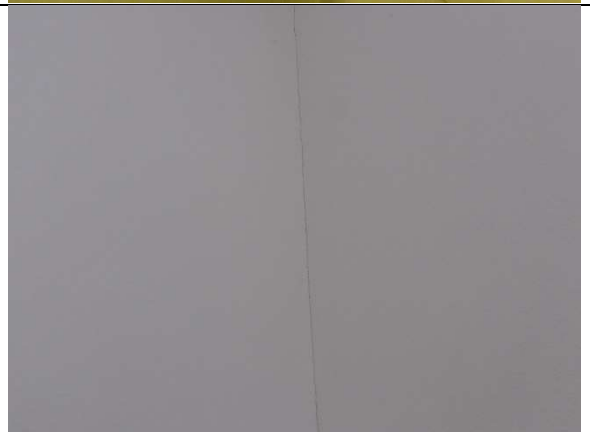
Front bedroom – there is a hairline crack in the plaster where the stud wall meets the front elevation.

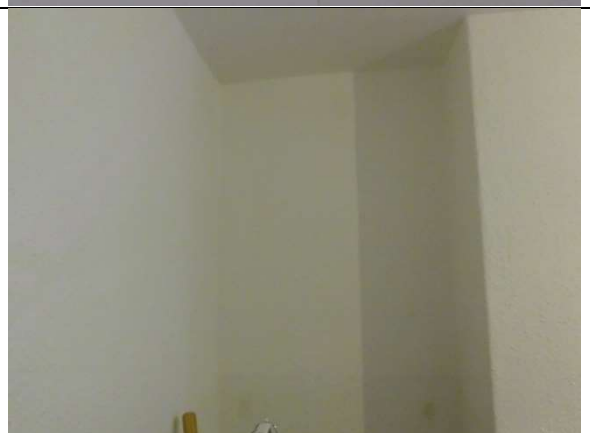
First-floor rear bedroom – two of the walls are finished in woodchip wallpaper which can be very difficult to remove.

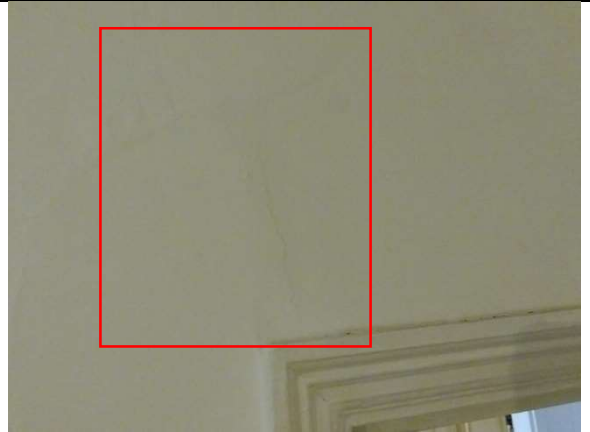
First-floor rear bedroom – the wall is a little damaged above the door frame and needs repair and redecoration.

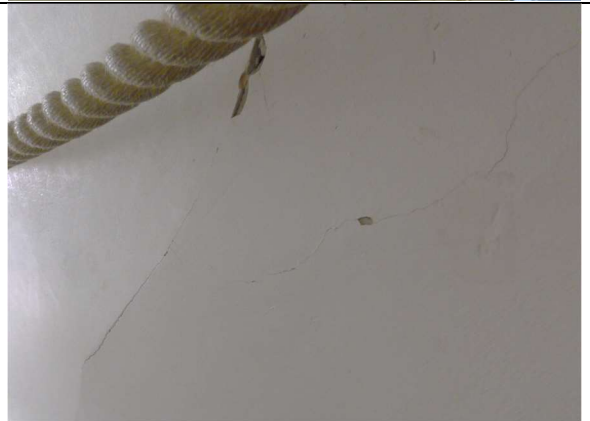
Ground to first-floor staircase – the plaster is damaged around the top of the stairs. This should be repaired.

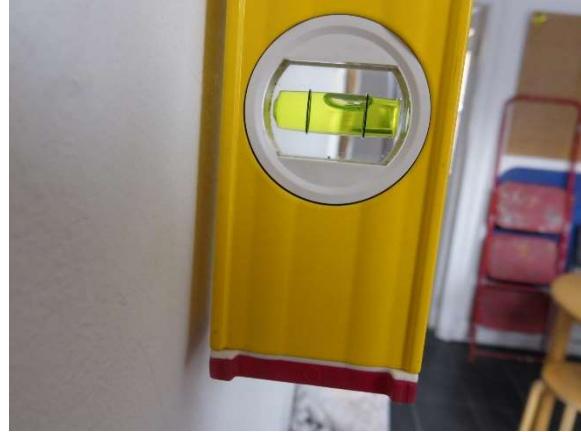
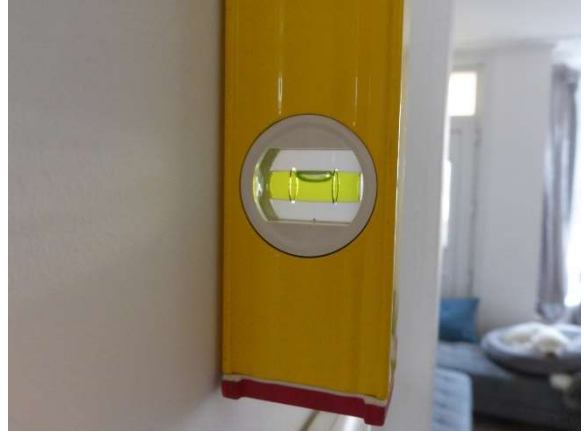
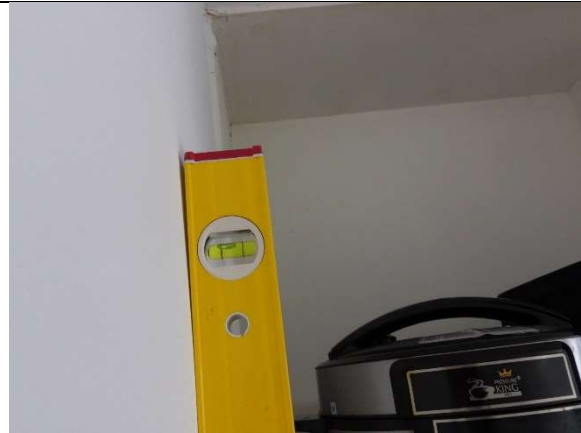
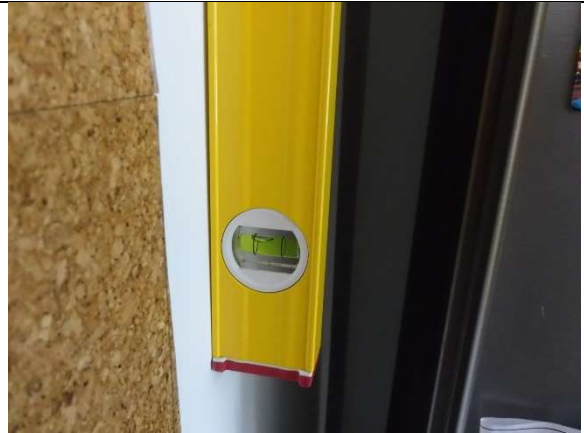
Kitchen – the walls are generally out of plumb, however, most of the surface finishes were not flat either. Note the gaps at the back of the level.

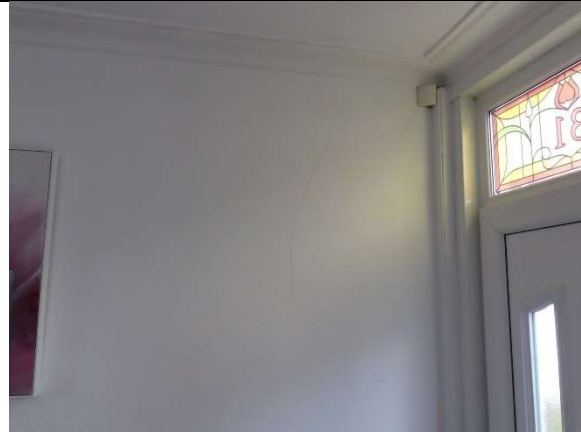
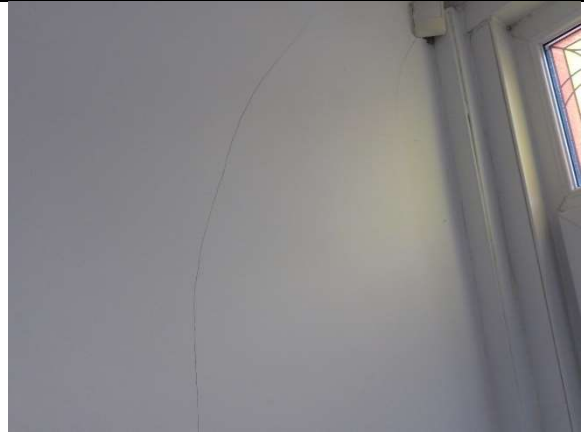
Living room – passageway wall – there were two areas of hairline cracking towards the front of the room. This may be as a result of the abovementioned cracked lintel or the material being very brittle and the house moving a little. The area should be recorded, repaired and monitored going forward.

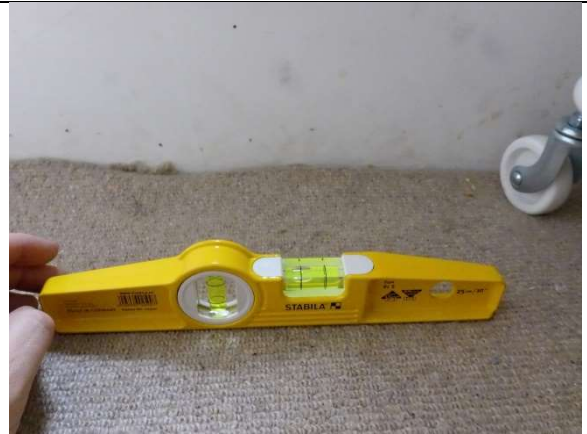
Landing – the floors are uneven front-to-back and side-to-side. Likely as a result of undersized timbers/missing noggins/reconfiguration and service penetrations.

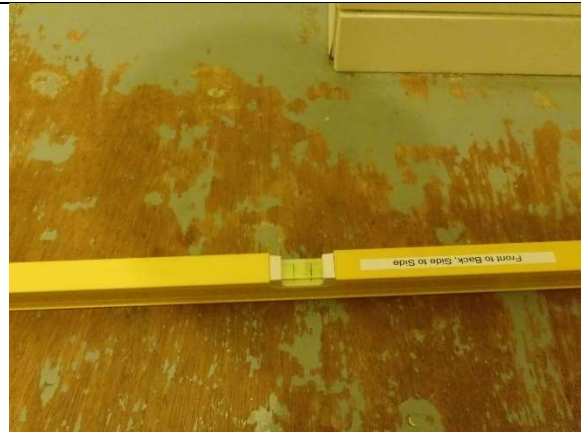
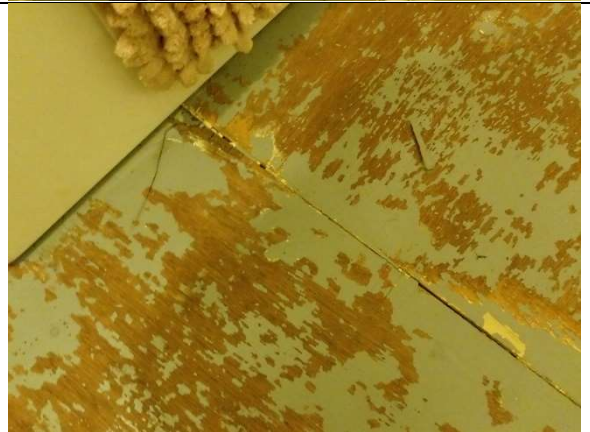
Bathroom – note that there is no floor covering down in the bathroom. The surface timber is moisture-damaged in places.

Ideally, there should be a water-impermeable covering down across the bathroom floor.

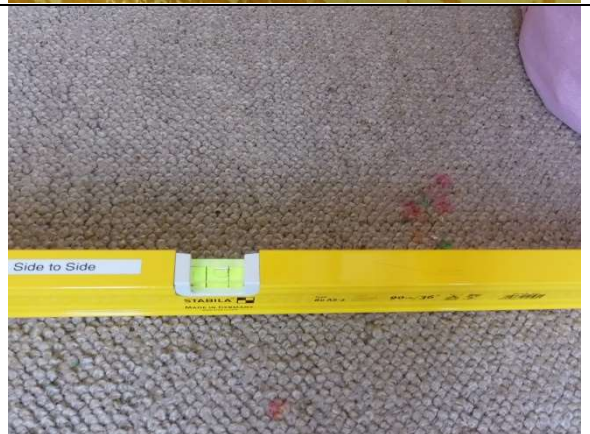
Front bedroom – the floor is slightly out of level side-to-side.

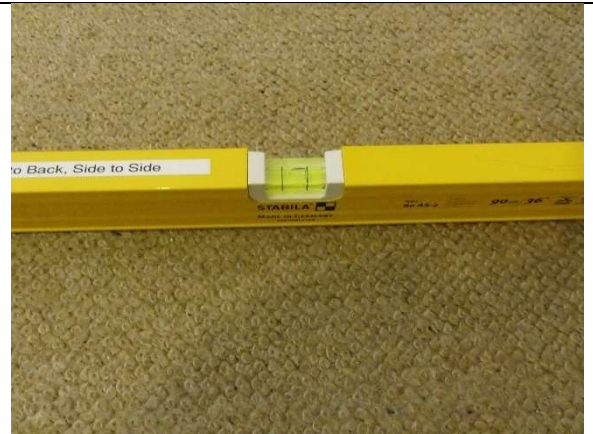
First-floor rear bedroom – the floor is slightly out of level side-to-side.

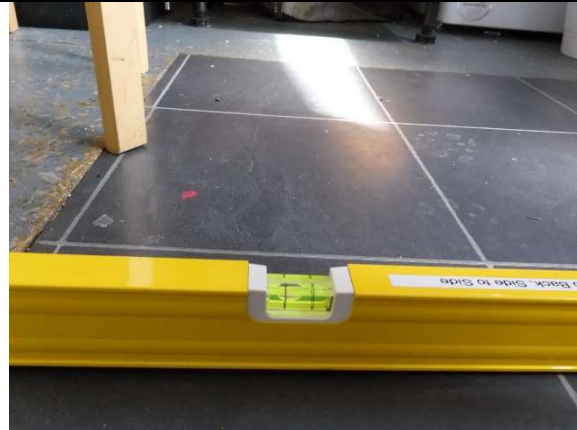
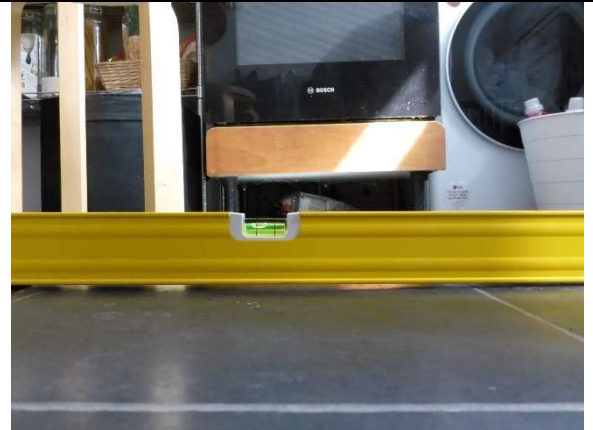
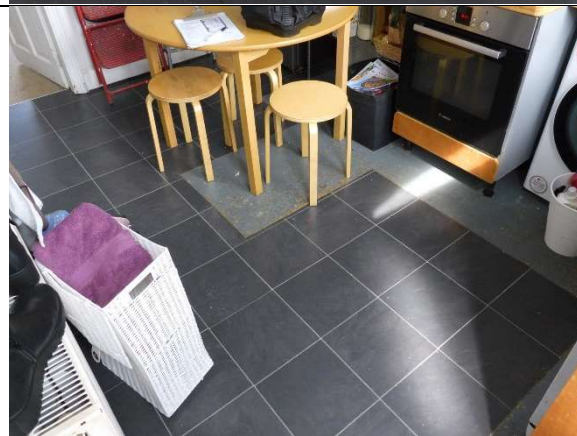
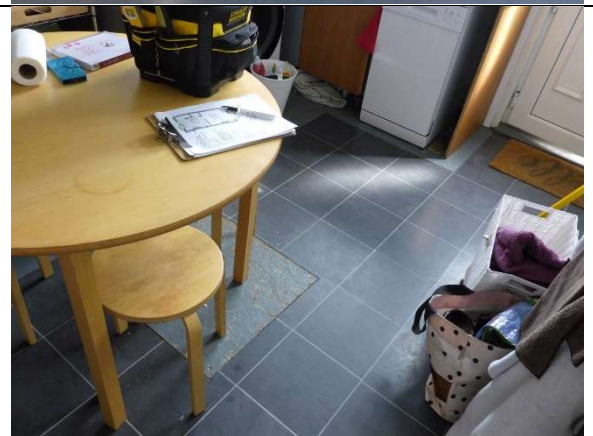
Kitchen – there are two types of floors in the kitchen – painted OSB/chipboard and laminate flooring.

The kitchen floor really needs an impermeable floor covering putting down on it. The floor is out of level and deflecting in areas front to back.

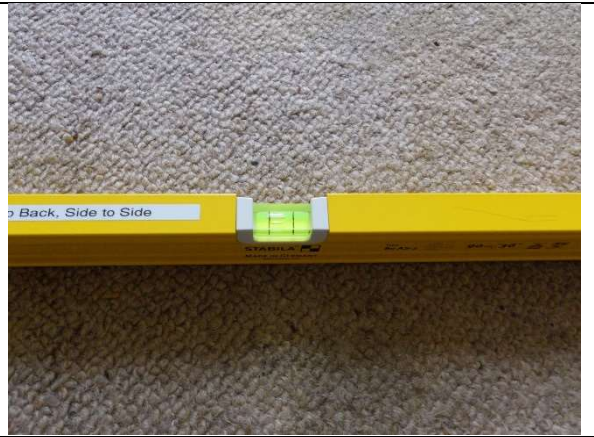
Living room – the floor was slightly out of level side-to-side.

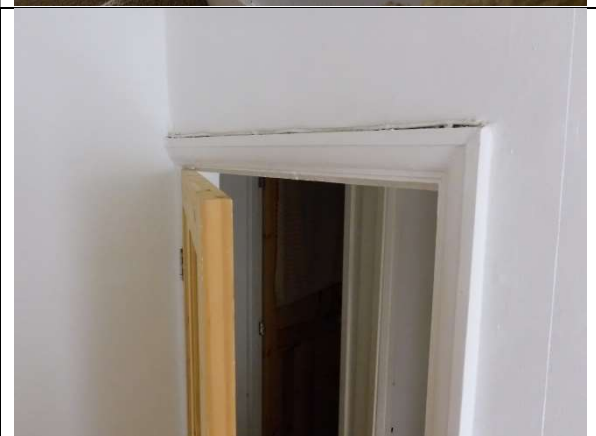
First floor landing up to attic room – there is no fire door/protected escape and the door does not sit square in the frame.

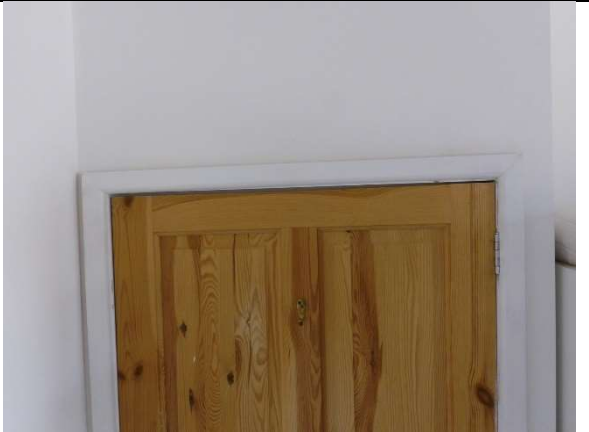
Front bedroom - the door is a little too small for the frame and there is a gap at the top.

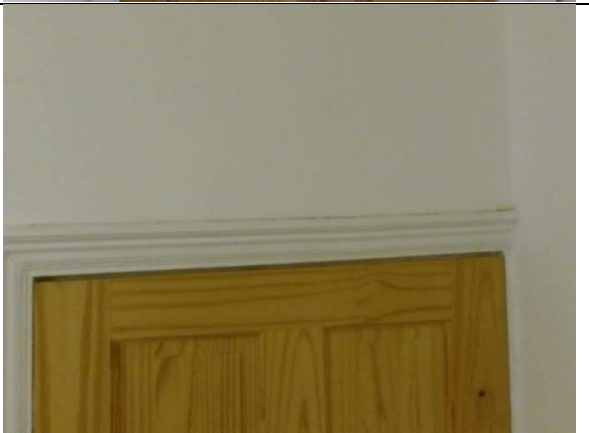
First-floor rear bedroom – the door is a little too small for the frame and there is a gap at the top.

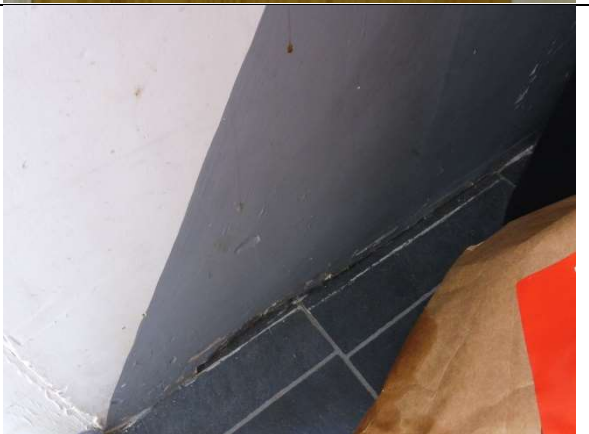
Ground floor – there is no skirting board around the bottom of the stairs.

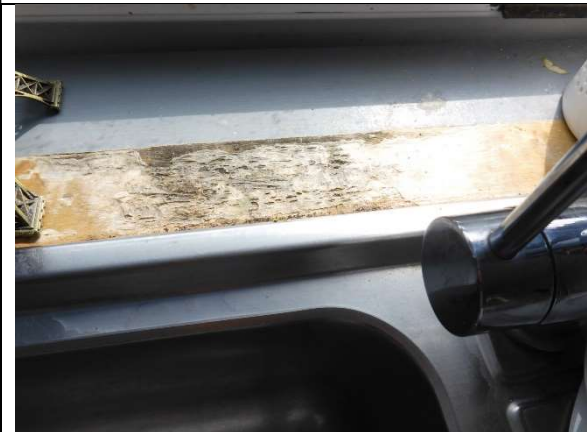
Kitchen – there are areas of water damage to the timber worktop. This should be rubbed back and treated.

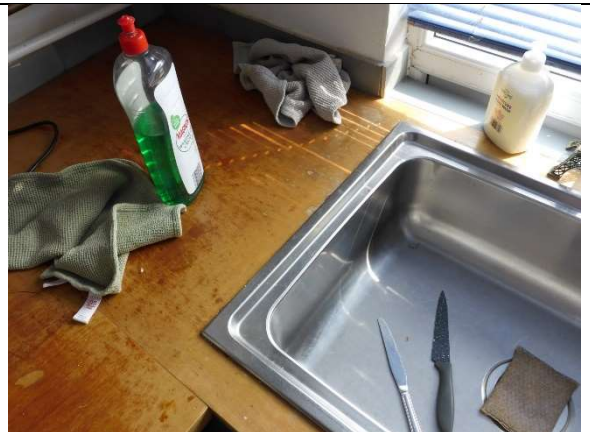
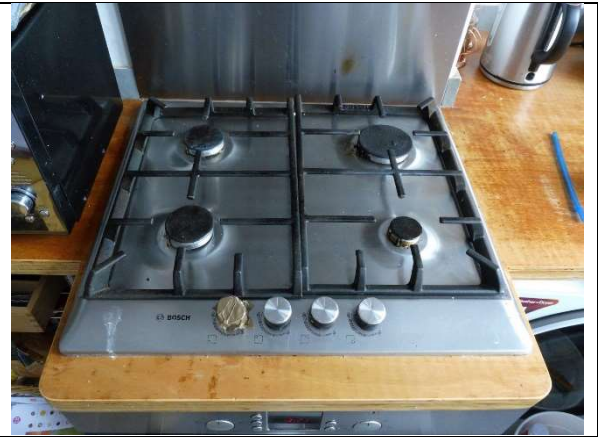
Kitchen – one of the hob burner controllers has been taped over.

This should be inspected by a suitable qualified gas engineer before use.

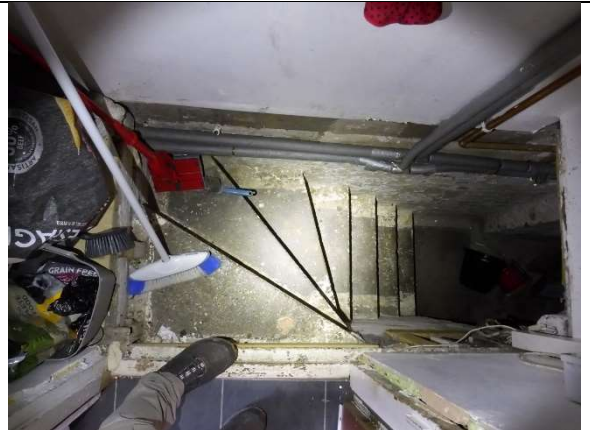
Note that the access stairs down to the cellar are steep and narrow.

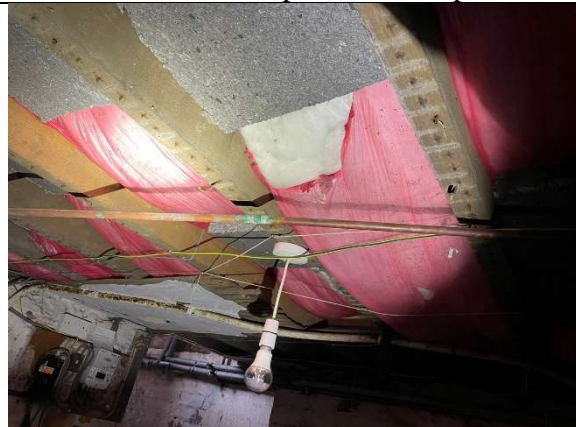
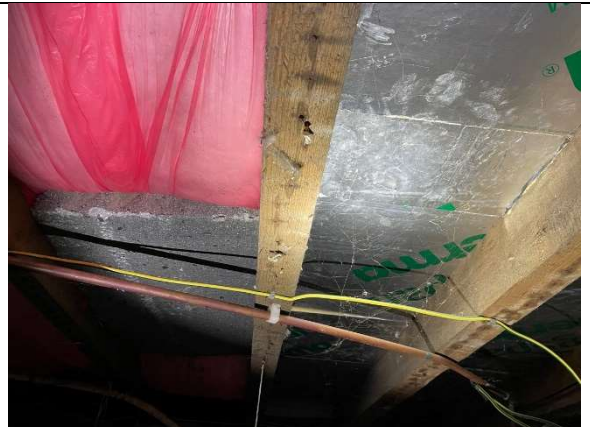
The living room floor/cellar ceiling joist bays have been insulated with several different materials including PIR board, polystyrene and some sort of blanket wrapped in plastic sheeting. These materials are inappropriate and have been pushed up hard against the underside of the flooring, with no ventilation gap (as specified in Building Regulations). We recommend that this insulation is removed and replaced with a more suitable product such as one hundred per cent sheep wool.

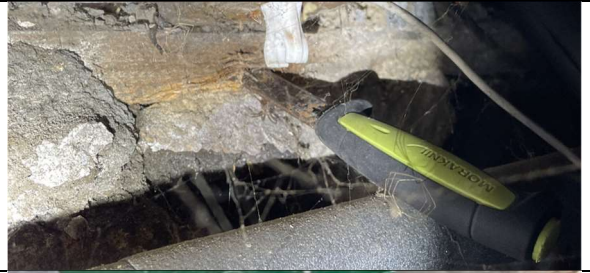
... other than the timber barer that some of the joists along the right-hand elevation sit on. This timber is softening and there is some minor decay. The debris around this needs to be cleared and the ventilation improved to give the timber a chance of surviving. If not, the floor will need to be propped and the timber bearer replaced.

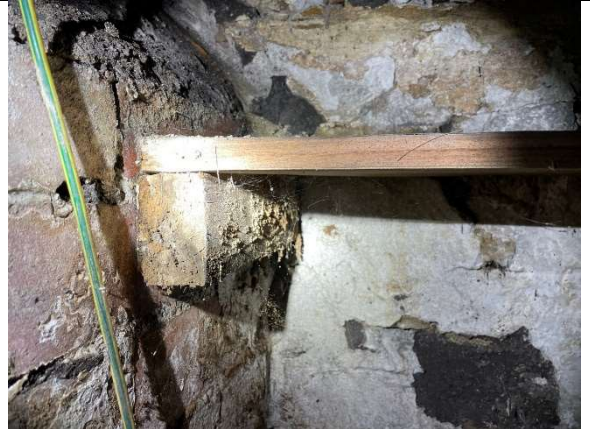
Example of timber decay to the shelving. We recommend these are removed.

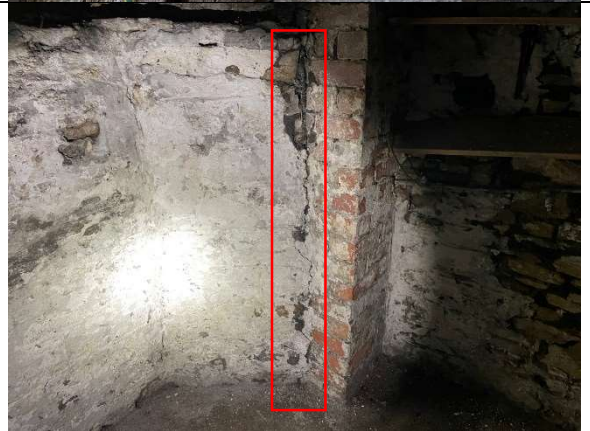
Left-hand side of the bay window – there is a small gap where the bay window and front elevation abut. This should be recorded and monitored going forward.

No repairs are required unless active movement is established, however, you may wish to tidy up the abutment by raking out and repointing.

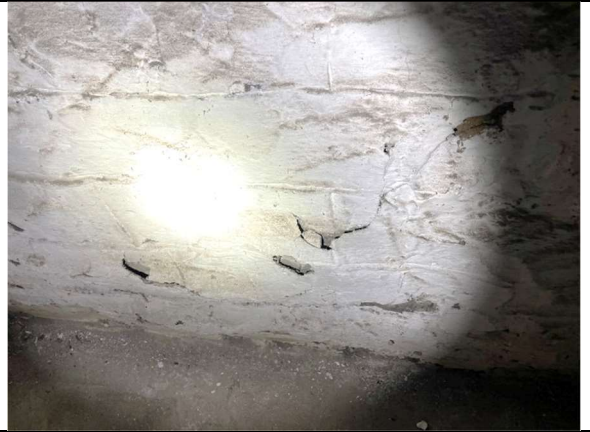
There are areas of damage to the surface coatings around the cellar.

Loose areas should be knocked off to prevent them from holding moisture.

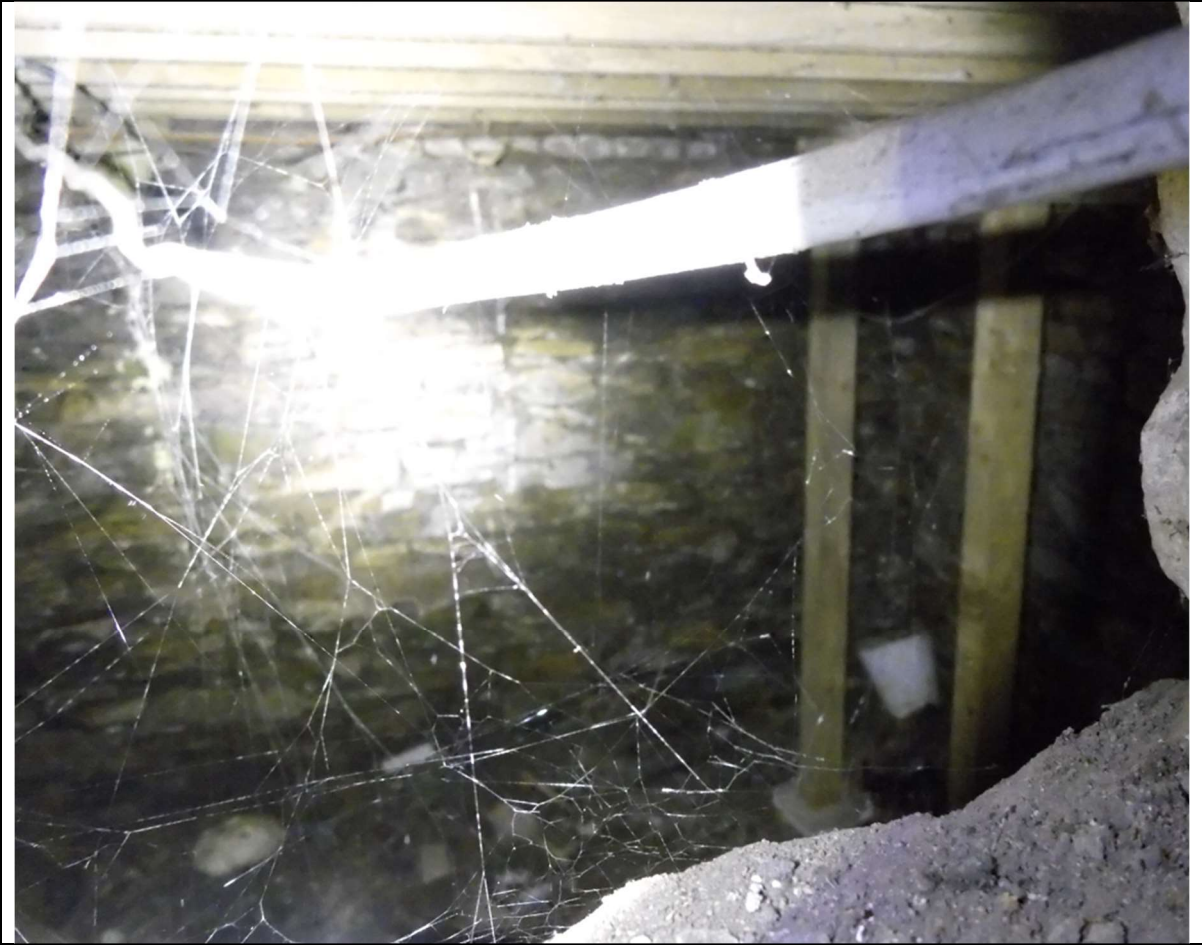
A photo taken of the sub-floor area under the kitchen (there was no access into this area). From what we can see, it looks like the floor structure has been rebuilt at some point.

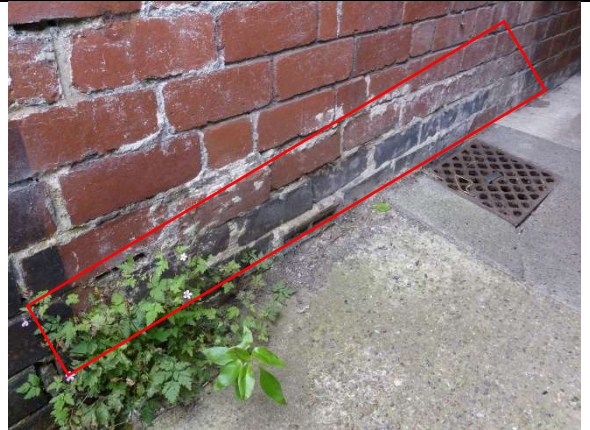
The front section of the passageway – an attempt has been made to retrofit engineering bricks, likely to act as a damp-proof course.

This work has been undertaken to a poor standard and a more sympathetic repair should be undertaken to this area.

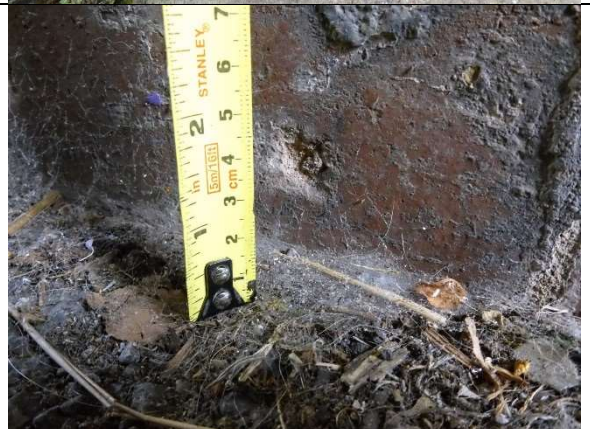
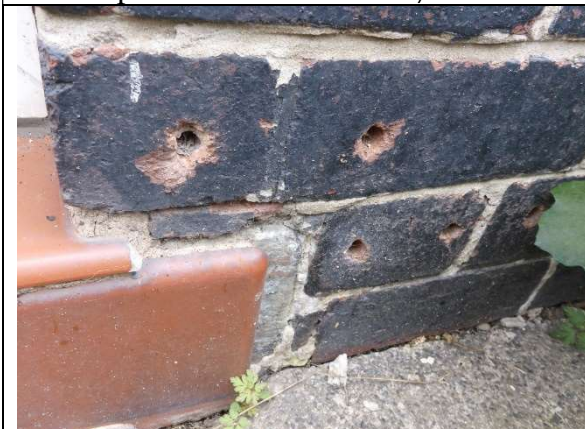
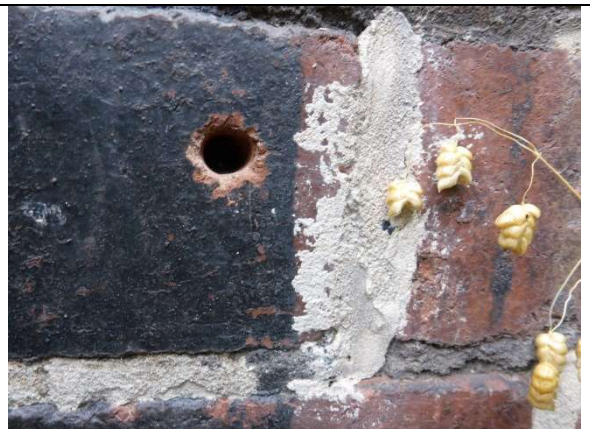
A retrofit chemical injection damp proof course has been ‘installed’ around the property. This has not been installed at the correct height – (it should be 150 mm above ground level, it is only 40 mm above ground level in places), it is bridged by the garden walls at the front and rear of the passageway and has been installed to a poor standard, damaging many bricks.

In the short term, the drill holes should be appropriately pointed up and the bricks repaired. See our comments on mortars and brick repair above in Section 1.7.

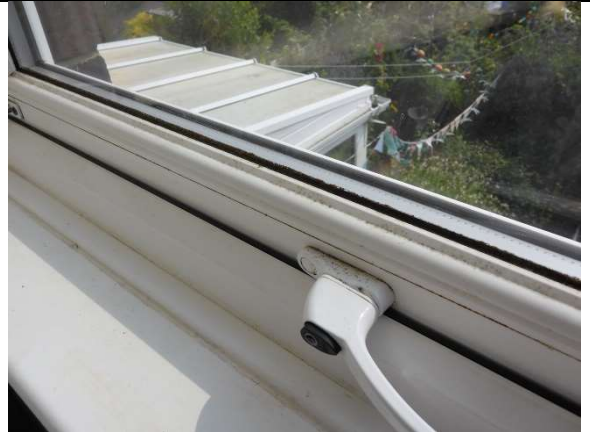
First floor rear bedroom – there is mildew building up on the window frame as a result of inadequate heating and ventilation.

Heating and ventilation should be improved in the short term.

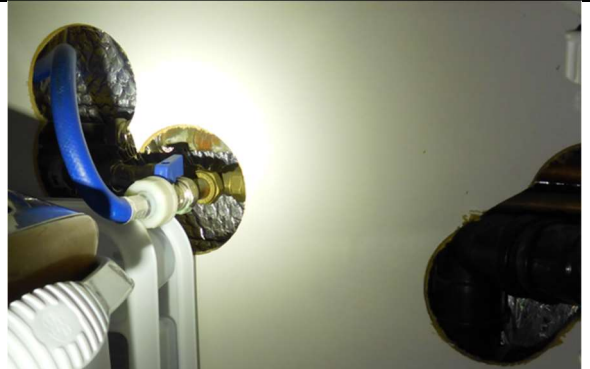
Kitchen – visible through holes in the back of the kitchen units is some sort of membrane on the internal leaf of the external wall.

This was likely added as an ill-advised ‘damp treatment’ and should be removed when the kitchen is next refurbished and the wall re-inspected.

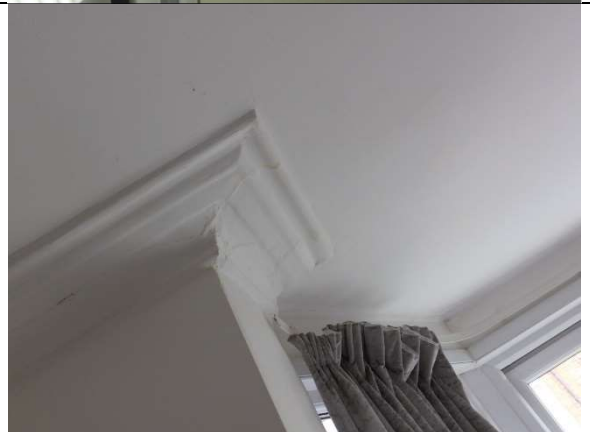
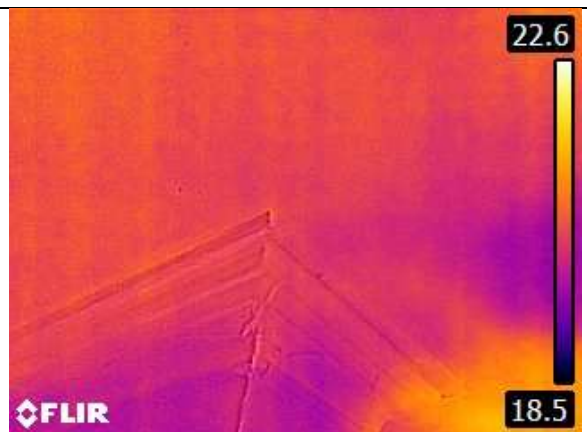
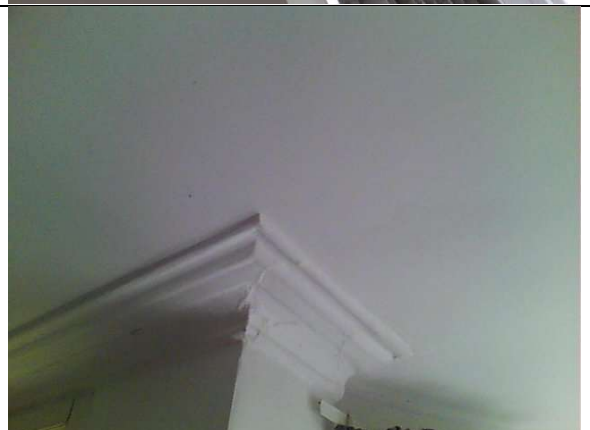
There is moisture-related damage in the area from the passageway wall to the right-hand edge of the bay window.

This could explain why the bay window has been altered.

There was nothing unusual on the thermal imaging at the time of our inspection.

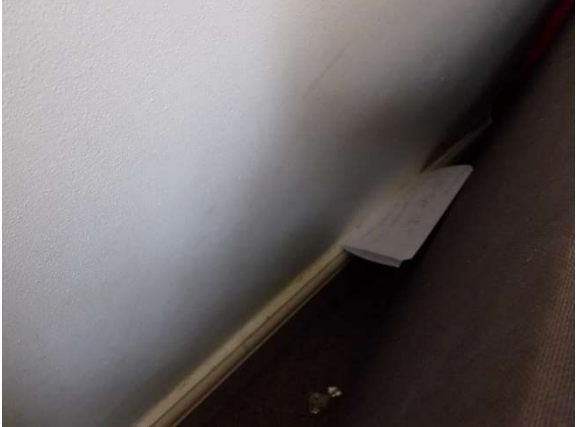
| <p>Front bedroom – the fireplace has been removed and the flue blocked up. This should be appropriately ventilated in the short term.</p> | |

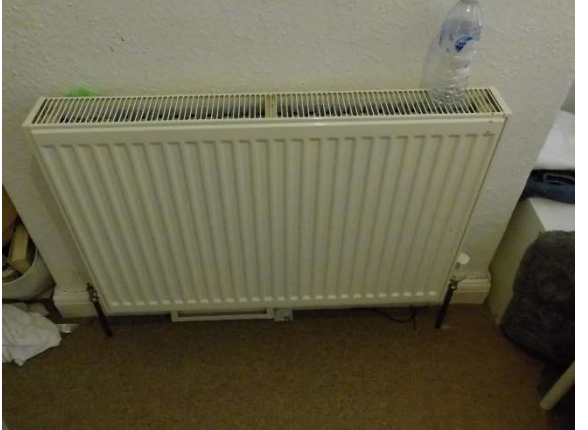
| <p>First floor rear bedroom – the fireplace has been removed and the flue blocked up and a radiator placed over.</p> <p>This should be appropriately ventilated in the short term.</p> | |

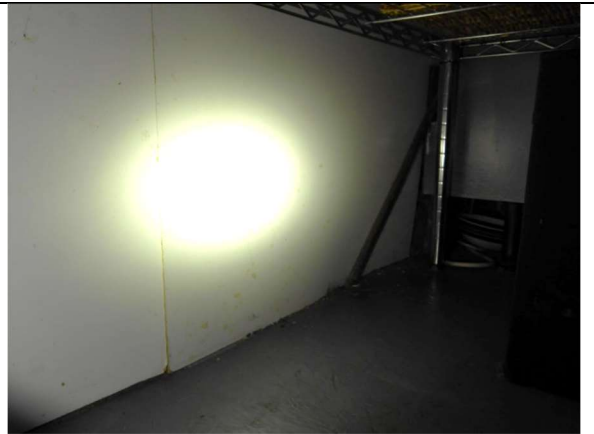
Kitchen - the fireplace has been removed and the flue blocked up.

The redundant flue should be appropriately ventilated in the short term.

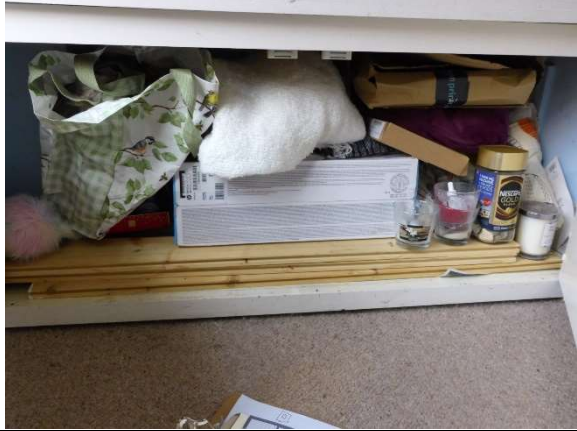
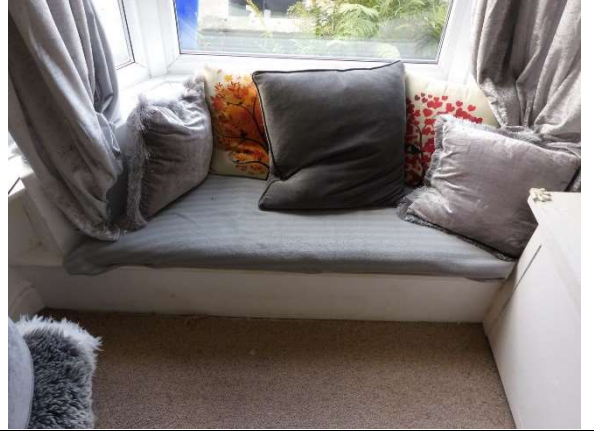
Living room – the built-in window seat and cupboard should both be adequately ventilated into the room/cellar.

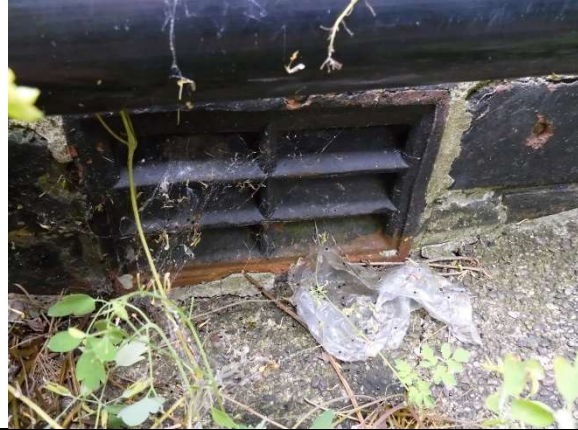
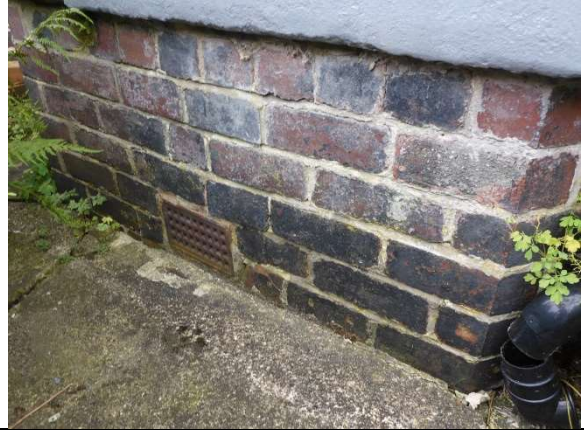
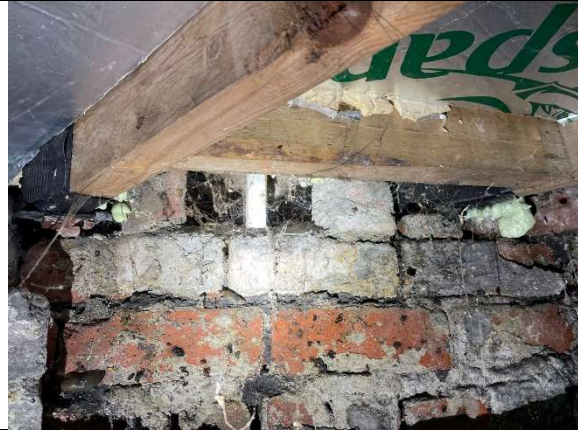
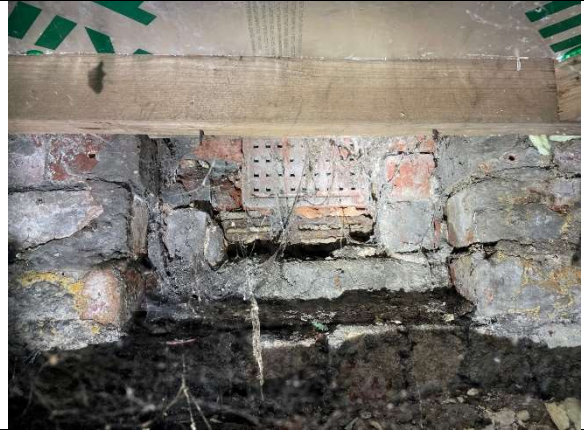
The two sub-floor vents in the bay window need to be cleared of debris to improve their efficiency in the short term. The vents are in the photos below, external and internal.

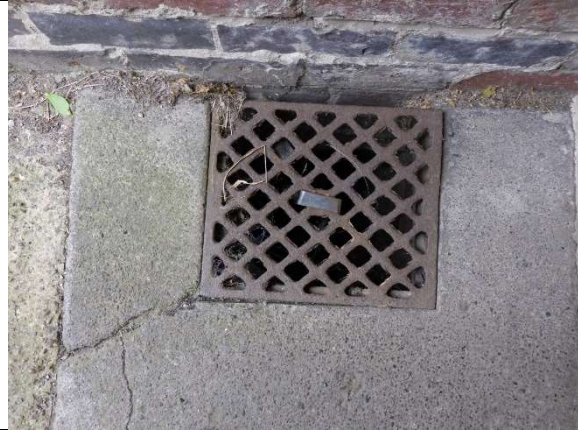
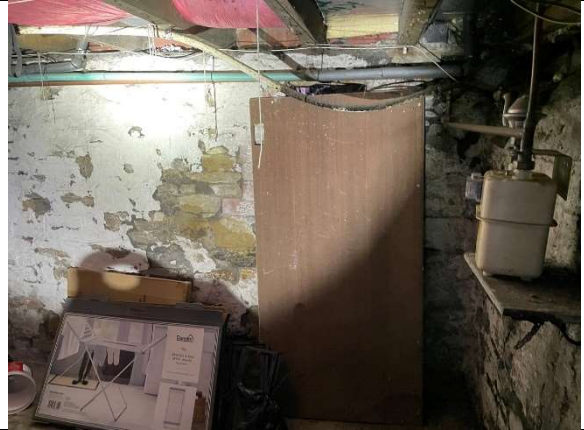
The coal hole vent has been blocked by a door. This should be removed and the vent cleared of debris to improve its efficiency in the short term.

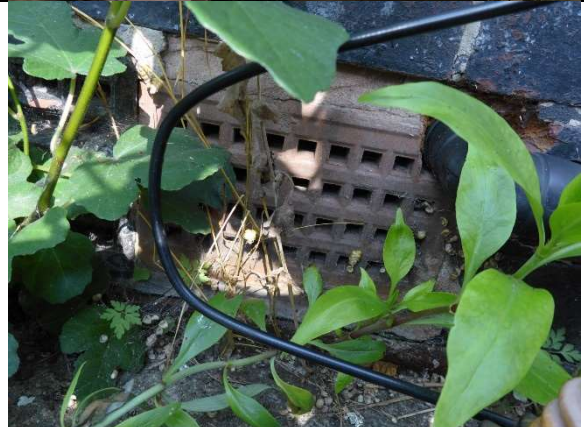
Rear elevation – the sub-floor ventilation brick in the rear elevation is blocked by a plant.

The plant should be removed and the vent cleared out as soon as possible.

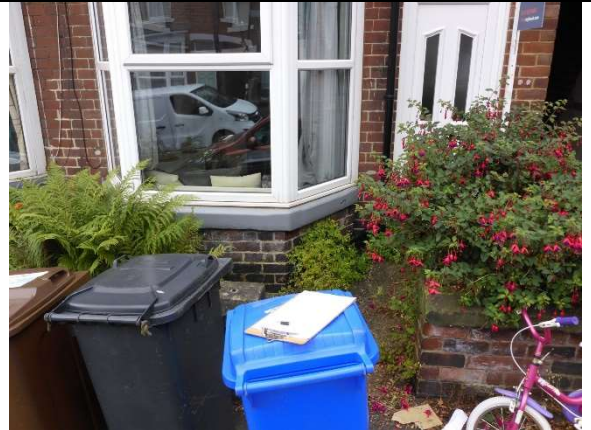
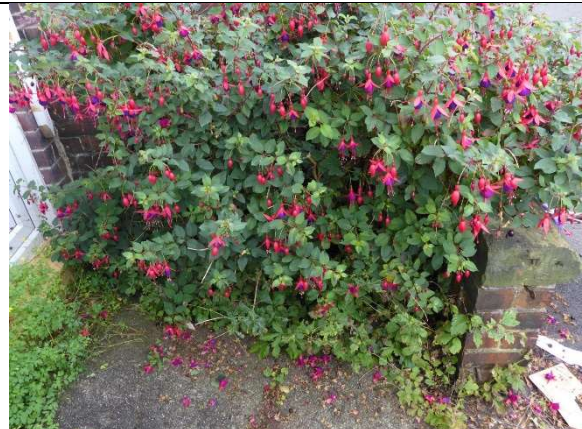
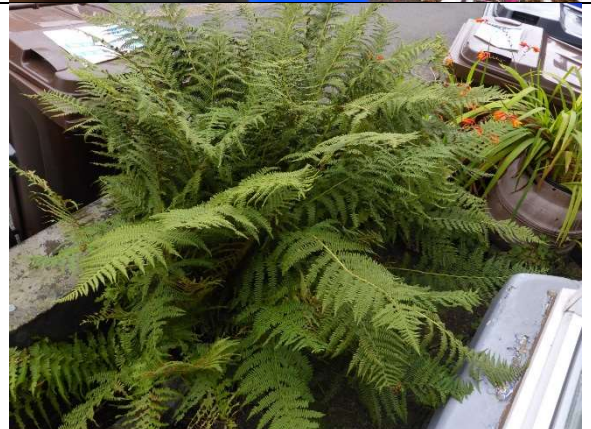
Front garden walls – there is damage to the stone coping stones, the front and return walls are not plumb and there are areas around the top courses that are displaced.

At some point, some localised rebuilding of these walls will be required.
