Level 3 Building Survey

Report prepared by Simon  
Hollis MRICS

31<sup>st</sup> August 2023

## Building Survey Report

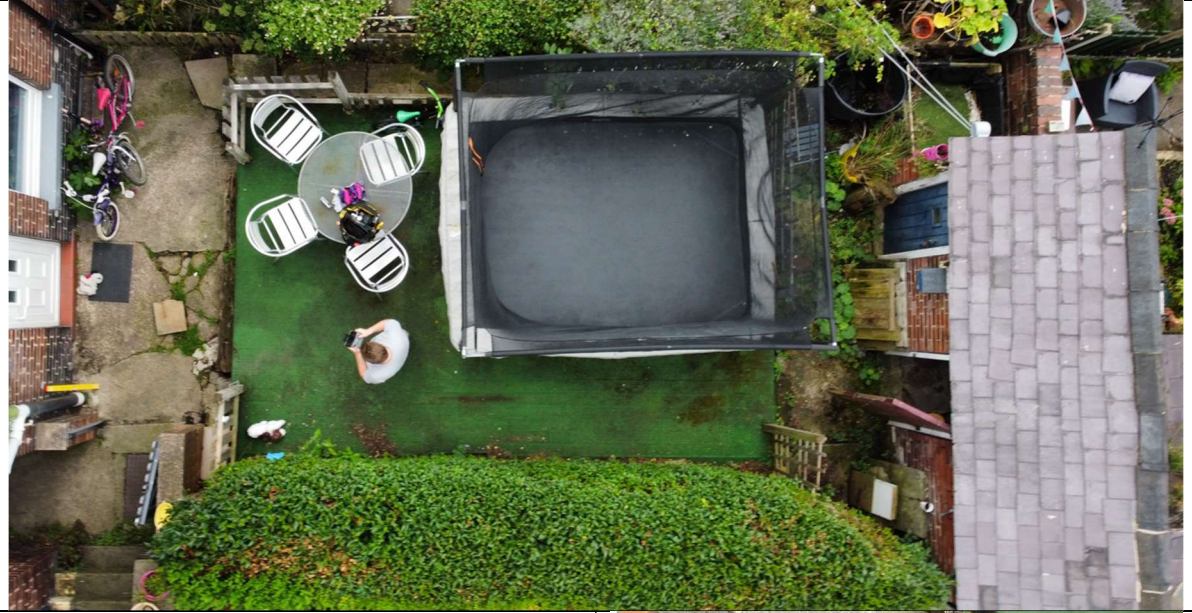
Overhead photo of the rear garden.

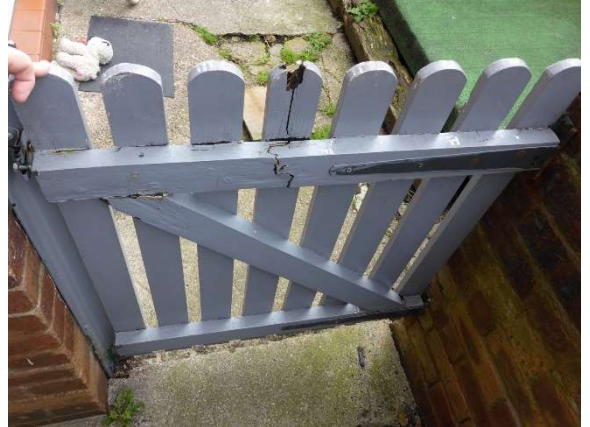
The gate into the garden is damaged and needs to be repaired/replaced.

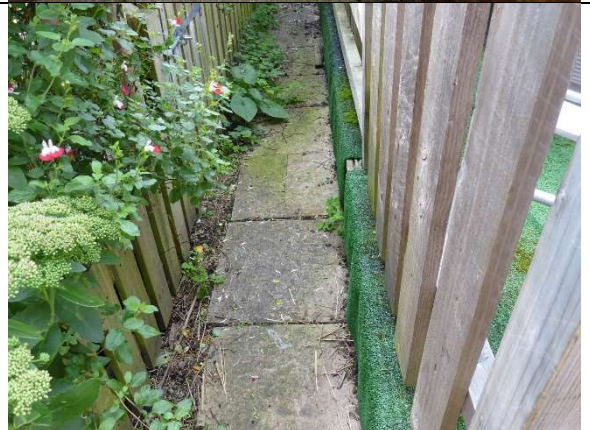
Left-hand side path – there are several damaged paving slabs along this path. These should be replaced in the short-medium term depending on if the pathway will be used.

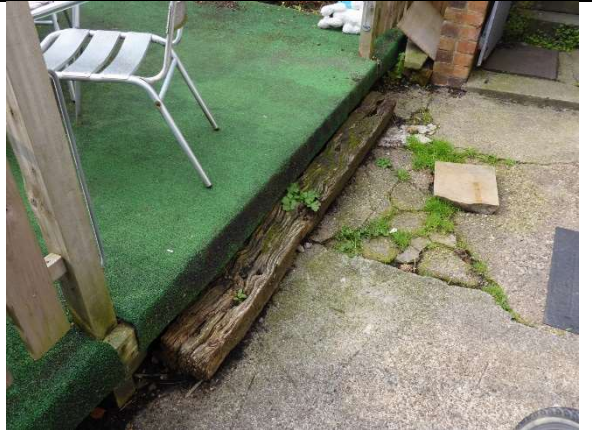
The step up to the deck area is decaying and will need to be replaced if the area is to be used safely.

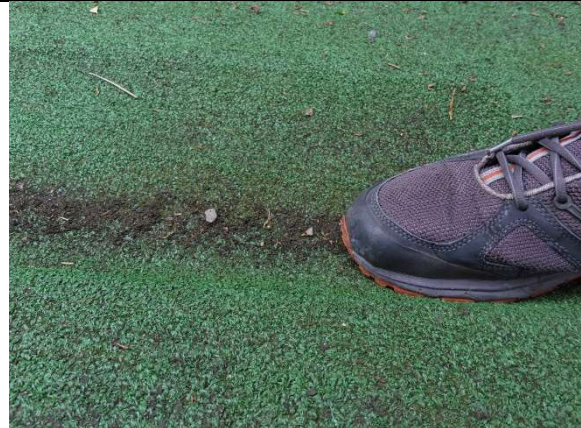
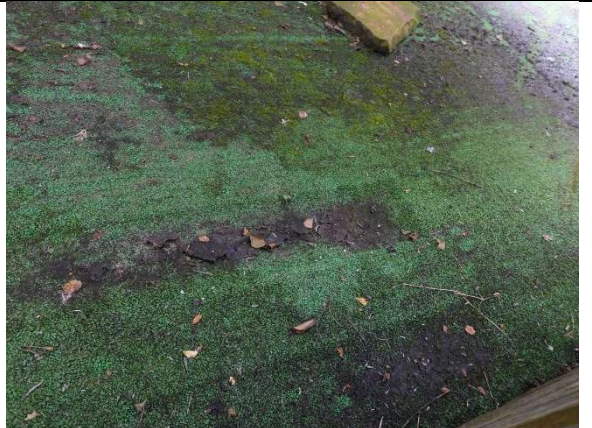
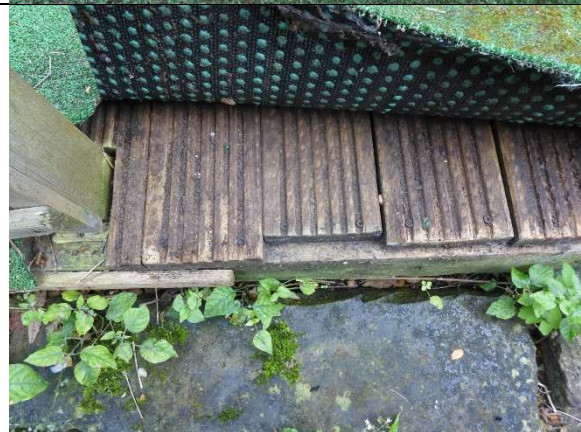
The decking and associated fencing and imitation grass are in poor condition. Several areas of the decking are unsafe to walk on, however, we have not been able to properly ascertain the condition of all the decking as the imitation grass is mechanically affixed down in most areas.

Works to make the decking and fencing safe should be undertaken before the area is used on a regular basis.

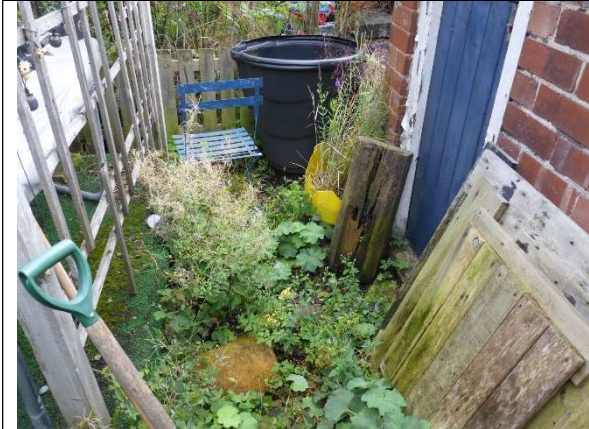
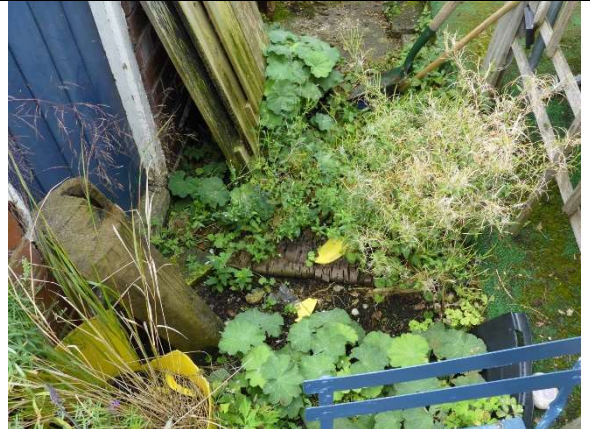
Debris restricted our inspection of the rear right-hand corner of the yard area. This should be cleared and disposed of.

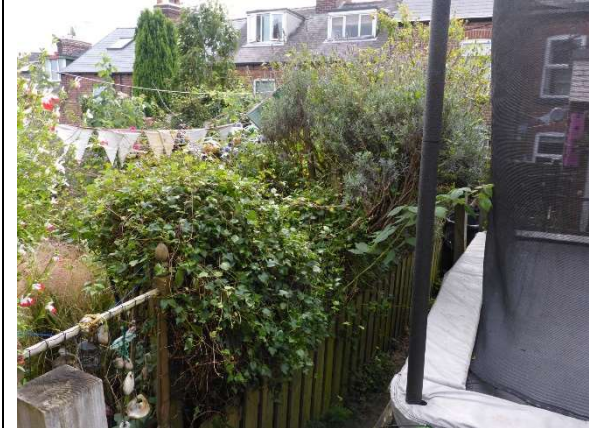
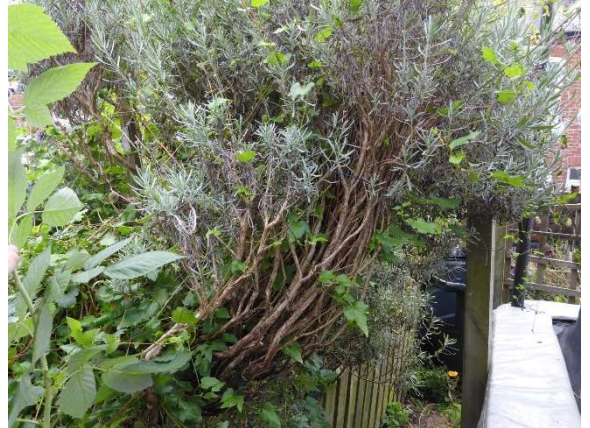
Along the left-hand boundary, there are plants growing over from the neighbouring garden.

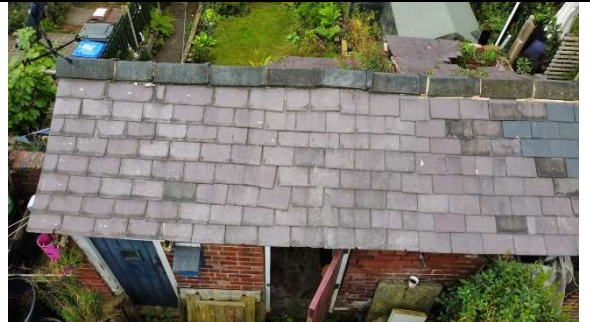
Outhouse roof – there are several slipped slates and the ridge needs to be repointed.

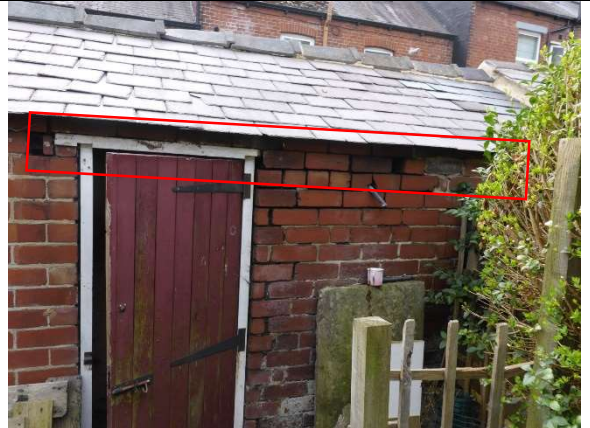
Note that there is no guttering on the outhouses. We recommend that guttering is added before winter and that the fall pipe is directed into the mains drainage or a suitably located soak away.

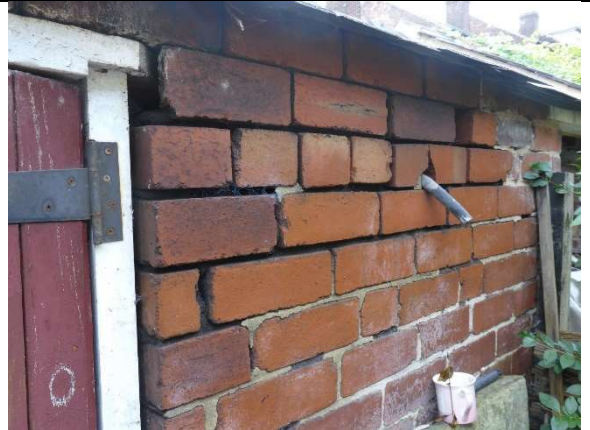
There are areas of the wall where the pointing has washed out.

These areas should be properly raked out and repointed.

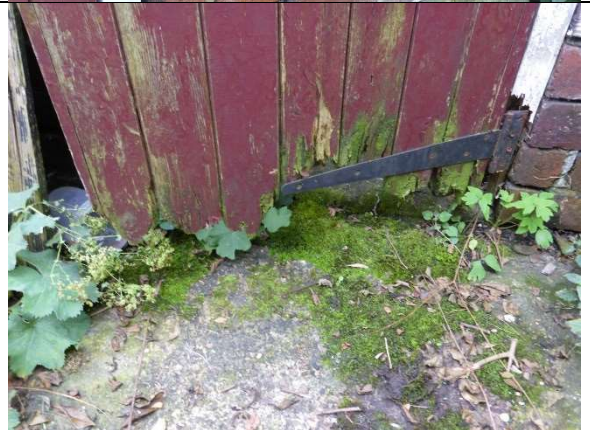
The lower section of the right-hand door has been lost to decay and needs repairing/replacing.

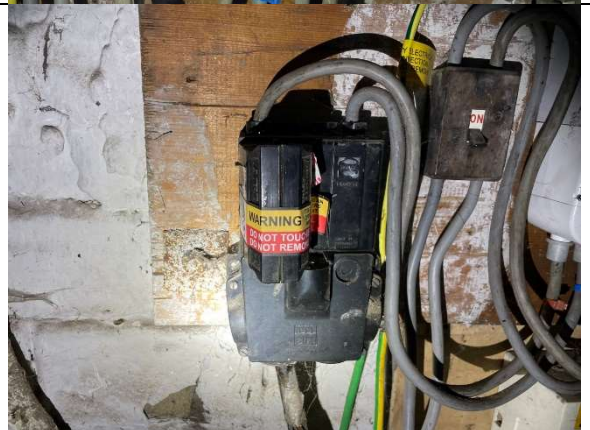
The main incoming fuse does not have a sticker stating the ampauge of the incoming supply.

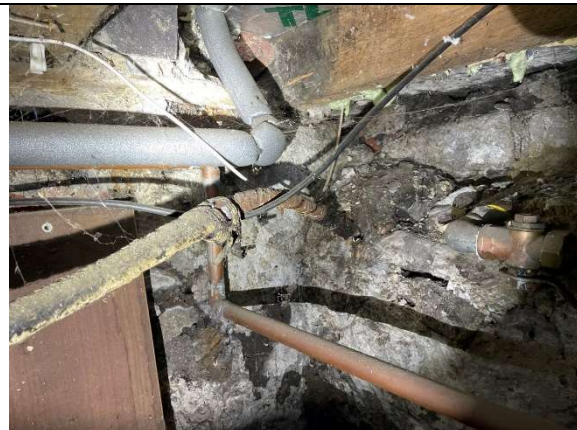
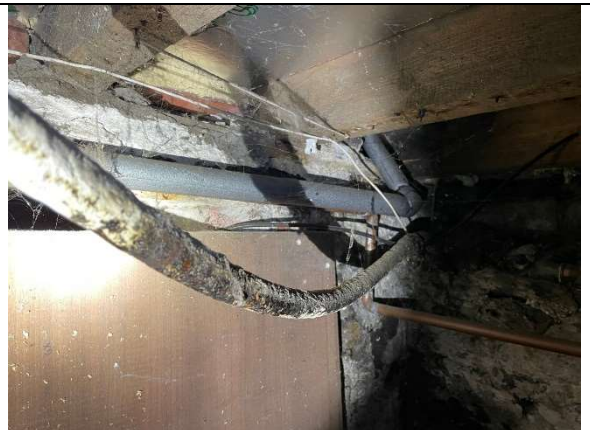
The sheath around the incoming mains supply is in poor condition and is inadequately supported.

The cable should be inspected by the electricity distributor and properly affixed in the short term.

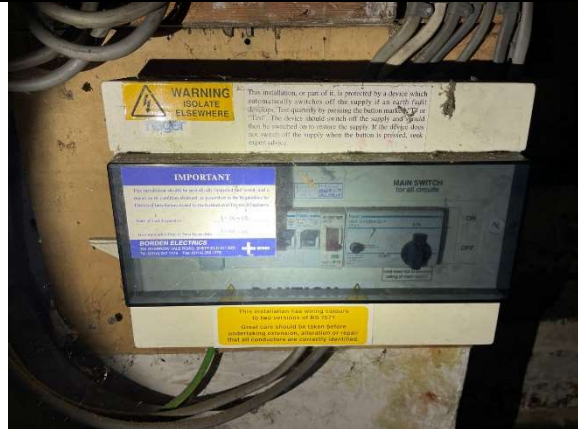
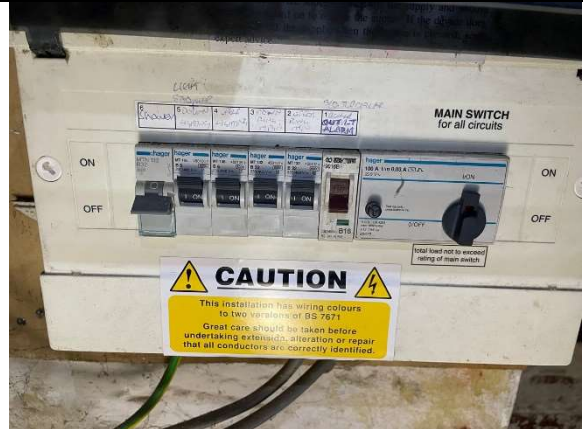
The distribution board is located on the rear wall of the cellar. There is a sticker stating that the next service was recommended on 1<sup>st</sup> October 2015.

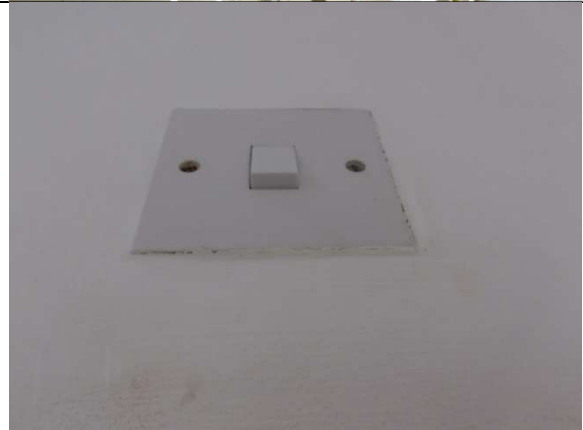
An example of where a backbox and face plate have been plastered right up to.

This is poor practice.

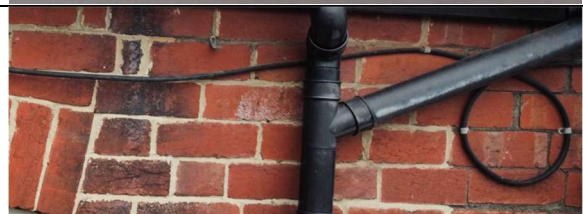
The original redundant electricity supply is affixed across the rear of the property.

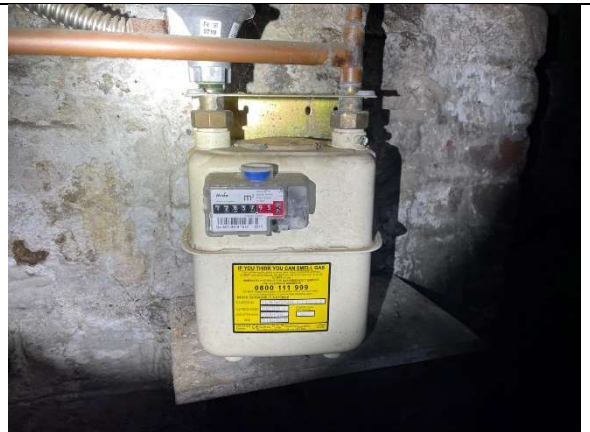
The brackets under the gas meter are corroded and may need to be replaced.

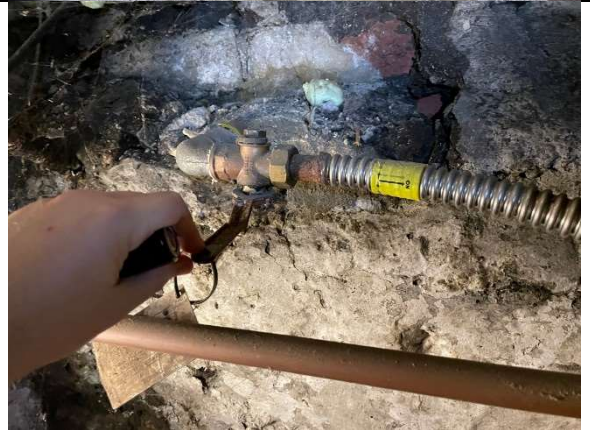
The bar isolator moved freely at the time of our inspection.

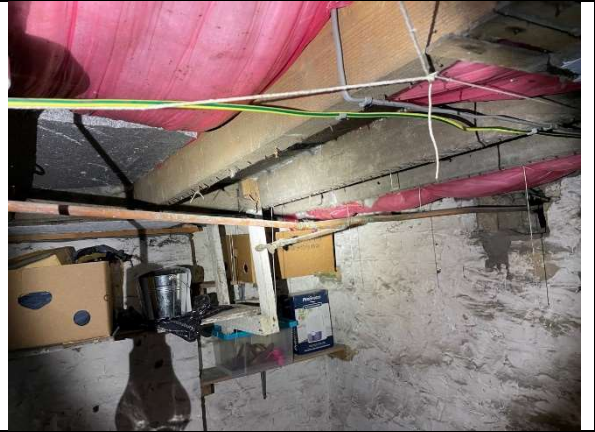
The gas supply to the living room hearth and the kitchen is not properly supported.

Additional pipe clips should be added in the short term.

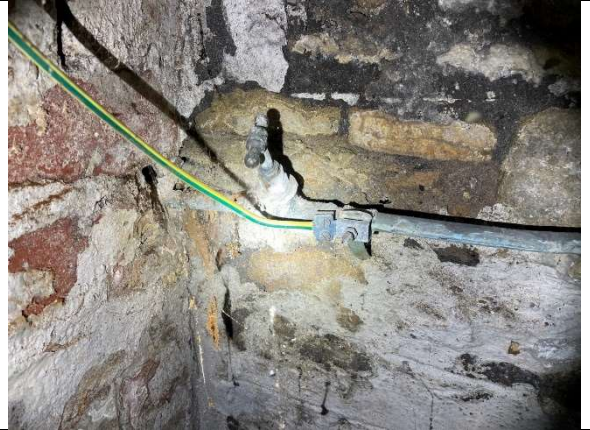
We could not get the stop tap to turn freely and recommend that this is addressed as soon as possible in case it is needed in an emergency.

We recommend that this is clearly labelled and that occupants know where it is in case of emergency.

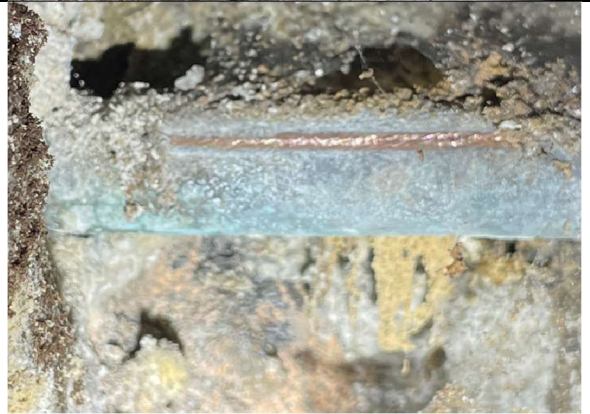
The vendor advised that they are on a Ratable Value for their water as opposed to a meter. The incoming supply pipe is copper which is unusual – we would expect this to be lead or MDPE. This should be checked by the water distributor – Yorkshire Water.

Scratch test for copper.

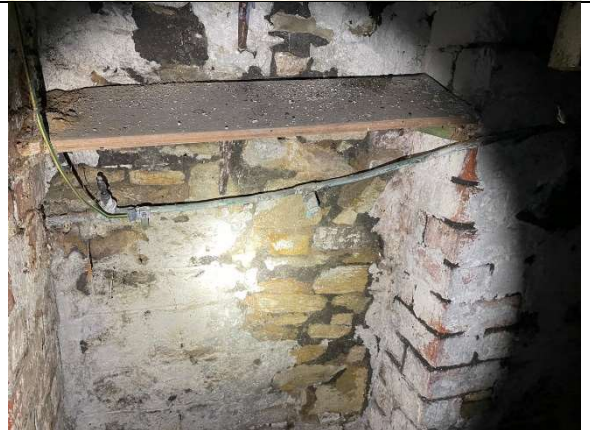
The water supply pipe is inadequately supported. Additional pipe clips should be added in the short term.

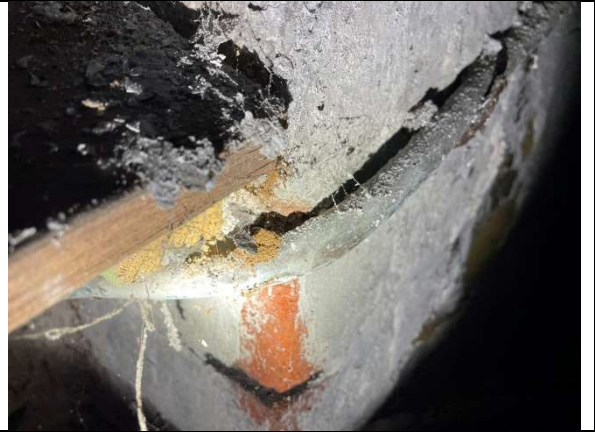
The supply pipe is crushed where it goes around the chimney breast – this should be addressed in the short term.

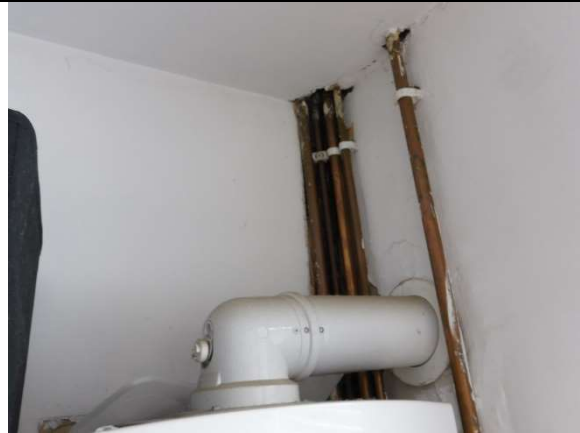
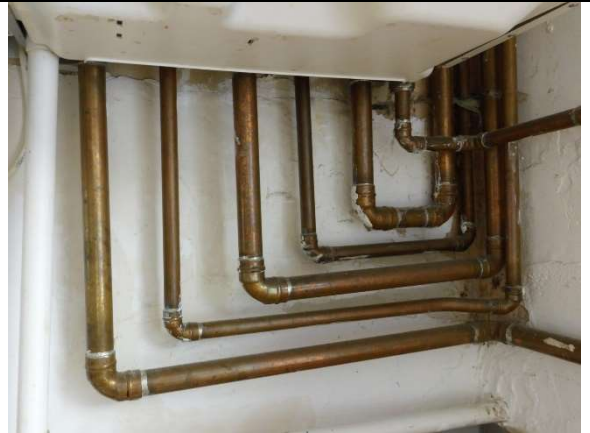
Combination boiler – Worcester Bosch Greenstar 30SI in the kitchen. There were no service stickers or a commissioning certificate on/around the boiler.

There was no CO2 detector near the boiler (or wood-burning stove).

Note that none of the pipework we could see has been insulated. We recommend pipework be insulated to improve efficiency.

Your legal advisor should obtain service records for the stove and boiler and we recommend CO2 detectors are added in both rooms following the manufacturer's instructions.

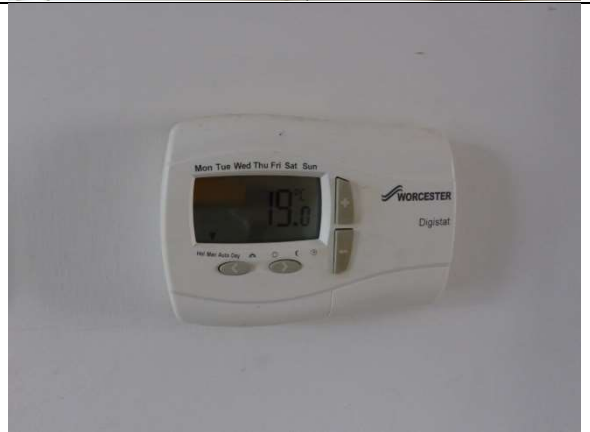
The thermostat and programmer on the wall in the kitchen.
