**Is there confusion within the surveying profession about the  
existence of rising damp and is the correct advice being  
given to homeowners?**

Submitted in partial fulfilment of the requirements for the degree of MSc Building Surveying at  
Sheffield Hallam University

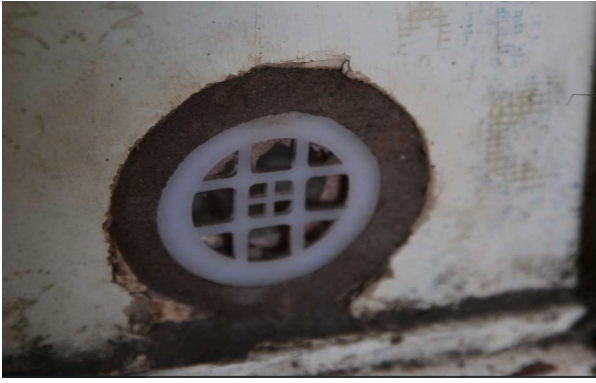
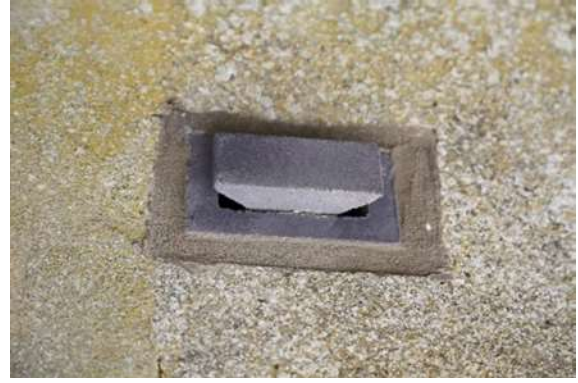
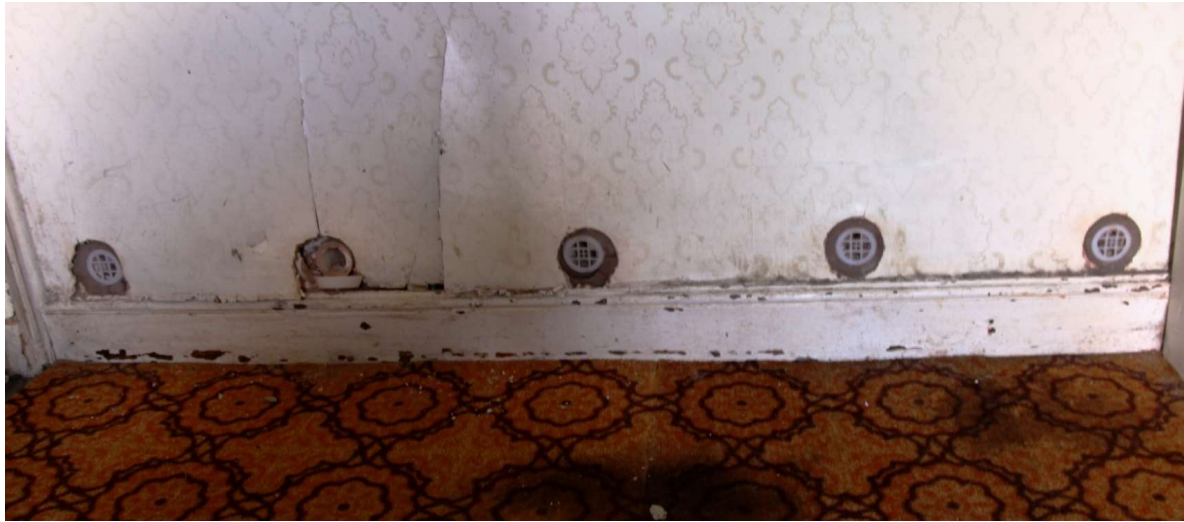
Fig. 9 – Photos of evaporation systems (photos used with permission from Heritage House).

These systems go under several names, for example, The Schrijver System, Wallguard, Knappen Tubes and Holland Damp Proofing, although the latter company was dissolved in December 2016 (<https://beta.companieshouse.gov.uk/company/03880387>). Interestingly, the Director, Evert Frederick De Graaf, is also the Director of Schrijver Systeem Damp Control UK Limited. As the evaporation systems are lesser known, some photographic examples of the different systems are shown in Fig. 9.

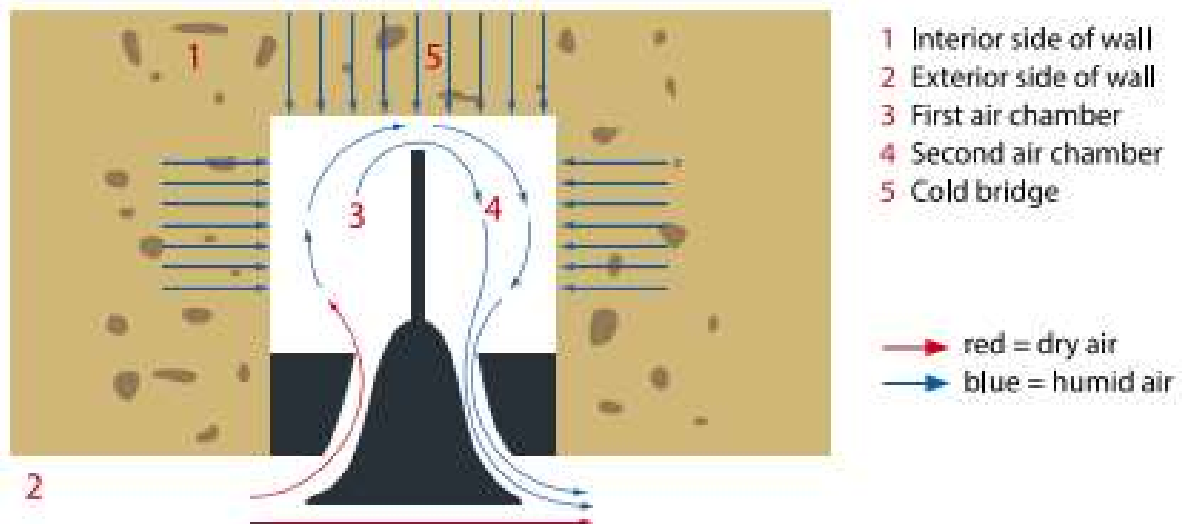
Fig. 10 – How it works - Schrijver System.

This system is described by the manufacturer as a *'natural and permanent solution to problems caused by rising damp and condensation and removes any excess moisture from the building.'* The theory behind the systems is that moisture will be drawn to the various different types of ceramic brick/tube and then evaporate out leaving the house dry (as seen in Fig. 10). The theory sounds plausible; however, the tubes are bedded in cement which as it is impermeable, does not allow water to travel through it.

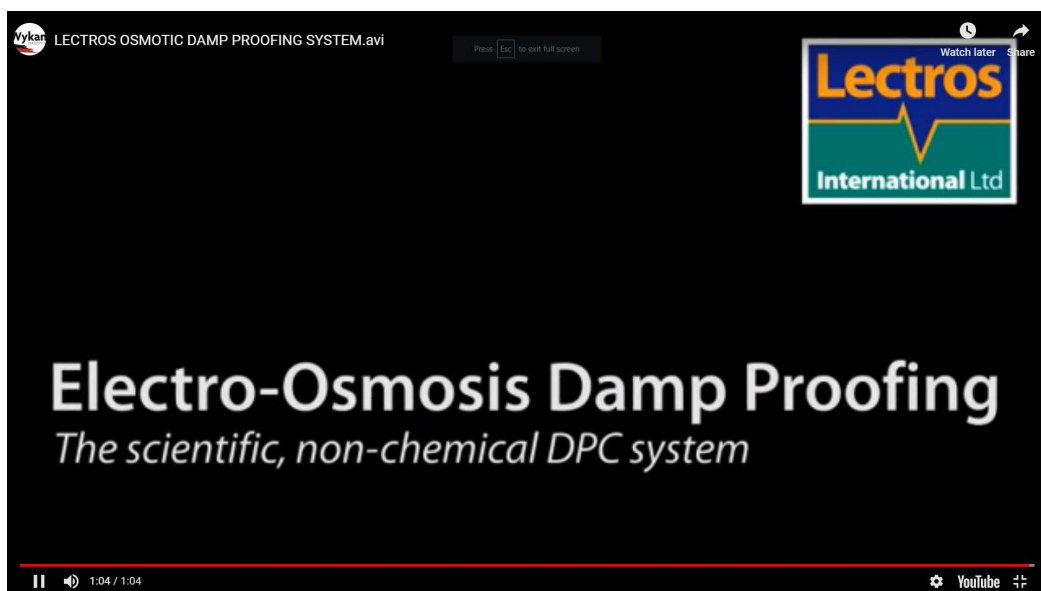
Fig. 12 – Scientific claims made by Lectros International Limited.

To say that they are the manufacturer and retailer of this system, there is very little information on their website as to how the system works, save for a silent video (screenshot shown in Fig. 12) which is almost childlike in its simplicity and shows a wire being attached to a wall, and connected to an earth rod which then draws water from the base of the wall towards it. The video does, however, describe the system as scientific but offers nothing to back this up. The manufacturer also produced a brochure (Lectros, 2010) referring to the system as scientific.

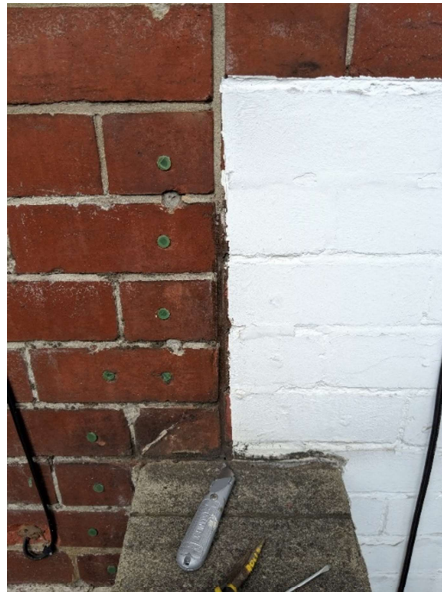
Fig. 15 – Pointing to the party wall above the front LHS boundary wall.

There was an area of missing pointing on the party wall. Rain has been bouncing up off the coping stone onto the mortar joint, and this has gradually eroded the pointing. A temporary fix was carried out by filling the joint with silicone after a prolonged period of dry weather.

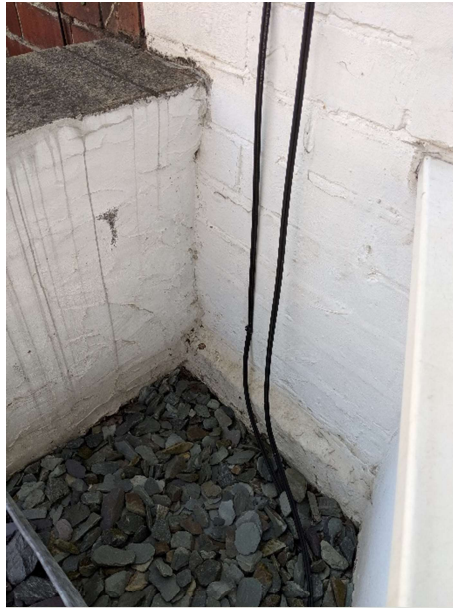
Fig. 16 – The LHS front boundary wall abuts the front elevation.

The boundary wall abuts the front elevation (Fig. 16). When water gets down the back, it has no way to escape and thus can cause areas of penetrating damp. There is no quick fix to this problem. The most efficient way of mitigating this problem would be to ensure that the pointing is sound where the coping stone meets the front elevation and to drill some weep holes near the bottom of the wall to ensure that trapped moisture can escape.

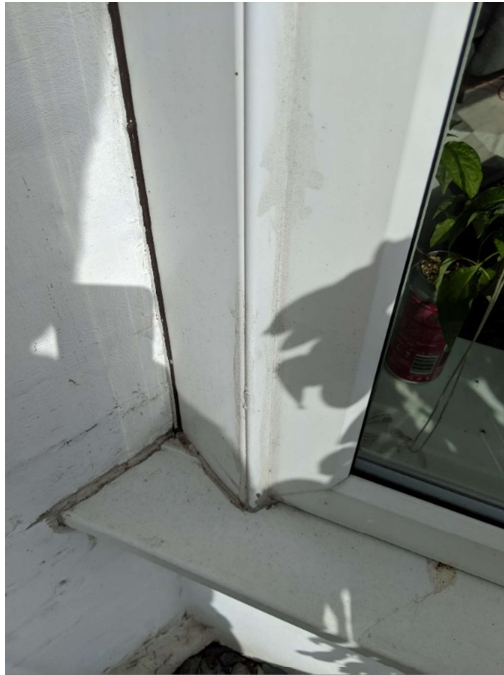
Fig. 17 – uPVC window trim.

The original timber casement bay window has been replaced with a uPVC one. To keep the installation weathertight, it was necessary to use uPVC trim bar (Fig. 17). These trim pieces are affixed with dabs of silicone and then sealed with silicone around the edges. Silicone is prone to UV degradation (GCRIO, (n.d.)) and can dry out and shrink/crack. This happened on the subject window, leaving the bottom piece of trim loose, and no longer preventing weather ingress behind the frame. This was remedied with a cartridge of silicone.

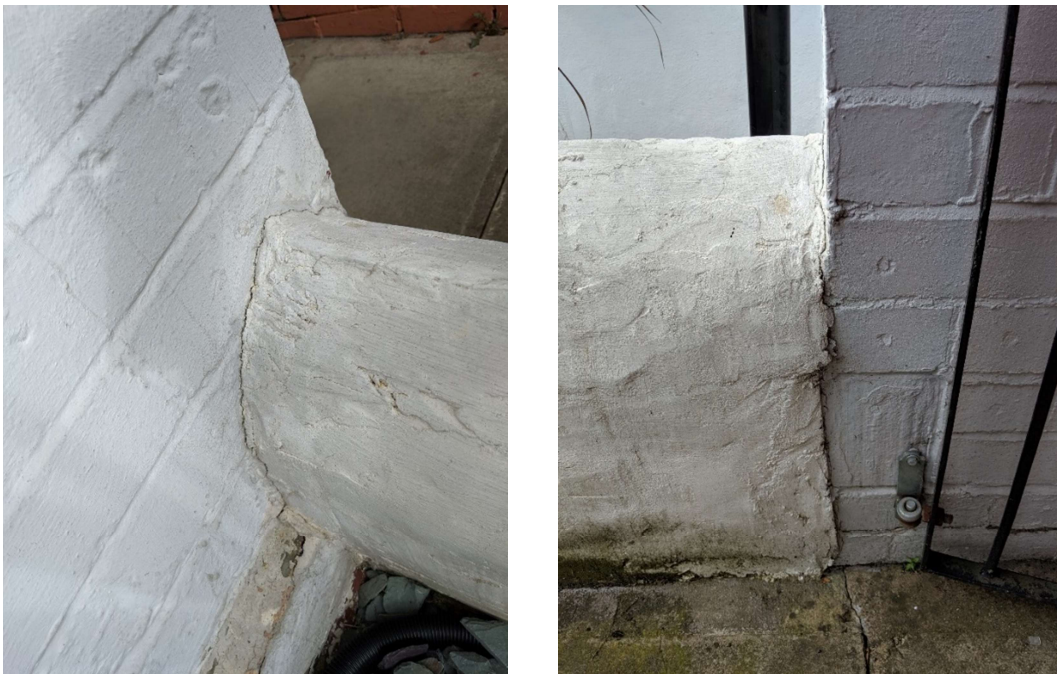
Fig. 18 – The RHS front boundary wall abuts the front elevation.

Fig. 18 shows the abutment detail, the defect is as per the Left-Hand Boundary wall above.

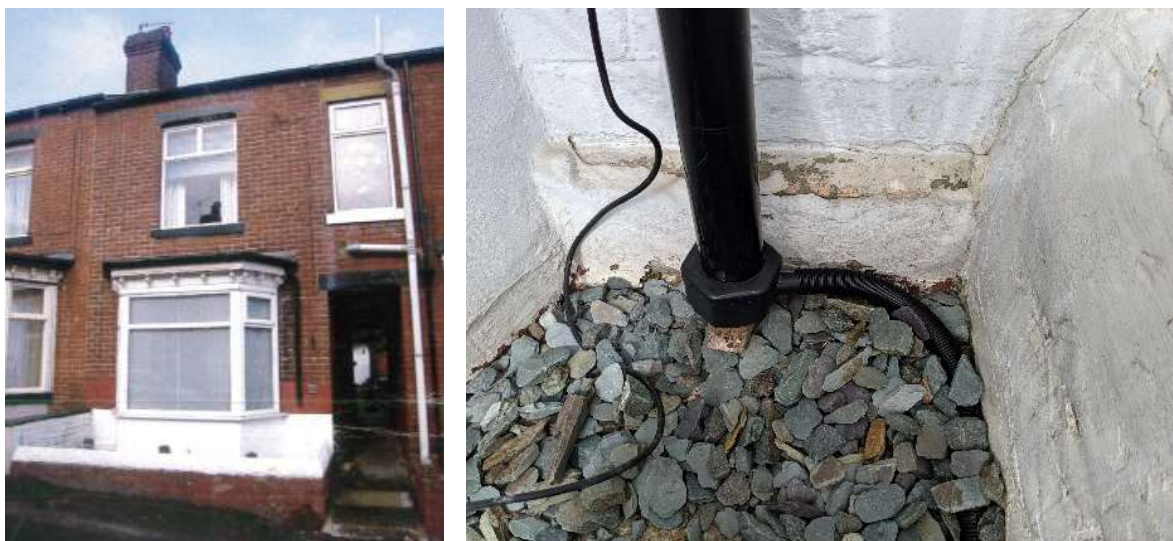
Fig. 19 – Missing bottom section of fall pipe (left) and water butt connection modification to fall pipe (right).

When the property was purchased, the fall pipe for the bay window guttering stopped halfway down the front elevation (Fig. 19) which would have caused penetrating damp to the surrounding area. This defect was addressed by replacing the fall pipe and fitting a ninety-degree elbow at the bottom. Although this stopped the penetrating damp, during heavy rainfall water ponded in the front garden at the bottom of the pipe as there is no drain. This was remedied with the use of a water butt attachment (Fig. 19) which now takes the water from the fall pipe to the drain in the front garden wall.

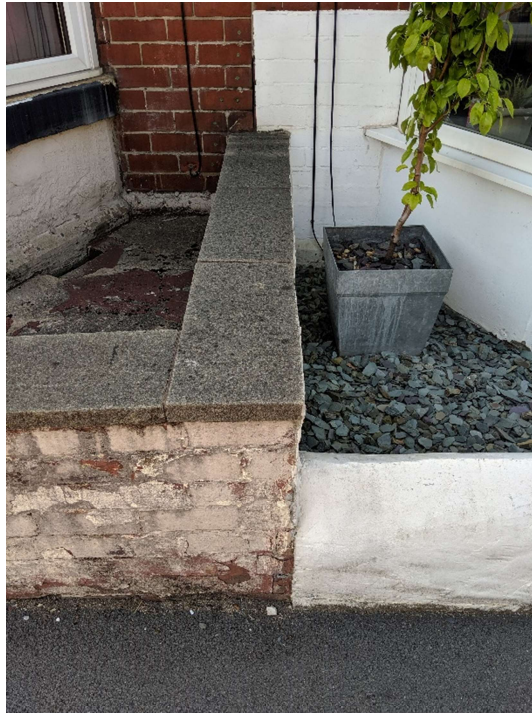
Fig. 20 – The property next to the subject is circa 300mm higher.

The property adjoining the subject property sits approximately 300mm higher (Fig. 20). There is no practical way to address this defect.

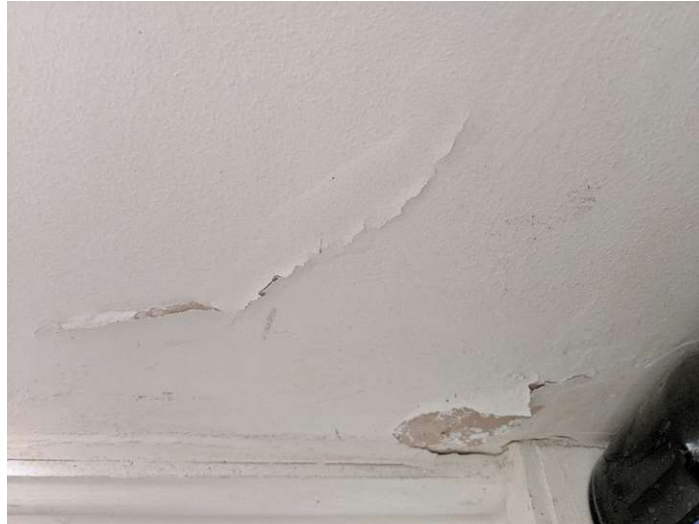
Fig. 21 – Signs of Damp on living room wall.

The specialist recommended a chemical injection DPC together with other works. These were undertaken following the purchase. Around four years ago, signs of damp were noted in the front room (see Fig. 21). The company that undertook the works were contacted to claim under the guarantee. They advised that there would be a reinspection fee for them to re-survey the problem which was not acceptable. As the patches were contained and the damage was not significant, a trial and error process of solving the problem was adopted. The following six defects were found to be causing the damp:

Although the walls appear to have dried out (at this point they have not been tested with a calcium carbide meter), redecoration has not been undertaken, as such some of the signs of damp remain (Fig. 21).

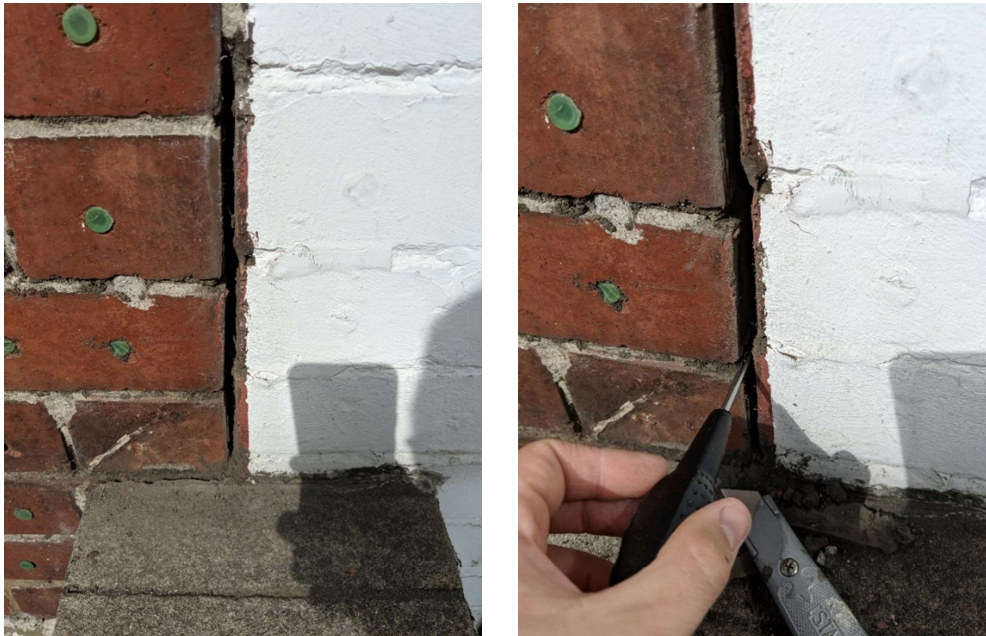
Fig. 22 – Silicone removal to reveal exposed joint.

The silicone from the party wall joint was cut out to leave an exposed mortar joint (Fig. 22). This created a very visible defect that is above an area of peeling paint on the inside wall and as such should be a simple defect to identify.

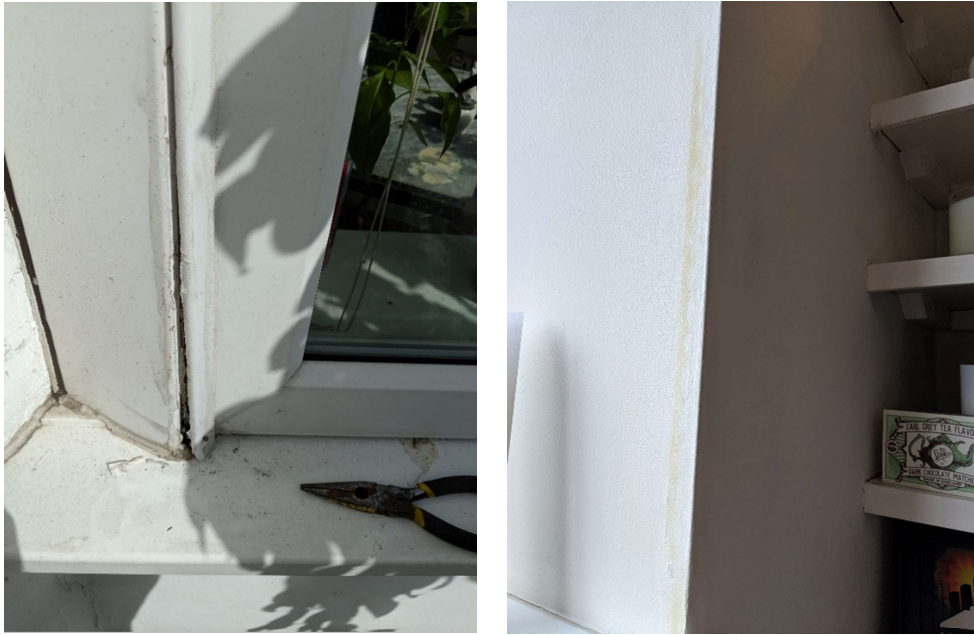
Fig. 23 – The silicone bead sealing the window trim to the frame has been removed to leave the trim loose (left) and brown staining to the finish on the inside of the bay window (right).

The silicone around the uPVC trim was cut out and the trim piece was left loose with a visible gap between this and the frame (Fig. 23). This was harder to identify from further away, but it is directly in front of the area of brown staining on the inside of the bay window (Fig. 23).

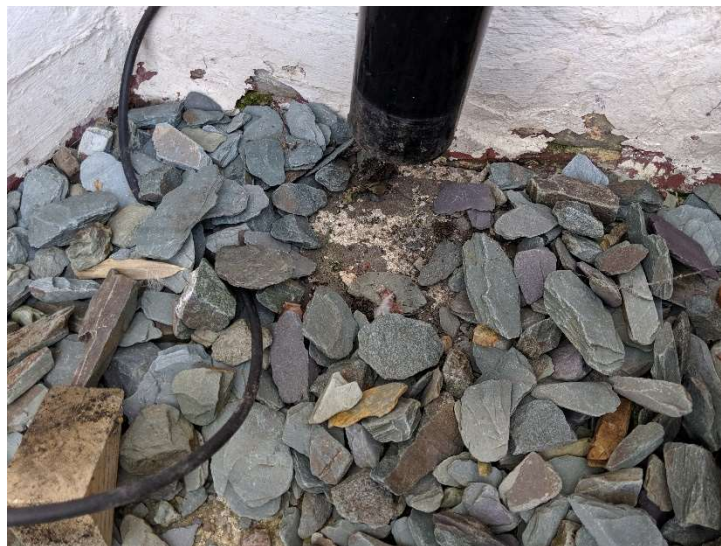
Fig. 24 – Fall pipe with water butt connector removed.

The water butt connector was removed from the bottom of the fall pipe so that it was easy to see that it discharged at the foot of the wall (Fig. 24).

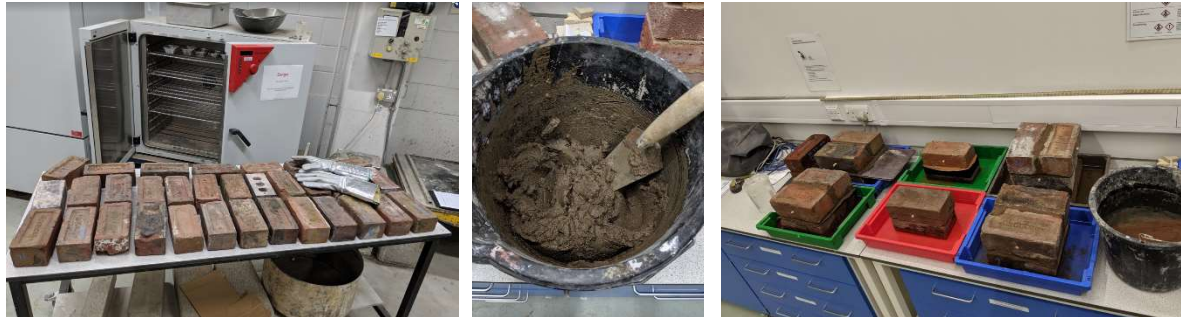
Fig. 25 – The testing process.

In his book, *The Rising Damp Myth*, Howell attempted to recreate rising damp in a lab at Southbank University but was unsuccessful. In order to observe first-hand how bricks behave, a number of experiments were undertaken at SHU (Fig. 25).

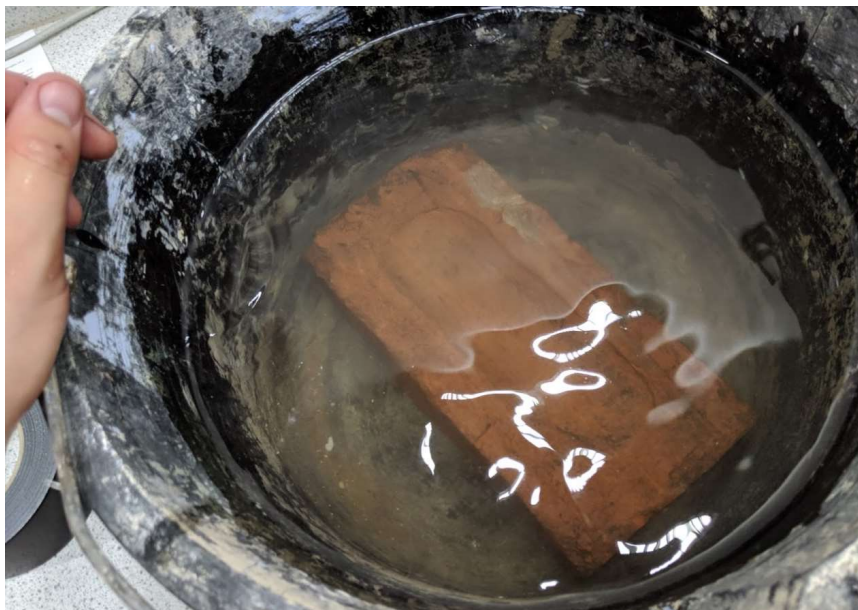
Fig. 27– Submersion testing.

Brick 29 was used. When the brick went into the water (Fig. 27), it weighed 3,357 grams. This test will show how much water the brick can absorb and will mimic the situation found in areas where foundations are submerged in a high water table, potentially causing moisture to rise.

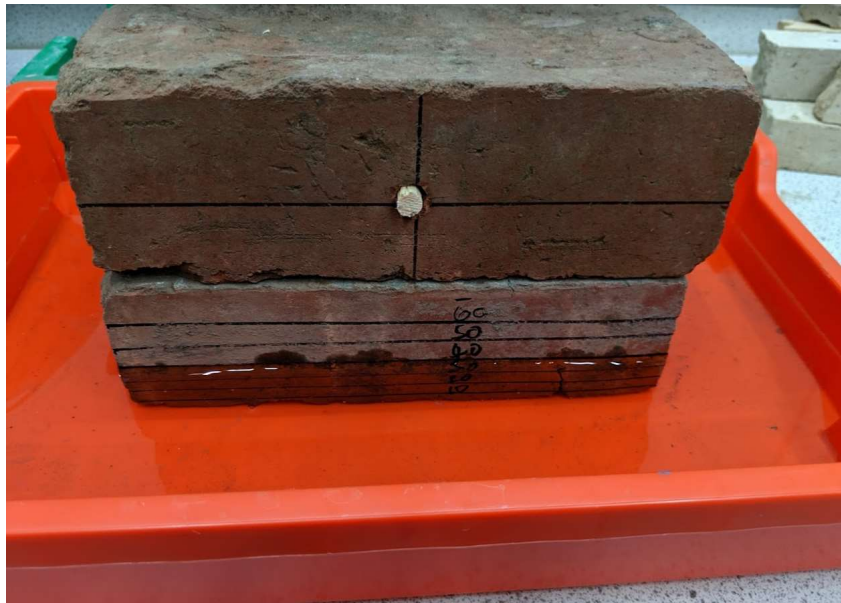
Fig. 28 – Brick on Brick test.

Bricks 3 and 24 were used. A hole was drilled in the centre of 24, and a wooden dowel inserted then 24 was put on 3 (Fig. 28). For this experiment, the bricks with the two flattest tops/bottoms were chosen to give the best chance of seeing moisture transfer. Note that the bricks do not sit flush on each other and as such moisture may evaporate. This is how damp was controlled in some older (medieval) stone buildings.

The results for this test (Table 8 and Fig. 61) were as expected: the bottom brick absorbed around 194g of water whilst the top brick did not absorb any. Despite the two flattest bricks being chosen, the gaps where they did not sit flush allowed the bricks to breathe and no moisture transfer occurred. This is difficult to apply to a real-life situation as you would not be able to build a stable structure with bricks of this size without using mortar.

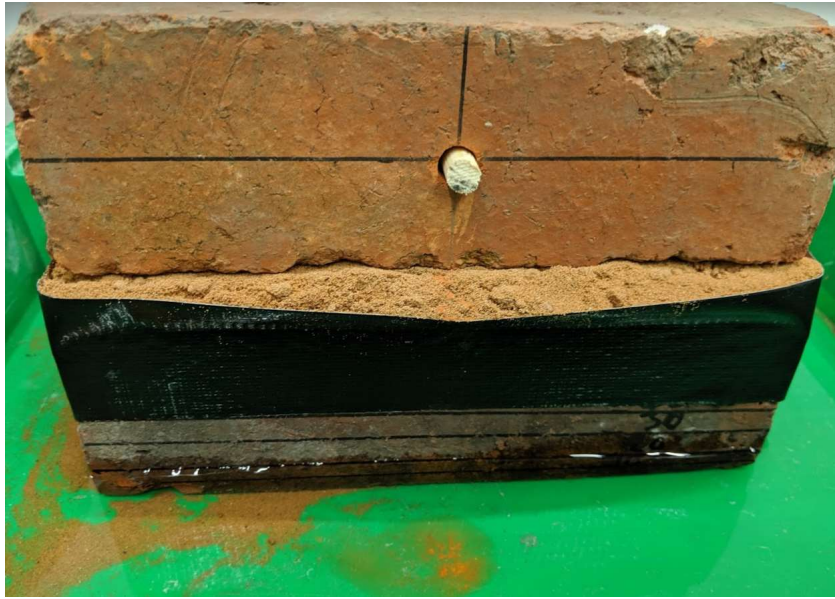
Fig. 29 – Brick on Sand test.

Bricks 8 and 23 were used. A strip of cloth tape was placed near the top of 23 with a lip of 10mm sticking over the top. Sand was packed on top of the brick to level with the top of the tape, and then 8 was placed on top of the sand (Fig. 29). These bricks were chosen as 23 is the largest and 8 the smallest meaning that 8 could sit on top of the sand without being in contact with the tape so any moisture in 8 would have tracked through the sand as opposed to the tape. In his experiments, Howell was unable to get moisture to transfer between bricks and suggested this was because the cement in the mortar made the mortar impervious to water. By removing cement from the mix, I expect to be able to get moisture to transfer through the sand from the base brick to the top brick.

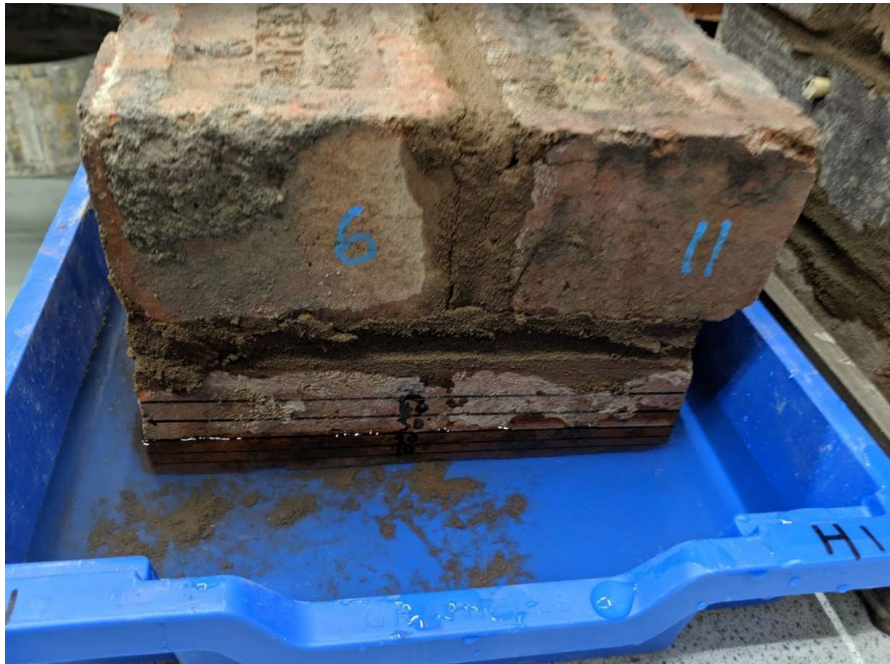
Fig. 29 – Brick on Mortar test.

Bricks 2, 6, 11 and 22 were used to build a larger pillar (Fig. 29) that is more representative of a traditionally constructed solid wall house constructed without a DPC. If Howell's theory is correct, the cement content of the mortar should stop moisture transfer from the submerged base to the top bricks. If the damp-proof specialist's theory is correct, moisture will wick up the pillar via capillary action.

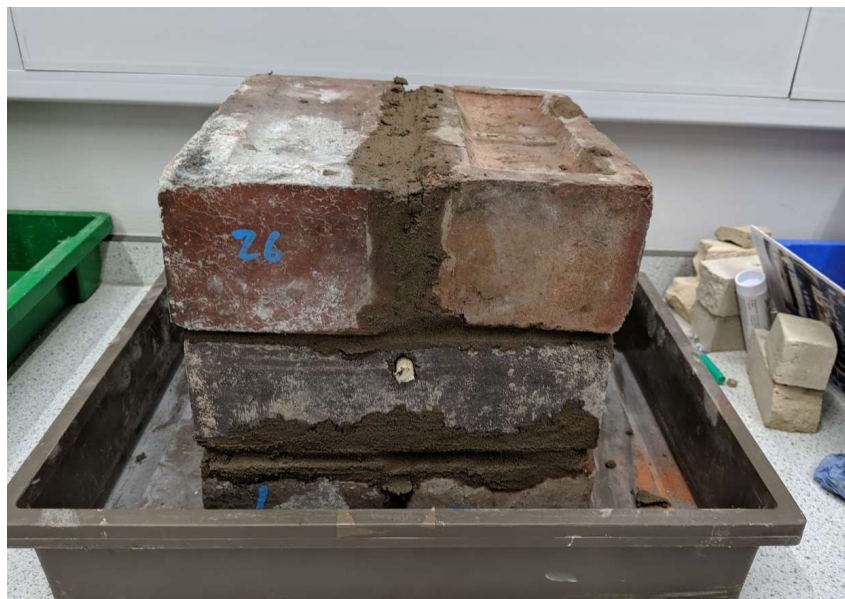
Fig. 31– Engineering Brick test.

Bricks 4 and 12 were used as the base with 16 and 17 being the engineering bricks, and 7 and 26 formed the top (Fig. 31). Engineering bricks are used as a physical DPC as their dense clay and high firing temperature make them impervious to water (water absorption less than 7% (<https://www.wienerberger.co.uk>)). Having observed a house on Eastwood Road, Sheffield with four layers of engineering bricks and chemical DPC above (Fig. 32), it was thought worthy of investigation as to their reliability. These bricks are an established physical DPC method, and no research dismissing using them for this purpose has been found.

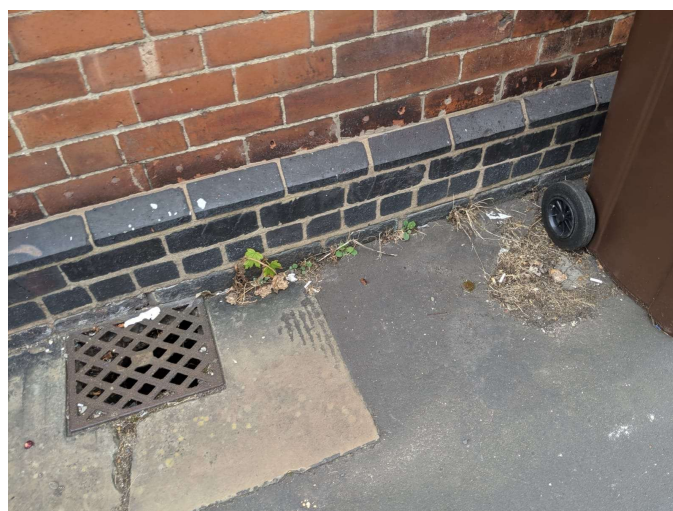
Fig. 32 – House on Eastwood Road, Sheffield where a chemical injection DPC sits above 4 courses of engineering bricks.

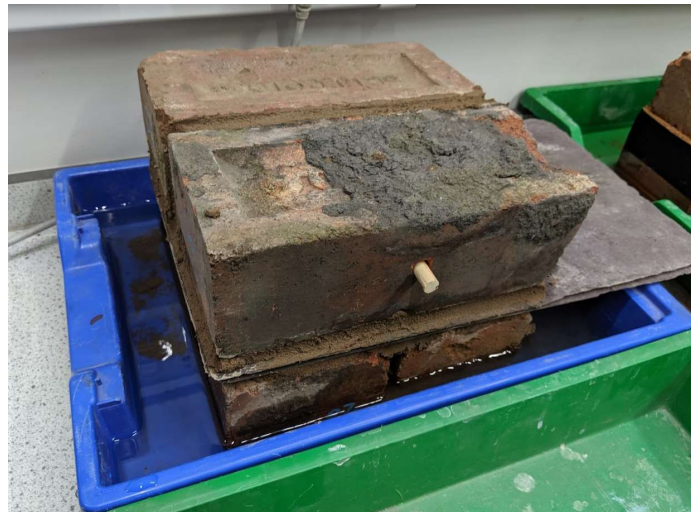
Fig. 33 – Slate test.

Bricks 20, 30, 31 and 32 were used. Although the majority of information suggests that slate DPC's do not suffer degradation, information from the damp specialists' state that slates crack, delaminate and degrade over time and properties with them need a chemical DPC. To see if that can be proved, a double layer of slates that are c. 50 years old has been used (Fig. 33).

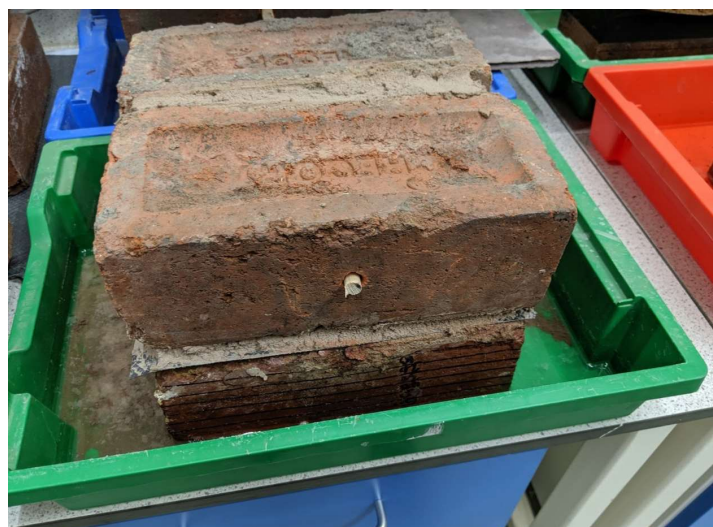
Fig. 34 – DPC test.

Bricks 25 and 28 were used to test a modern Low-density Polyethylene DPC. It is expected that no moisture will penetrate through this.

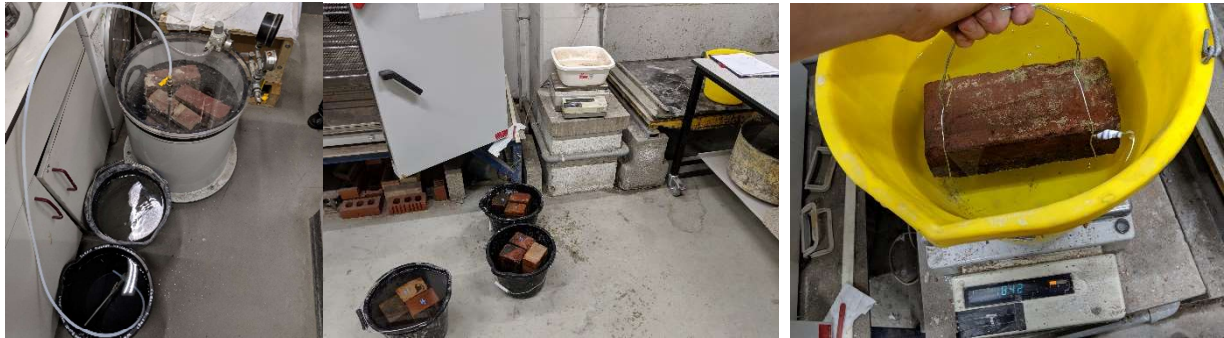
Fig. 35 – Testing process.

Bricks 5, 9, 10, 13, 14, 21 and 27 were used. Testing was undertaken so that an accurate moisture reading of the brick could be taken and then directly compared to readings taken by an electronic moisture meter to see if the results were comparable (Fig 35).

Bricks were collected, cleaned, dried out and weighed as detailed above. Buckets of de-ionised water were prepared, and the bricks placed in the vacuum chamber. Bricks were left in the vacuum chamber for one hour. Water was then pulled through to flood the chamber.

A carrier was made from wire so that the bricks could be held on the surface of the water and then submerged. This enabled suspended and saturated weights to be taken to complete the calculations. Once the bricks had been weighed, a Protimeter was used to take moisture readings. The results will be analysed in section 4.

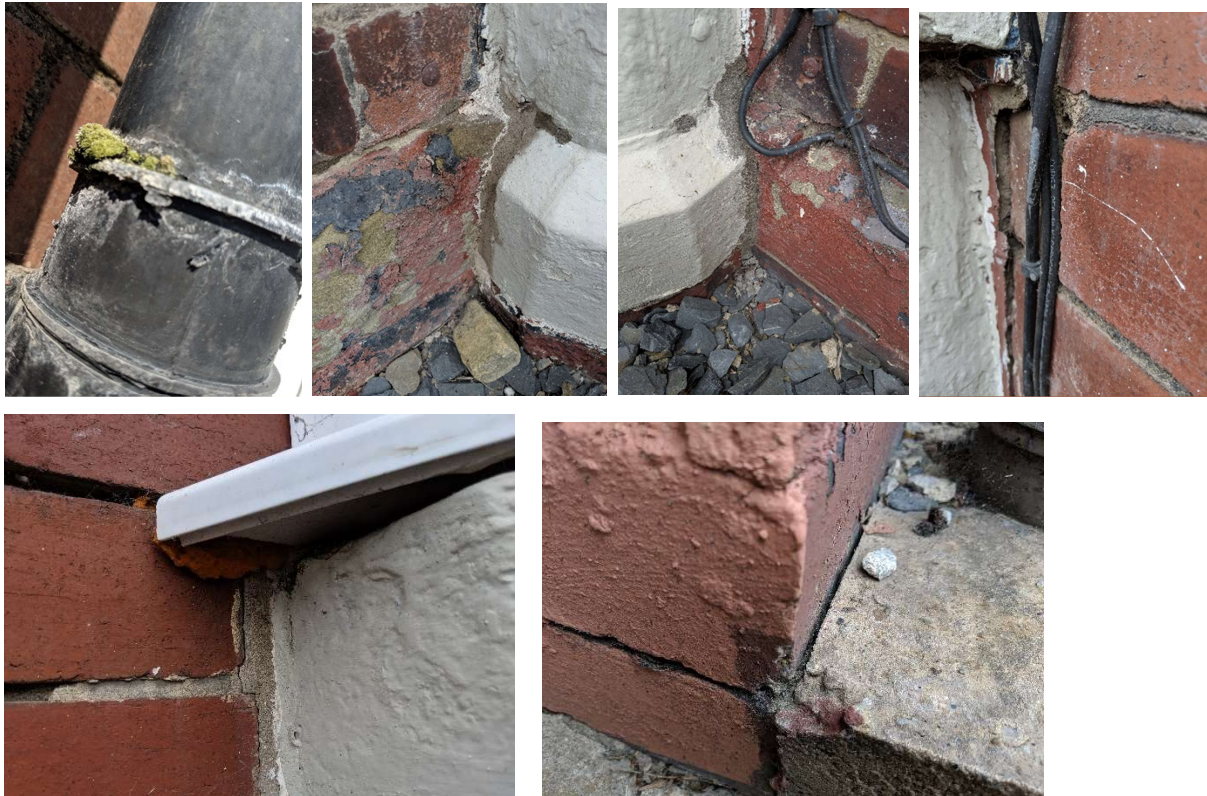
Fig. 49 – Case Study One Defects.

Case Study One - Defects to Consider	
One	Fall pipe is leaking around a joint. Evident this has been ongoing for some time as moss has formed.
Two	Bay window has no guttering. Rain water falls backwards towards the front elevation and runs off the LHS and RHS of the roof.
Three	Where the edges of the window sill meet the front elevation, the gap is filled with expanding foam where it should be detailed in silicone. This is allowing water to get behind the frame as opposed to off the front of the sill.
Four	Pointing had been washed away where the lower stone sill meets the front elevation on both the LHS and RHS. I suspect this was caused by the rain water coming off the bay roof, hitting the floor and bouncing back up. These areas were repointed by the specialist when they installed the DPC.
Five	The lower section of the bay window is coming away from the front elevation on the RHS. This is taking the pointing with it and leaving a gap for moisture to enter.

Six	The slab that has been cast in the front garden has a gap where it meets the front elevation. It is likely that water from the leaking fall pipe is getting down this gap from where it cannot escape.

The homeowner advised in the interview that the internal damp patch got worse during periods of heavy rain. The above defects (Table 5 and Fig. 49) would allow water penetration in the affected areas during periods of heavy rain. None of these defects were noted in the report prepared by the specialist and if these repairs had been undertaken, the new chemical DPC may not have been necessary.

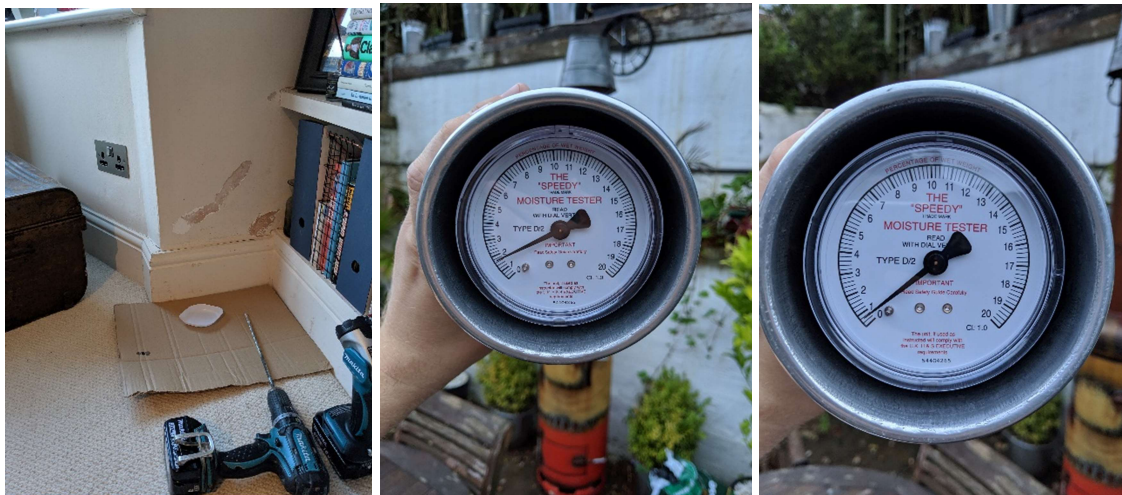
Fig. 58 – Carbide Testing

To establish if there was any need for these treatments, the wall was carbide tested to see if it was damp.

When tested, the lower area of the wall recorded 1.7% moisture content. A second sample was taken at 1500mm which recorded 0.3% moisture content.

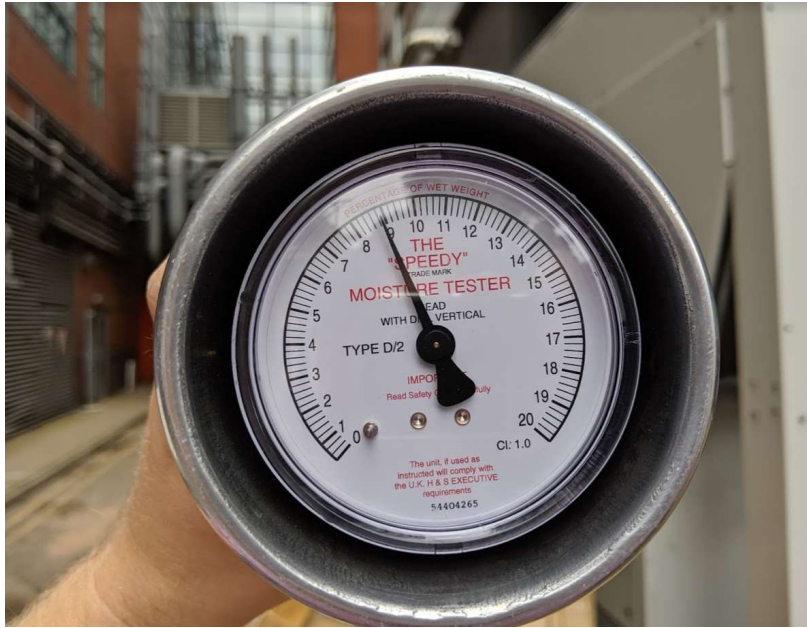
Fig. 60 – Carbide Test – Submersion.

After 45 hours in the oven, the brick weighed 3,357g. After being submerged for six weeks, the brick was removed from the bucket and it weighed 3,116g which represents a loss of 241g. This experiment did not go as intended. It was expected that the brick would be heavier as the dried out porous clay took on moisture. The only explanation that can be offered is that the scales were incorrect and as the readings were not compared until the experiments had been dismantled this was not picked up on until it was too late. Unfortunately, therefore, this part of the experiment has yielded a null result.

Carbide testing (Fig. 5) gave a moisture content of 8.9% which is considered to be on the verge of concern by the BRE. A value of 8.9% equates to 277.5 grams of moisture and is on the lower side of what was expected based on the porosity testing undertaken previously which gave readings for similar bricks of between 8.49% and 26.05%. The figure may have increased over a longer test period.

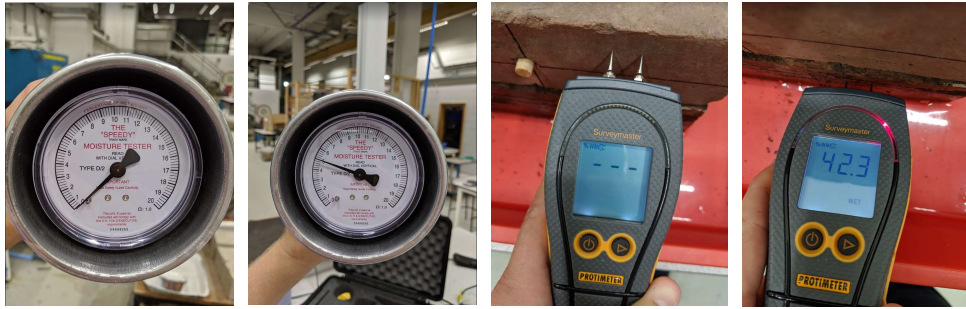
Fig. 61– Brick on Brick.

Brick on Brick		
	Protimeter	Carbide
Top	DNR	0%
Bottom	42.3	5%

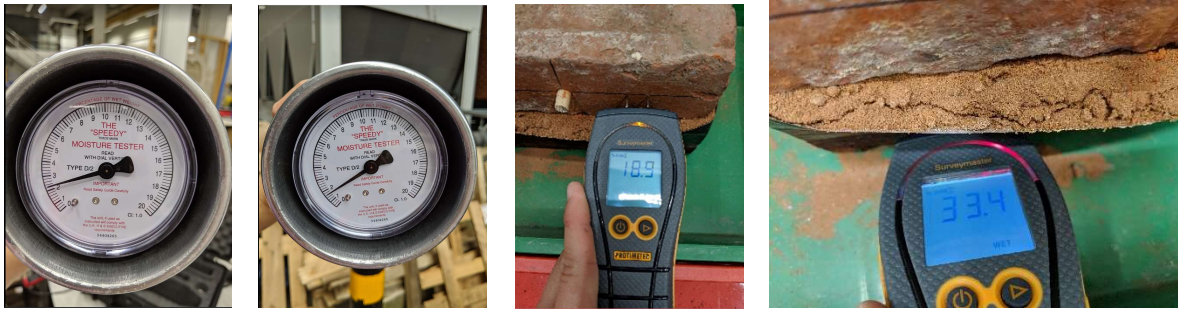
Fig. 62 – Brick on Sand.

The top and bottom brick were tested with a Protimeter and carbide tester. The results are shown in Table 9 and Fig. 62.

Brick on Sand		
	Protimeter	Carbide
Top	18.9%	1.6%
Bottom	33.4%	2.2%
Sand - Edge	20.8%	n/a
Sand - Centre	30.8%	n/a
Dowel	20.0%	n/a

The results of this experiment and the next (section 4.3.4) support Howell’s theory that the cement content in mortar makes it impermeable to moisture. Whilst a significant amount of moisture did not track up through the top brick, the sand was taking on a lot of water, so much so that in the last week of testing all the water from the tray was absorbed (this accounts for the top brick having a higher moisture content than the bottom one and is a lesson learned if this was to be done again).

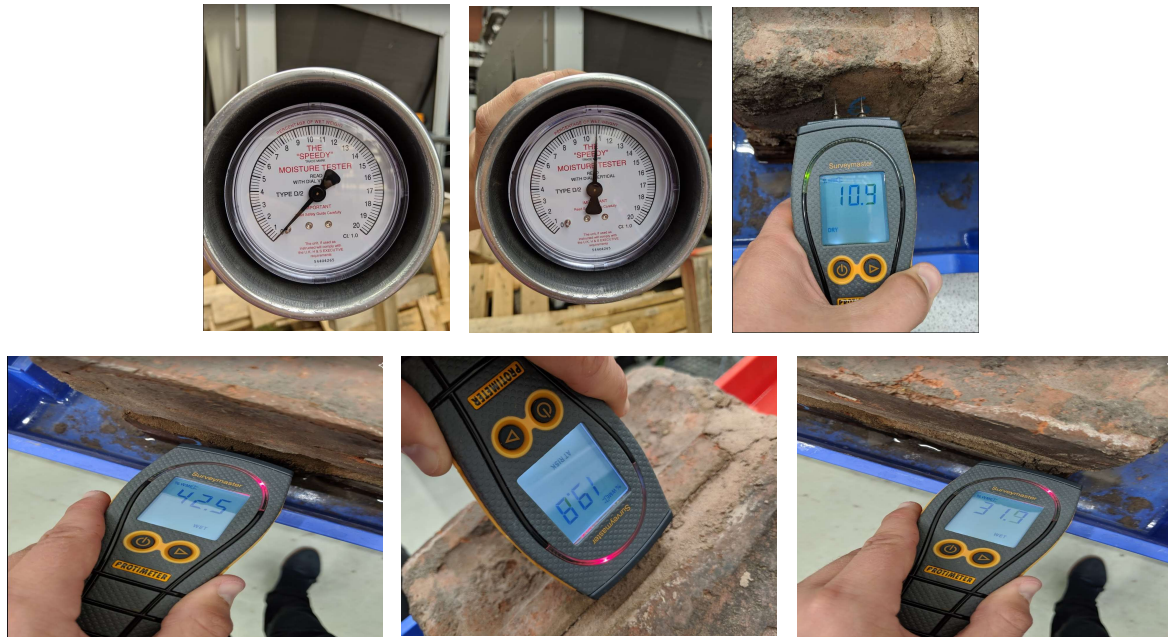
Fig. 63 – Brick on Mortar.

The top and bottom brick were tested with a Protimeter and carbide tester, with the results shown in Table 10 and Fig. 63.

Brick on Mortar		
	Protimeter	Carbide
Top	10.9%	0.2%
Bottom	31.9%	10.8%
Mortar		
Course 1	42.5%	
Mortar		
Course 2	19.8%	
Dowel 1	10.4%	
Dowel 2	11.9%	
Dowel 3	12.8%

The outcome of this experiment is perhaps the most significant. The bottom brick took on a significant amount of moisture, but this did not transfer to the top brick. This replicated the results in Howell’s testing but together with the experiment above, goes a step further to prove that the cement in the mortar creates an impervious barrier to moisture.

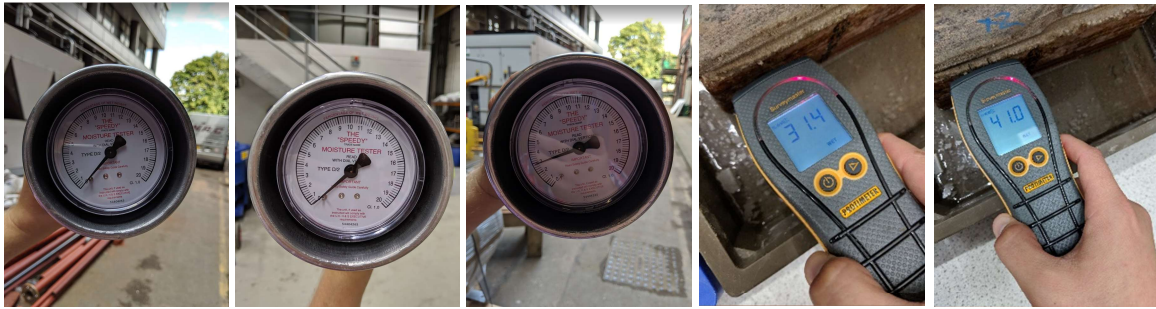
Fig. 64– Engineering Brick

Bricks from the three courses were tested with a Protimeter and carbide tester, with the results shown in Table 11 and Fig. 64.

Engineering Brick		
	Protimeter	Carbide
Top	DNR	0.0%
Centre	DNR	0.0%
	31.4%	3.0%
Bottom		
Mortar	41.0%	n/a
Course 1		
Course 2	16.1%	n/a
Course 3	13.8%	n/a
Dowel 1	29.9%	n/a
Dowel 2	10.8%	n/a
Dowel 3	8.1%	n/a

This experiment went as predicted: moisture from the bottom brick did not travel into the engineering brick or top brick. As such, there should be no need for a chemical DPC to be installed above an engineering course.

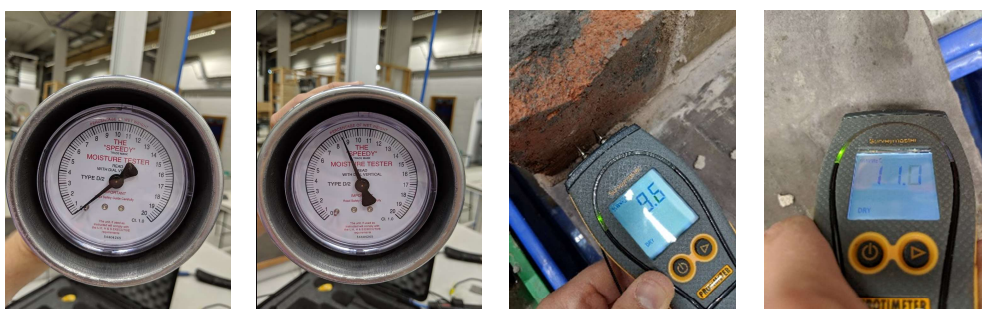
Fig. 65 Slate

The top and bottom brick were tested with a Protimeter and carbide tester. The results are shown in Table 12 and Fig. 65.

Slate		
	Protimeter	Carbide
Top	9.6%	0.0%
Bottom		8.8%
Slate	11.0%	n/a
Mortar		
Course 1	47.4%	n/a
Dowel	8.8%	n/a

The results of this experiment were less predictable: surveyors tend to agree that slates continue to be an effective physical DPC, whereas damp specialists argue that they become ineffective with age. As the results show, the bottom brick took on a significant amount of

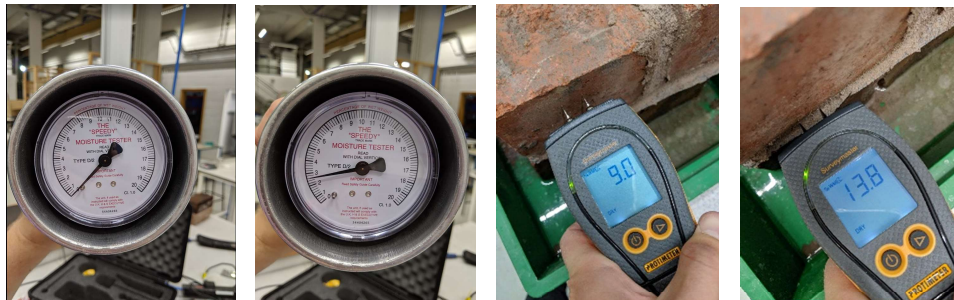
Fig. 66 – DPC.

The top and bottom brick were tested with a Protimeter and carbide tester. The results are shown in Table 13 and Fig. 66.

DPC		
	Protimeter	Carbide
Top	9.0%	0.0%
Bottom	30.8%	2.6%
Mortar		
Course 1	54.6%	n/a
Mortar		
Course 2	13.8%	n/a
Dowel 1	DNR	n/a

This experiment went as expected. The bottom brick absorbed moisture but this did not transfer through the DPC to the top course proving its effectiveness.

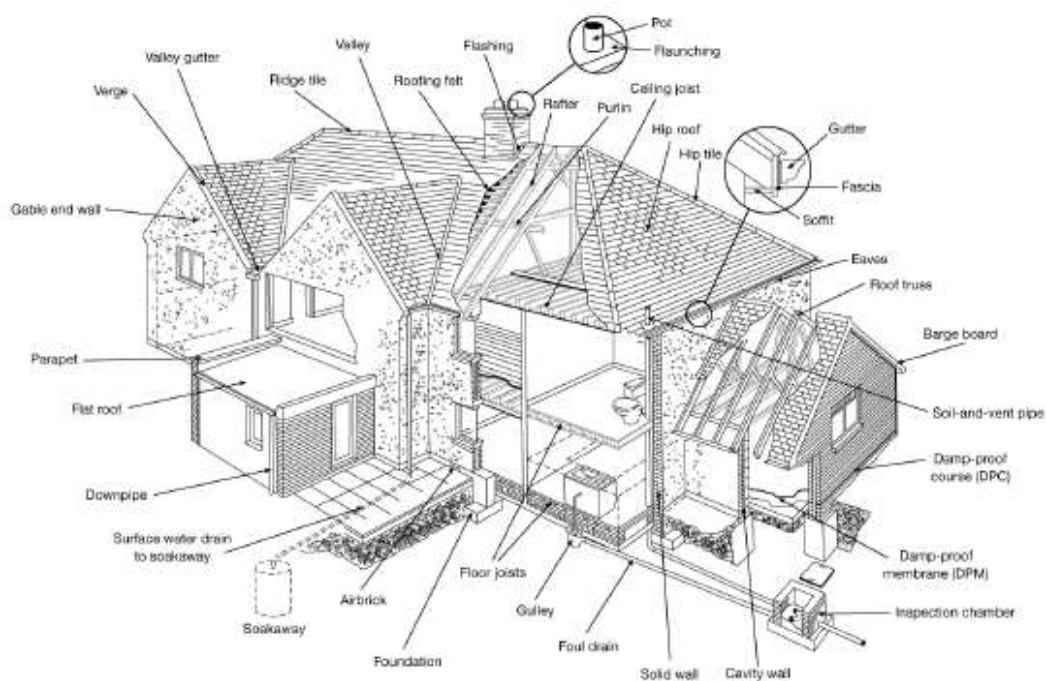
## Typical house diagram

This diagram illustrates where you may find some of the building elements referred to in the report.

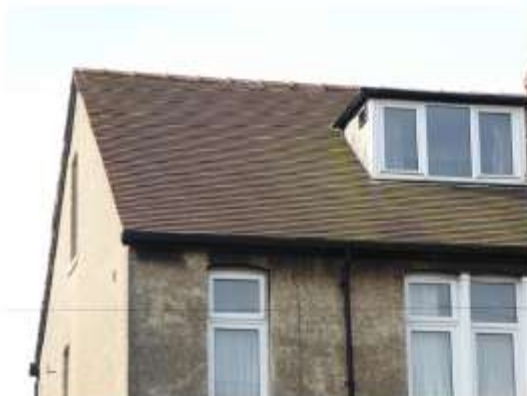
Slipped / missing tiles / dormer

- The roof has a dormer to the front pitch which overlooks the main roof. The leadwork appeared in fair condition and no leaks were visible internally. Medium term we would allow to inspect and budget costs are allowed for the lead replacement.

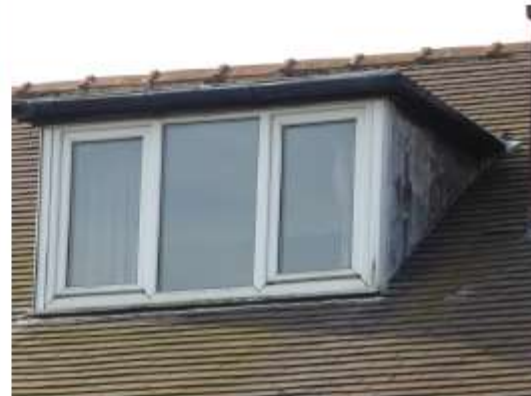
Slipped / missing tiles / dormer

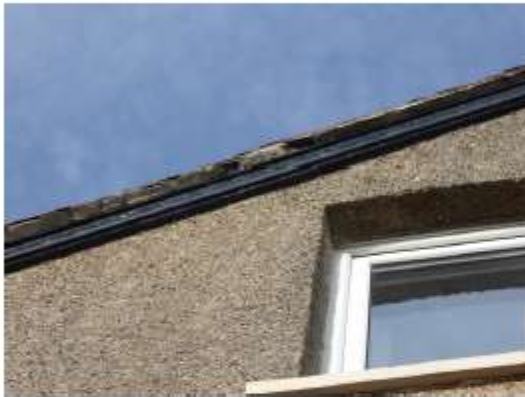
Wet verge

- The overhang projection of the tiles at the verge is inadequate but does not appear to be causing any moisture ingress or saturation of the gable wall.

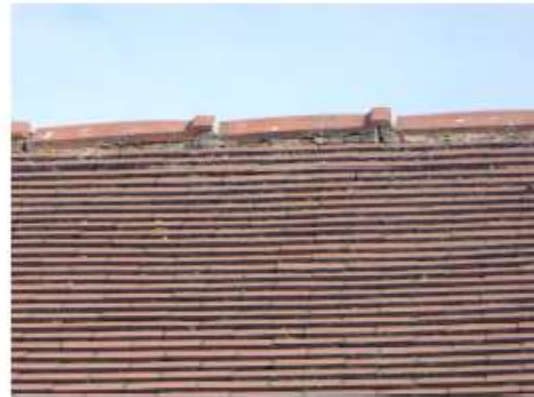
Ridge line

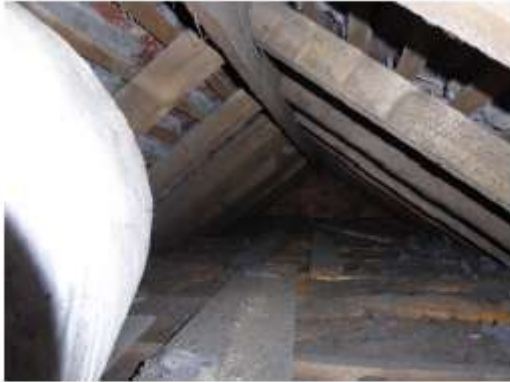
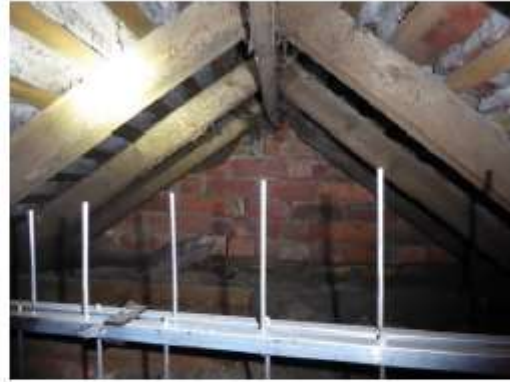
Roof Space

- Repairs have been carried out to the roof with newspaper and felt.
