**Is there confusion within the surveying profession about the  
existence of rising damp and is the correct advice being  
given to homeowners?**

Submitted in partial fulfilment of the requirements for the degree of MSc Building Surveying at  
Sheffield Hallam University

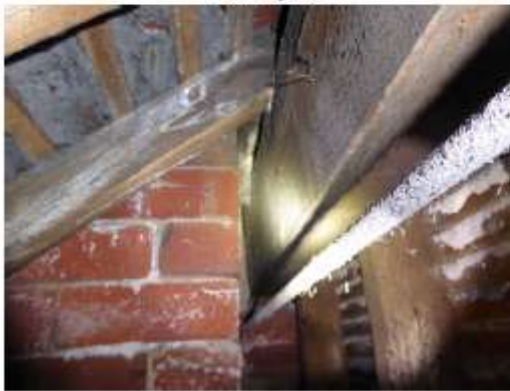
Salts around chimney breast

- Salts were noted internally on the stack as noted above. There was minor staining noted on the chimney breasts; this is likely to be as a result of condensation. Masonry in and around chimneys can be contaminated with salts from the burning of fossil fuels. Soot deposits on the inside of chimney flues contain salts, which, if they get wet because of condensation and lack of ventilation (caused by fireplaces being blocked up, restricted or altered) will form on the surface of the masonry. These salt deposits are hygroscopic, which means they will absorb moisture from the internal environment; once internal relative humidity exceeds 80% the salts will absorb the moisture in the air and become damp, staining the decorative finishes.

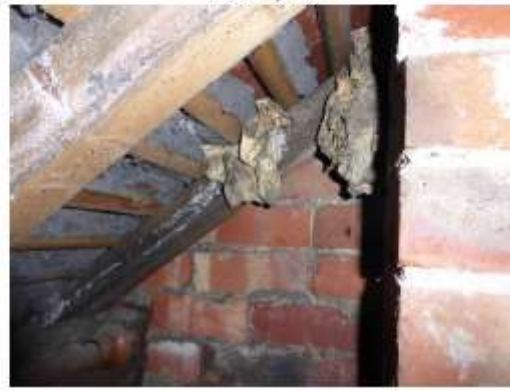
Salts and staining to timbers and repairs

- Repairs have been carried out to the roof with newspaper and felt.

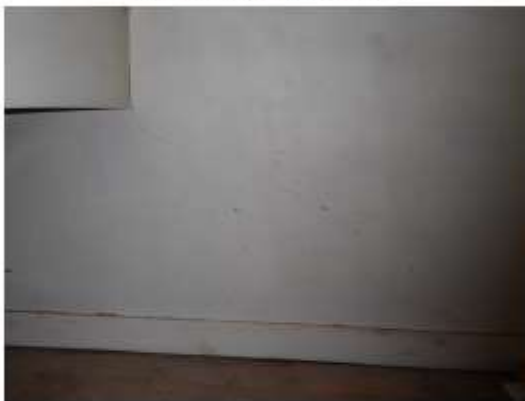
Cracking below purlins

- There is minor cracking around the purlins which are placed in the gable wall. It is difficult to inspect externally due to the render. These do span to the ceiling of the 1<sup>st</sup> floor. There were no signs of failure or signs of progressive movement at the time of our inspection and the decoration was dated.

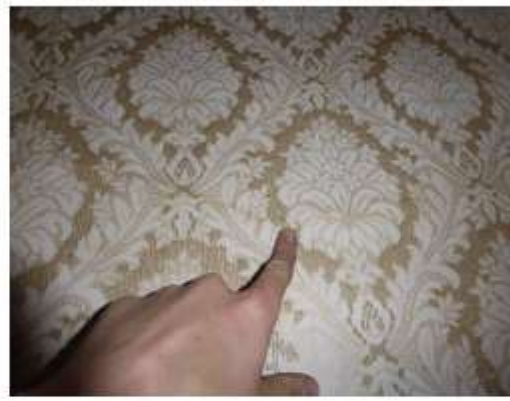
Crack going down the stairs

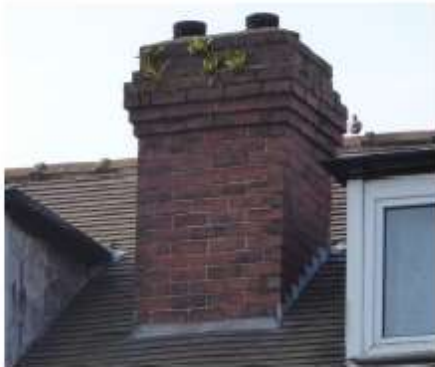
Front chimney stack – vegetation / loose pointing / dated leadwork

- The majority of the lead flashing was in fair condition, to the rear sections of the leadwork were had become loose which could result in moisture ingress.

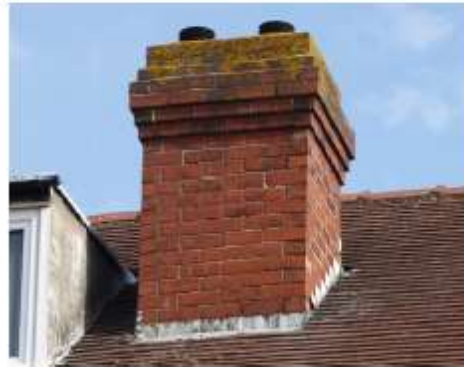
Rear chimney stack – lichen / loose pointing / dated and loose leadwork

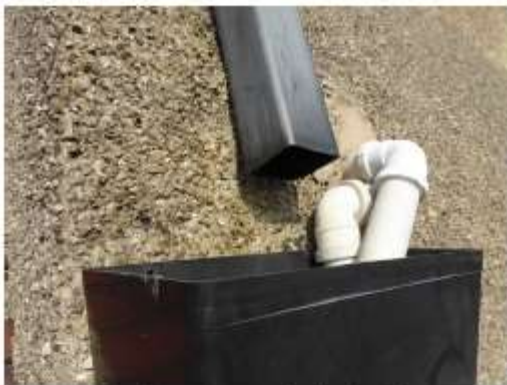
Downpipe not correctly discharging

- The right-hand side downpipe does not discharge into the hopper correctly and it is evident that water splashes on to the render.
- The plaster gutter and downpipes are stained in places
- The gullies are littered with debris and to the rear various pipes discharge into the gully.
- Cement from the ridge has fallen into the gutters and will be restricting the flow of water.
- Cement is also visible within the downpipe.
- Two manhole covers were lifted and the clay drains appeared to be in working order as they were clear of debris.
- To the rear it was evident that there had previously been structural movement around the door. There is a manhole within close proximity but the manhole could not be lifted.

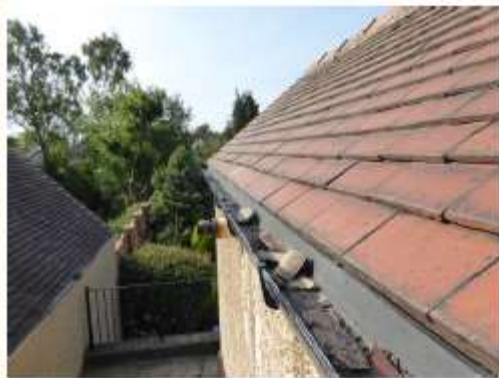
Gutter full of debris

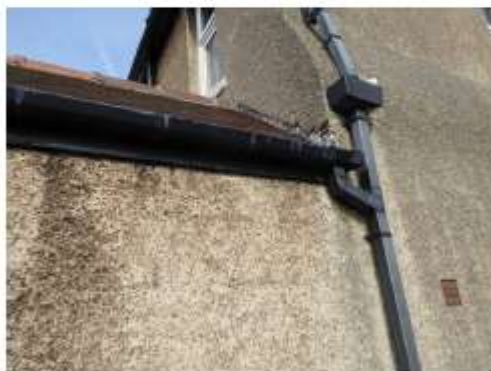
Staining to render

It is evident that there has been leaks from previous guttering as there was staining on the render. This should be reviewed when it rains. Several issues are listed below:

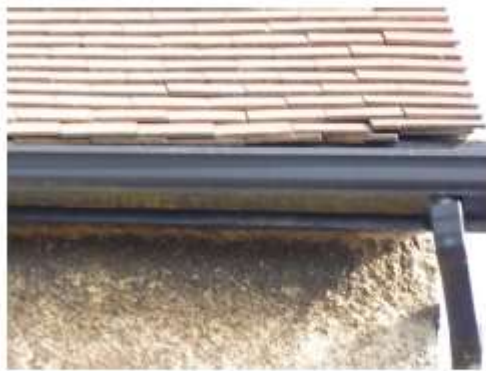
Square downpipe connecting into round gutter

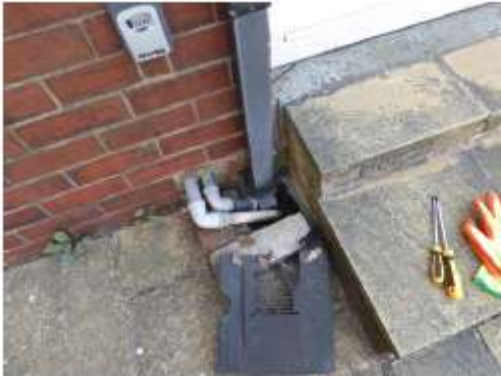
Blocked gully

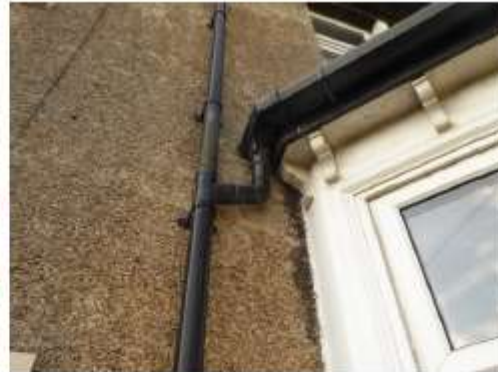
Staining to downpipe

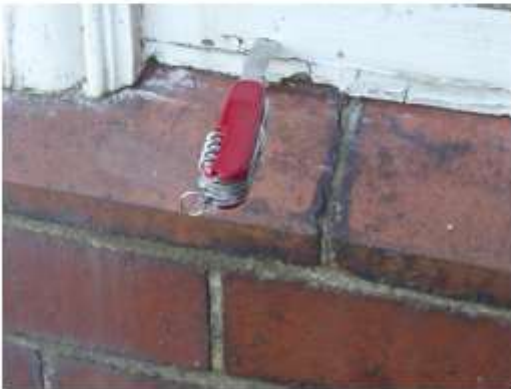
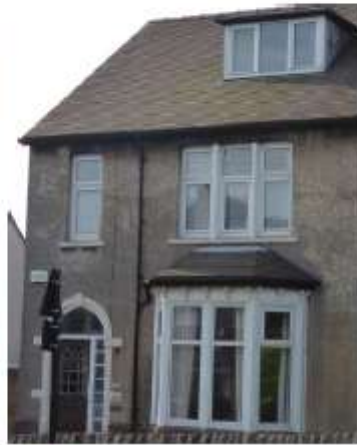
Decay to timbers and UPVC windows

The front door is timber the timber frame has decayed and the door is dated.

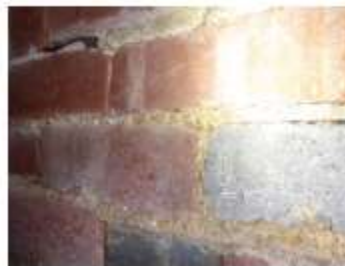
Softer mortar than cement – white flecks visible likely to be un-slaked lime

The external walls to the house are of a cavity construction. The walls are covered with a cementitious pebbledash render. The full mix of the mortar which the property was built with could not be fully determined without further analysis. Internally there was evidence to suggest the walls were built with a mortar containing lime and given the age of the building the breathability principals would apply. [Link to Energy Efficiency in Historic Building – Early Cavity Walls](#)

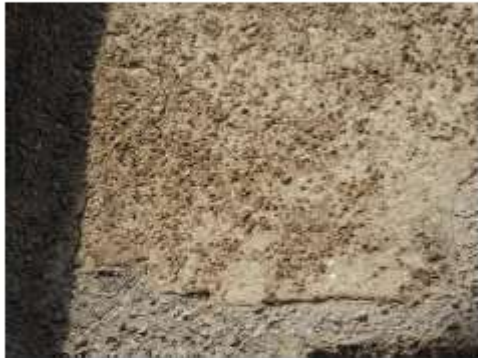
Cracks around the joints were repairs have been undertaken

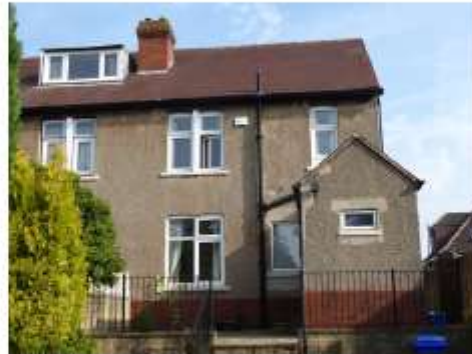
Areas of repairs and Staining

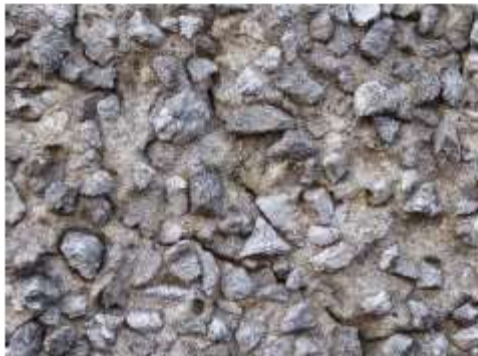
Example of cracks to render

We are not ruling out cavity wall tie failure. This is where the wall ties have become dirty or covered in mortar dripping during construction. This then results in moisture penetrating into the building and causes corrosion which causes the tie to fail. Normally the wall will crack at regular intervals and bulging would be present. Although cracking was noted the render restricted a further inspection but no bulging

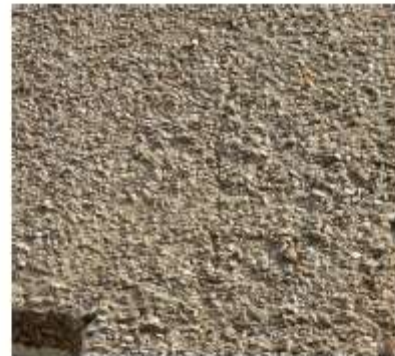
Cracks above window head

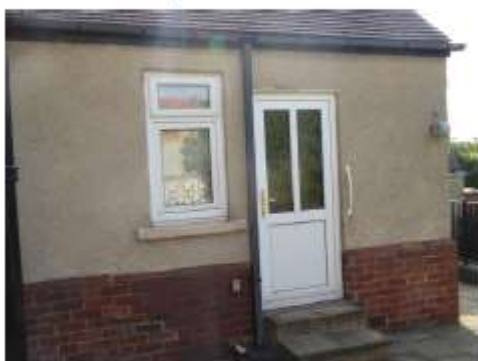
Section of rebuilding and new render which has a vertical crack

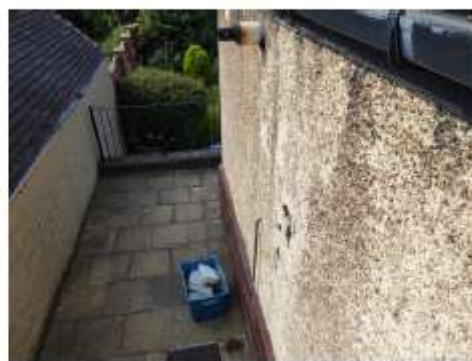
Worn render to extension

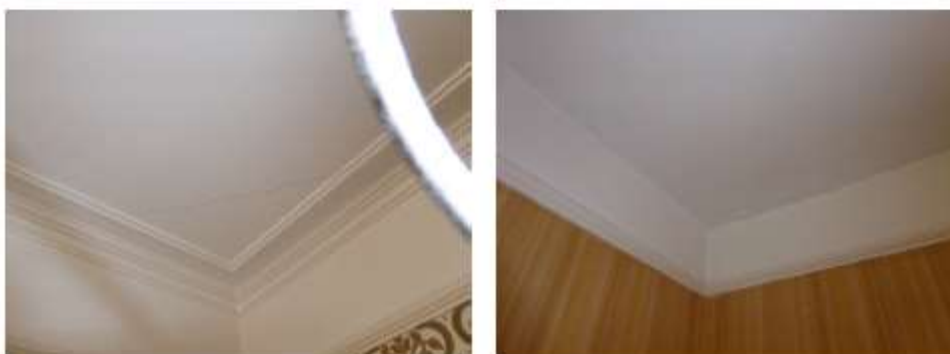
Example of cracks to ceiling

Lath and plaster ceilings will crack due to movement; there was limited evidence to suggest that any of the cracks were as a result of a serious defect.

The original in-situ coving is present there is also cracking visible which will be rectified when the re-decoration works are undertaken.

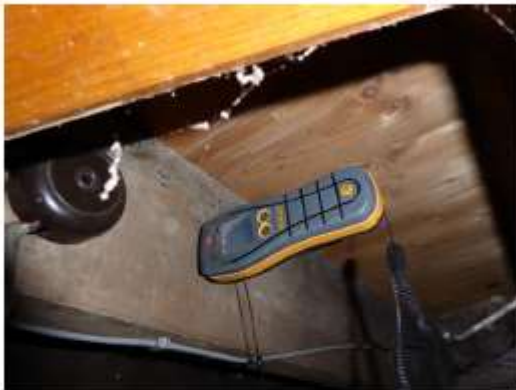
Moisture meter showing high readings

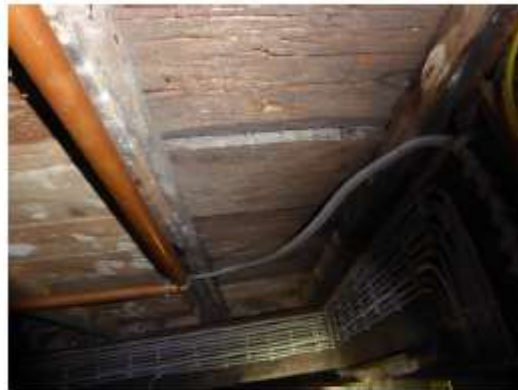
Decay to timber floor under porch

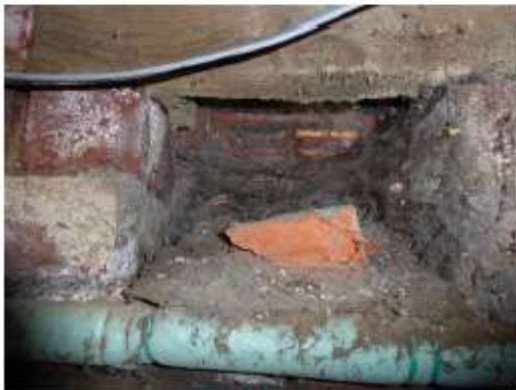
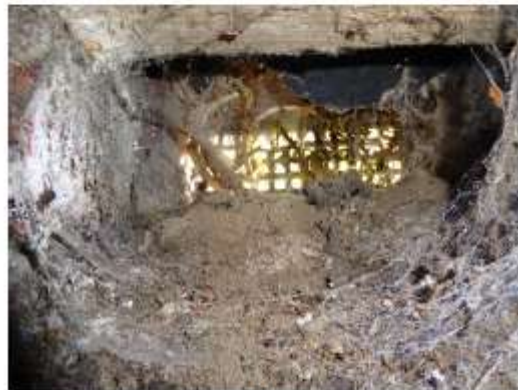
Blocked up air vent

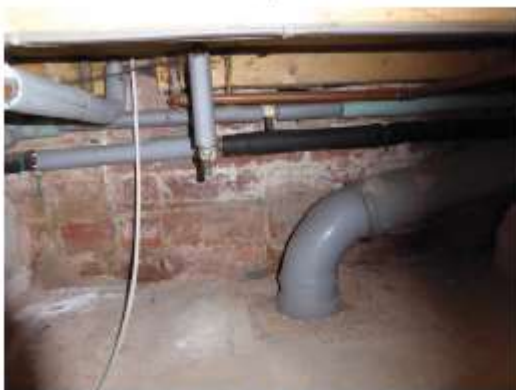
Plastic DPM visible and moisture at the base of the wall

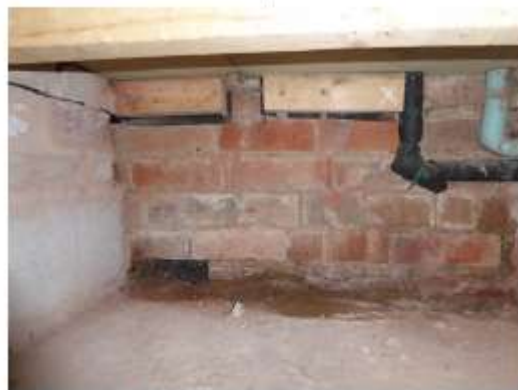
Plastic DPM visible and moisture at the base of the wall

Internally there is no visible evidence of internal damp with the exception of the toilet in the extension. Humidity levels were recorded and there was no evidence to suggest any issues. We did note the ground levels have bridged the sub-floor vents in places especially to the rear. In these types of property, it is common for the cavities to become blocked with debris resulting in a bridge allowing moisture to penetrate into the internal leaf.

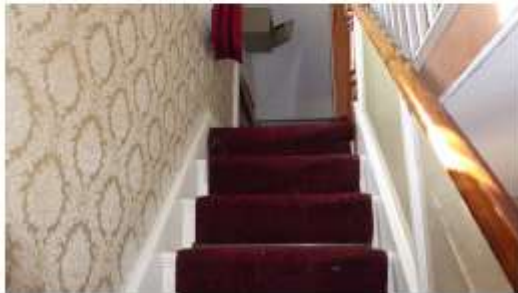
Staircase with glass panelling

The glass to the staircase leading up to the roof space is dangerous and should be replaced and strengthened with timber.

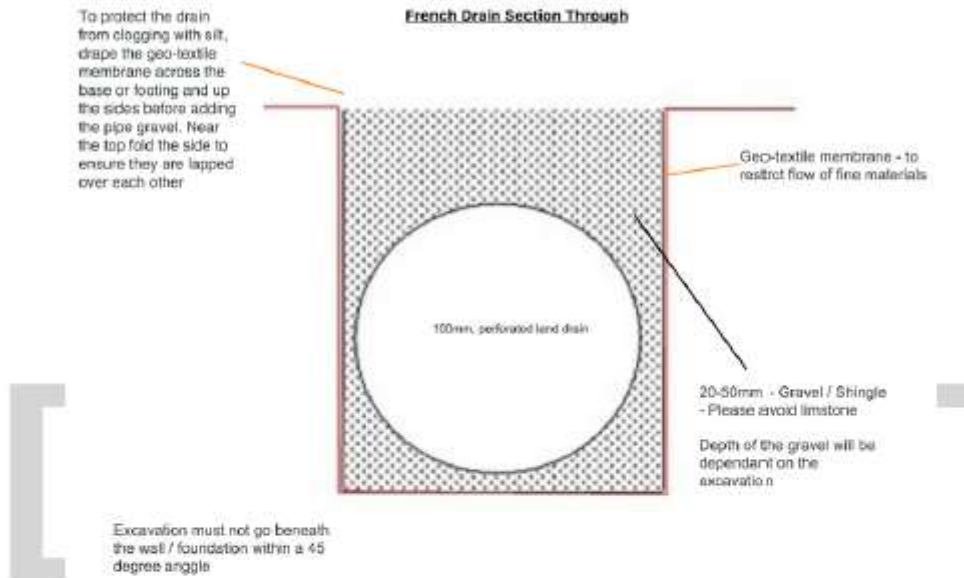
To install a French drain below the DPC, this will enable water to drain away from the property. Some key points and a section through are detailed below:

1. The drain must have a "fall" around 6mm per metre
2. The 100-150mm perforated land drain must discharge into a storm drain as if left to drain within the ground moisture would just build up
3. A French drain will work more efficiently within a clay soil trench as if the ground is loose fill the water would just seep through the drain saturating the surrounding ground and walls

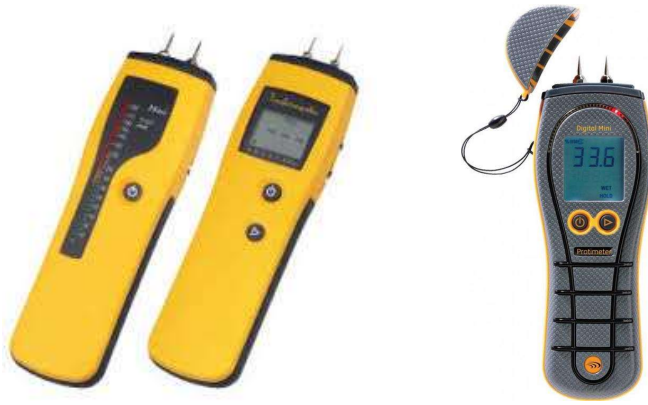
14. The report advises that the visual evidence was confirmed by moisture meter readings. Did you see what sort of meter was used? Can you recall if it looked like this (picture of a Protimeter Surveymaster moisture meter)?

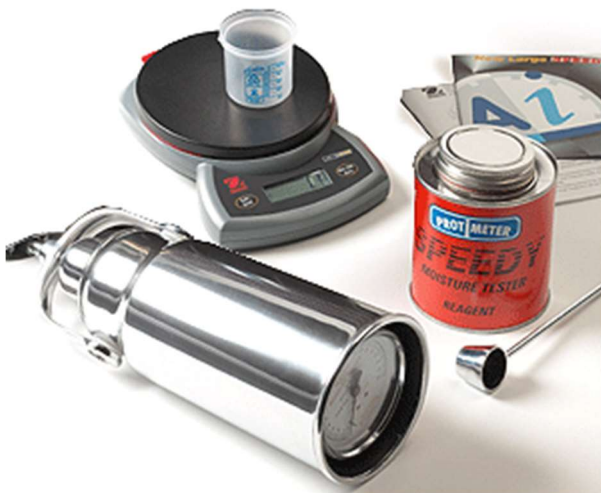
Or this (Protimeter Speedy carbide meter) If it was this option, the surveyor would have had to have used a drill to take a number of samples of the masonry, weighed them and shaken them up in the flask with calcium carbide). Note that in Page ten of their report \*\*\*\*\* advise that they use a carbide meter to take mortar samples).
